## PHOTOGRAPHS

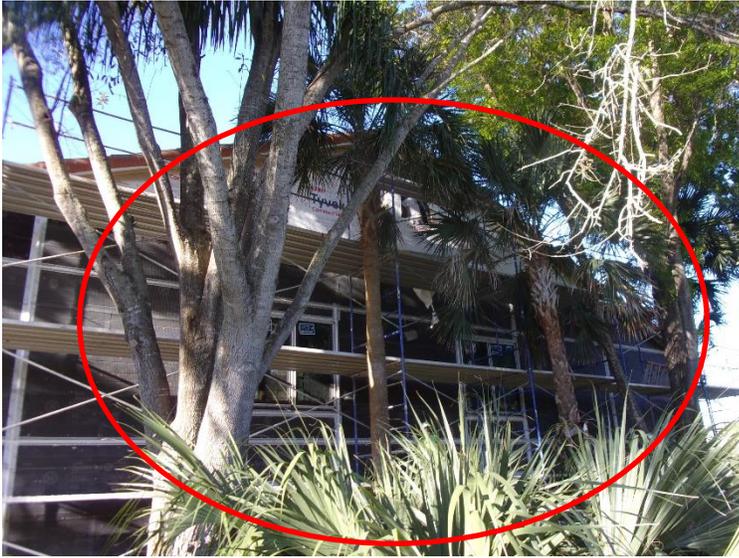
PHOTOGRAPH #1

### BUILDING 1 SECTION H

Stucco sub-contractor installing stucco accessories. New GreenHeck louvers being installed at gable end.

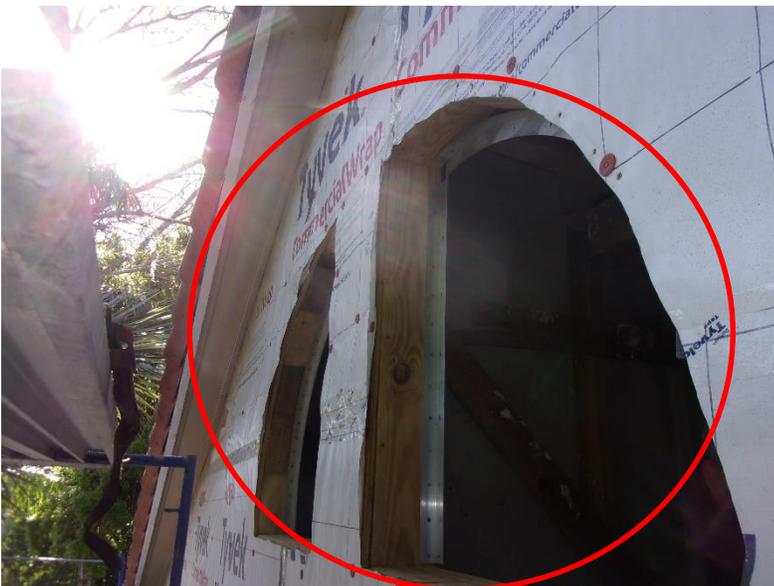
PHOTOGRAPH #2

### BUILDING 1 SECTION H

Contractor preparing opening for installation of new GreenHeck louver.

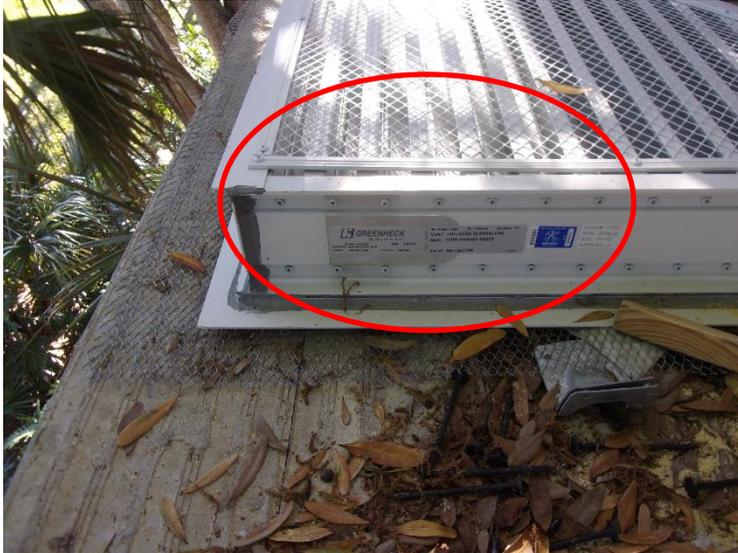
**PHOTOGRAPH #3**

**BUILDING 1  
SECTION H**

Contractor preparing opening for installation of new GreenHeck louver.

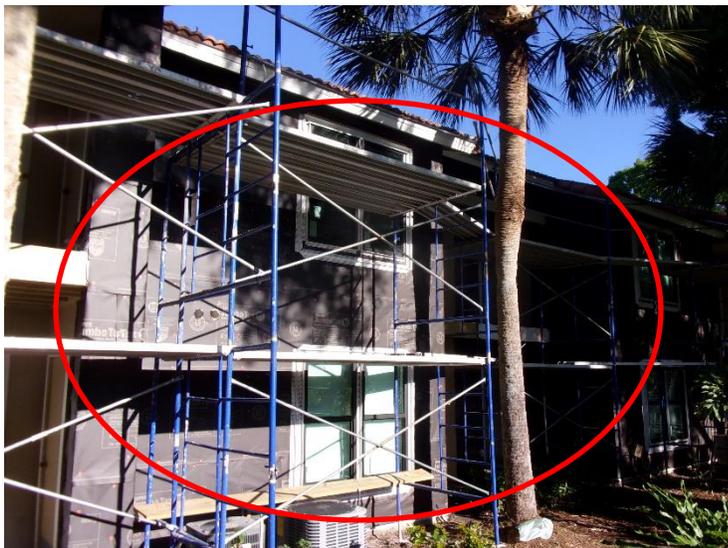
**PHOTOGRAPH #4**

**BUILDING 1  
SECTION F**

Stucco sub-contractor has installed second water resistant barrier and begun installing stucco accessories.

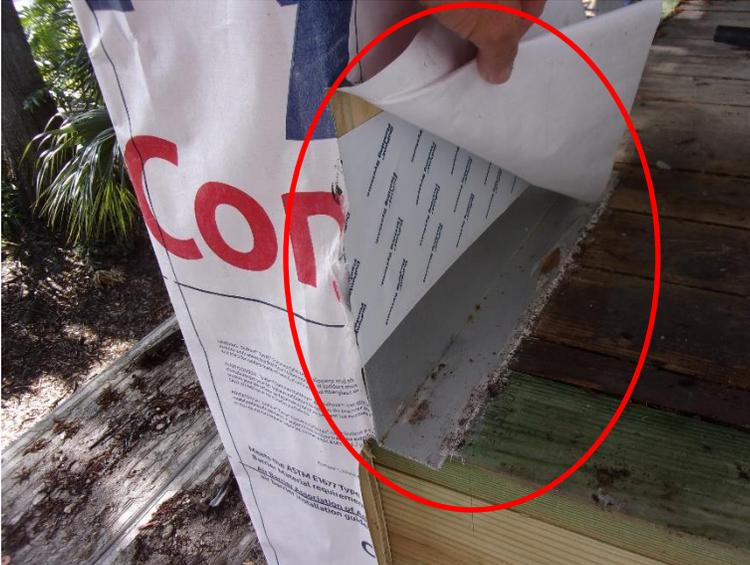
**PHOTOGRAPH #5**

**BUILDING 1  
SECTION F**

Contractor has completed kick out flashings and flashed to sheathing with DuPont straight flash at balcony decks.

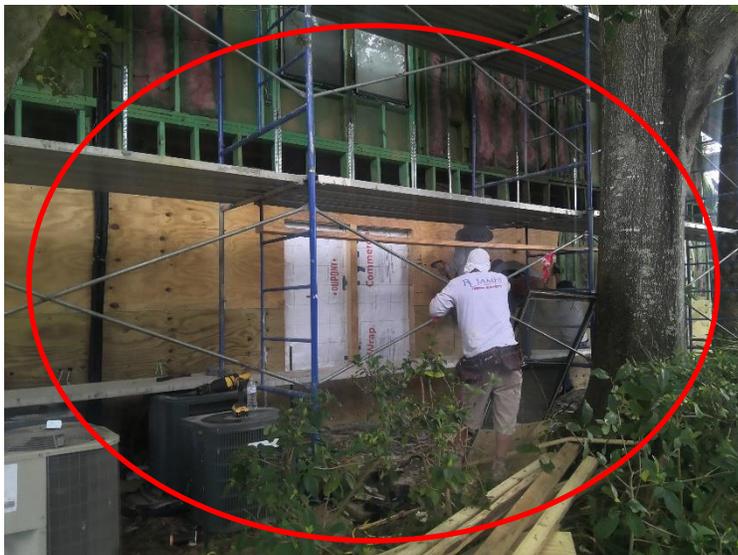
**PHOTOGRAPH #6**

**BUILDING 1  
SECTION D**

New 15/32" plywood sheathing installation in progress.

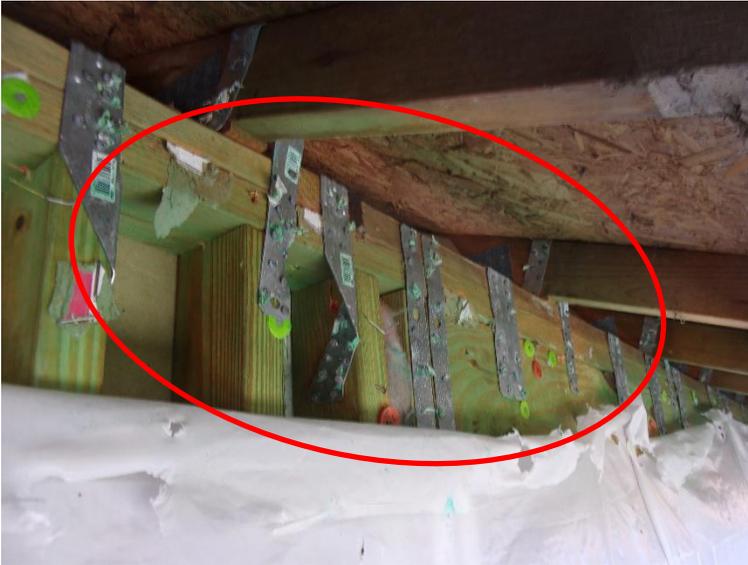
**PHOTOGRAPH #7**

**BUILDING 1  
SECTION C**

Simson Strong-Tie connectors and screws installed at top plates and roof trusses.

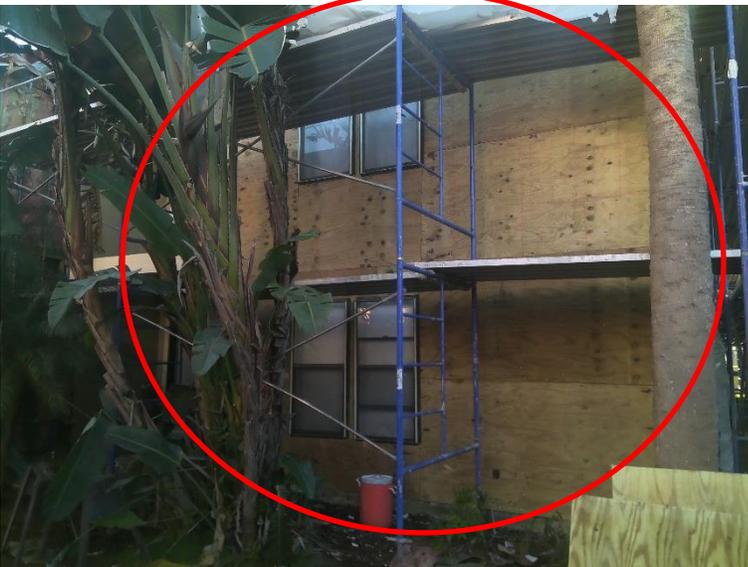
**PHOTOGRAPH #8**

**BUILDING 1  
SECTION C**

New 15/32" plywood sheathing installation in progress.

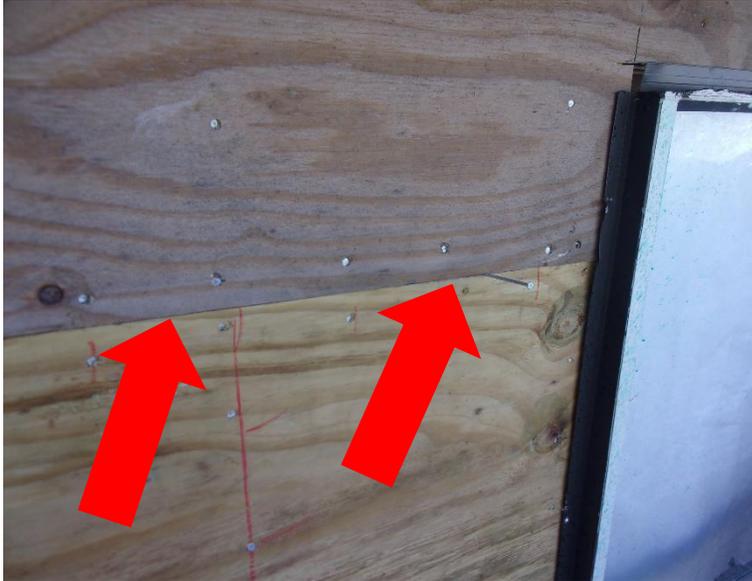
**PHOTOGRAPH #9**

**BUILDING 1  
SECTION C**

Required spacing has not been provided between plywood sheathing at a few locations. Contractor has been notified for corrections.

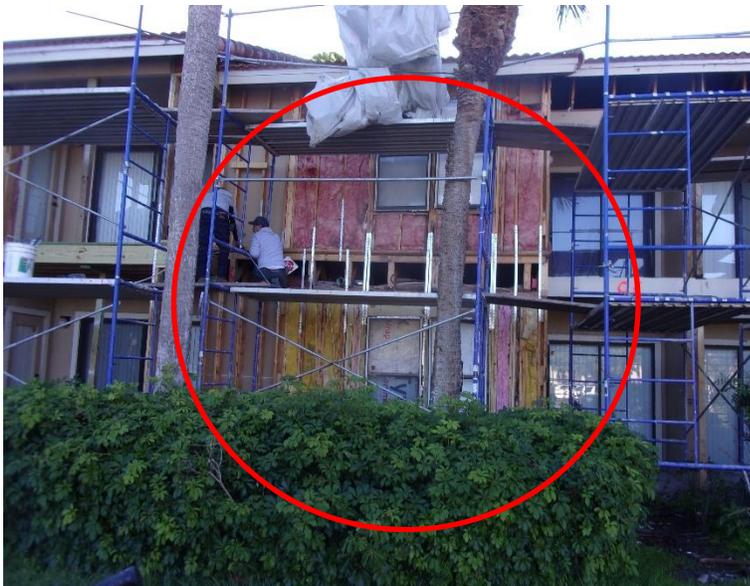
**PHOTOGRAPH #10**

**BUILDING 1  
SECTION B**

Installation of Simpson Strong-Tie strap connectors in progress.

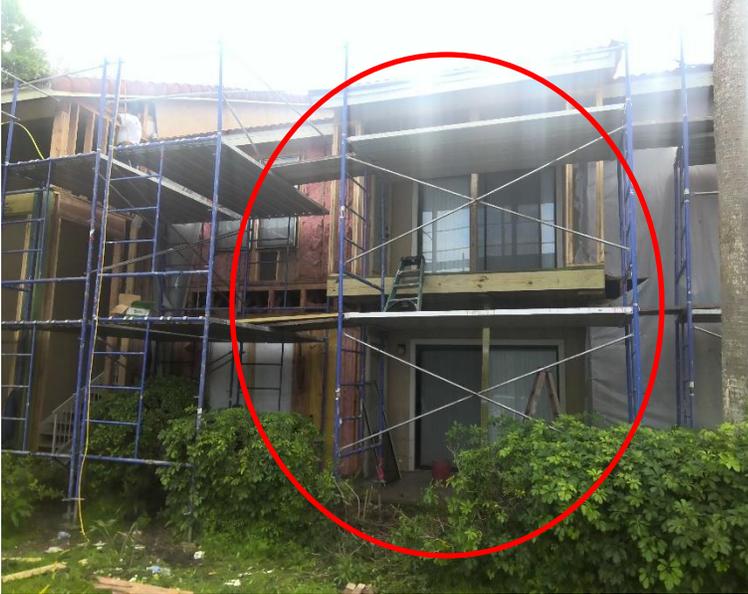
**PHOTOGRAPH #11**

**BUILDING 1  
SECTION B**

Full framing repairs in progress at damaged balconies.

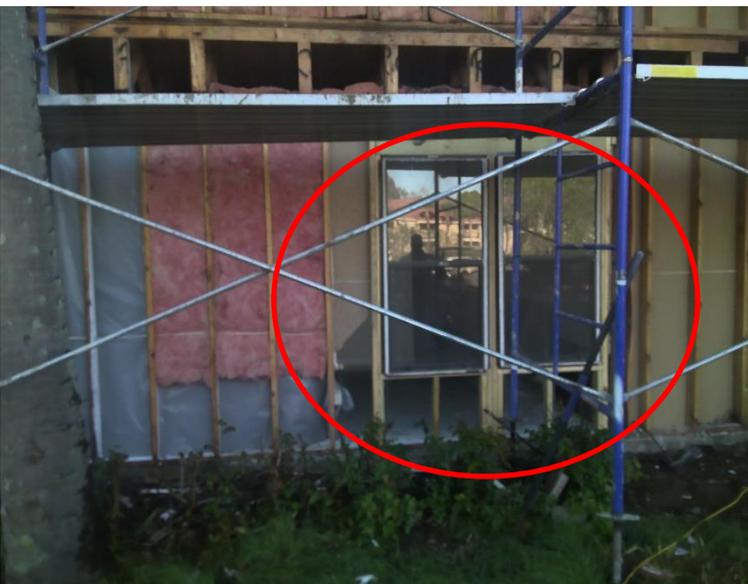
**PHOTOGRAPH #12**

**BUILDING 1  
SECTION A**

Framing repairs performed at damaged window headers and openings. Interior drywall has been removed by homeowners.

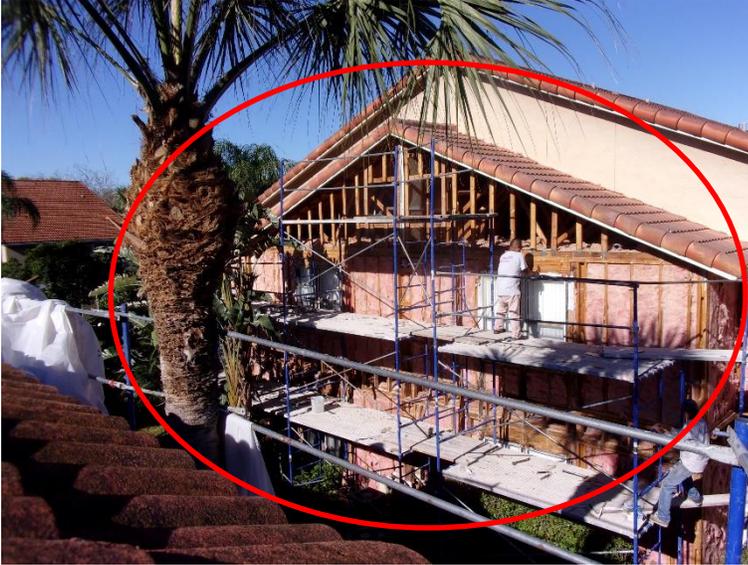
**PHOTOGRAPH #13**

**BUILDING 2  
SECTION H**

Removal of stucco and preexisting ThermoPly performed. Damaged framing observed and marked for repairs.

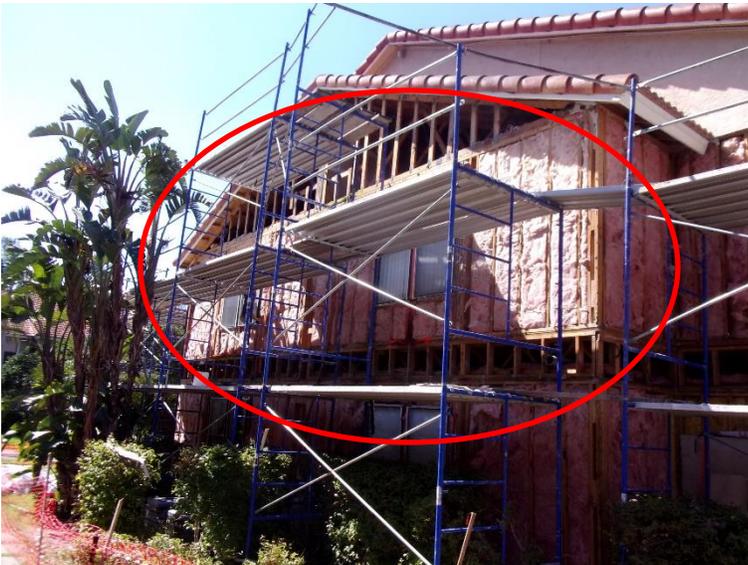
**PHOTOGRAPH #14**

**BUILDING 2  
SECTION H**

Removal of stucco and preexisting ThermoPly performed. Damaged framing observed and marked for repairs.

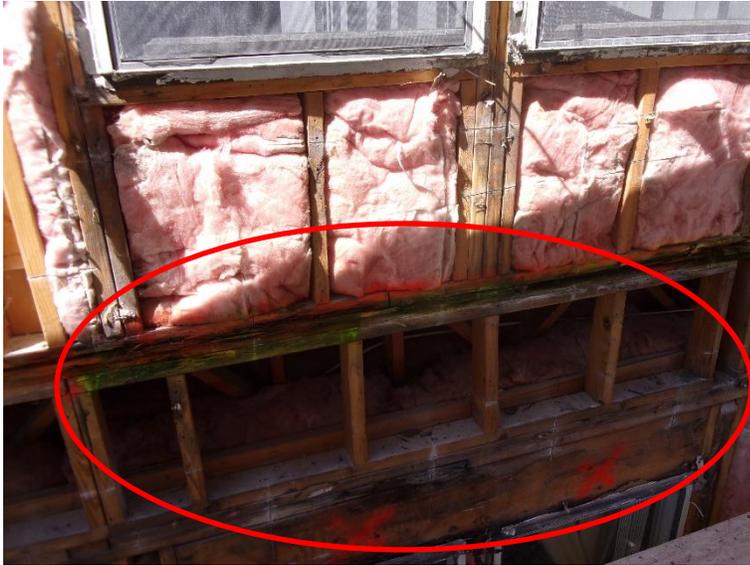
**PHOTOGRAPH #15**

**BUILDING 2  
SECTION H**

Damaged framing marked for repairs at second floor bottom plate and first floor window header.

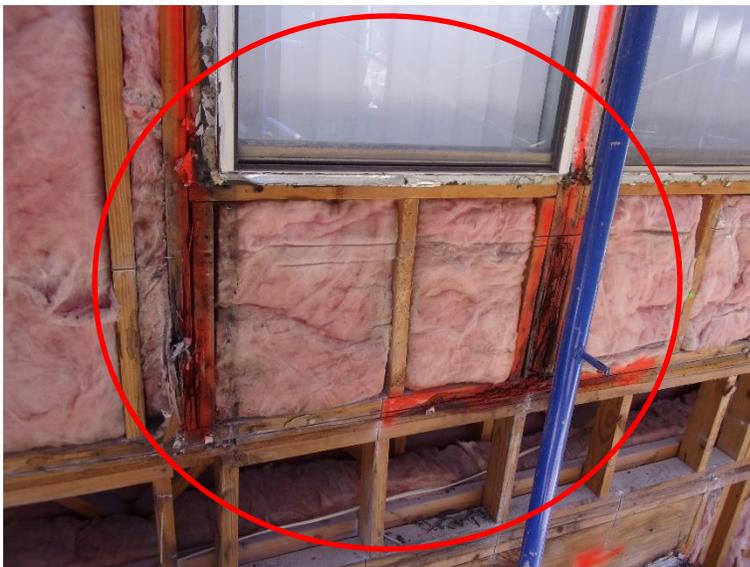
**PHOTOGRAPH #16**

**BUILDING 2  
SECTION H**

Damaged framing marked for repairs at second floor bottom plate and window opening framing.

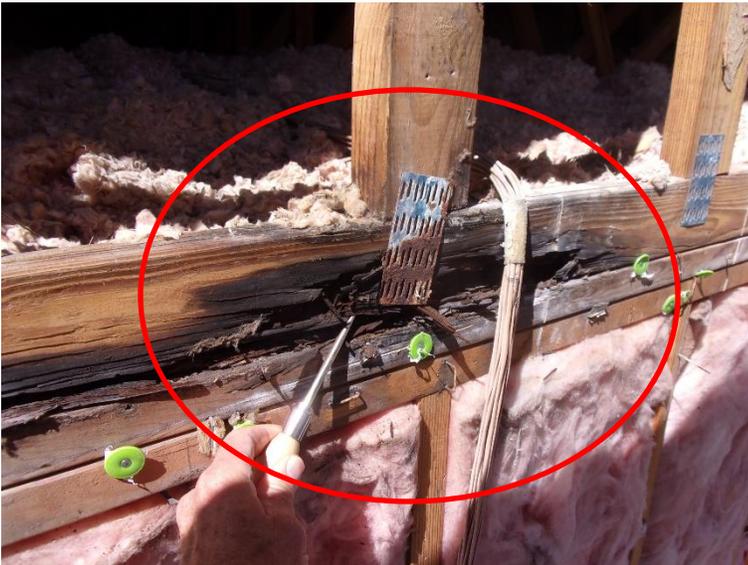
**PHOTOGRAPH #17**

**BUILDING 2  
SECTION H**

Wood rot damage marked for repairs at  
gable end roofing truss.
