## PHOTOGRAPHS

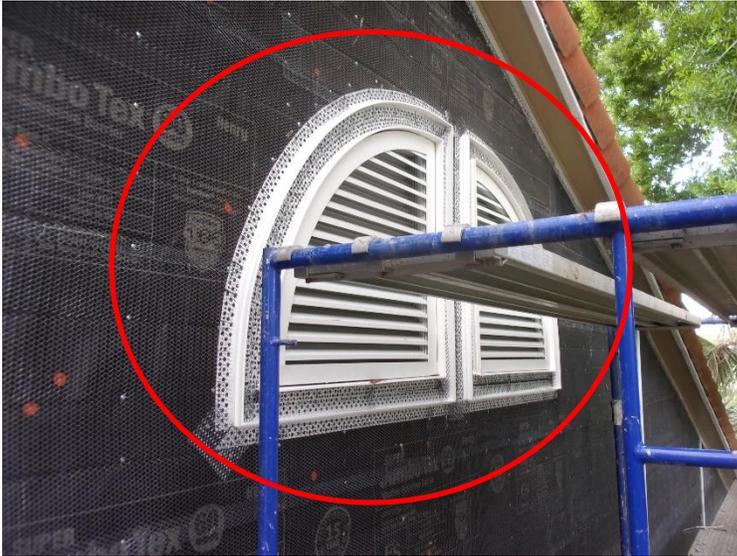
PHOTOGRAPH #1

### BUILDING 1 SECTION H

New GreenHeck louvers installed and prepared for stucco application at gable end.

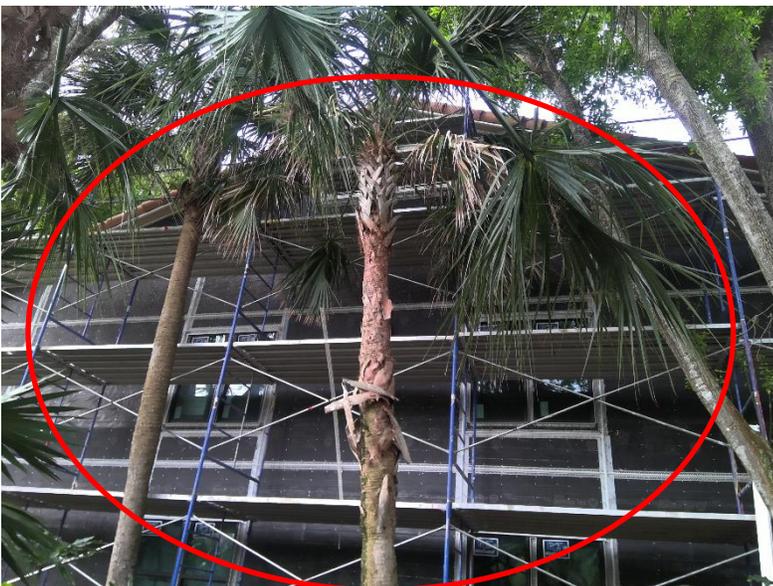
PHOTOGRAPH #2

### BUILDING 1 SECTION H

Stucco contractor has completed lath and stucco accessories.

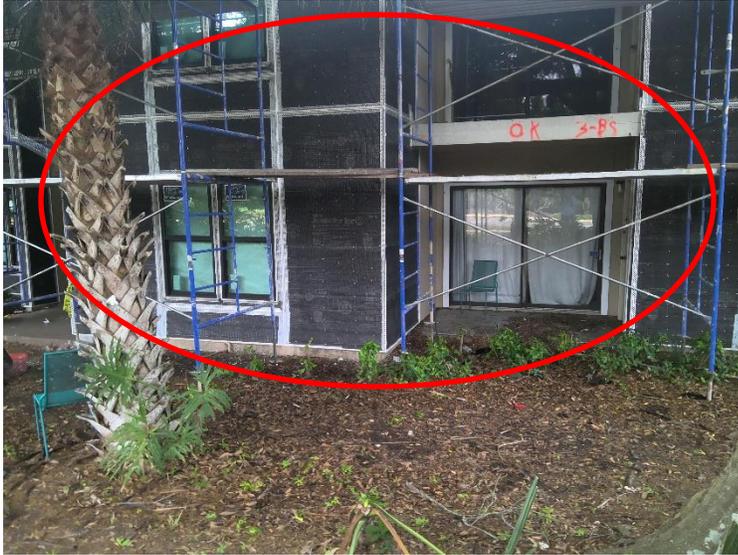
**PHOTOGRAPH #3**

**BUILDING 1  
SECTION G**

Stucco contractor has completed lath and stucco accessories.

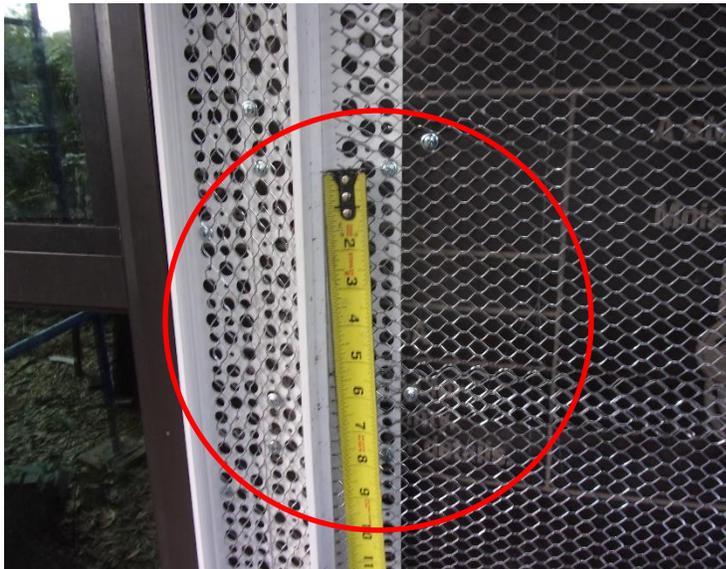
**PHOTOGRAPH #4**

**BUILDING 1  
SECTION G**

Lathing and stucco accessories fastening in compliance with specifications.

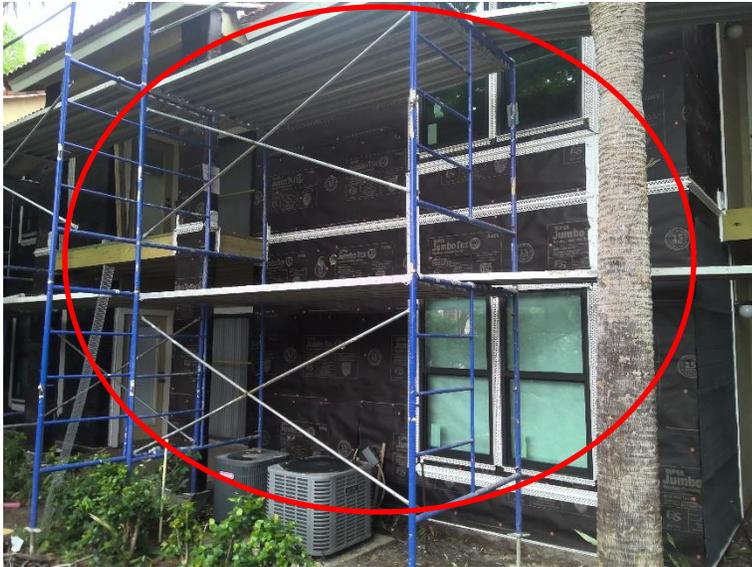
**PHOTOGRAPH #5**

**BUILDING 1  
SECTION F**

Stucco contractor in process of applying Vinyl Corp. stucco accessories, joints, and casing beads.

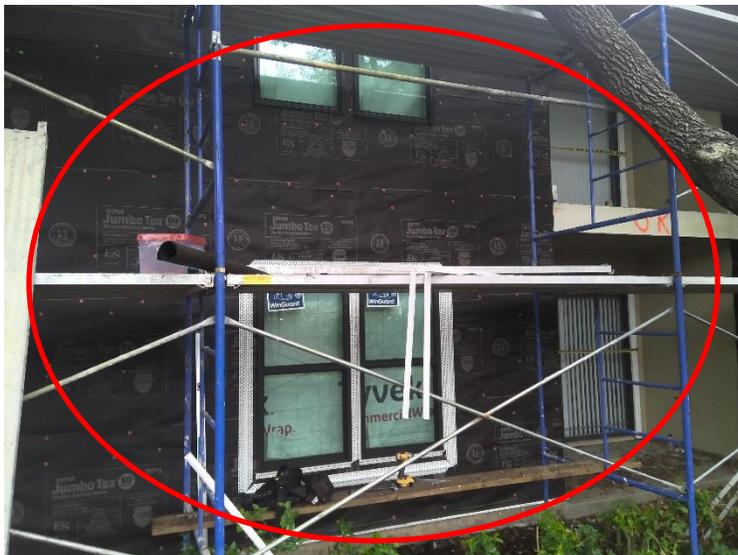
**PHOTOGRAPH #6**

**BUILDING 1  
SECTION E**

Stucco contractor in process of applying Vinyl Corp. stucco accessories, joints, and casing beads.

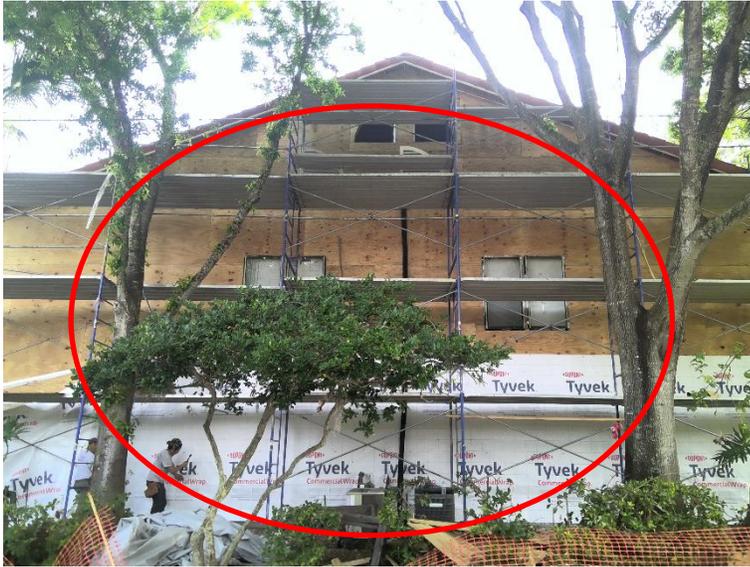
**PHOTOGRAPH #7**

**BUILDING 1  
SECTION D**

Plywood sheathing installed and Tyvek WRB wrap in progress.

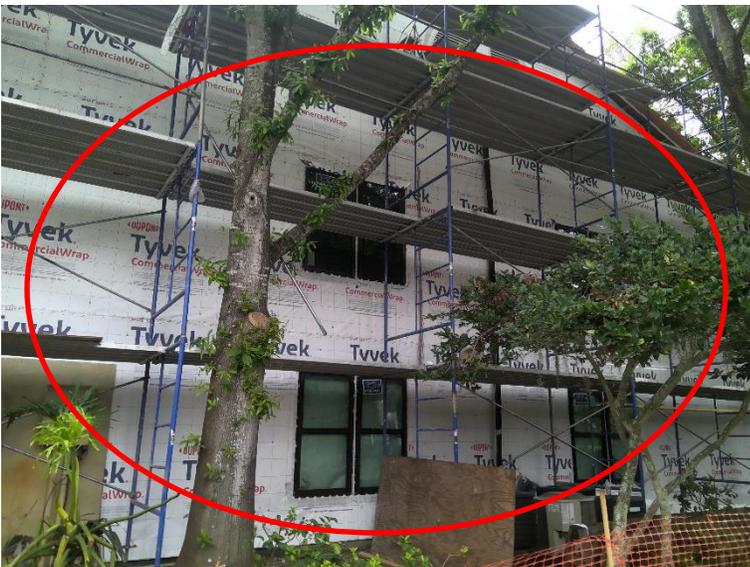
**PHOTOGRAPH #8**

**BUILDING 1  
SECTION D**

New PGT window installed with Dupont / Tyvek flashing system.

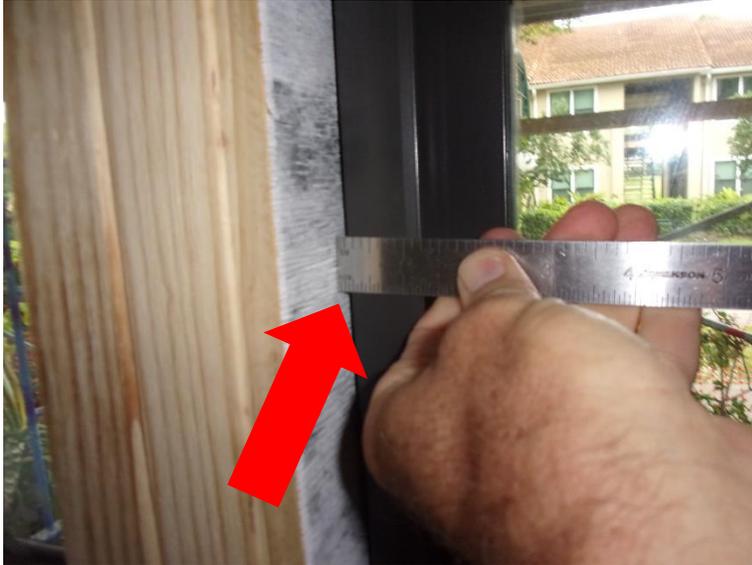
**PHOTOGRAPH #9**

**BUILDING 1  
SECTION D**

Interior gaps between window frame and jamb in compliance with manufacturers NOAs.

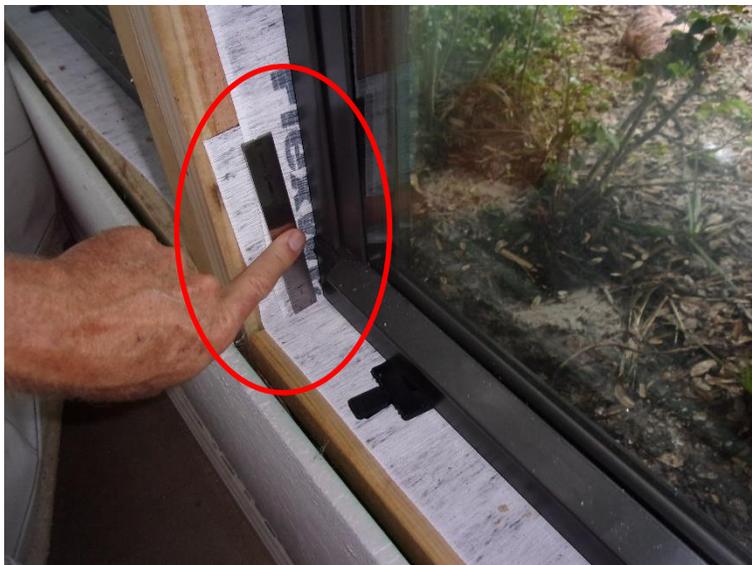
**PHOTOGRAPH #10**

**BUILDING 1  
SECTION D**

Overlapping of Dupont flashings at window opening in compliance with manufactures instructions and specifications.

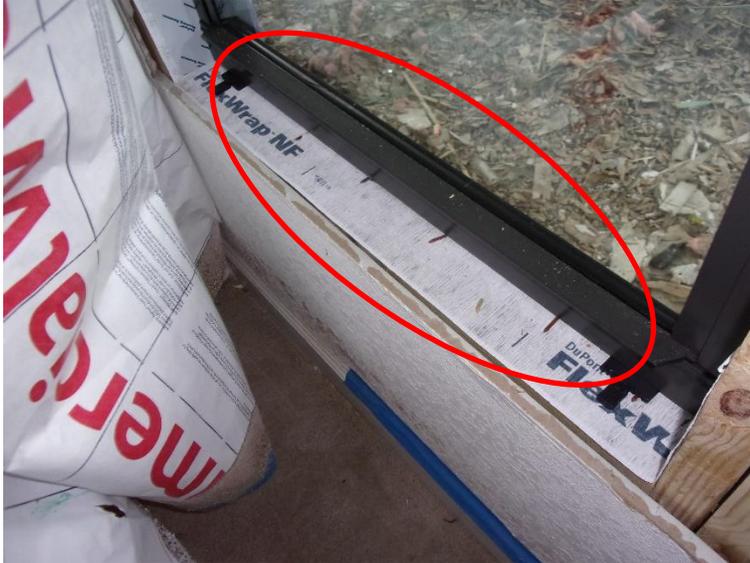
**PHOTOGRAPH #11**

**BUILDING 1  
SECTION D**

Nails installed at improper angle have penetrated flashing at windowsill.

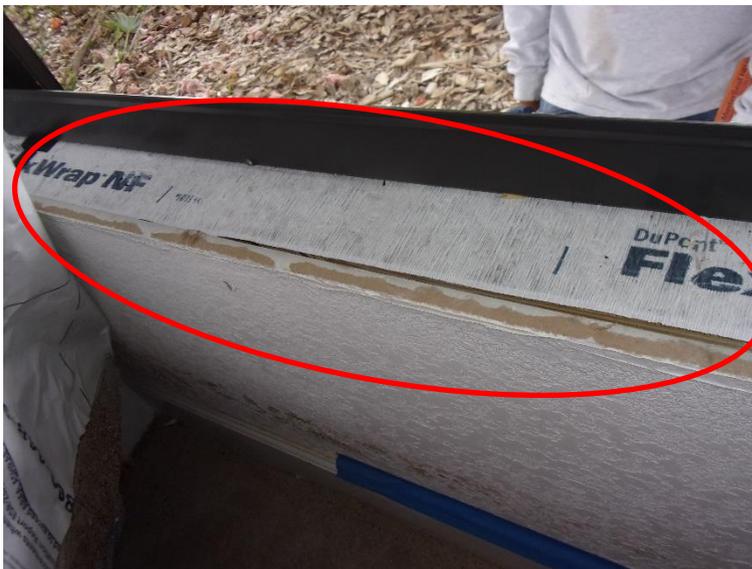
**PHOTOGRAPH #12**

**BUILDING 1  
SECTION D**

Corrections performed were nails penetrated flashing at windowsill.

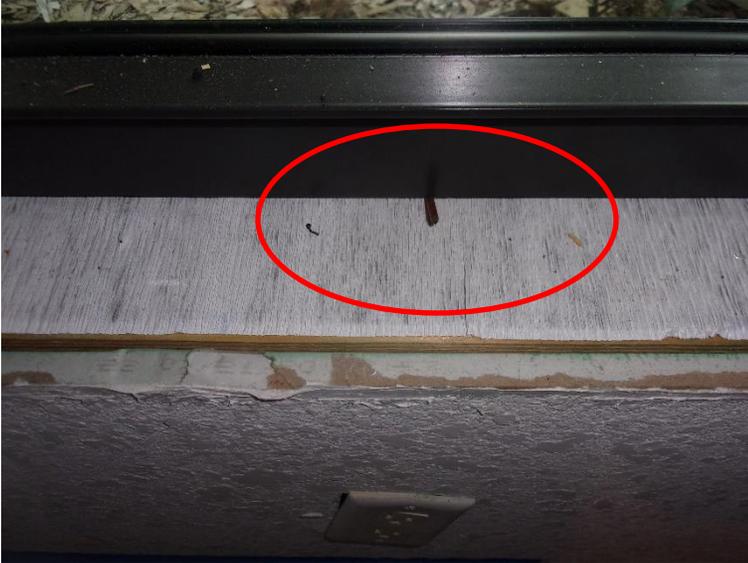
**PHOTOGRAPH #13**

**BUILDING 2  
SECTION D**

Nails installed at improper angle have penetrated flashing at windowsill.

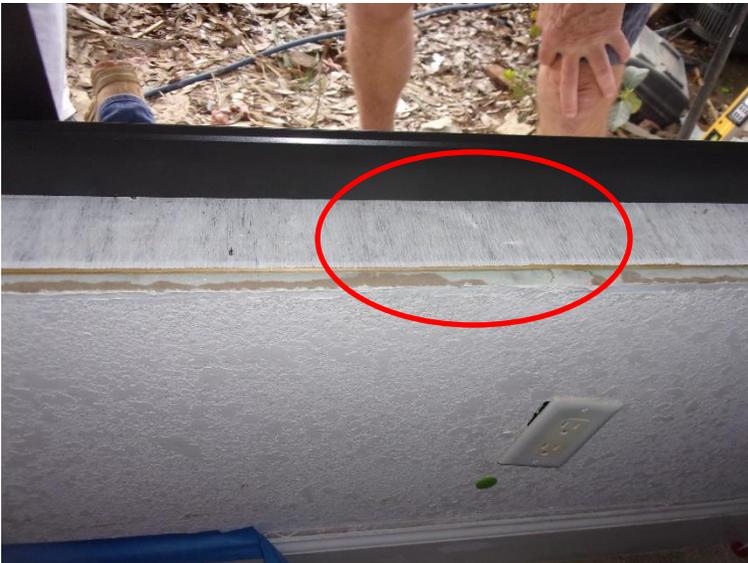
**PHOTOGRAPH #14**

**BUILDING 2  
SECTION D**

Corrections performed were nails penetrated flashing at windowsill.

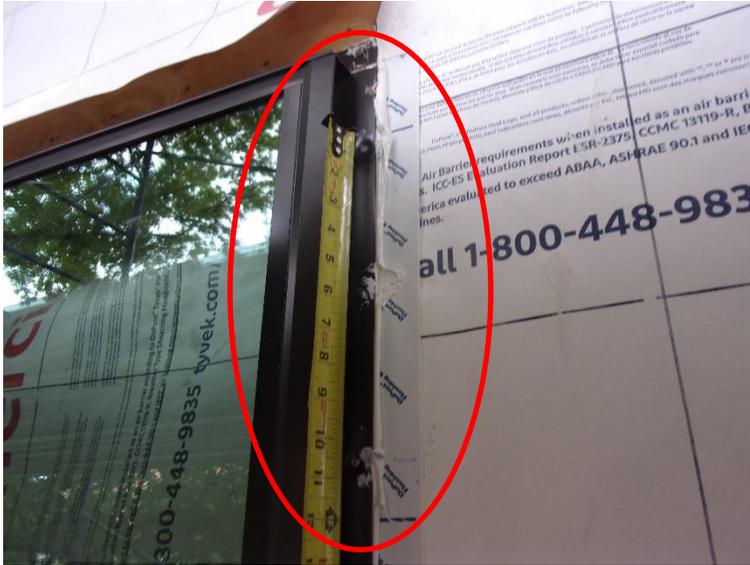
**PHOTOGRAPH #15**

**BUILDING 2  
SECTION D**

New PGT window fastened at flange as per specifications.

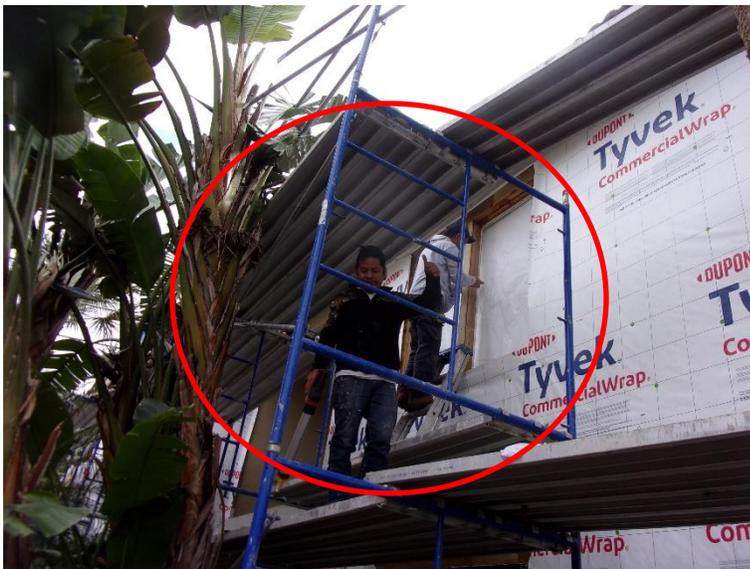
**PHOTOGRAPH #16**

**BUILDING 2  
SECTION C**

Window installation in progress. Contractor utilizing primer for proper adhesion of Dupont flashings.

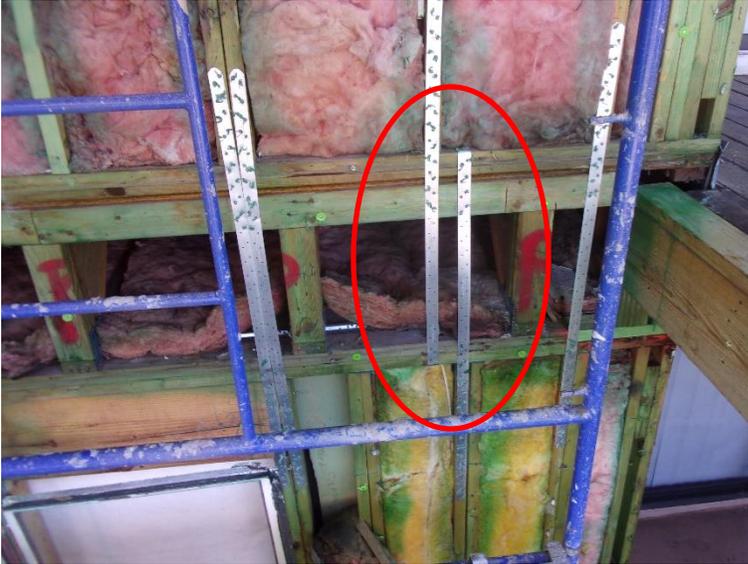
**PHOTOGRAPH #17**

**BUILDING 2  
SECTION B**

Simpson Strong-Tie straps installed improperly at top and several subfloor locations.

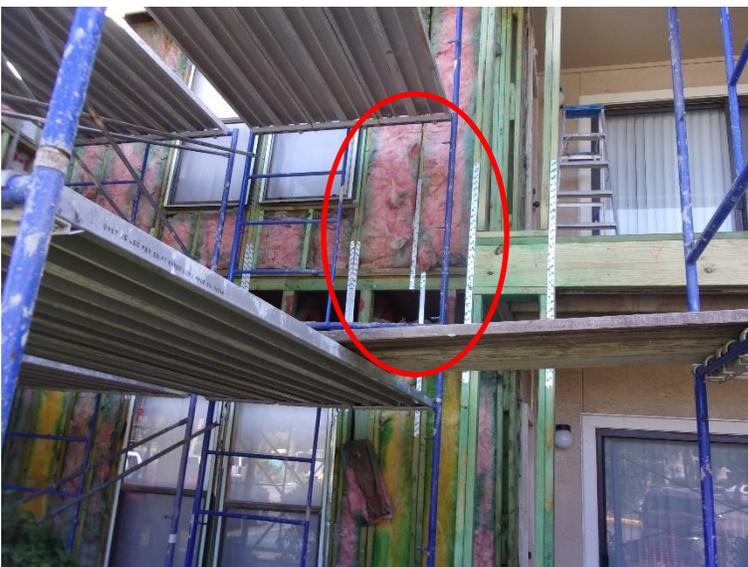
**PHOTOGRAPH #18**

**BUILDING 2  
SECTION B**

Contractor has corrected strapping where improperly applied at several locations.

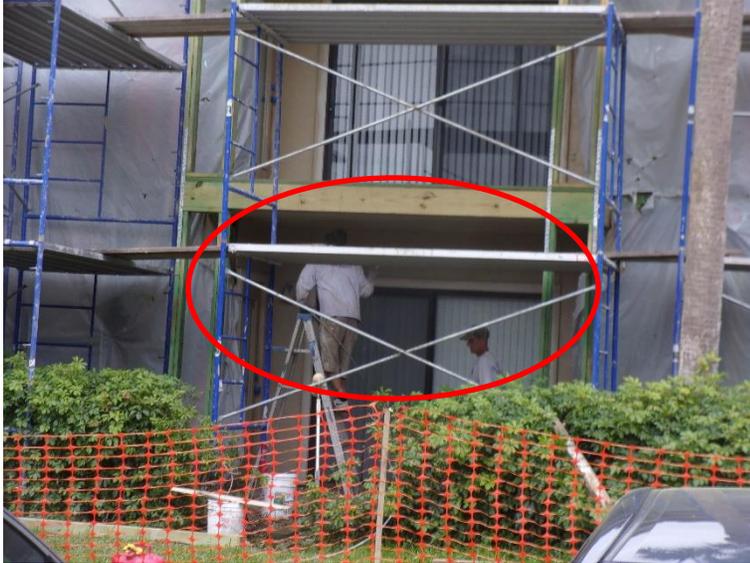
**PHOTOGRAPH #19**

**BUILDING 2  
SECTION B**

Florida Paint Ultra Supercoat acrylic being applied at patio ceilings and walls.

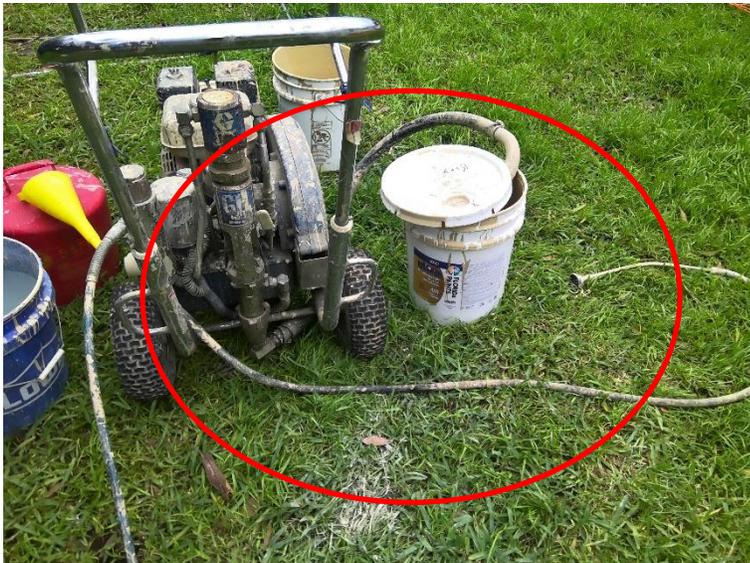
**PHOTOGRAPH #20**

**BUILDING 2  
SECTION B**

Florida Paint Ultra Supercoat acrylic being applied at patio ceilings and walls.

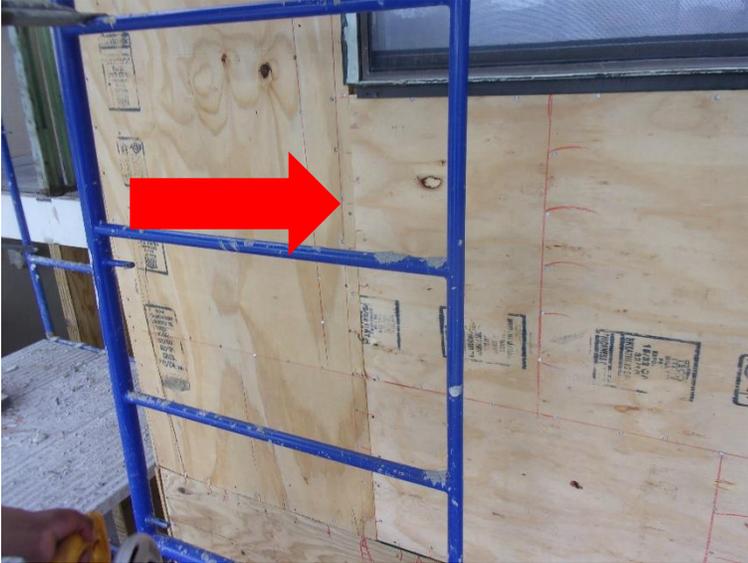
**PHOTOGRAPH #21**

**BUILDING 2  
SECTION B**

Required spacing not been provided between plywood sheathing at a few locations.

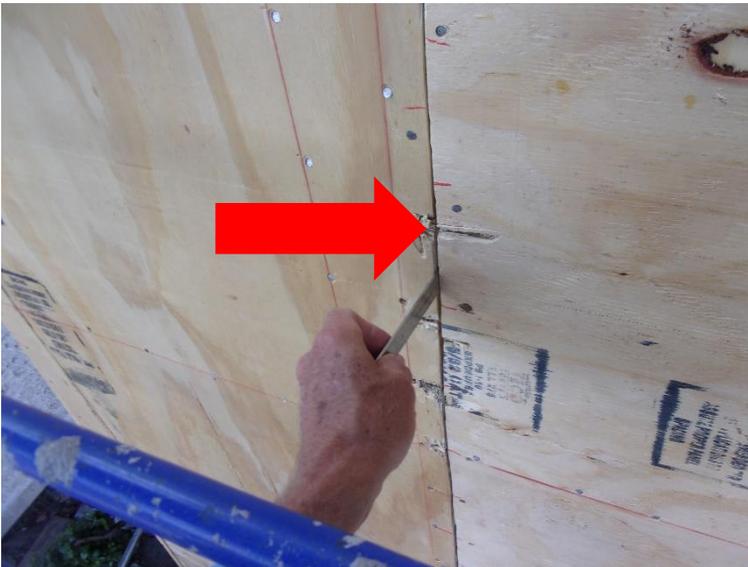
**PHOTOGRAPH #22**

**BUILDING 2  
SECTION B**

Contractor has corrected spacing at plywood sheathing where observed.

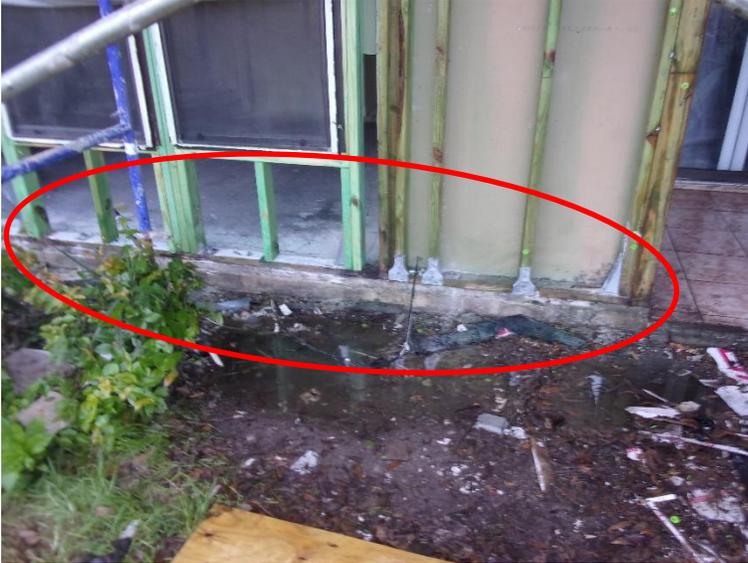
**PHOTOGRAPH #23**

**BUILDING 2  
SECTION A**

Simpson Strong -Tie connectors and anchors installed as per drawings and specifications.

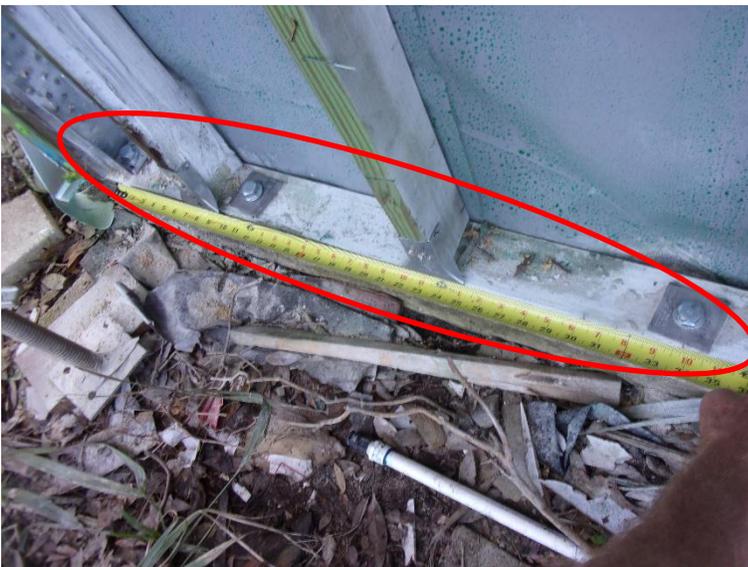
**PHOTOGRAPH #24**

**BUILDING 2  
SECTION A**

Simpson Strong -Tie connectors and anchors installed as per drawings and specifications.
