PHOTOGRAPHS

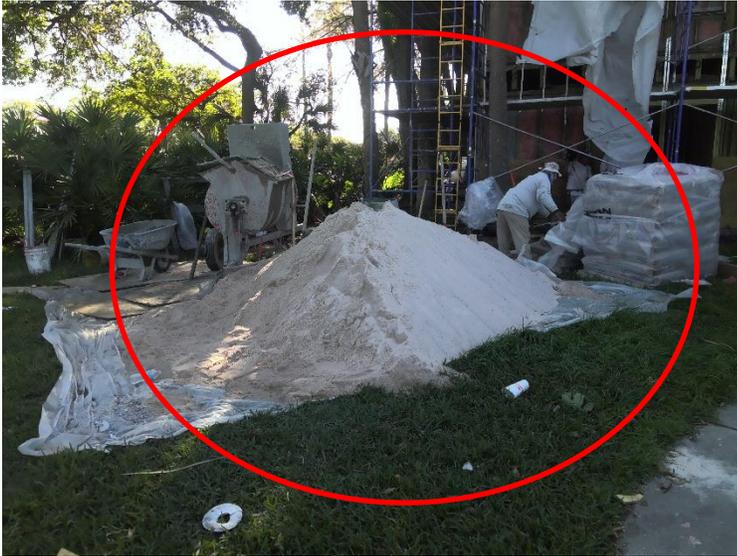
PHOTOGRAPH #1

BUILDING 1 SECTION H

Stucco sub-contractor mixing stucco at staging area.

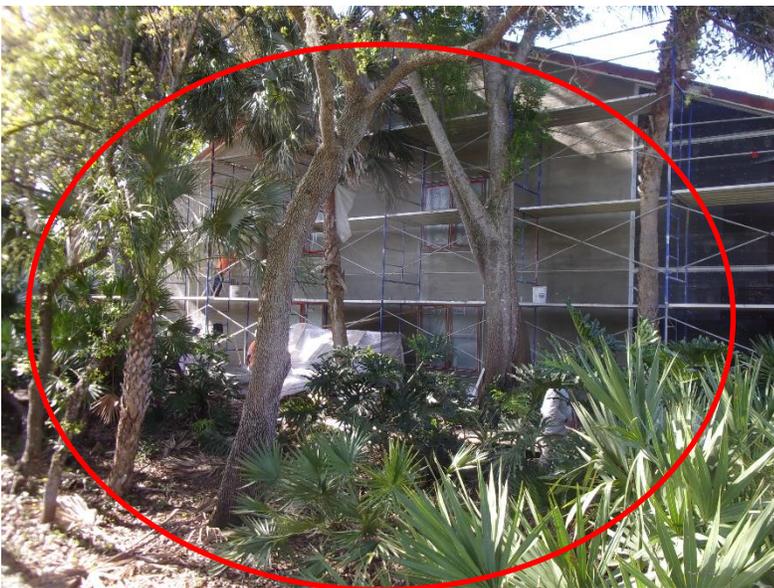
PHOTOGRAPH #2

BUILDING 1 SECTION H

Stucco sub-contractor has applied scratch coat and begun brown coat.

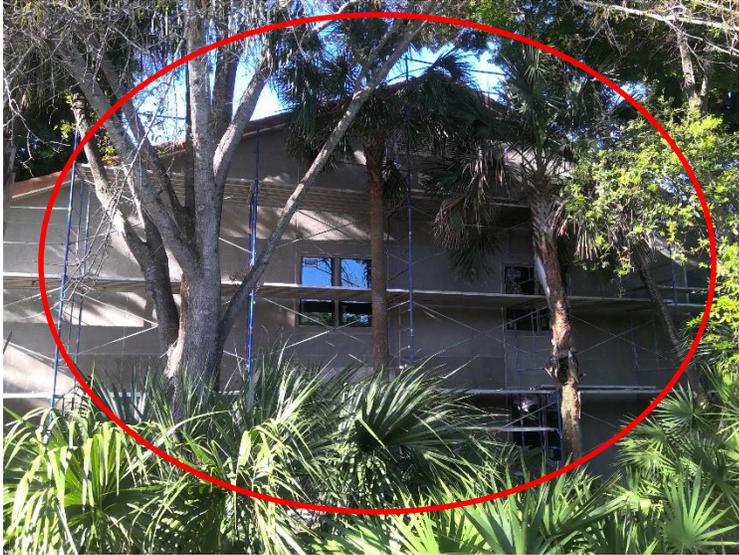
PHOTOGRAPH #3

**BUILDING 1
SECTION H**

Stucco sub-contractor has completed finish coat of stucco.

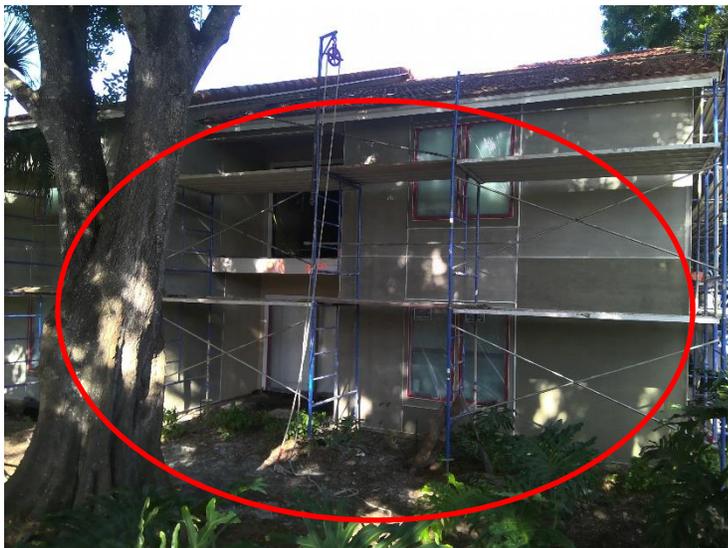
PHOTOGRAPH #4

**BUILDING 1
SECTION G**

Stucco sub-contractor has applied scratch coat and begun brown coat.

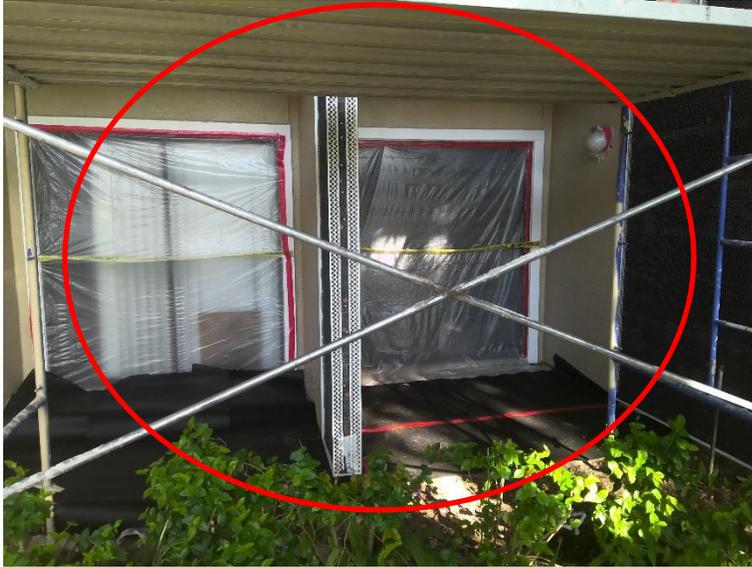
PHOTOGRAPH #5

**BUILDING 1
SECTION F**

Stucco contractor has protected windows and other adjacent surfaces from stucco applications.

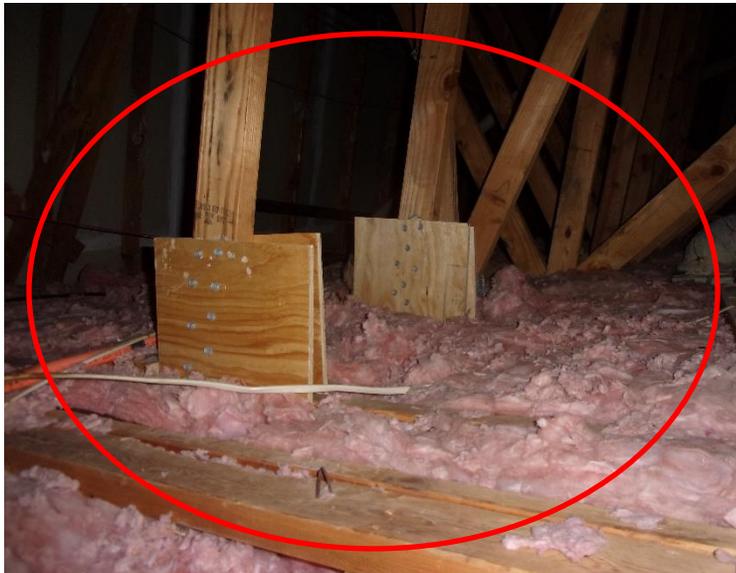
PHOTOGRAPH #6

**BUILDING 1
UNIT #123 – ATTIC**

Gusset, scabs, and fire wall repairs performed and quantified.

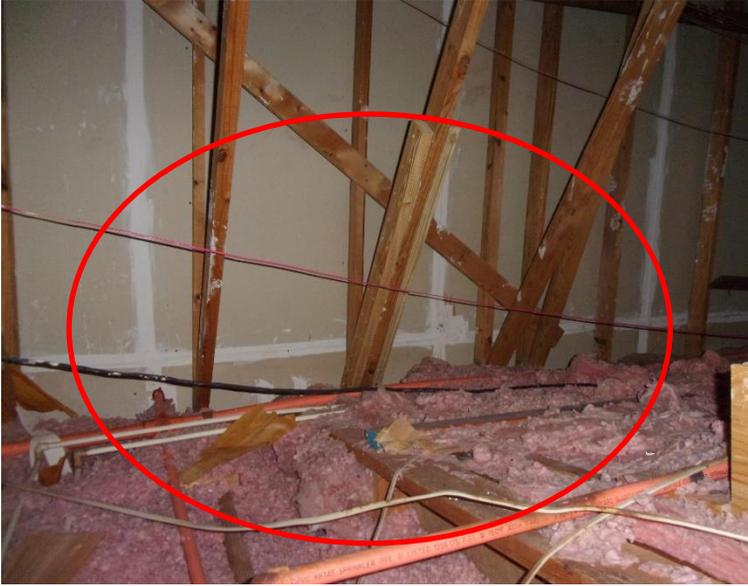
PHOTOGRAPH #7

**BUILDING 1
UNIT #123 – ATTIC**

Gusset, scabs, and fire wall repairs performed and quantified.

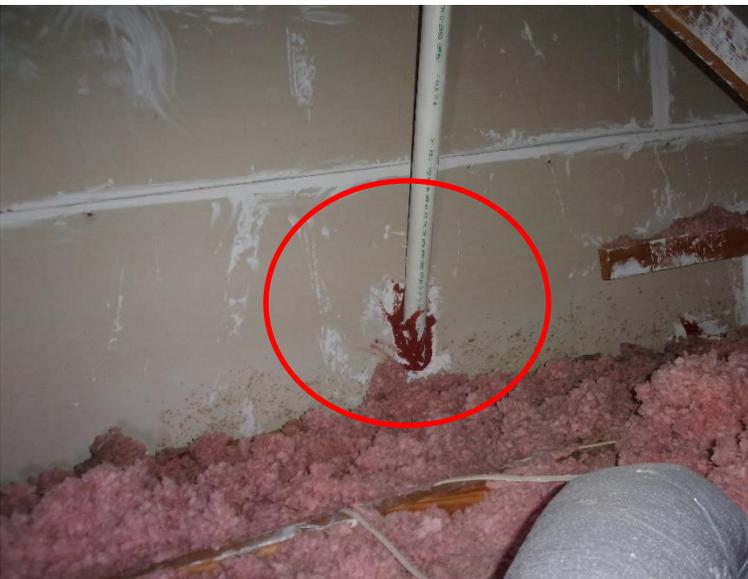
PHOTOGRAPH #8

**BUILDING 1
UNIT #126 – ATTIC**

Gusset, scabs, and fire wall repairs performed and quantified.

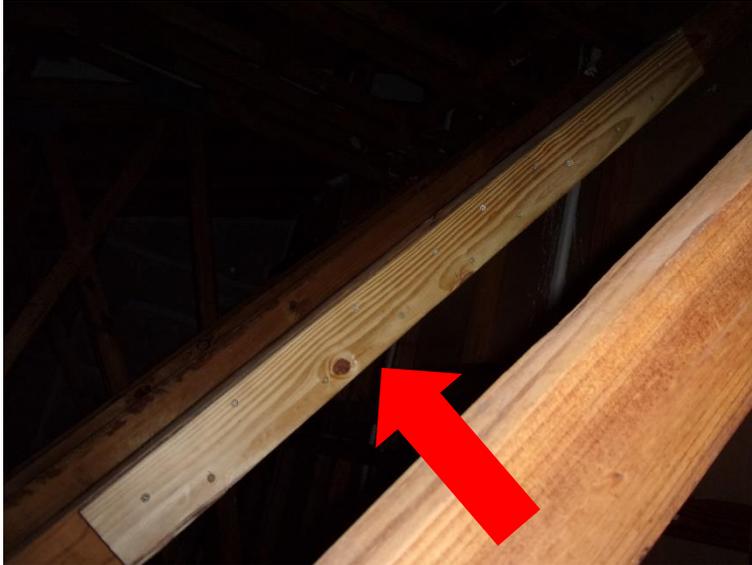
PHOTOGRAPH #9

**BUILDING 1
UNIT #126 – ATTIC**

Gusset, scabs, and fire wall repairs performed and quantified.

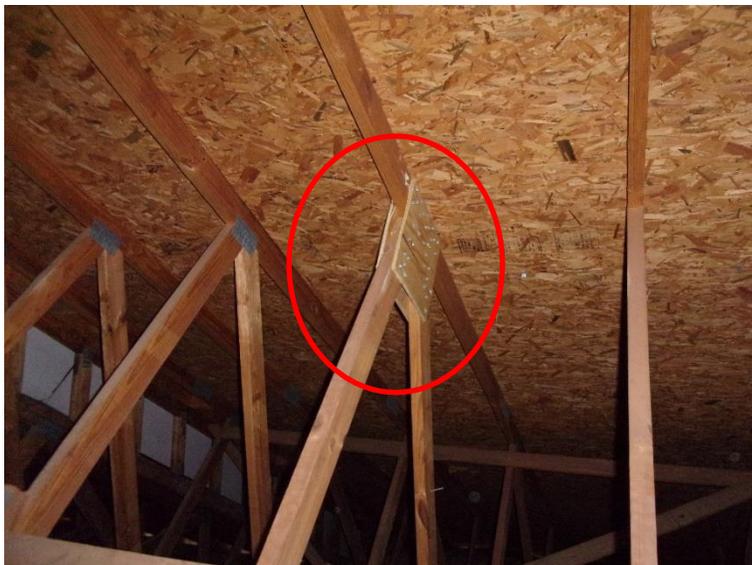
PHOTOGRAPH #10

**BUILDING 1
UNIT #127 – ATTIC**

Gusset, scabs, and fire wall repairs performed and quantified.

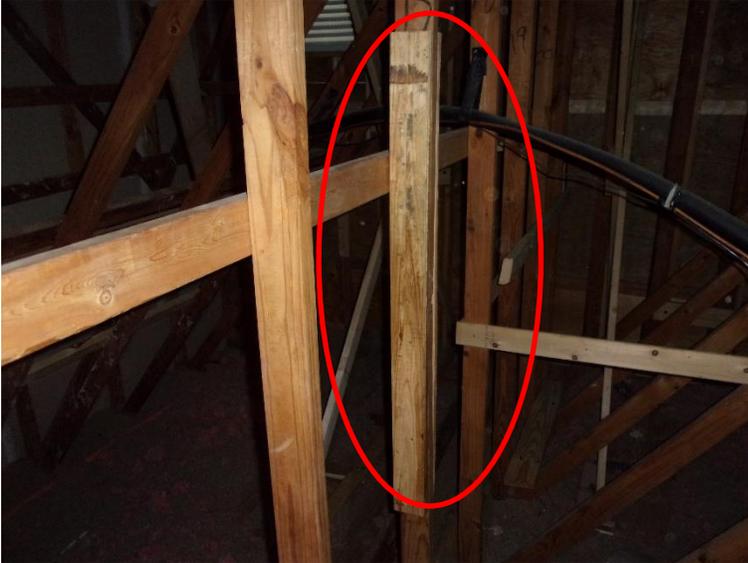
PHOTOGRAPH #11

**BUILDING 1
UNIT #127 – ATTIC**

Gusset, scabs, and fire wall repairs performed and quantified.

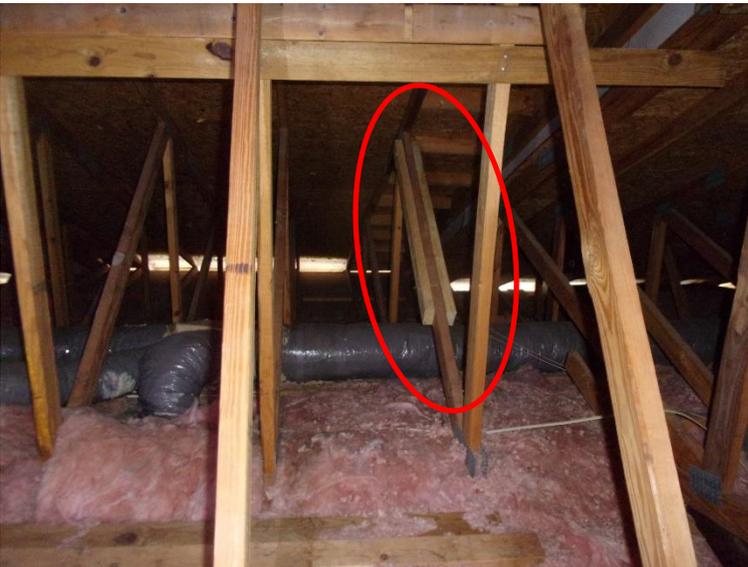
PHOTOGRAPH #12

**BUILDING 1
UNIT #128 – ATTIC**

Gusset, scabs, and fire wall repairs performed and quantified.

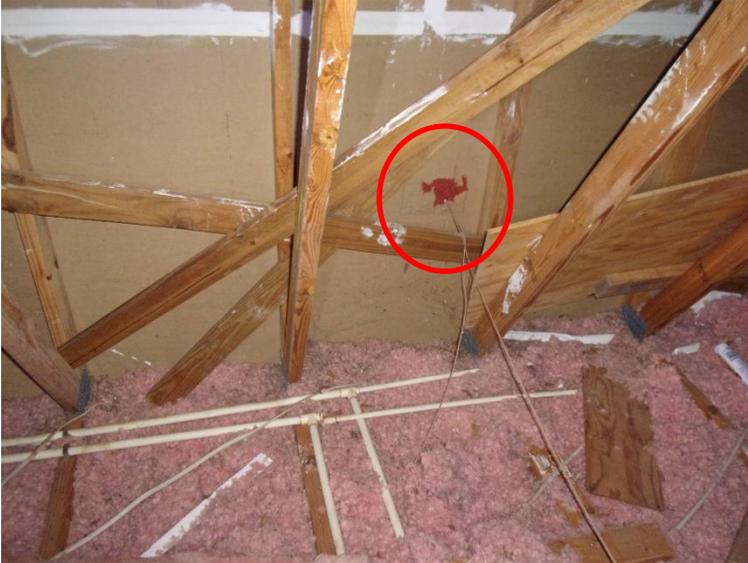
PHOTOGRAPH #13

**BUILDING 1
UNIT #128 – ATTIC**

Gusset, scabs, and fire wall repairs performed and quantified.

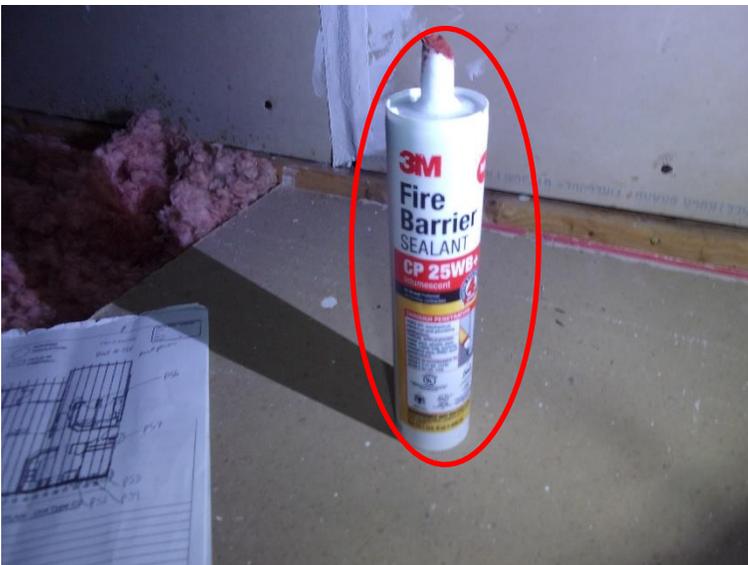
PHOTOGRAPH #14

**BUILDING 1
UNIT #128 – ATTIC**

3M fire barrier sealant applied at fire wall penetrations.

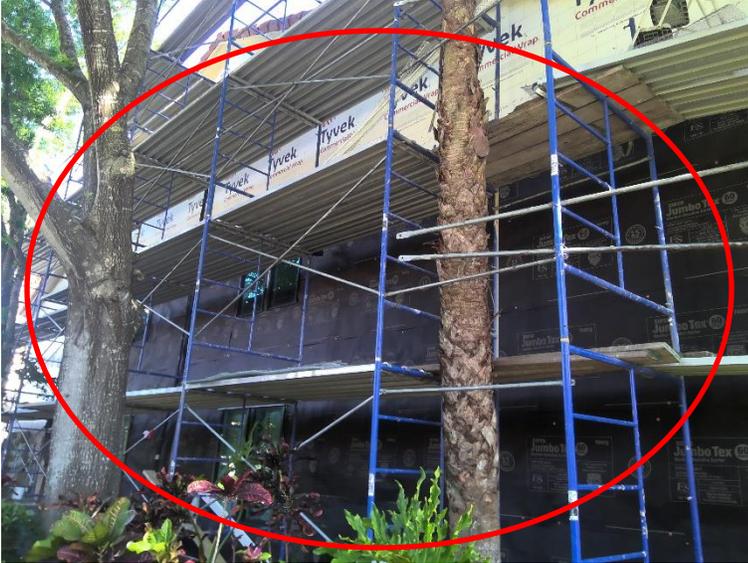
PHOTOGRAPH #15

**BUILDING 2
SECTION D**

Super Jumbo Tex 60, water resistant barrier applied over Tyvek Commercial wrap.

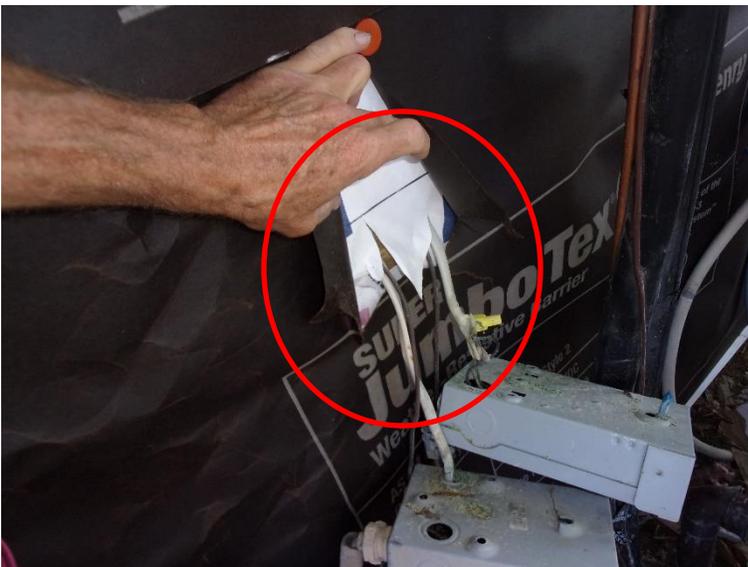
PHOTOGRAPH #16

**BUILDING 2
SECTION D**

Electrical and A/C penetrations have not been detailed with Tyvek Flex Wrap (as required by manufacture) prior to cover with Super Jumbo Tex 60.

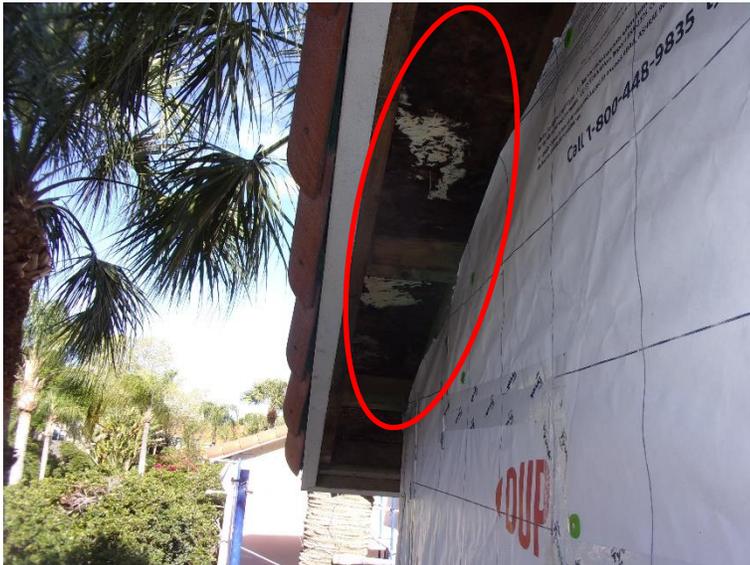
PHOTOGRAPH #17

**BUILDING 2
SECTION D**

Roofing sheathing deteriorated at several soffit locations.

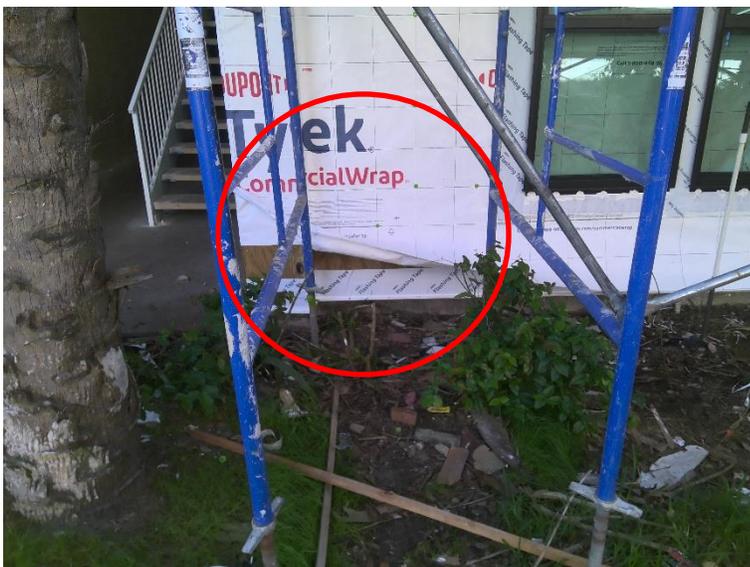
PHOTOGRAPH #18

**BUILDING 2
SECTION C**

Weep screed at wall base applied and flashed with Dupont flashing.

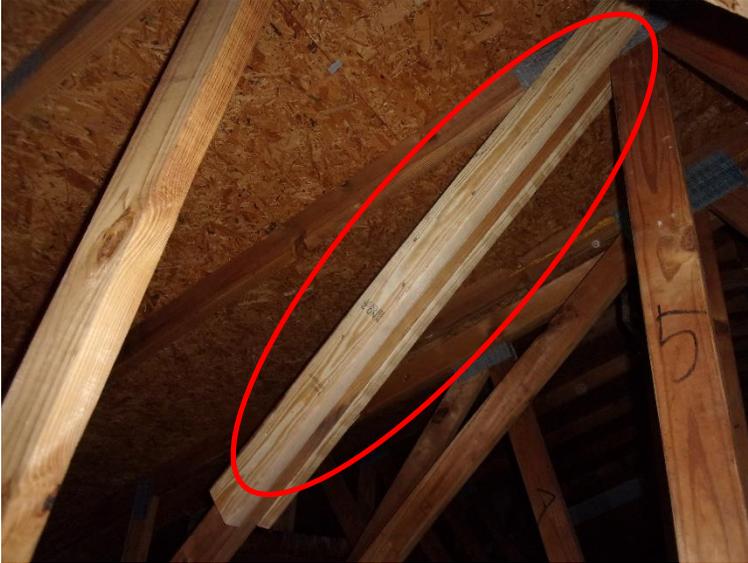
PHOTOGRAPH #19

**BUILDING 1
UNIT #125 – ATTIC**

Gusset, scabs, and fire wall repairs performed and quantified.

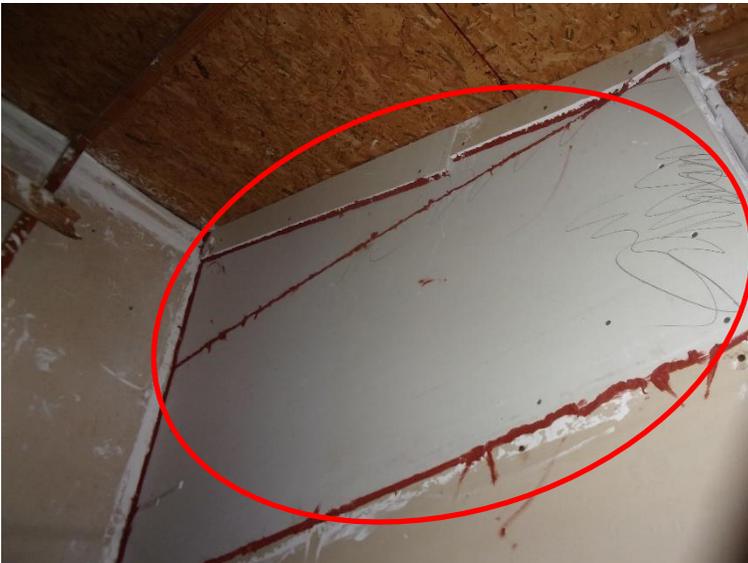
PHOTOGRAPH #20

**BUILDING 1
UNIT #125 – ATTIC**

Gusset, scabs, and fire wall repairs performed and quantified.

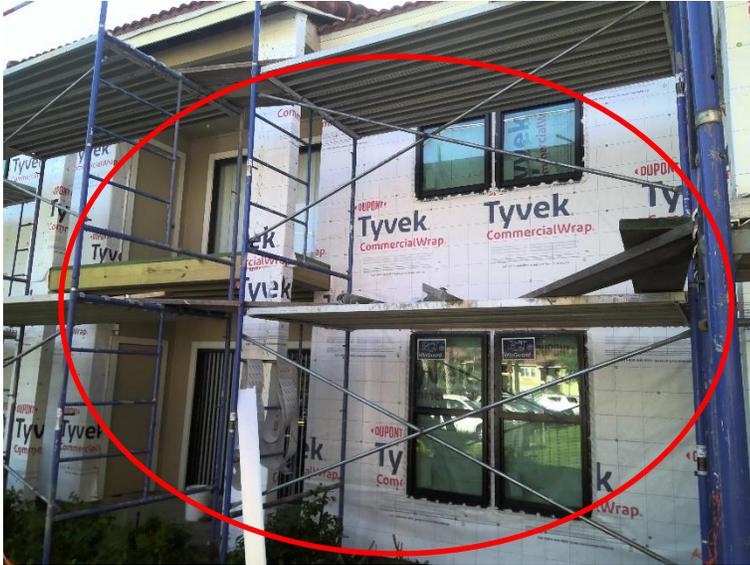
PHOTOGRAPH #21

**BUILDING 2
SECTION B**

New PGT windows installed with DuPont flashing details and Tyvek CommercialWrap.

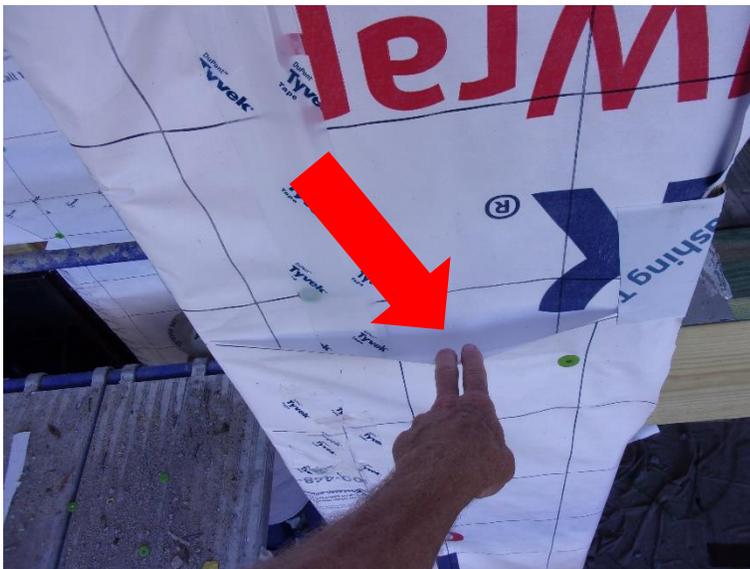
PHOTOGRAPH #22

**BUILDING 2
SECTION B**

Tyvek CommercialWrap WRB negatively overlapped at balcony columns.

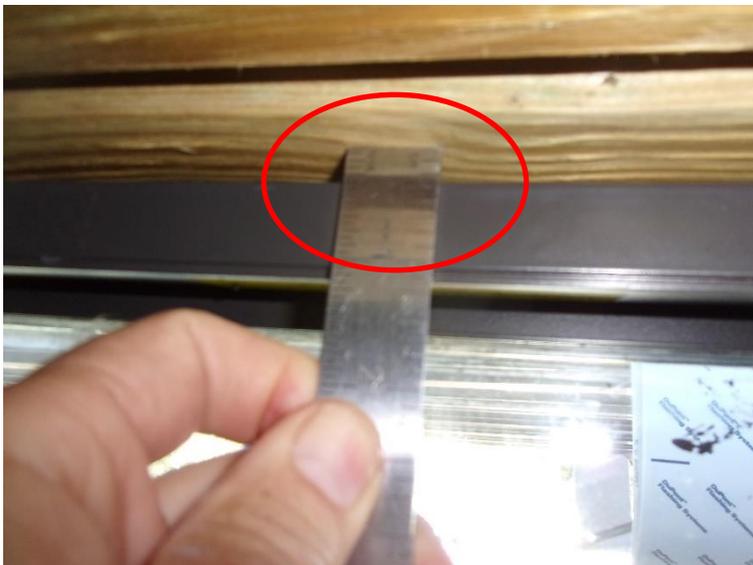
PHOTOGRAPH #23

**BUILDING 2
SECTION A**

Window installations inspected for proper gaps and flashing overlaps per manufacturers specifications and NOAs.

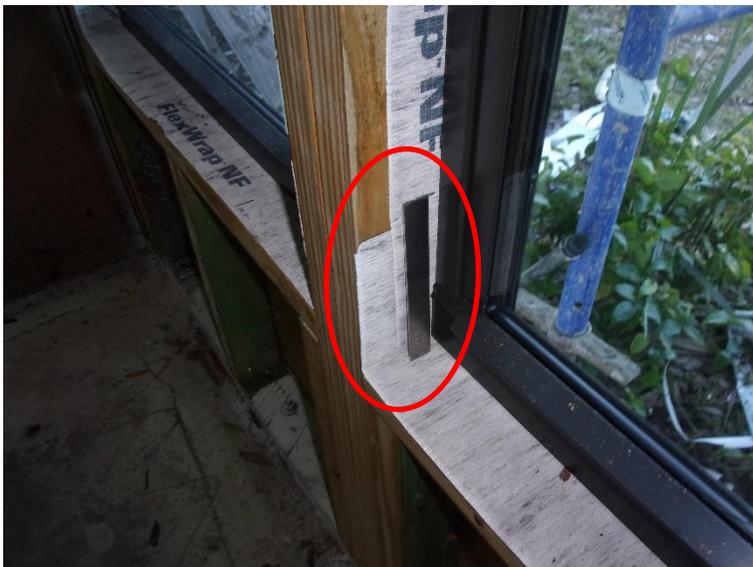
PHOTOGRAPH #24

**BUILDING 2
SECTION A**

Window installations inspected for proper gaps and flashing overlaps per manufacturers specifications and NOAs.

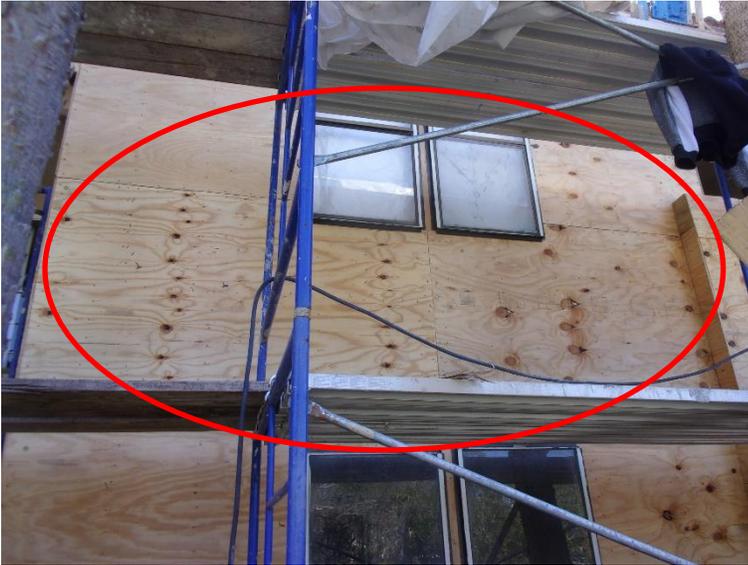
PHOTOGRAPH #25

**BUILDING 2
SECTION A**

15/32" plywood sheathing applied.
Existing windows temporarily reinstalled.

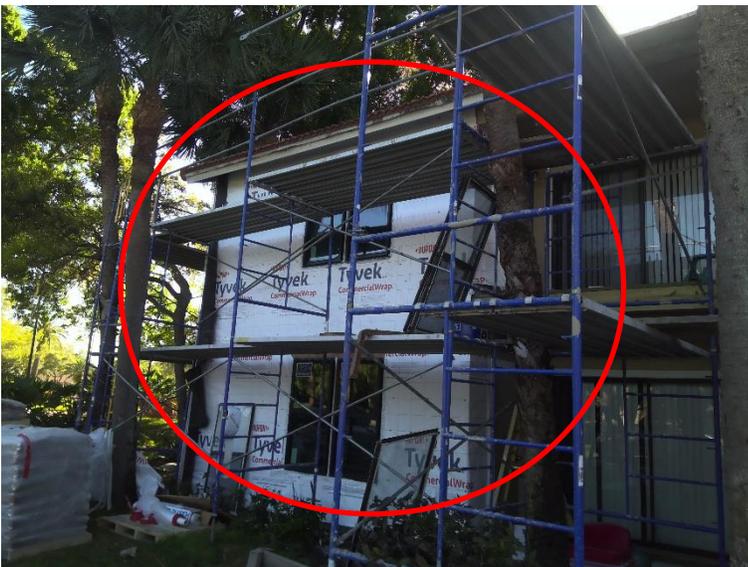
PHOTOGRAPH #26

**BUILDING 2
SECTION A**

New PGT windows installed with DuPont
flashing details and Tyvek
CommercialWrap.
