PHOTOGRAPHS

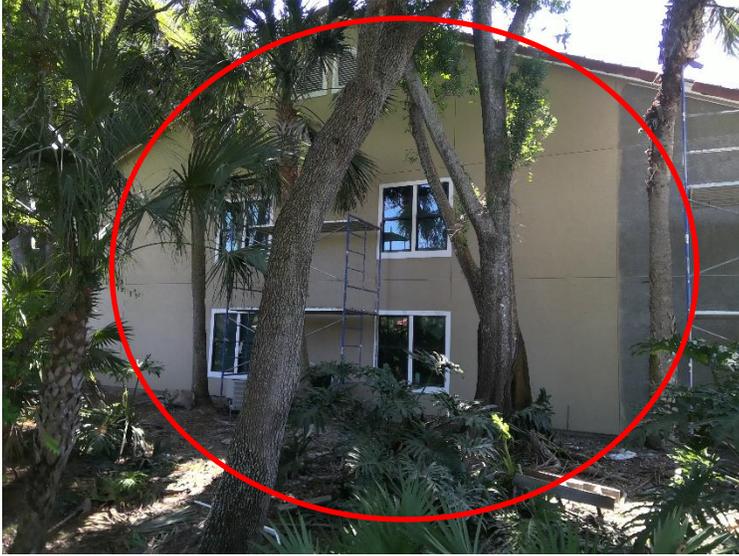
PHOTOGRAPH #1

BUILDING 1 SECTION H

Florida Paints primer and finish paint applied.

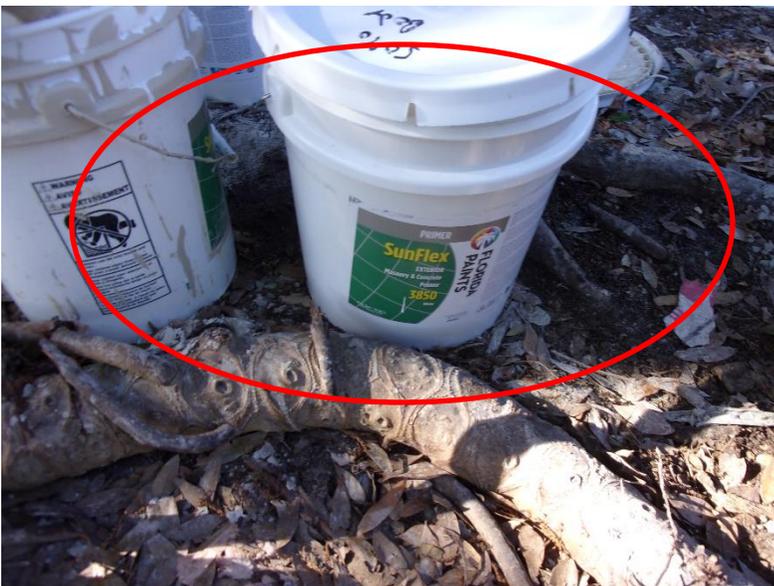
PHOTOGRAPH #2

BUILDING 1 SECTION H

Florida Paints primer and finish paint applied.

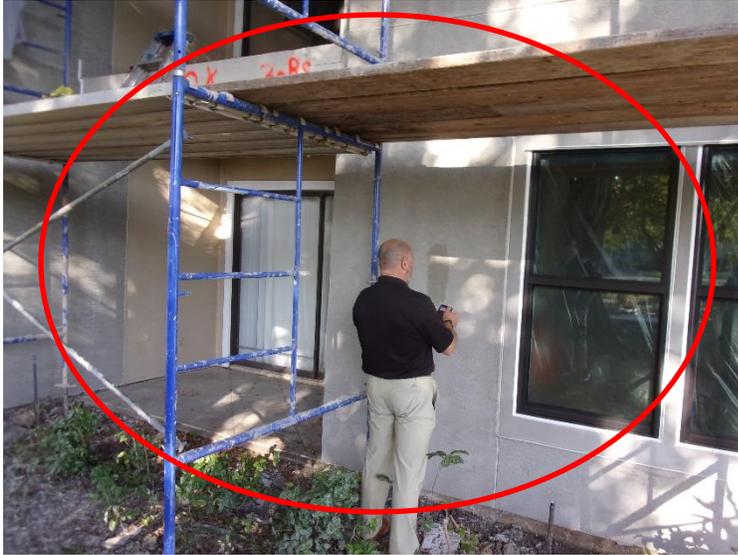
PHOTOGRAPH #3

**BUILDING 1
SECTION G**

Florida Paints manufacturer's representative testing for PH levels in new stucco.

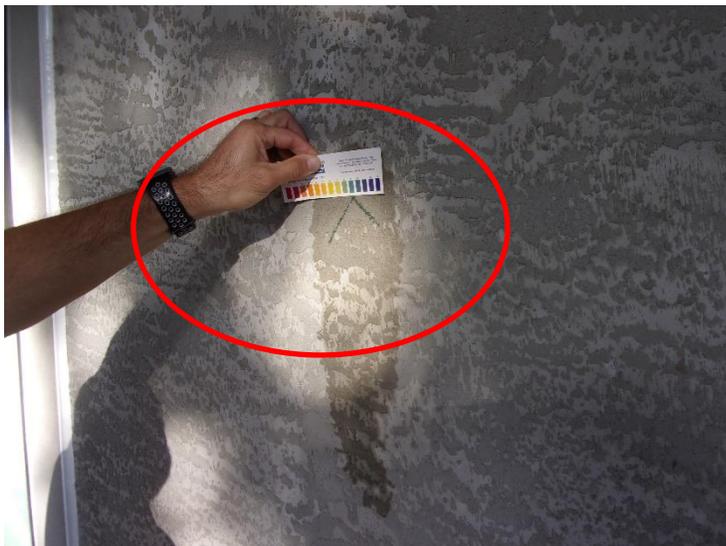
PHOTOGRAPH #4

**BUILDING 1
SECTION G**

Florida Paints manufacturer's representative testing for PH levels in new stucco.

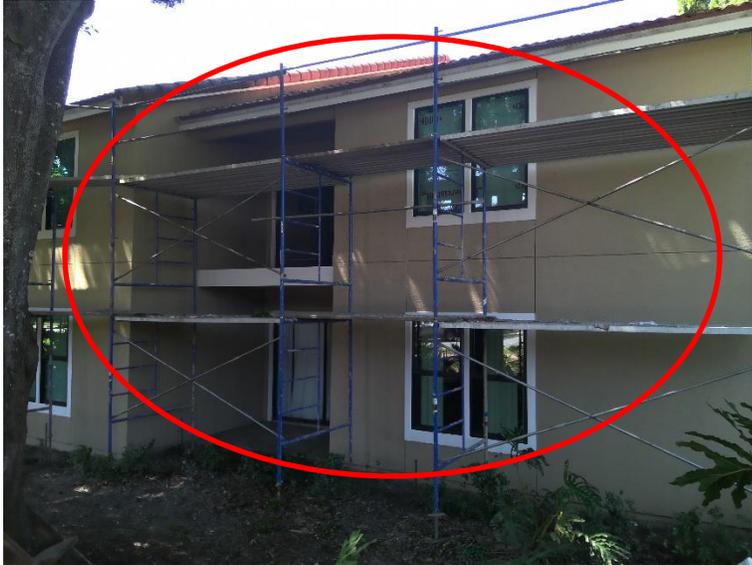
PHOTOGRAPH #5

**BUILDING 1
SECTION G**

Florida Paints primer and finish paint applied.

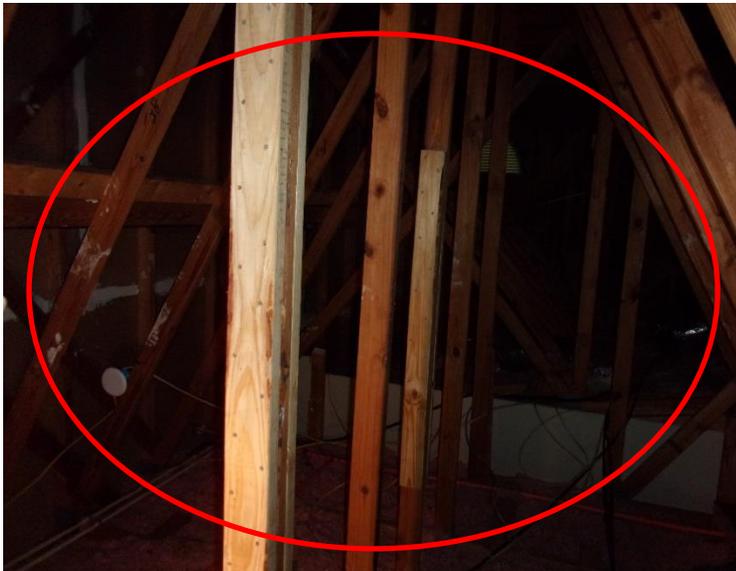
PHOTOGRAPH #6

**BUILDING 1
UNIT #122 – ATTIC**

Gusset, scabs, and fire wall repairs performed and quantified.

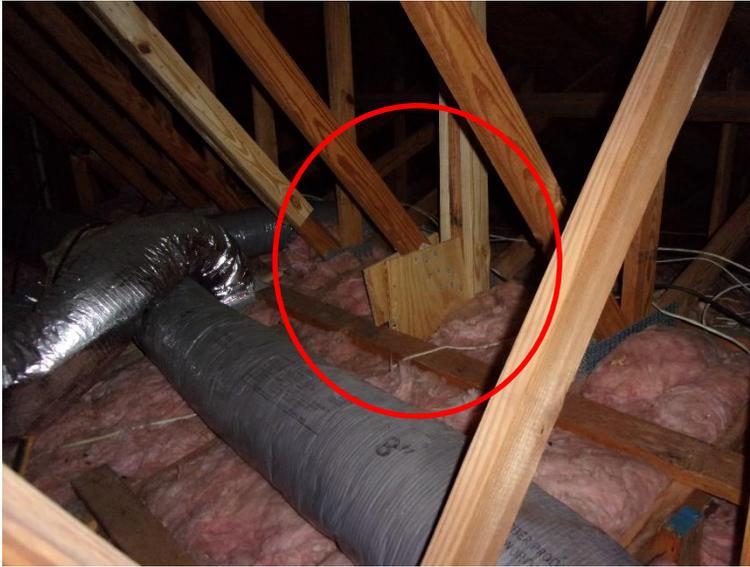
PHOTOGRAPH #7

**BUILDING 1
UNIT #122 – ATTIC**

Gusset, scabs, and fire wall repairs performed and quantified.

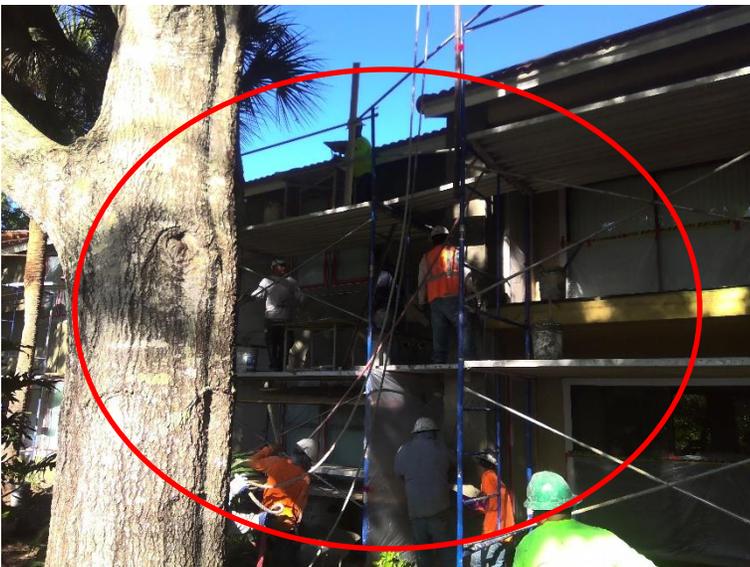
PHOTOGRAPH #8

**BUILDING 1
SECTION F**

Stucco subcontractor applying Broco stucco scratch coats and brown coats.

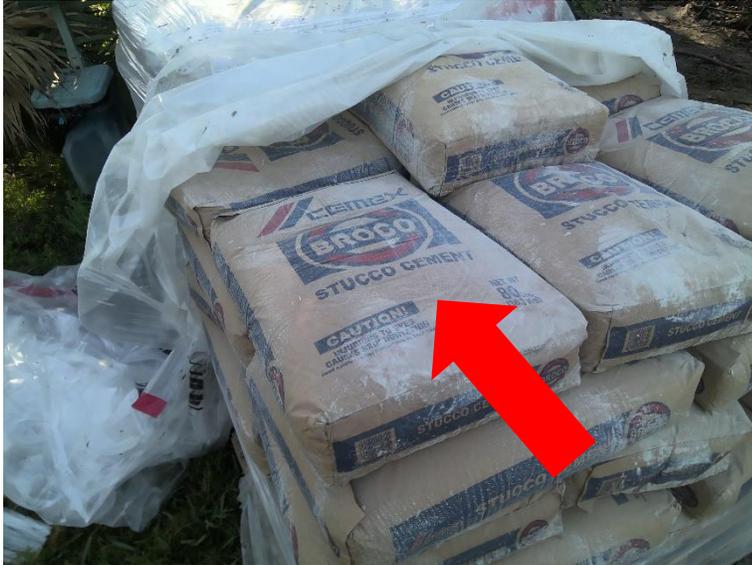
PHOTOGRAPH #9

**BUILDING 1
SECTION F**

Stucco subcontractor applying Broco stucco scratch coats and brown coats.

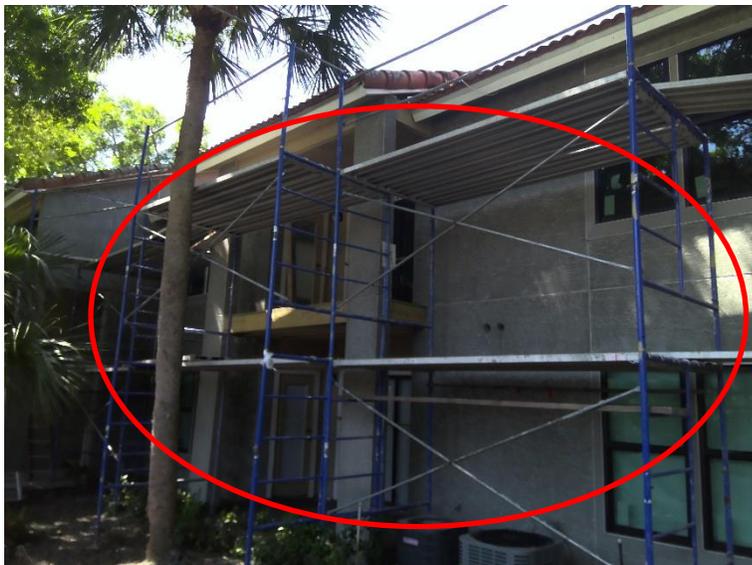
PHOTOGRAPH #10

**BUILDING 1
SECTION F**

Stucco subcontractor has applied Broco stucco finish texture coat.

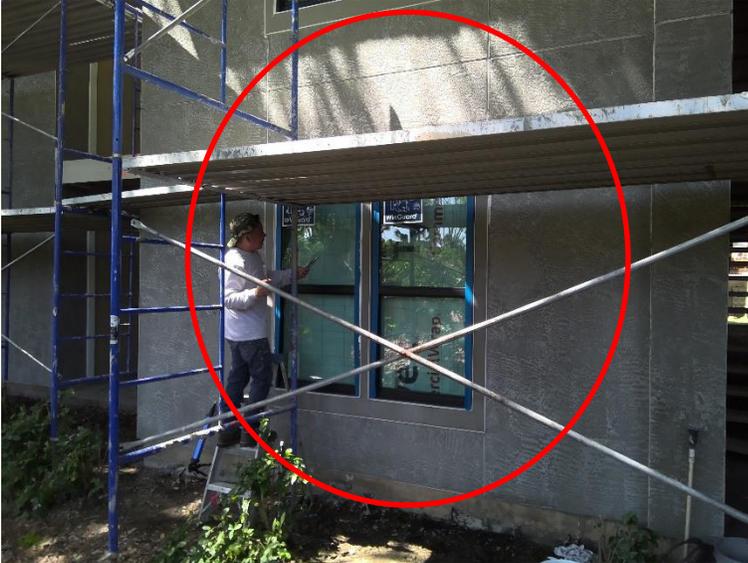
PHOTOGRAPH #11

**BUILDING 1
SECTION E**

MasterSeal NP 150 sealant application in progress at window perimeters and transitions.

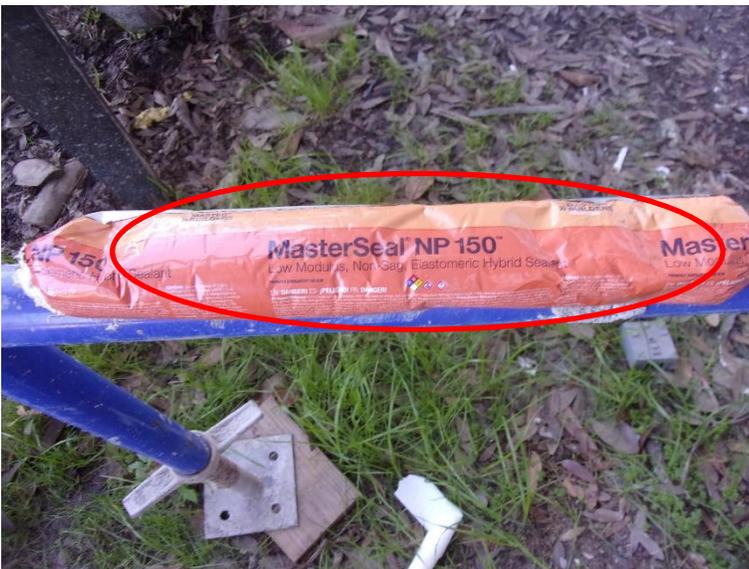
PHOTOGRAPH #12

**BUILDING 1
SECTION E**

MasterSeal NP 150 sealant application in progress at window perimeters and transitions.

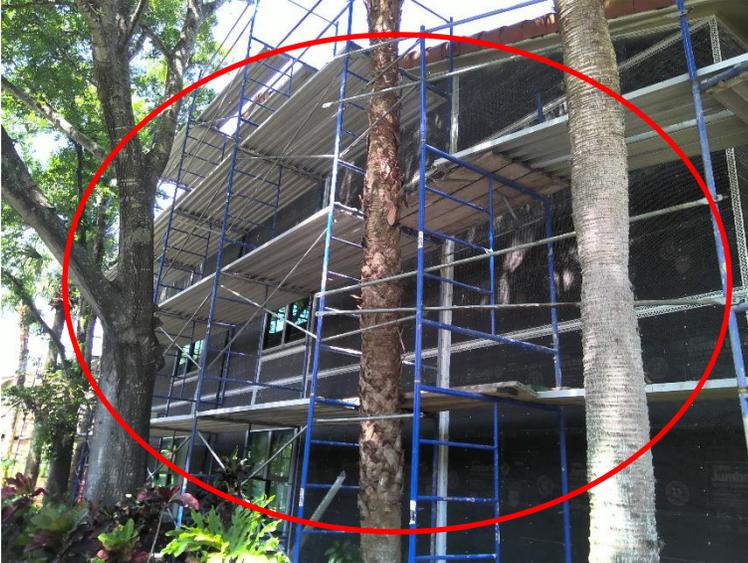
PHOTOGRAPH #13

**BUILDING 1
SECTION D**

Stucco accessories and lathing applied.

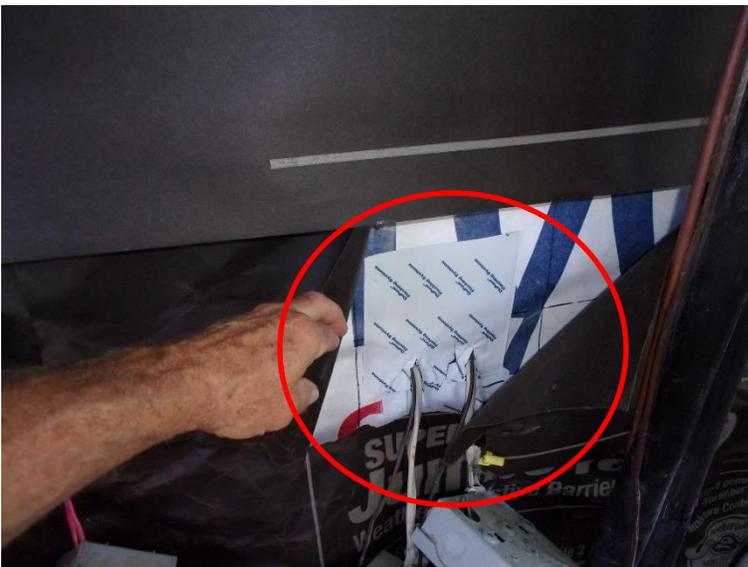
PHOTOGRAPH #14

**BUILDING 2
SECTION D**

Electrical and A/C penetrations detailed with Tyvek flashing prior to cover with Super Jumbo Tex 60.

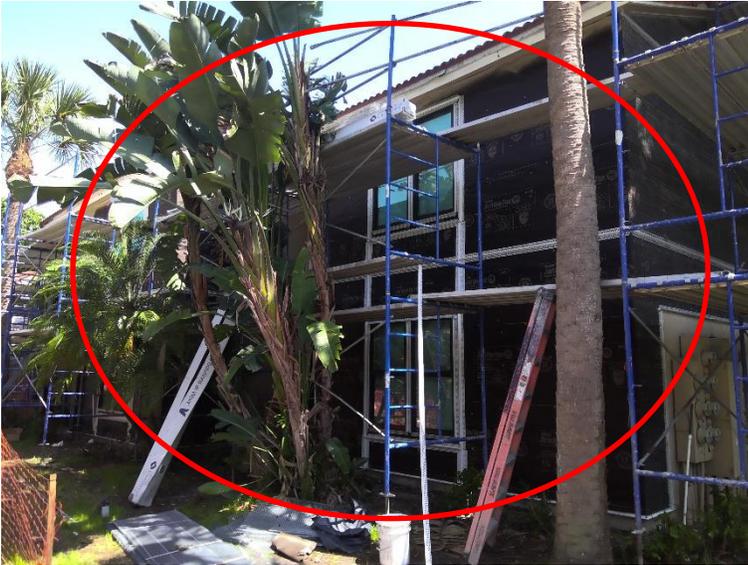
PHOTOGRAPH #15

**BUILDING 1
SECTION C**

Subcontractor applying stucco accessories at windows and joints.

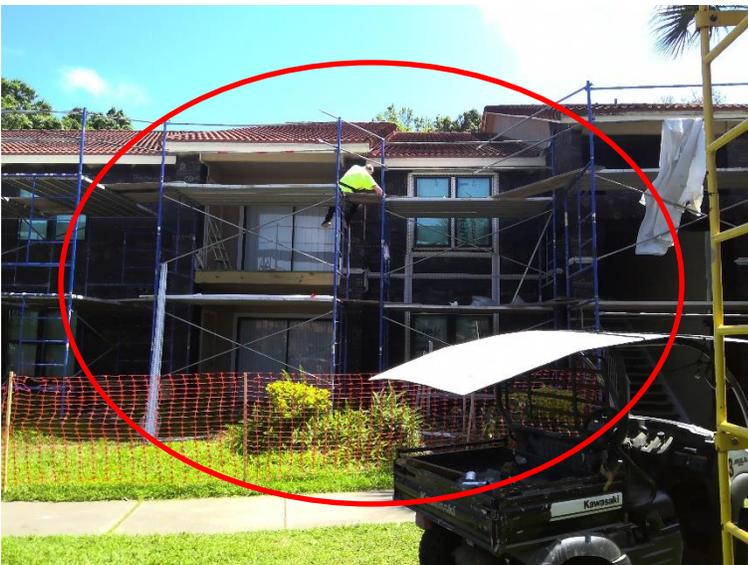
PHOTOGRAPH #16

**BUILDING 2
SECTION B**

Subcontractor applying Super Jumbo Tex 60 water resistant barrier.

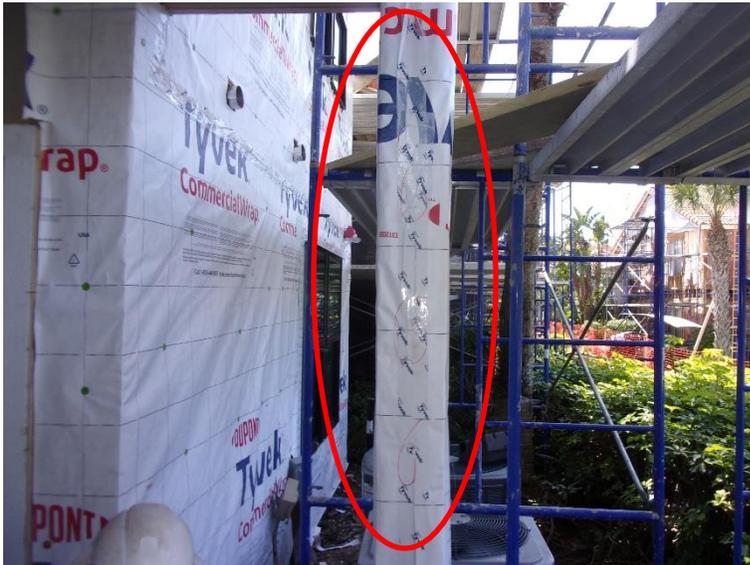
PHOTOGRAPH #17

**BUILDING 2
SECTION B**

Tyvek seam tape corrected where previously covered nail tabs.

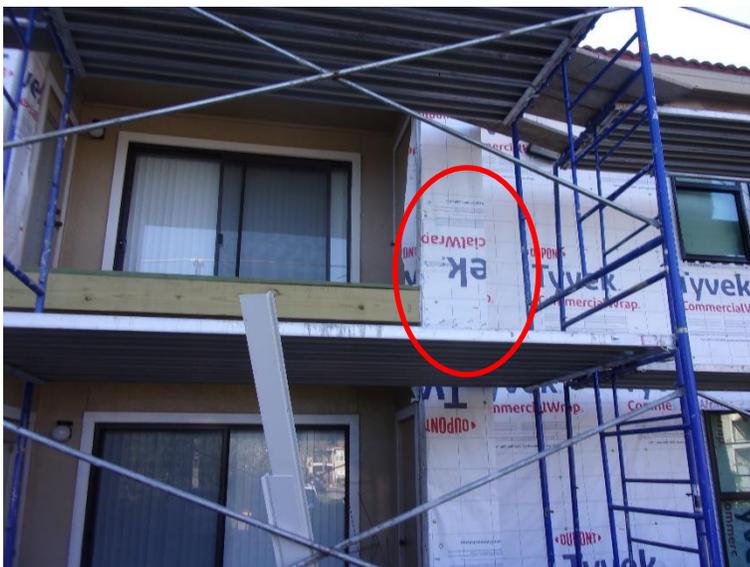
PHOTOGRAPH #18

**BUILDING 2
SECTION B**

Tyvek CommercialWrap WRB positively overlapped at balcony columns.

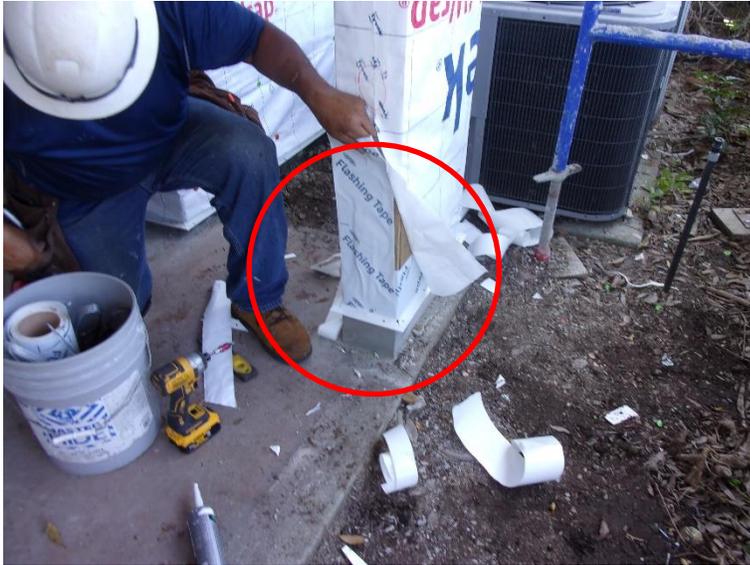
PHOTOGRAPH #19

**BUILDING 1
SECTION B**

Weep screed stucco termination detailed with Tyvek straight flash.

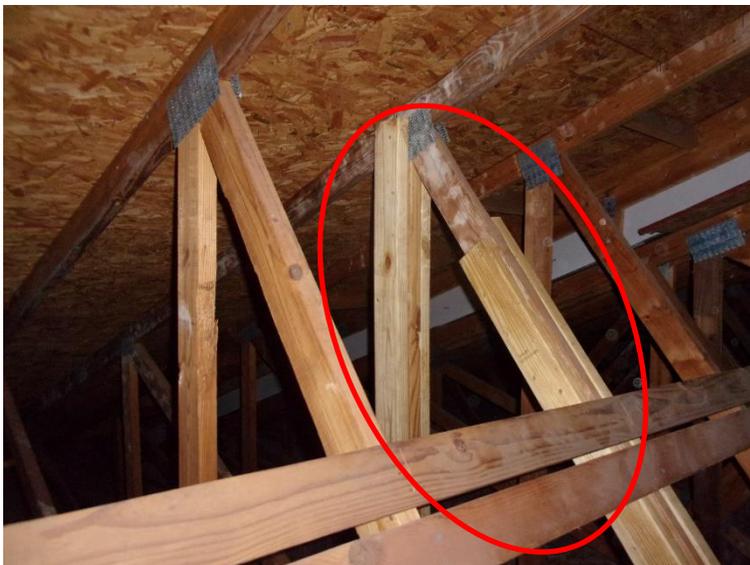
PHOTOGRAPH #20

**BUILDING 1
UNIT #124 – ATTIC**

Gusset, scabs, and fire wall repairs performed and quantified.

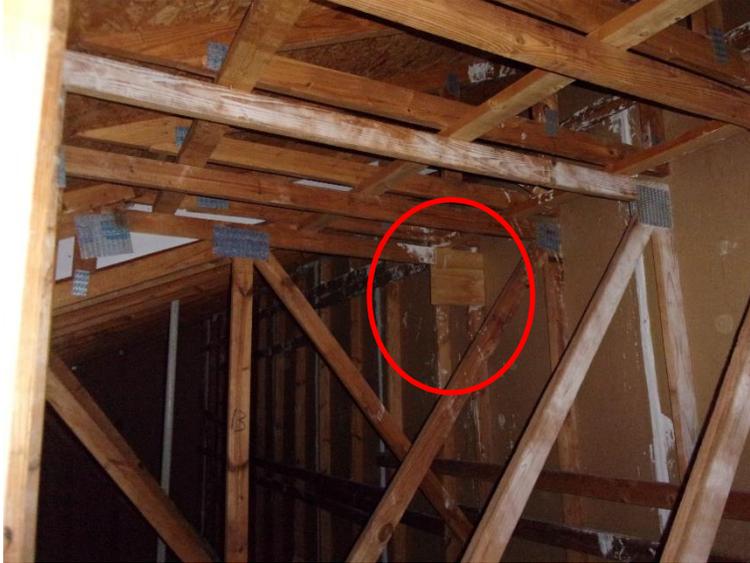
PHOTOGRAPH #21

**BUILDING 1
UNIT #124 – ATTIC**

Gusset, scabs, and fire wall repairs performed and quantified.

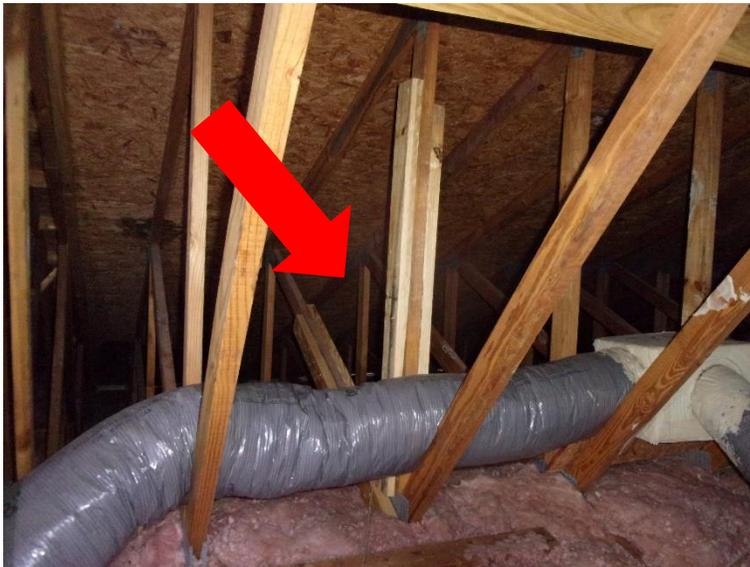
PHOTOGRAPH #22

**BUILDING 1
UNIT #121 – ATTIC**

Gusset, scabs, and fire wall repairs performed and quantified.

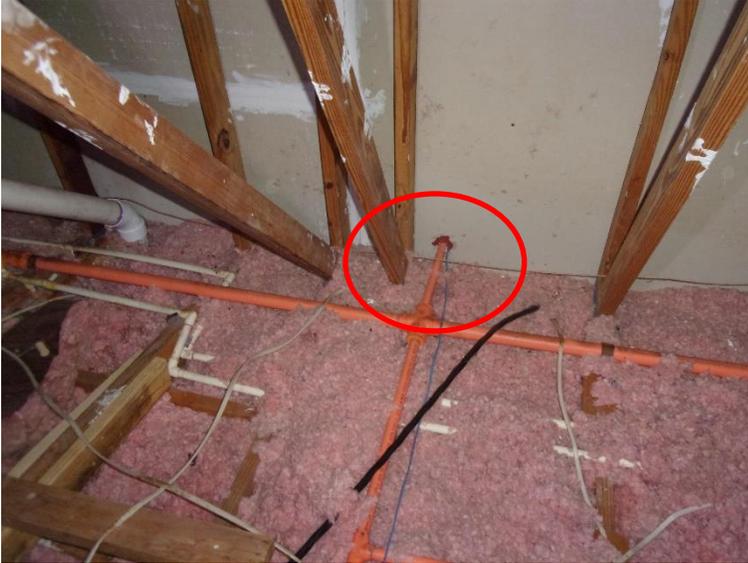
PHOTOGRAPH #23

**BUILDING 1
UNIT #121 – ATTIC**

Gusset, scabs, and fire wall repairs performed and quantified.

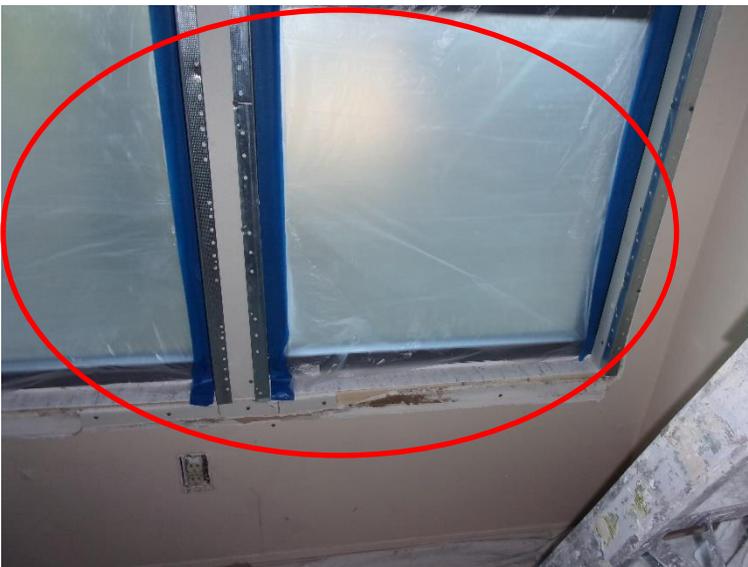
PHOTOGRAPH #24

**BUILDING 1
UNIT #112**

Drywall repairs in progress at interior window returns.

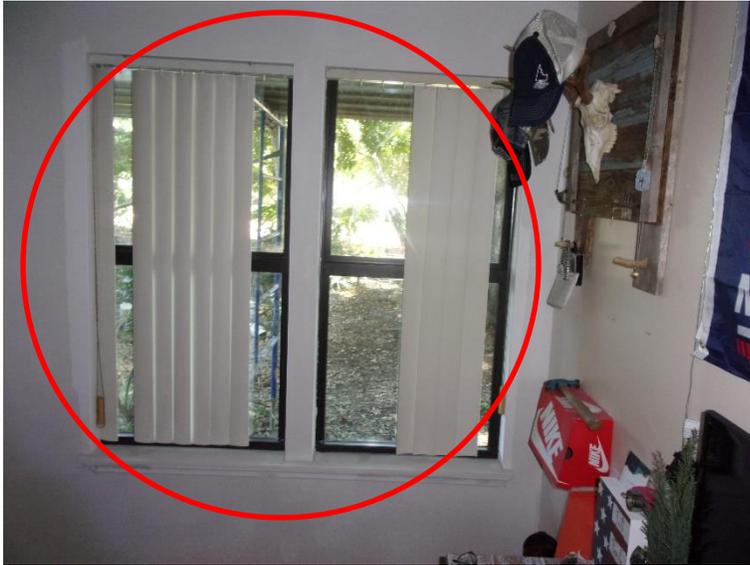
PHOTOGRAPH #25

**BUILDING 1
UNIT #112**

Drywall and sill repairs performed at window opening.

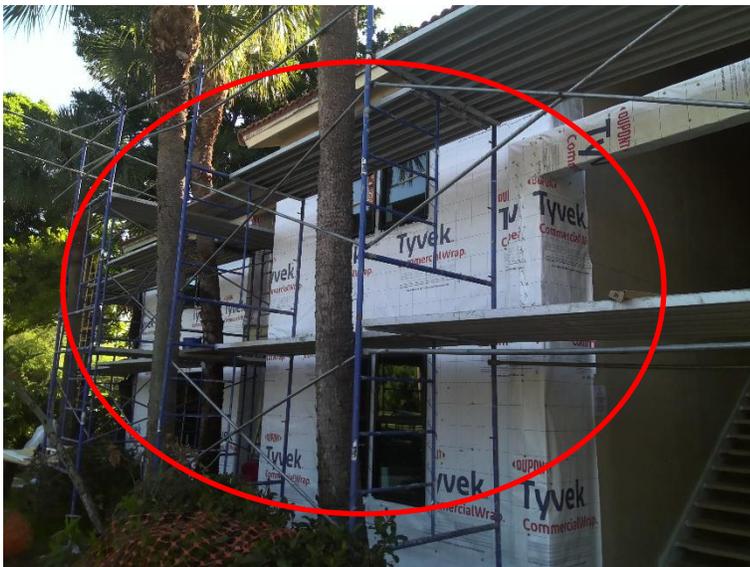
PHOTOGRAPH #26

**BUILDING 1
SECTION A**

New PGT windows installed with DuPont flashing details and Tyvek CommercialWrap.

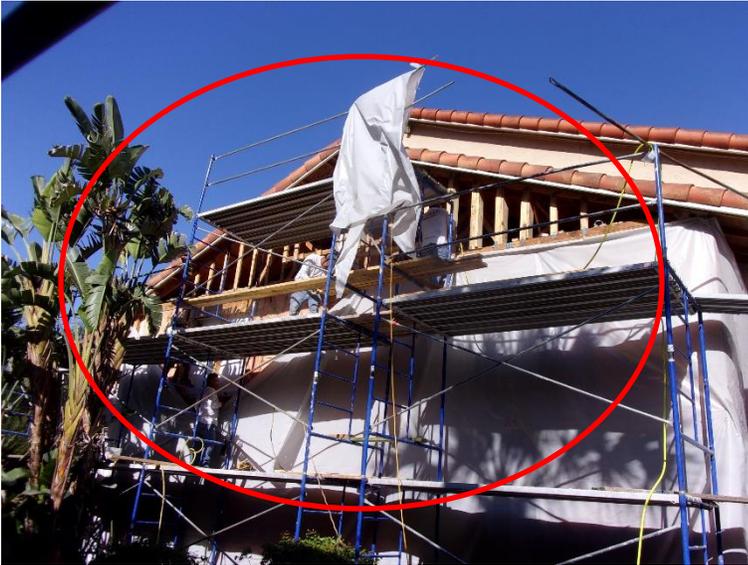
PHOTOGRAPH #27

**BUILDING 2
SECTION H**

Framing and reinforcing repairs in progress at gable end wall.

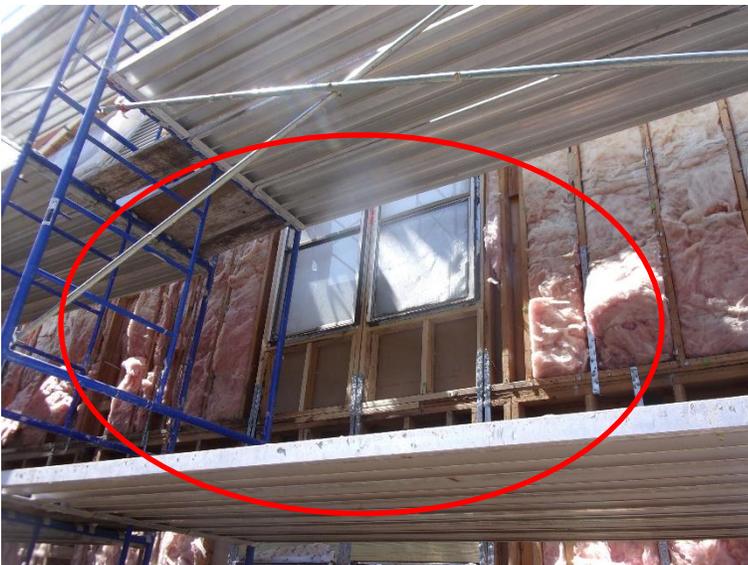
PHOTOGRAPH #28

**BUILDING 2
SECTION H**

Framing repairs performed at top plates, bottom plates, headers, and window openings.

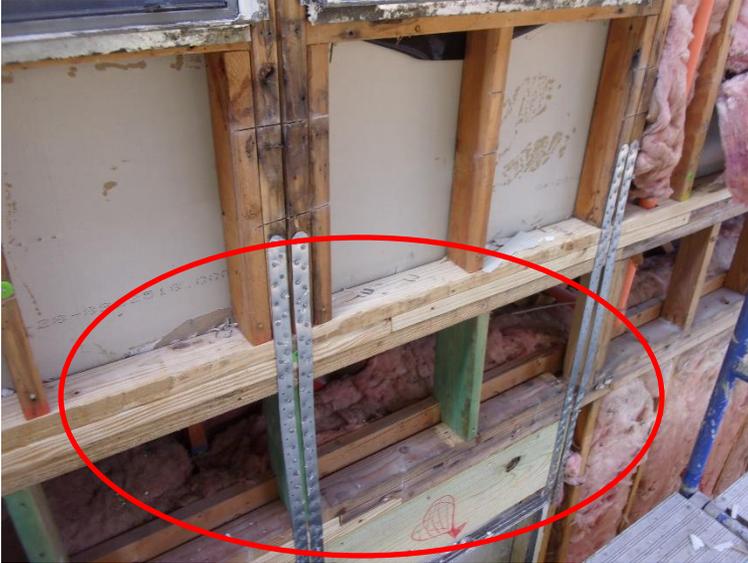
PHOTOGRAPH #29

**BUILDING 2
SECTION H**

Framing repairs performed at top plates, bottom plates, headers, and window openings.

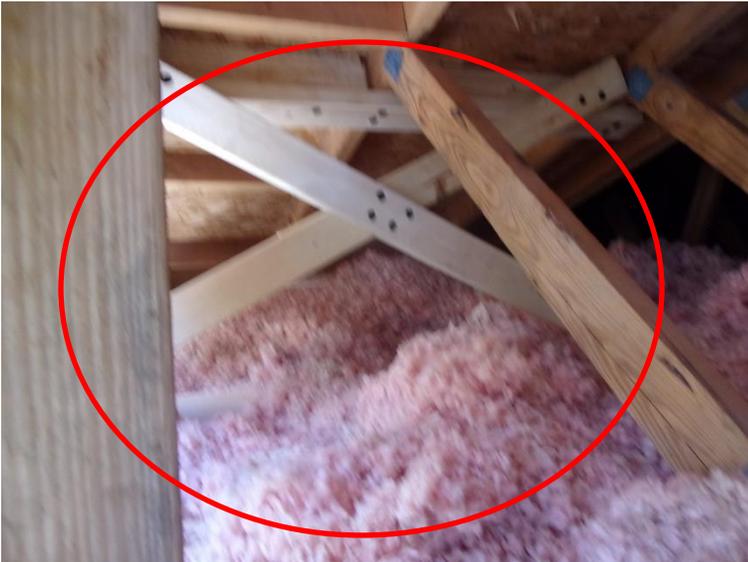
PHOTOGRAPH #30

**BUILDING 2
SECTION H**

Gable end reinforcing and cross bracing repair in progress.
