PHOTOGRAPHS

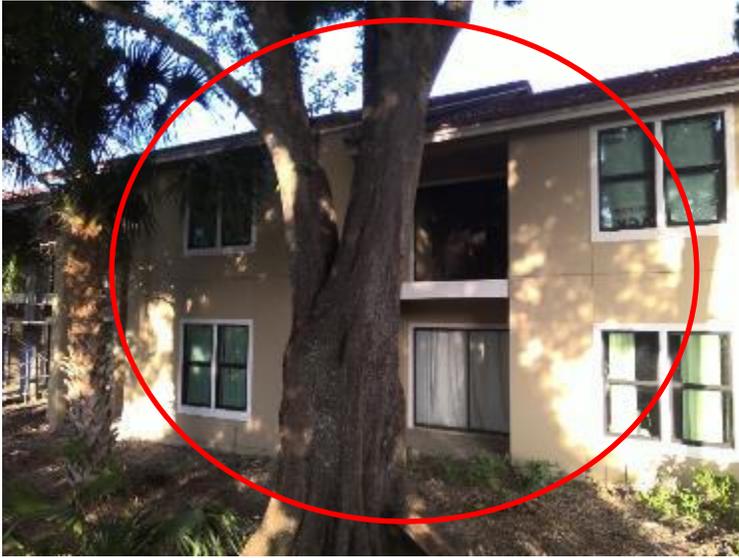
PHOTOGRAPH #1

**BUILDING 1
SECTION G**

Florida Paints primer and finish paint applied.

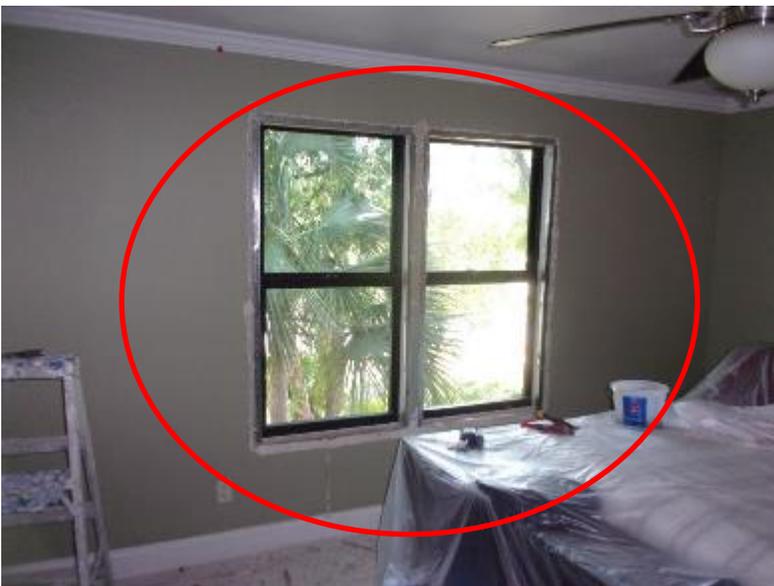
PHOTOGRAPH #2

**BUILDING 1
SECTION G- UNIT # 122**

Drywall repairs in progress at interior window openings.

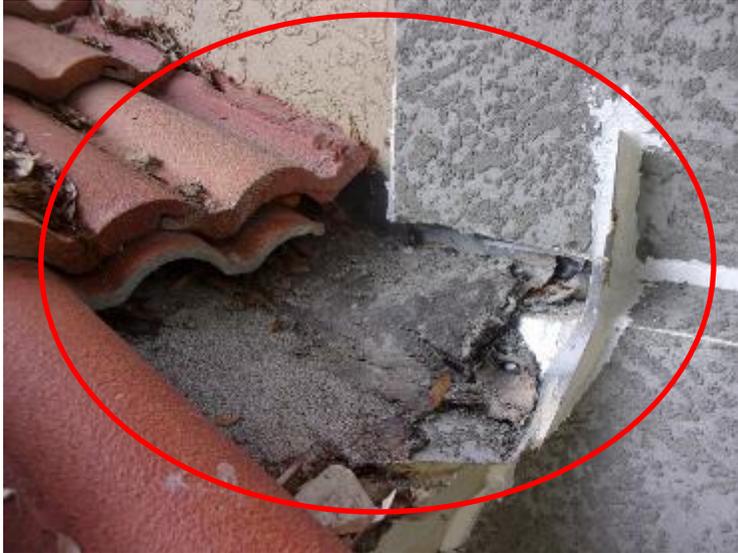
PHOTOGRAPH #3

**BUILDING 1
SECTION F**

Roof kick out details incomplete. Full bed of roofing mastic required prior to reinstallation of tiles and final details.

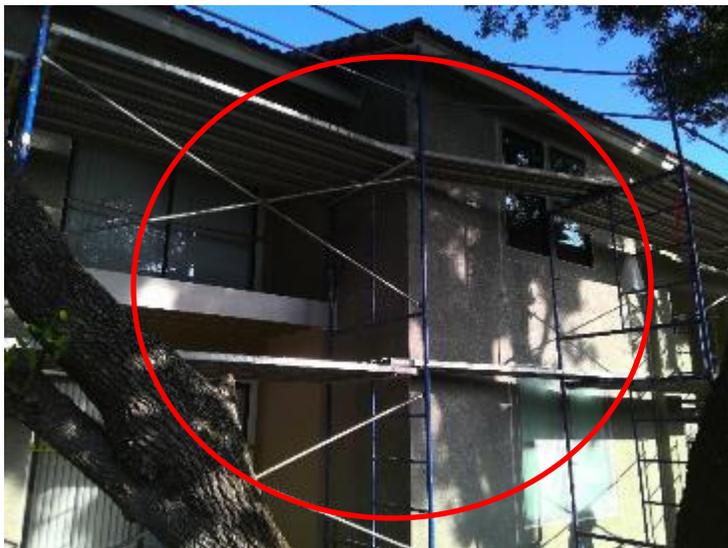
PHOTOGRAPH #4

**BUILDING 1
SECTION E**

Stucco finishes applied and Florida Paints primer coat in progress.

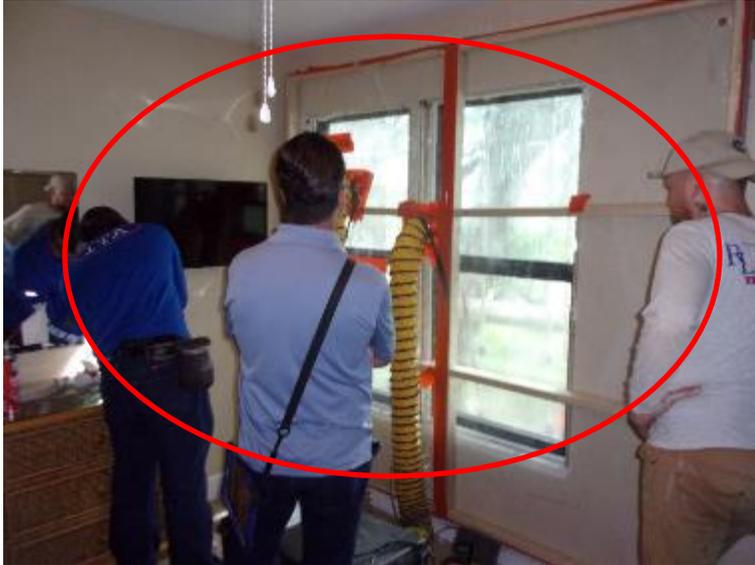
PHOTOGRAPH #5

**BUILDING 1
SECTION E – UNIT #128**

Independent Testing agency performing AAMA 502 testing at double windows.

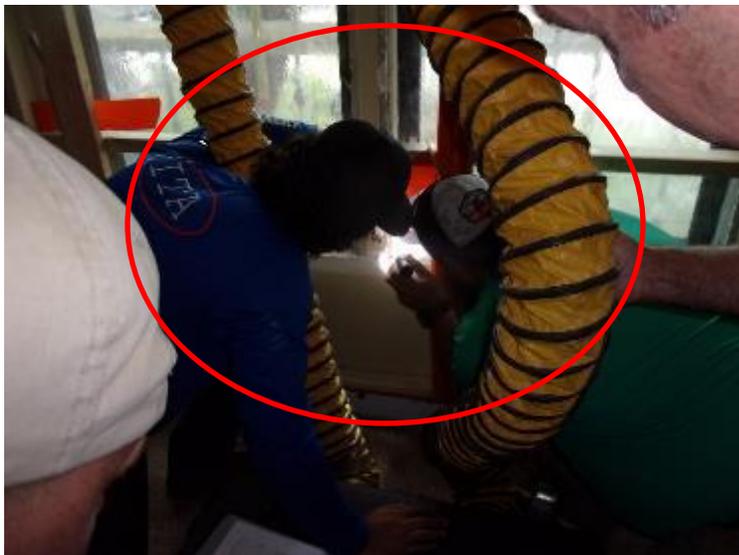
PHOTOGRAPH #6

**BUILDING 1
SECTION E – UNIT #128**

Testing failed allowing water penetration at left bottom corner of right window.

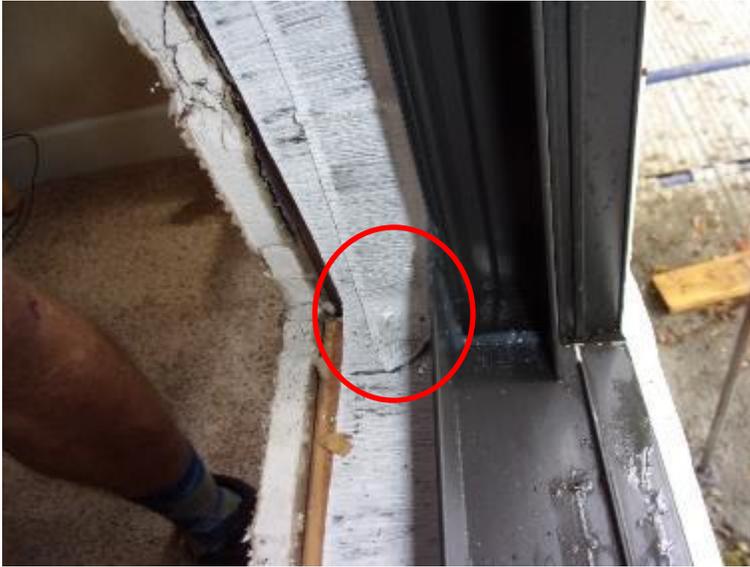
PHOTOGRAPH #7

**BUILDING 1
SECTION E – UNIT #128**

Testing failed allowing water penetration at left bottom corner of right window.

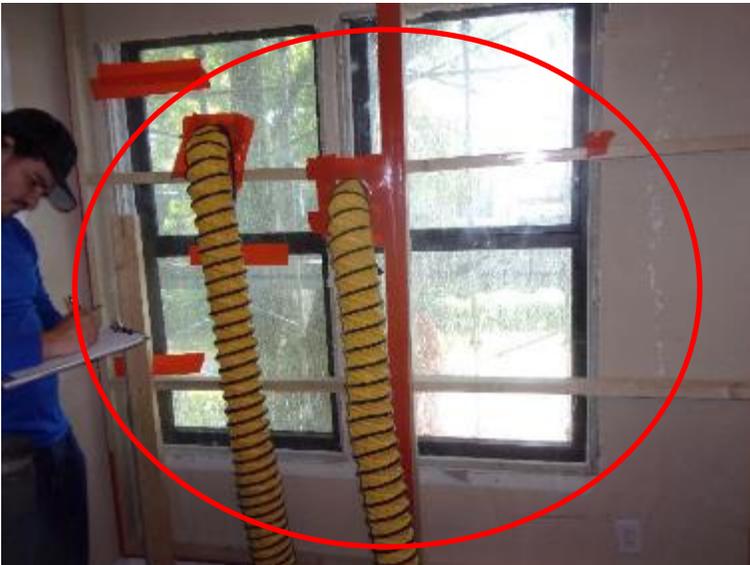
PHOTOGRAPH #8

**BUILDING 1
SECTION D – UNIT #128**

Independent Testing agency performing AAMA 502 testing at double windows.

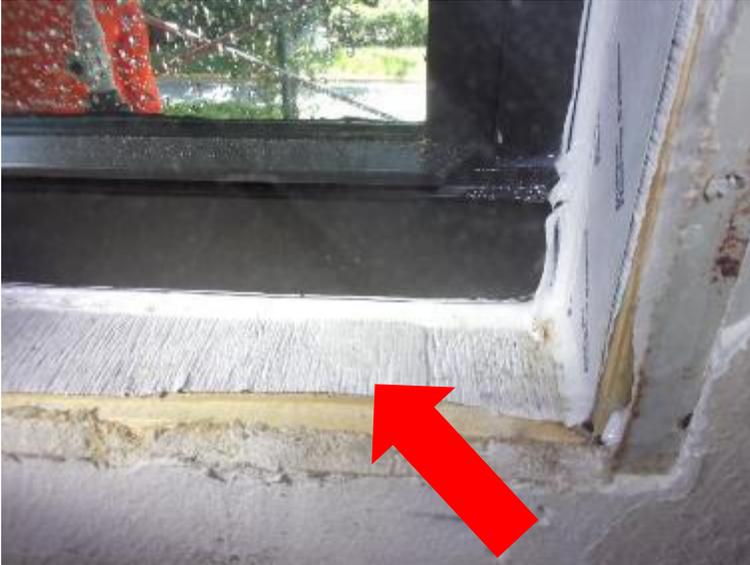
PHOTOGRAPH #9

**BUILDING 1
SECTION D – UNIT #128**

Testing failed allowing water penetration at bottom of right window. Retesting successful after sealant remediation performed with silicone sealant at window framing.

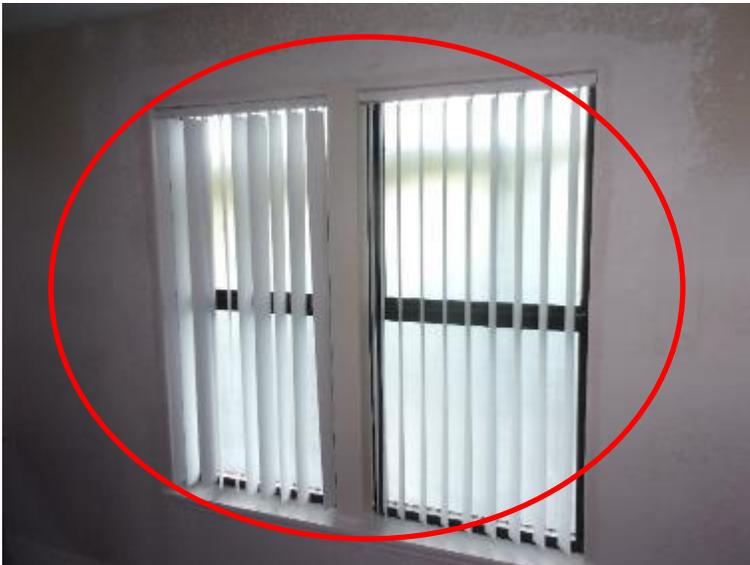
PHOTOGRAPH #10

**BUILDING 1
SECTION D / UNIT #118**

Drywall, windowsill repairs and texture performed at window openings.

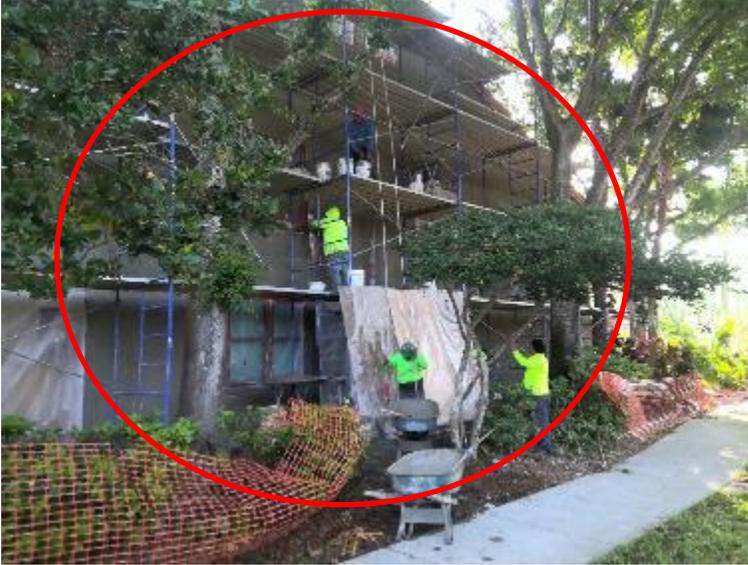
PHOTOGRAPH #11

**BUILDING 1
SECTION D**

Stucco contractor performing scratch and brown coats of stucco.

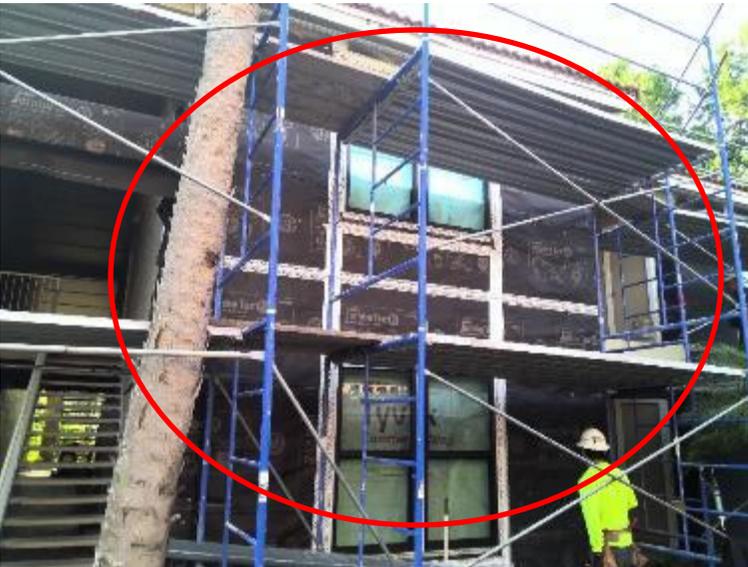
PHOTOGRAPH #12

**BUILDING 1
SECTION C**

Stucco contractor applying stucco accessories and lathing.

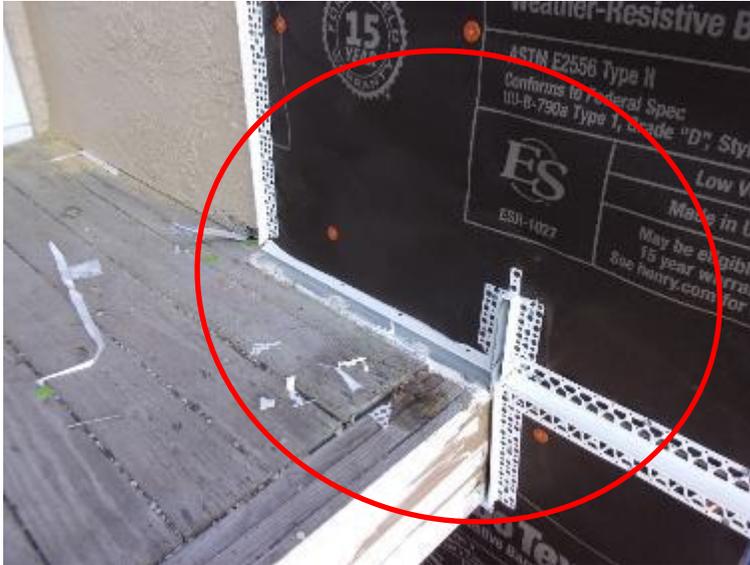
PHOTOGRAPH #13

**BUILDING 1
SECTION B**

Kick out flashing details installed with stucco accessories at balcony edges.

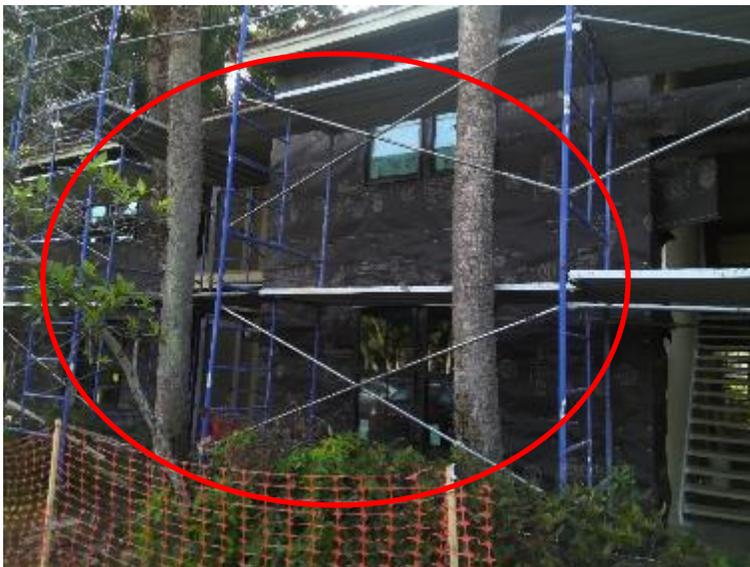
PHOTOGRAPH #14

**BUILDING 1
SECTION A**

Super Jumbo Tex 60 WRB applied over Tyvek WRB.

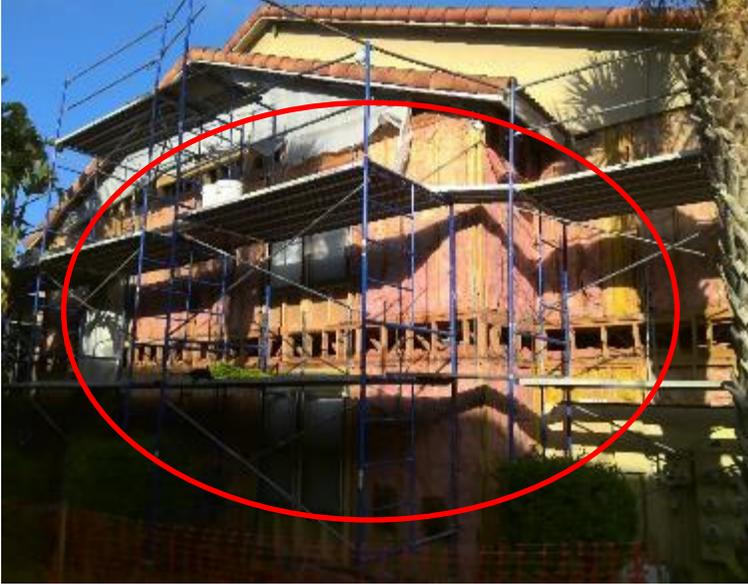
PHOTOGRAPH #15

**BUILDING 2
SECTION H**

Framing repairs, strapping, connectors, Termite protection and wood preservative performed.

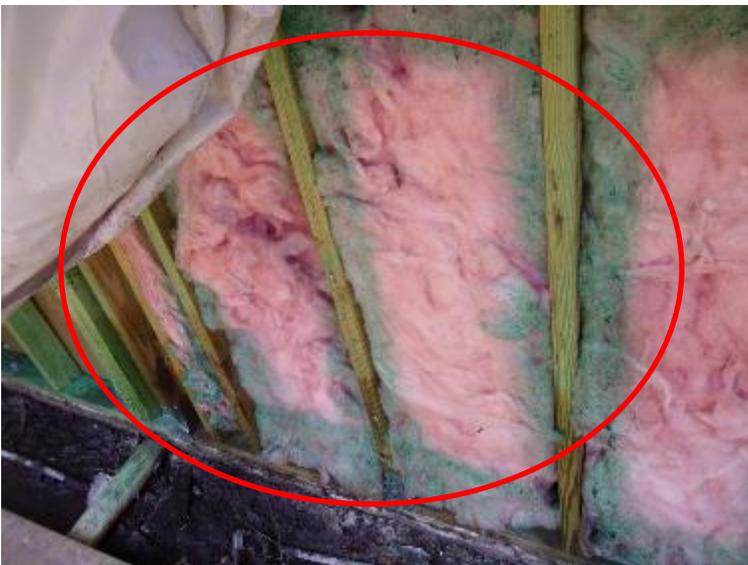
PHOTOGRAPH #16

**BUILDING 2
SECTION H**

Borra Care Termite treatment applied by pest sub-contractor.

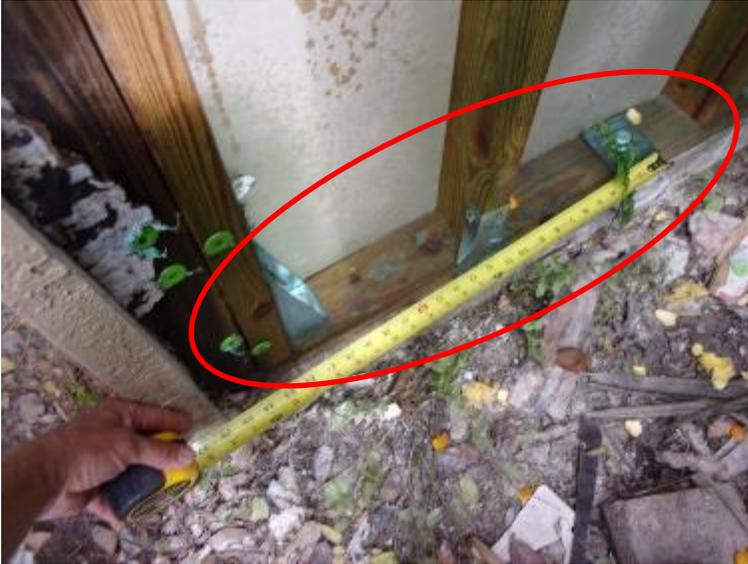
PHOTOGRAPH #17

**BUILDING 2
SECTION H**

Simpson Strong-Tie connectors and anchors installed according to drawings and specifications.

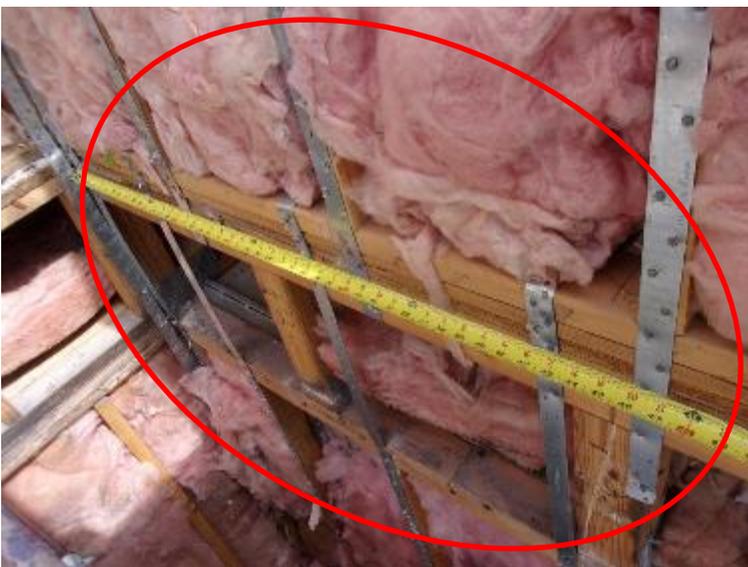
PHOTOGRAPH #18

**BUILDING 2
SECTION H**

Simpson Strong-Tie straps installed according to drawings and specifications.

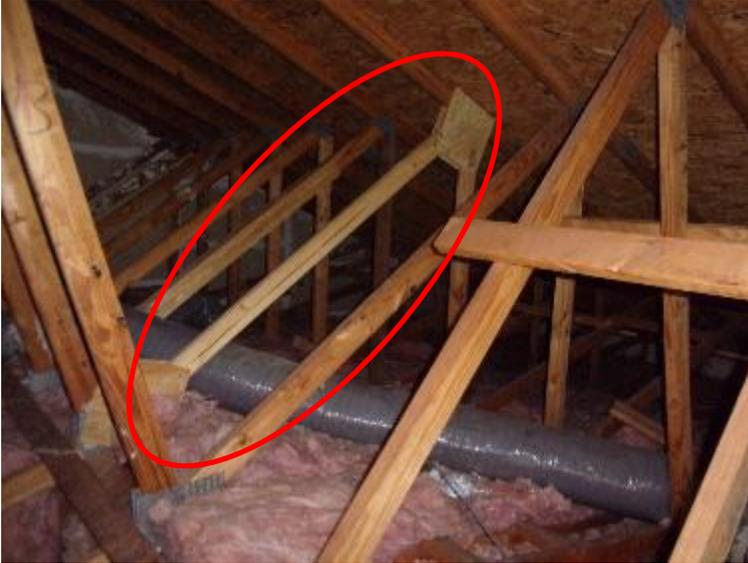
PHOTOGRAPH #19

**BUILDING 2
UNIT #221 - ATTIC**

Gusset, scabs, and fire wall repairs performed and quantified.

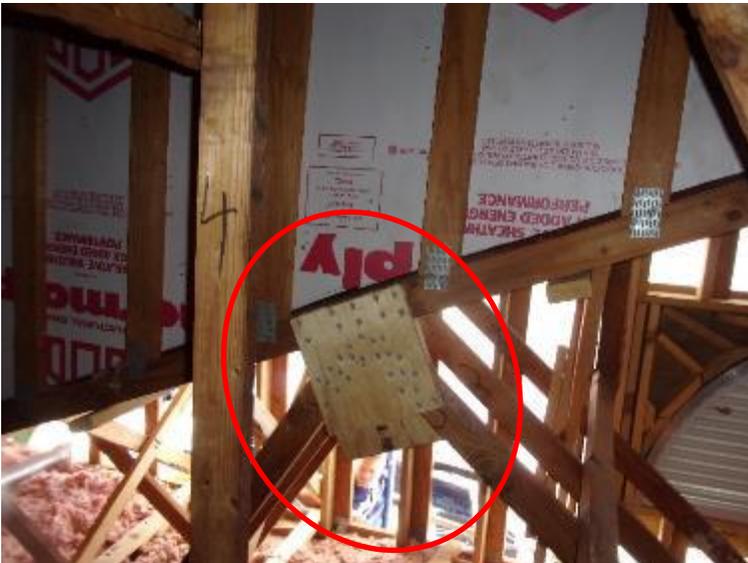
PHOTOGRAPH #20

**BUILDING 2
UNIT #221 - ATTIC**

Gusset, scabs, and fire wall repairs performed and quantified.

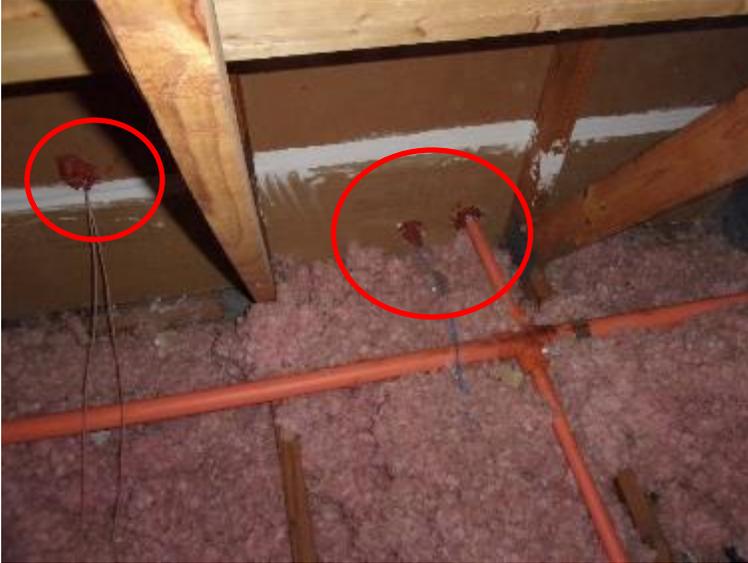
PHOTOGRAPH #21

**BUILDING 2
UNIT #222 – ATTIC**

Gusset, scabs, and fire wall repairs performed and quantified.

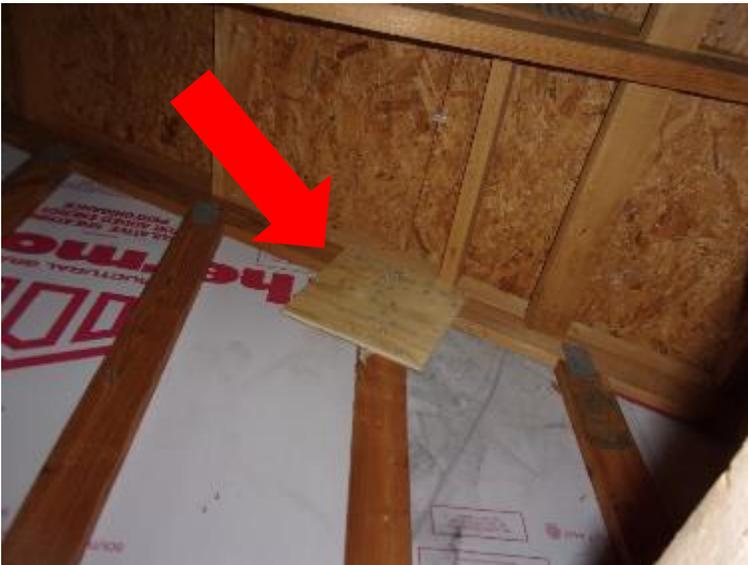
PHOTOGRAPH #22

**BUILDING 2
UNIT #222 – ATTIC**

Gusset, scabs, and fire wall repairs performed and quantified.

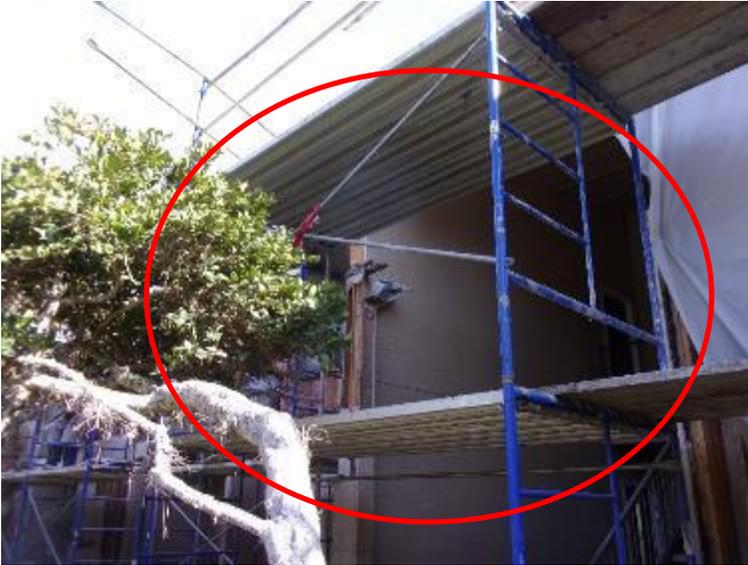
PHOTOGRAPH #23

**BUILDING 2
SECTION G**

Breezeway beam collapsed when stucco was removed.

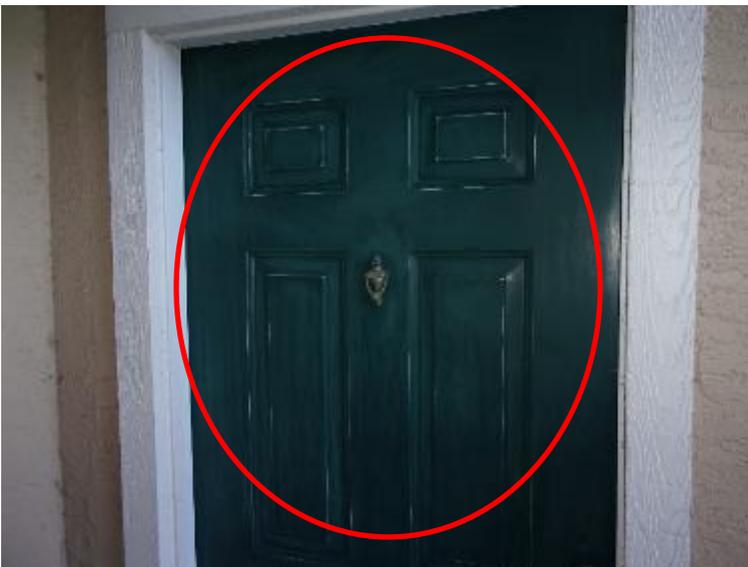
PHOTOGRAPH #24

**BUILDING 2
SECTION G-BREEZEWAY**

Entry doors sanded in preparation for prim coat of paint.

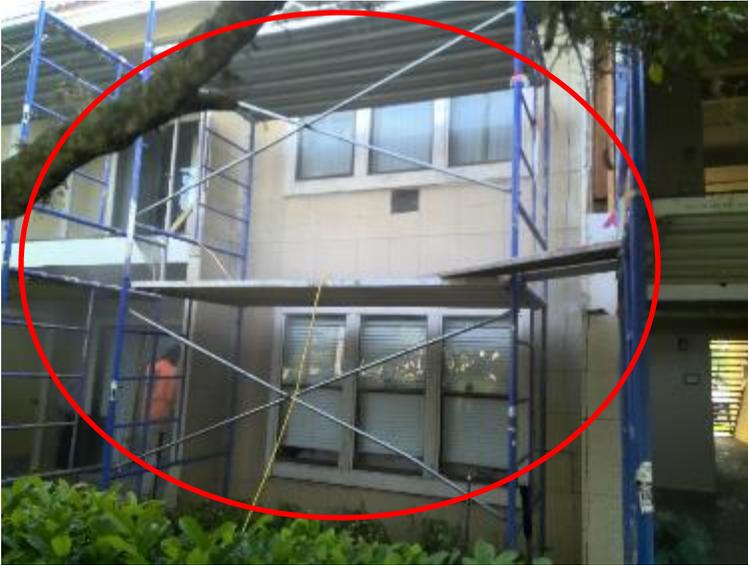
PHOTOGRAPH #25

**BUILDING 2
SECTION F**

Contractor has erected access scaffold and begun removal of stucco.

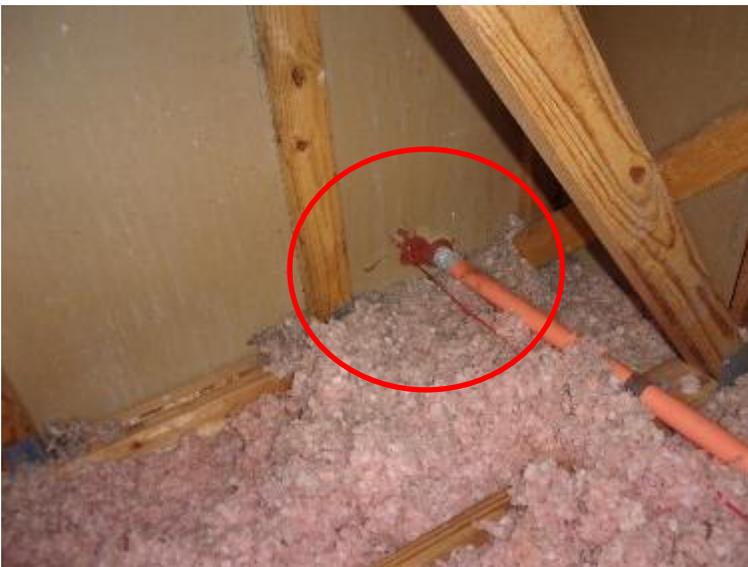
PHOTOGRAPH #26

**BUILDING 2
UNIT #224 – ATTIC**

Holes in new fire caulk require contractor to repair.

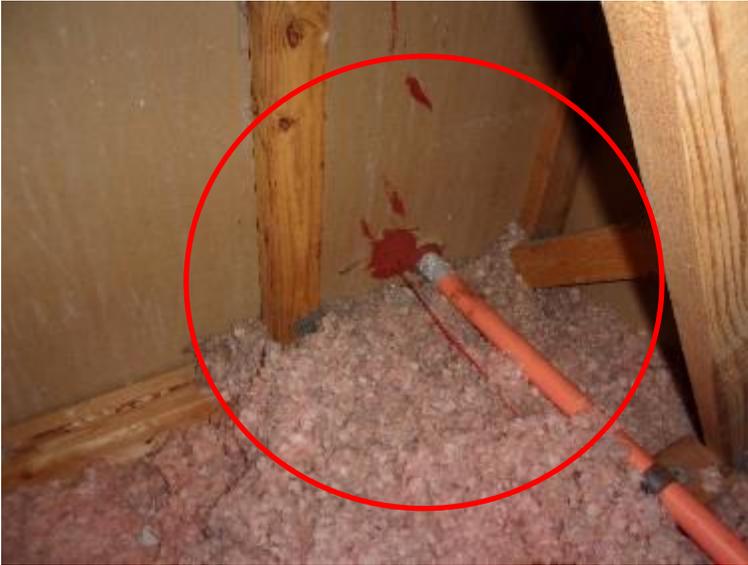
PHOTOGRAPH #27

**BUILDING 2
UNIT #224 – ATTIC**

Contractor has repaired holes in new fire caulk.

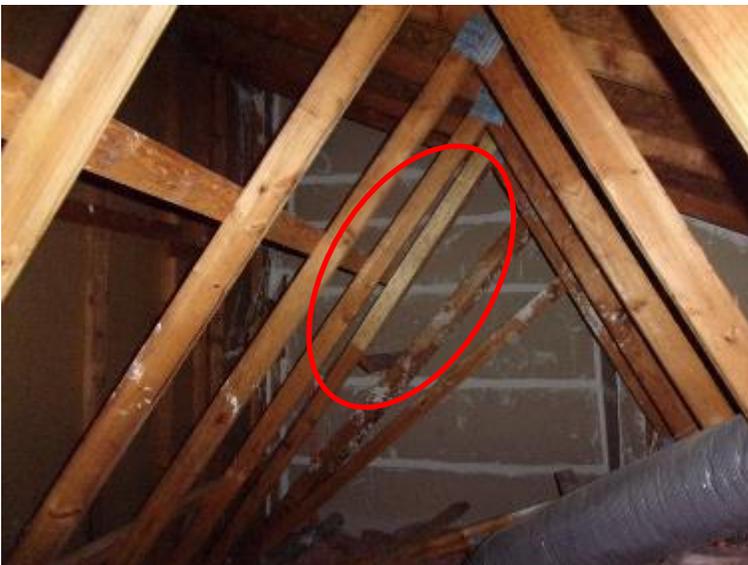
PHOTOGRAPH #28

**BUILDING 2
UNIT #224 – ATTIC**

Gusset, scabs, and fire wall repairs performed and quantified.

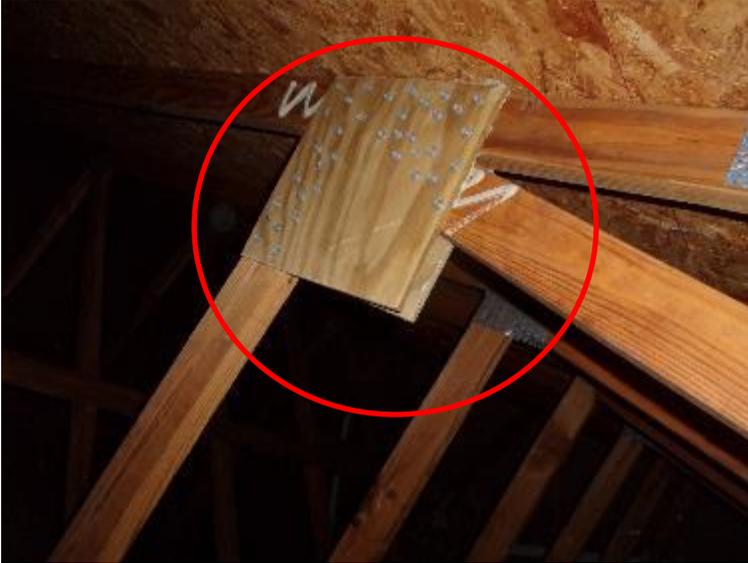
PHOTOGRAPH #29

**BUILDING 2
UNIT #226 – ATTIC**

Gusset, scabs, and fire wall repairs performed and quantified.

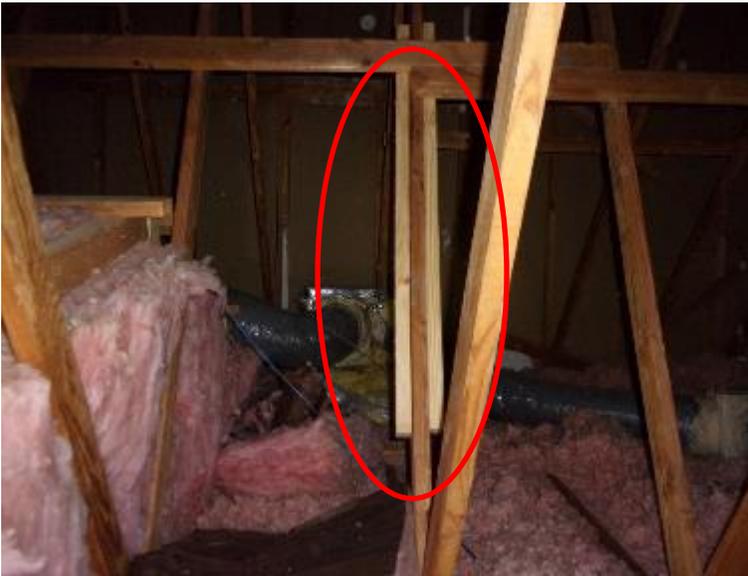
PHOTOGRAPH #30

**BUILDING 2
UNIT #226 – ATTIC**

Gusset, scabs, and fire wall repairs performed and quantified.

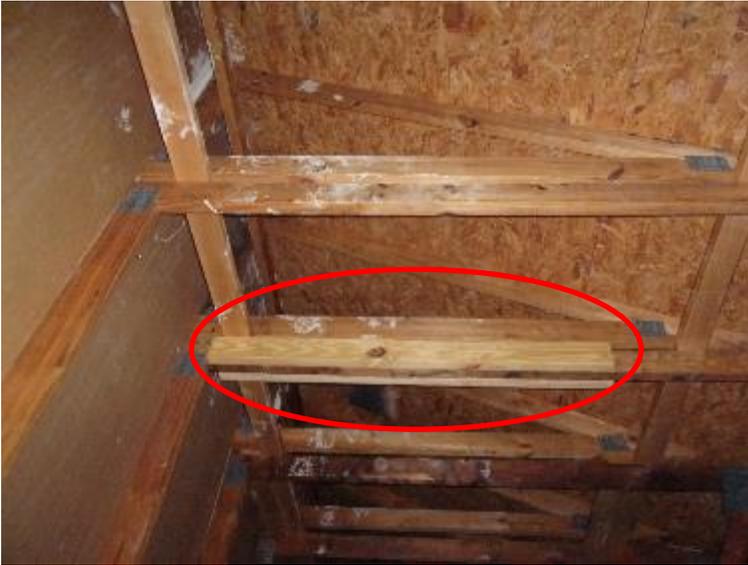
PHOTOGRAPH #31

**BUILDING 2
UNIT #228 – ATTIC**

Gusset, scabs, and fire wall repairs performed and quantified.

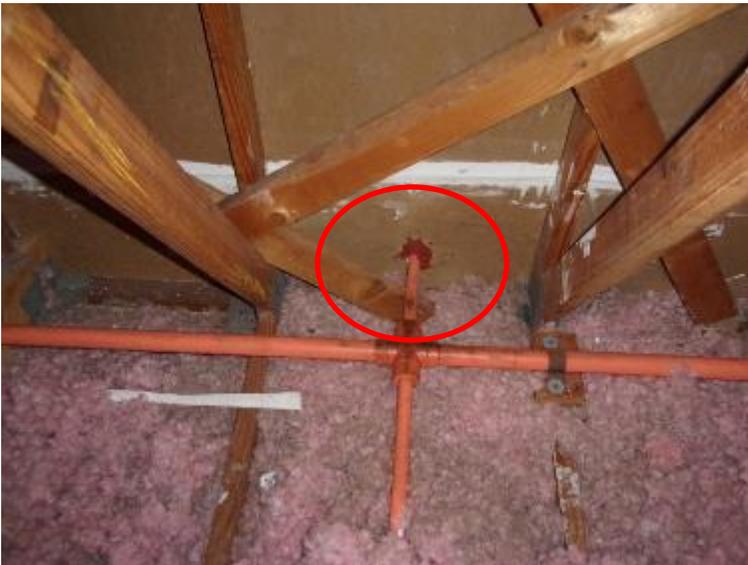
PHOTOGRAPH #32

**BUILDING 2
UNIT #228 – ATTIC**

Gusset, scabs, and fire wall repairs performed and quantified.

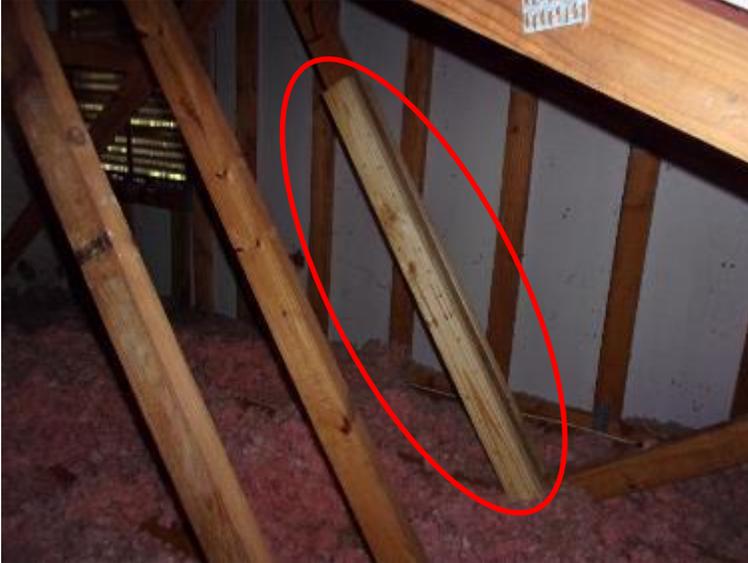
PHOTOGRAPH #33

**BUILDING 2
UNIT #227 – ATTIC**

Gusset, scabs, and fire wall repairs performed and quantified.

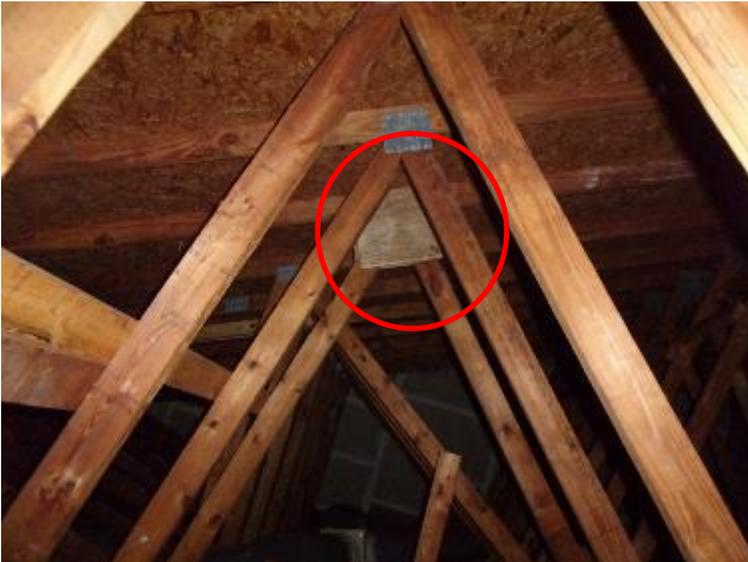
PHOTOGRAPH #34

**BUILDING 2
UNIT #227– ATTIC**

Gusset, scabs, and fire wall repairs performed and quantified.

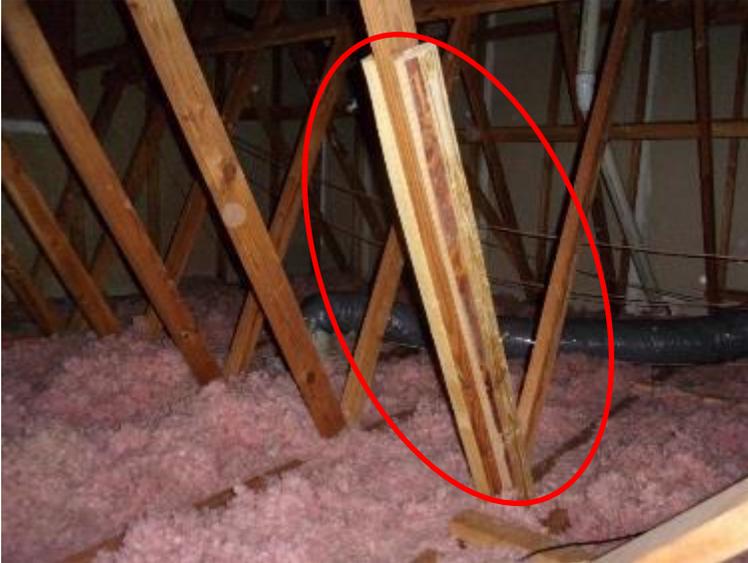
PHOTOGRAPH #35

**BUILDING 2
UNIT #225 – ATTIC**

Gusset, scabs, and fire wall repairs performed and quantified.

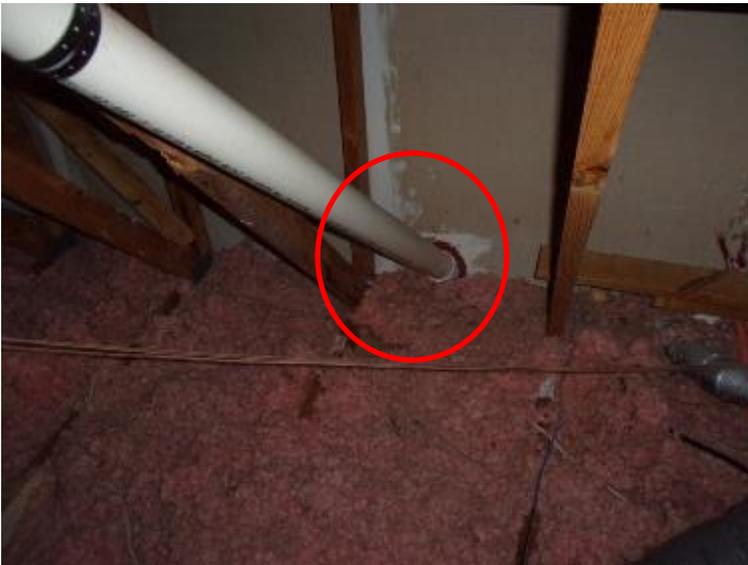
PHOTOGRAPH #36

**BUILDING 2
UNIT #225 – ATTIC**

Gusset, scabs, and fire wall repairs performed and quantified.

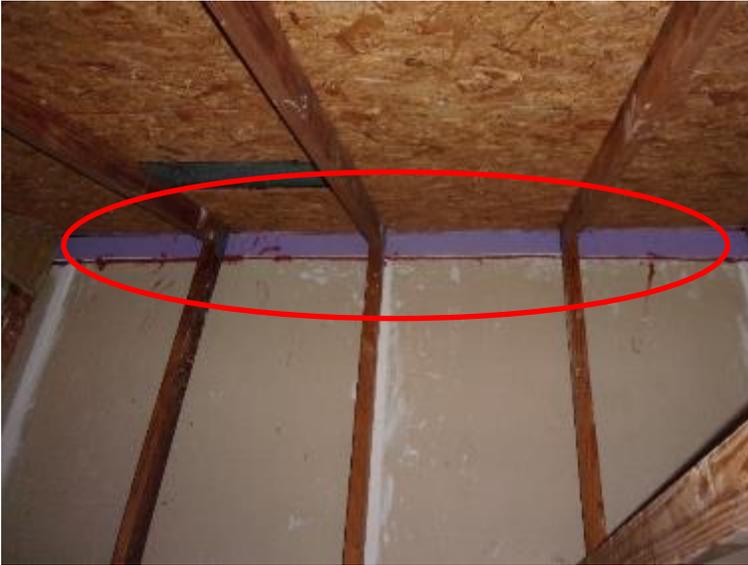
PHOTOGRAPH #37

**BUILDING 2
UNIT #223 – ATTIC**

Gusset, scabs, and fire wall repairs performed and quantified.

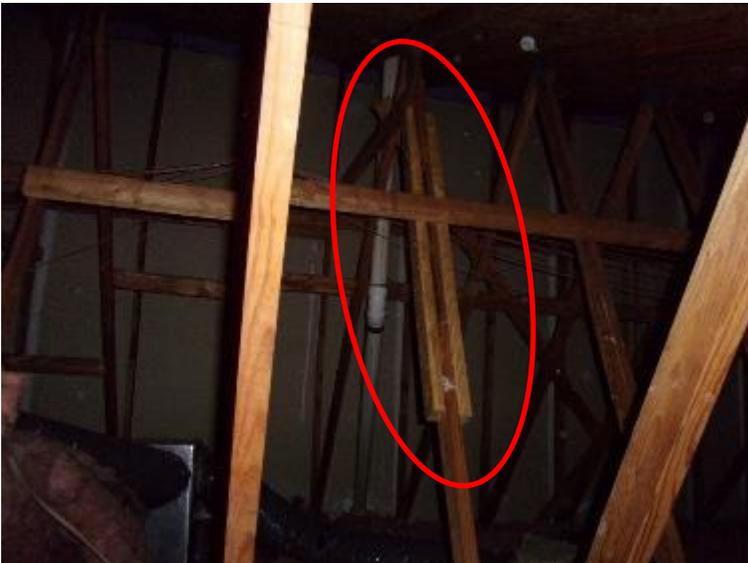
PHOTOGRAPH #38

**BUILDING 2
UNIT #223 – ATTIC**

Gusset, scabs, and fire wall repairs performed and quantified.
