**Vintage Grand Condominium Association  
Hurricane Irma  
Damage Assessment**

ESi Project #: 78360G

# Investigative Report

## Vintage Grand Condominium Association Hurricane Irma Damage Assessment

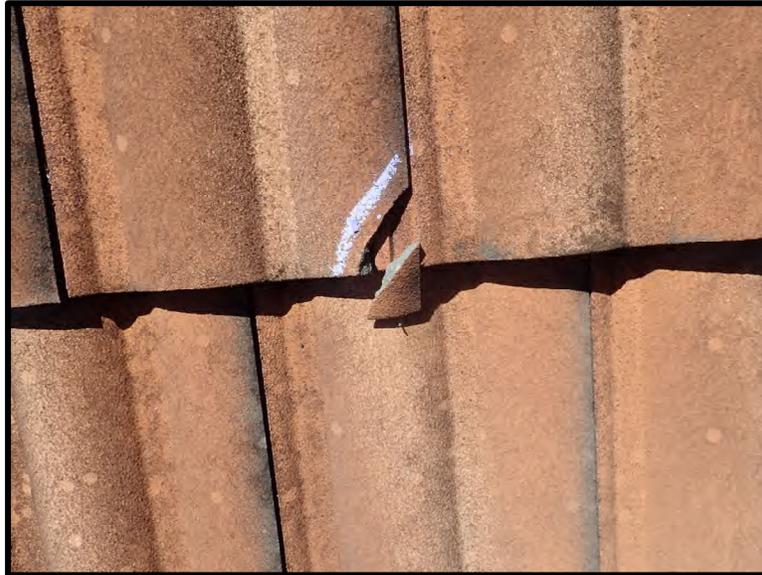
**Figure 9** – Example of chipped tile corner in close proximity of the source tile.

The observed damage was indicative of footfall and/or expansion and contraction due to changes in temperature and is not associated with wind from the Hurricane Irma. This opinion is well documented by a wide range of industry supported research on the causation of the corner cracked roof tiles.

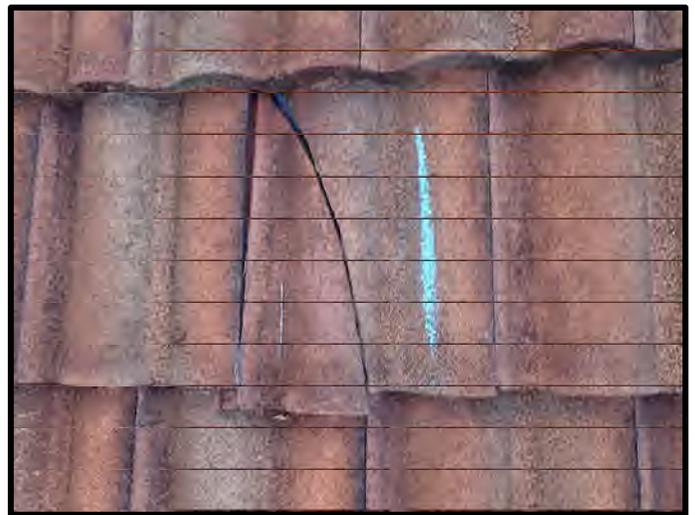
Photograph 3 – Loose Monier T210A tile.

Photograph 4 – Cracked concrete roof tile.

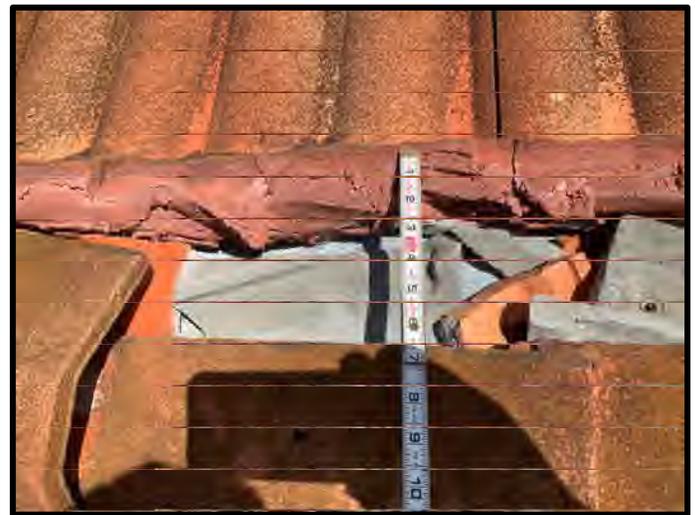
Photograph 3 – Loose ridge cap tiles.

Photograph 4 – Loose ridge cap tiles, displaced approximately 6 inches.

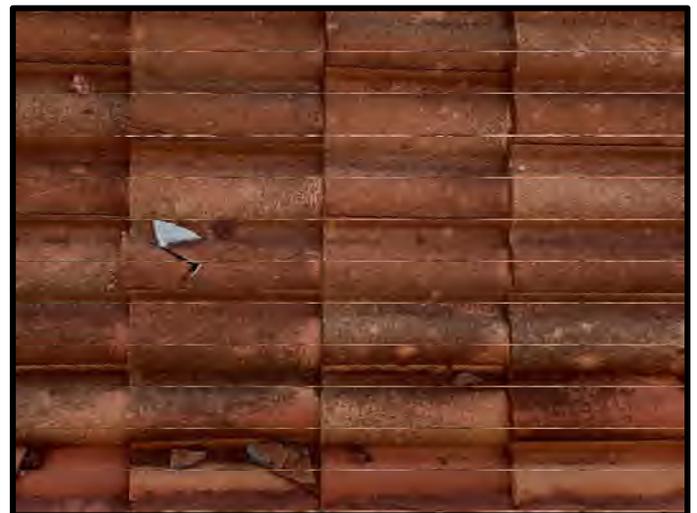
Photograph 7 – Loose rake tiles.

Photograph 8 – Cracked tile on the roof slope below the displaced rake tiles.

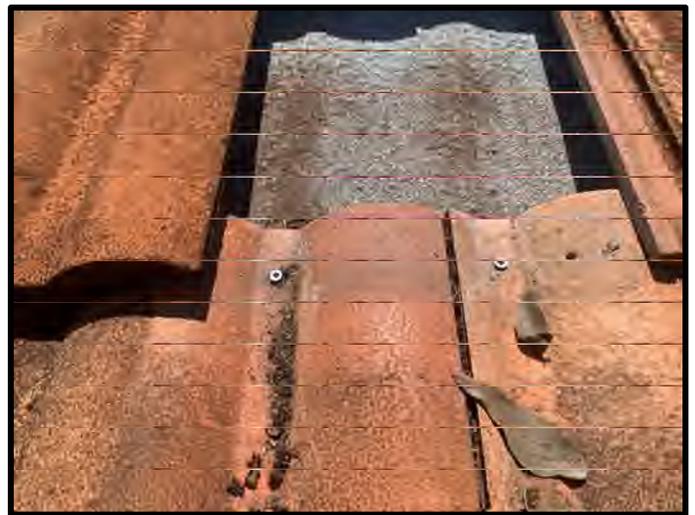
Photograph 3 – Loose Monier T210A concrete roof tile.

Photograph 4 – Loose tile was temporarily removed to observe the underlayment and tile fasteners.

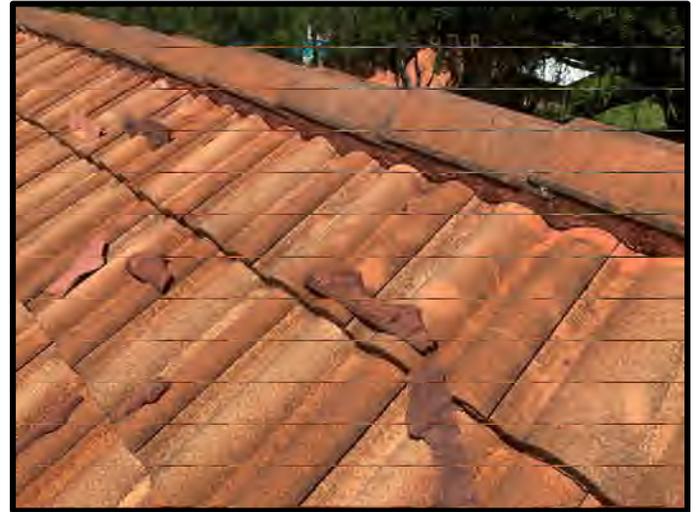
Photograph 5 – Cracked concrete roof tile.

Photograph 6 – Mortar parging detached from ridge caps.

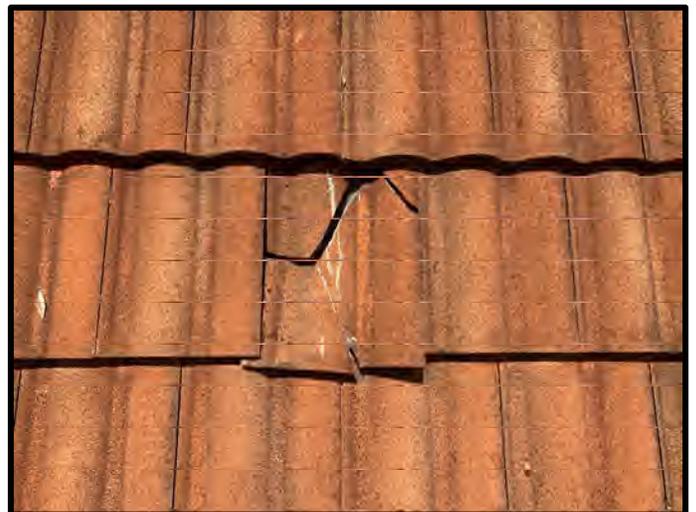
Photograph 3 – Loose Monier T210A concrete roof tile.

Photograph 4 – Loose tile was temporarily removed to observe the underlayment and tile fasteners.

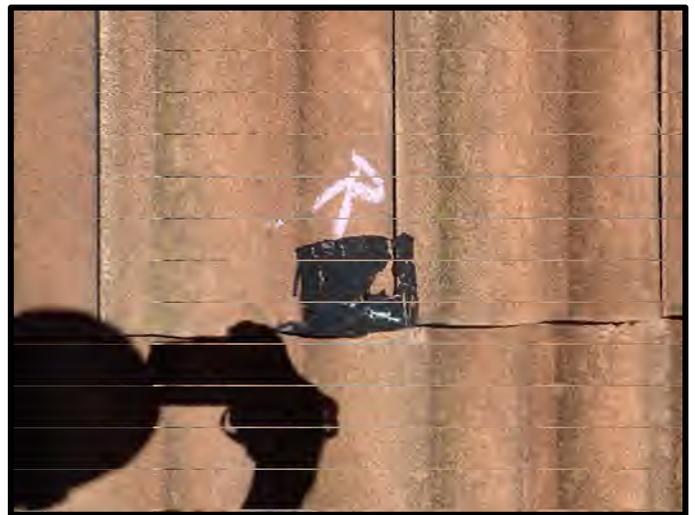
Photograph 3 – Cracked concrete roof tile at roof vent.

Photograph 4 – Previously repaired concrete roof tile.

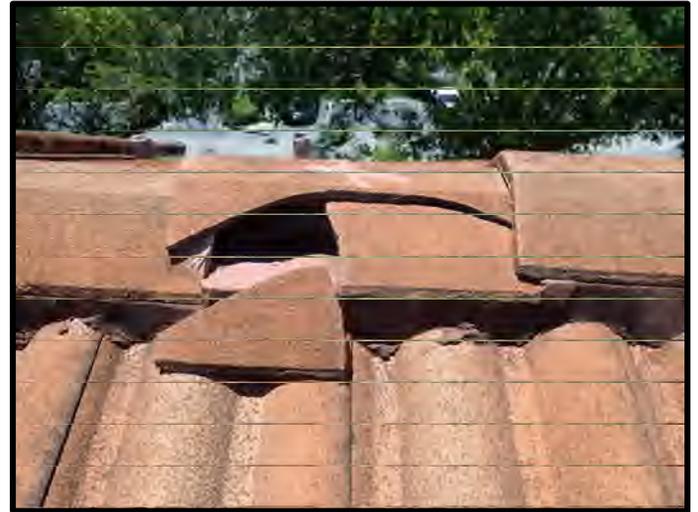
Photograph 5 – Cracked ridge cap tile.

Photograph 6 – Close up view of cracked ridge cap tile.

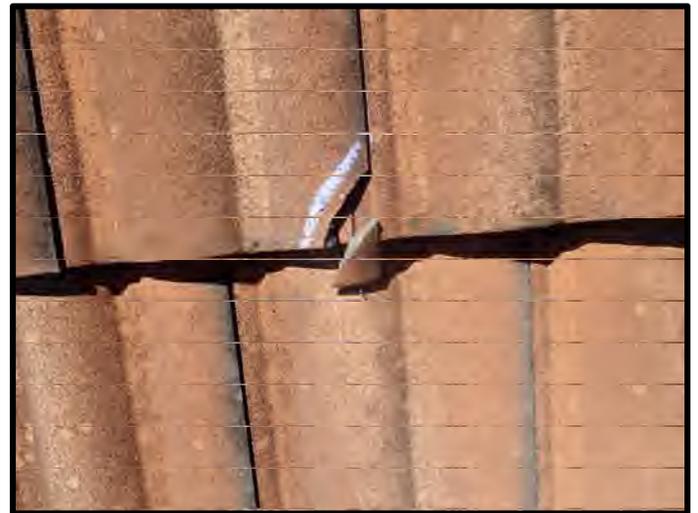
Photograph 7 – Cracked concrete roof tile.

Photograph 8 – Concrete roof tile with corner chip still in place.

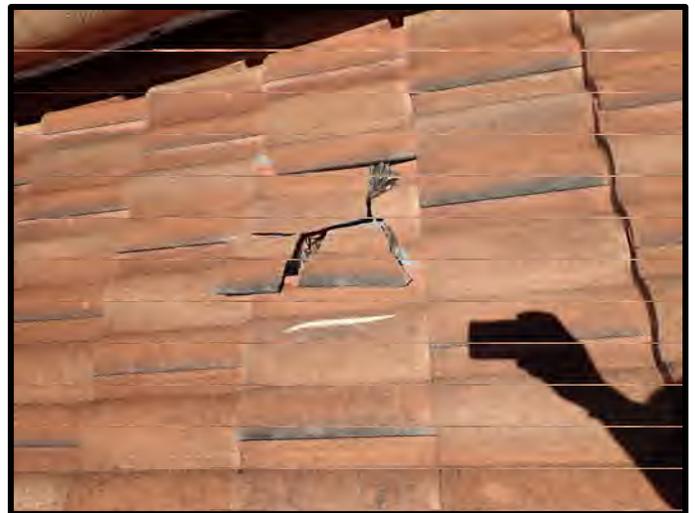
Photograph 3 – Concrete roof tile with chipped corner still in place.

Photograph 4 – Cracked concrete roof tile.

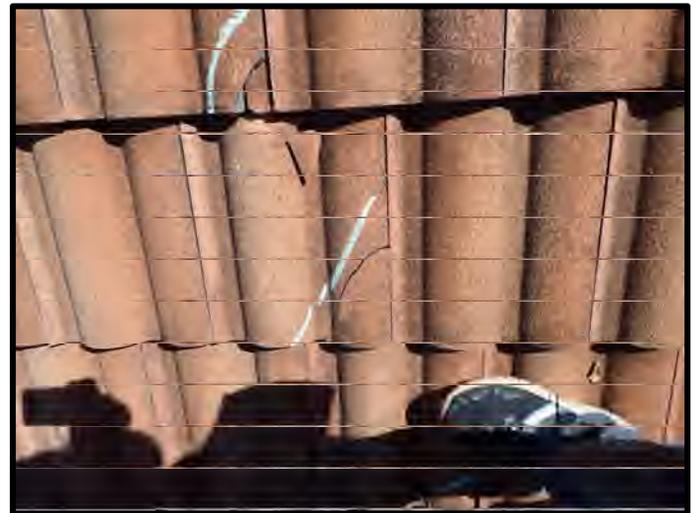
Photograph 7 – Concrete roof tile with chipped corner.

Photograph 8 – Cracked concrete roof tile.

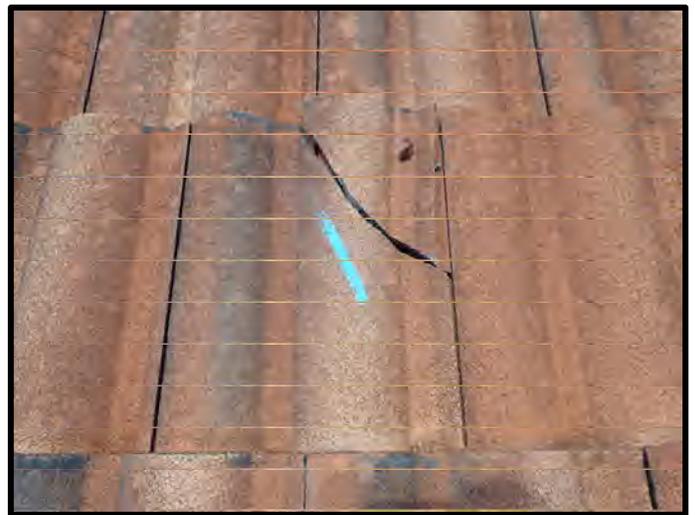
Photograph 3 – Concrete roof tile with chipped corner.

Photograph 4 – Cracked concrete roof tile.

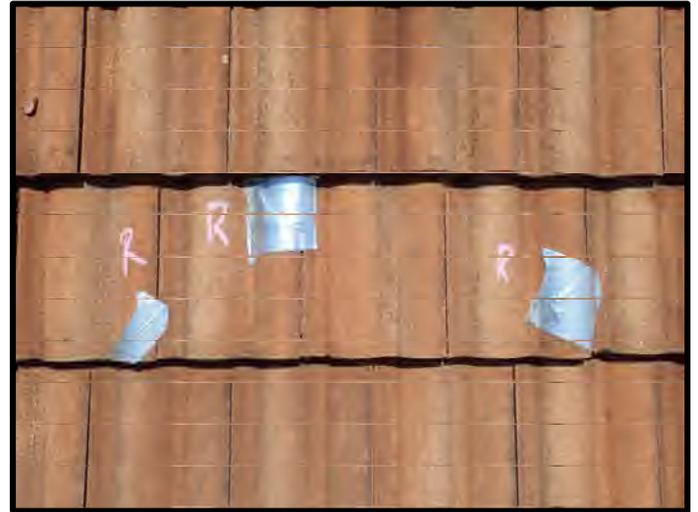
Photograph 5 – Previously repaired concrete roof tile at roof vent.

Photograph 6 – Previously repaired concrete roof tiles with metal tape.

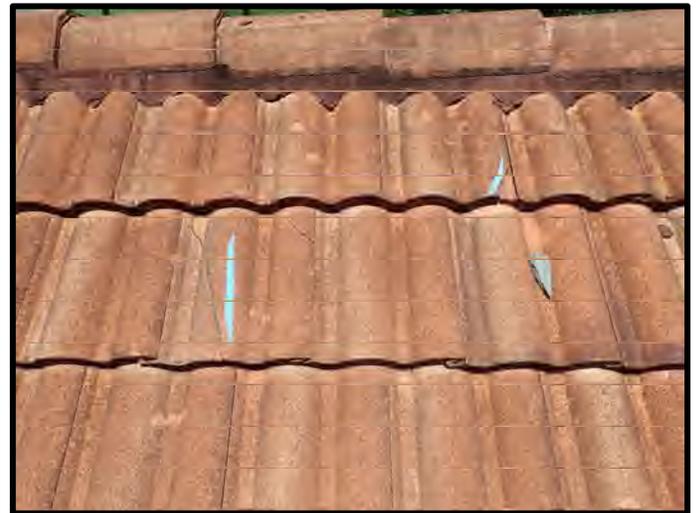
Photograph 7 – Cracked concrete roof tile with previous sealant repair.

Photograph 8 – Concrete roof tile with corner chip and hairline longitudinal crack.

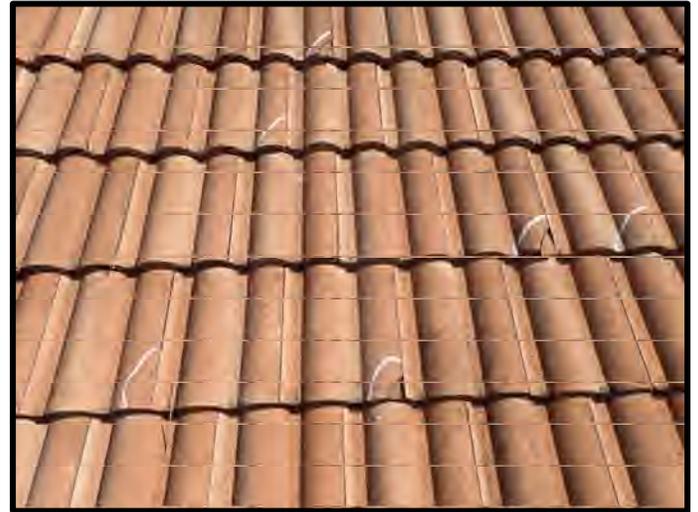
Photograph 5 – Cracked concrete roof tile.

Photograph 6 – Several concrete roof tiles with bottom right corner cracks/chips.

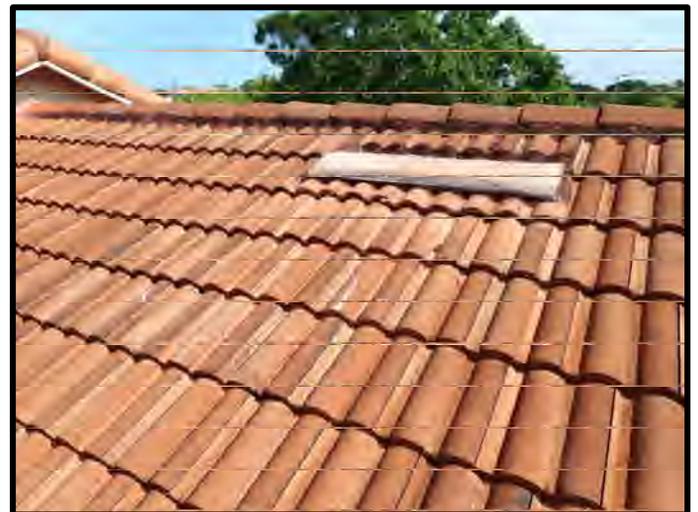
Photograph 7 – Hairline longitudinal crack and right corner crack in concrete roof tile.

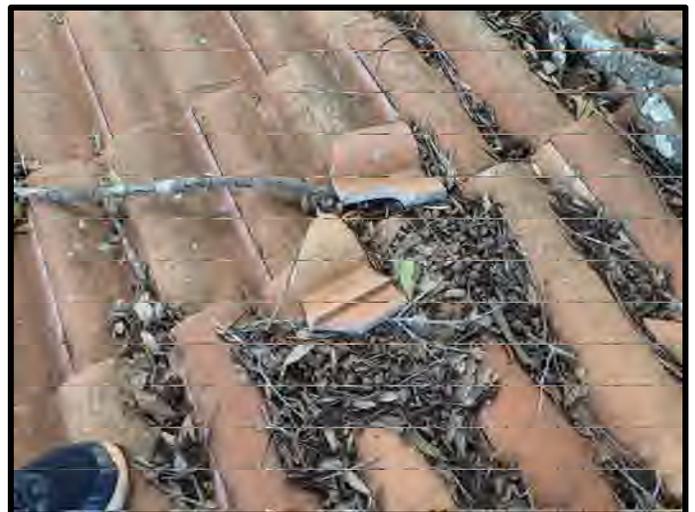
Photograph 3 – Broken concrete roof tiles under tree.

Photograph 4 – Broken concrete roof tiles under tree.

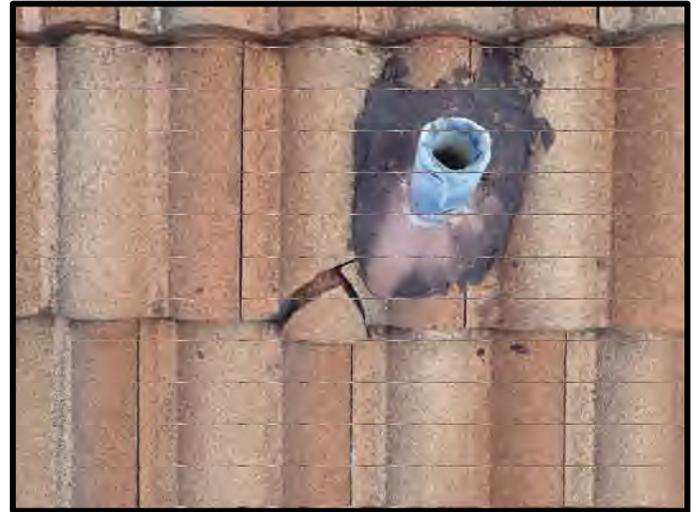
Photograph 5 – Concrete roof tile with corner crack.

Photograph 6 – Cracked concrete roof tile.

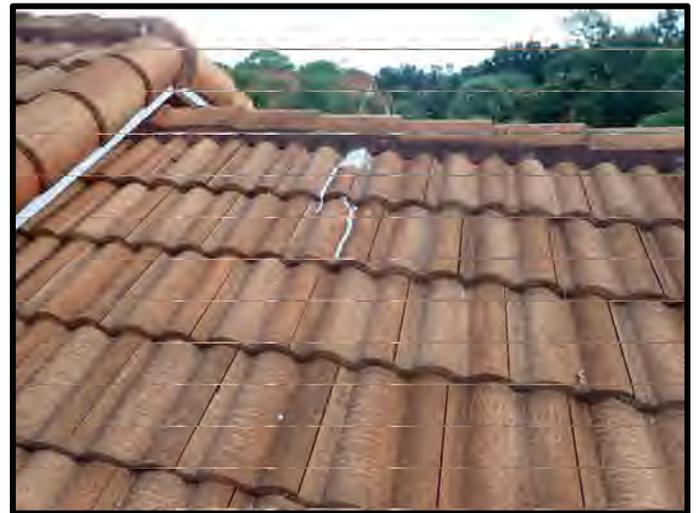
Photograph 7 – Previously repaired corner crack on concrete tile.

Photograph 8 – Concrete roof tiles with previous sealant repairs.

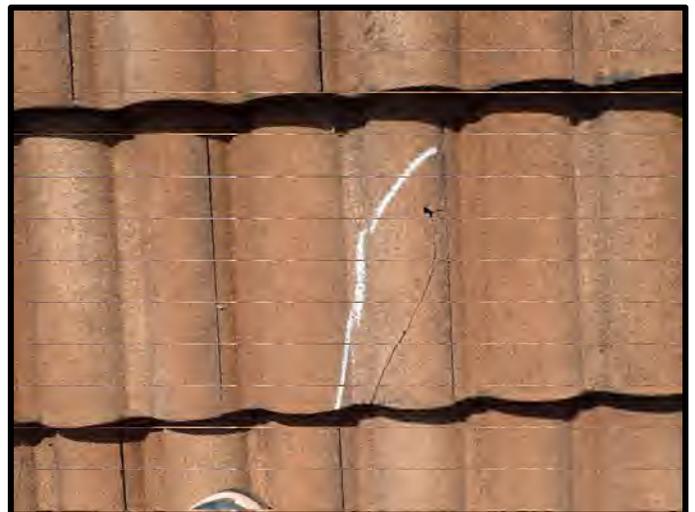
Photograph 3 – Concrete roof tiles with corner cracks.

Photograph 4 – Cracked concrete roof tile.

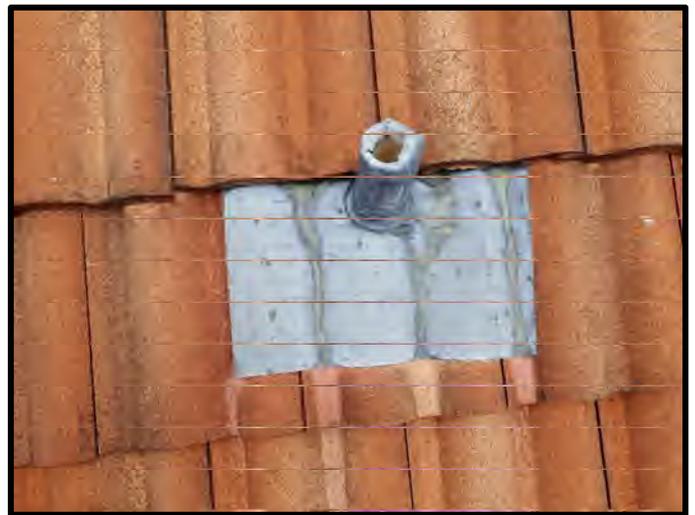
Photograph 3 – Concrete roof tile with corner crack.

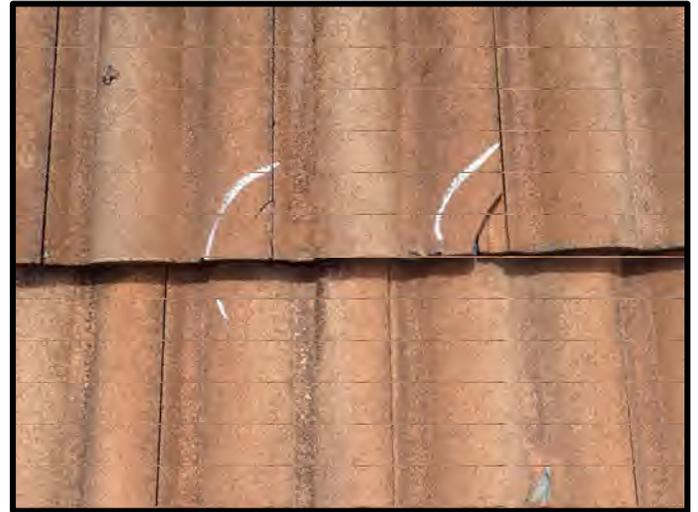
Photograph 6 – Concrete roof tiles with corner cracks.

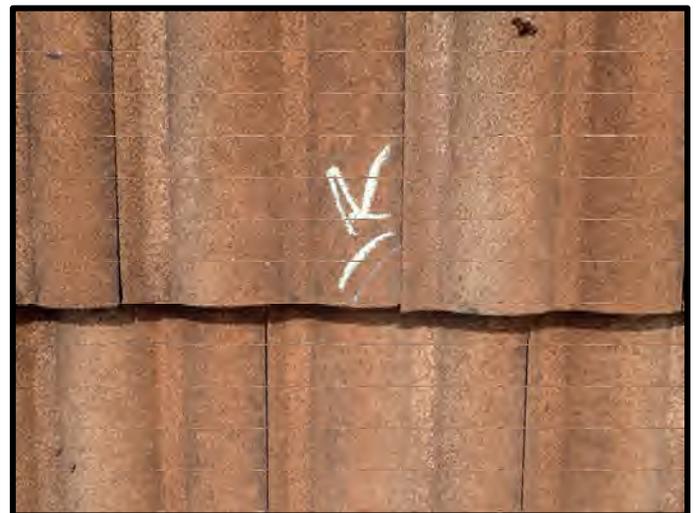
Photograph 7 – Several concrete roof tiles with chipped corners.

Photograph 8 – Previously repaired tile corner.

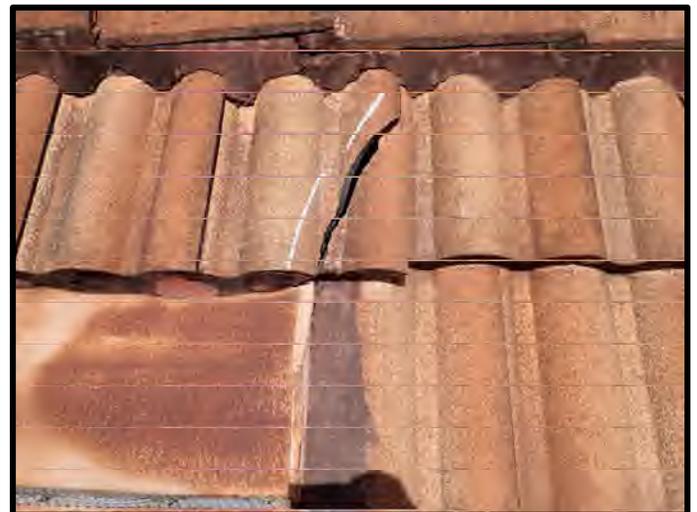
Photograph 3 – Several concrete roof tiles with corner cracks and roof tile with longitudinal crack.

Photograph 4 – Cracked concrete roof tile.

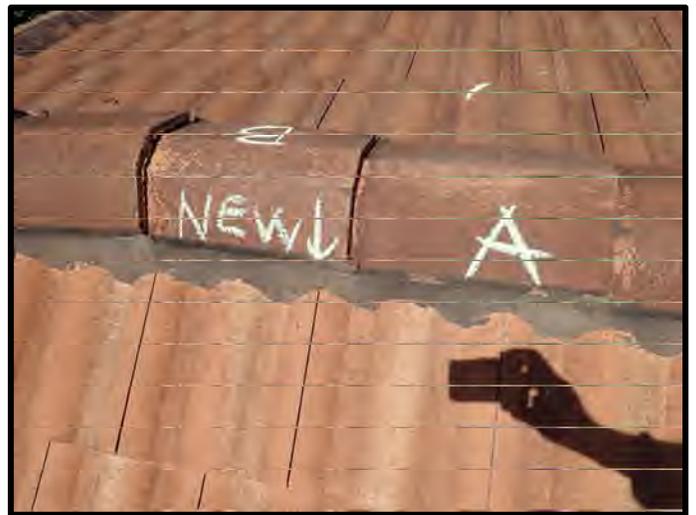
Photograph 3 – Previously repaired concrete roof tiles with metal tape.

Photograph 4 – Ridge cap tiles with recent mortar repair.

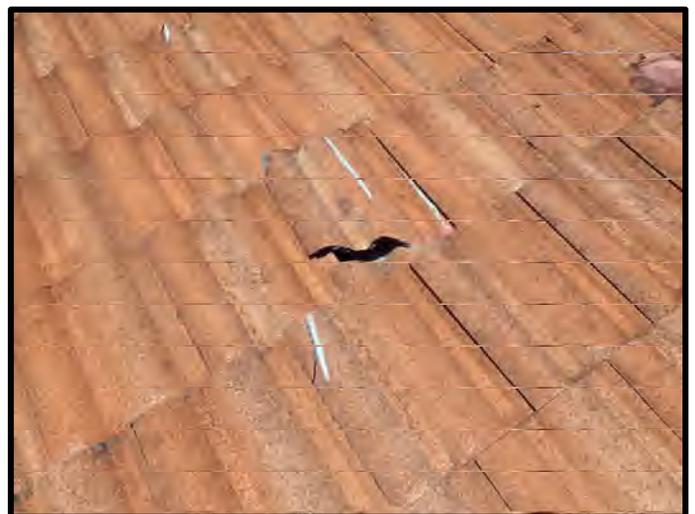
Photograph 3 – Slipped concrete roof tiles under roof vent.

Photograph 4 – Broken concrete roof tile.

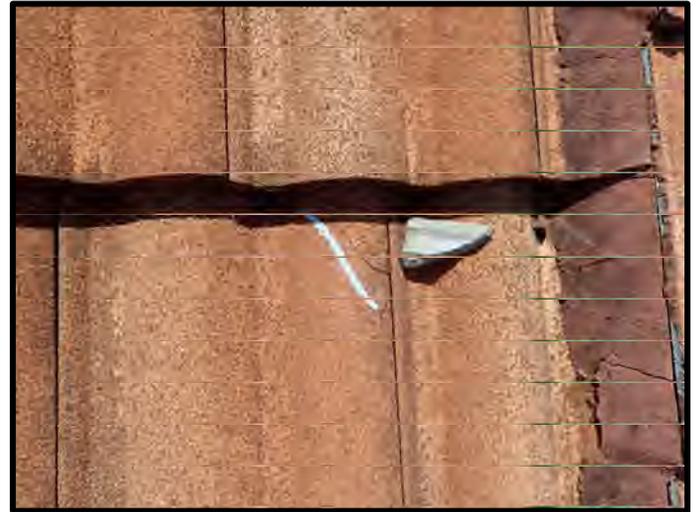
Photograph 5 – Concrete roof tile with previously repaired corner crack.

Photograph 6 – Chipped roof tile corner still in place on roof surface.

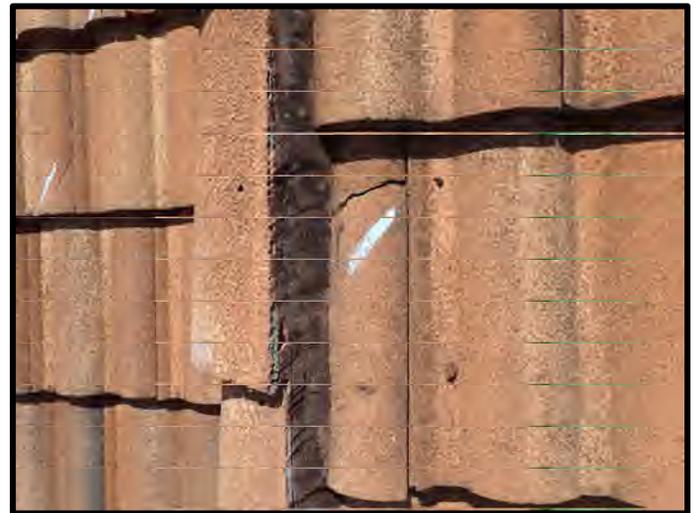
Photograph 7 – Slipped concrete roof tile and several roof tiles with corner cracks/chips.

Photograph 8 – Cracked concrete roof tile.

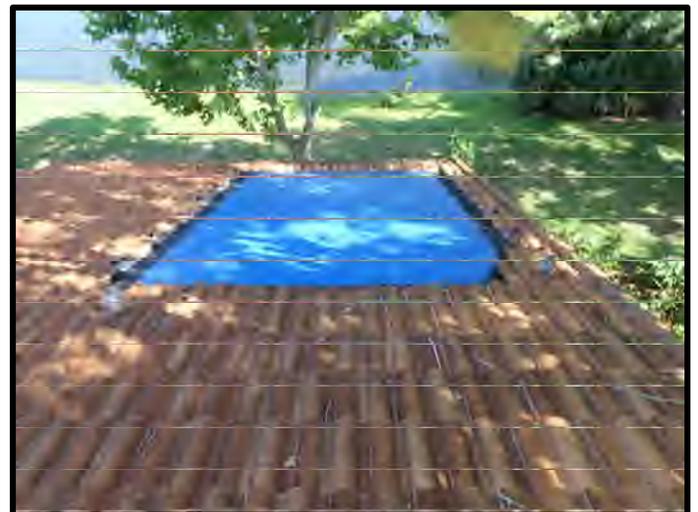
Missing sections of concrete roof tiles were observed in several locations on the roofs of the buildings at the Property. At Buildings 7, 16, 19, and 26, there were large areas of missing tiles that had been covered with a weather resistant membrane. These removed tiles appeared to be related to pre-existing conditions, such as investigative work to determine the source/extent of previous roof leaks, and did not appear to be related to the wind or wind-borne debris experienced during Hurricane Irma. If the Insured has additional documentation to provide on this matter, ESi will review and re-evaluate. However, at this time it does not appear that these conditions are related to Hurricane Irma.

Photograph 3 – Area of roof with tiles missing and covered with tarp.

Photograph 4 – Area of roof with tiles missing and covered with tarp.

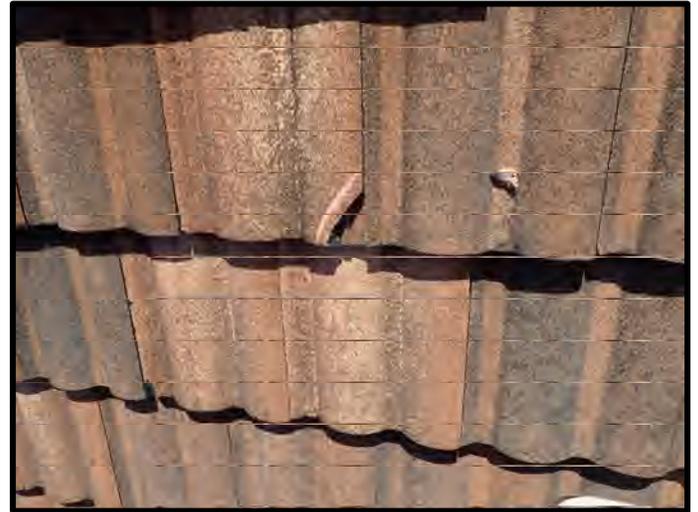
Photograph 5 – Concrete roof tile with hairline longitudinal crack.

Photograph 6 – Chipped roof tile corner still in place on roof surface.

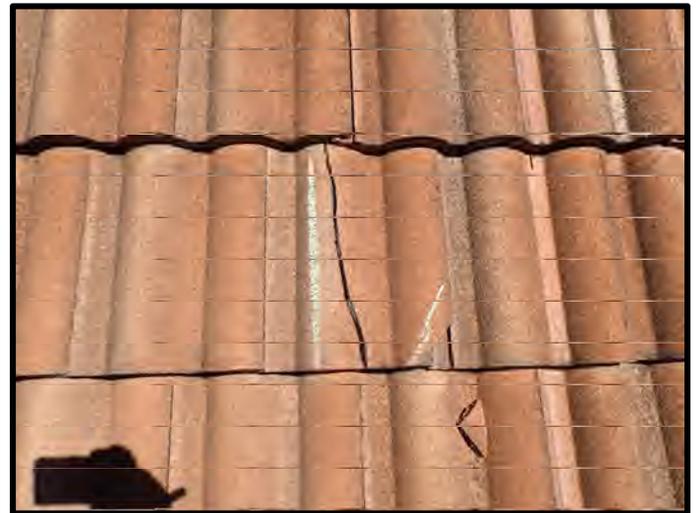
Photograph 7 – Previous mortar repairs at ridge cap tiles.

Photograph 8 – Cracked concrete roof tile.

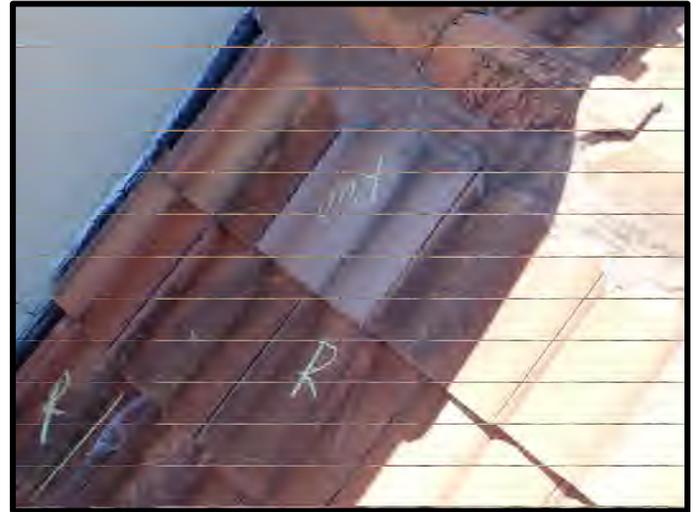
Photograph 5 – Concrete roof tile with corner crack.

Photograph 6 – Previously repaired concrete roof tiles.

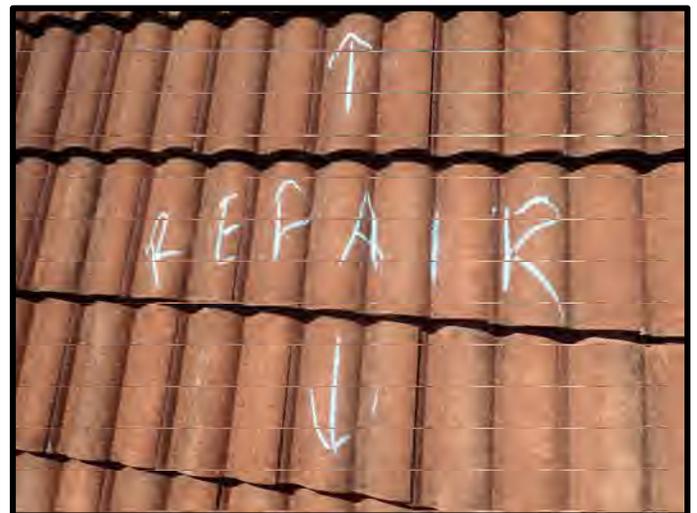
Photograph 7 – Area of previously repaired concrete roof tiles.

Photograph 8 – Previously repaired concrete roof tiles.

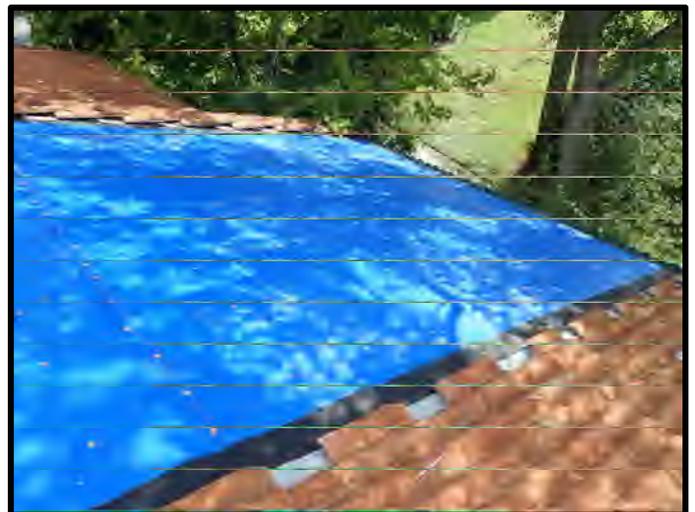
Photograph 3 – Tarpaulin (tarp) covering area of missing tiles.

Photograph 4 – Tarp attached to roofing with screws.

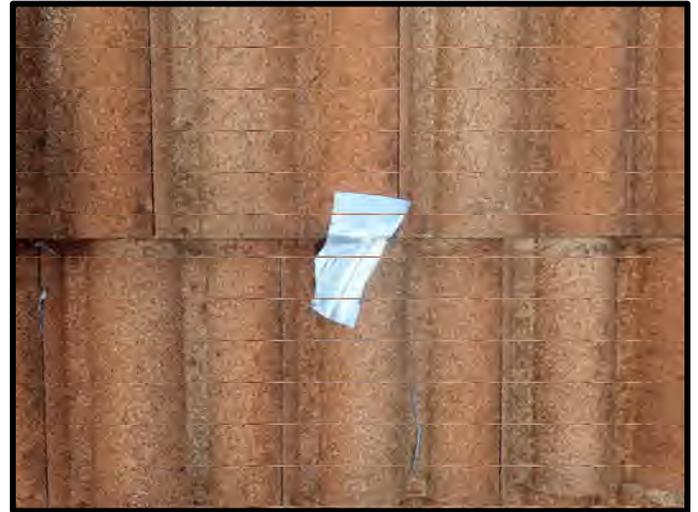
Photograph 5 – Concrete roof tile with corner chip still in place on roof surface.

Photograph 6 – Previously repaired concrete roof tile with metal tape.

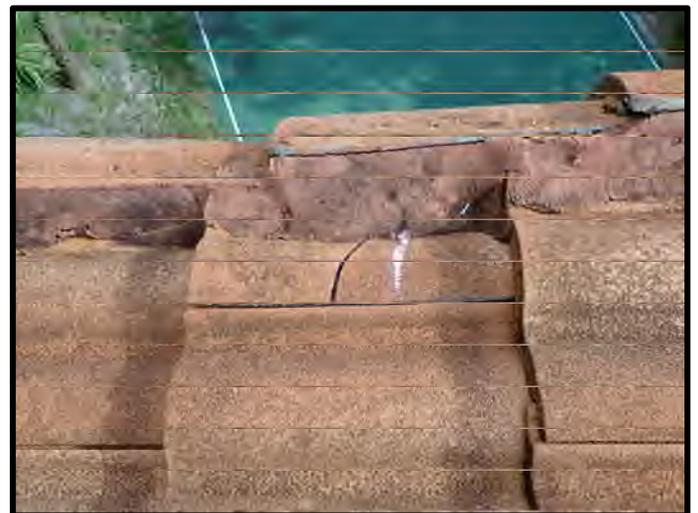
Photograph 7 – Previously repaired concrete roof tile with metal tape.

Photograph 8 – Cracked concrete roof tile.

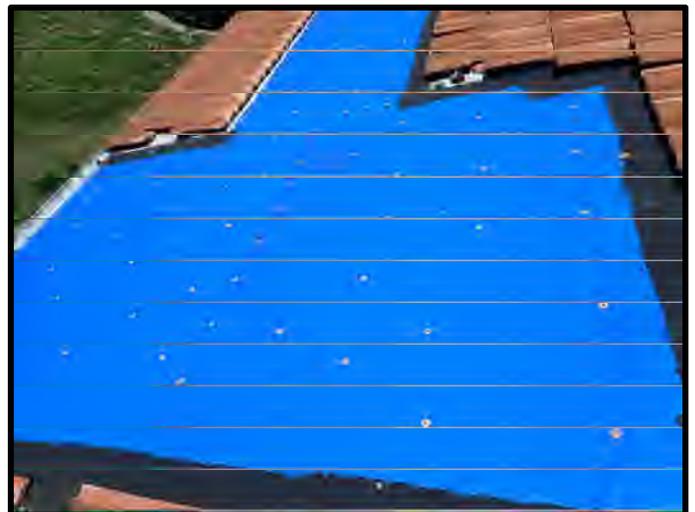
Photograph 3 – Tarpaulin (tarp) covering area of missing roof tiles.

Photograph 4 – Close up view of tarp covering area with missing roof tiles.

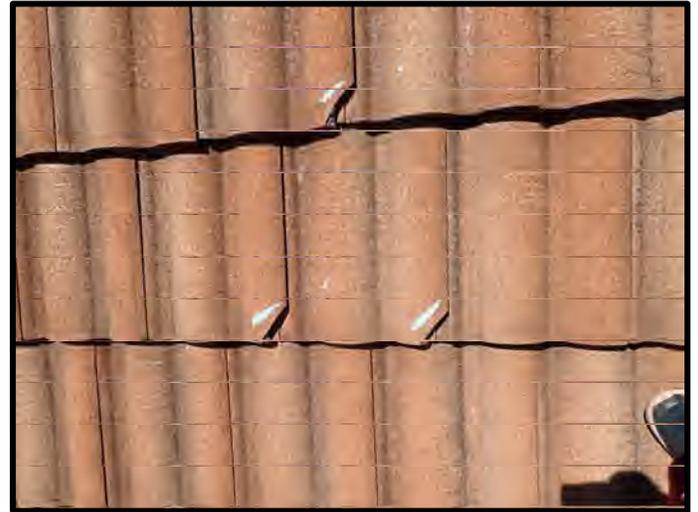
Photograph 5 – Ridge cap tile with previous repair.

Photograph 6 – Several concrete roof tiles with corner chips.

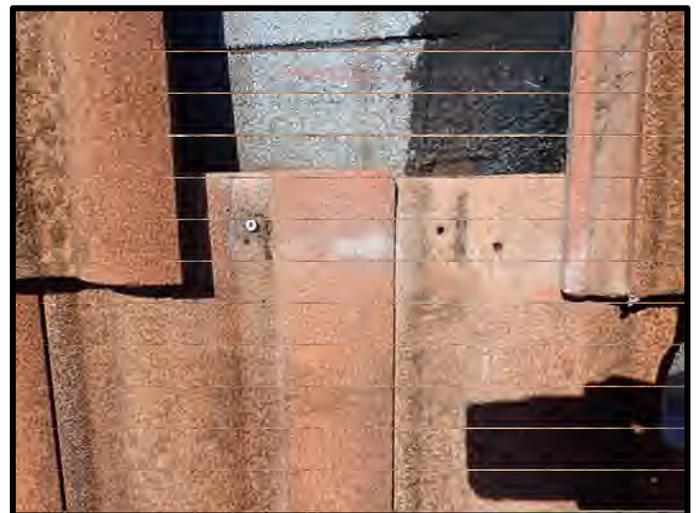
Photograph 7 – Loose Monier A210T tile temporarily removed for inspection.

Photograph 8 – Roof underlayment and fastening of underlying tiles exposed under loose tile.

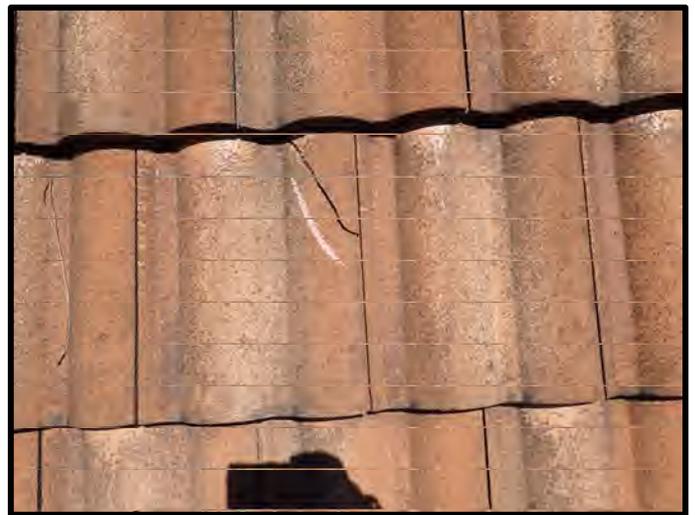
Photograph 3 – Slipped concrete roof tile.

Photograph 4 – Concrete roof tile with corner crack.

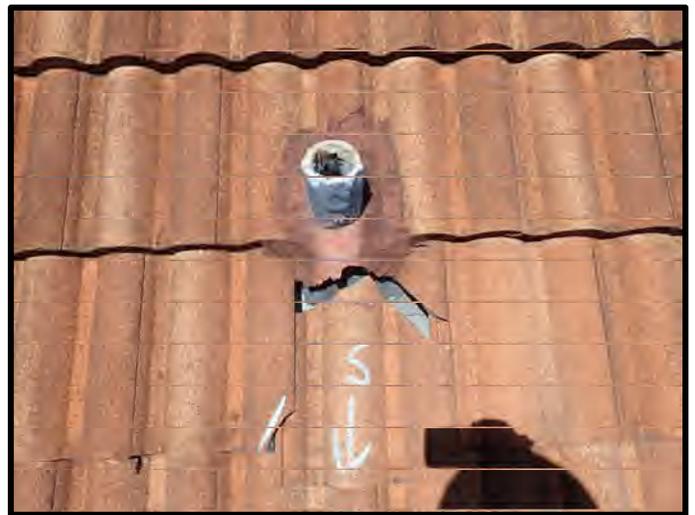
Photograph 3 – Previously repaired concrete roof tiles.

Photograph 4 – Broken and slipped concrete roof tile.

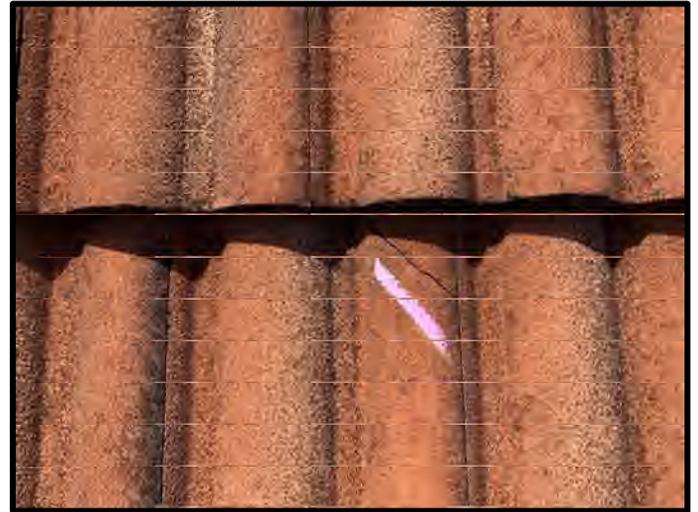
Photograph 5 – Concrete roof tile with corner chip.

Photograph 6 – Concrete roof tile with corner crack.

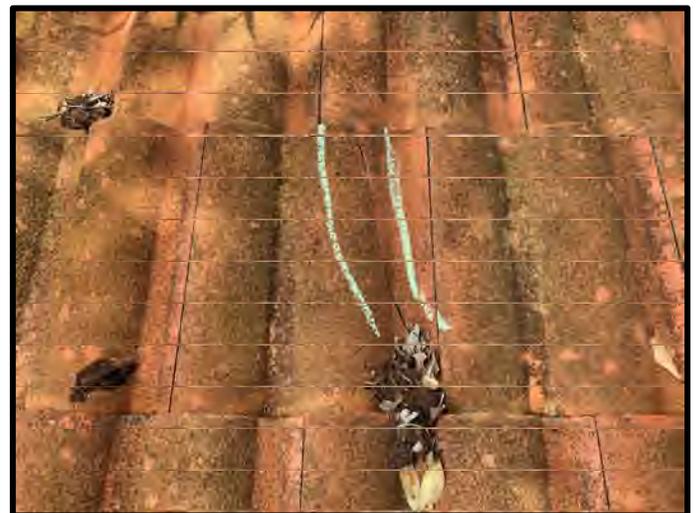
Photograph 7 – Cracked concrete roof tile.

Photograph 8 – Concrete roof tile with longitudinal crack.

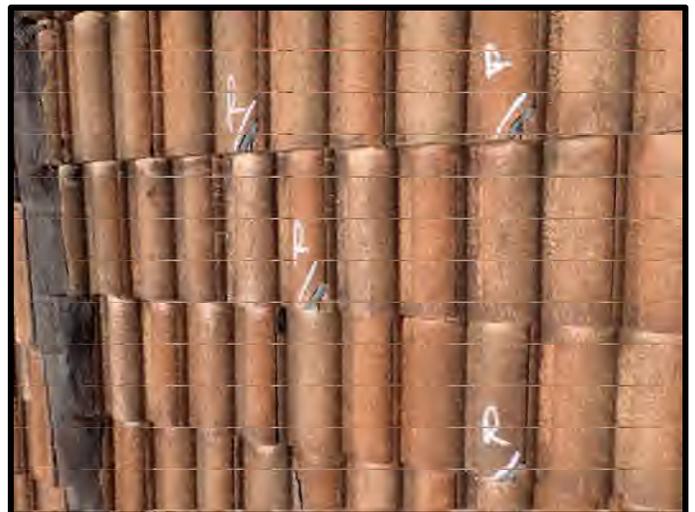
Photograph 3 – Previously repaired concrete roof tile with sealant.

Photograph 4 – Several previously repaired roof tiles with sealant.

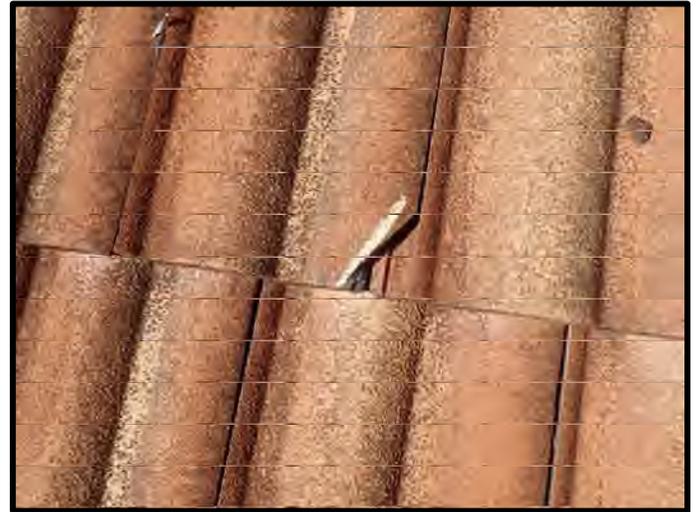
Photograph 5 – Previously repaired concrete roof tile with sealant.

Photograph 6 – Chipped concrete roof tile.

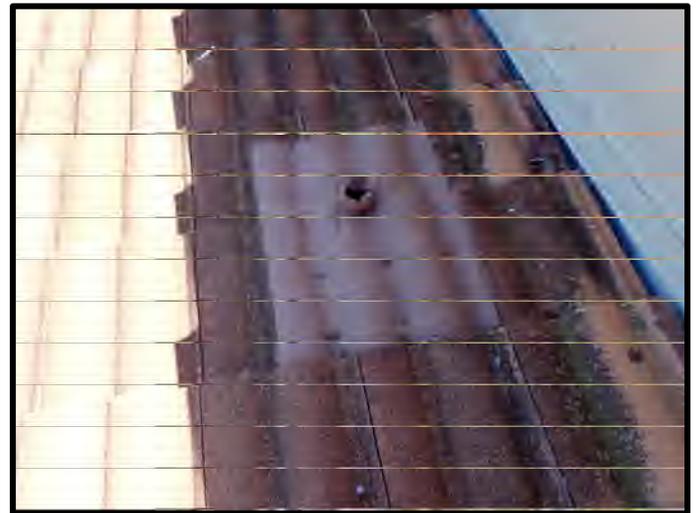
Photograph 7 – Cracked concrete roof tile with cracked portion still in place on roof surface.

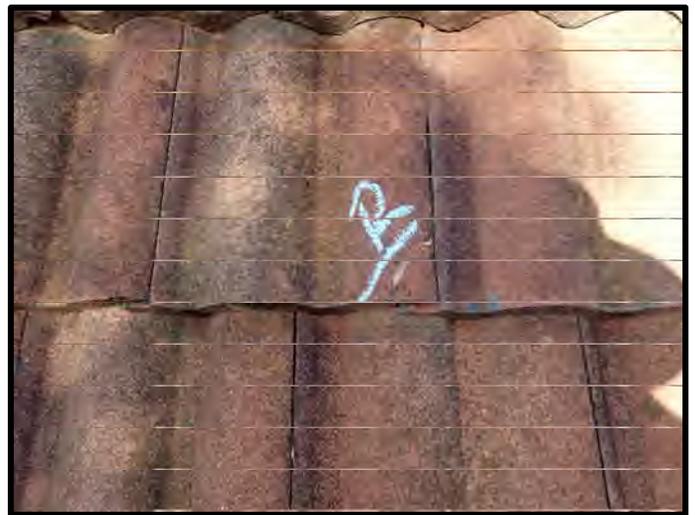
Photograph 3 – Cracked concrete roof tile.

Photograph 4 – Previously repaired concrete roof tile with sealant.

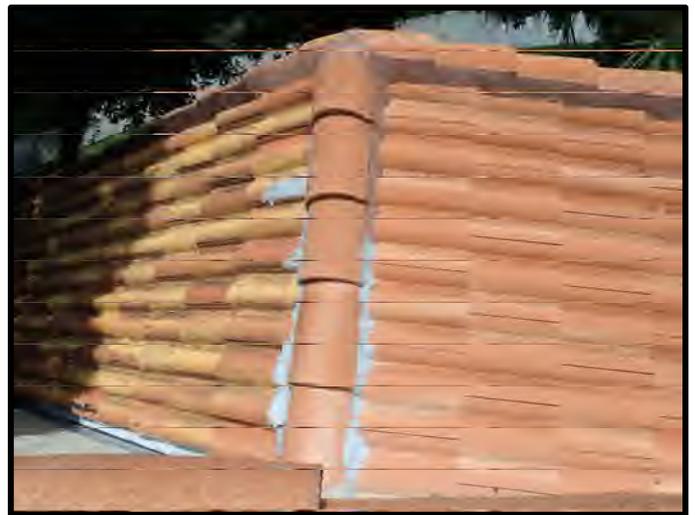
Photograph 3 – Cracked concrete roof tile.

Photograph 4 – Previous mortar repairs at ridge.

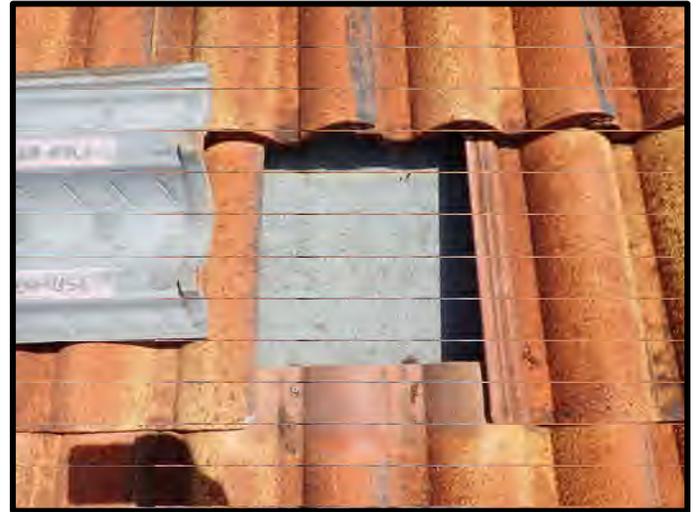
Photograph 5 – Loose Venetian Roll roof tile temporarily removed for inspection.

Photograph 6 – Roof underlayment where loose tile temporarily removed.

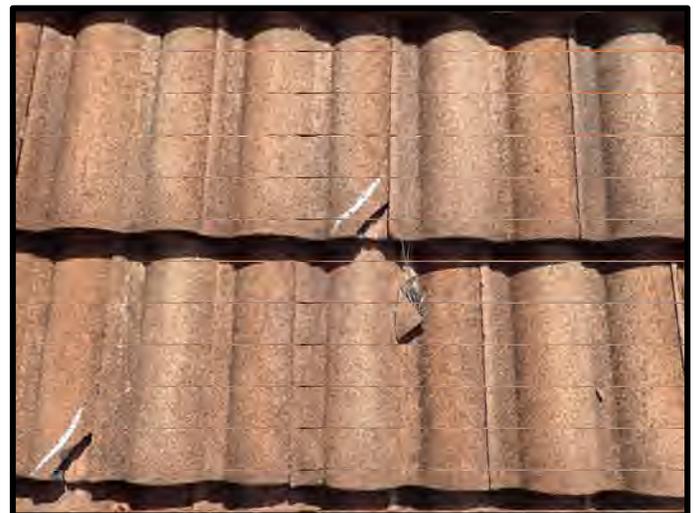
Photograph 7 – Concrete roof tile with longitudinal crack.

Photograph 8 – Concrete roof tiles with chipped corners still in place on roof surface.

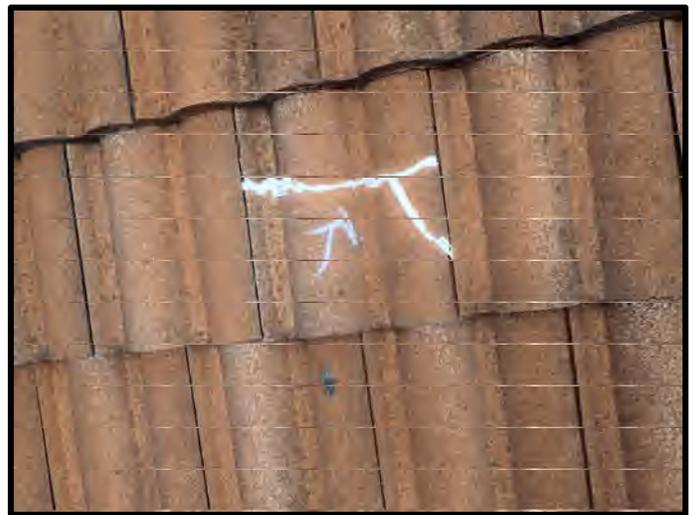
Photograph 3 – Concrete roof tile with longitudinal crack.

Photograph 4 – Previously repaired concrete roof tile with sealant.

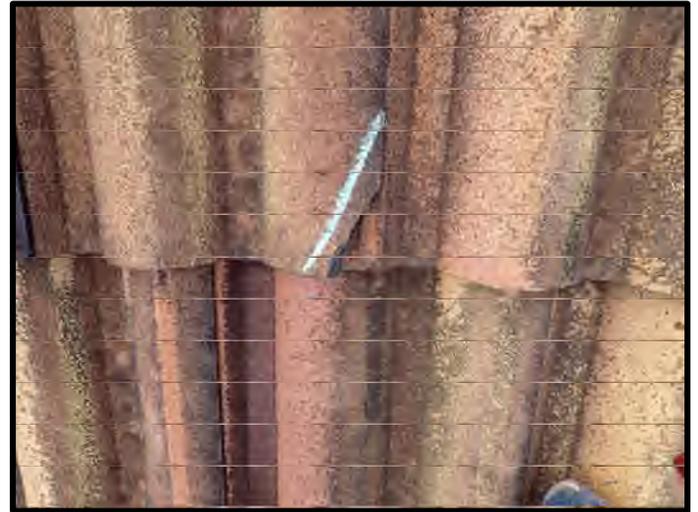
Photograph 6 – Concrete roof tile with chipped corner.

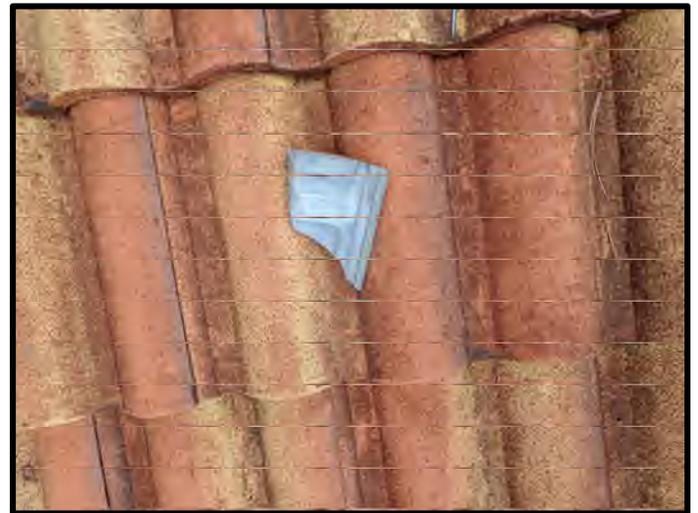
Photograph 7 – Cracked concrete roof tile.

Photograph 8 – Cracked piece of concrete roof tile remaining on the surface of the roof.

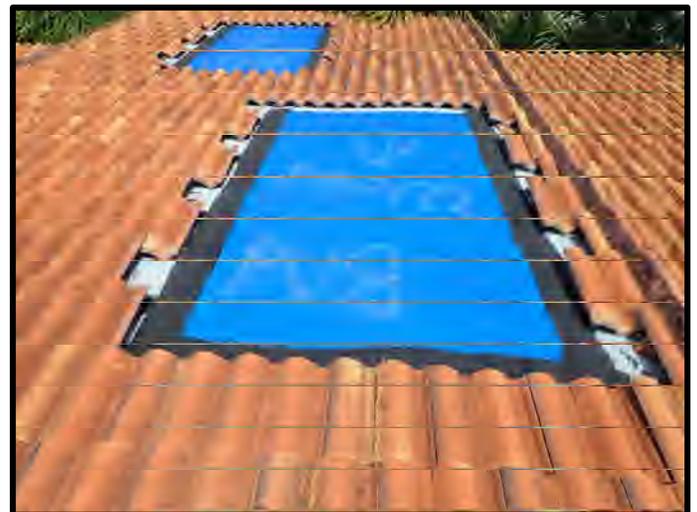
Photograph 3 – Tarpaulin (tarp) covering two areas where roof tiles were removed.

Photograph 4 – Tarp covering area of missing tiles is marked "Bad Wood."

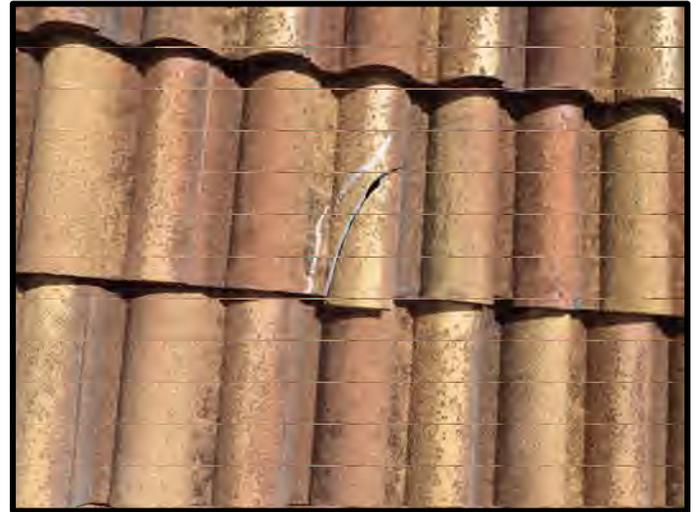
Photograph 5 – Several concrete roof tiles with corner chips.

Photograph 6 – Cracked concrete roof tile.

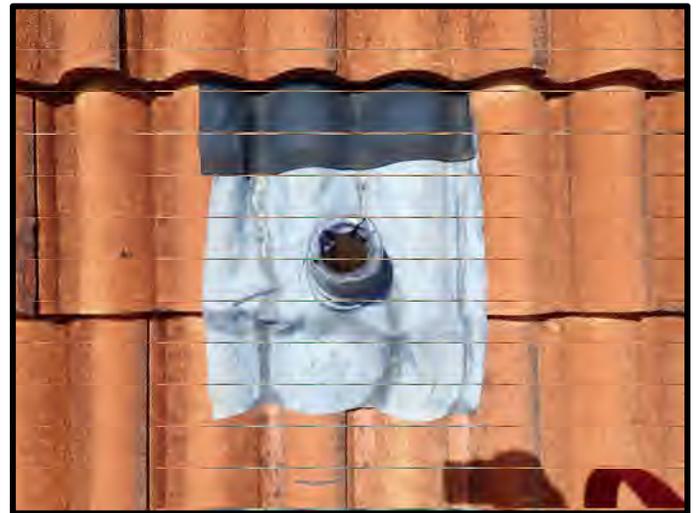
Photograph 7 – Previously repaired concrete roof tile.

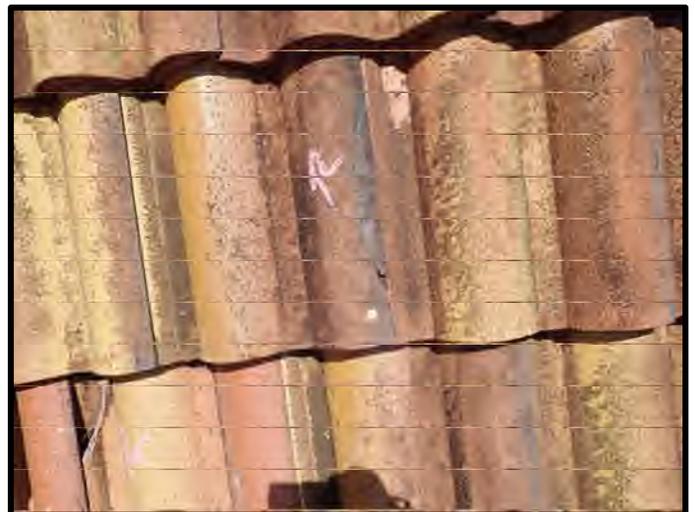
Photograph 3 – Concrete roof tiles with chipped corners.

Photograph 4 – Previously repaired concrete roof tile with sealant.
