**Vintage Grand Condominium Association  
Hurricane Irma  
Damage Assessment**

ESi Project #: 78360G

# Investigative Report

## Vintage Grand Condominium Association Hurricane Irma Damage Assessment

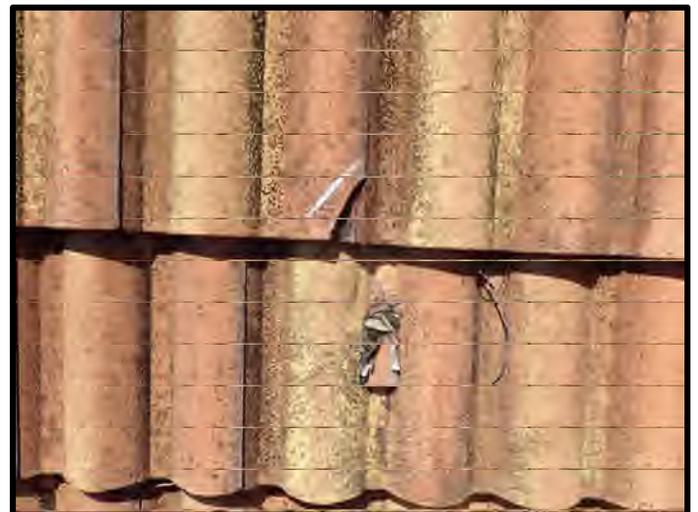
Photograph 3 – Cracked concrete roof tile and pine needles covering roof.

Photograph 4 – Concrete roof tile with chipped corner still in place on roof surface.

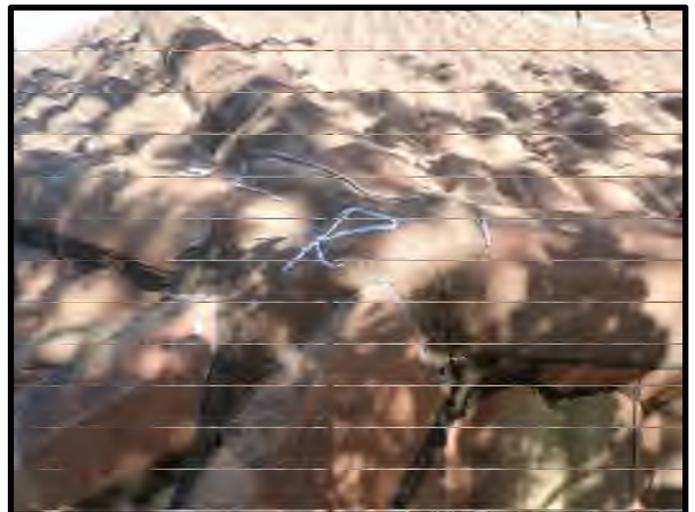
Photograph 3 – Loose Monier T210A tile.

Photograph 4 – Cracked concrete roof tile.
