PHOTOGRAPHS

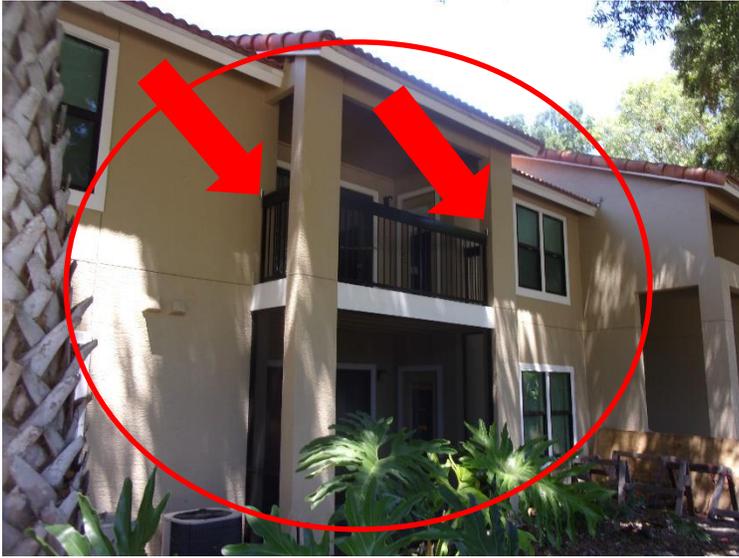
PHOTOGRAPH #1

**BUILDING 1
SECTION F**

Balcony handrail attachment angels have been welded to railing and fasted through stucco into framing.

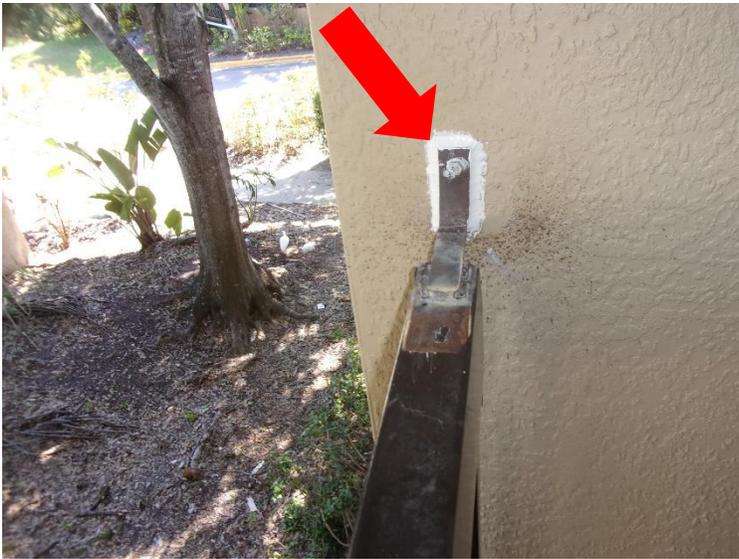
PHOTOGRAPH #2

**BUILDING 1
SECTION F**

Balcony handrail attachment angels have been welded to railing and fasted through stucco into framing.

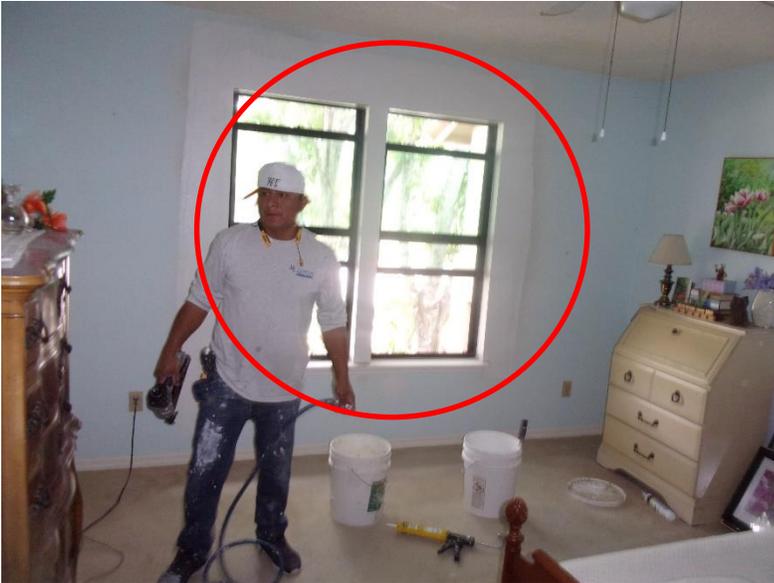
PHOTOGRAPH #3

**BUILDING 1
SECTION F - UNIT #126**

Interior drywall repairs and finish at window openings in progress.

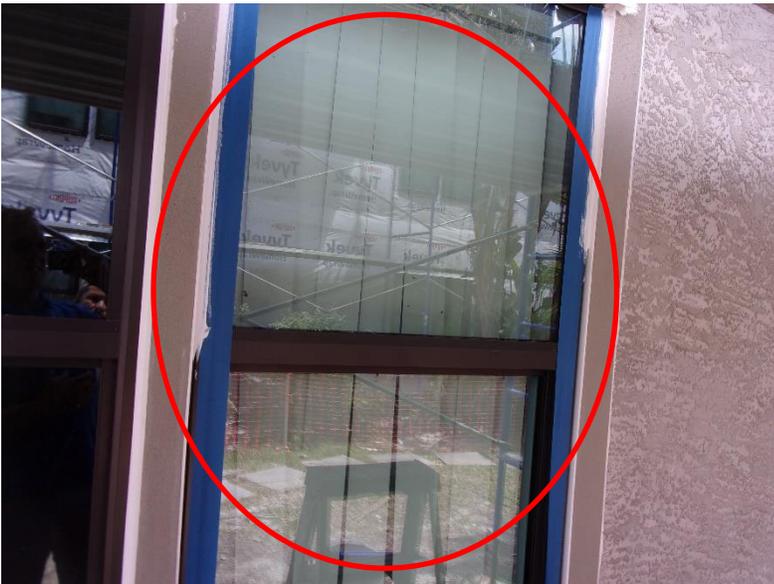
PHOTOGRAPH #4

**BUILDING 1
SECTION C**

Backing rod and new sealants installed at window perimeter with BASF 150 sealant.

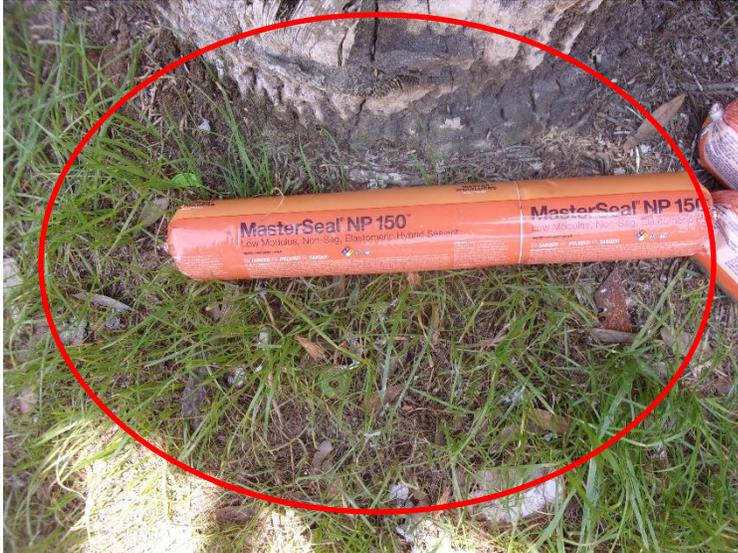
PHOTOGRAPH #5

**BUILDING 1
SECTION C**

Backing rod and new sealants installed at window perimeter with BASF 150 sealant.

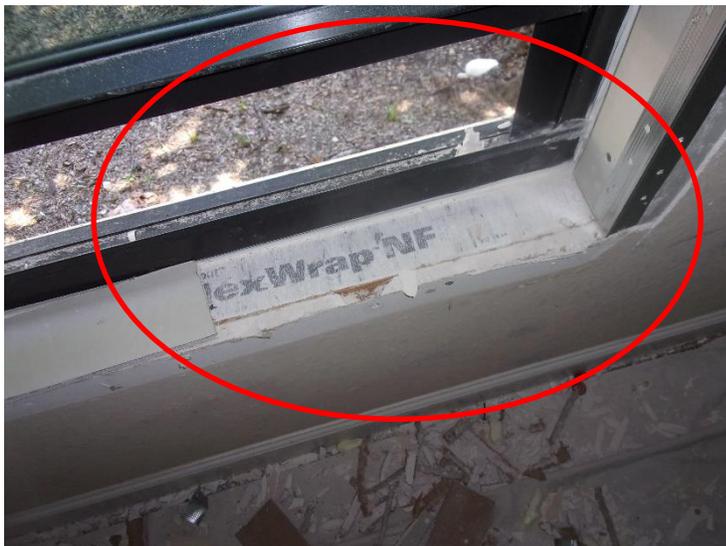
PHOTOGRAPH #6

**BUILDING 1
SECTION C - UNIT #128**

Interior drywall and sill repairs at window openings in progress.

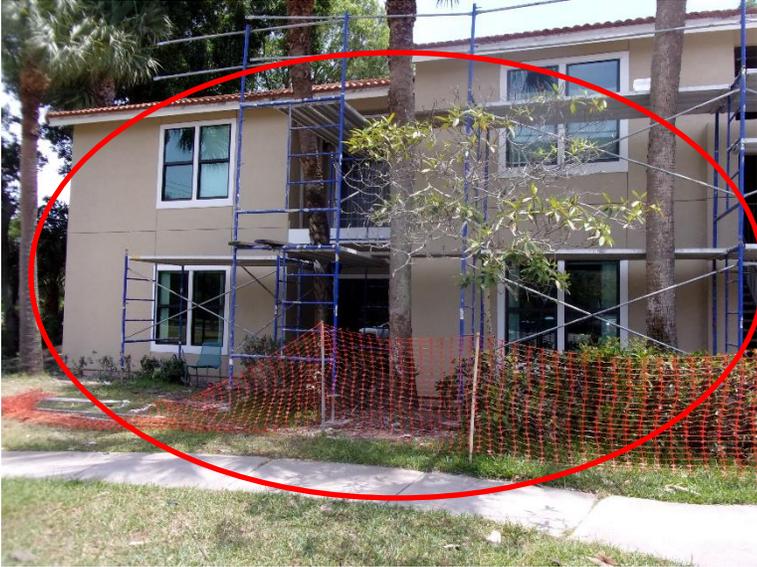
PHOTOGRAPH #7

**BUILDING 1
SECTION A**

Florida Paints Ultra Exterior Super Coat applied at new stucco surfaces.

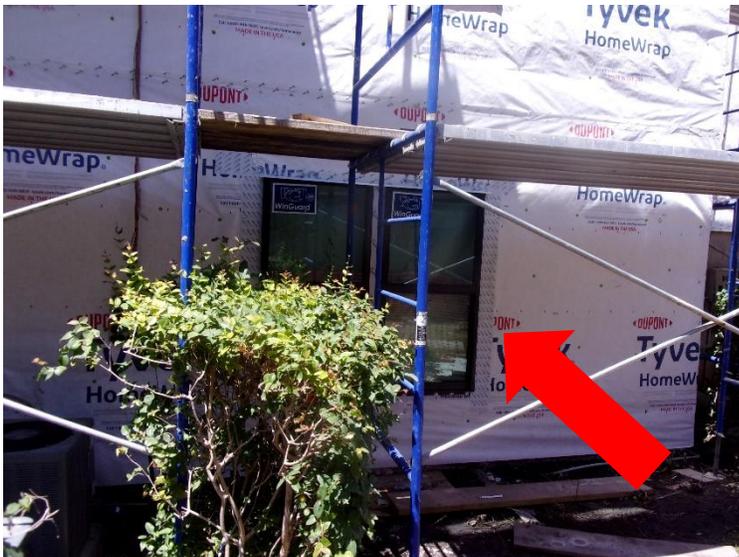
PHOTOGRAPH #8

**BUILDING 2
SECTION H**

Dupont/Tyvek flashing details have been completed per manufacturers instruction and AAMA/FMA guidelines.

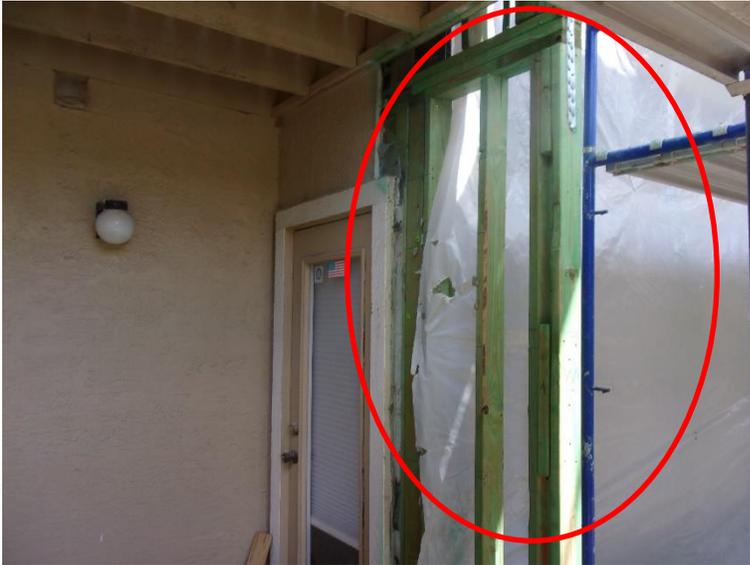
PHOTOGRAPH #9

**BUILDING 2
SECTION G**

Bora Care Terminate treatment applied by pest contractor to wood framing prior to new sheathing.

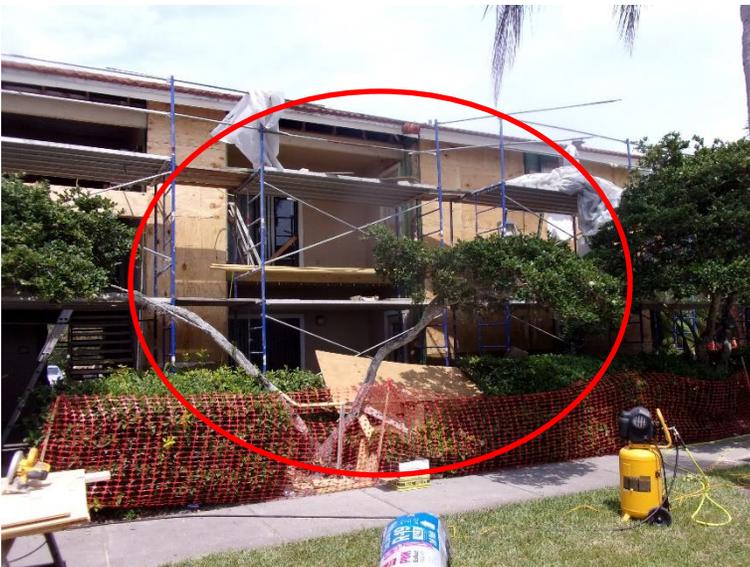
PHOTOGRAPH #10

**BUILDING 2
SECTION G**

Contractor in process of installing new plywood sheathing.

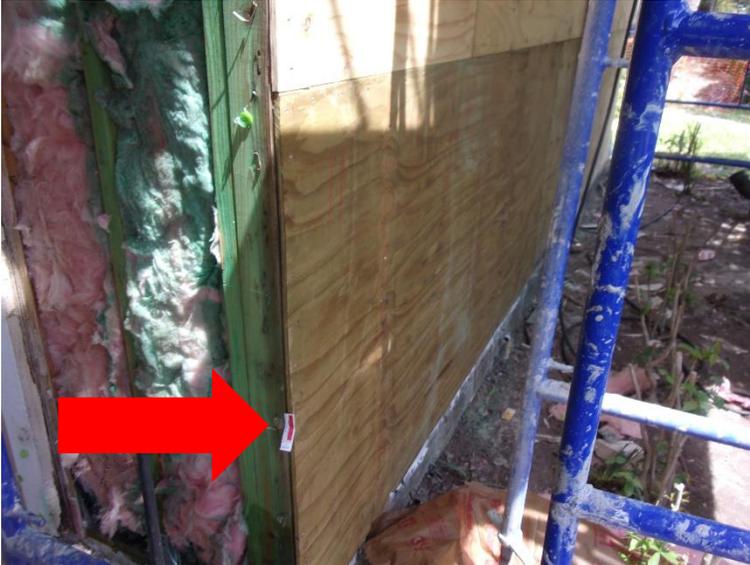
PHOTOGRAPH #11

**BUILDING 2
SECTION G**

New pressure treated 15/32 " sheathing installed at bottom row of wall.

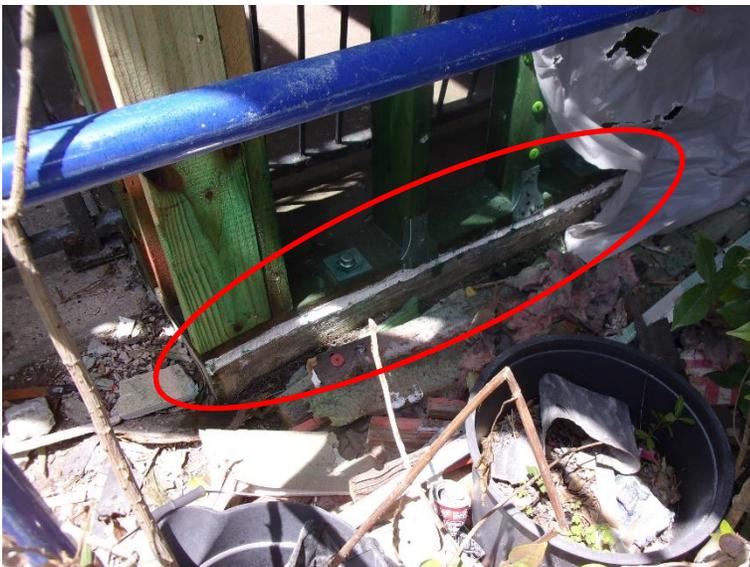
PHOTOGRAPH #12

**BUILDING 2
SECTION G**

BASF urethane sealants installed at bottom plate to concrete slab.

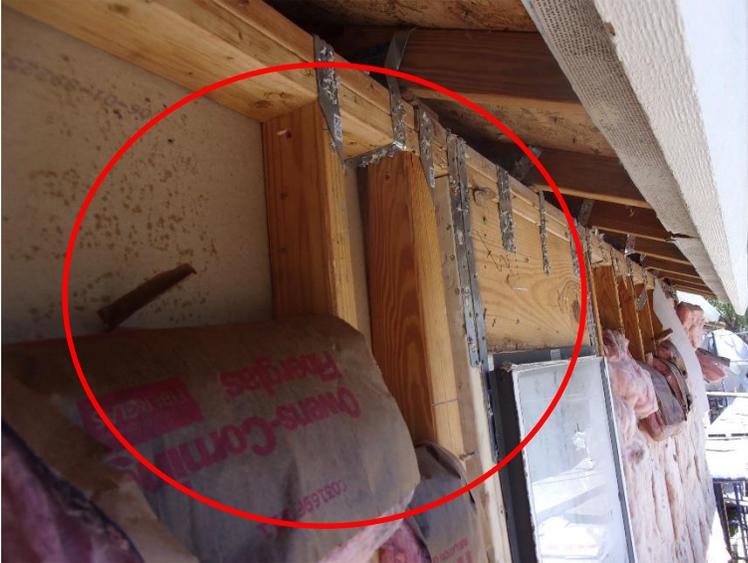
PHOTOGRAPH #13

**BUILDING 2
SECTION E**

Simpson Strong-Tie strapping, connectors, and screws installation in progress at second floor headers, top plate, and studs.

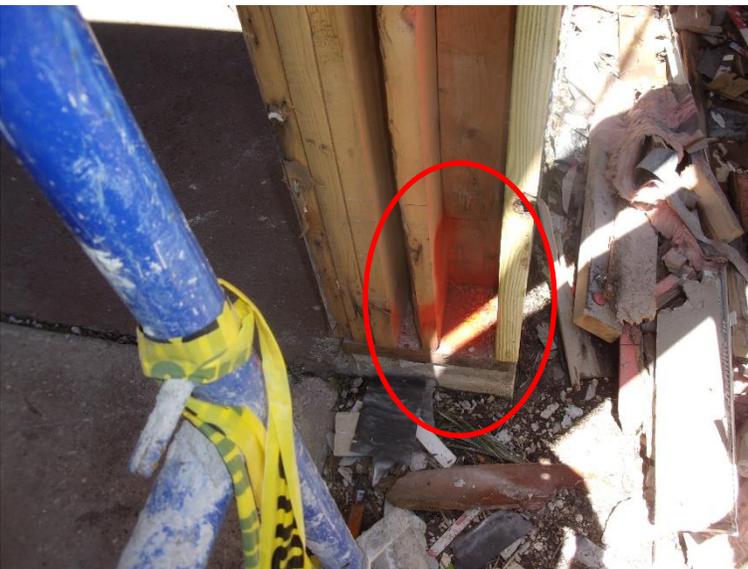
PHOTOGRAPH #14

**BUILDING 2
SECTION E**

Missing Simpson Strong-Tie Titen anchor at breezeway base plate.

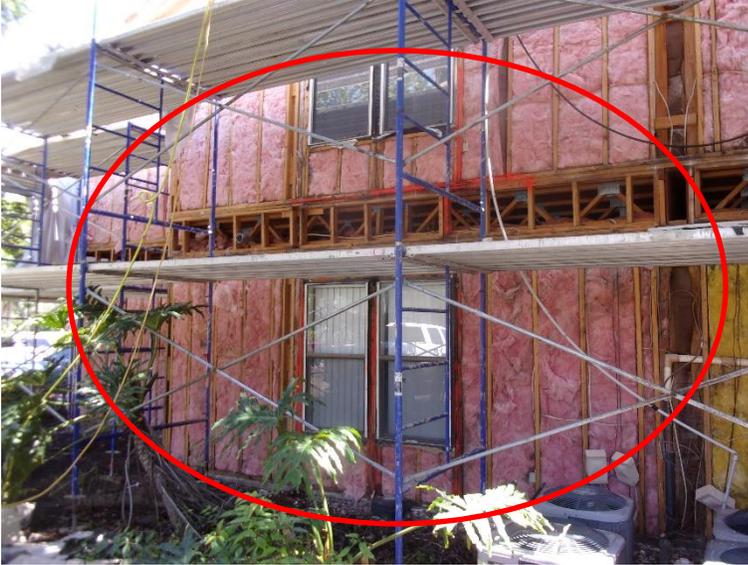
PHOTOGRAPH #15

**BUILDING 2
SECTION D**

Framing damage marked for repairs at window headers, studs, and bottom plates of second floor.

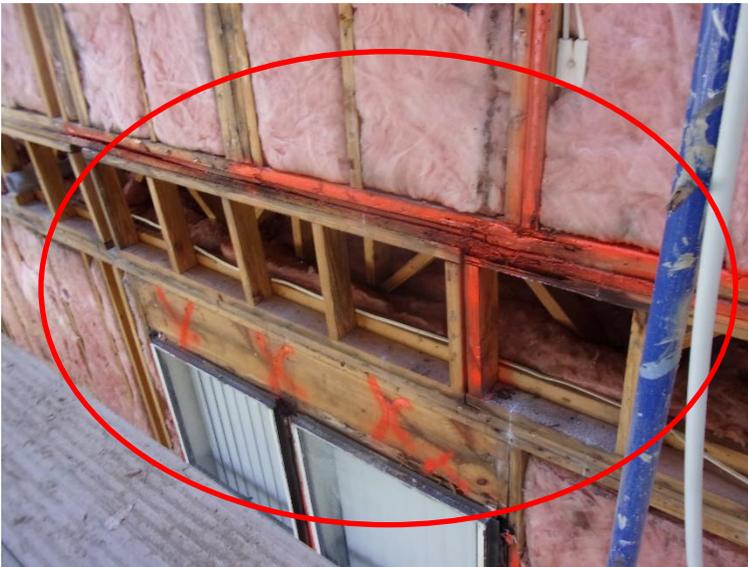
PHOTOGRAPH #16

**BUILDING 2
SECTION D**

Framing damage marked for repairs at window headers, studs, and bottom plates of second floor.

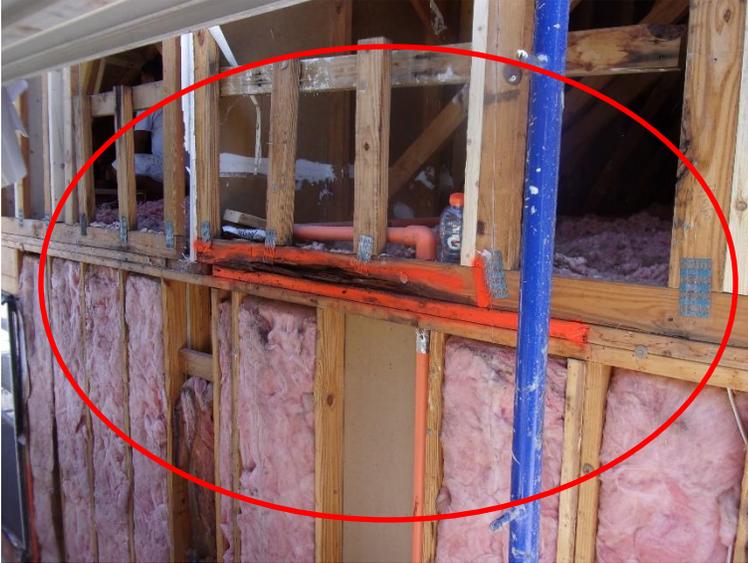
PHOTOGRAPH #17

**BUILDING 2
SECTION D**

Damage marked for repairs at gable end trusses and second floor top plate.

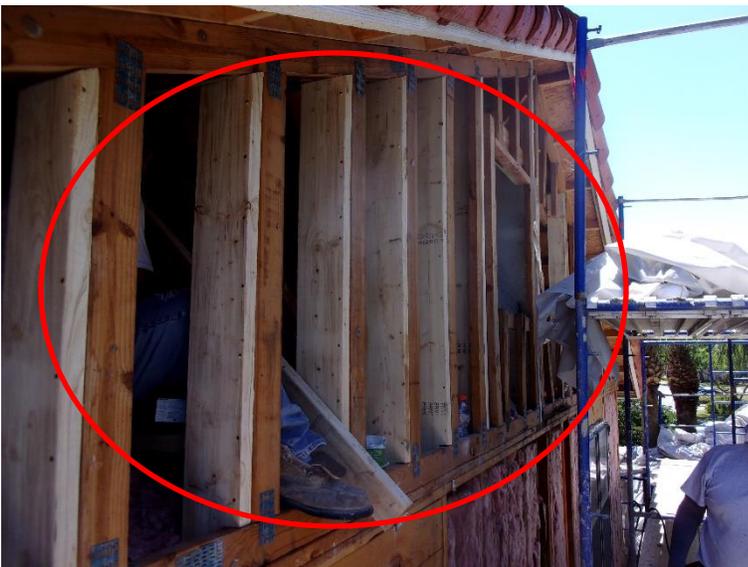
PHOTOGRAPH #18

**BUILDING 2
SECTION D**

Contractor performing reinforcement repairs at gable end trusses.

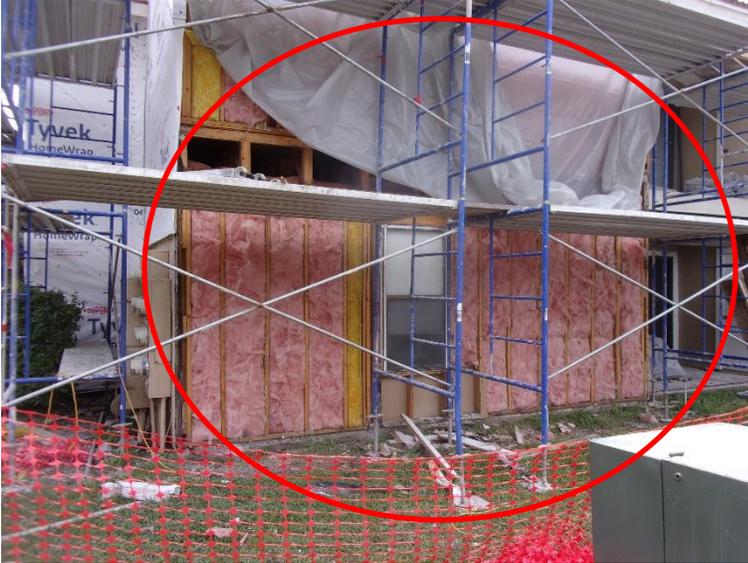
PHOTOGRAPH #19

**BUILDING 2
SECTION A**

Contractor has removed stucco and Thermo-Ply exposing damage and wood repairs.
