PHOTOGRAPHS

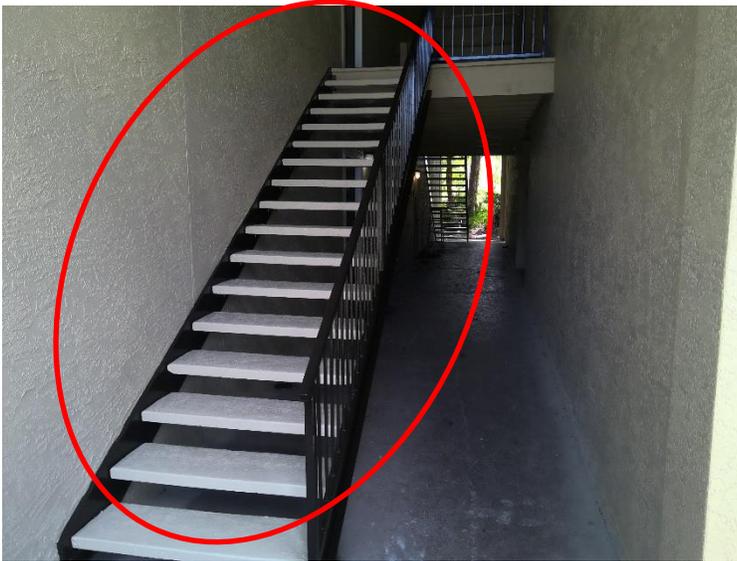
PHOTOGRAPH #1

BUILDING 1 SECTION A

Railings and steel stairway stringers have been finish painted with Florida Paint Urethane Gloss enamel.

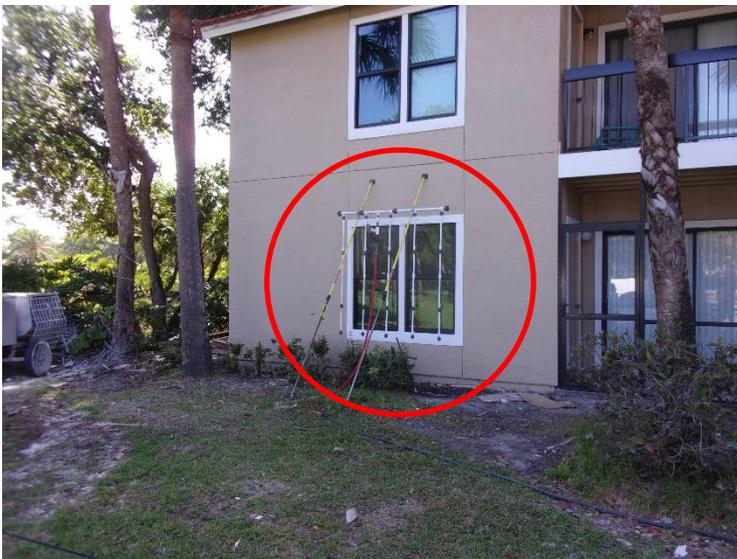
PHOTOGRAPH #2

BUILDING 1 SECTION A-UNIT #111

Independent testing agency began re water testing double windows. Left window that previously leaked did not leak but right-side window leaked at right corner sill.

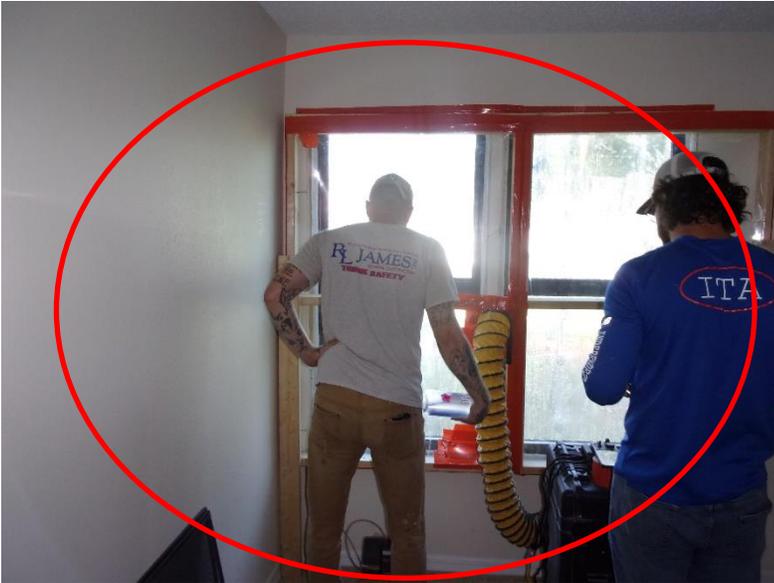
PHOTOGRAPH #3

**BUILDING 1
SECTION A-UNIT #111**

Independent testing agency began re water testing double windows. Left window that previously leaked did not leak but right-side window leaked at right corner sill.

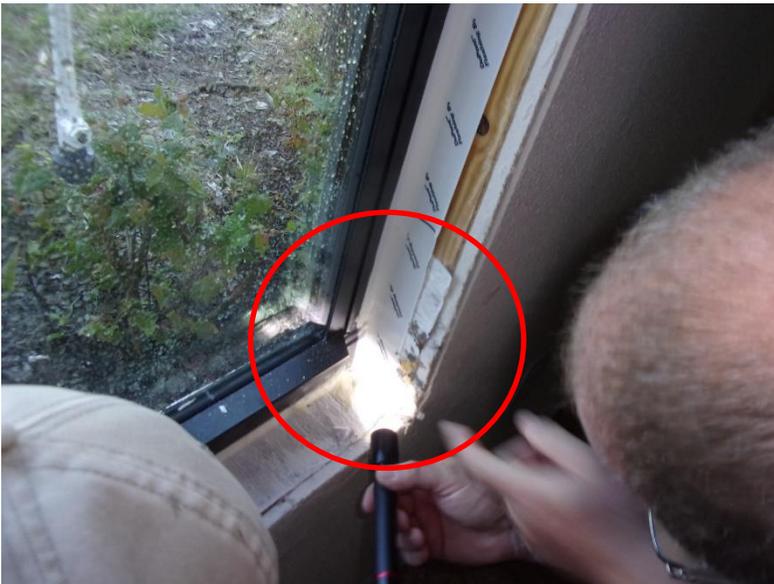
PHOTOGRAPH #4

**BUILDING 1
SECTION A- UNIT #111**

Independent testing agency began re water testing double windows. Left window that previously leaked did not leak but right-side window leaked at right corner sill.

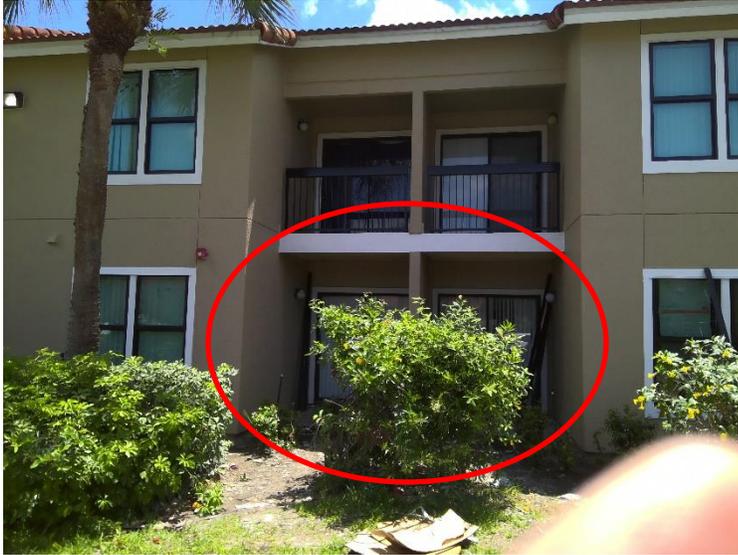
PHOTOGRAPH #5

**BUILDING 1
SECTION B**

New screen enclosures installations in progress.

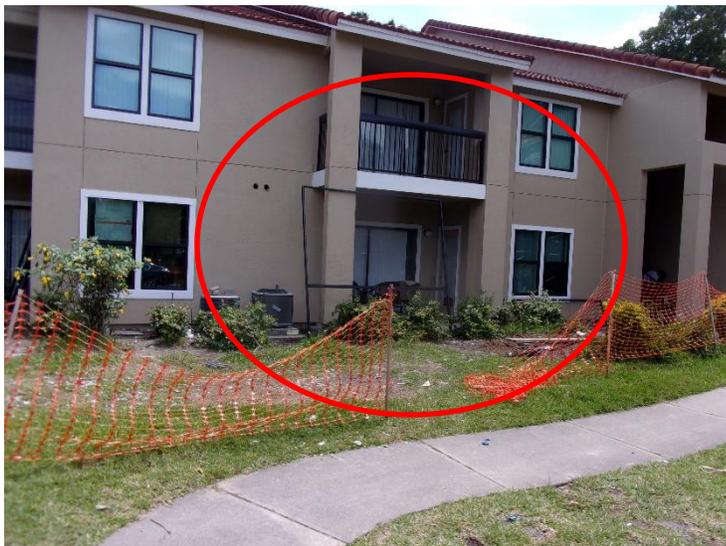
PHOTOGRAPH #6

**BUILDING 1
SECTION B**

New screen enclosures installations in progress.

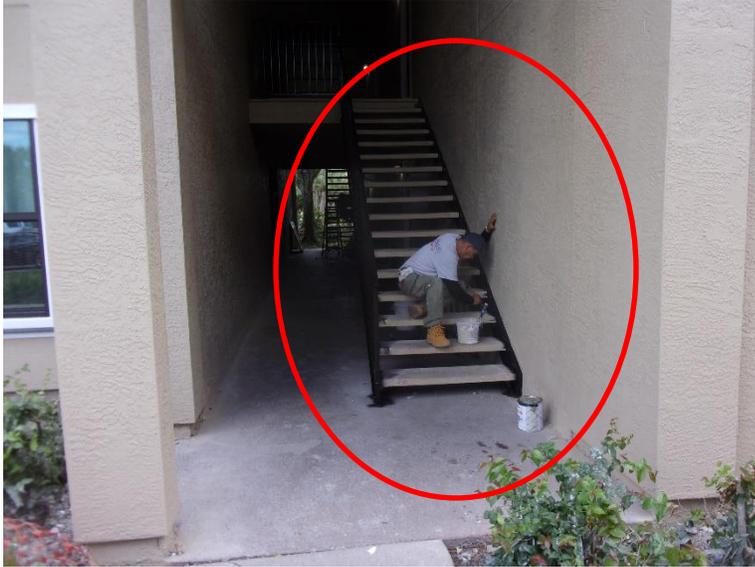
PHOTOGRAPH #7

**BUILDING 1
SECTION C**

Concrete stair pads being coated with Florida Paints, TropiCrete Exterior Concrete sealer.

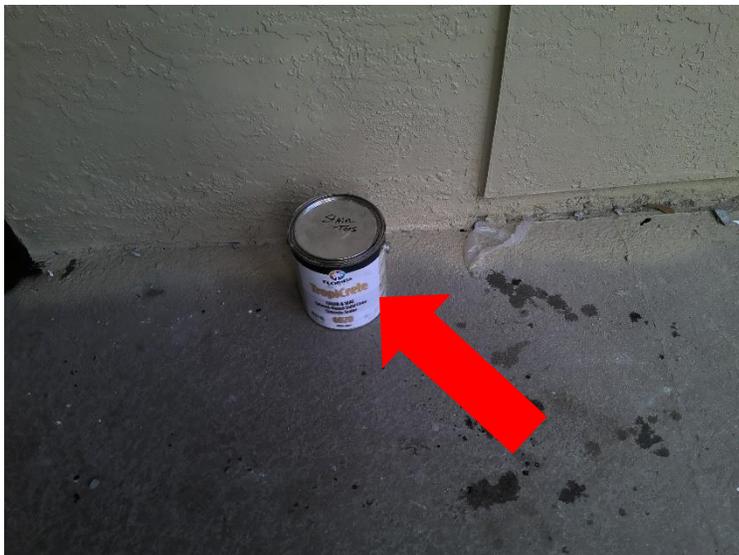
PHOTOGRAPH #8

**BUILDING 1
SECTION C**

Concrete stair pads being coated with Florida Paints, TropiCrete Exterior Concrete sealer.

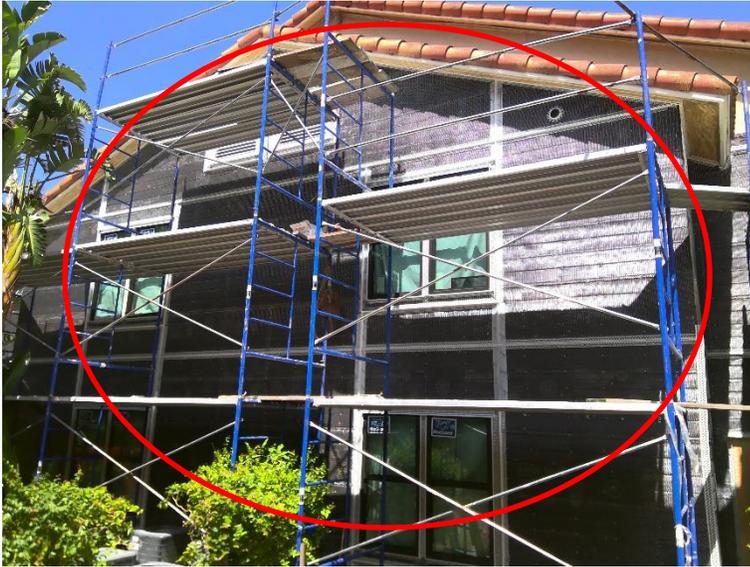
PHOTOGRAPH #9

**BUILDING 2
SECTION H**

Stucco sub-contractor proceeding with WRB, lath and stucco accessories.

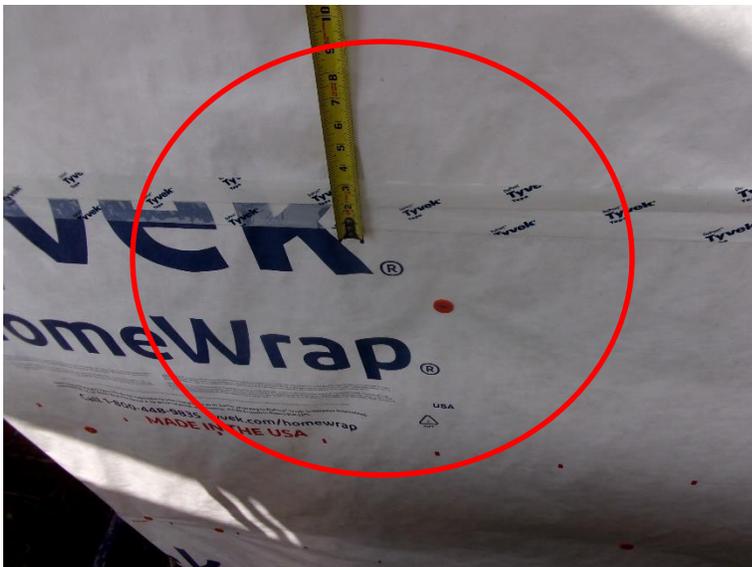
PHOTOGRAPH #10

**BUILDING 2
SECTION G**

Tyvek HomeWrap water resistant barrier applied and taped at overlapping seams with Tyvek 3" seam tape.

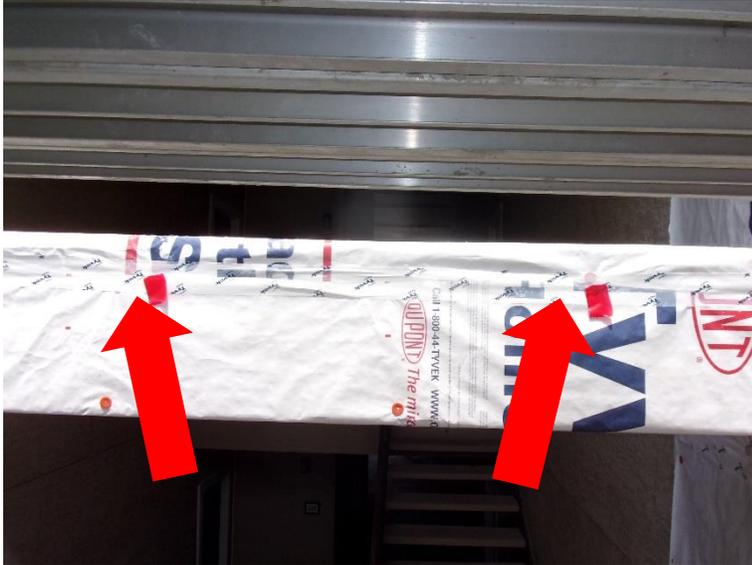
PHOTOGRAPH #11

**BUILDING 2
SECTION G**

Tyvek seam tape applied improperly over nail tabs have been marked for corrections.

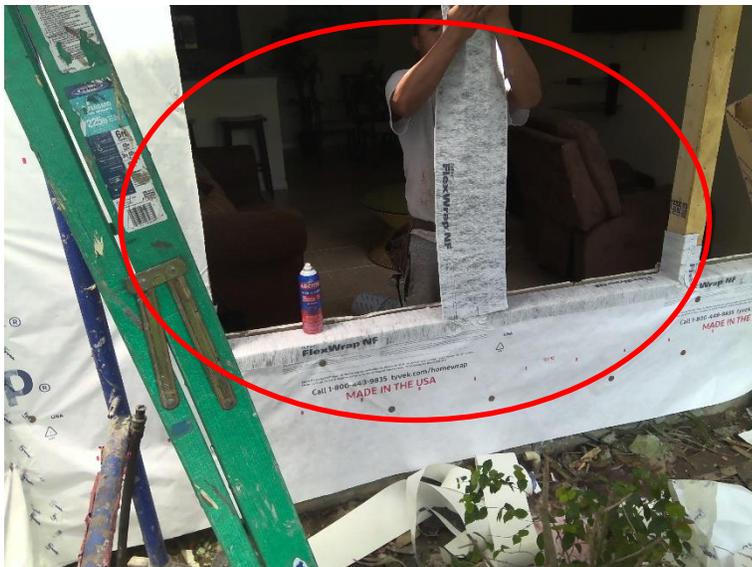
PHOTOGRAPH #12

**BUILDING 2
SECTION F**

DuPont FlexWrap flashing applied at windowsills and at window jambs between windows.

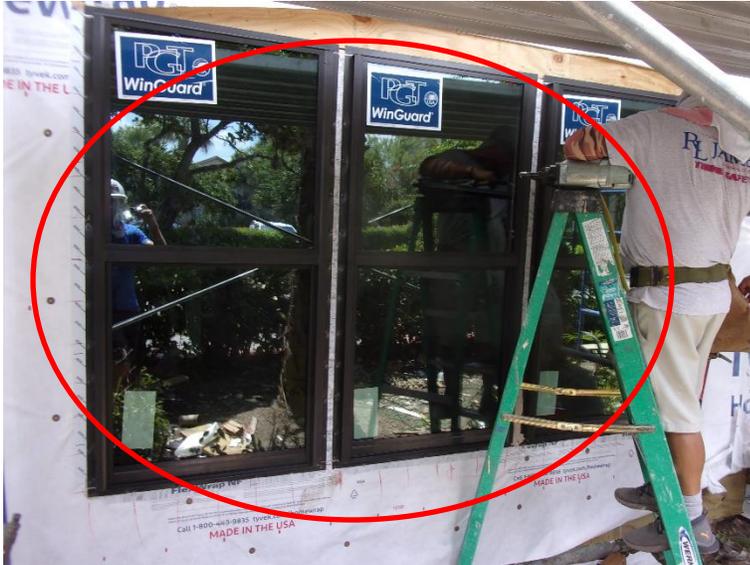
PHOTOGRAPH #13

**BUILDING 2
SECTION F**

New PGT WindGuard windows installed with Dupont / Tyvek flashing and WRB system.

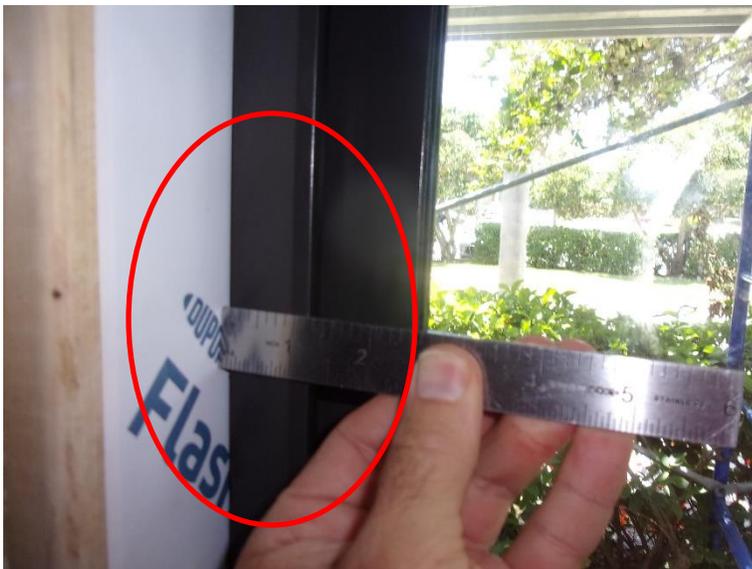
PHOTOGRAPH #14

**BUILDING 2
SECTION F- UNIT #218**

Interior gaps between wood framing and window checked for spacing tolerance to meet manufacturers fastening requirements.

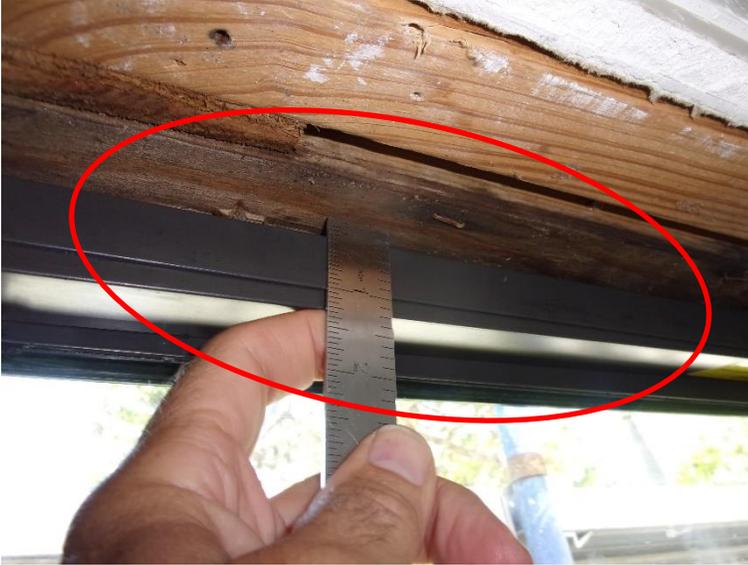
PHOTOGRAPH #15

**BUILDING 2
SECTION F- UNIT #218**

Interior gaps between wood framing and window checked for spacing tolerance to meet manufacturers fastening requirements.

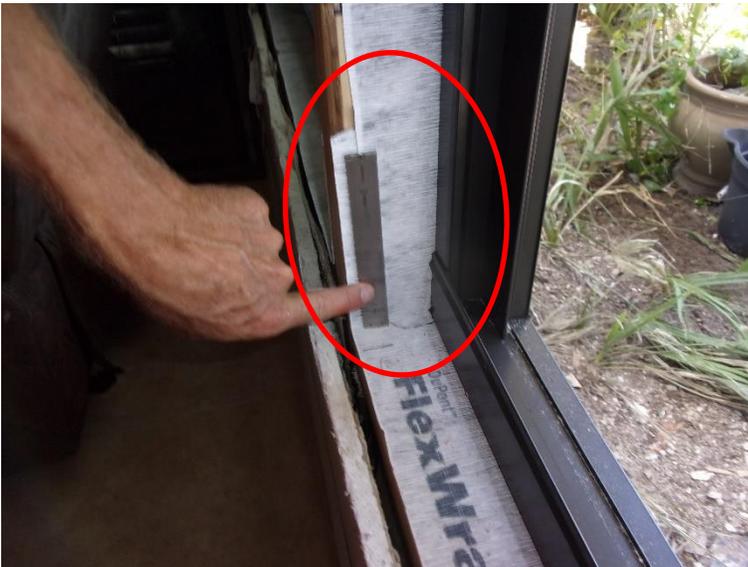
PHOTOGRAPH #16

**BUILDING 2
SECTION F- UNIT #216**

Dupont flashing overlaps and details checked for manufactures requirements.

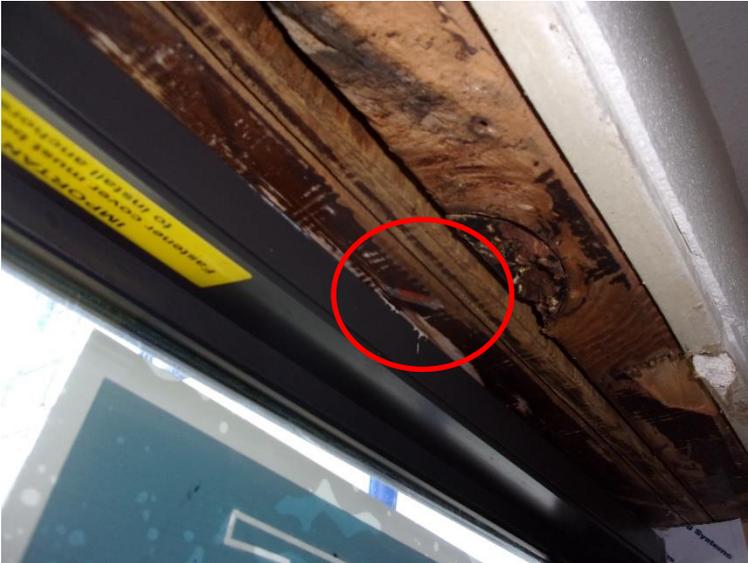
PHOTOGRAPH #17

**BUILDING 2
SECTION F- UNIT #216**

Fastening nail installed improperly at window header will require removal and refastening.

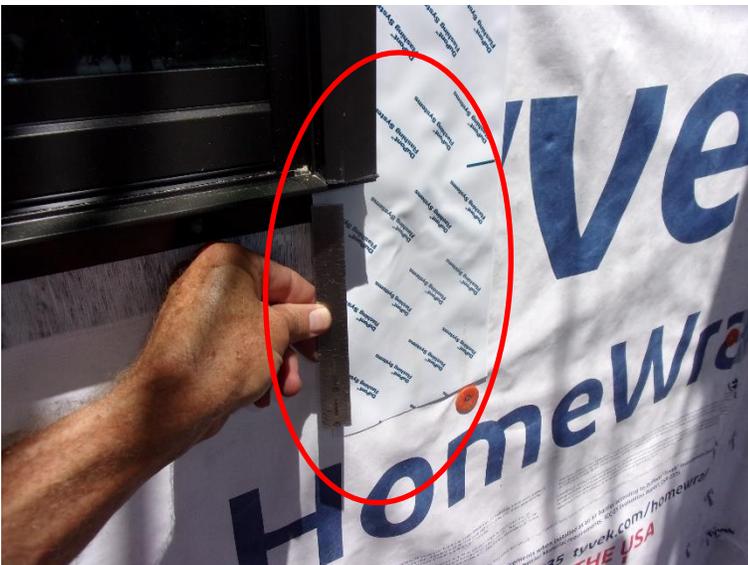
PHOTOGRAPH #18

**BUILDING 2
SECTION F**

Dupont / Tyvek window flashing detail check at exterior for overlaps and details to meet manufactures requirements.

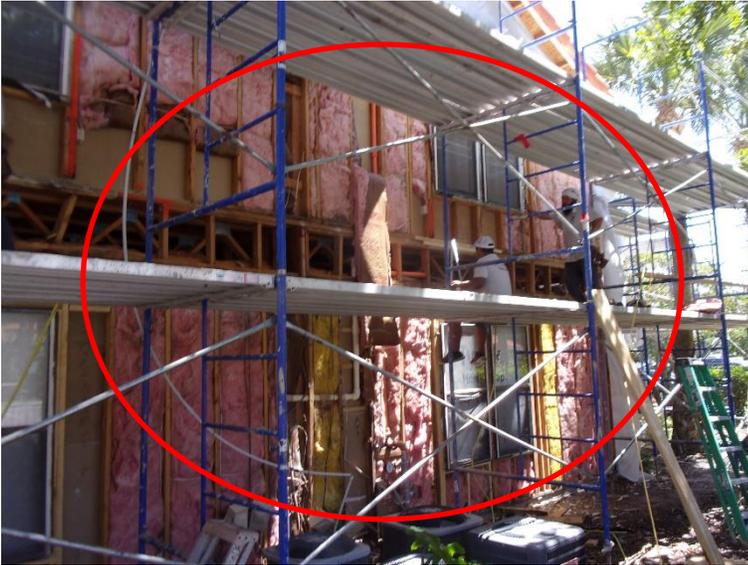
PHOTOGRAPH #19

**BUILDING 2
SECTION D**

Framing repairs in progress at subfloor, top plates and bottom plate locations as marked for repairs.

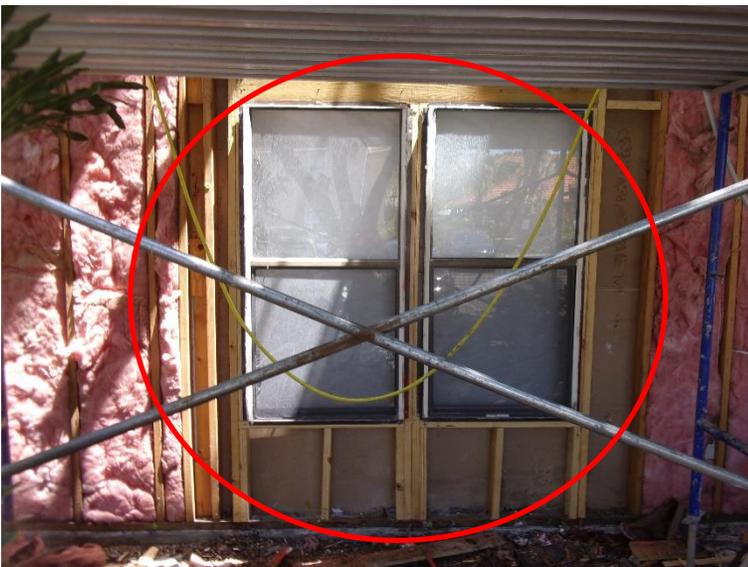
PHOTOGRAPH #20

**BUILDING 2
SECTION D**

Framing repairs in progress at window opening framing as marked for repairs.

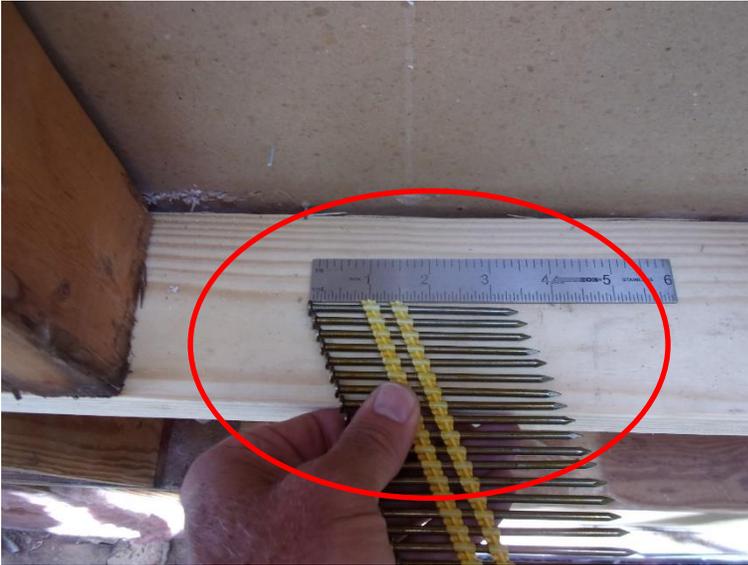
PHOTOGRAPH #21

**BUILDING 2
SECTION D**

16P framing nails used as specified for framing repairs.

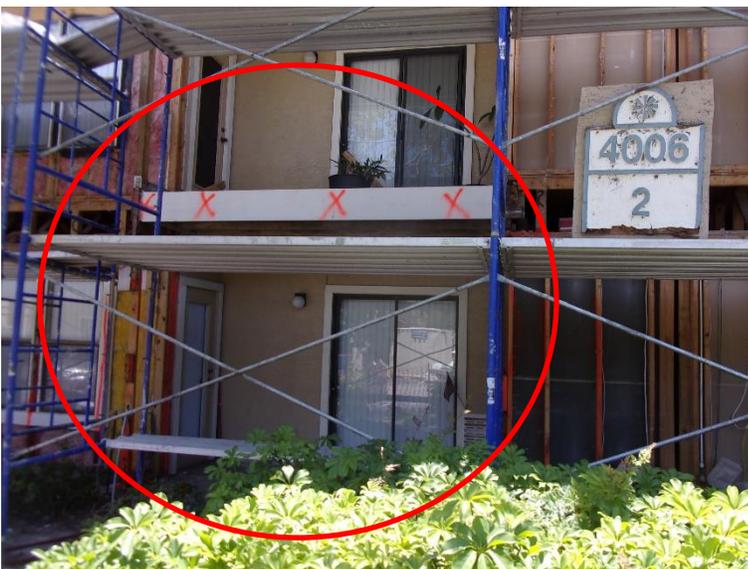
PHOTOGRAPH #22

**BUILDING 2
SECTION B**

Wall framing damage and balconies marked for repairs.

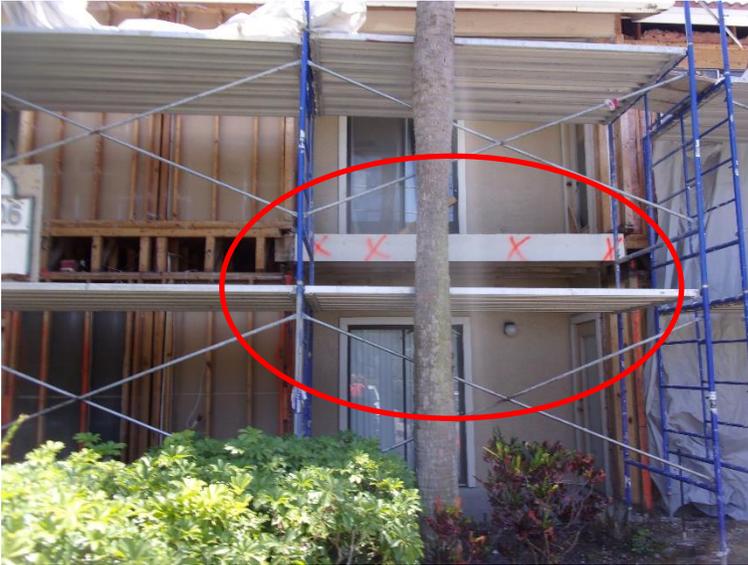
PHOTOGRAPH #23

**BUILDING 2
SECTION B**

Wall framing damage and balconies marked for repairs.

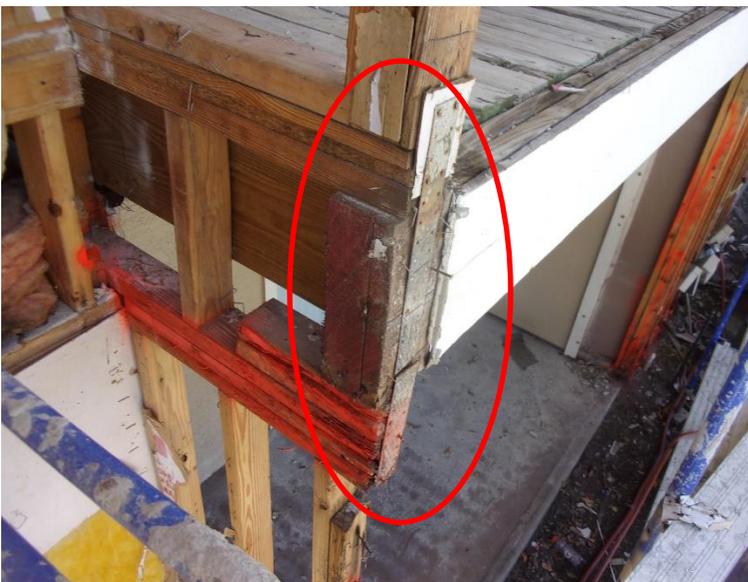
PHOTOGRAPH #24

**BUILDING 2
SECTION B**

Previous repairs of buildup balcony edge beams did not extend out for proper bearing on framing wall.

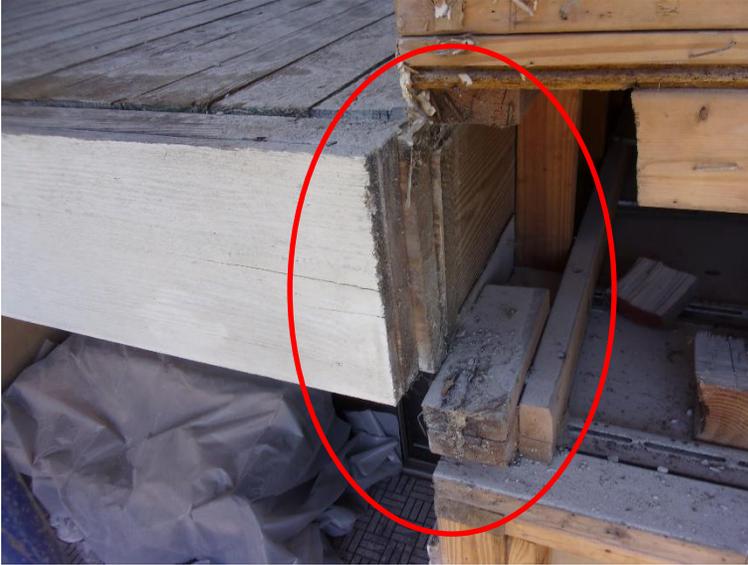
PHOTOGRAPH #25

**BUILDING 2
SECTION B**

Previous repairs of buildup balcony edge beams did not extend out for proper bearing on framing wall.

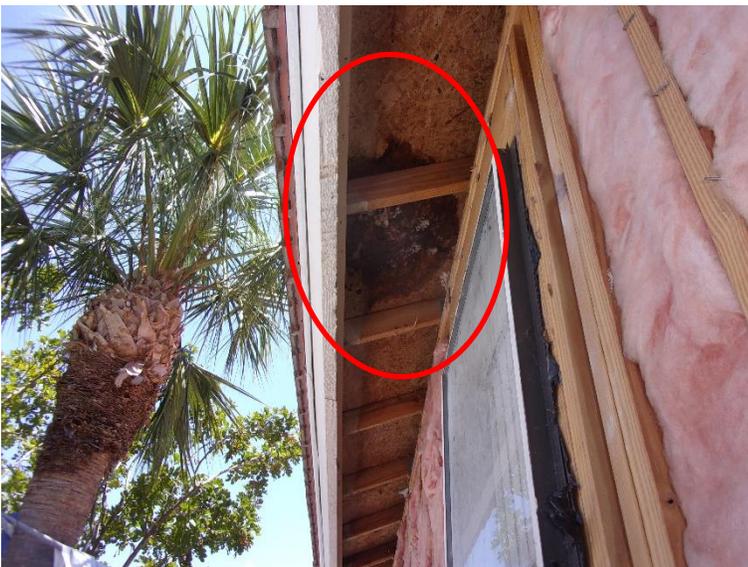
PHOTOGRAPH #26

**BUILDING 2
SECTION B**

Damage at roof sheathing from roof leaks to be repaired by other owners' contractor.

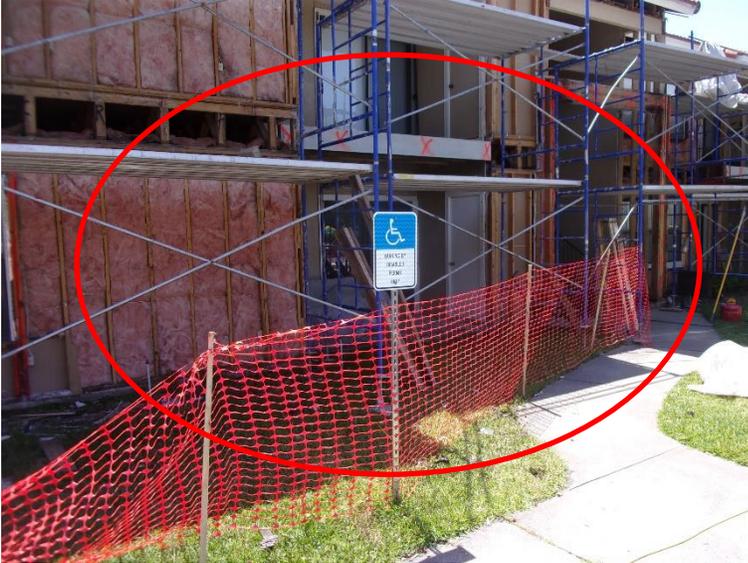
PHOTOGRAPH #27

**BUILDING 2
SECTION A**

Wall framing damage and balconies marked for repairs.
