PHOTOGRAPHS

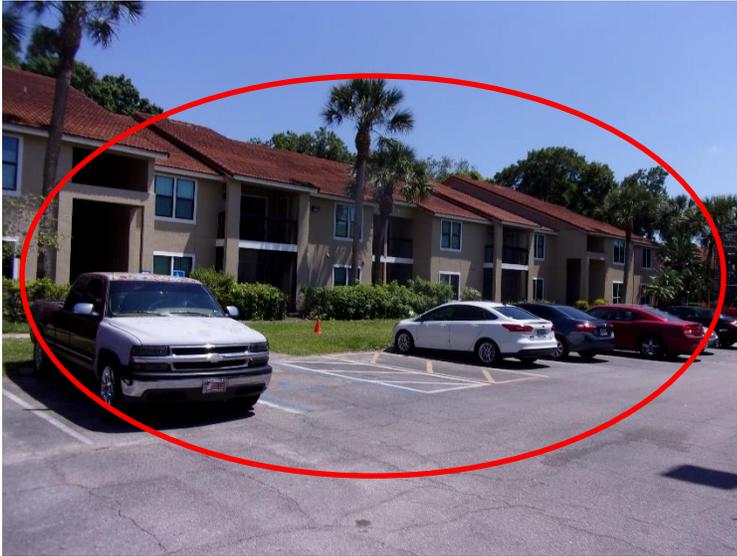
PHOTOGRAPH #1

BUILDING 1 OVERVIEW

Completion of screen enclosures and exterior punch list items in progress.

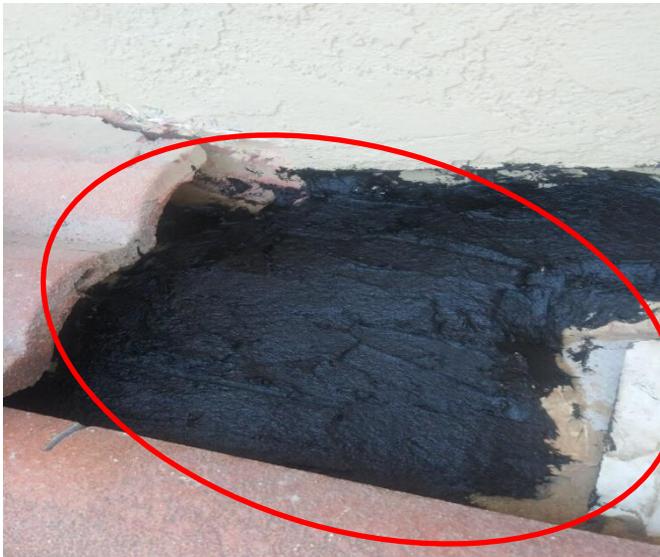
PHOTOGRAPH #2

BUILDING 1 SECTION A

Contractor has applied full bed of roofing mastic at roof kick out locations prior to replacing roof tiles as required.

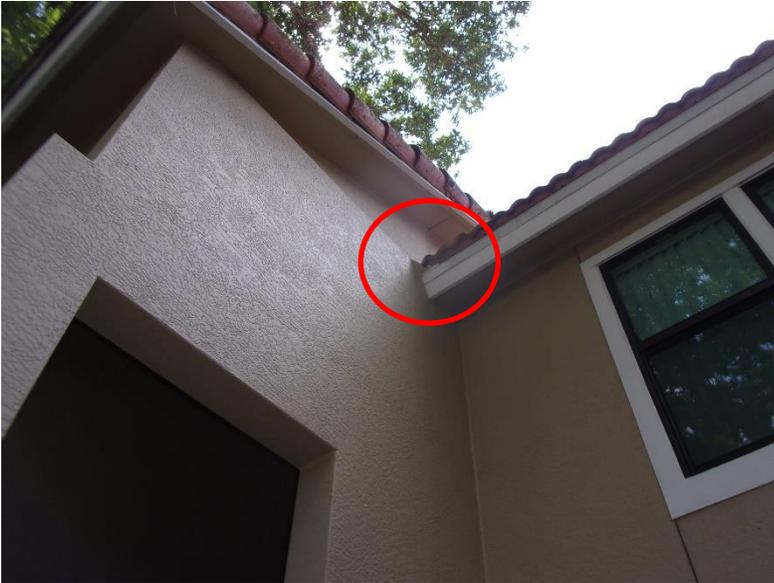
PHOTOGRAPH #3

**BUILDING 1
SECTION A**

Contractor has applied full bed of roofing mastic at roof kick out locations prior to replacing roof tiles as required.

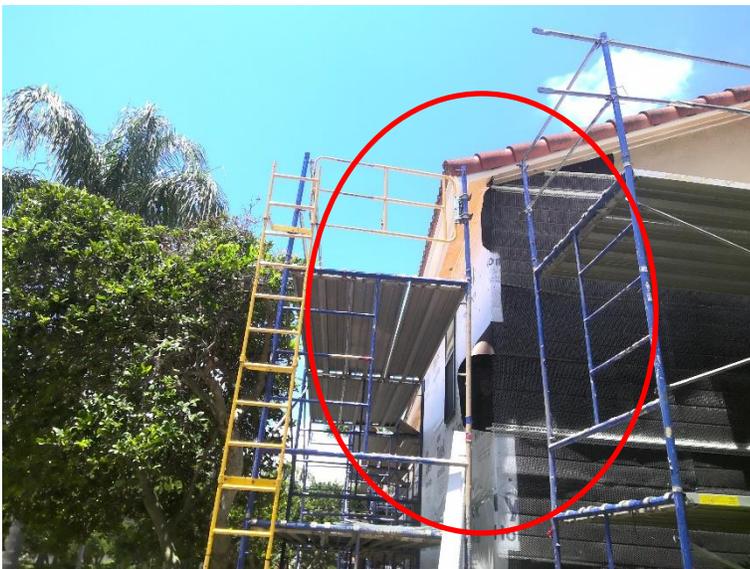
PHOTOGRAPH #4

**BUILDING 2
SECTION H**

Stucco sub-contractor proceeding with lapping of Super JumboTex 60 WRB at corners.

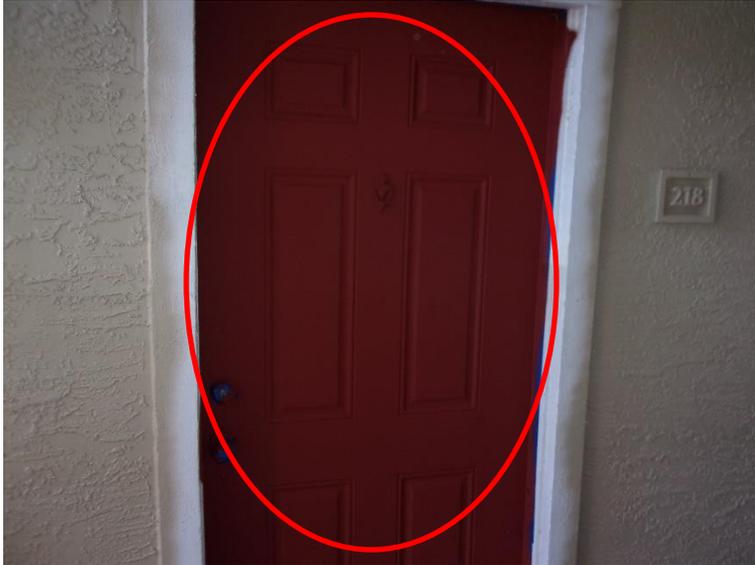
PHOTOGRAPH #5

**BUILDING 2
SECTION E**

Unit entrance doors prepped and primed with Florida Paint Encapsulon industrial primer.

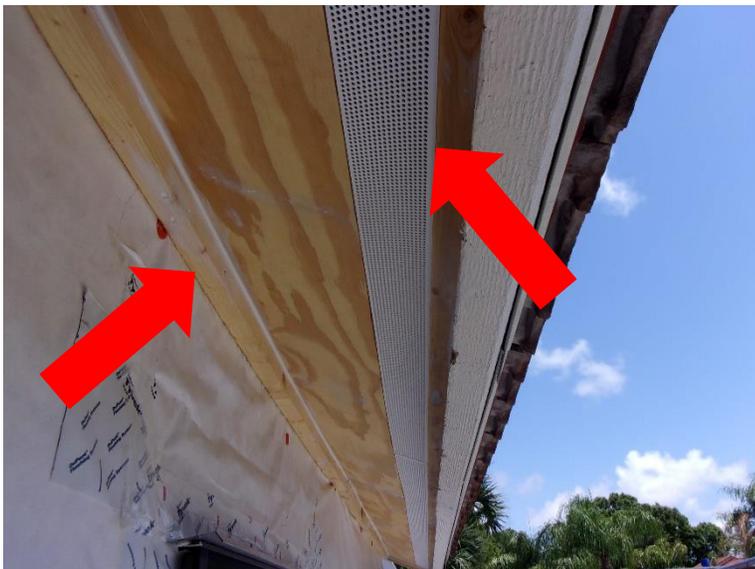
PHOTOGRAPH #6

**BUILDING 2
SECTION E**

New wood soffits provided with new vinyl vented screen.

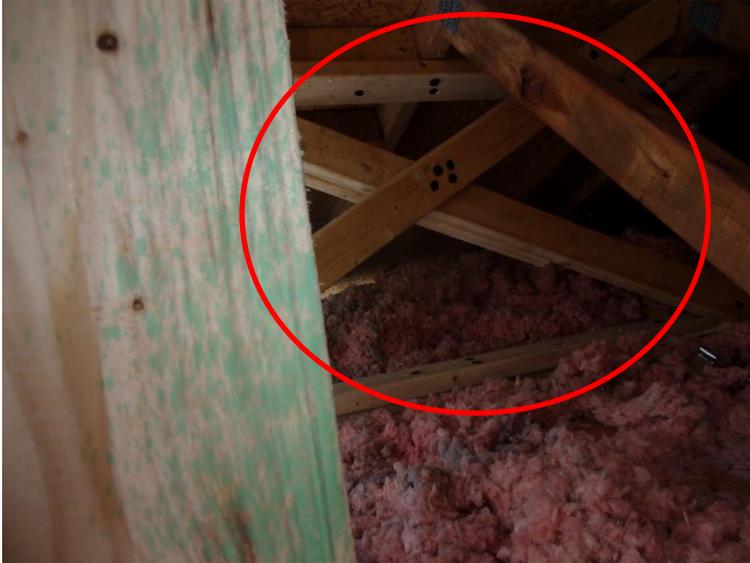
PHOTOGRAPH #7

**BUILDING 2
SECTION D**

Gable end cross bracing repairs performed and attached as per drawings and specification to trusses in attic space.

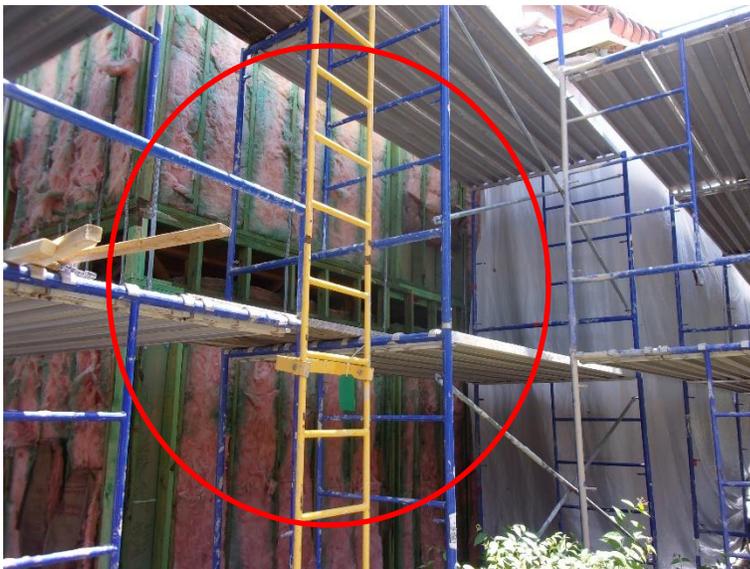
PHOTOGRAPH #8

**BUILDING 2
SECTION D**

Termite sub-contractor has applied BoraCare termite treatment to framing.

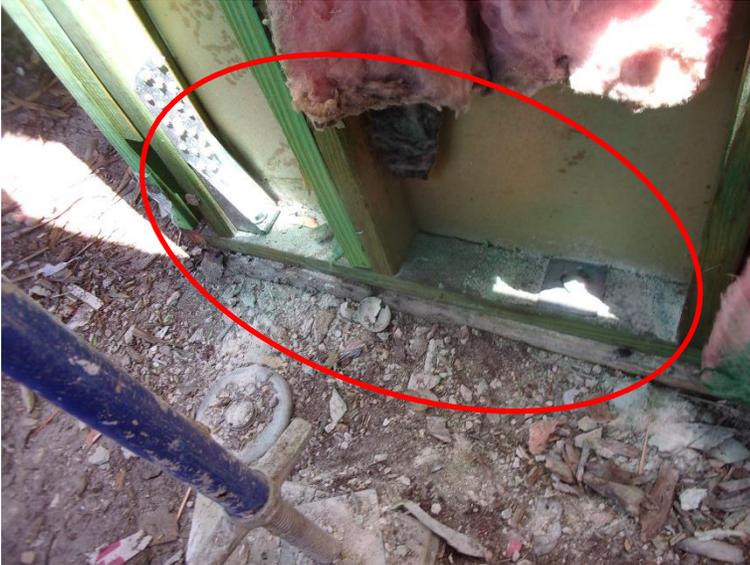
PHOTOGRAPH #9

**BUILDING 2
SECTION D**

Simpson Strong-Tie Connectors and Titen fasteners installed at base plates and king studs.

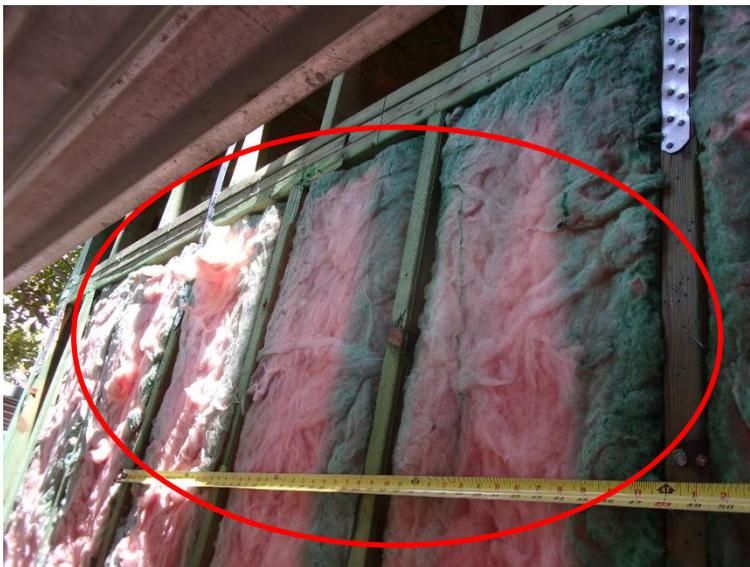
PHOTOGRAPH #10

**BUILDING 2
SECTION D**

Simpson Strong-Tie straps provided at 48" O.C. at gable end wall.

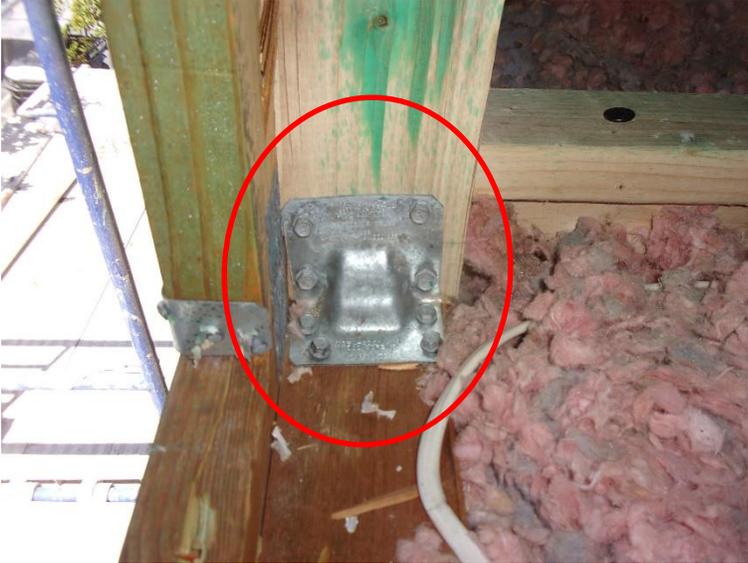
PHOTOGRAPH #11

**BUILDING 2
SECTION D**

Simpson Strong-Tie #HGA10 clips provided at gable end truss to plate.

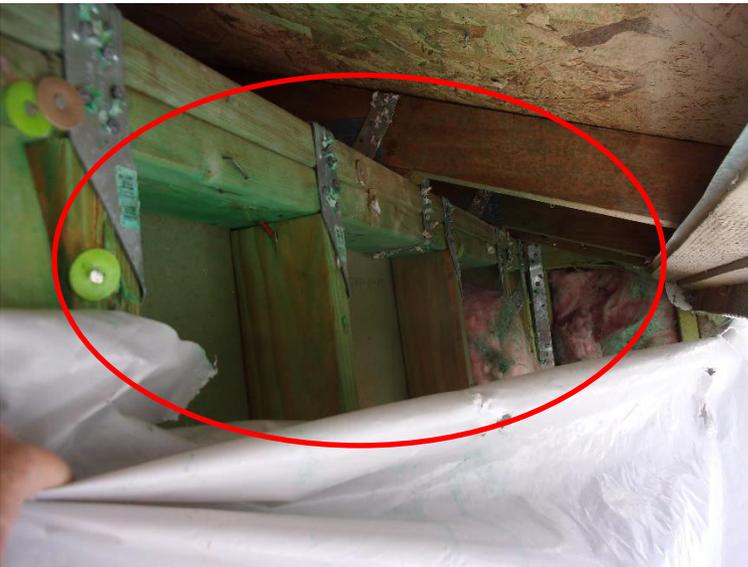
PHOTOGRAPH #12

**BUILDING 2
SECTION D**

Simpson Strong-Tie connectors and screws installed at top plate to trusses and wall studs to top plate.

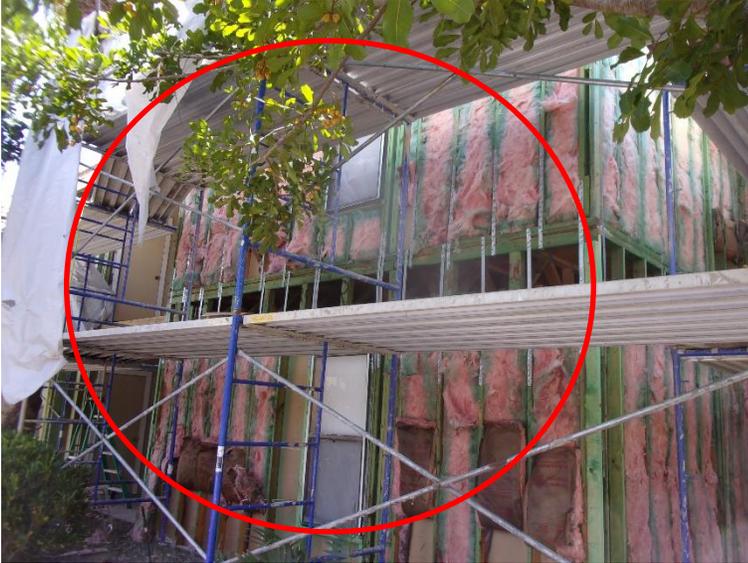
PHOTOGRAPH #13

**BUILDING 2
SECTION C**

Contractor has begun installing Simpson Strong-Tie connectors and strapping.

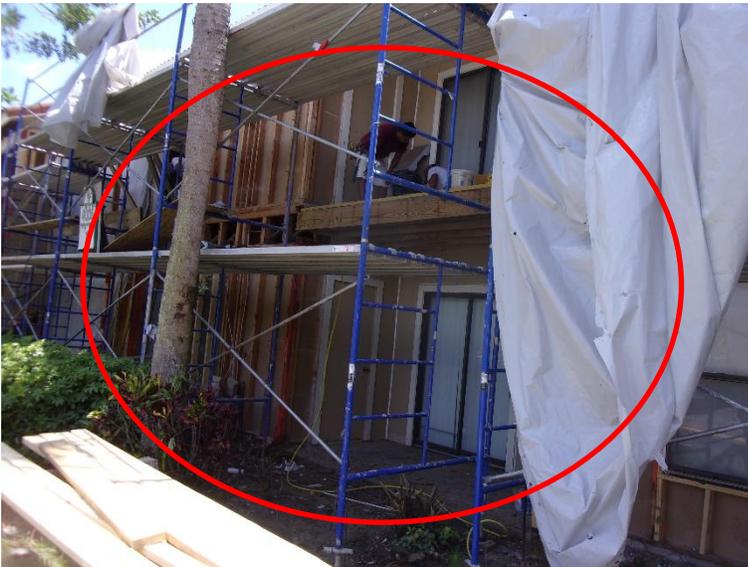
PHOTOGRAPH #14

**BUILDING 2
SECTION B**

Framing repairs in progress at balcony built up beams and decks as marked for repairs.

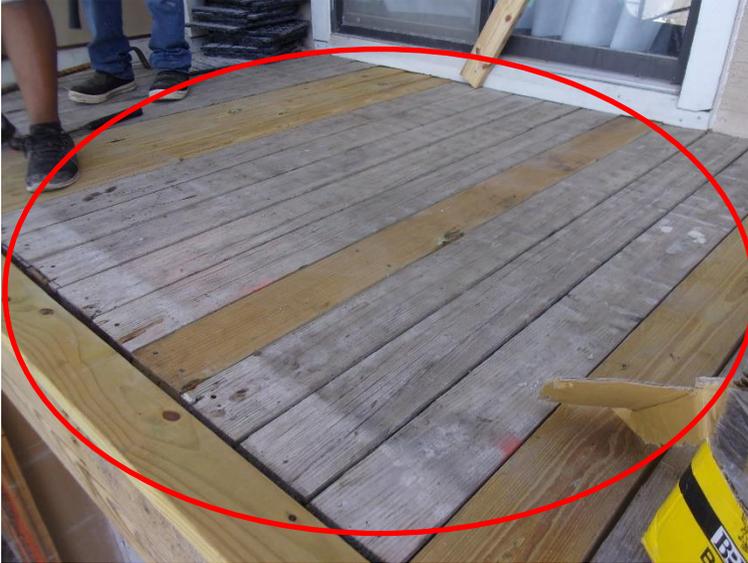
PHOTOGRAPH #15

**BUILDING 2
SECTION B**

Selective balcony deck boards replaced
as marked for repairs.
