PHOTOGRAPHS

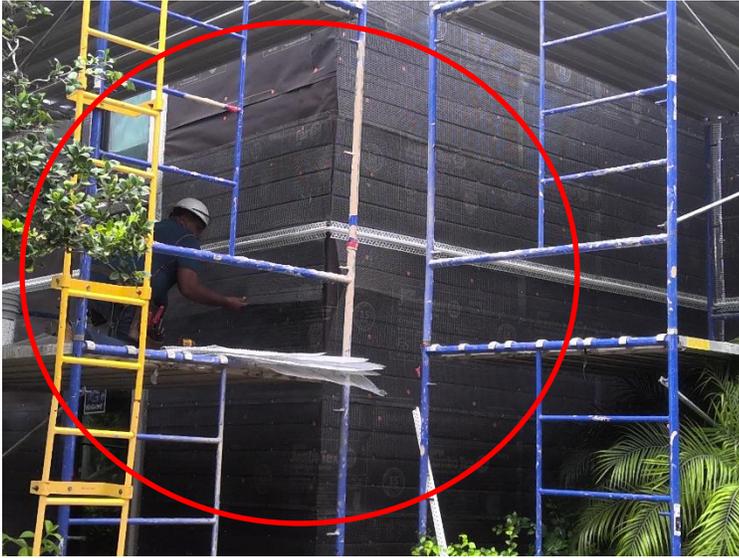
PHOTOGRAPH #1

BUILDING 2 SECTION G

Stucco sub-contractor in process of applying metal lath and stucco accessories.

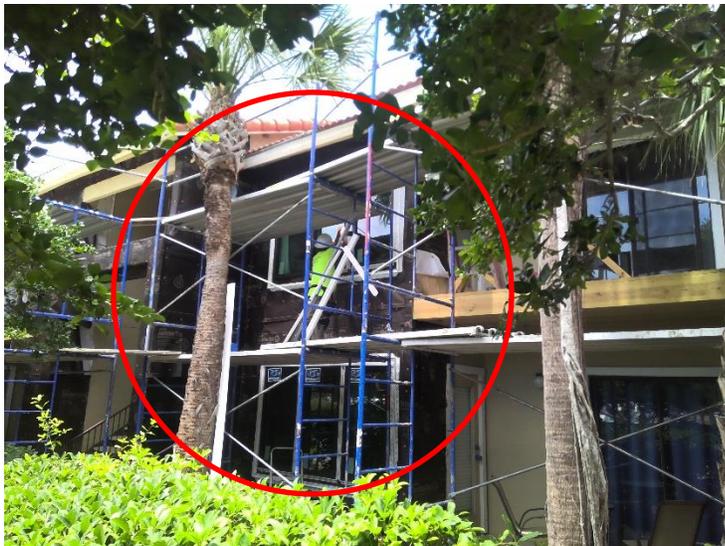
PHOTOGRAPH #2

BUILDING 2 SECTION F

Stucco sub-contractor in process of applying metal lath and stucco accessories.

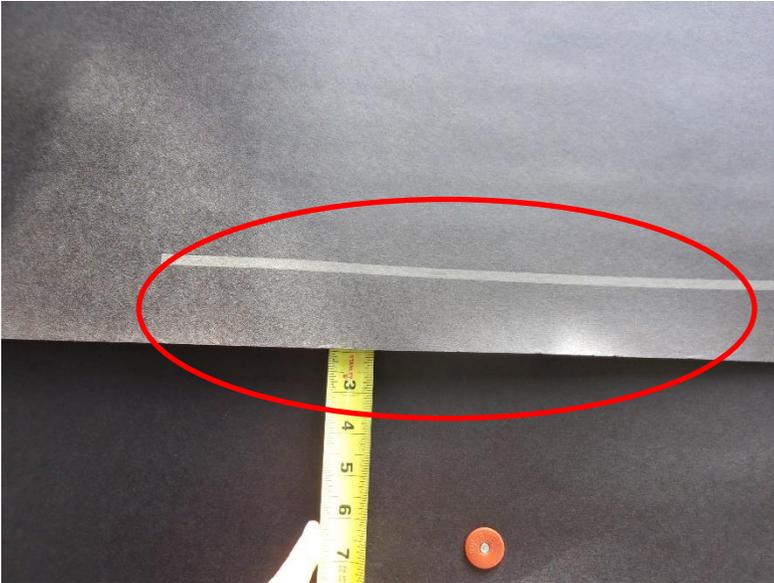
PHOTOGRAPH #3

**BUILDING 2
SECTION F**

Super JumboTex 60 water resistant barrier overlapped as per manufacturers requirements.

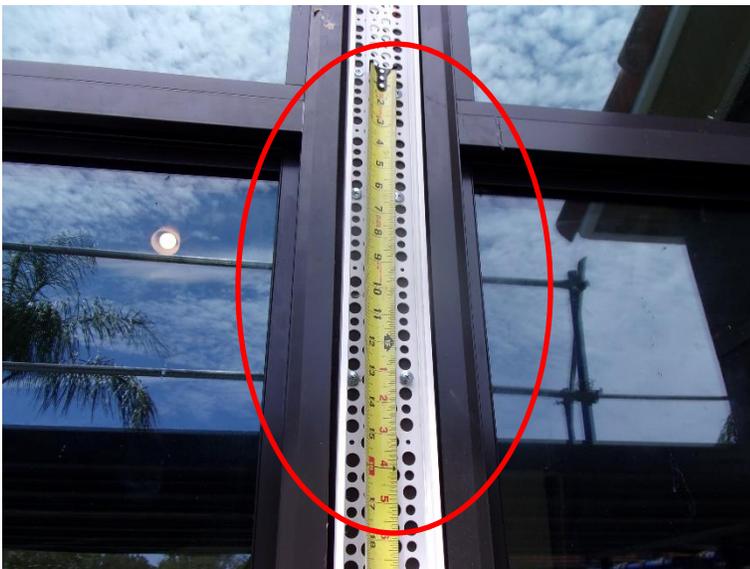
PHOTOGRAPH #4

**BUILDING 2
SECTION F**

Vinyl stucco accessories attached at flange at no more than 7" intervals as per ASTM C1063.

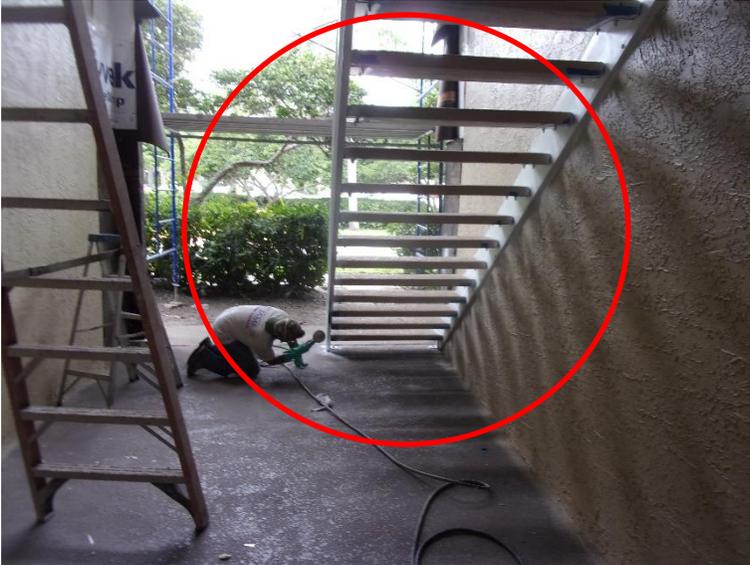
PHOTOGRAPH #5

**BUILDING 2
SECTION E**

Contractor in process of priming breezeway handrails with Florida Paint Encapsulon industrial primer.

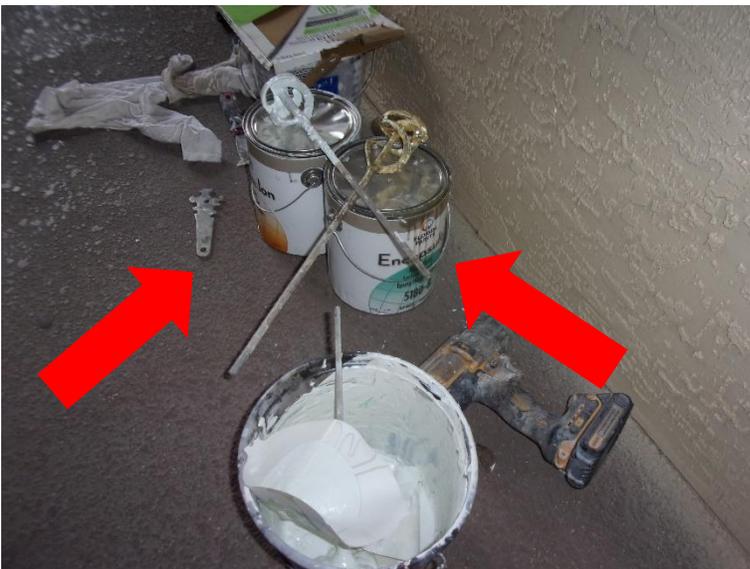
PHOTOGRAPH #6

**BUILDING 2
SECTION E**

Contractor in process of priming breezeway handrails with Florida Paint Encapsulon industrial primer.

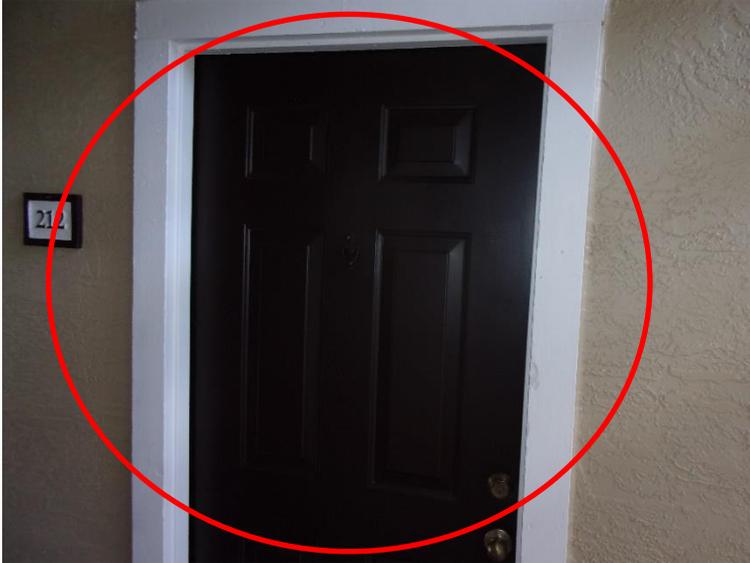
PHOTOGRAPH #7

**BUILDING 2
SECTION E**

Front entrance doors have received finish coat of enamel paint.

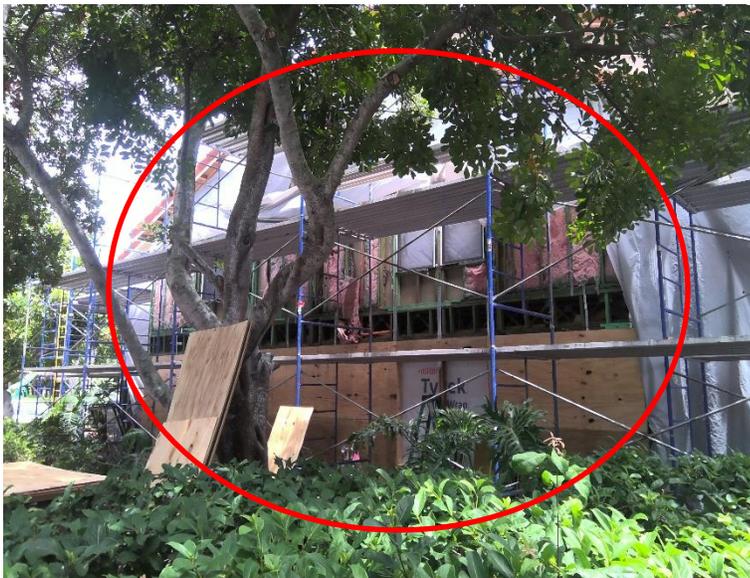
PHOTOGRAPH #8

**BUILDING 2
SECTION D**

Contractor has begun plywood sheathing application at gable end wall.

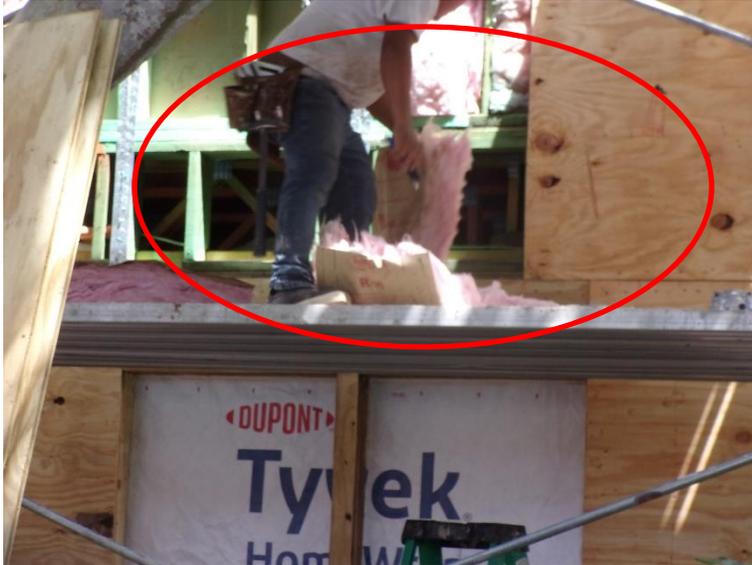
PHOTOGRAPH #9

**BUILDING 2
SECTION D**

Owens Corning R-13 insulation provided were missing or damaged.

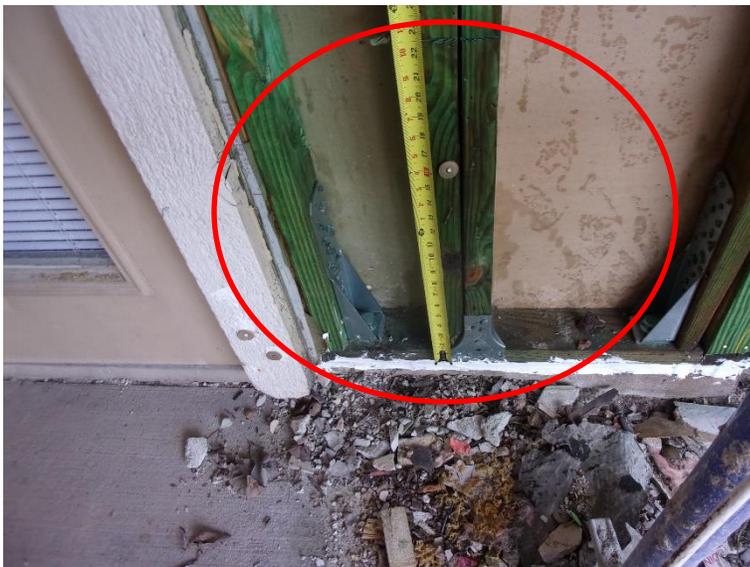
PHOTOGRAPH #10

**BUILDING 2
SECTION C**

Copper-Green wood preservative provided at lower two feet of wall framing.

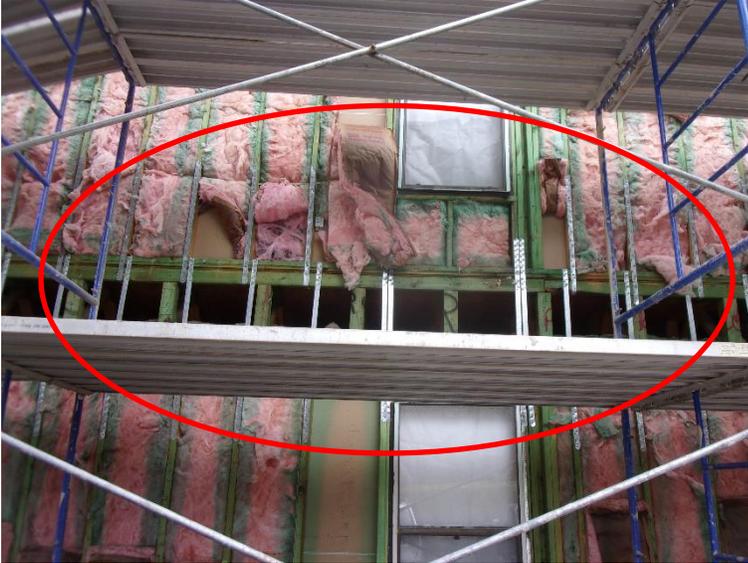
PHOTOGRAPH #11

**BUILDING 2
SECTION C**

Simpson Strong-Tie straps provided at 16" O.C. at bearing wall.

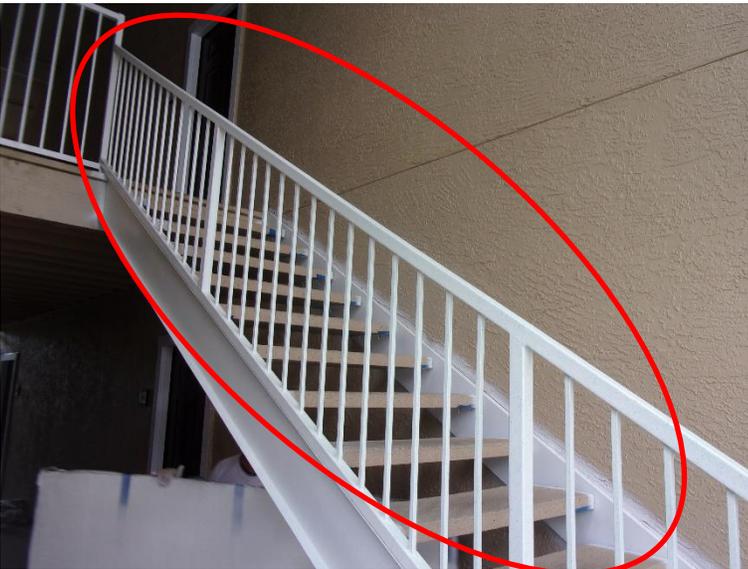
PHOTOGRAPH #12

**BUILDING 2
SECTION C**

Contractor has applied primer at breezeway handrails with Florida Paint Encapsulon industrial primer.

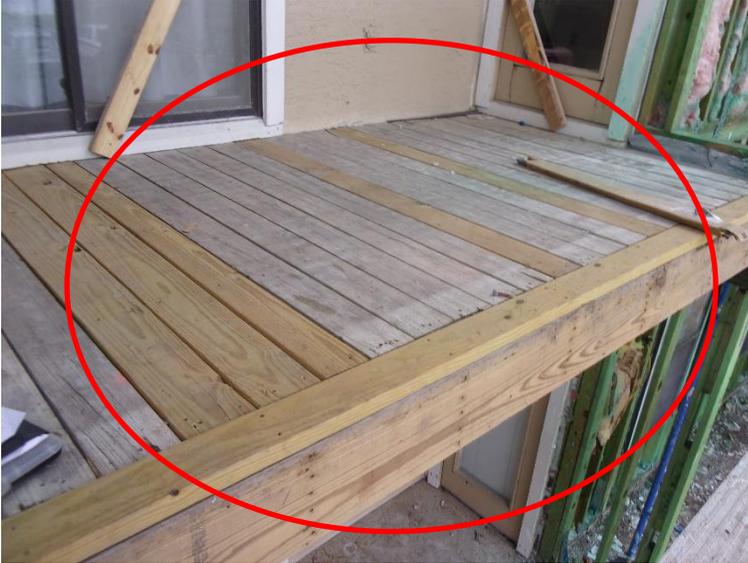
PHOTOGRAPH #13

**BUILDING 2
SECTION B**

Selective balcony deck boards replaced as marked for repairs.

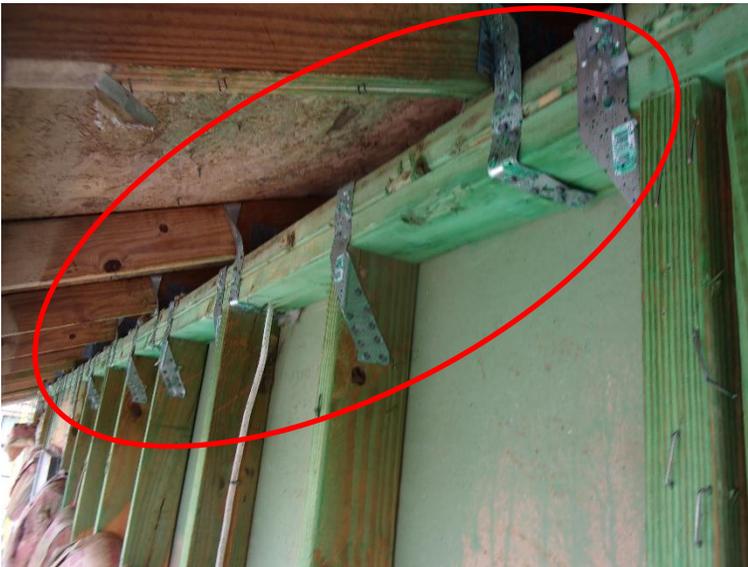
PHOTOGRAPH #14

**BUILDING 2
SECTION A**

Simpson Strong -Tie connector clips and screws provided at top plates and trusses.

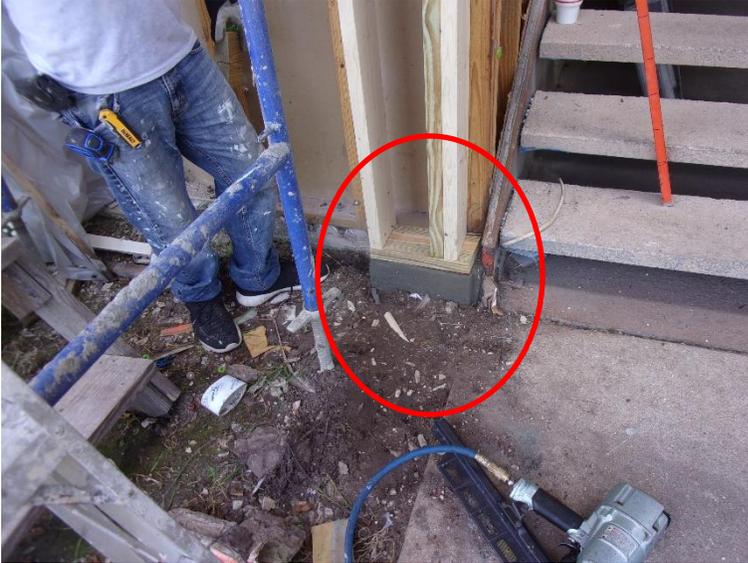
PHOTOGRAPH #15

**BUILDING 2
SECTION A**

Built up concrete pedestal provided at
breezeway column.
