PHOTOGRAPHS

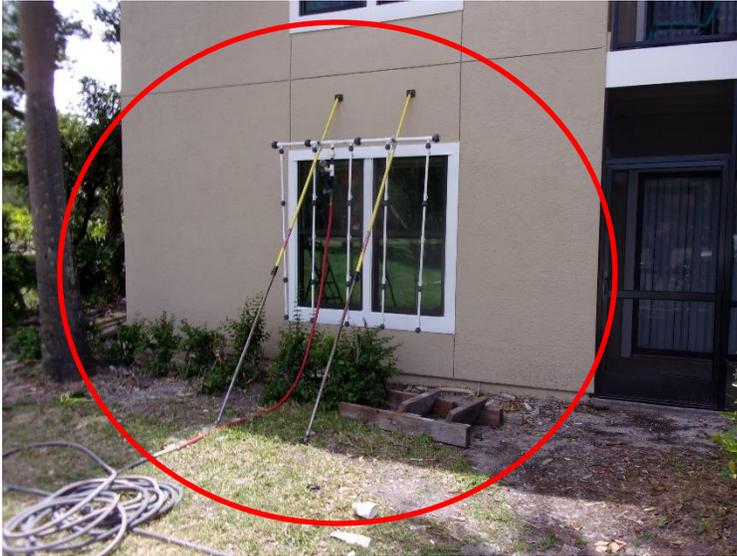
PHOTOGRAPH #1

**BUILDING 1
SECTION A**

Unit #111- Master bedroom double window water testing performed by Independent water testing agency in accordance with AAMA 502. Test passed with no water intrusion.

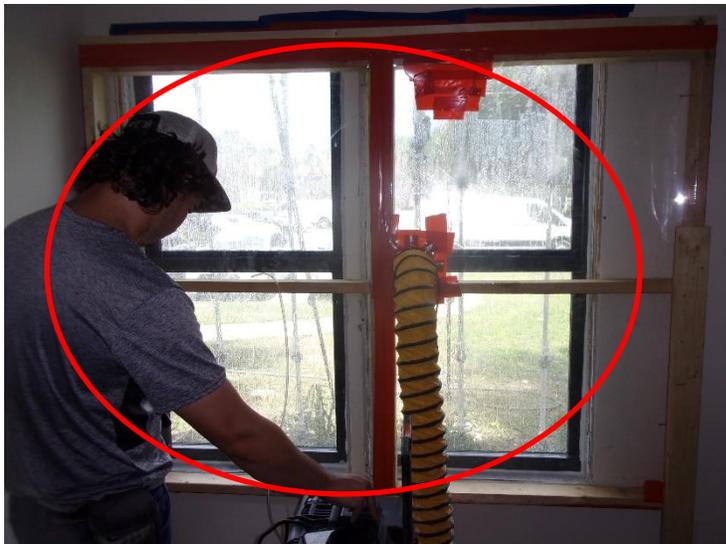
PHOTOGRAPH #2

**BUILDING 1
SECTION A**

Unit #111- Master bedroom double window water testing performed by Independent water testing agency in accordance with AAMA 502. Test passed with no water intrusion.

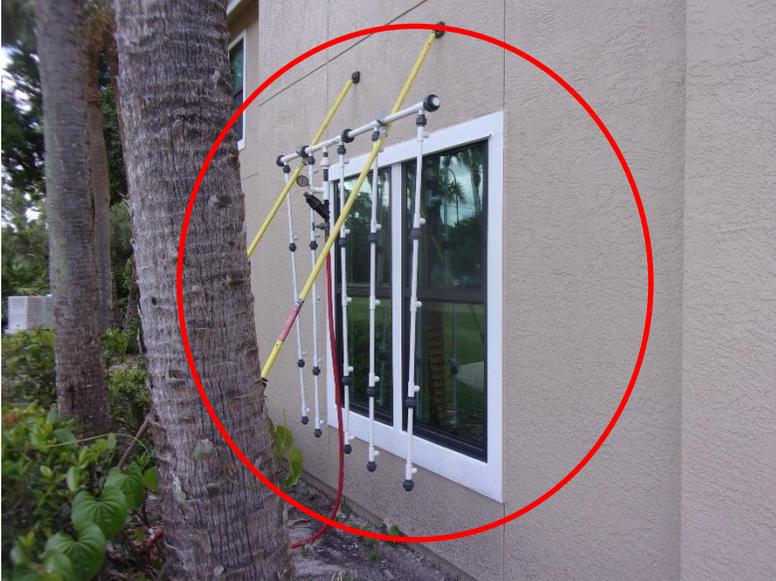
PHOTOGRAPH #3

**BUILDING 1
SECTION A**

Unit #111- Guest bedroom double window water testing performed by Independent water testing agency in accordance with AAMA 502. Test passed with no water intrusion.

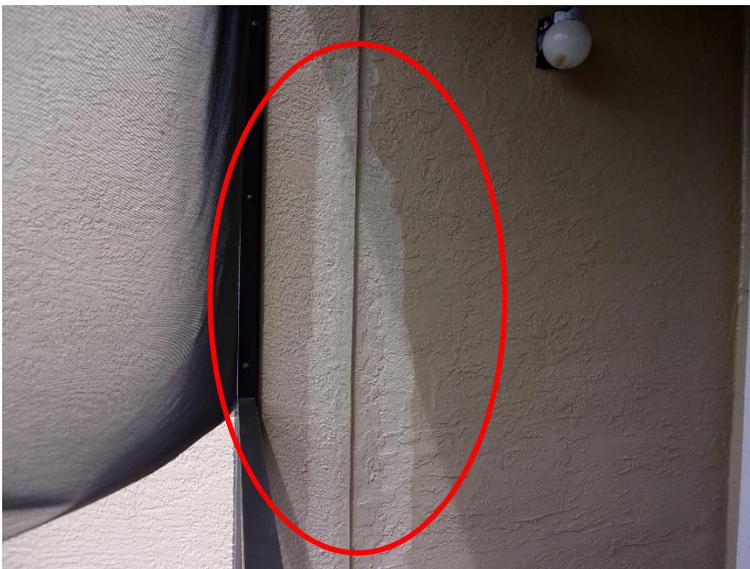
PHOTOGRAPH #4

**BUILDING 1
SECTION B**

Contractor has straightened stucco stop, and finished stucco at patio.

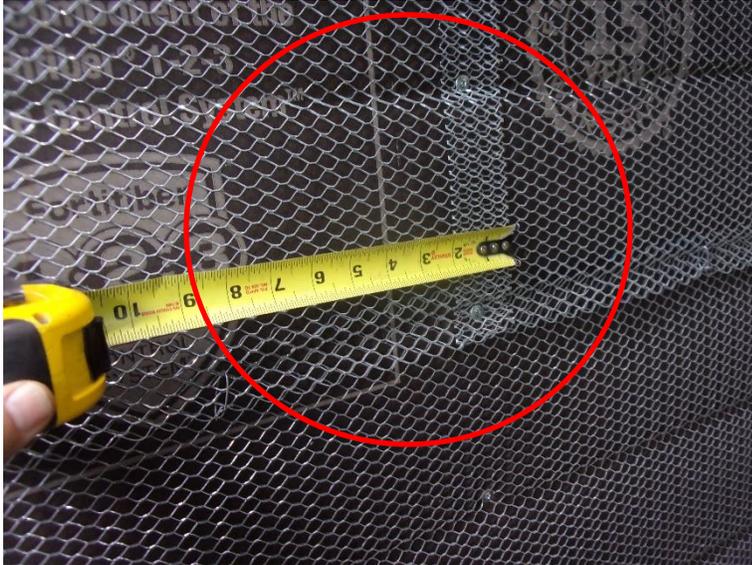
PHOTOGRAPH #5

**BUILDING 2
SECTION G**

Metal lathing overlap meeting minimum 1" requirements per specifications and drawings.

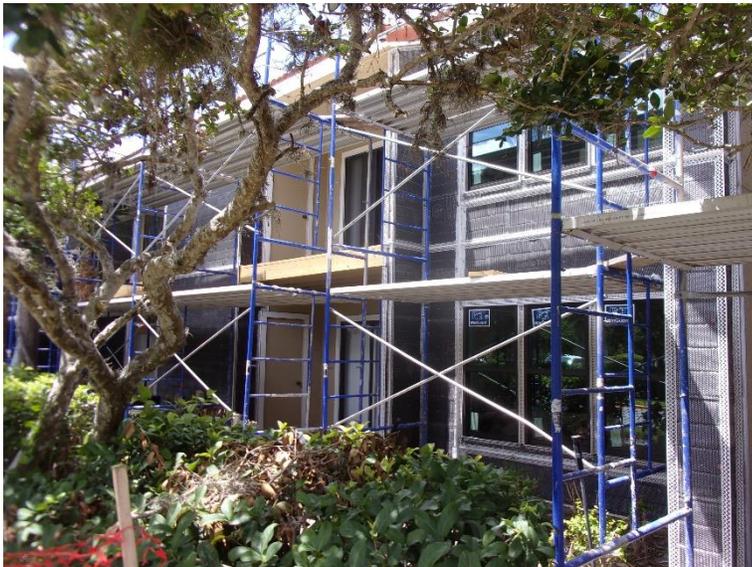
PHOTOGRAPH #6

**BUILDING 2
SECTION F**

Contractor has applied new vinyl stucco accessories and metal lathing.

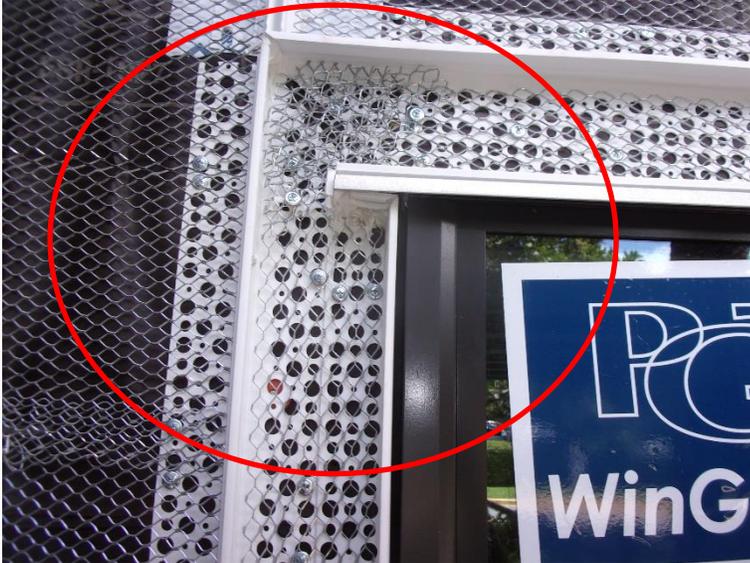
PHOTOGRAPH #7

**BUILDING 2
SECTION F**

Stucco accessories at window bands in progress as per drawings.

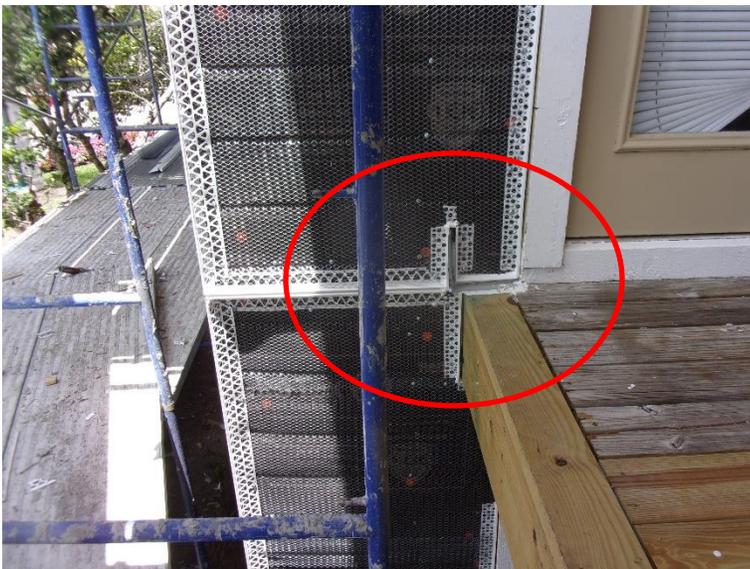
PHOTOGRAPH #8

**BUILDING 2
SECTION F**

New galvanized kick out flashings installed at balcony decks.

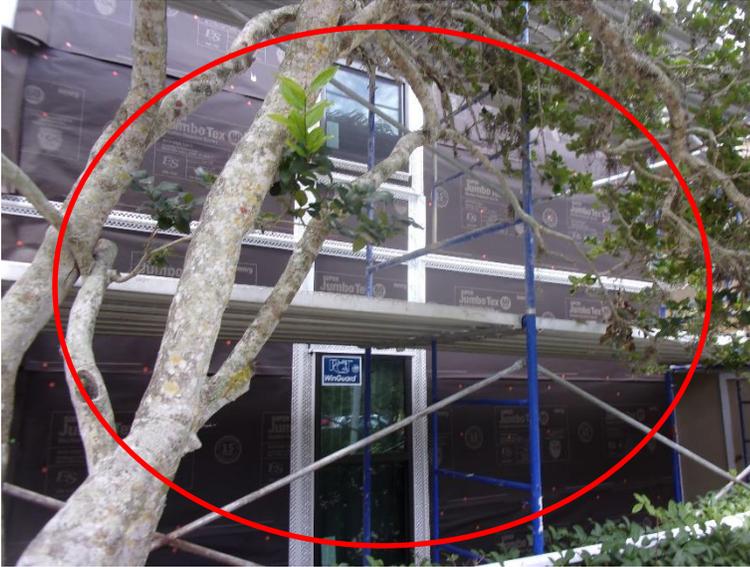
PHOTOGRAPH #9

**BUILDING 2
SECTION E**

Stucco sub-contractor has installed JumboTex 60 Minute WRB and begun joints and window accessories.

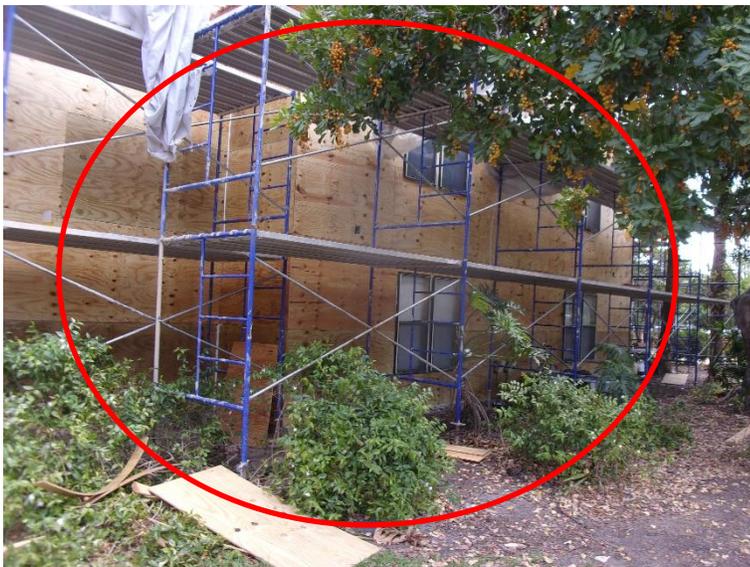
PHOTOGRAPH #10

**BUILDING 2
SECTION D**

Contractor has applied new 15/32" plywood sheathing at gable end elevation.

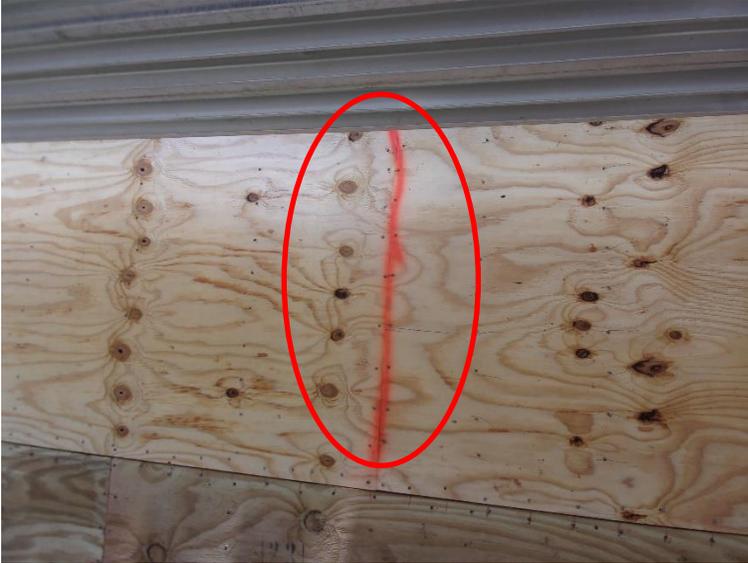
PHOTOGRAPH #11

**BUILDING 2
SECTION D**

Contractor has not allowed 1/8" minimum spacing between plywood sheathing.

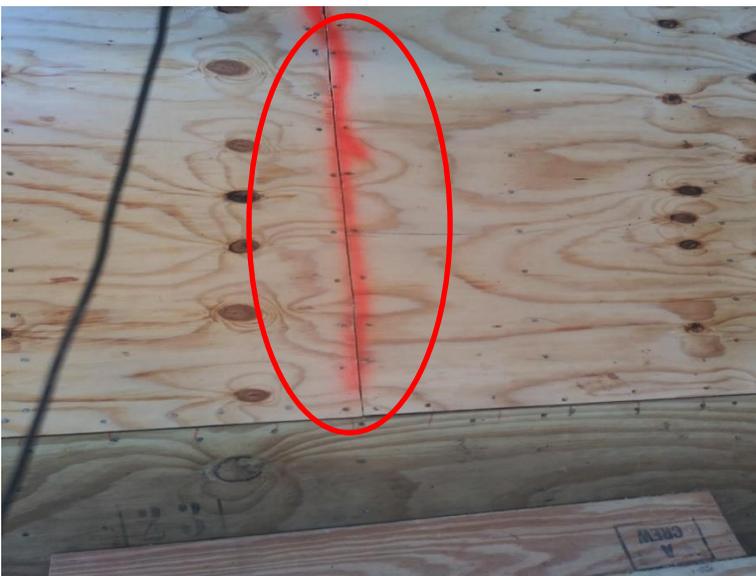
PHOTOGRAPH #12

**BUILDING 2
SECTION D**

Contractor has corrected lack of spacing between plywood.

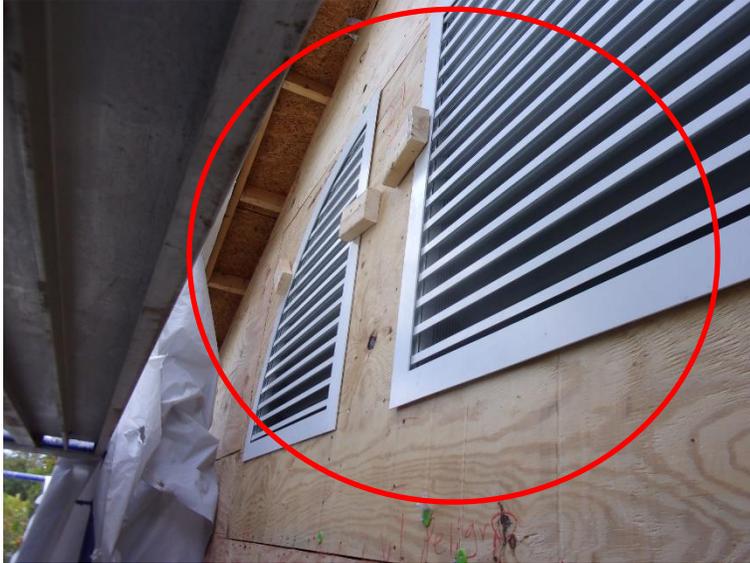
PHOTOGRAPH #13

**BUILDING 2
SECTION D**

Contractor has preset Green Heck louvered vents into gable end plywood and framing.

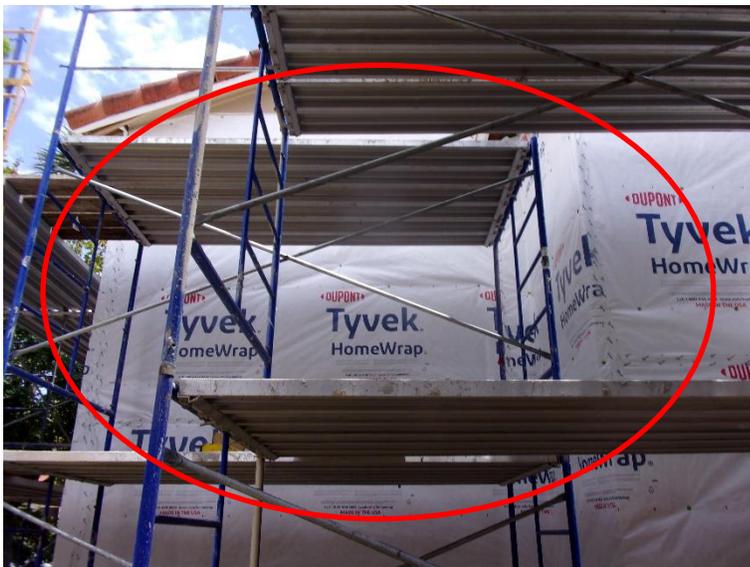
PHOTOGRAPH #14

**BUILDING 2
SECTION D**

Tyvek HomeWrap provided at gable end wall with 3" Dupont seam tape at overlapping joints.

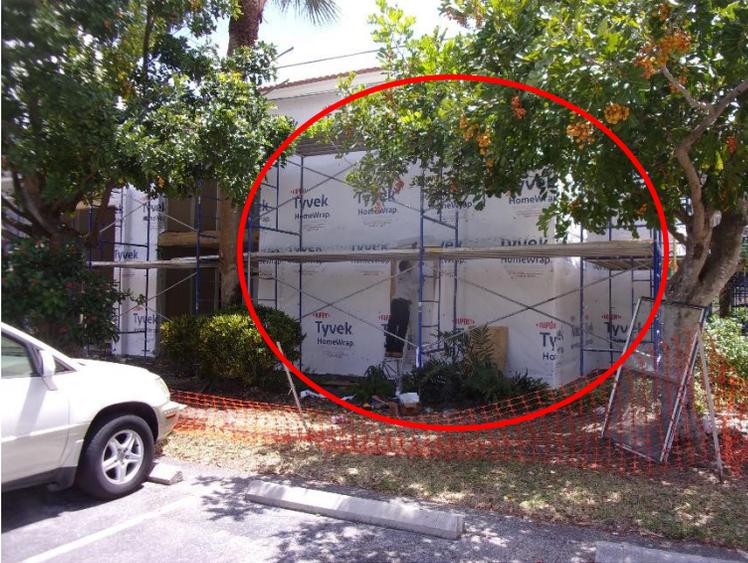
PHOTOGRAPH #15

**BUILDING 2
SECTION C**

Tyvek HomeWrap provided at bearing wall with 3" Dupont seam tape at overlapping joints.

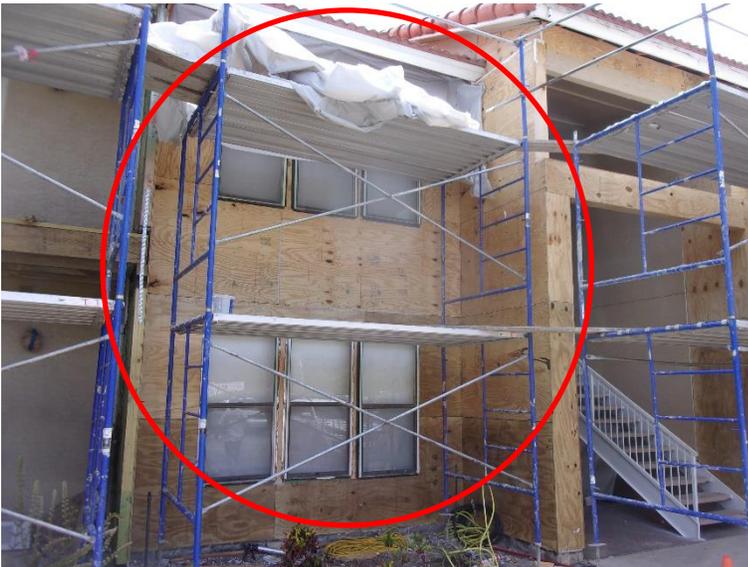
PHOTOGRAPH #16

**BUILDING 2
SECTION B**

Contractor has applied new 15/32" plywood sheathing at bearing walls.

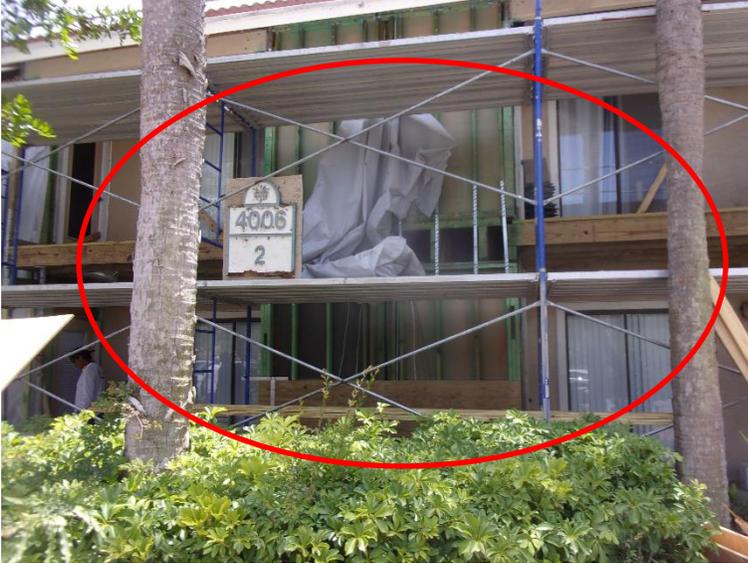
PHOTOGRAPH #17

**BUILDING 2
SECTION B**

Simpson Strong -Tie straps and connectors provided, and plywood sheathing application has begun.
