Roof Damage Assessment

**Vintage Grand Condominium Association
4002-4069 Crocker's Lake Boulevard
Sarasota, FL 34238
Claim Number: CLM-33876**

Regarding: Roof Damage Assessment
Vintage Grand Condominium Association
4002-4069 Crocker's Lake Boulevard
Sarasota, FL 34238
Date of Loss: September 10, 2017 (Hurricane Irma)
Type of Loss: Wind
Claim Number: CLM-33876

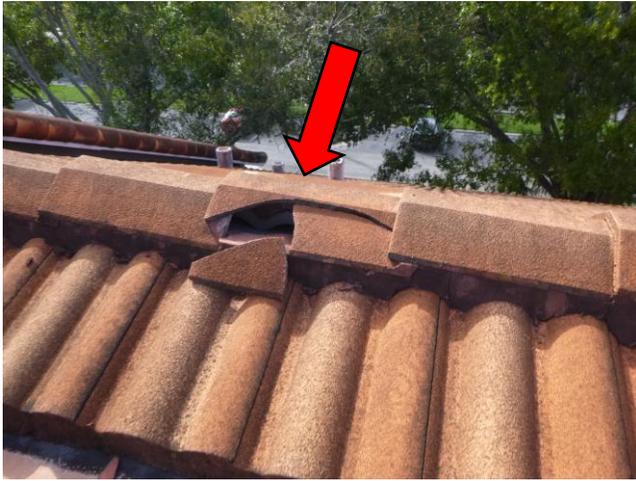
Example of broken ridge tile(s)

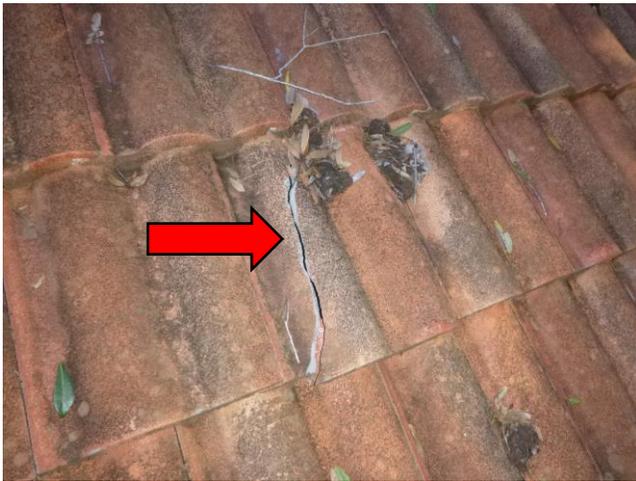
Example of broken field tile(s)

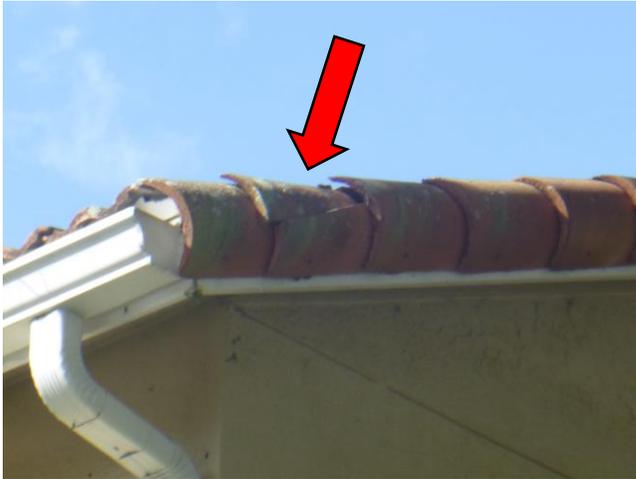
Example of broken rake tile(s)

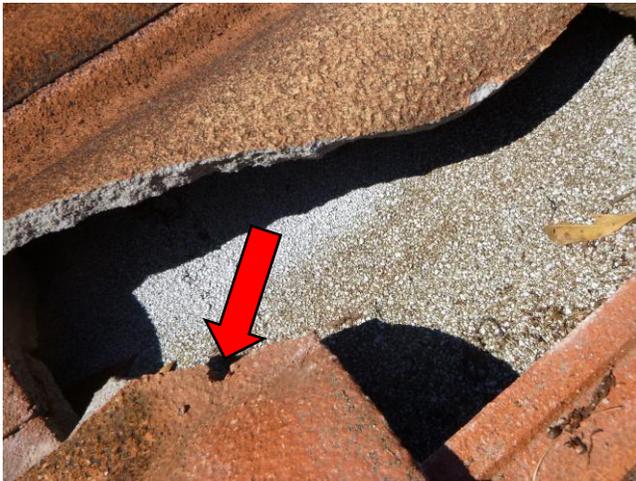
Example of broken field tile(s) at fastener location

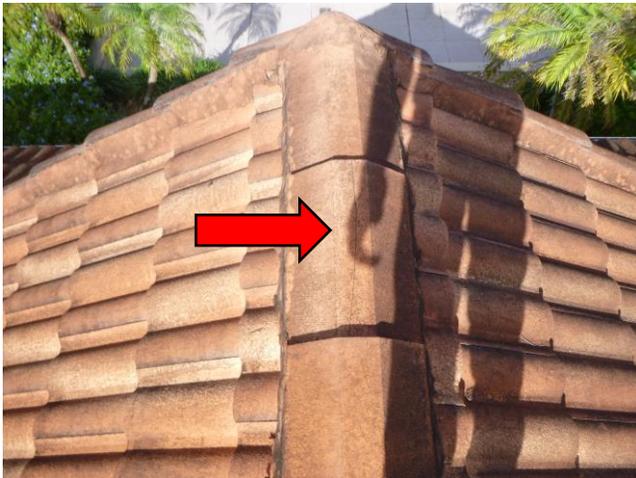
Example of cracked ridge tile(s)

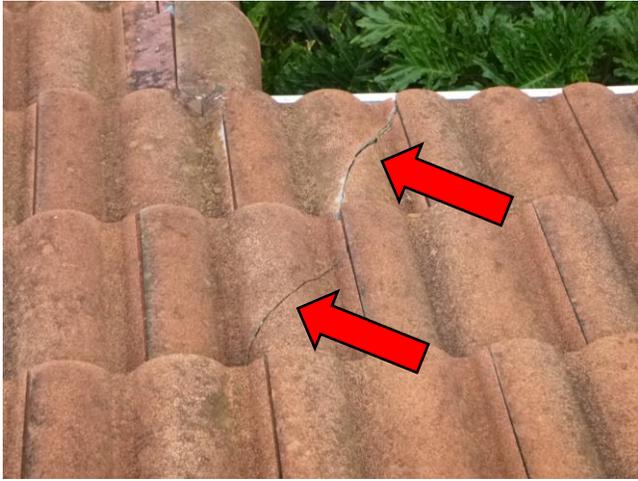
Example of cracked field tile(s)

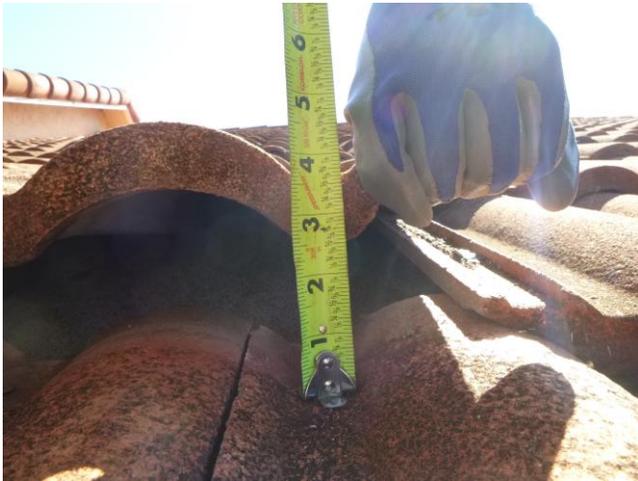
Example of field tile(s) deflecting more than 2 inches at the tile bottom

16. According to the Tile Roofing Institute – Evaluation of Tile Systems After Wind Events, “*In simplistic terms, we found that once the bottom edge (downslope) of the tile is allowed to lift 2” the wind will have sufficient access to withdraw the tile fastener and prevent the tile from properly securing to the sub straight for the design wind uplift resistance. The formal test protocols were reflective of a 2” lift as one of the failure mechanisms for tile approvals.*” See **Appendix K** for additional information.

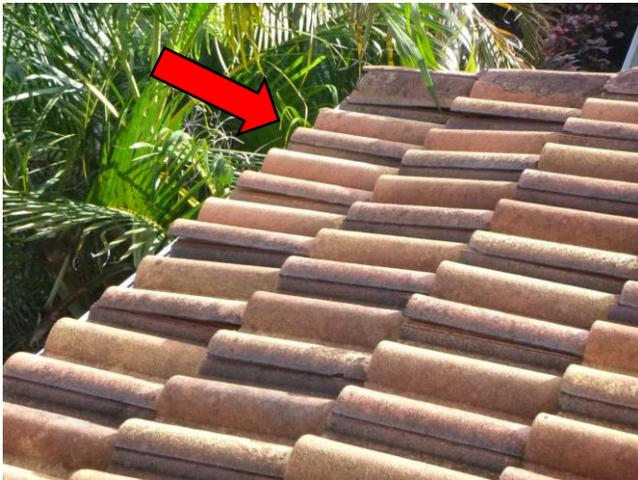
Example of deflected field tile(s) at corner zones

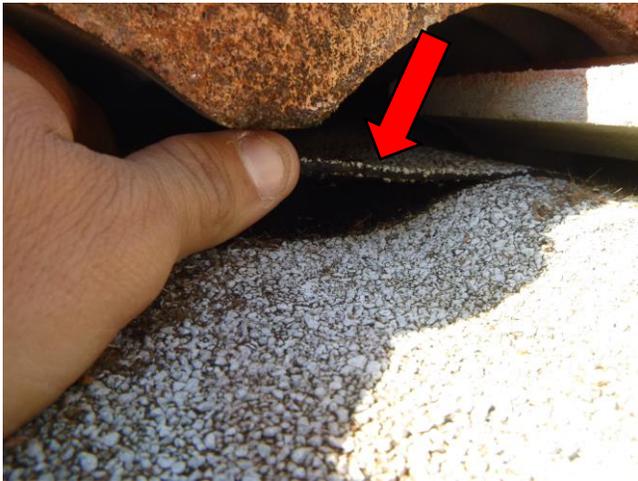
Example of delaminated underlayment

7. The underlayment under the roof tiles is approximately 15 years old, damaged and near the end of its useful life. Spot replacing tiles will further damage the underlayment and lead to future leaks. Furthermore, it is not possible to put the underlayment back into a building complaint condition when attempting a spot repair.

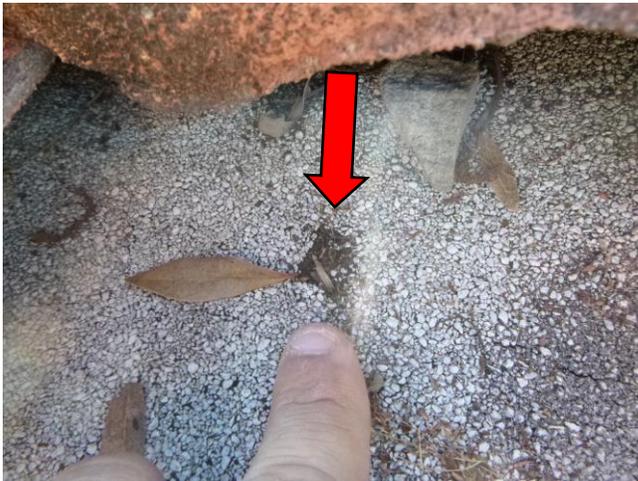
Example of damaged underlayment

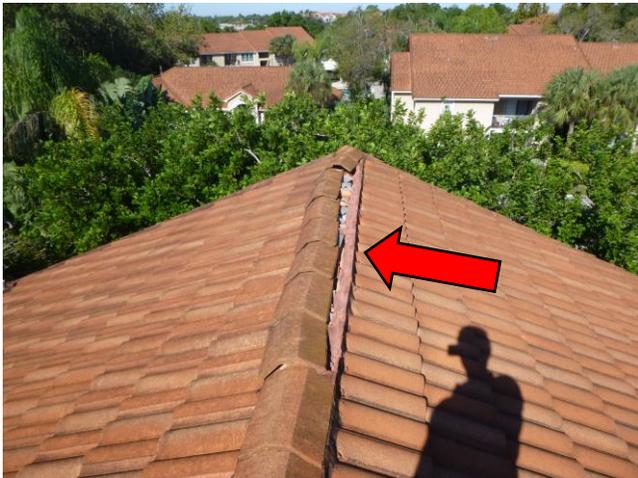
Example of displaced ridge tile(s)

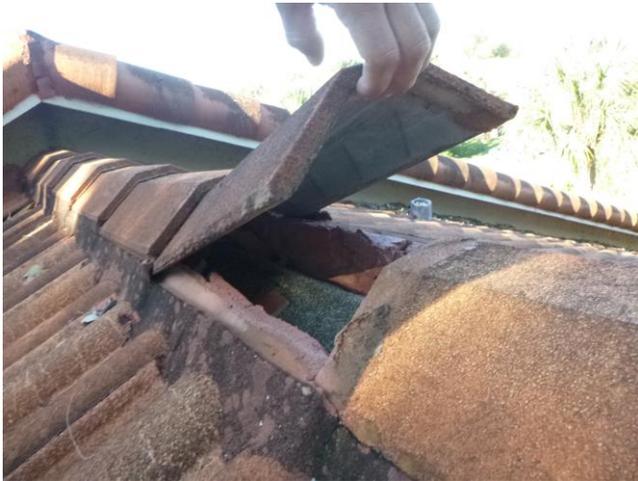
Example of loose ridge / hip tile(s)

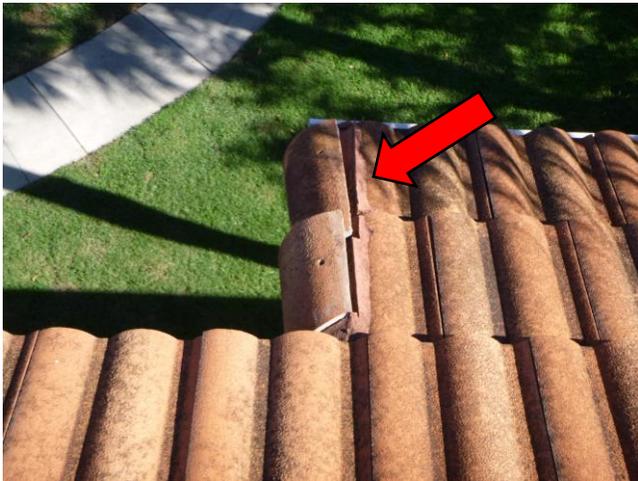
Example of debonded rake tile(s)

A ***dangerous condition*** letter was submitted on November 30, 2020 addressing this issue on several buildings.

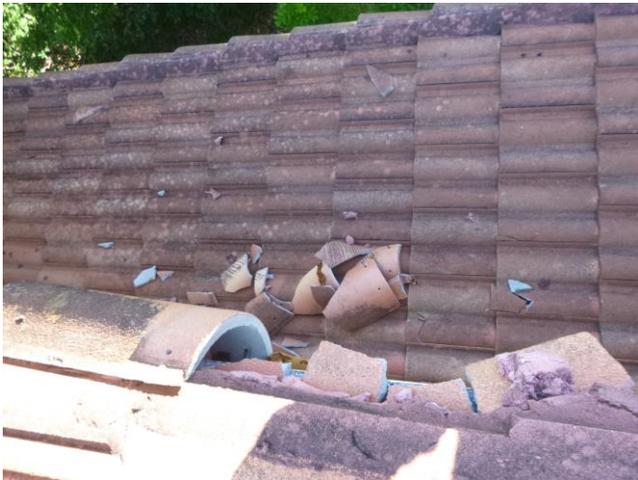
Example of missing rake tile(s) / tile pieces on roof

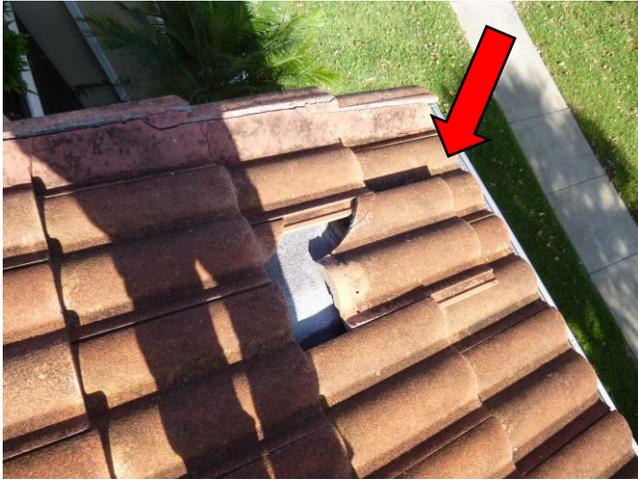
Example of slid / loose field tile(s)

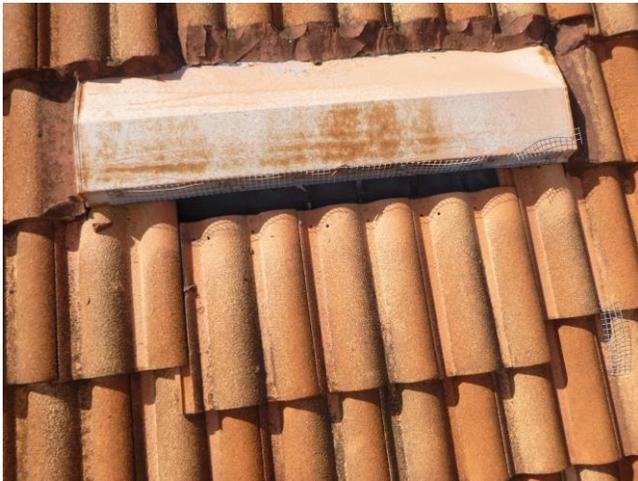
Example of slid / loose tile(s) below off-ridge vents

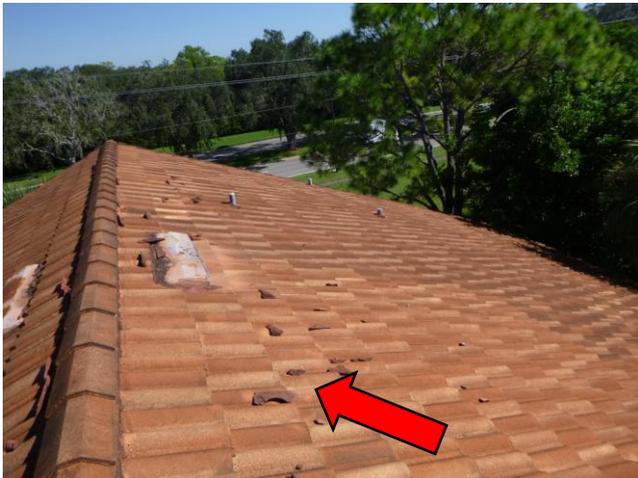
Example of displaced ridge tiles mortar

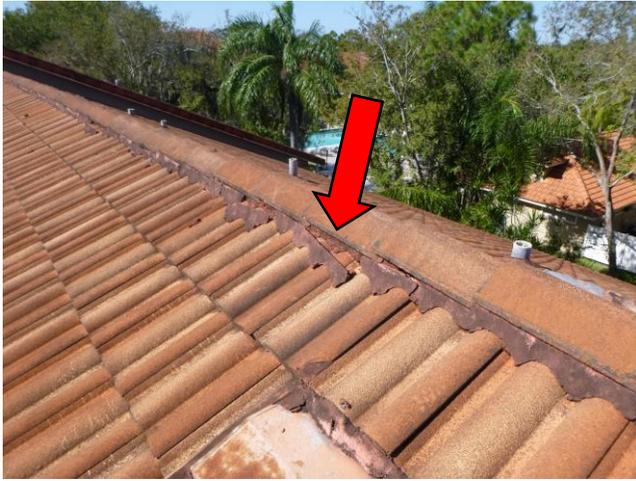
Example of damaged mortar on ridge tile(s)

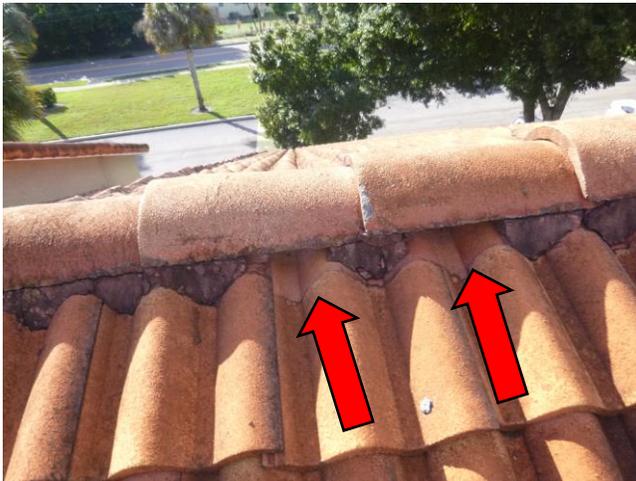
Example of missing mortar on ridge tile(s)

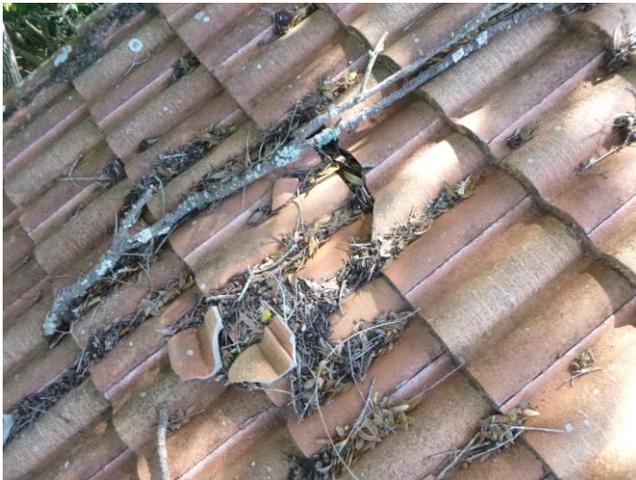
Example of tree debris on roof

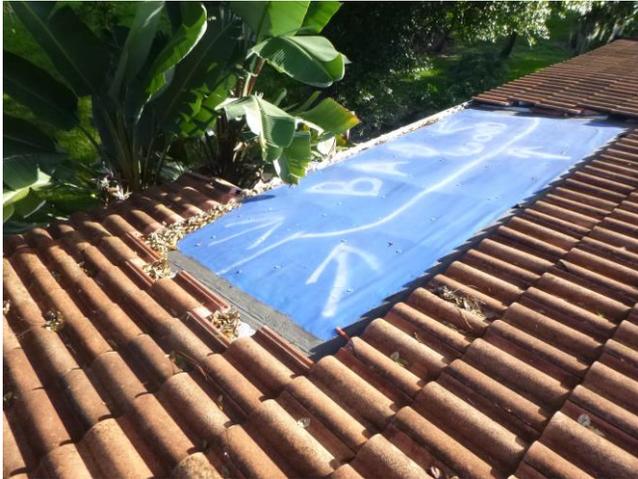
Example of apparent damaged roof sheathing

- Any damaged wood framing or sheathing shall be repaired or replaced.
 - New flashing, roof vents, plumbing stack boots, eave drip, etc. shall be installed. Specifically, new off-ridge vents shall be installed in accordance with the FBC and manufacturer specifications in order to provide adequate ventilation to the attic space.

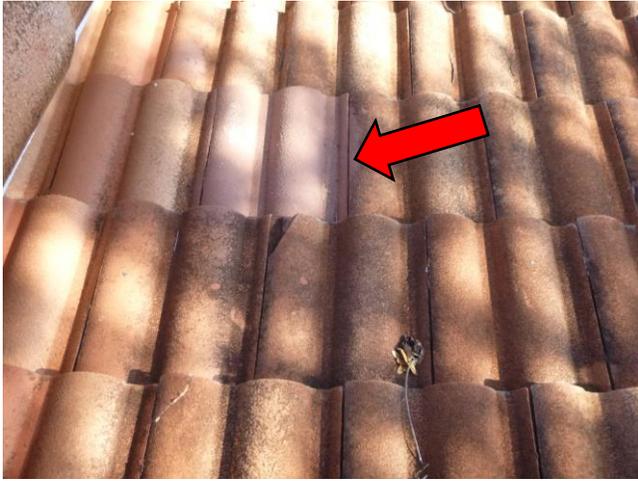
Example of replaced field tile(s)

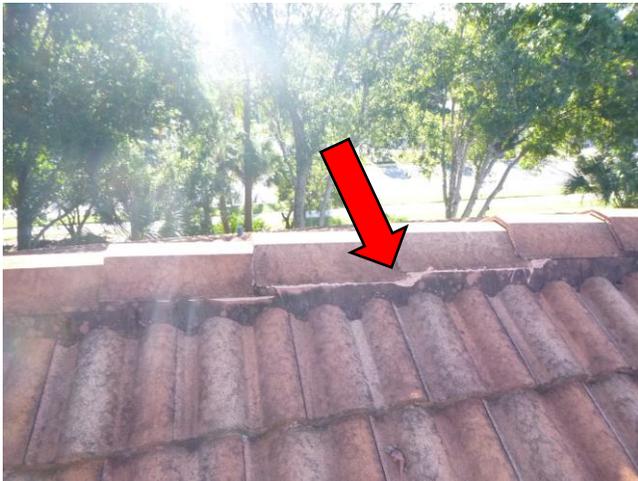
Example of ridge tile(s) patched with adhesive

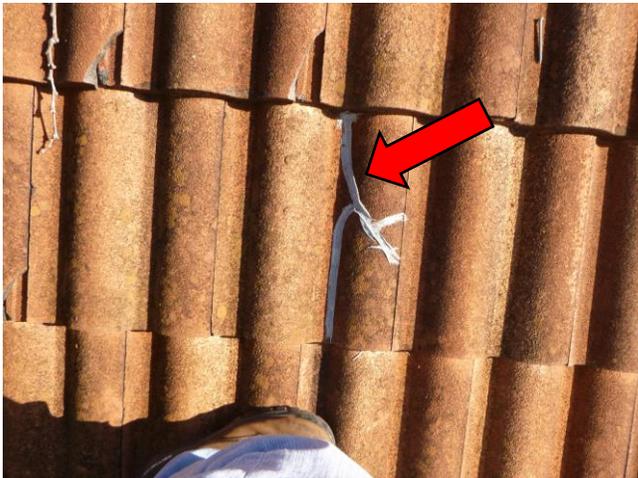
Example of field tile(s) patched with adhesive

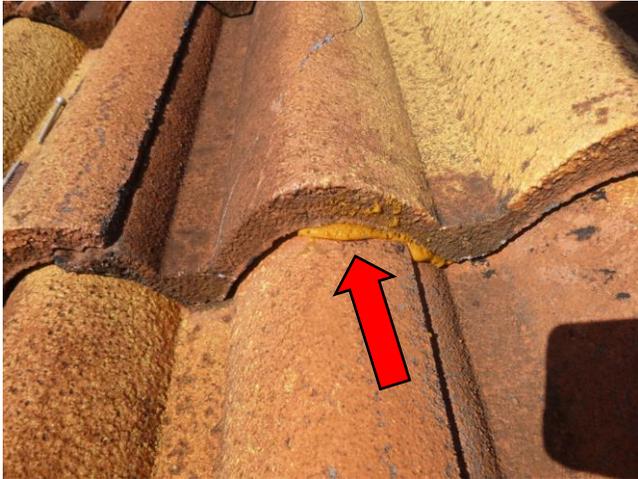
Example of field tile(s) reset with foam adhesive

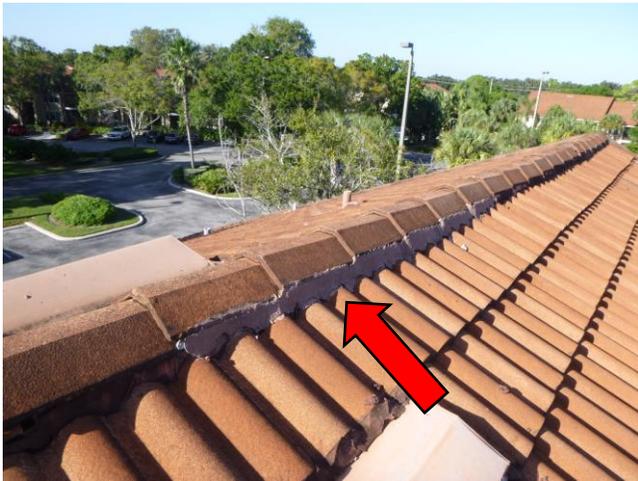
Example of mortar patches on ridge tile(s)

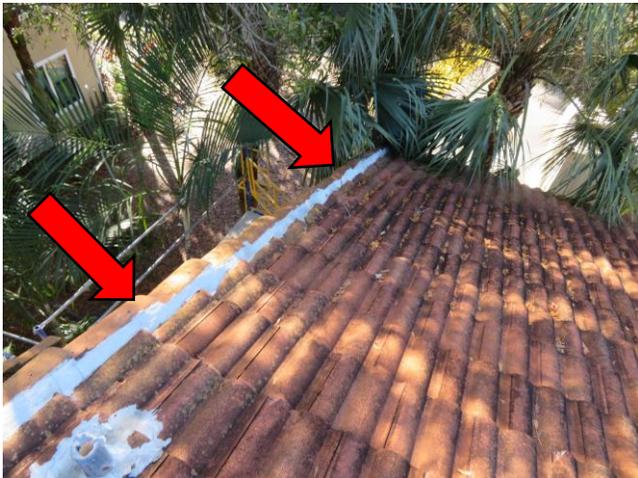
Example of mortar patches on rake tile(s)

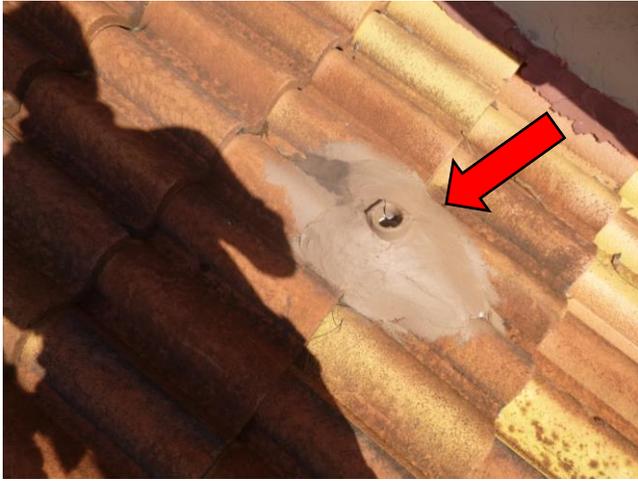
Example of mortar patches around vent pipe(s)

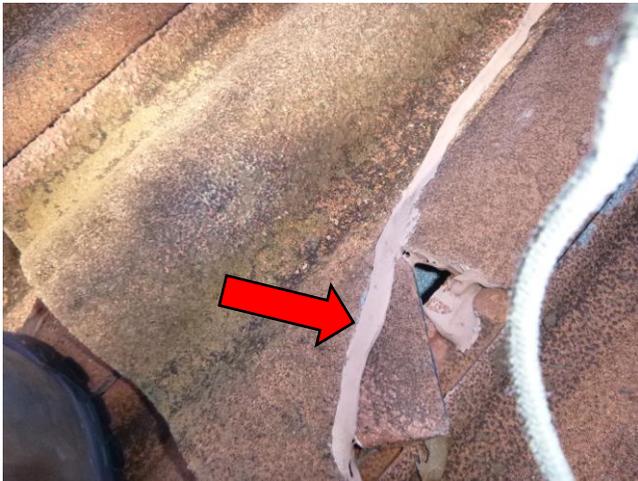
Example of improper patches on field tile(s)

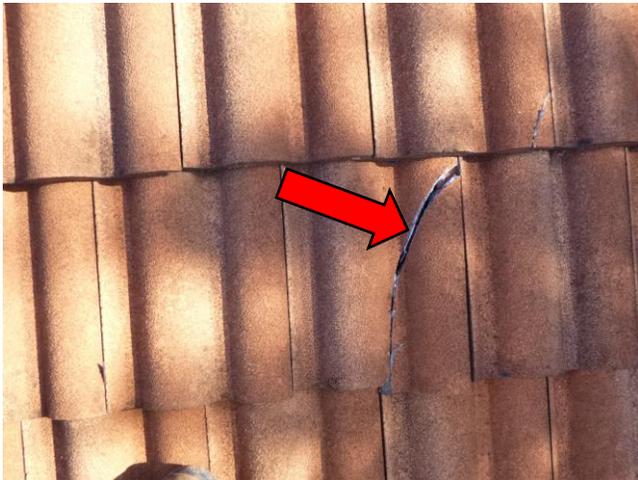
Example of failing temporary repair(s)

10. The temporary repairs that have been attempted on the roofs are failing, which is further evidence that the roofs are not repairable and require replacement.

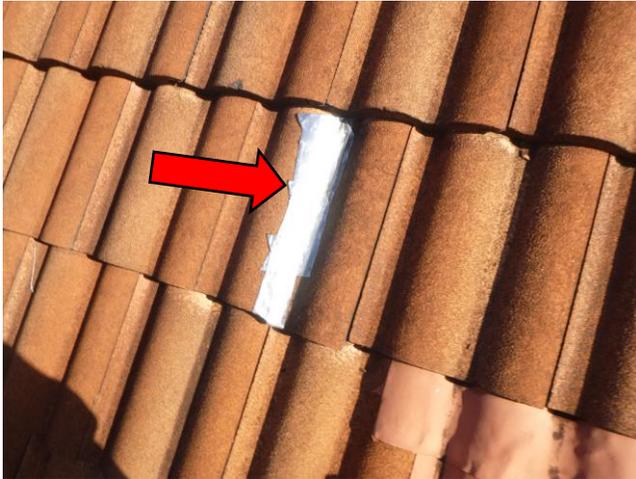
Example of peel-and-stick patches to field tile(s)

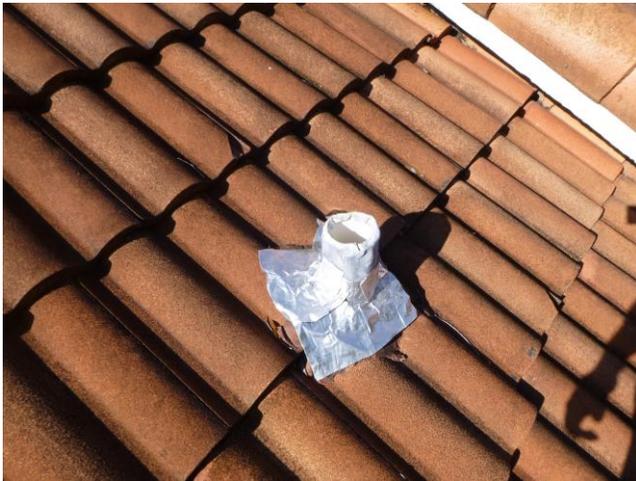
Example of peel-and-stick patches to vent pipe(s)

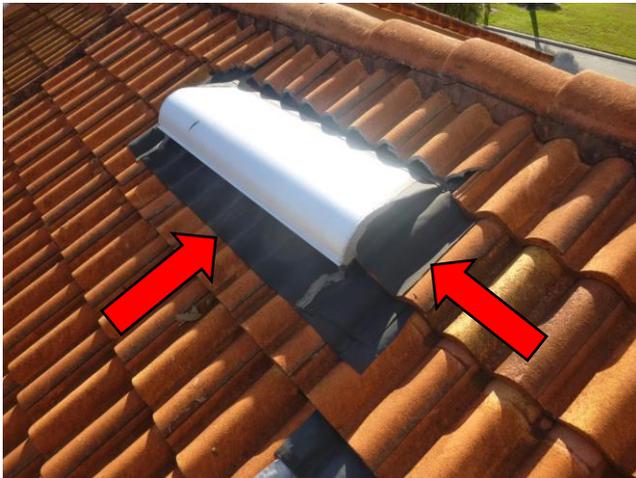
Example of peel-and-stick patches to off-ridge vent(s)

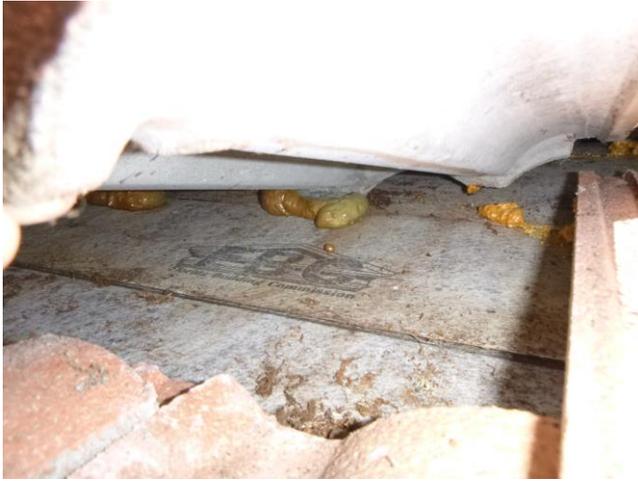
Example of underlayment patches

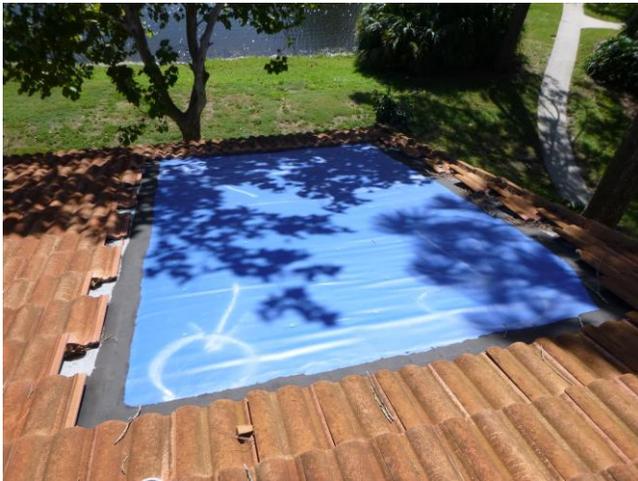
Example of underlayment patches left without tiles

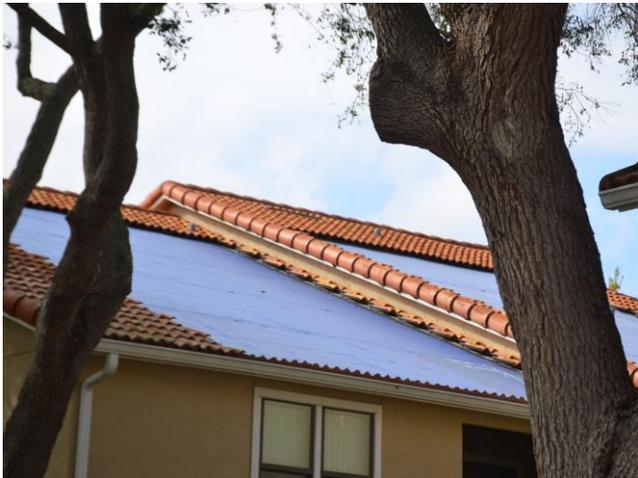
Example of underlayment patches

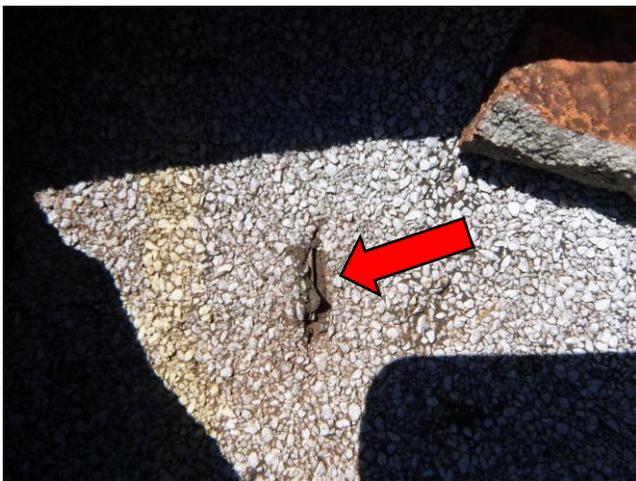
Example of roof sheathing clip(s) protruding underlayment

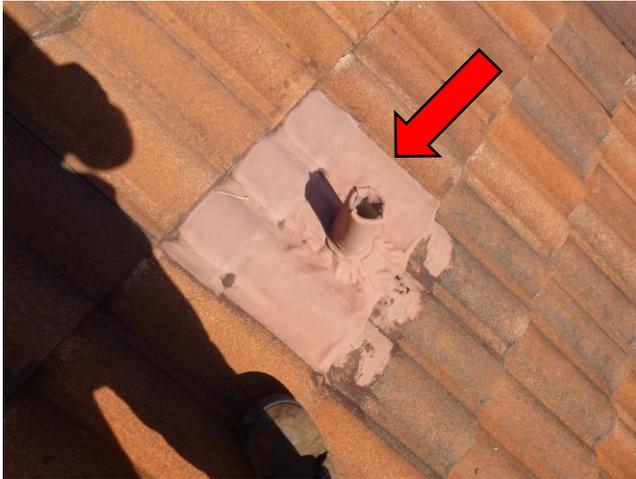
Example of painted roof vent(s)

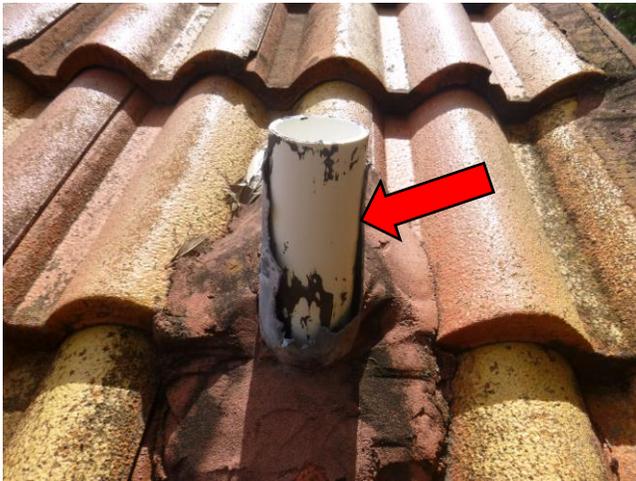
Example of damaged vent pipe lead boot(s)

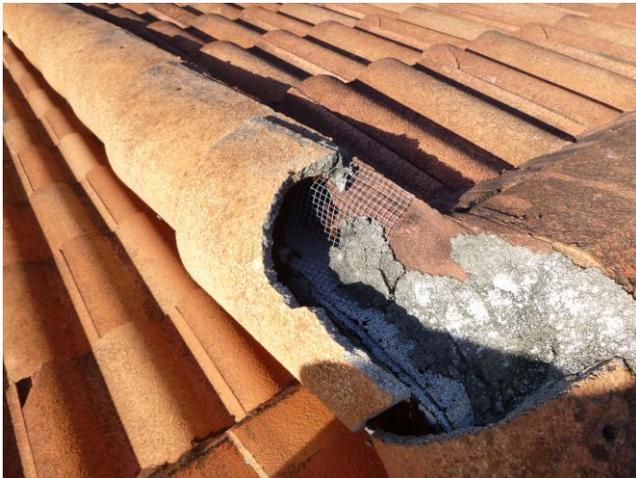
Example of damaged rake tile(s)

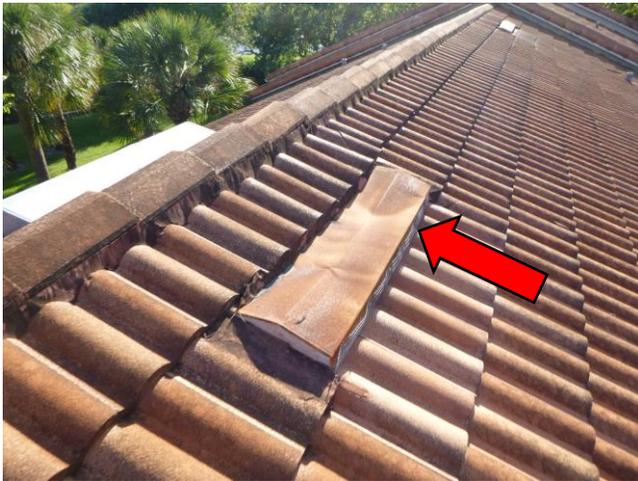
Example of bent off-ridge vent(s)

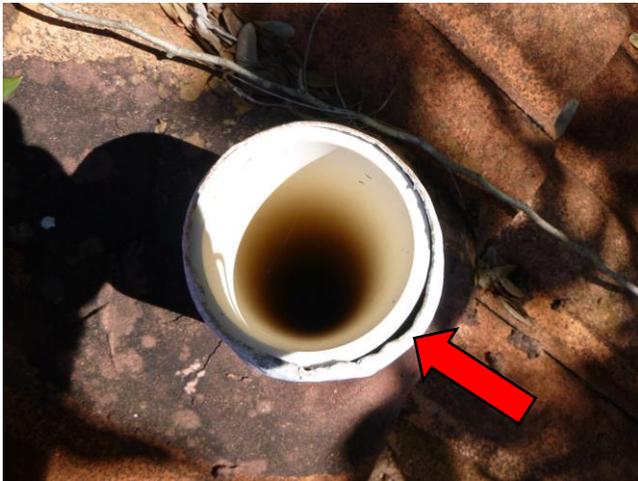
Example of improper installation of vent pipe lead boot(s)

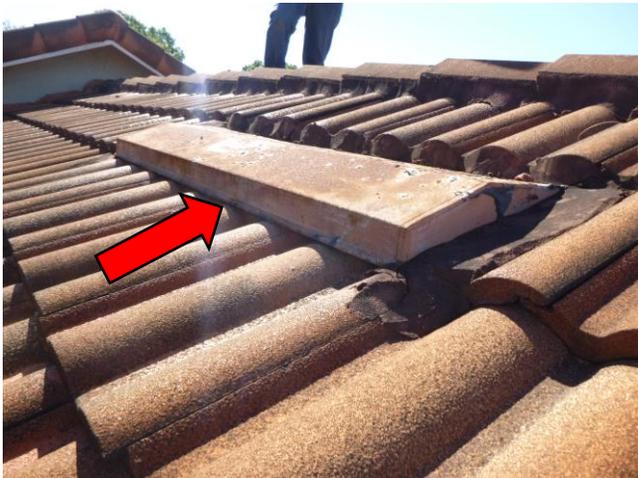
Example of improper installation of off-ridge vent(s)

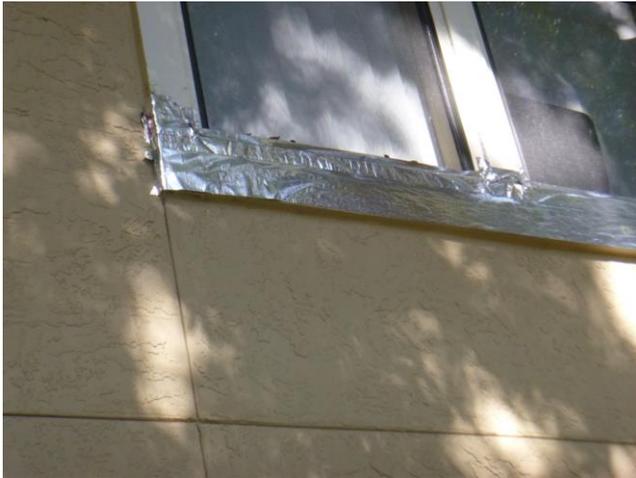
Example of tape patches above and below window(s)

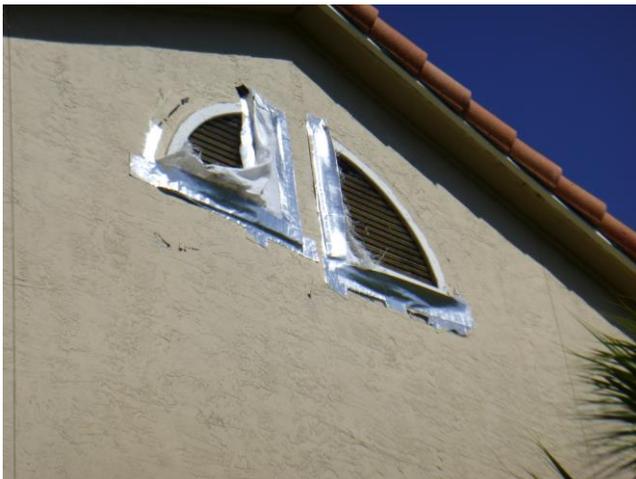
Example of patched attic space vent(s)

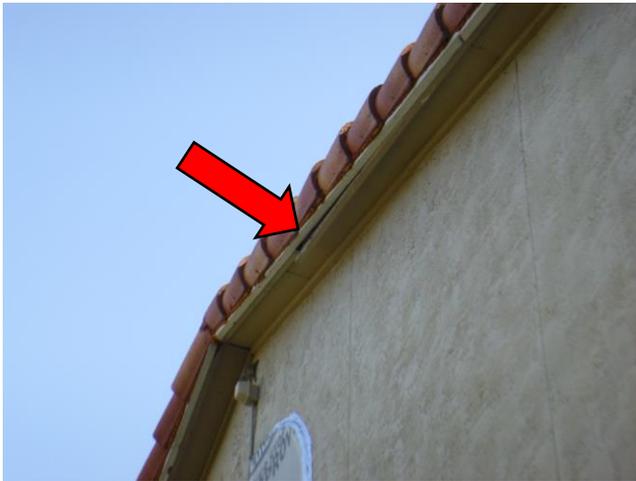
Example of loose fascia board(s)

- Remove and replace damaged fascia board(s).

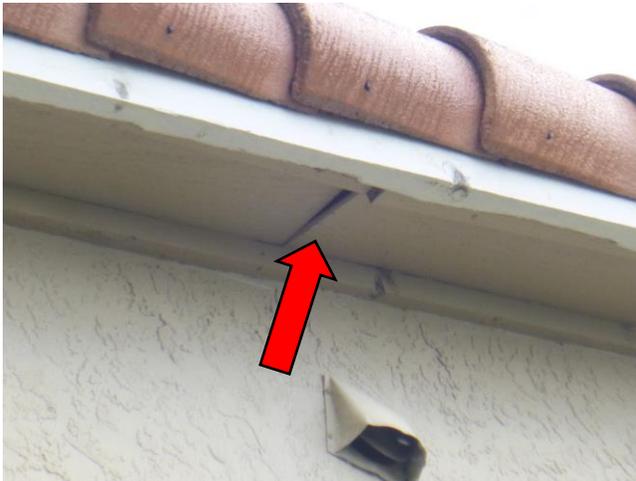
Example of displaced soffit

- Remove and replace damaged soffit(s).
 - Remove and replace damaged gutter(s).
 - All the materials shall be installed in accordance with manufacturers specifications.
12. All work shall be performed by a Florida Certified Contractor in accordance to applicable building codes and standard building practices.

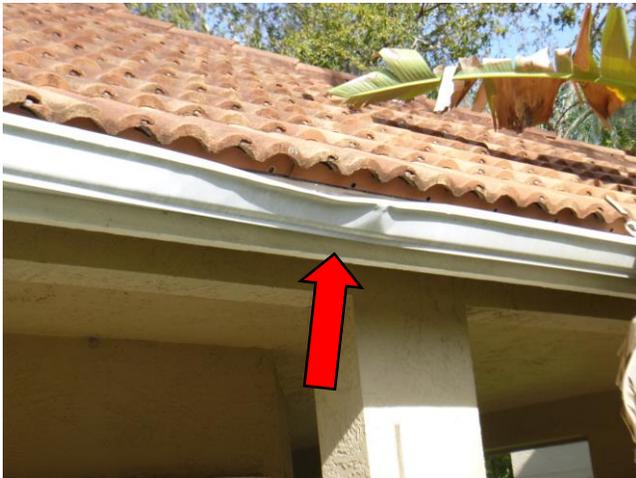
Example of bent gutter(s)
