## PHOTOGRAPHS

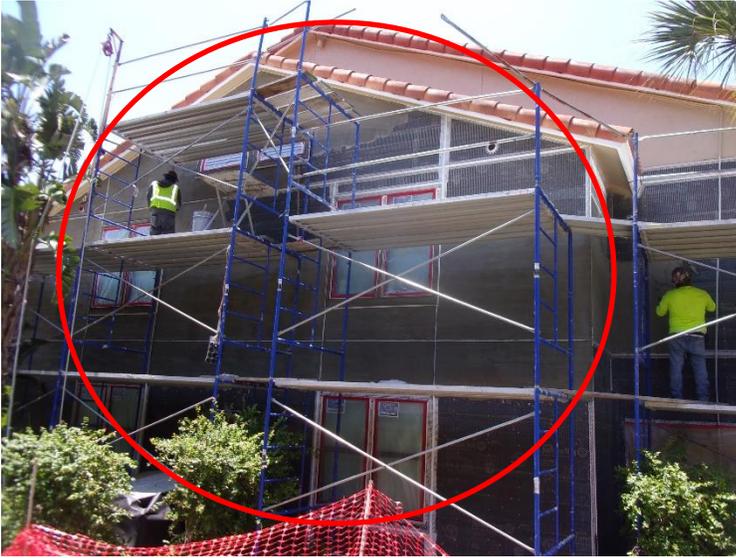
PHOTOGRAPH #1

### BUILDING 2 SECTION H

Stucco sub-contractor has begun to apply scratch coat of stucco.

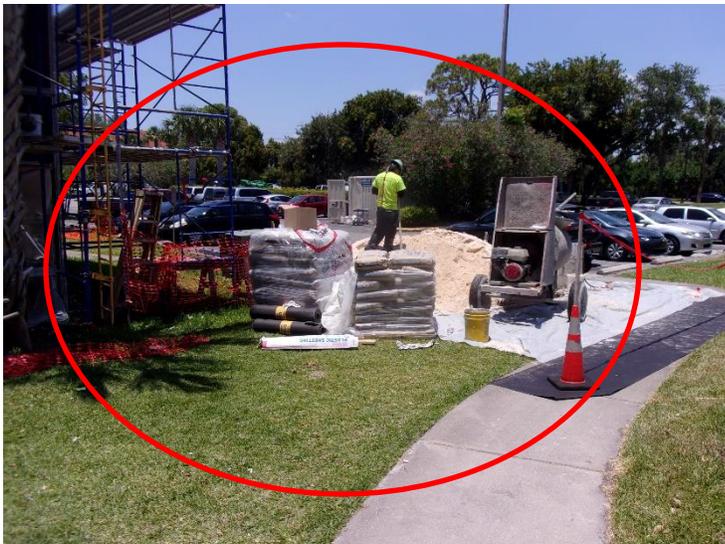
PHOTOGRAPH #2

### BUILDING 2 SECTION H

Sub-contractor mixing sand with Cemex Broco stucco bag cement.

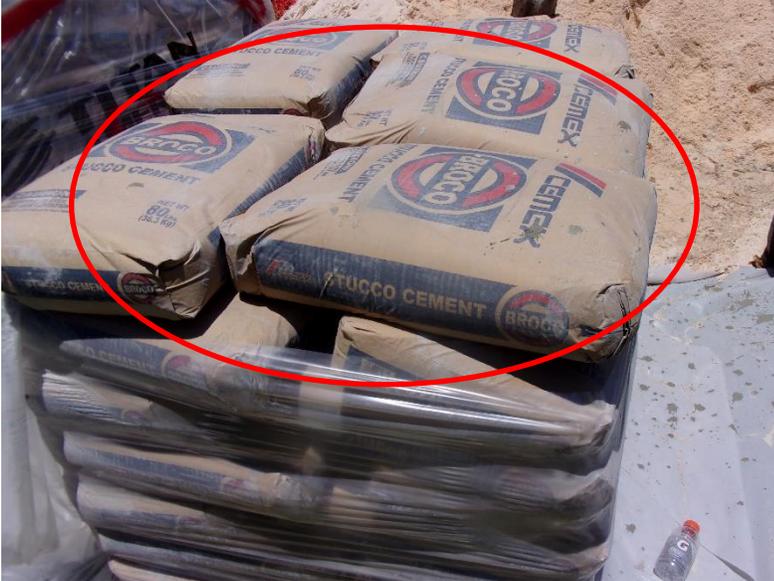
**PHOTOGRAPH #3**

**BUILDING 2  
SECTION H**

Sub-contractor mixing sand with Cemex Brocco stucco bag cement.

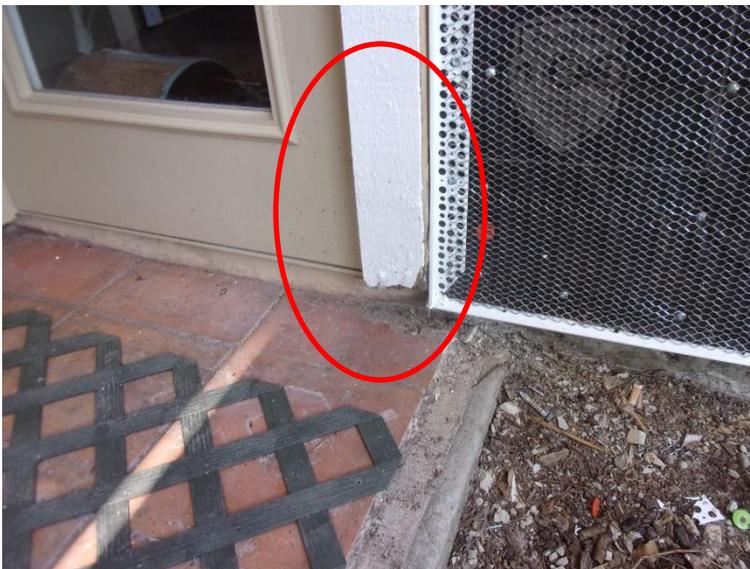
**PHOTOGRAPH #4**

**BUILDING 2  
SECTION G**

**Unit #212** – Trim at patio door damaged and marked for replacement.

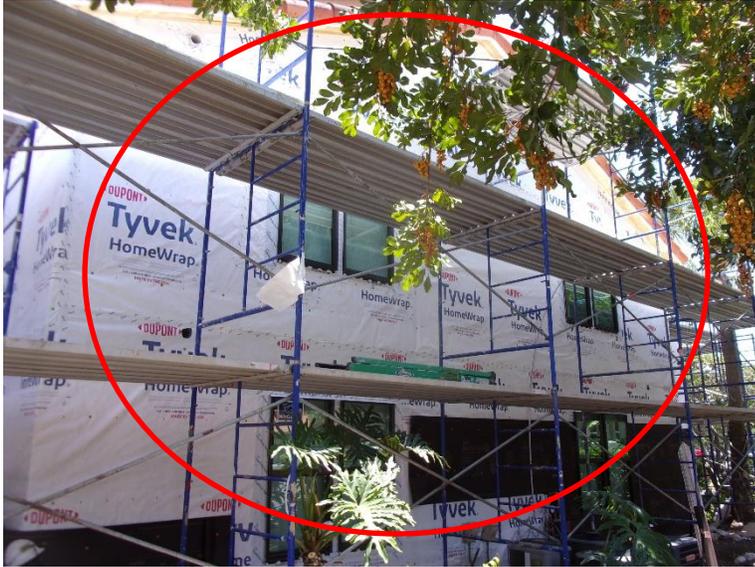
**PHOTOGRAPH #5**

**BUILDING 2  
SECTION D**

New PGT window installed, and flashing performed with DuPont Tyvek flashing system.

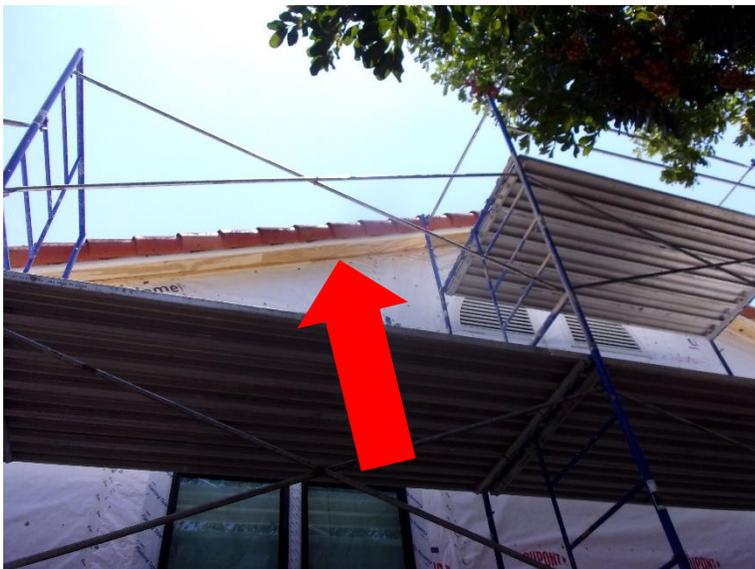
**PHOTOGRAPH #6**

**BUILDING 2  
SECTION D**

Contractor has installed new wood soffit and vinyl soffit venting.

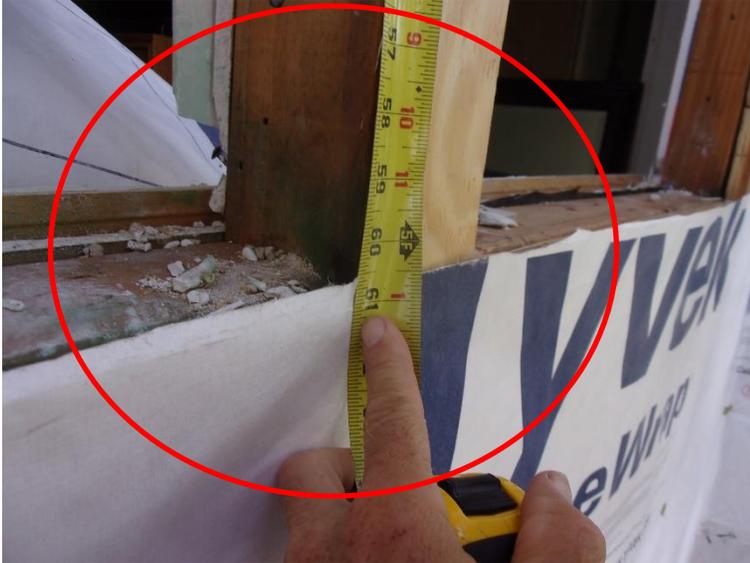
**PHOTOGRAPH #7**

**BUILDING 2  
SECTION B**

Window dimensions confirmed to meet window manufacturer's NOA requirements and **ESI # 4**.

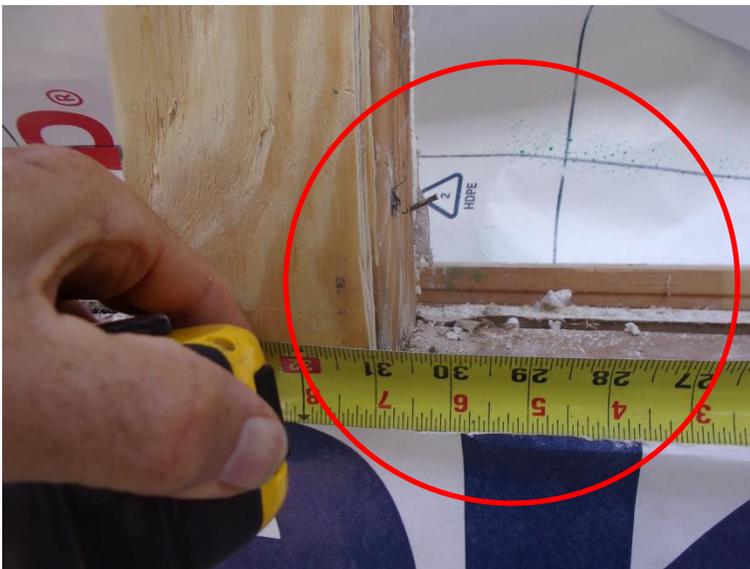
**PHOTOGRAPH #8**

**BUILDING 2  
SECTION B**

Window dimensions confirmed to meet window manufacturer's NOA requirements and **ESI # 4**.

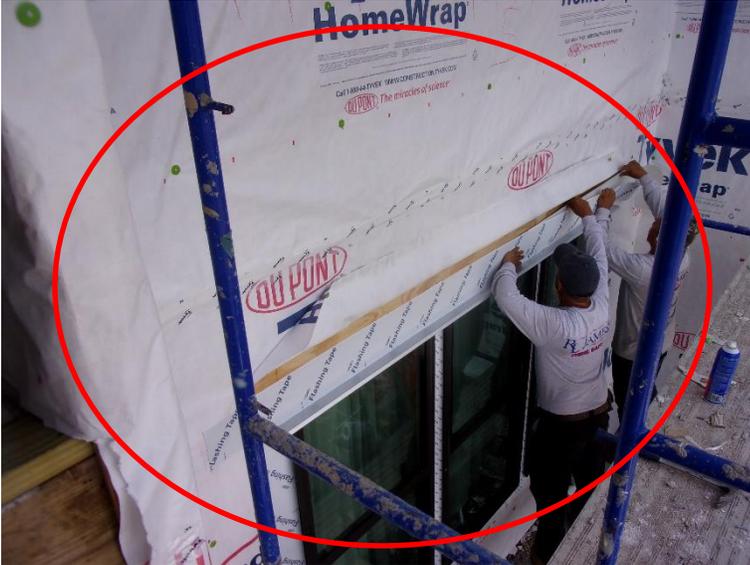
PHOTOGRAPH #9

**BUILDING 2  
SECTION B**

Dupont Tyvek flashings applied as per manufacturers recommendations at window openings.

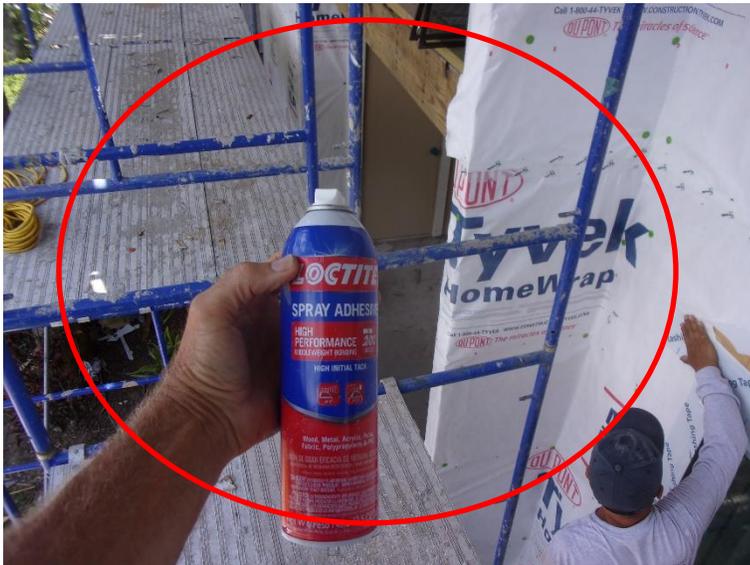
PHOTOGRAPH #10

**BUILDING 2  
SECTION B**

Contractor using Dupont approved spray primer to enhance bond of new Dupont flashing.

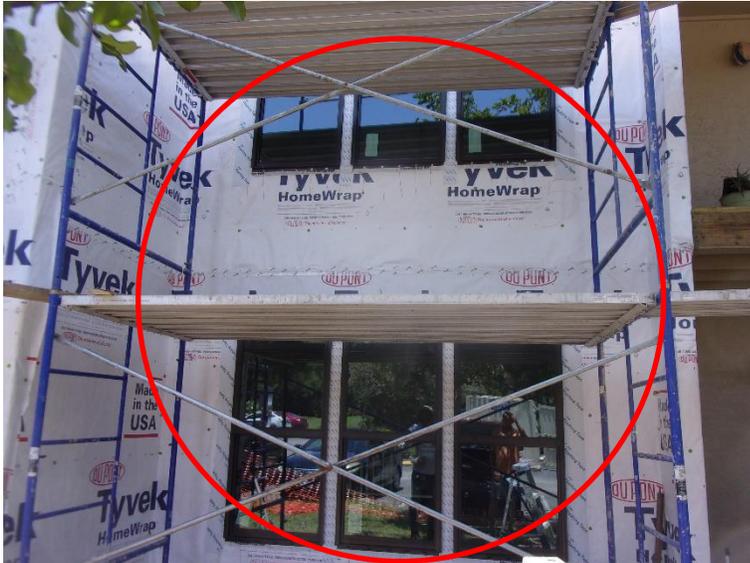
**PHOTOGRAPH #11**

**BUILDING 2  
SECTION B**

New PGT window installed, and flashing performed with DuPont Tyvek flashing system.

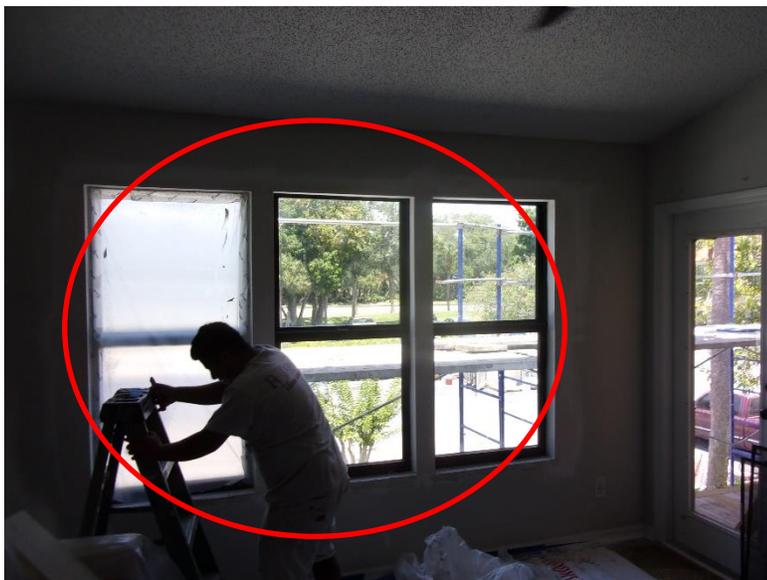
**PHOTOGRAPH #12**

**BUILDING 2  
SECTION B**

**Unit #228-** Contractor performing drywall and sill repairs at new window openings.

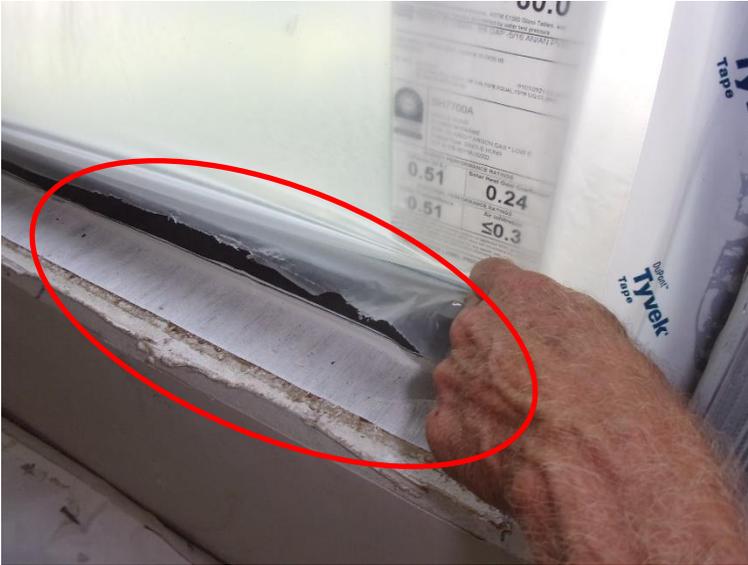
**PHOTOGRAPH #13**

**BUILDING 2  
SECTION B**

**Unit #228-** New urethane sealant applied at interior side of window frame to Tyvek flashing.

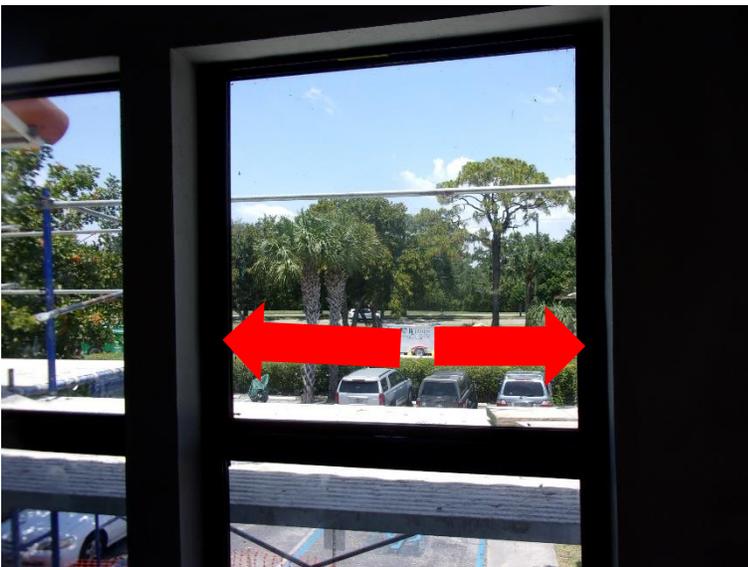
**PHOTOGRAPH #14**

**BUILDING 2  
SECTION B**

PGT windows with factory installed WOCDs not used for several 2<sup>nd</sup> floor windows as required.

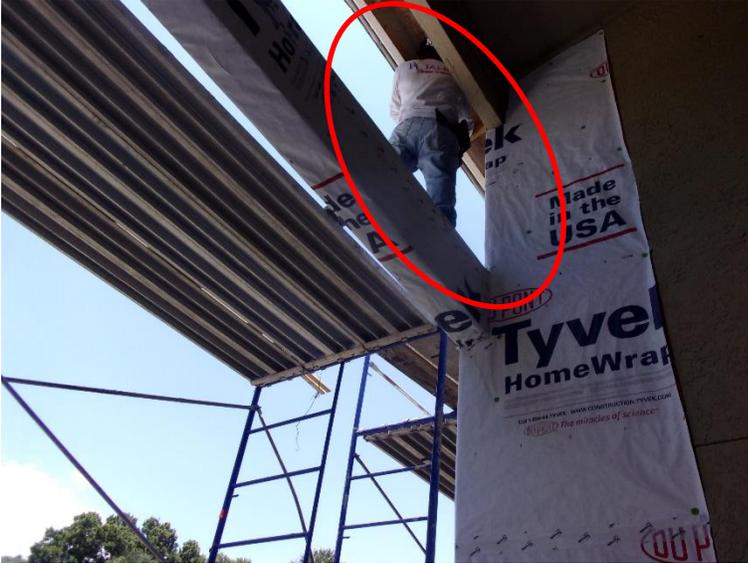
**PHOTOGRAPH #15**

**BUILDING 2  
SECTION A**

New wood soffit and vinyl soffit venting installation in progress.

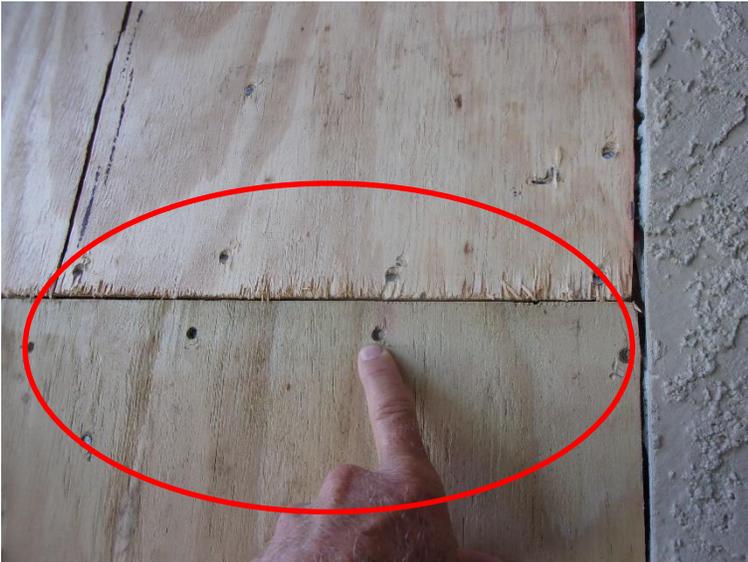
**PHOTOGRAPH #16**

**BUILDING 2  
SECTION A**

Contractor has over sunk nails in sheathing at this location.

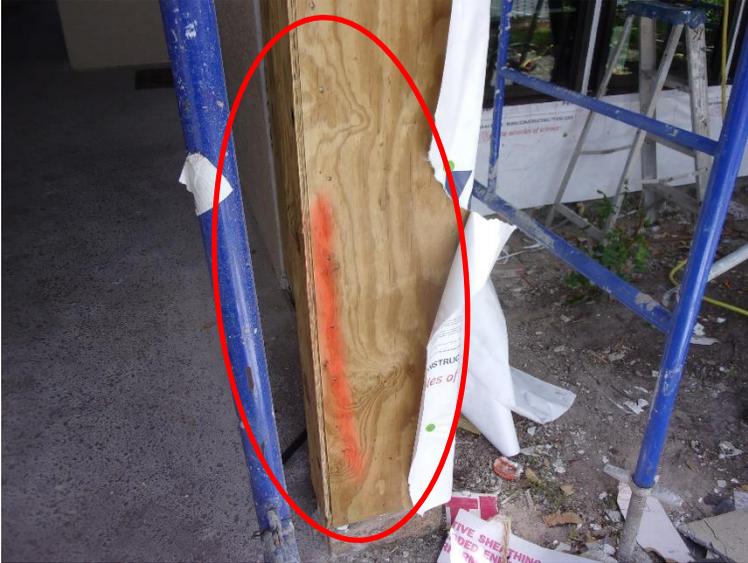
**PHOTOGRAPH #17**

**BUILDING 2  
SECTION A**

Over sunken nails in sheathing marked for correction and re nailed by contractor.

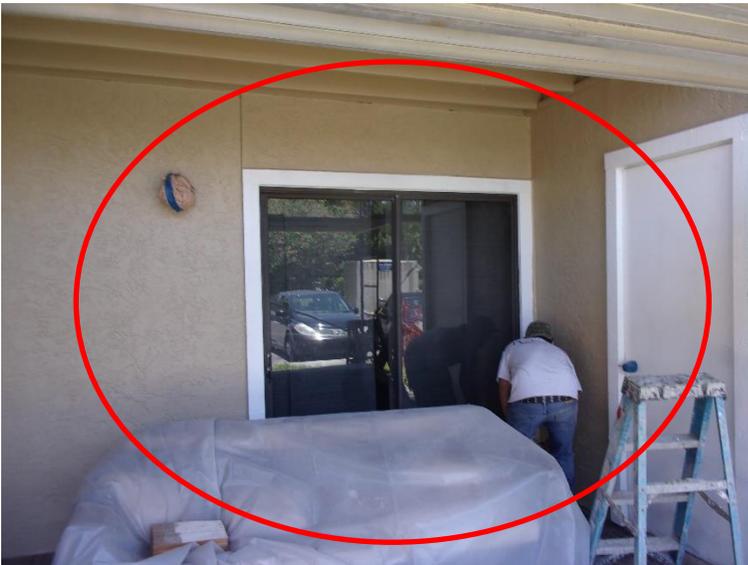
**PHOTOGRAPH #18**

**BUILDING 2  
SECTION A**

Patio painting in progress with Florida Paints acrylic paint.

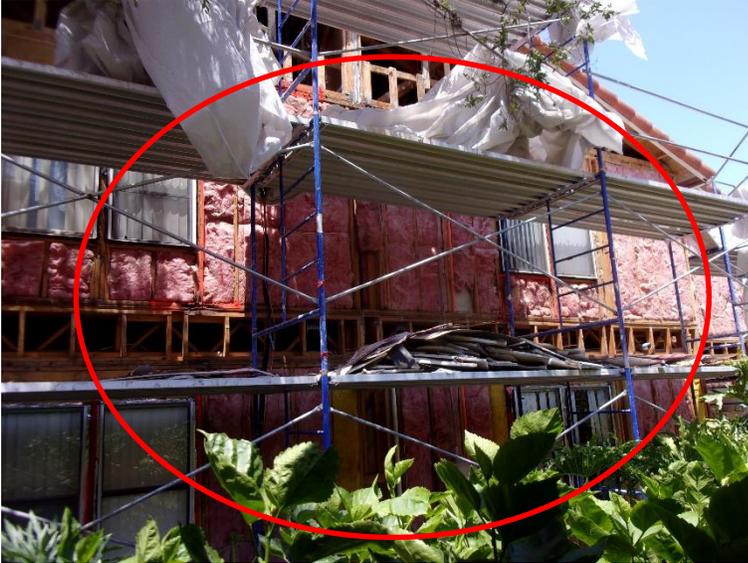
**PHOTOGRAPH #19**

**BUILDING 3  
SECTION H**

Stucco and sheathing removed.  
Damaged framing marked for repairs.

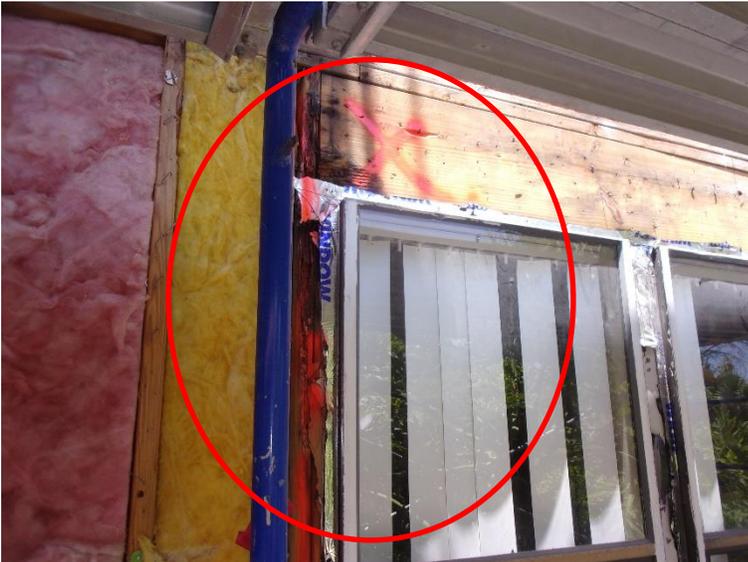
**PHOTOGRAPH #20**

**BUILDING 3  
SECTION H**

Damaged framing at window openings  
and headers marked for repairs.

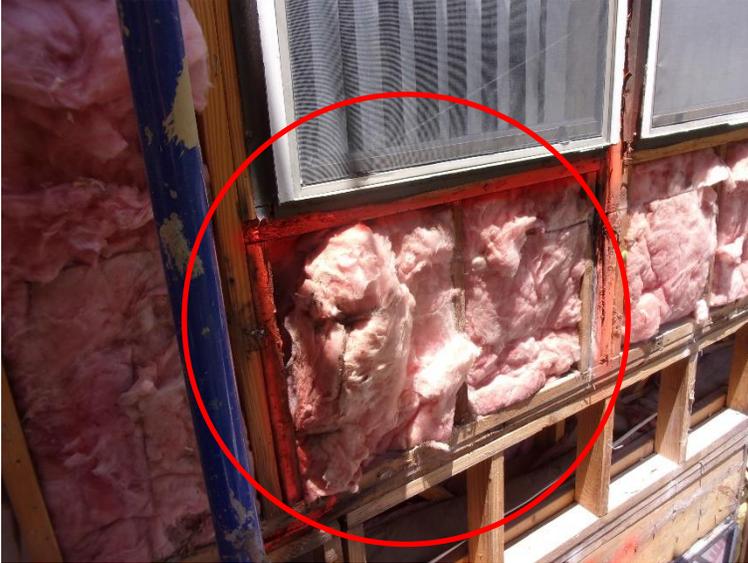
**PHOTOGRAPH #21**

**BUILDING 3  
SECTION H**

Damaged framing marked at window framing and bottom plates.

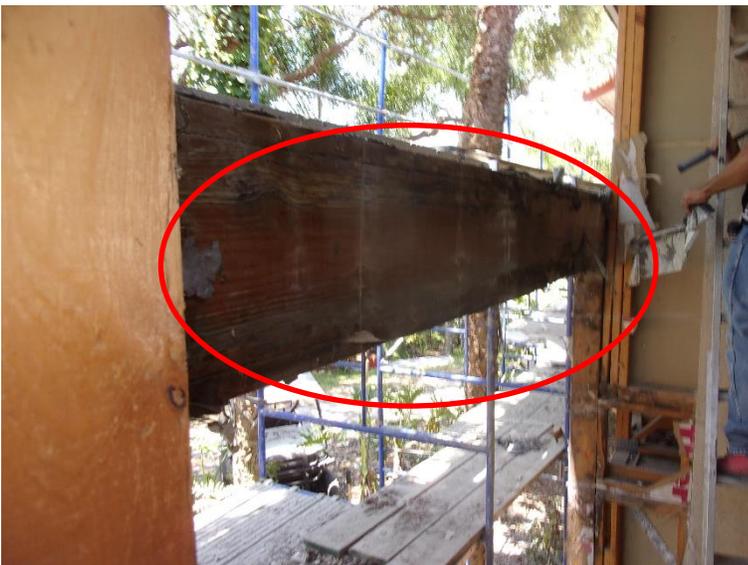
**PHOTOGRAPH #22**

**BUILDING 3  
SECTION G**

Damaged box beam at breezeway marked for repairs.

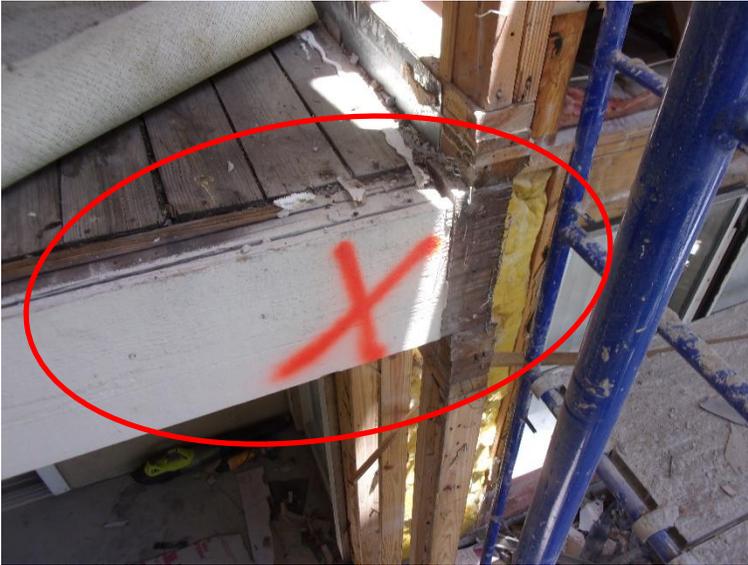
**PHOTOGRAPH #23**

**BUILDING 3  
SECTION F**

Previous repairs done at balcony built up beams cut short are not bearing at framing post and will require replacement.

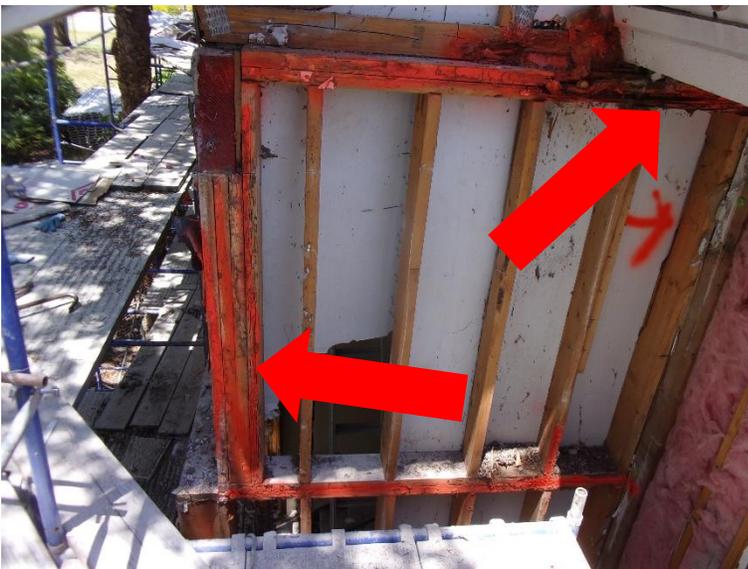
**PHOTOGRAPH #24**

**BUILDING 3  
SECTION F**

Damaged framing marked for repairs at posts, plates, and studs.

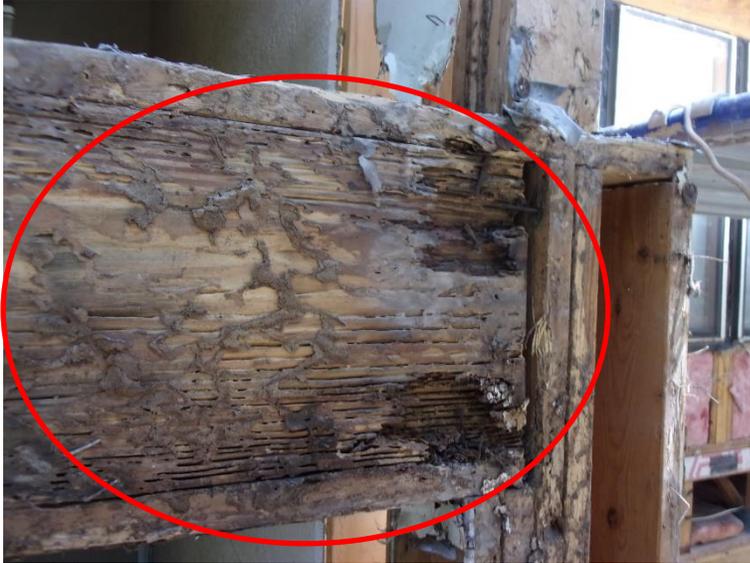
**PHOTOGRAPH #25**

**BUILDING 3  
SECTION E**

Termite damage marked for repairs at breezeway.

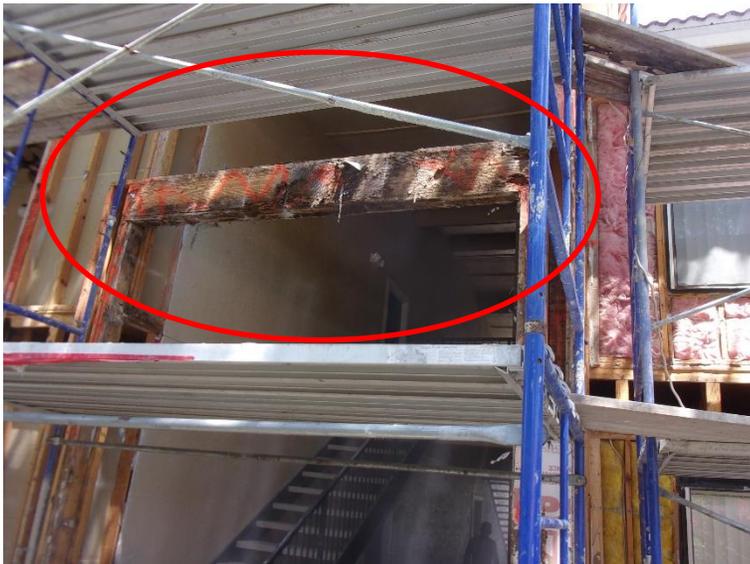
**PHOTOGRAPH #26**

**BUILDING 3  
SECTION E**

Damaged breezeway framing marked for full breezeway repair detail.
