PHOTOGRAPHS

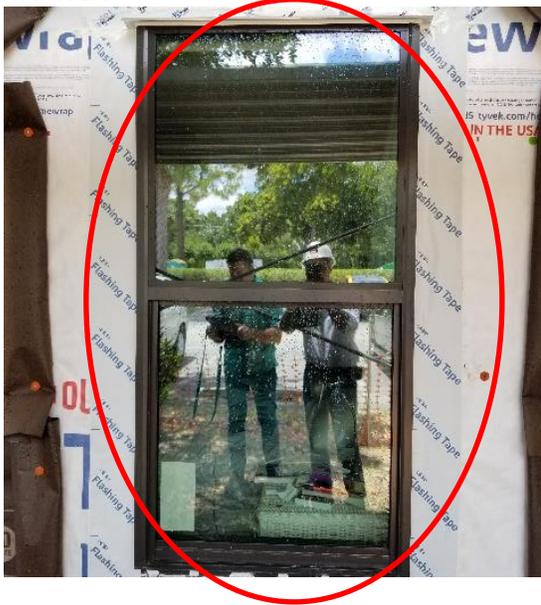
PHOTOGRAPH #1

**BUILDING 2
SECTION C**

Unit #217- Water testing performed by Independent water testing agency (at bedroom single window) in accordance with AAMA 502. Test passed with no water intrusion.

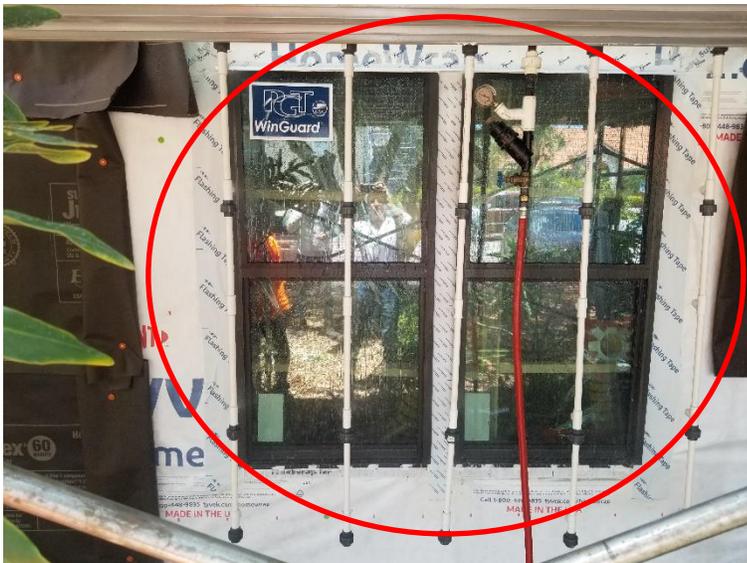
PHOTOGRAPH #2

**BUILDING 2
SECTION D**

Unit #217- Water testing performed by Independent water testing agency (at bedroom double window) in accordance with AAMA 502. Test passed with no water intrusion.

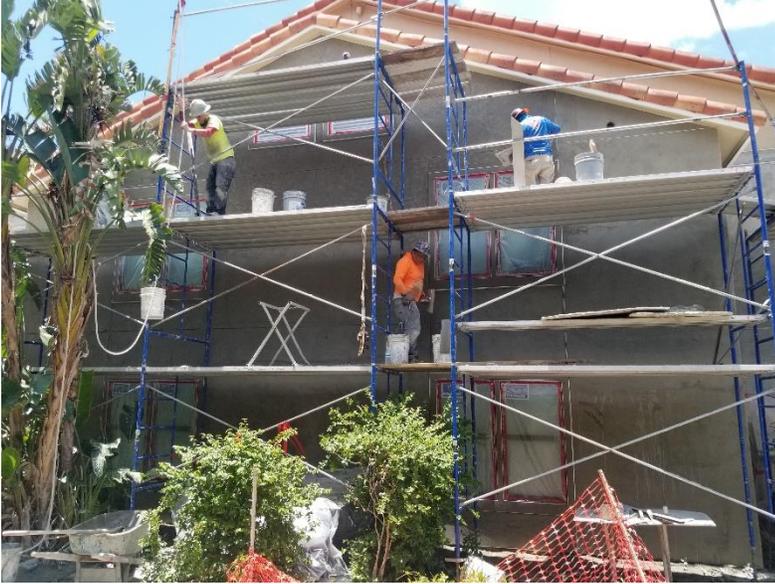
PHOTOGRAPH #3

**BUILDING 2
SECTION H**

Application of stucco finish coat in progress.

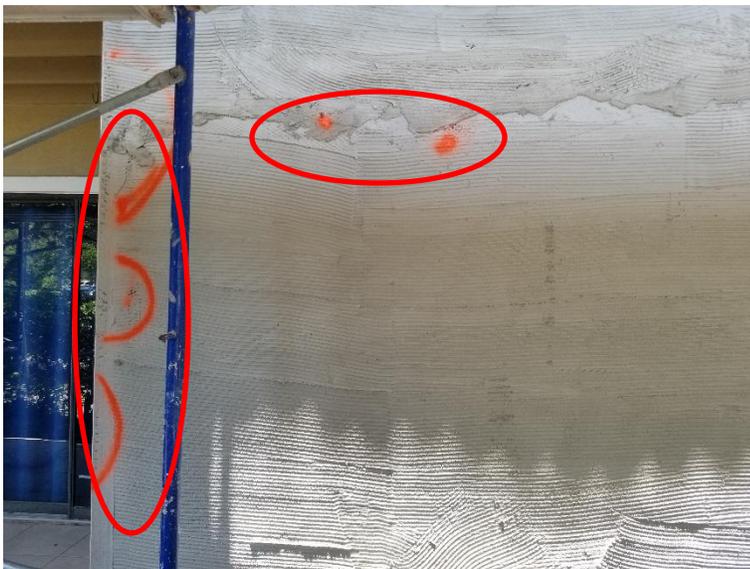
PHOTOGRAPH #4

**BUILDING 2
SECTION G**

Voids were identified after scratch coat application. Stucco sub-contractor applied stucco to fill voids prior to brown coat application.

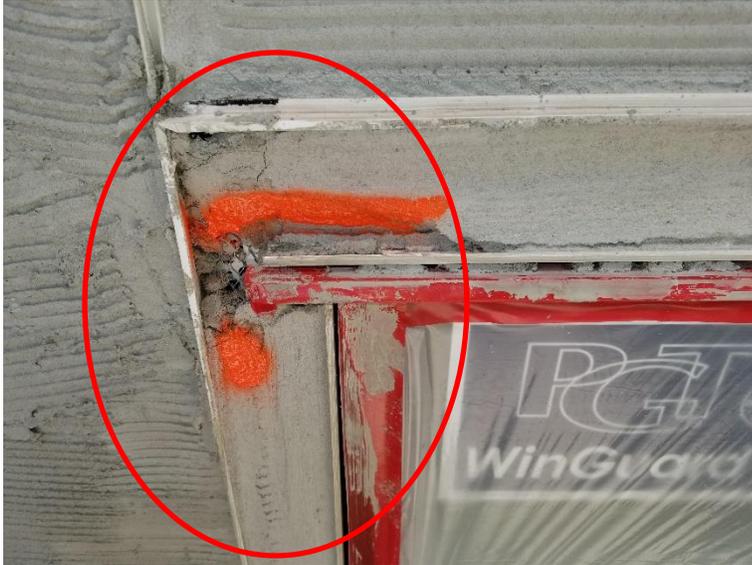
PHOTOGRAPH #5

**BUILDING 2
SECTION G**

Additional voids were located at boarder around window. Stucco sub-contractor applied stucco to fill voids.

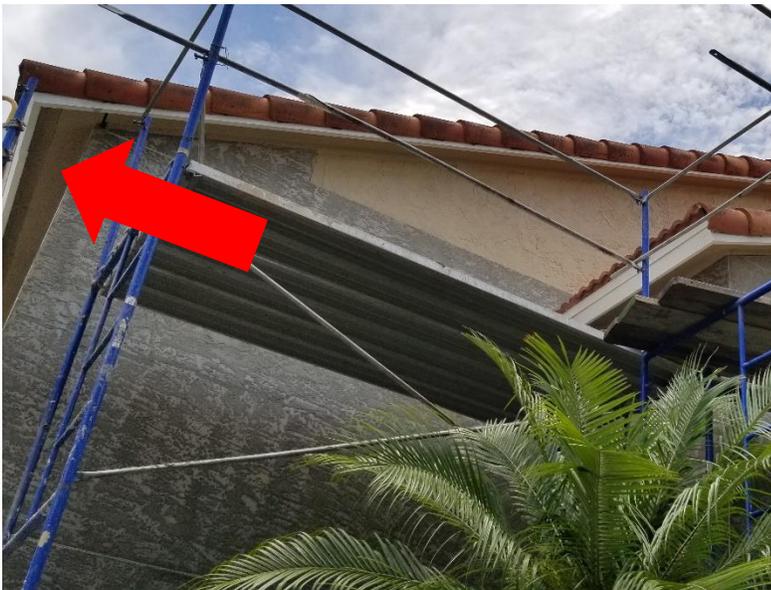
PHOTOGRAPH #6

**BUILDING 2
SECTION H**

Contractor has installed and painted new wood soffit and vinyl soffit venting. Caulking is to be performed.

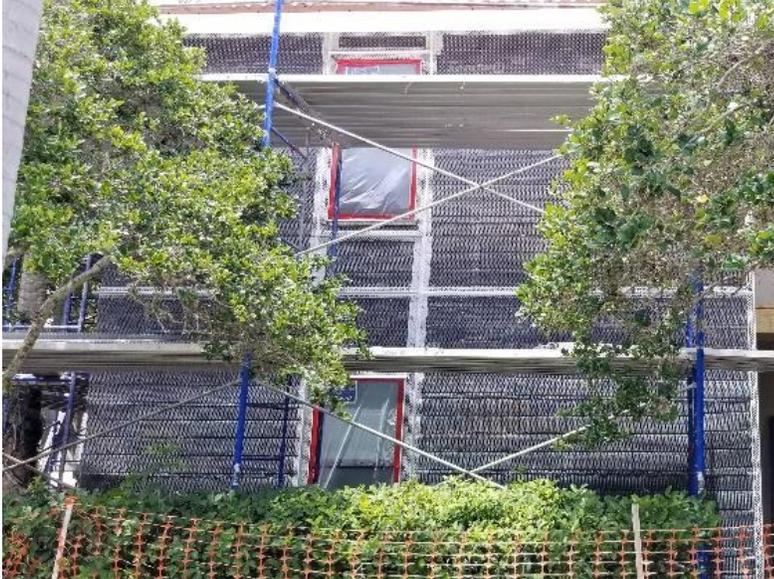
PHOTOGRAPH #7

**BUILDING 2
SECTION E**

Contractor installed new vinyl stucco accessories and metal lathing.

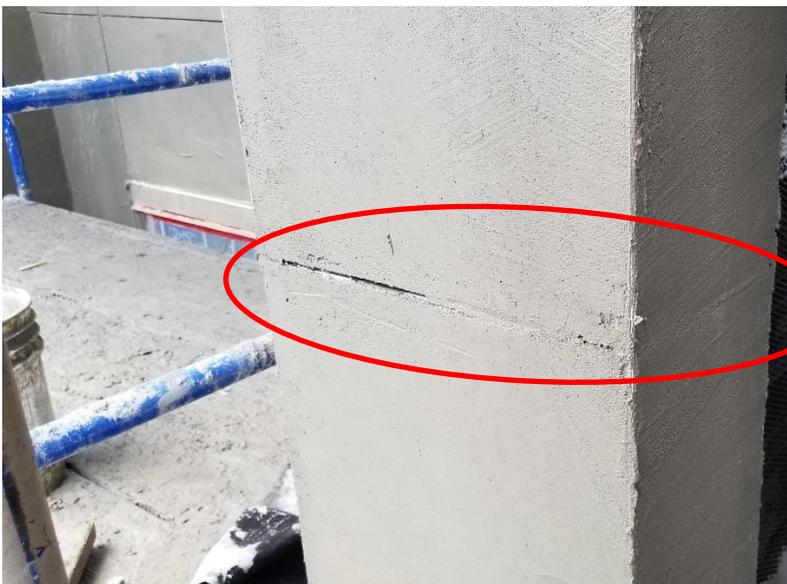
PHOTOGRAPH #8

**BUILDING 2
SECTION G**

Stucco sub-contractor filled vinyl joint during brown coat installation. Joints cleaned prior to application of finish coat.

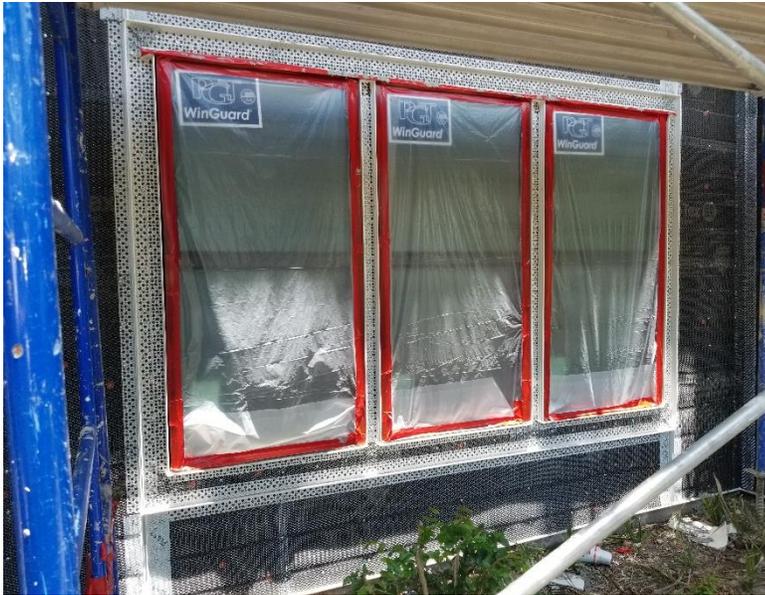
PHOTOGRAPH #9

**BUILDING 2
SECTION F**

Contractor installed metal lathing and stucco accessories at window bands as per the drawings. Temporary glass protection has been installed.

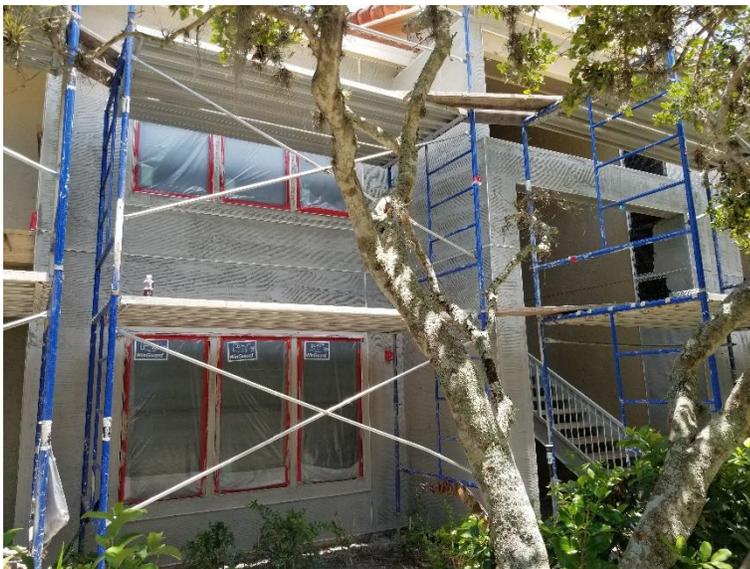
PHOTOGRAPH #10

**BUILDING 2
SECTION F**

Stucco sub-contractor applied scratch coat.

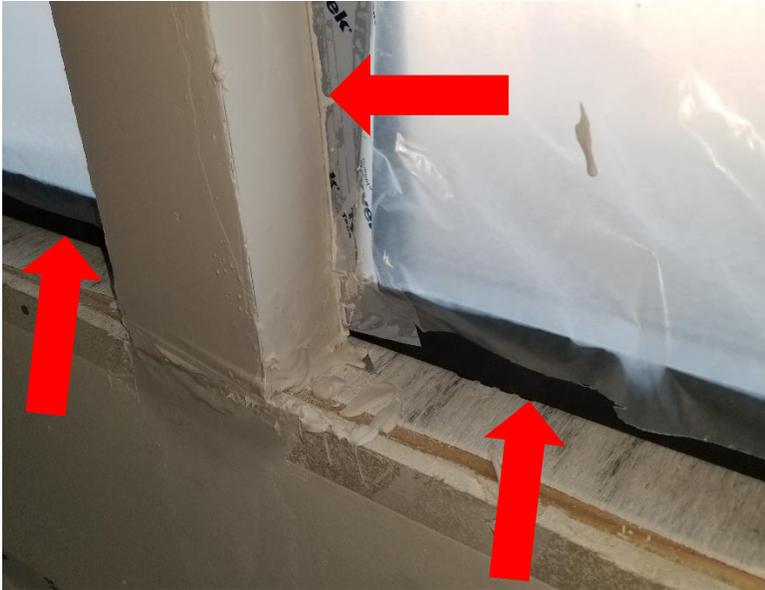
PHOTOGRAPH #11

**BUILDING 2
SECTION B**

Contractor to apply and allow urethane sealant to cure at interior side of window frames prior to performing drywall repairs.

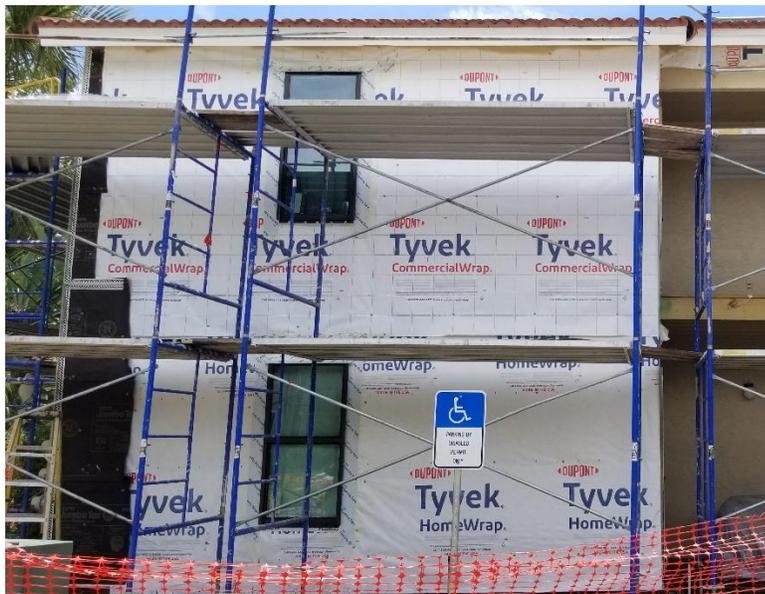
PHOTOGRAPH #12

**BUILDING 2
SECTION A**

Tyvek HomeWrap installed at Section A with 3" Dupont seam tape at overlapping joints. Dupont Tyvek flashings applied per manufacturers recommendations at window openings.

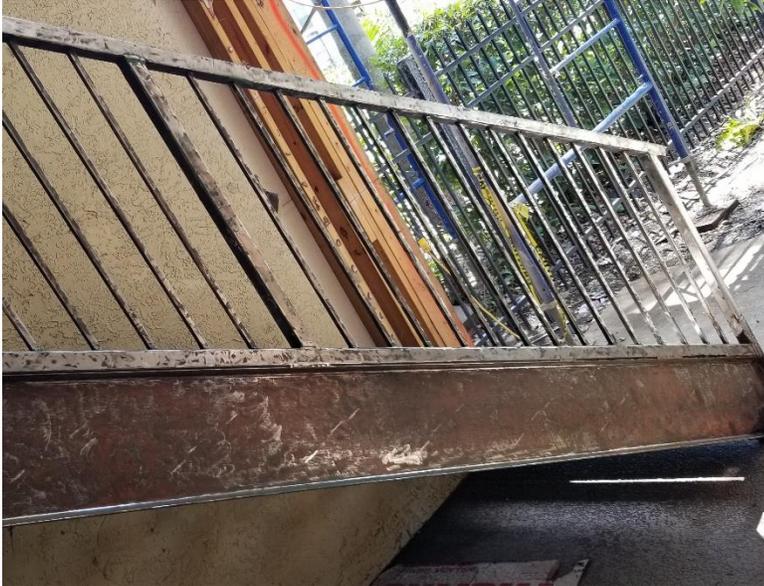
PHOTOGRAPH #13

**BUILDING 3
SECTION C**

Contractor removed old paint at stairway railing using hand grinders with wire wheels.

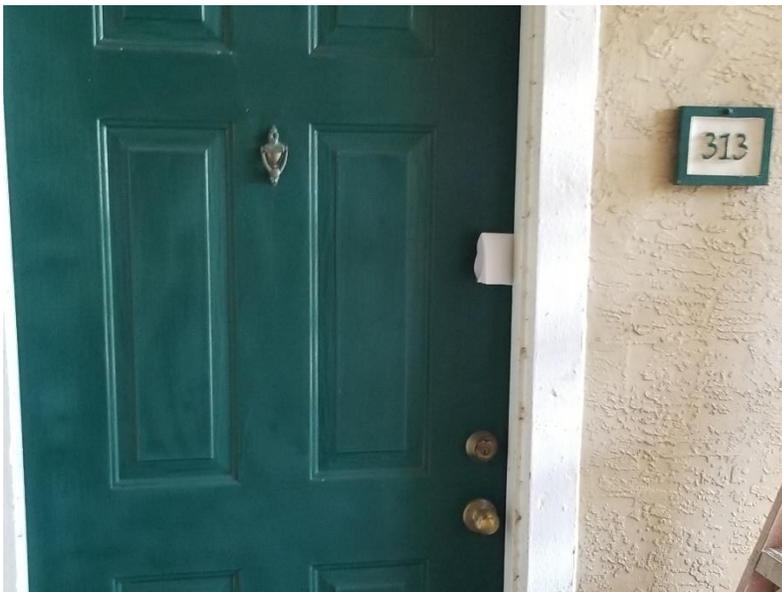
PHOTOGRAPH #14

**BUILDING 3
SECTION C**

Unit #313 – Entrance door has been sanded, prepped, and ready for prime coat.

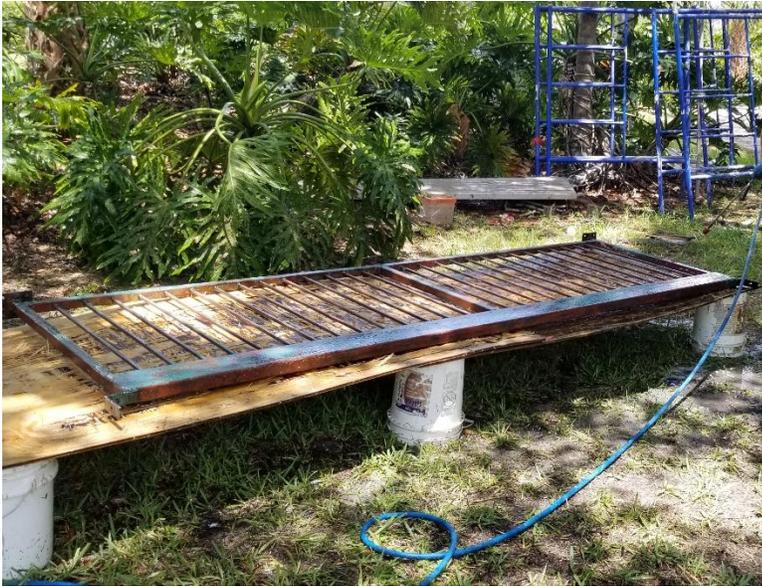
PHOTOGRAPH #15

**BUILDING 3
SECTION E**

Balcony railing old paint removal in progress utilizing Back to Nature stripper and high-pressure water method.

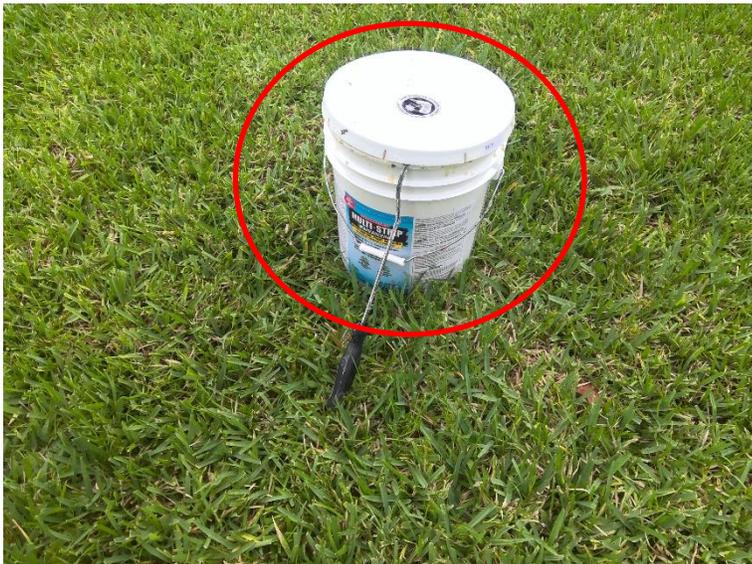
PHOTOGRAPH #16

**BUILDING 3
SECTION E**

Balcony railing old paint removal in progress utilizing Back to Nature stripper and high-pressure water method.

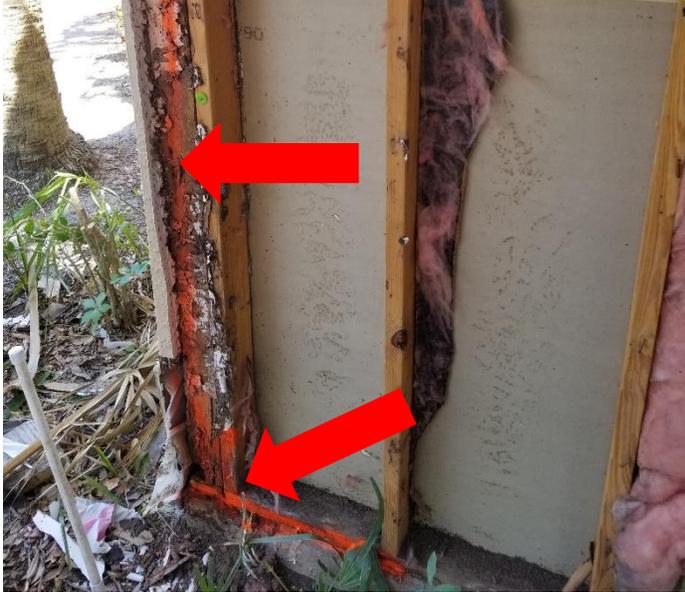
PHOTOGRAPH #17

**BUILDING 3
SECTION E**

Extent of damaged framing marked for repairs at posts, plates, and studs.

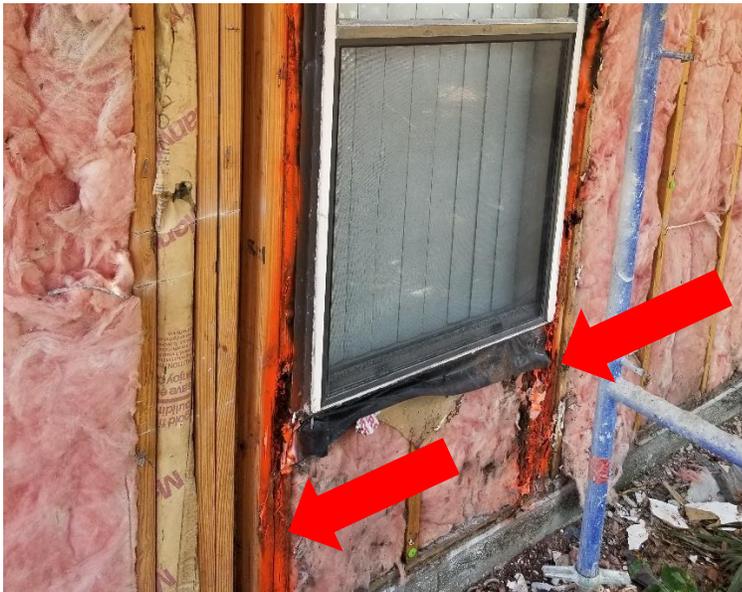
PHOTOGRAPH #18

**BUILDING 3
SECTION E**

Extent of damaged framing marked at window.

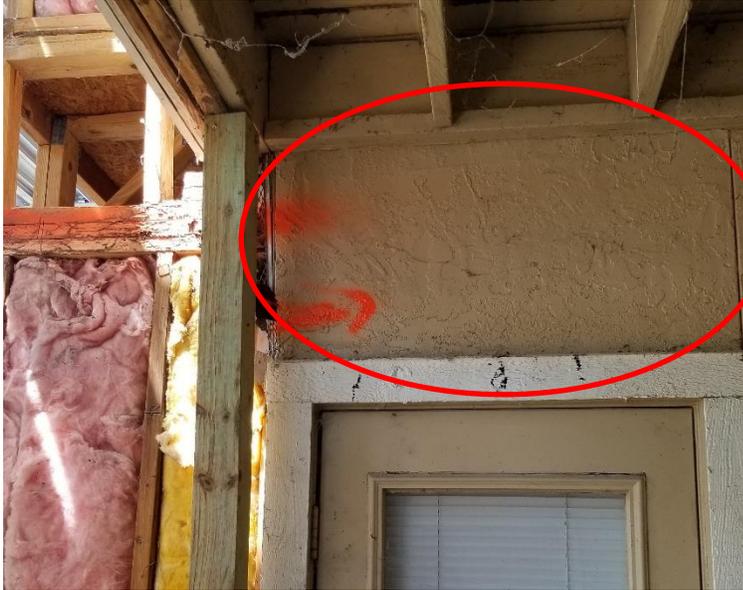
PHOTOGRAPH #19

**BUILDING 3
SECTION F**

Additional stucco marked for removal to reveal extent of damage.

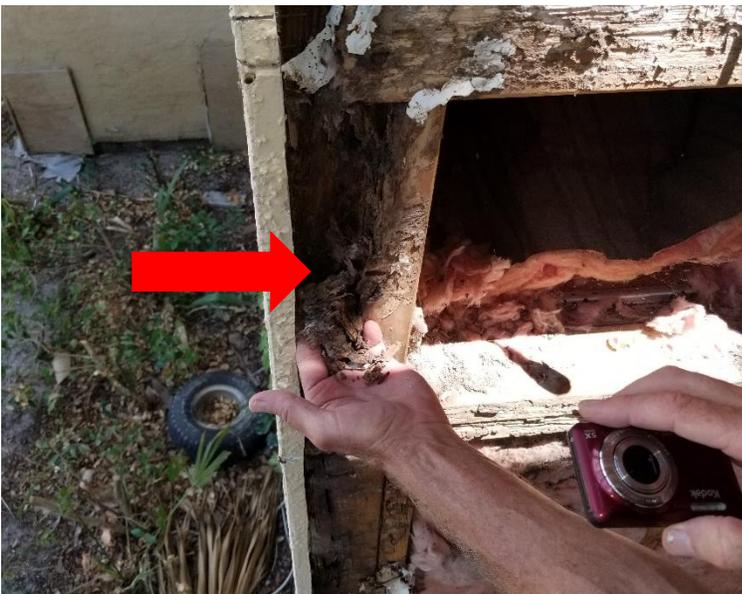
PHOTOGRAPH #20

**BUILDING 3
SECTION E**

Wood rotten and decomposed, post and framing marked for repair.

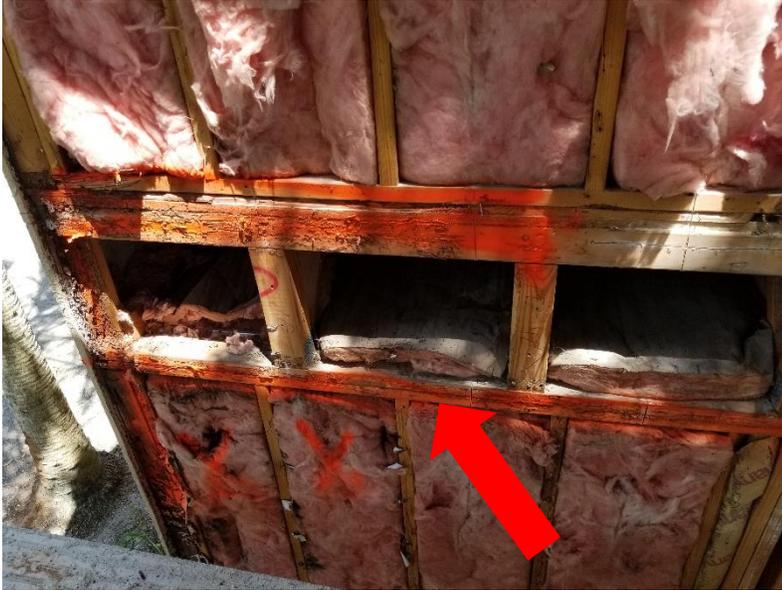
PHOTOGRAPH #21

**BUILDING 3
SECTION E**

Second level floor joists, posts, plates, and studs marked for repairs.

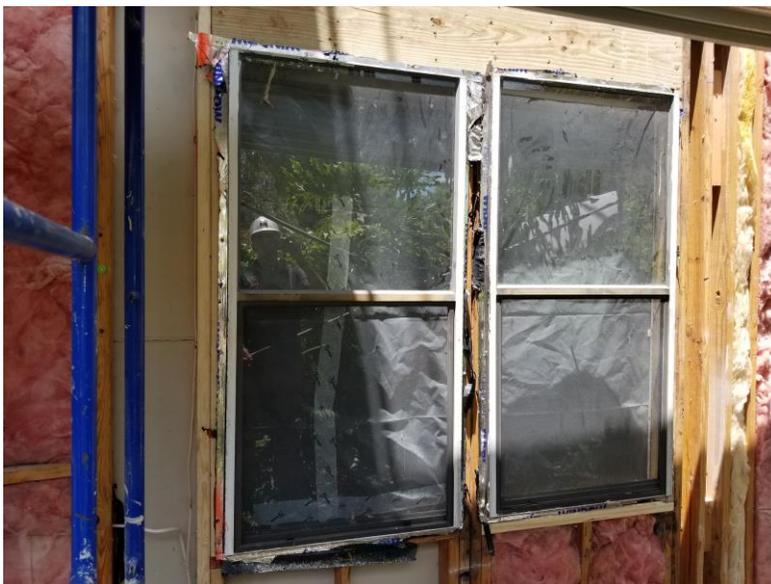
PHOTOGRAPH #22

**BUILDING 3
SECTION H**

New header and framing installed. Existing windows left in place until new windows arrive.

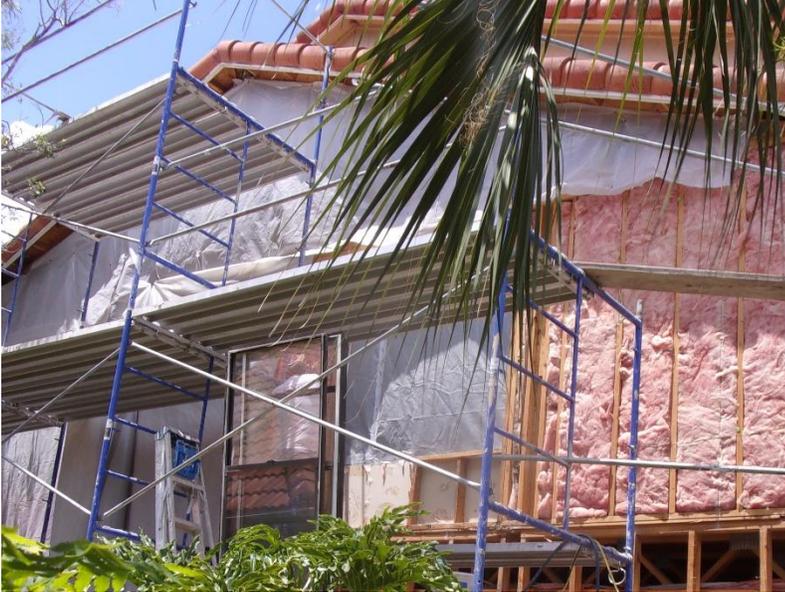
PHOTOGRAPH #23

**BUILDING 3
SECTION H**

Contractor performs framing repairs and installs new insulation. Contractor installs plastic covering at the end of each shift.
