PHOTOGRAPHS

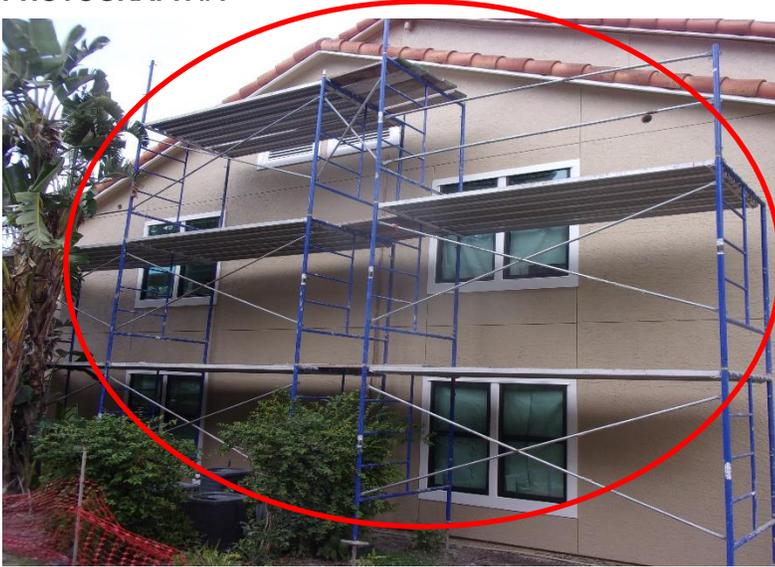
PHOTOGRAPH #1

BUILDING 2 SECTION H

Florida Paint has confirmed PH levels acceptable for coating by report Contractor has painted new stucco.

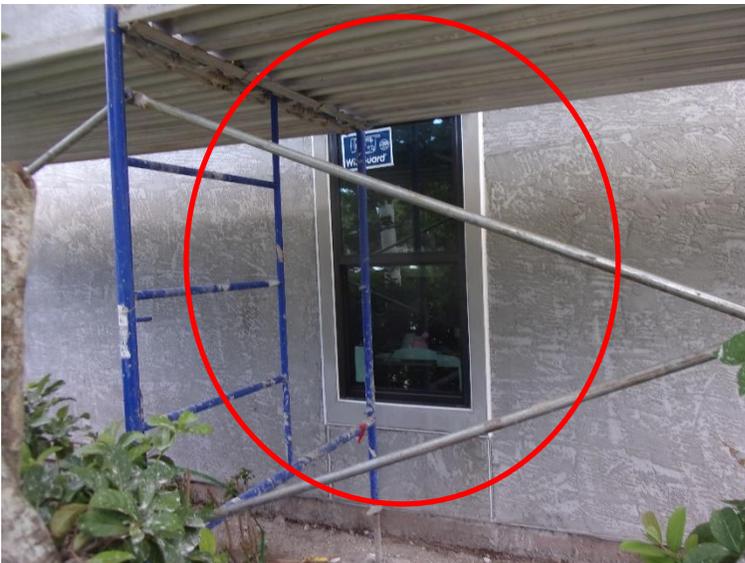
PHOTOGRAPH #2

BUILDING 2 SECTION G

BASF 150 sealant applied at window perimeters and all transitions from new stucco to adjacent substrates.

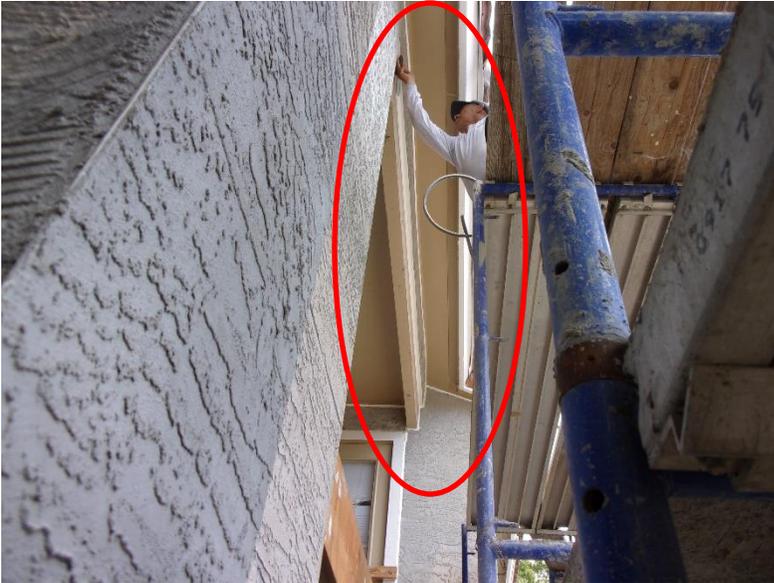
PHOTOGRAPH #3

**BUILDING 2
SECTION G**

BASF 150 sealant applied at window perimeters and all transitions from new stucco to adjacent substrates.

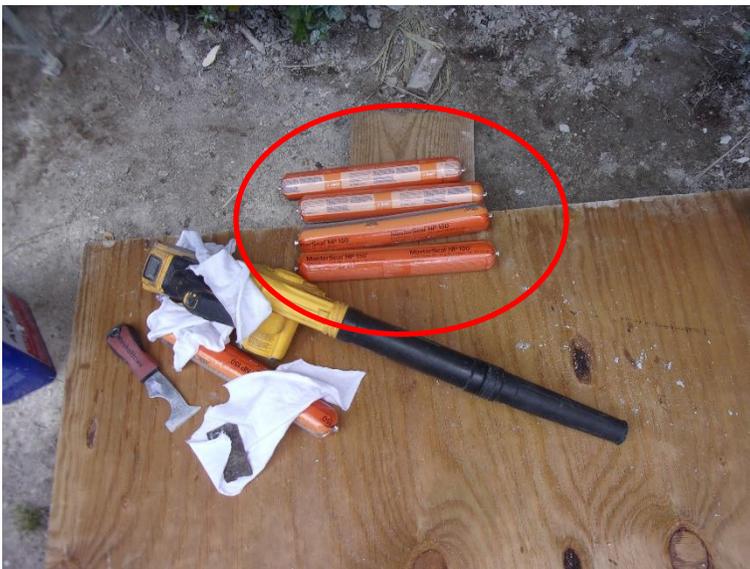
PHOTOGRAPH #4

**BUILDING 2
SECTION G**

BASF 150 sealant applied at window perimeters and all transitions from new stucco to adjacent substrates.

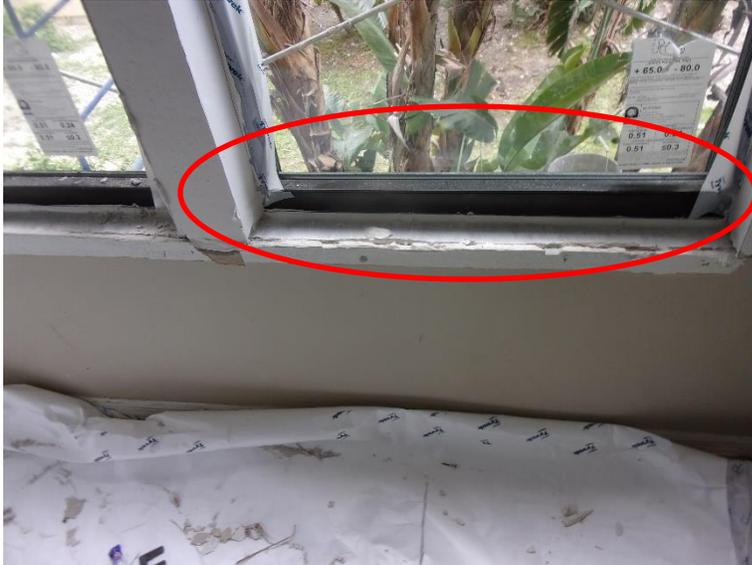
PHOTOGRAPH #5

**BUILDING 2
SECTION G**

Contractor has applied urethane sealant at interior side of new window to Dupont flashing system and allowed to cure before applying new drywall and sills.

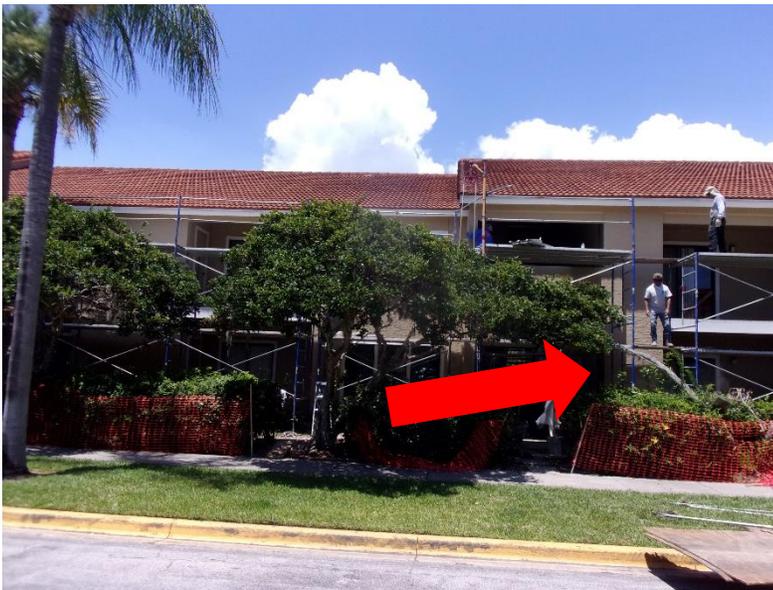
PHOTOGRAPH #6

**BUILDING 2
SECTION G**

Contractor has painted new stucco and in process of removing access scaffolding.

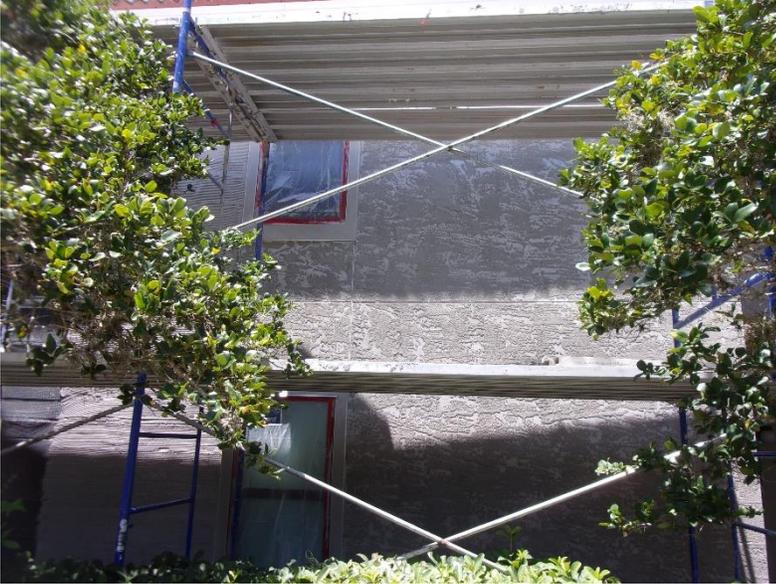
PHOTOGRAPH #7

**BUILDING 2
SECTION F**

Sub-contractor has protected windows and applied three coat stucco system.

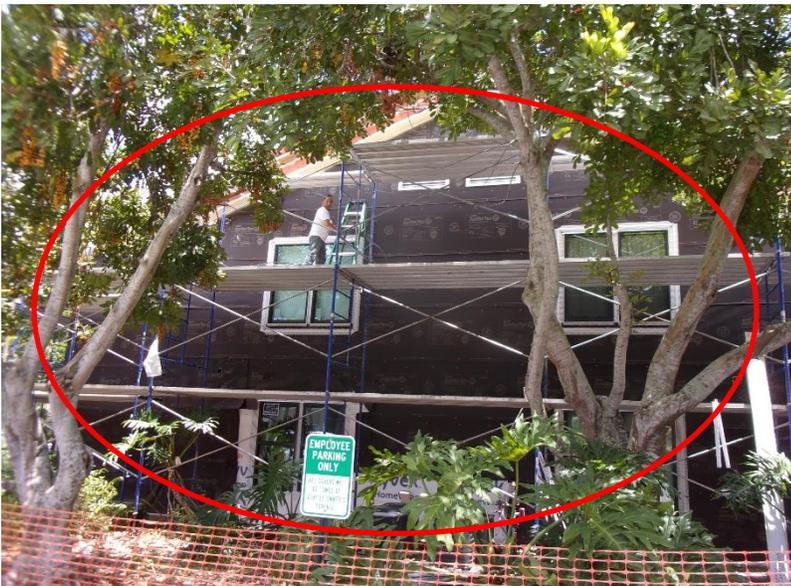
PHOTOGRAPH #8

**BUILDING 2
SECTION D**

Stucco sub-contractor has applied JumboTex WRB and begun to install vinyl stucco accessories.

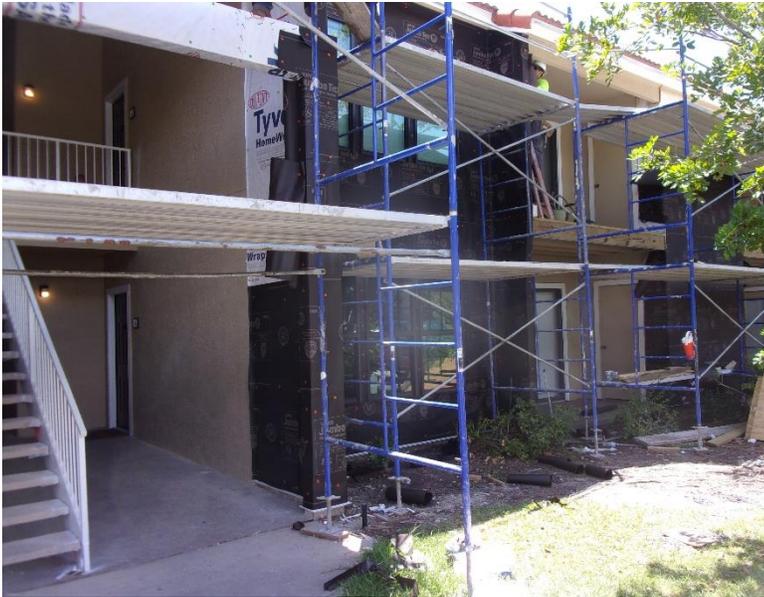
PHOTOGRAPH #9

**BUILDING 2
SECTION B**

Stucco sub-contractor has applied JumboTex Water resistant barrier.

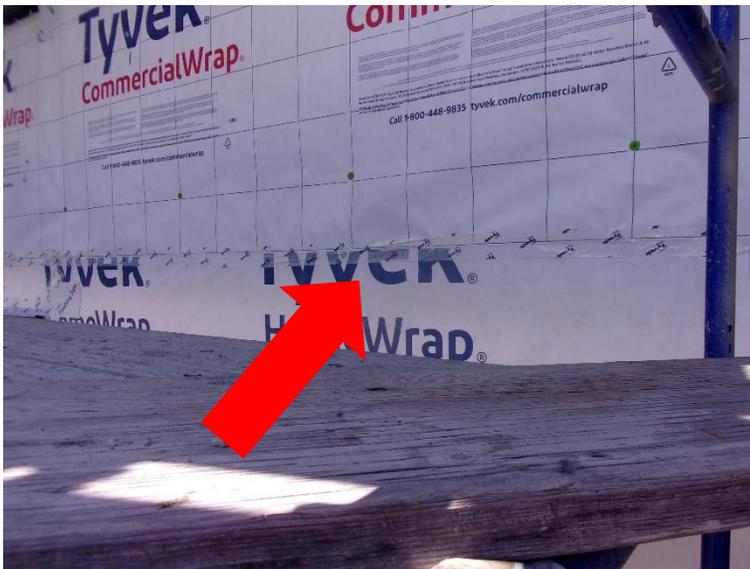
PHOTOGRAPH #10

**BUILDING 2
SECTION A**

Overlapping seams taped with Tyvek 3" seam tape.

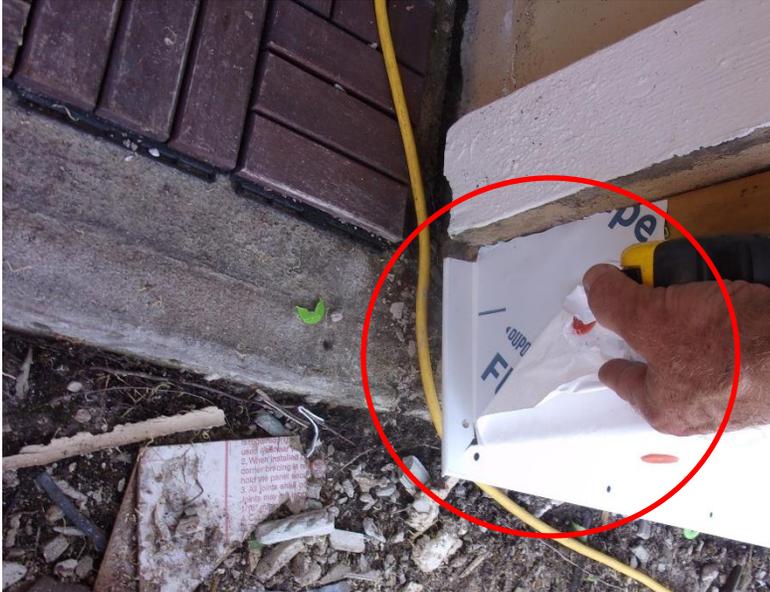
PHOTOGRAPH #11

**BUILDING 2
SECTION A**

Weep screed accessory detail at base of new plywood sheathing flashed with Dupont flashing and overlapped with Tyvek HomeWrap.

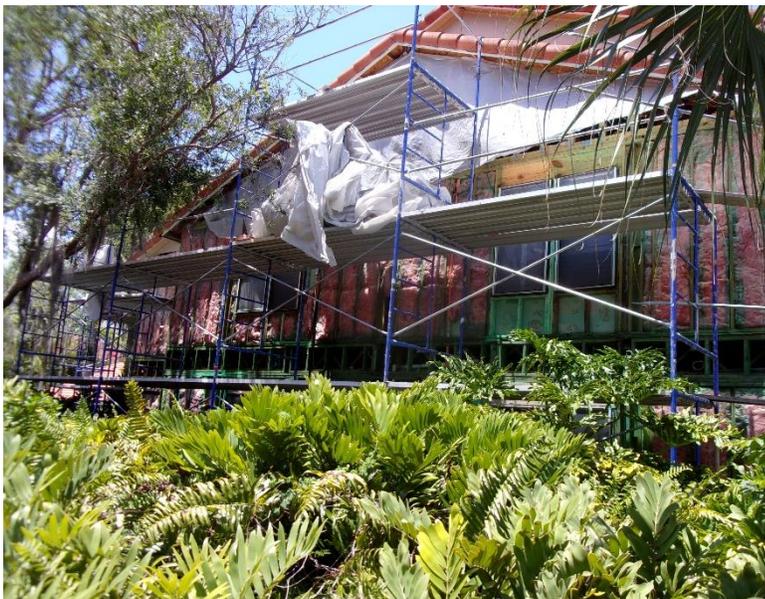
PHOTOGRAPH #12

**BUILDING 3
SECTION H**

Gable end wall framing treated with BoraCare Termite Treatment.

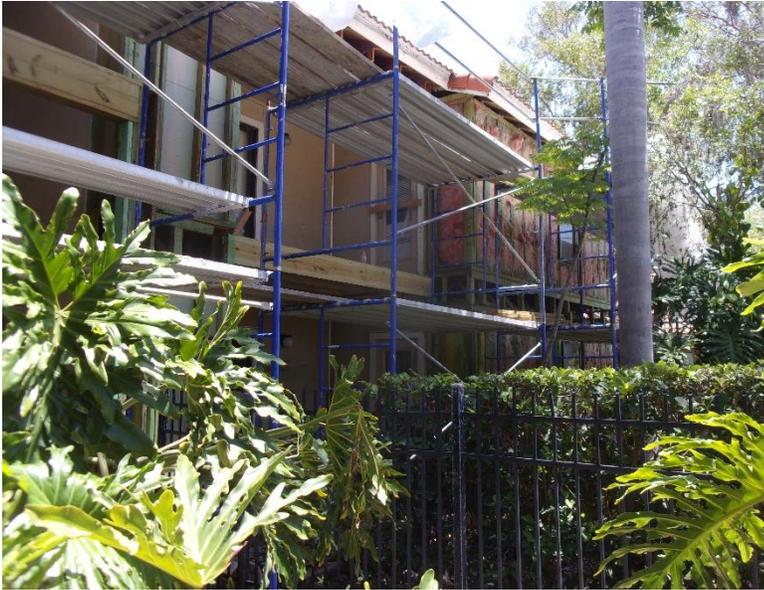
PHOTOGRAPH #13

**BUILDING 3
SECTION G**

Pest control contractor has treated wall framing with BoraCare Termite Treatment.

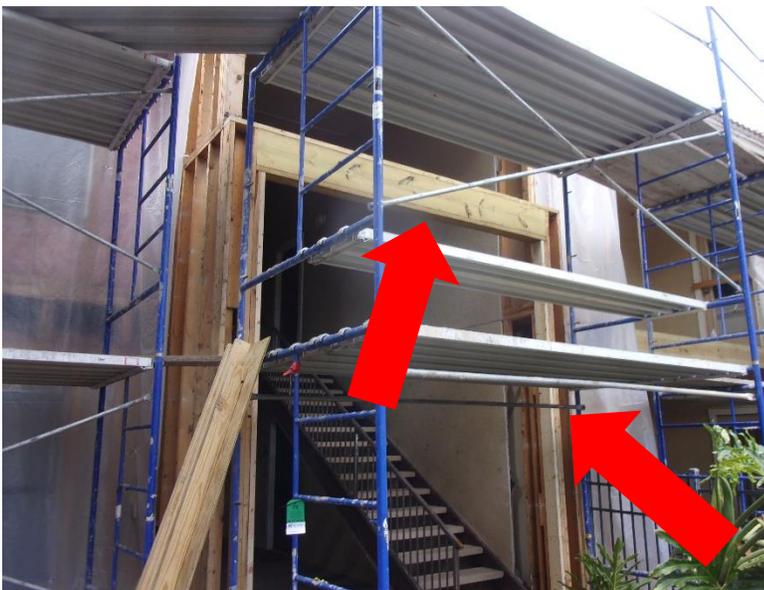
PHOTOGRAPH #14

**BUILDING 3
SECTION G**

Damaged framing at breezeway replaced at header and posts.

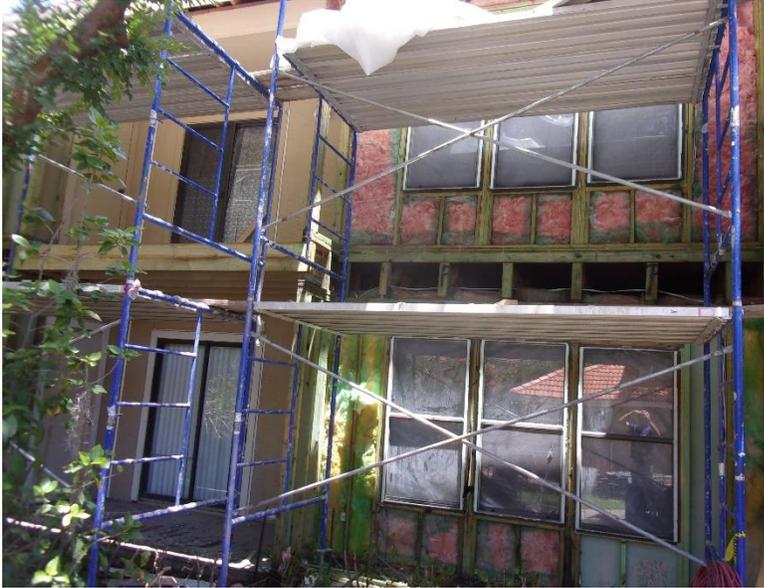
PHOTOGRAPH #15

**BUILDING 3
SECTION F**

Pest control contractor has treated wall framing with BoraCare Termite Treatment.

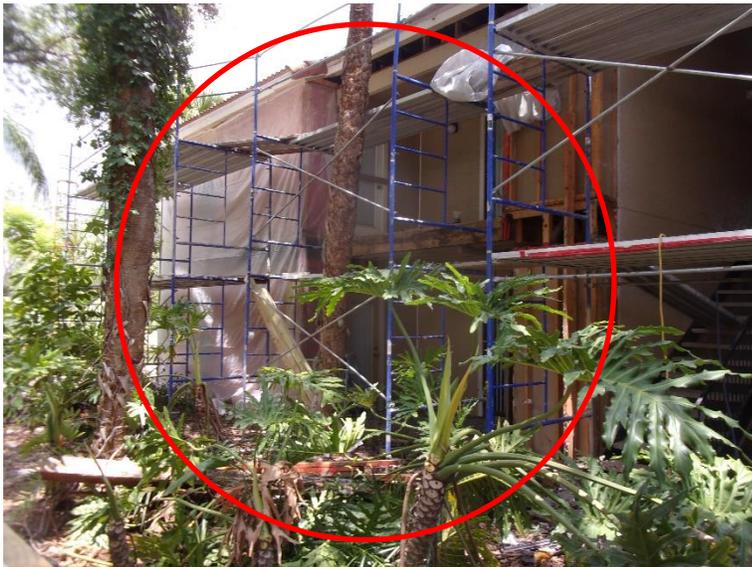
PHOTOGRAPH #16

**BUILDING 3
SECTION E**

Framing repairs in progress. Open walls covered for weather protection.

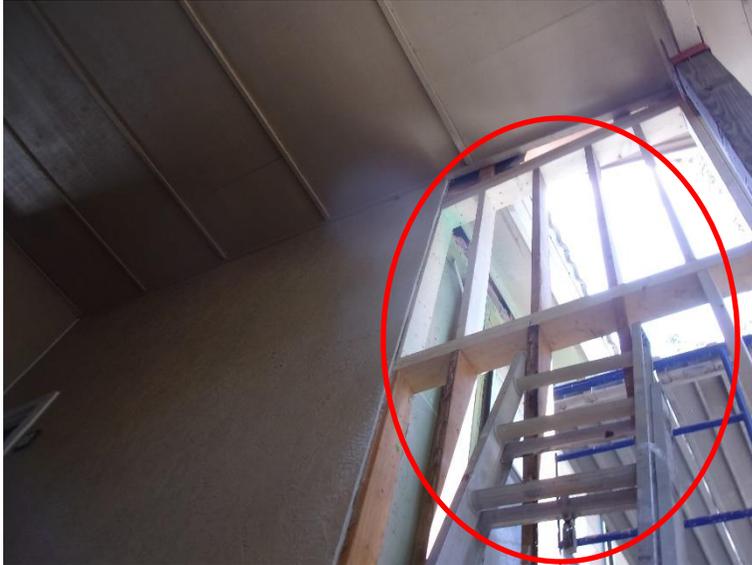
PHOTOGRAPH #17

**BUILDING 3
SECTION E**

Damaged breezeway wall framing replaced.

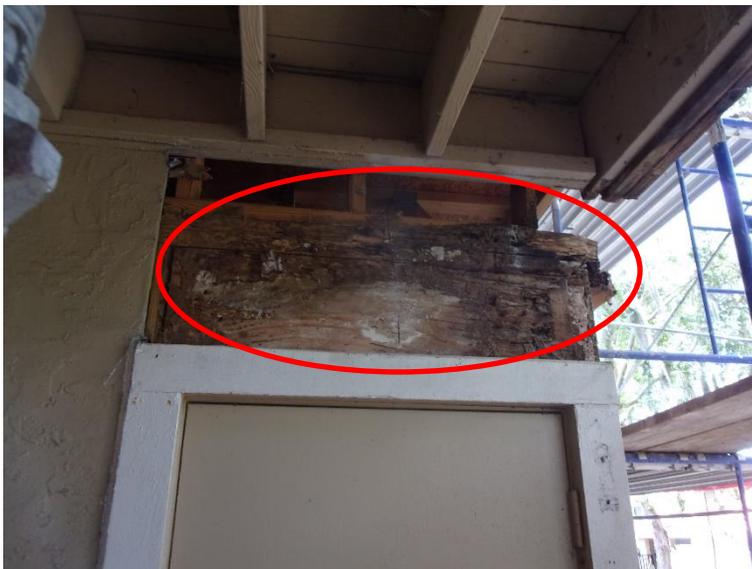
PHOTOGRAPH #18

**BUILDING 3
SECTION E**

Additional stucco removed exposing additional termite damaged headers and framing to be replaced.

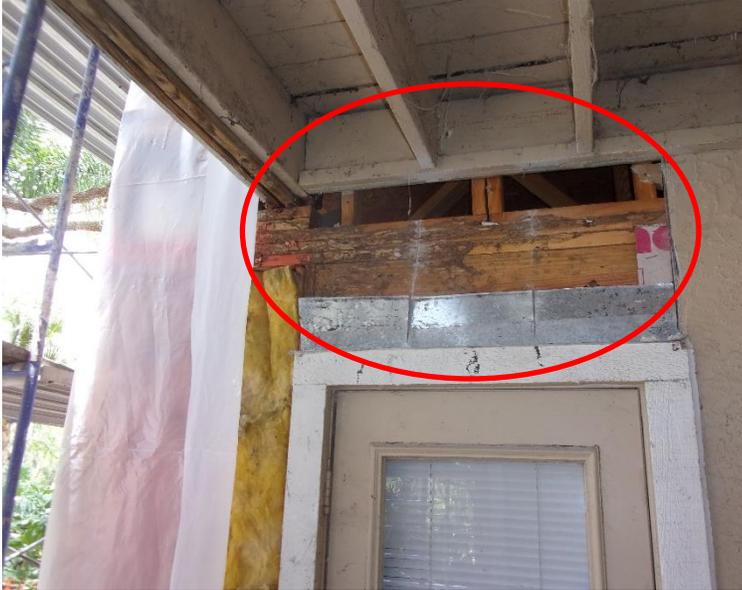
PHOTOGRAPH #19

**BUILDING 3
SECTION E**

Additional stucco removed exposing additional termite damaged headers and framing to be replaced.

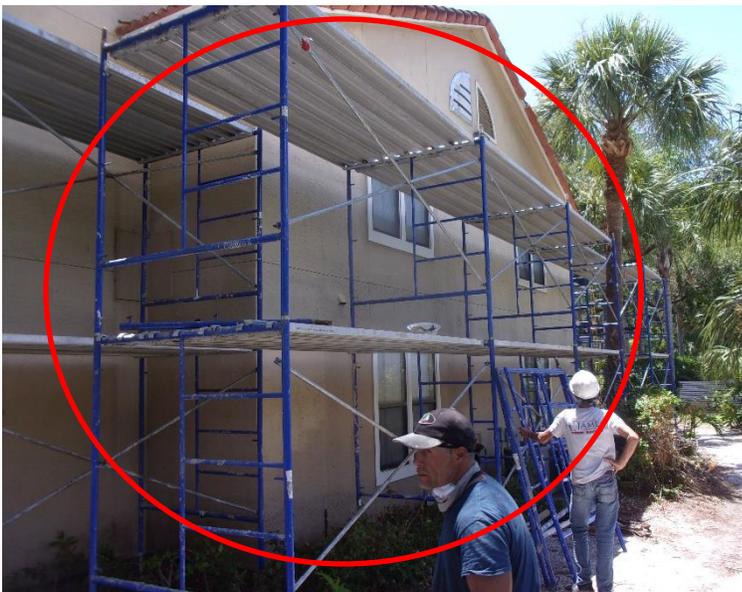
PHOTOGRAPH #20

**BUILDING 3
SECTION D**

Contractor mobilizing and setting up scaffolding for access to repairs.
