**PHOTOGRAPHS**

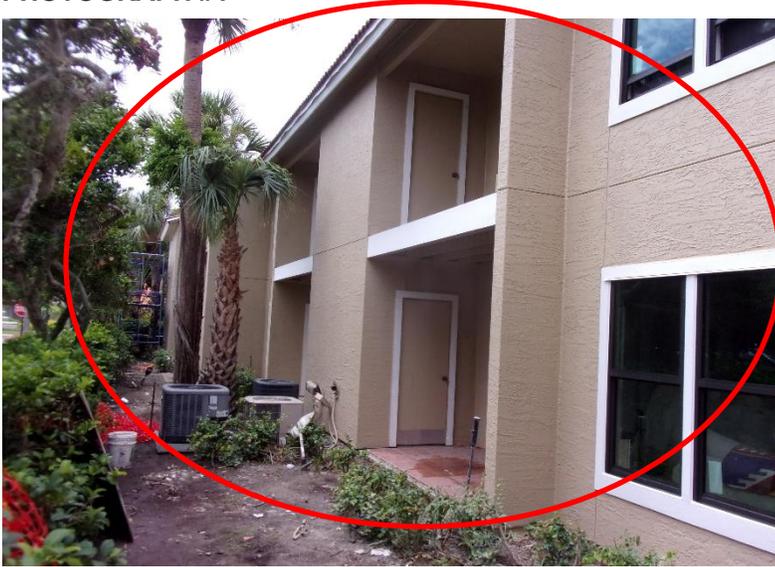
**PHOTOGRAPH #1**

**BUILDING 2  
SECTION F**

New stucco PH levels confirmed as acceptable for coating by Florida Paint report. Contractor has applied Ultra Super coat by Florida Paints.

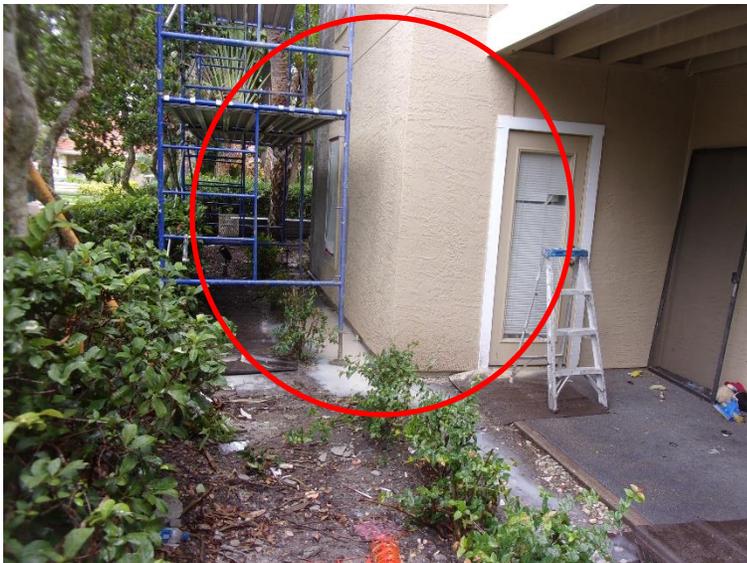
**PHOTOGRAPH #2**

**BUILDING 2  
SECTION E**

New stucco PH levels confirmed as acceptable for coating by Florida Paint report. Paint washed off by rain will require recoating.

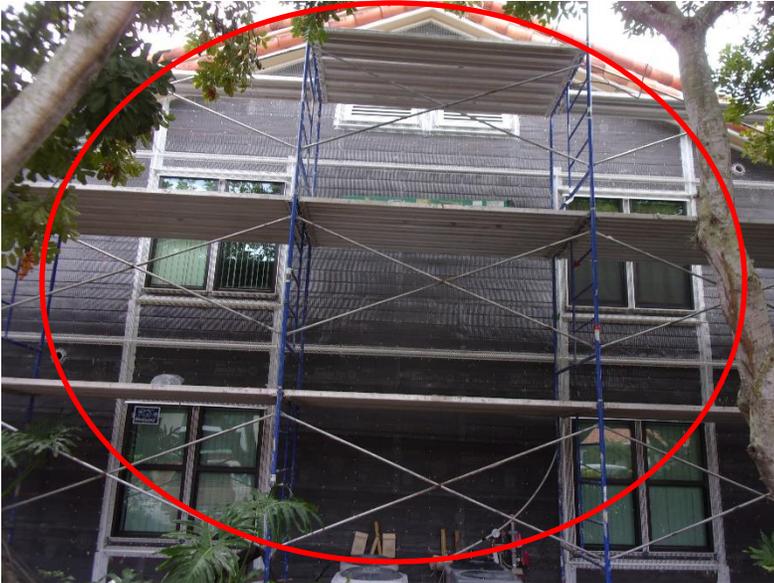
**PHOTOGRAPH #3**

**BUILDING 2  
SECTION D**

Stucco sub-contractor has applied Super Jumbo Tex 60 WRB, Vinyl stucco accessories and stucco lath.

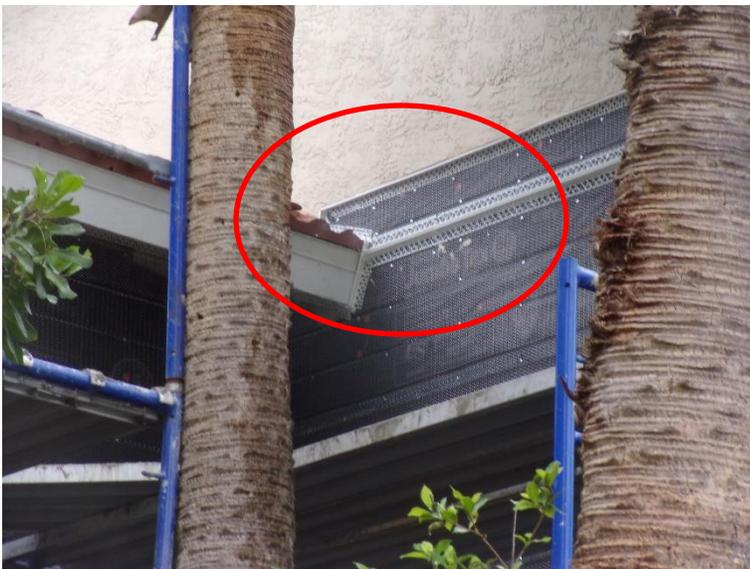
**PHOTOGRAPH #4**

**BUILDING 2  
SECTION D**

Roof kick out flashing was not installed as required before stucco accessories and lath was applied.

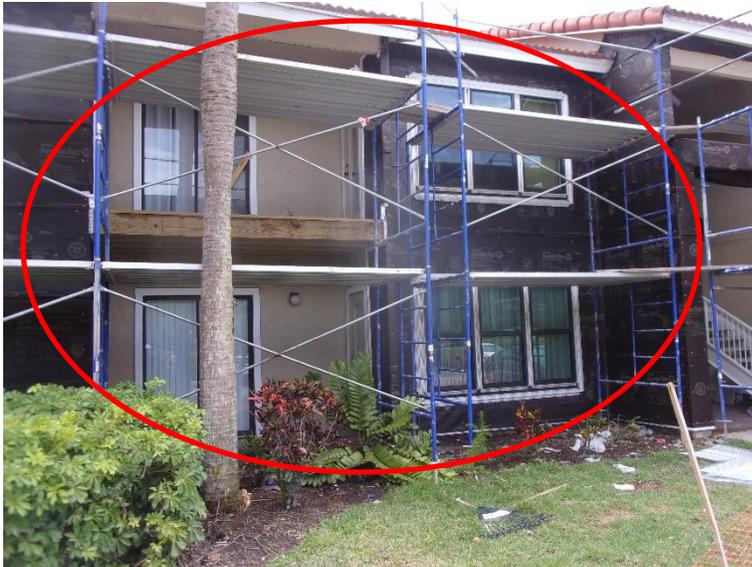
**PHOTOGRAPH #5**

**BUILDING 2  
SECTION B**

Stucco sub-contractor has applied water resistant barrier and begun attaching stucco accessories at window openings.

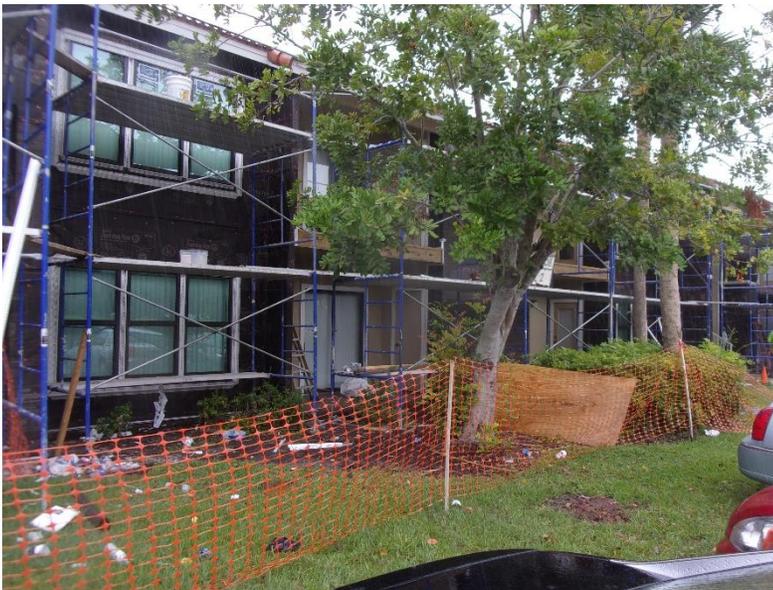
**PHOTOGRAPH #6**

**BUILDING 2  
SECTION B**

Stucco sub-contractor has applied water resistant barrier and begun attaching stucco accessories at window openings.

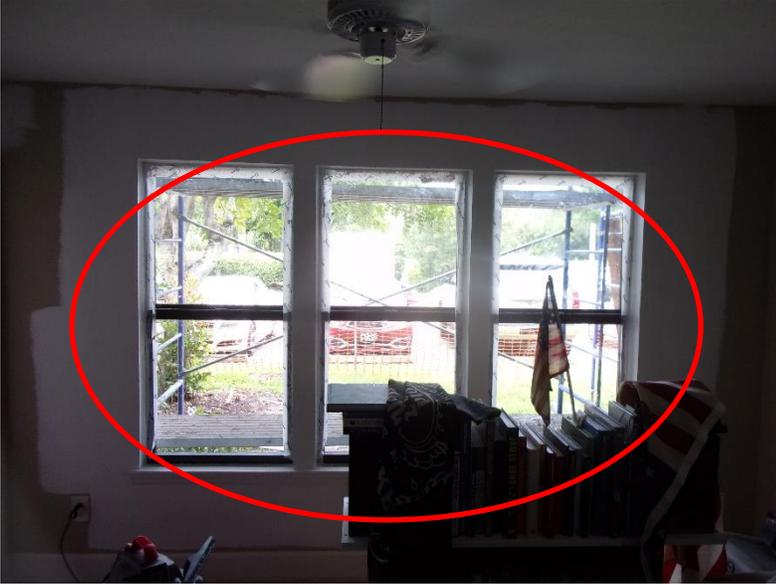
**PHOTOGRAPH #7**

**BUILDING 2  
SECTION B**

Drywall and windowsill replacement in progress at new window openings.

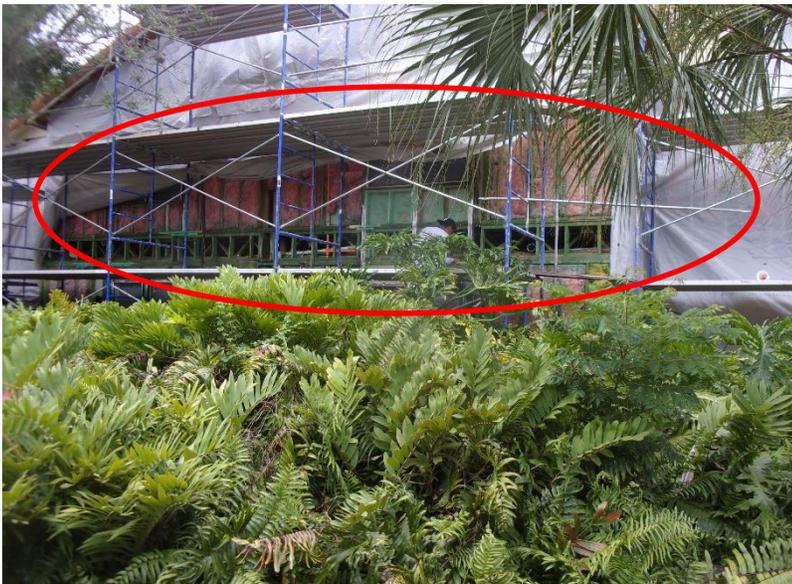
**PHOTOGRAPH #8**

**BUILDING 3  
SECTION H**

Framing repairs quantified and Simpson Strong – Tie connectors application in progress.

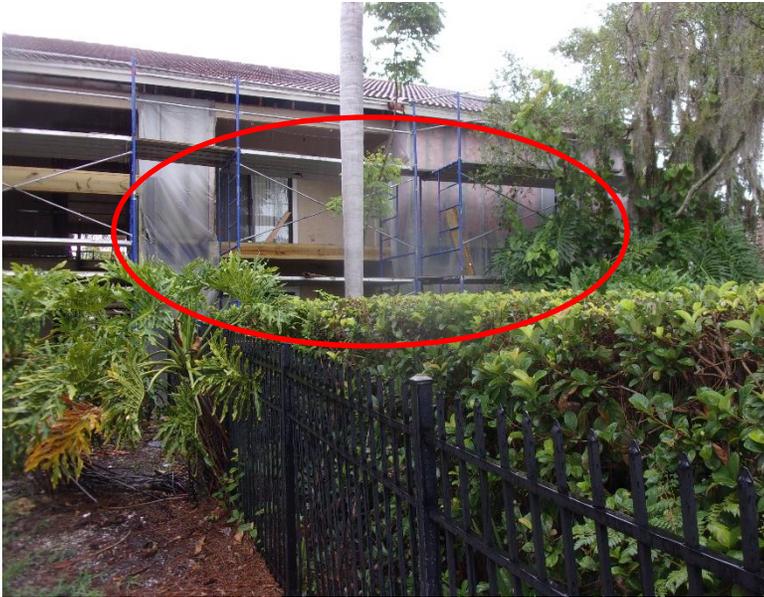
**PHOTOGRAPH #9**

**BUILDING 3  
SECTION G**

Balcony and wall framing repairs performed and quantified. Temporary plastic protection provided at open walls while repairs are in progress.

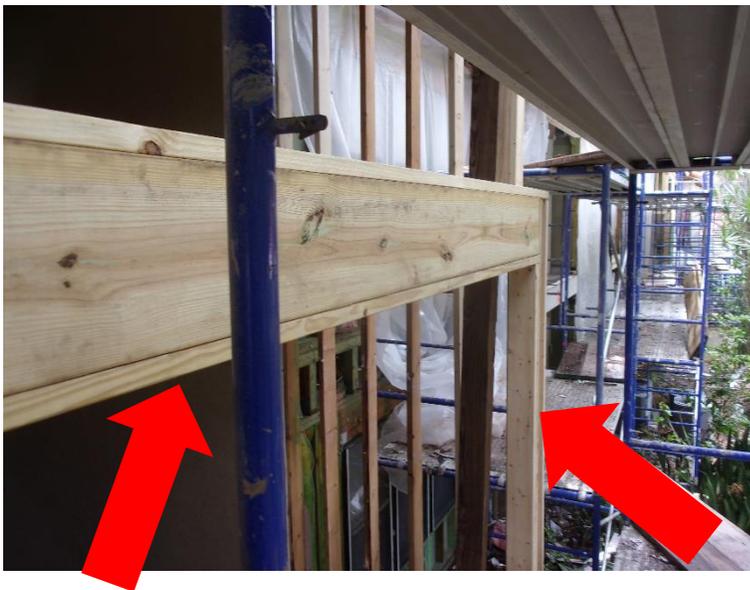
**PHOTOGRAPH #10**

**BUILDING 3  
SECTION G**

Breezeway entrance box beam and post replace as marked and quantified for billing.

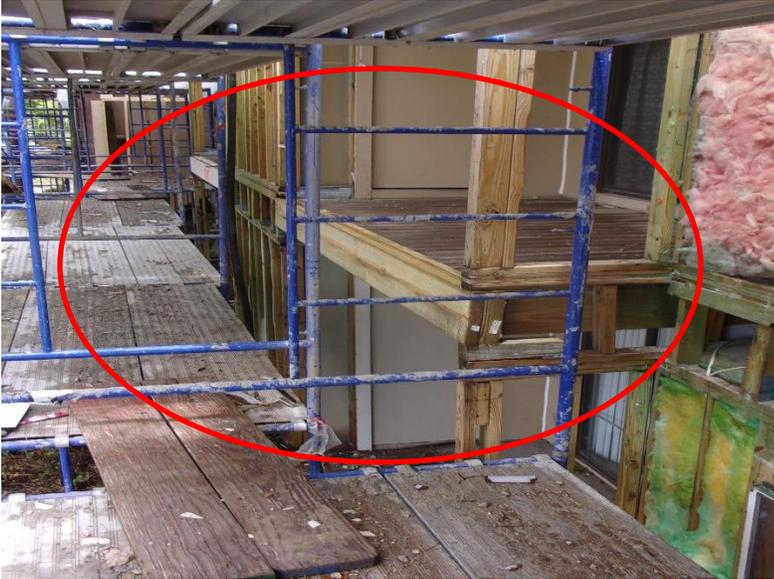
**PHOTOGRAPH #11**

**BUILDING 3  
SECTION F**

Contractor has performed balcony built up beam and framing repairs.

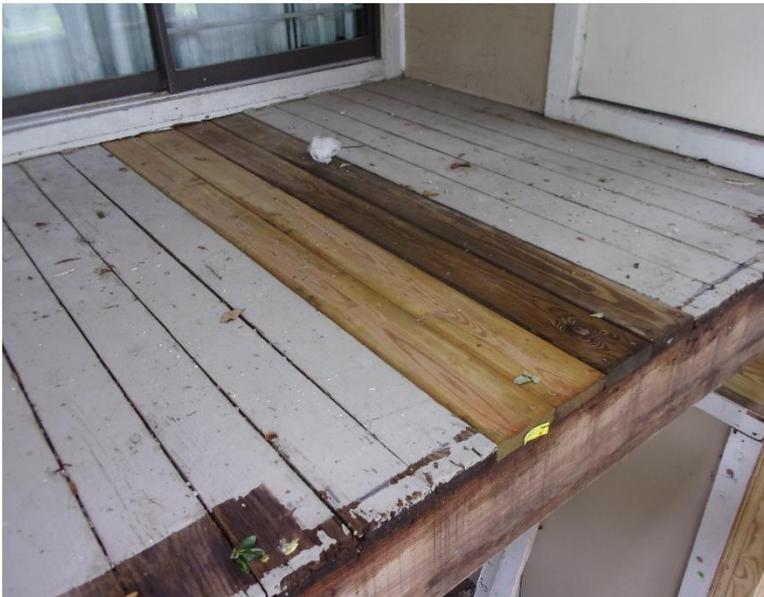
**PHOTOGRAPH #12**

**BUILDING 3  
SECTION E**

Selective damaged deck boards replace as marked.

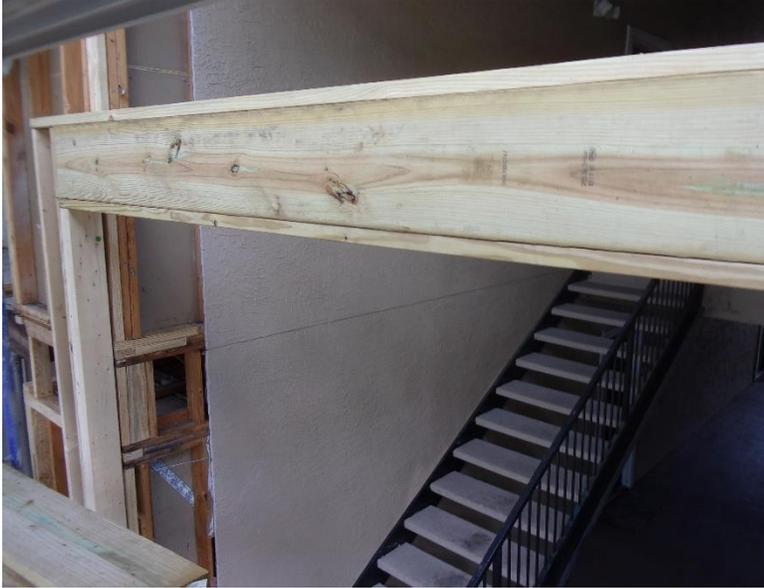
**PHOTOGRAPH #13**

**BUILDING 3  
SECTION E**

Full breezeway entrance framing replacement performed.

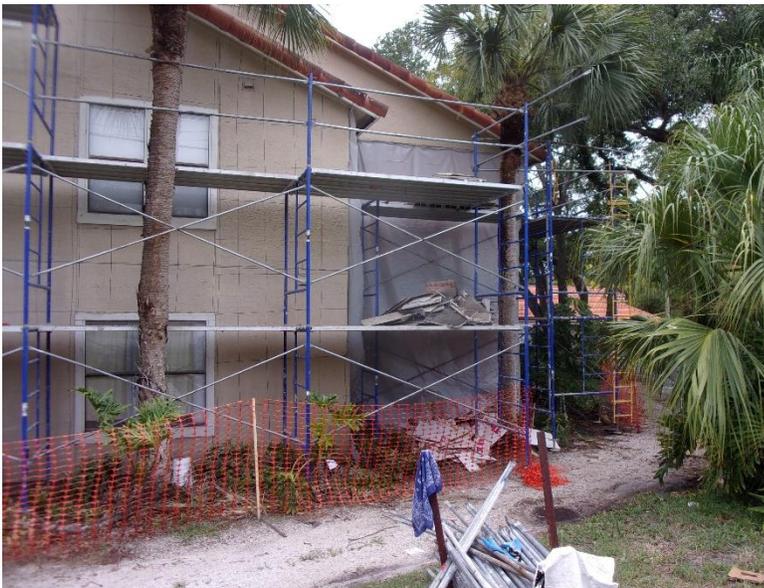
**PHOTOGRAPH #14**

**BUILDING 3  
SECTION D**

Removal of existing stucco and sheathing in progress. Temporary plastic protection provided at open walls while repairs are in progress.

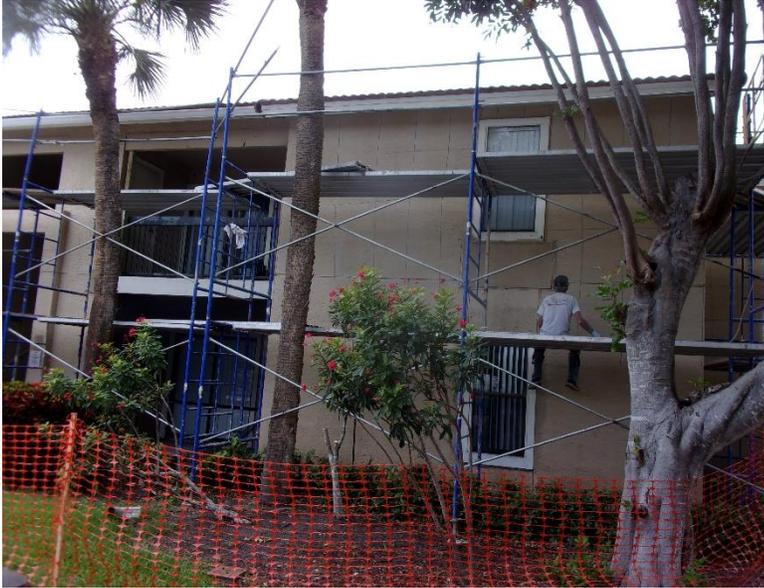
**PHOTOGRAPH #15**

**BUILDING 3  
SECTION C**

Access scaffolding erected and removal of stucco in progress.
