PHOTOGRAPHS

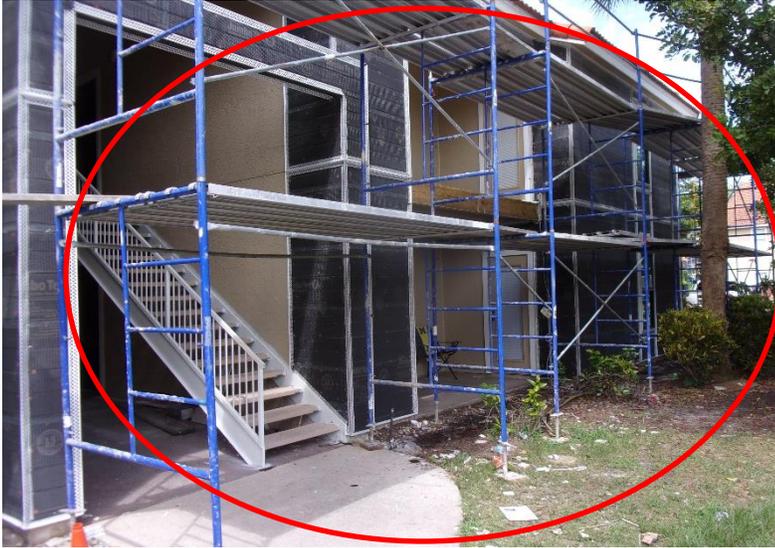
PHOTOGRAPH #1

BUILDING 2 SECTION C

Stucco sub-contractor has applied Super JumboTex 60 WRB, Vinyl stucco accessories and stucco lath.

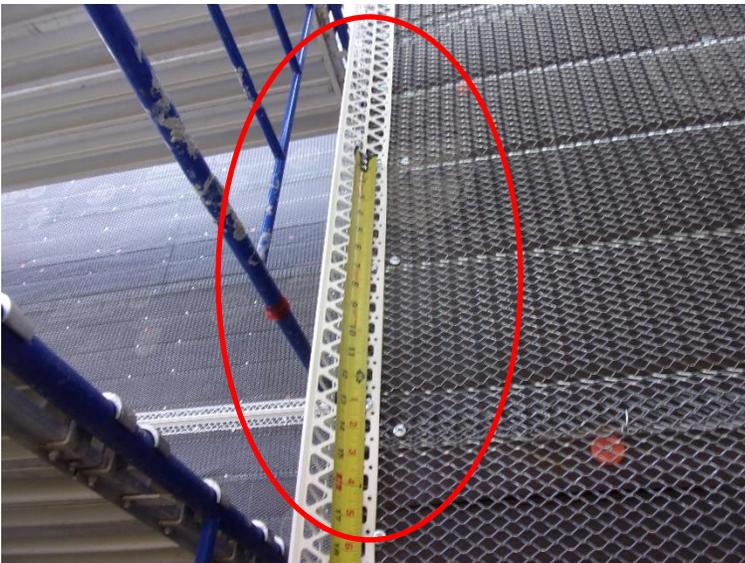
PHOTOGRAPH #2

BUILDING 2 SECTION C

Stucco lath attachment and accessories attachment inspected for fastener spacing and locations.

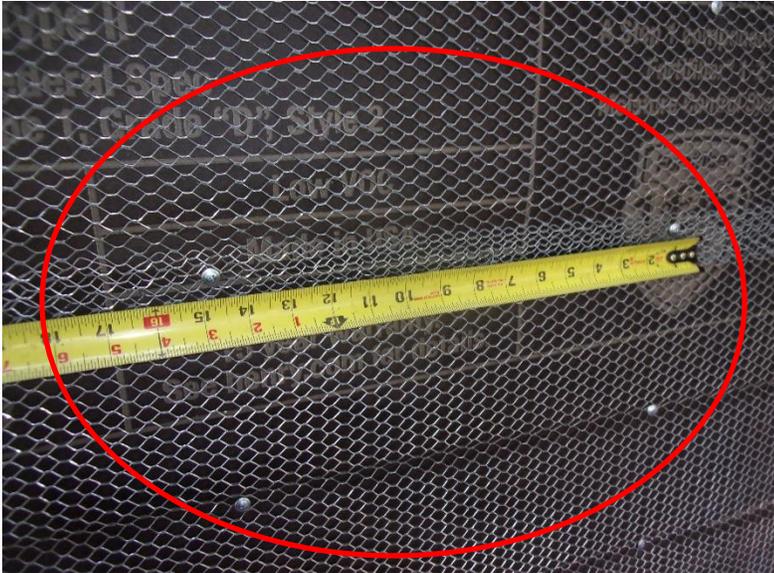
PHOTOGRAPH #3

**BUILDING 2
SECTION C**

Stucco lath attachment and accessories attachment inspected for fastener spacing and locations.

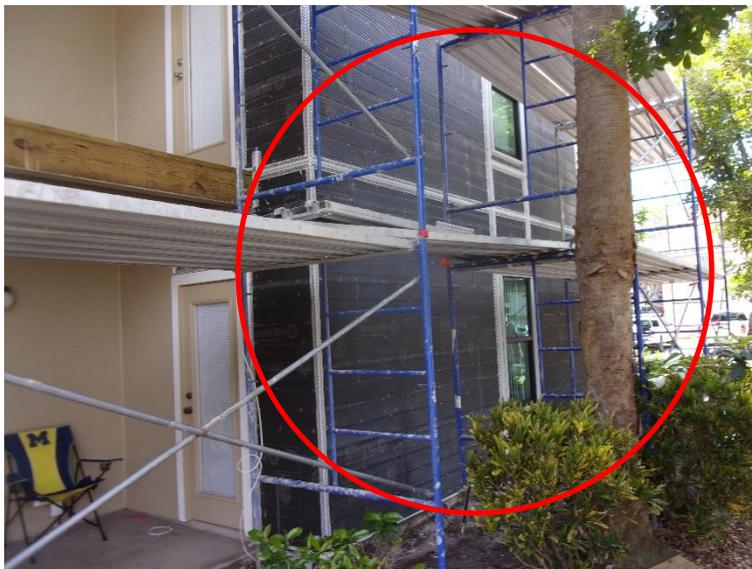
PHOTOGRAPH #4

**BUILDING 2
SECTION B**

Stucco sub-contractor in process of applying Vinyl stucco accessories and stucco lath.

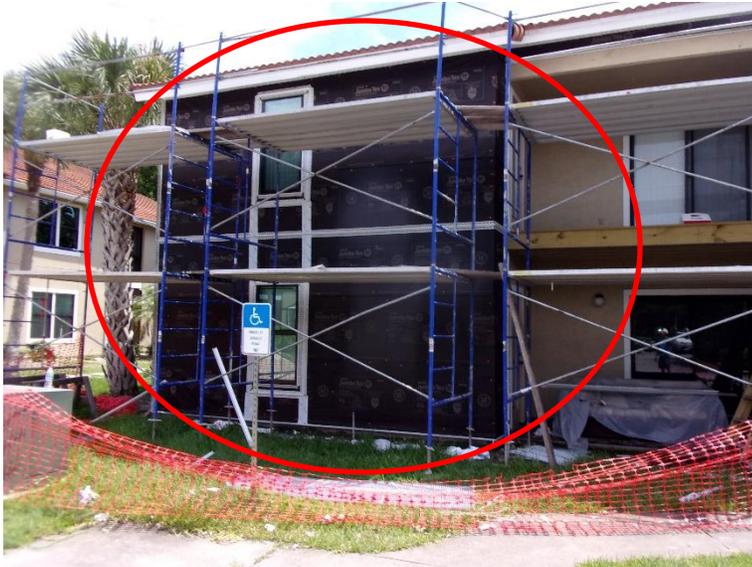
PHOTOGRAPH #5

**BUILDING 2
SECTION A**

Stucco sub-contractor has applied water resistant barrier and begun attaching stucco accessories.

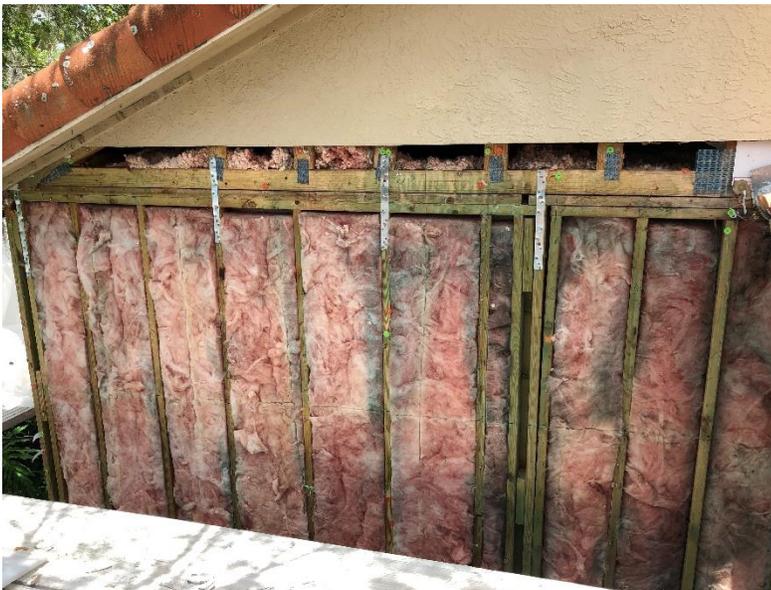
PHOTOGRAPH #6

**BUILDING 3
SECTION H**

BoraCare Termite treatment applied to all wall new and old wood framing members.

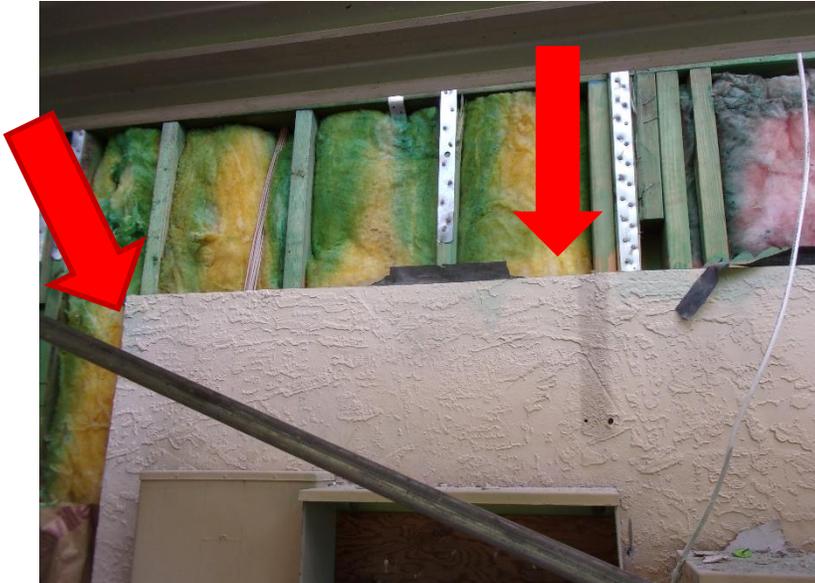
PHOTOGRAPH #7

**BUILDING 3
SECTION H**

Blocking and framing support is not complete for attachment of flashing and stucco stop accessory details.

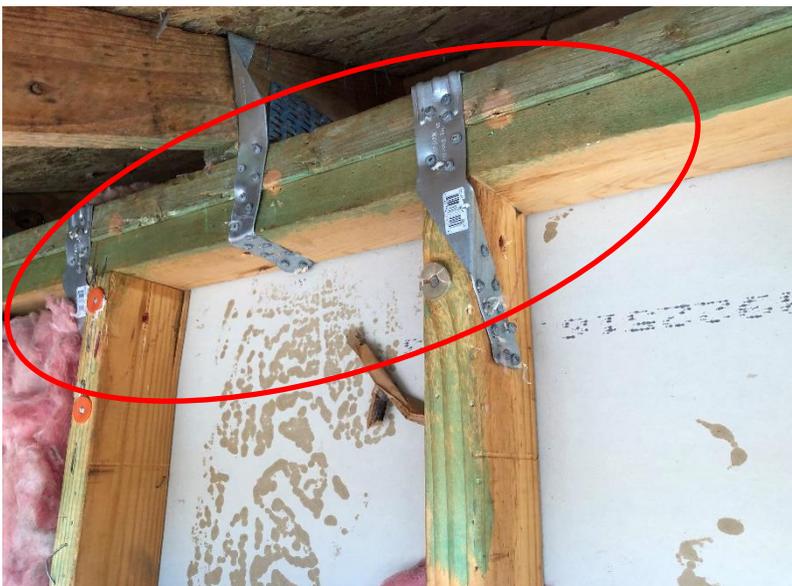
PHOTOGRAPH #8

**BUILDING 3
SECTION H**

Simpson Strong-Tie connectors and screws installed at studs to top plate and top plate to truss framing.

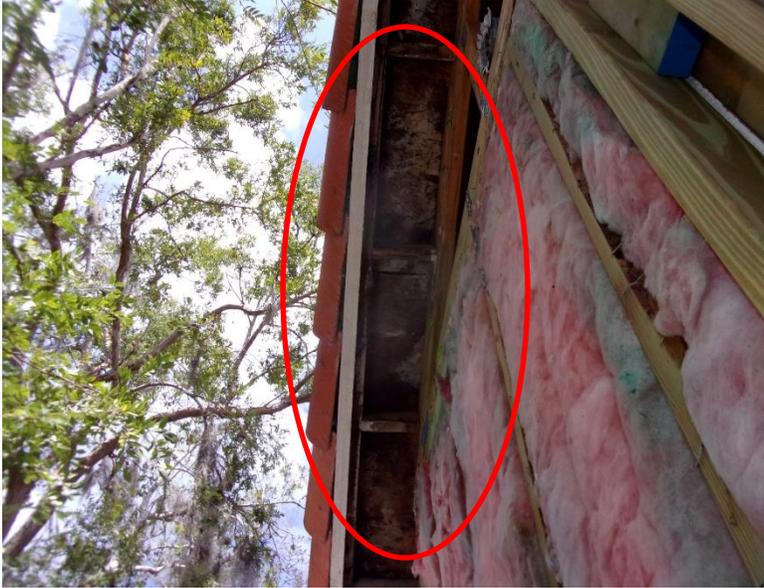
PHOTOGRAPH #9

**BUILDING 3
SECTION H**

Roofing sheathing damage and recent roofing leaks observed over soffit area. Owners to have roofing contractor perform repair.

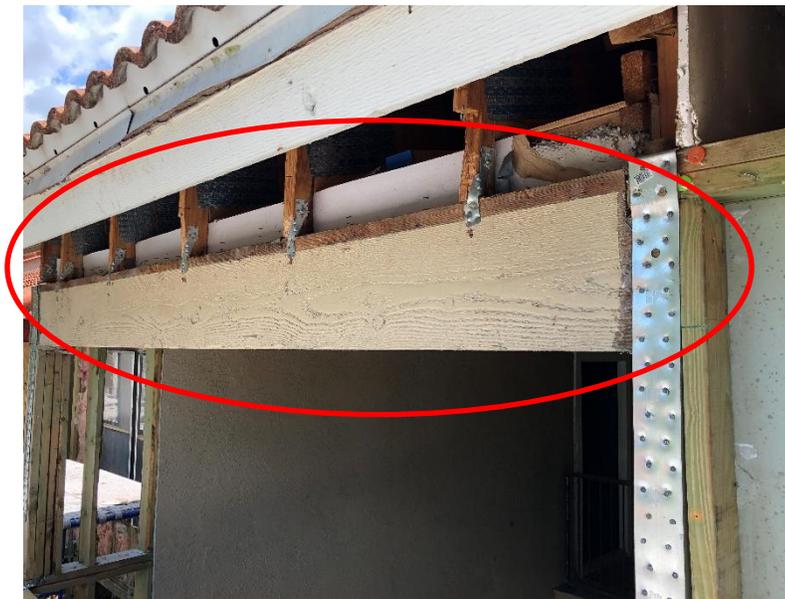
PHOTOGRAPH #10

**BUILDING 3
SECTION G**

Simpson Strong-Tie connectors and screws installed at header beam to trusses and king studs to top plate.

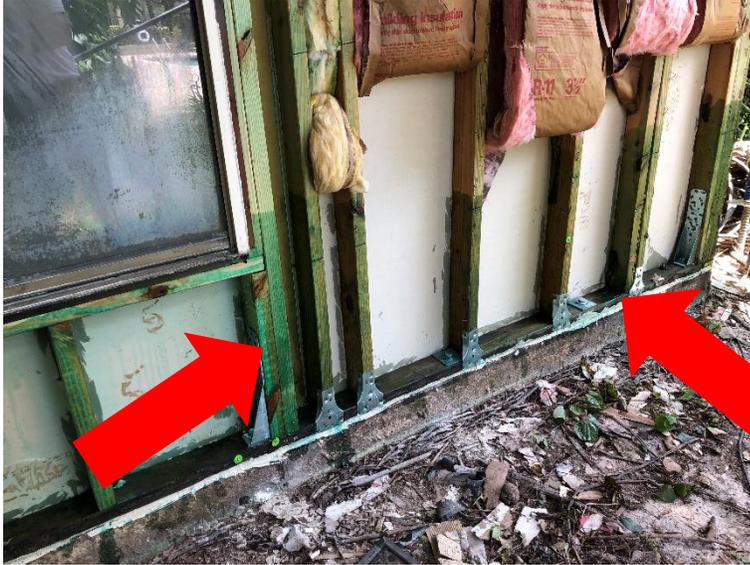
PHOTOGRAPH #11

**BUILDING 3
SECTION G**

Copper Green wood preservative applied at bottom 2' of new and old framing.

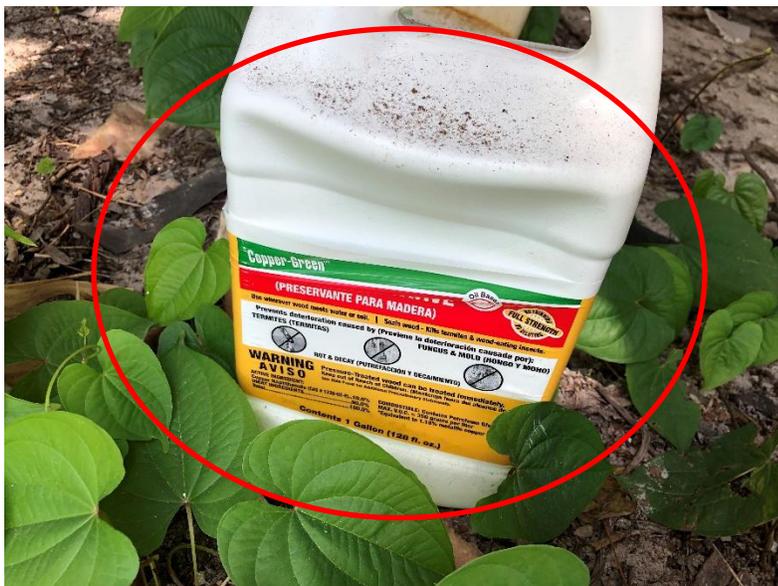
PHOTOGRAPH #12

**BUILDING 3
SECTION G**

Copper Green wood preservative applied at bottom 2' of new and old framing.

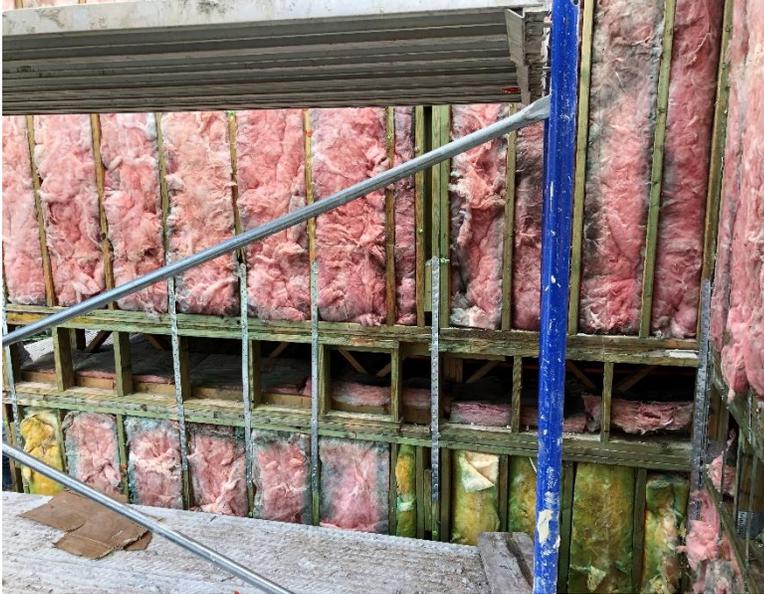
PHOTOGRAPH #13

**BUILDING 3
SECTION F**

BoraCare termite treatment applied and connector straps in place.

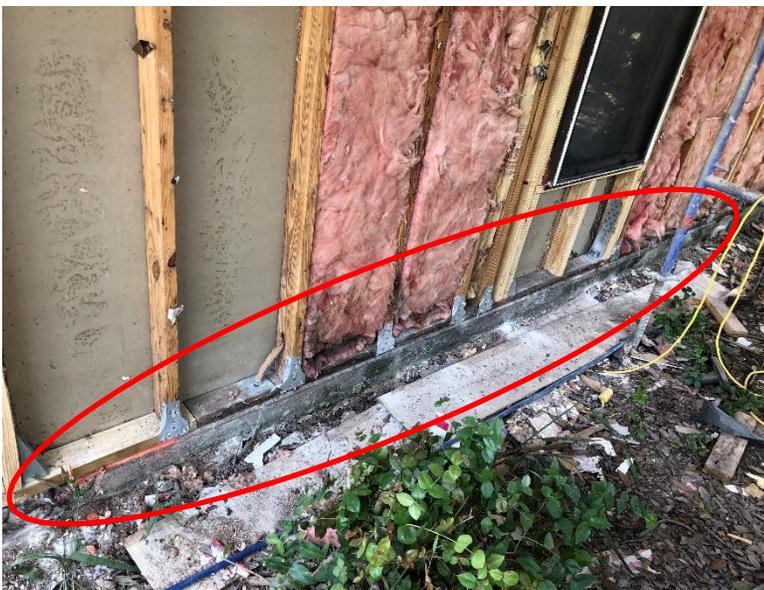
PHOTOGRAPH #14

**BUILDING 3
SECTION F**

Simson Strong-Tie connectors and Titen HD fasteners installed at studs to base plate and base plate to foundation slab.

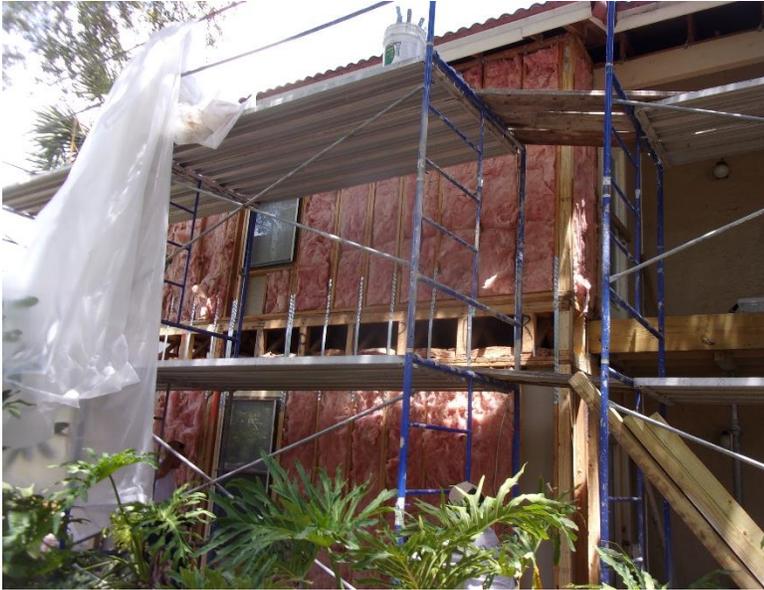
PHOTOGRAPH #15

**BUILDING 3
SECTION E**

Framing repairs performed and Simpson strong -Tie connectors installed.
