PHOTOGRAPHS

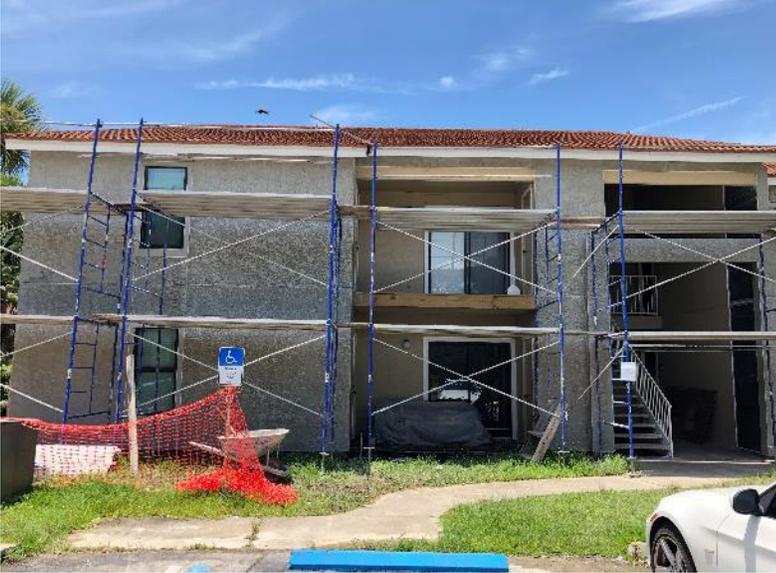
PHOTOGRAPH #1

BUILDING 2 SECTION A

Stucco sub-contractor applied stucco scratch coat, brown coat, and finish coat.

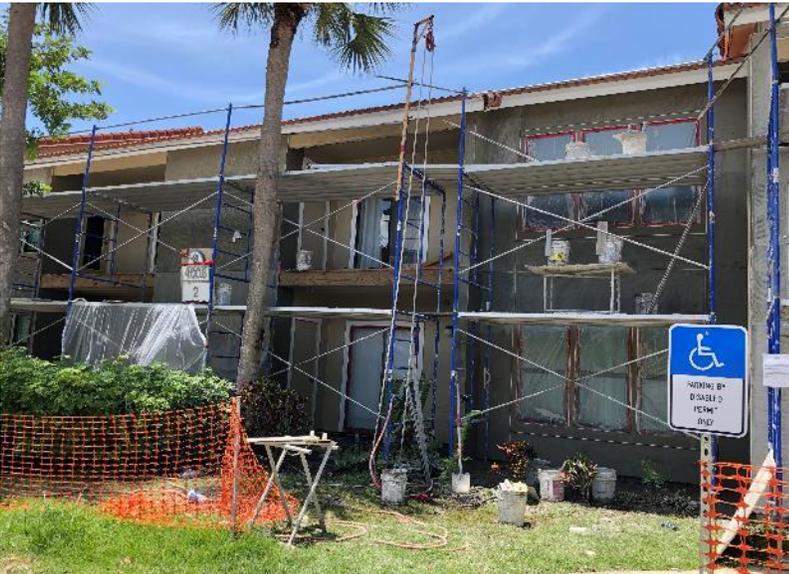
PHOTOGRAPH #2

BUILDING 2 SECTION B

Stucco sub-contractor applied stucco scratch coat and brown coat.

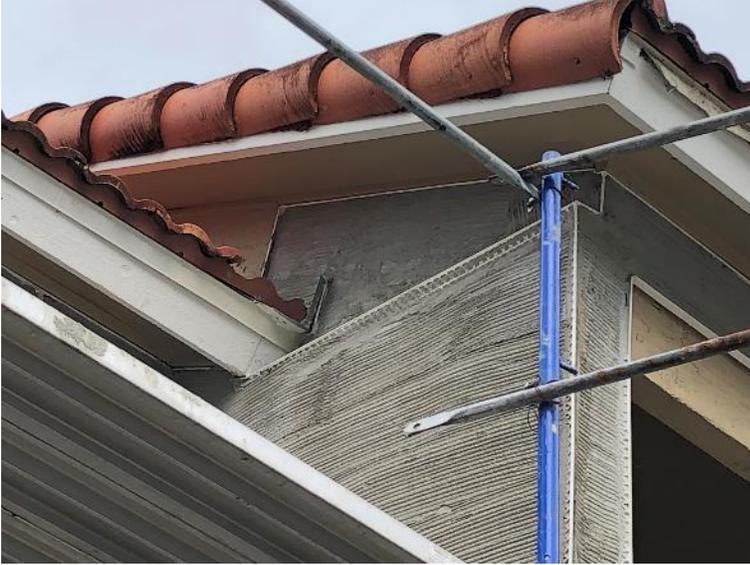
PHOTOGRAPH #3

**BUILDING 2
SECTION B**

Stucco sub-contractor applied stucco scratch coat at eave kick-out flashing.

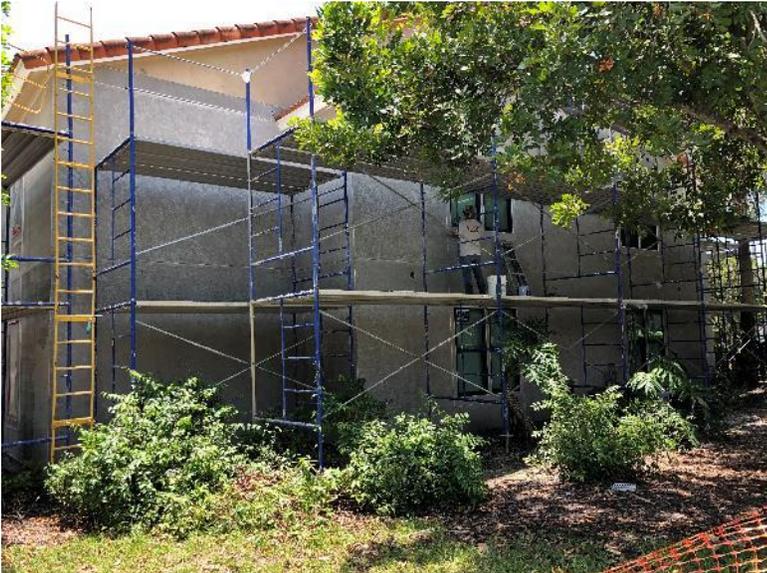
PHOTOGRAPH #4

**BUILDING 2
SECTION D**

Stucco sub-contractor applied stucco finish coat.

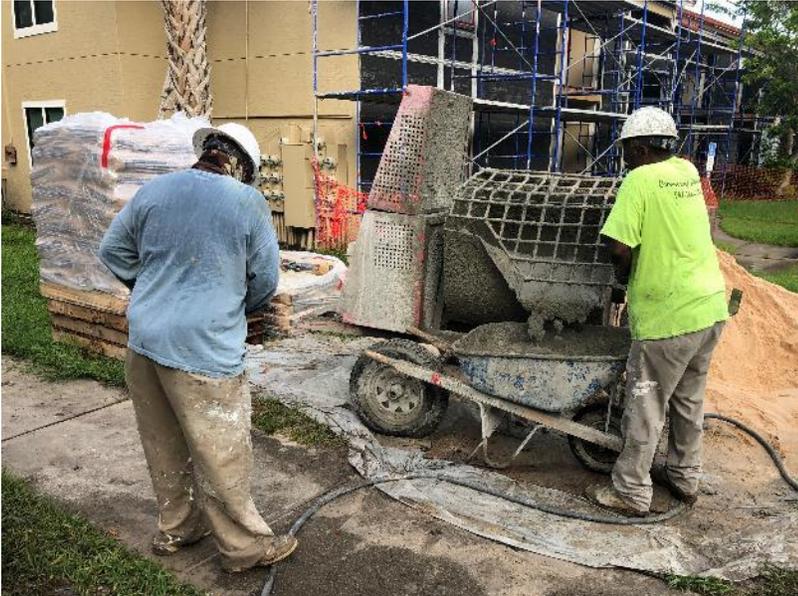
PHOTOGRAPH #5

**BUILDING 2
SECTION D**

Stucco sub-contractor mixes approved Cemex Broco Stucco Cement.

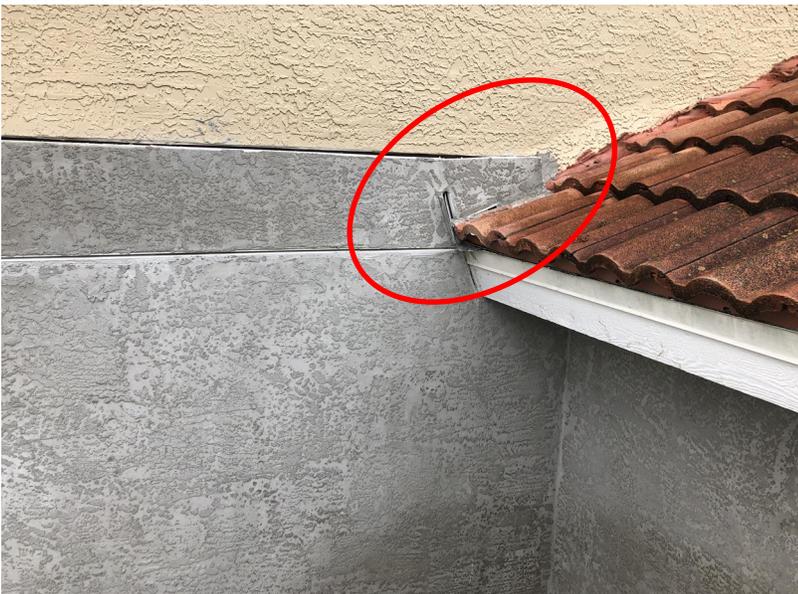
PHOTOGRAPH #6

**BUILDING 2
SECTION D**

Stucco sub-contractor applied stucco around kick-out flashing.

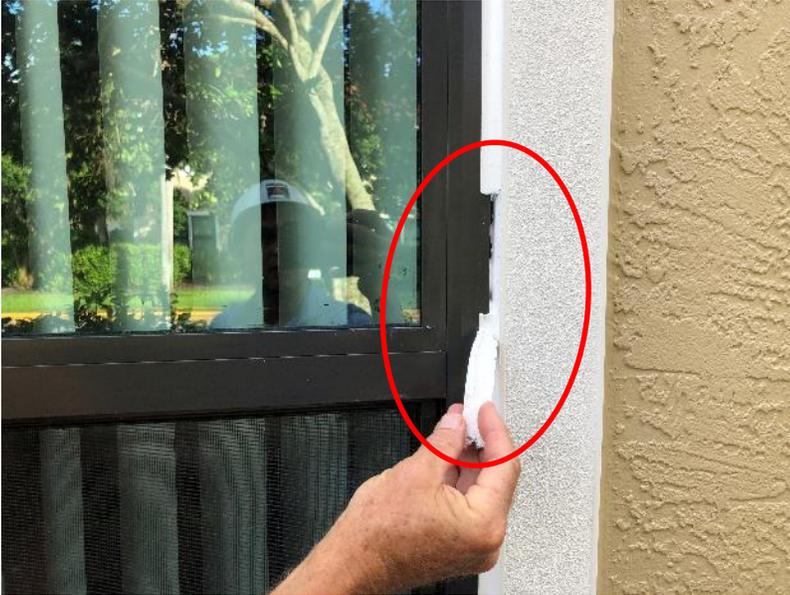
PHOTOGRAPH #7

**BUILDING 2
SECTION G**

A Standard Field Adhesion Test was performed to test weather sealed joint. The test passed, Contractor to reseal.

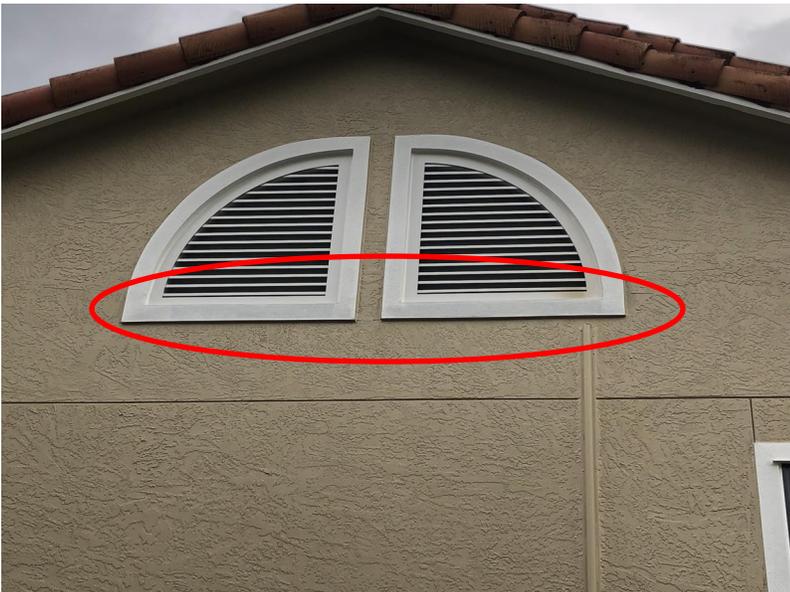
PHOTOGRAPH #8

**BUILDING 2
SECTION H**

Bottom of vent framing appears to only have one coat of paint. Contractor to apply second coat.

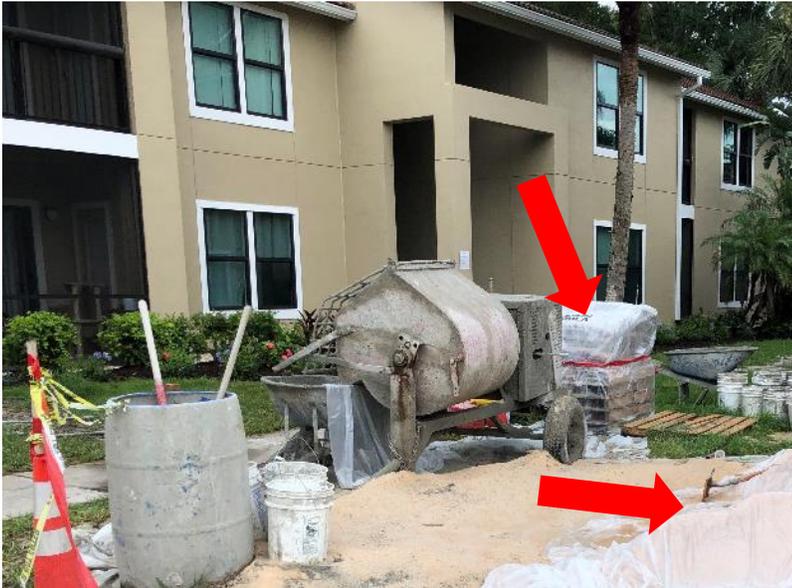
PHOTOGRAPH #9

**BUILDING 2
GENERAL OVERVIEW**

Contractor covered materials with heavy duty plastic to protect from storm Elsa.

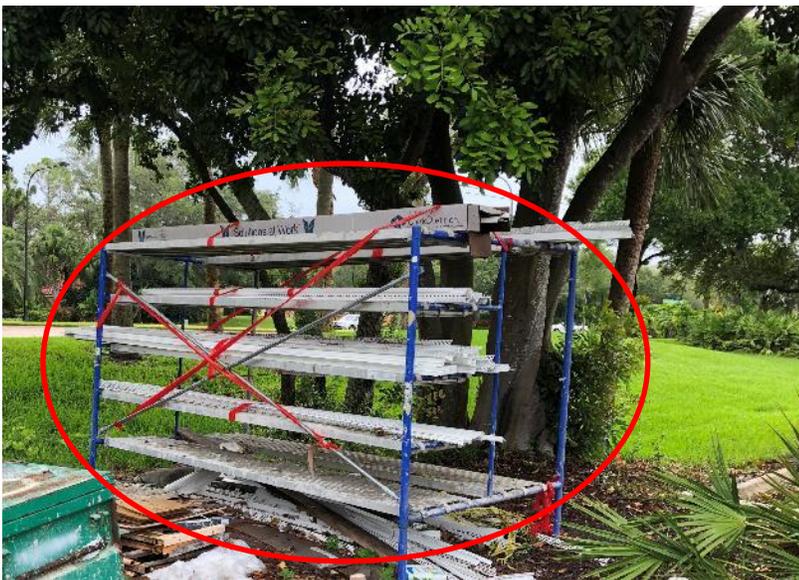
PHOTOGRAPH #10

**BUILDING 2
GENERAL OVERVIEW**

Contractor tied down loose materials to prepare for storm Elsa.

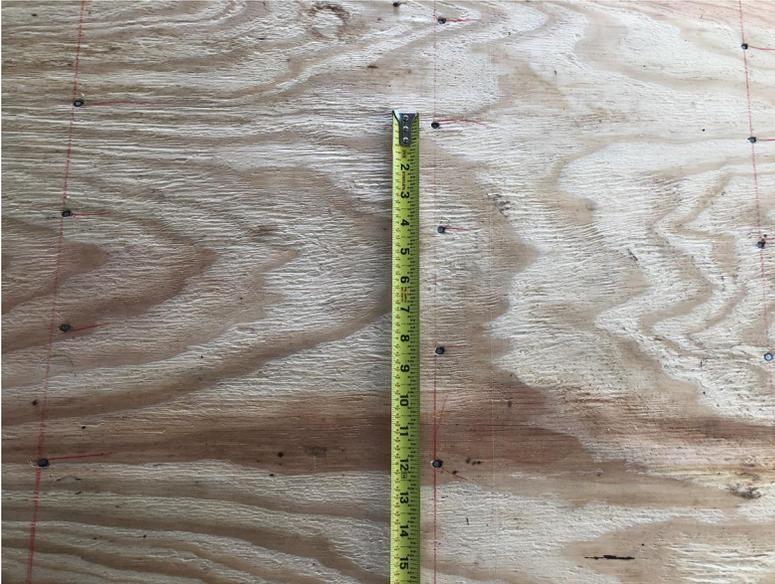
PHOTOGRAPH #11

**BUILDING 3
SECTION G**

Contractor finished plywood sheathing installation. 8d nails spaced 4" OC along end studs and 6" OC along interior studs.

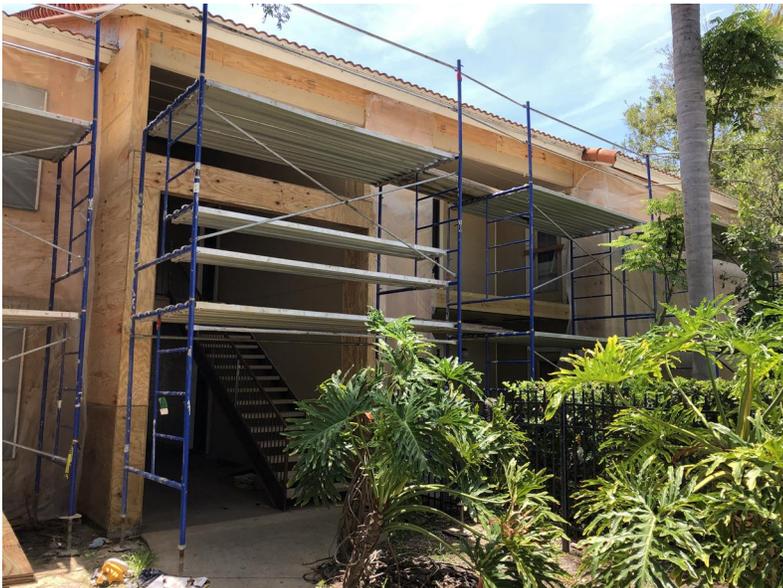
PHOTOGRAPH #12

**BUILDING 3
SECTION G**

Contractor finished plywood sheathing installation at Section G.

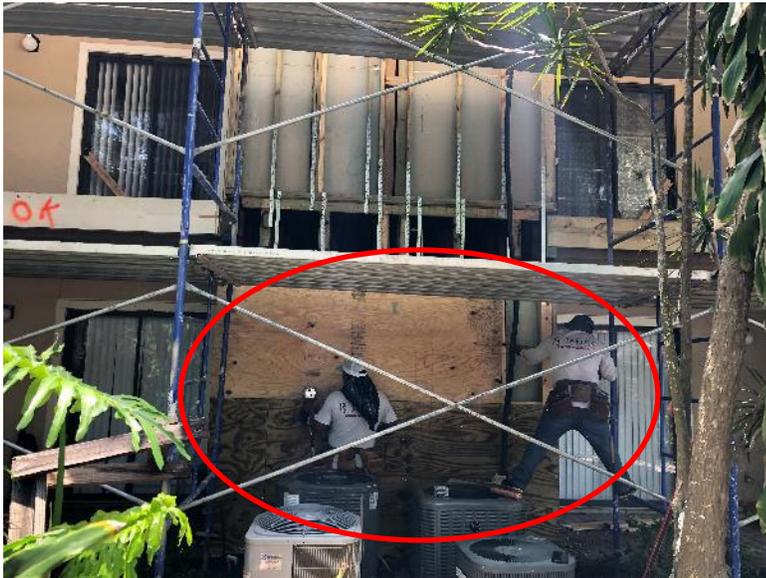
PHOTOGRAPH #13

**BUILDING 3
SECTION F**

Contractor started plywood sheathing installation.

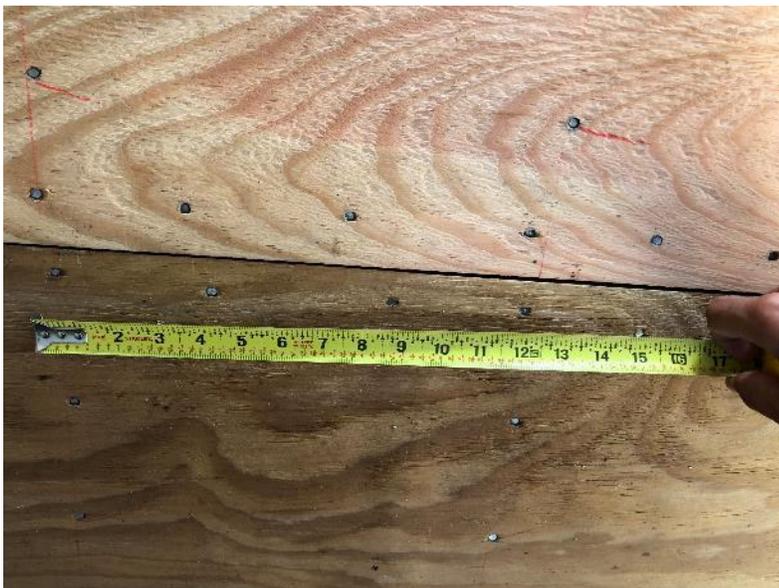
PHOTOGRAPH #14

**BUILDING 3
SECTION F**

Contractor started plywood sheathing installation. 8d nails spaced 4" OC along end studs and 6" OC along interior studs.

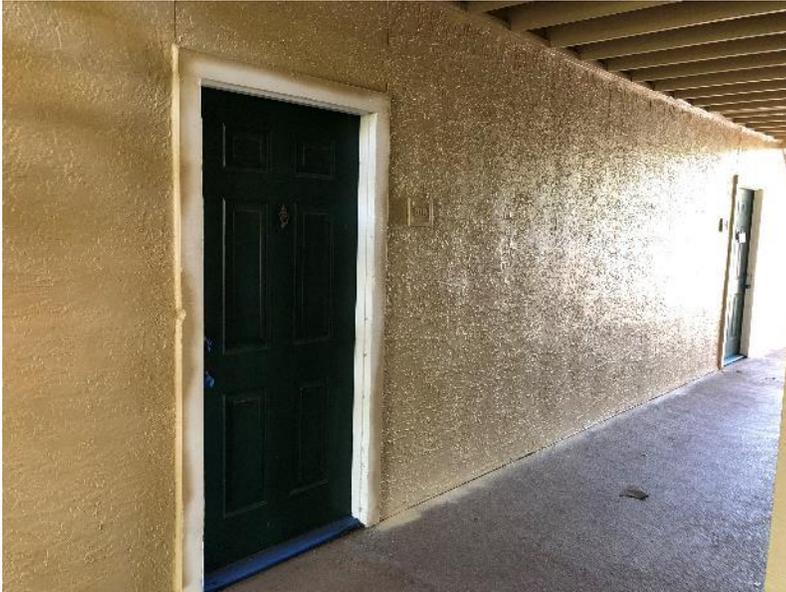
PHOTOGRAPH #15

**BUILDING 3
SECTION E**

Contractor painted Breezeway at elevation Section E using specified Florida Paint.

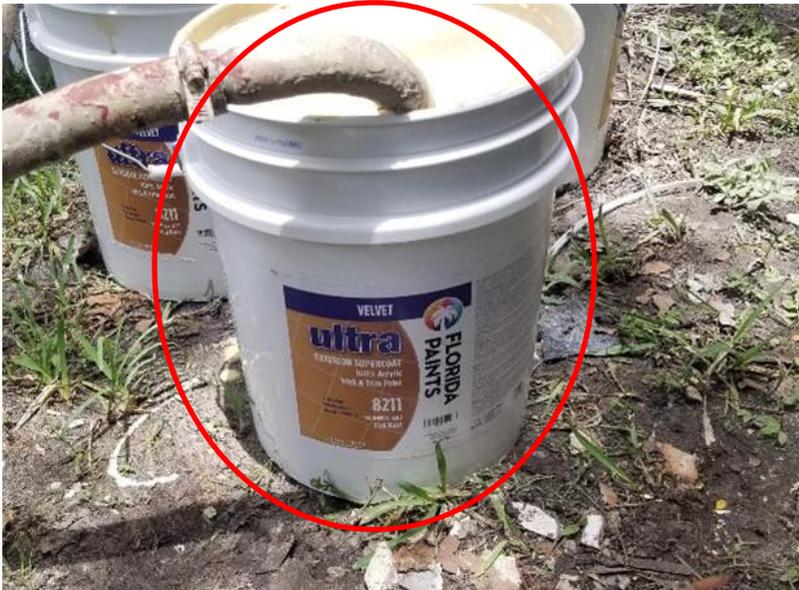
PHOTOGRAPH #16

**BUILDING 3
SECTION E**

Contractor painted Breezeway at elevation Section E using specified Florida Paint.

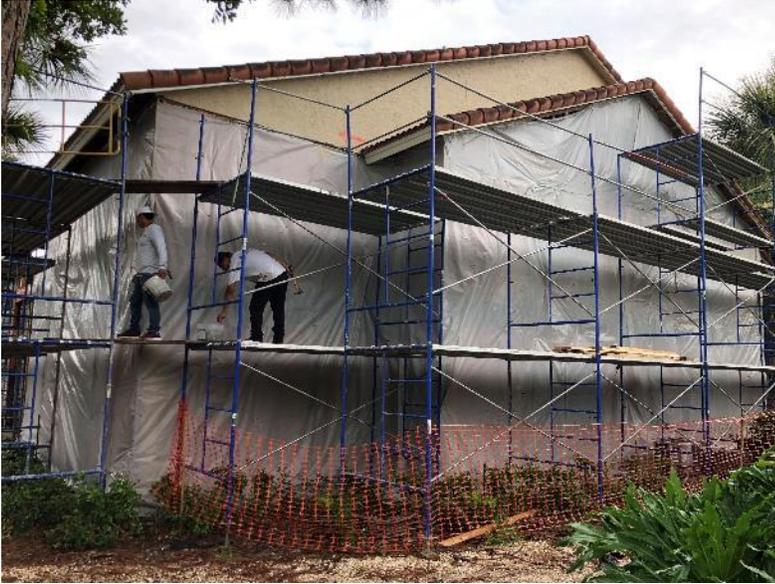
PHOTOGRAPH #17

**BUILDING 3
GENERAL OVERVIEW**

Contractor covered all building sections (in-progress) with heavy duty plastic to protect from storm Elsa.

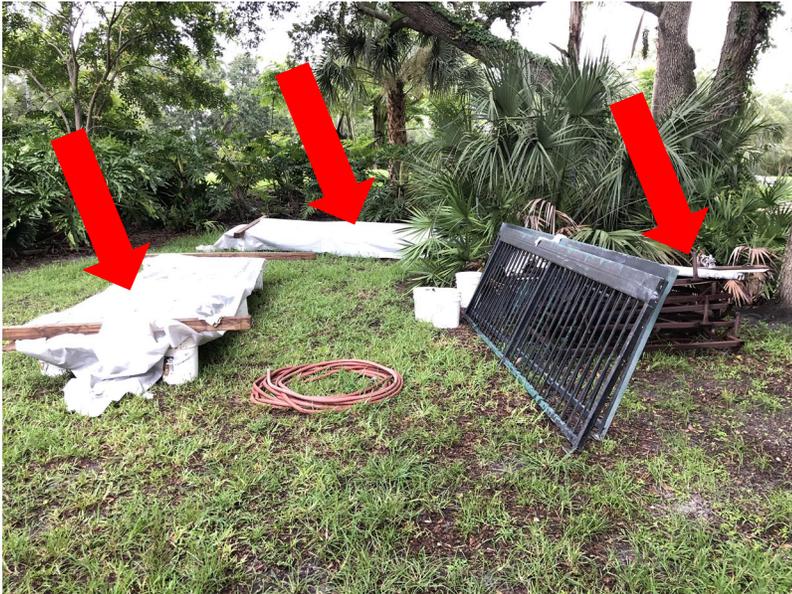
PHOTOGRAPH #18

**BUILDING 3
GENERAL OVERVIEW**

Contractor tied down loose materials to prepare for storm Elsa.
