**PHOTOGRAPHS**

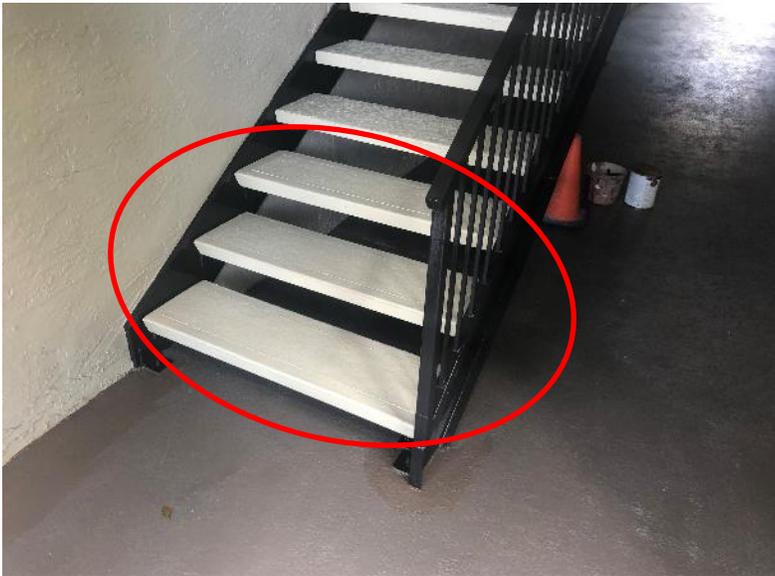
**PHOTOGRAPH #1**

**BUILDING 1  
SECTION E**

Contractor received and installed precast steps.

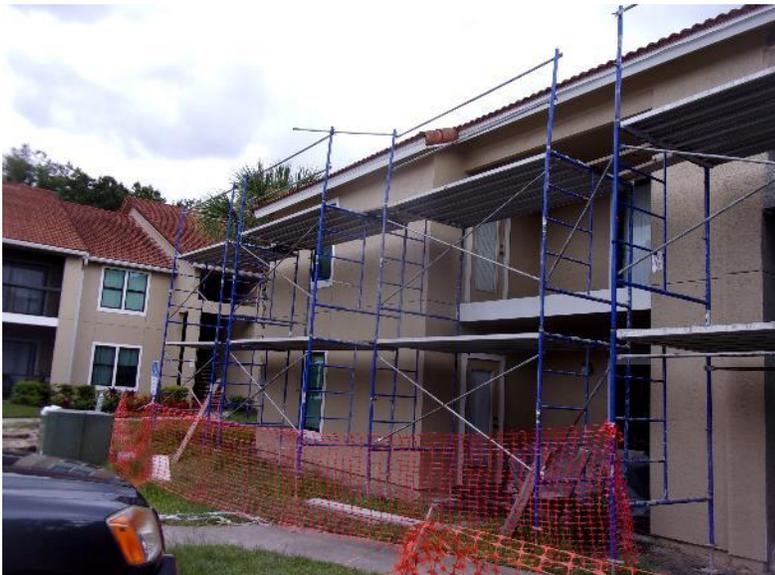
**PHOTOGRAPH #2**

**BUILDING 2  
SECTION A**

New stucco PH levels confirmed as acceptable for coating by Florida Paint report. Contractor has applied Ultra Super coat by Florida Paints.

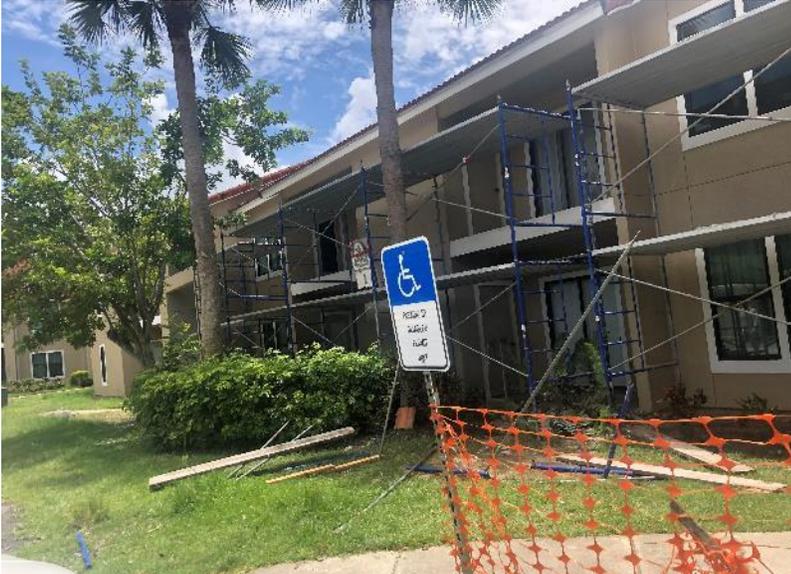
**PHOTOGRAPH #3**

**BUILDING 2  
SECTION B & C**

New stucco PH levels confirmed as acceptable for coating by Florida Paint report. Contractor has applied Ultra Super coat by Florida Paints.

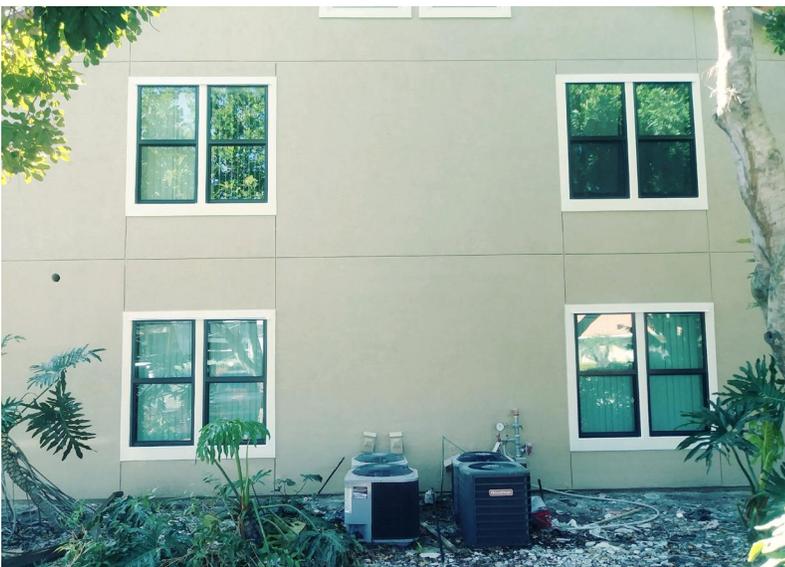
**PHOTOGRAPH #4**

**BUILDING 2  
SECTION D**

New stucco PH levels confirmed as acceptable for coating by Florida Paint report. Contractor has applied Ultra Super coat by Florida Paints.

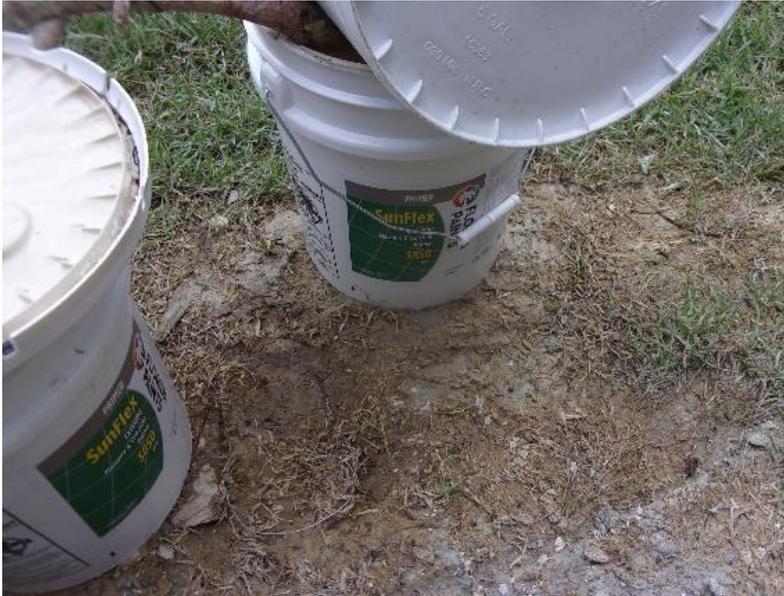
**PHOTOGRAPH #5**

**BUILDING 2  
GENERAL**

Contractor applied Ultra Super coat by Florida Paints.

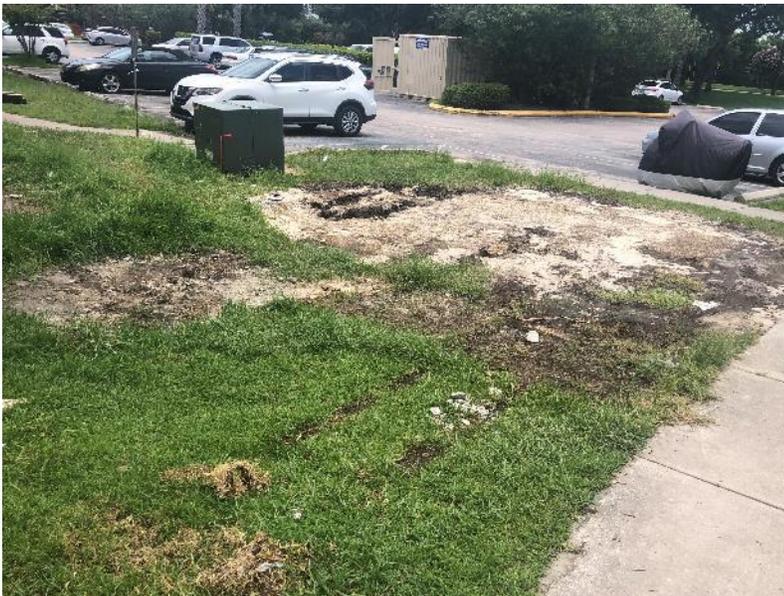
**PHOTOGRAPH #6**

**BUILDING 2  
GENERAL**

Stucco sub-contractor removed materials and mixing equipment from site.

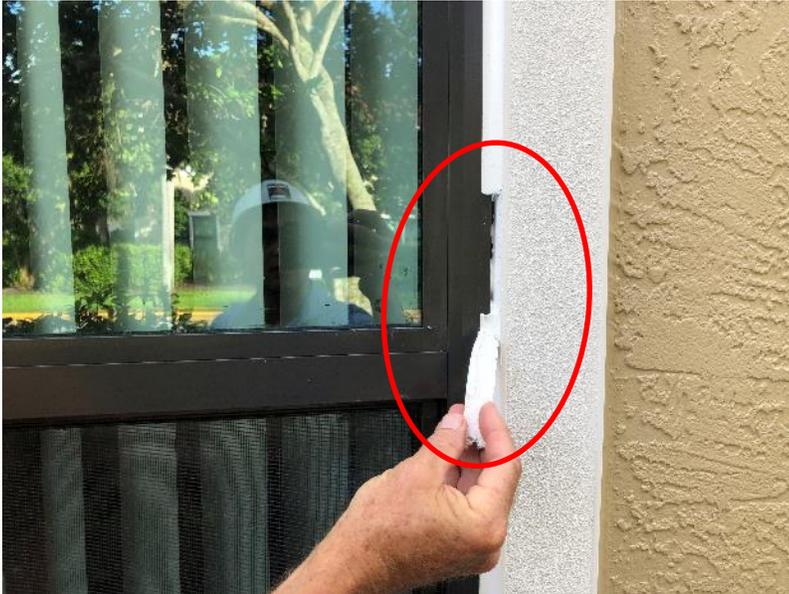
**PHOTOGRAPH #7**

**BUILDING 2  
SECTION G**

A Standard Field Adhesion Test was performed to test weather sealed joint. The test passed, Contractor to reseal.

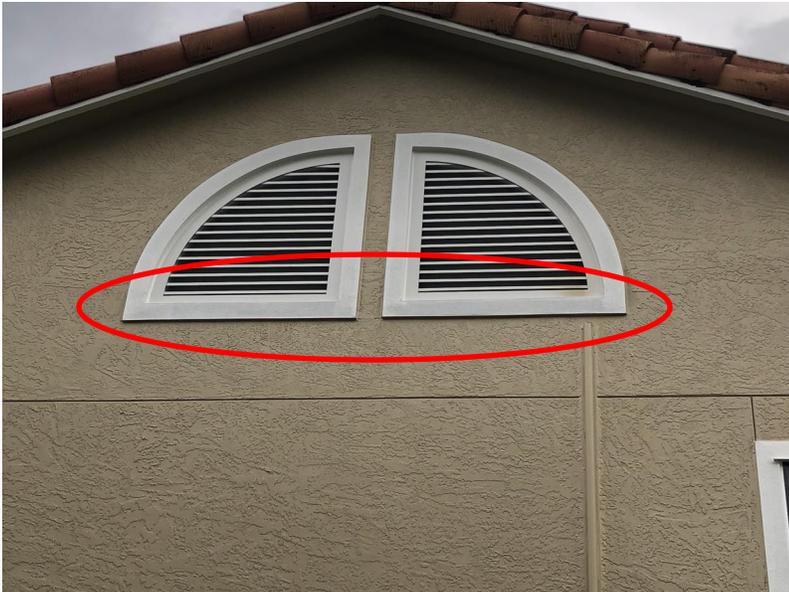
**PHOTOGRAPH #8**

**BUILDING 2  
SECTION H**

Bottom of vent framing appears to only have one coat of paint. Contractor to apply second coat.

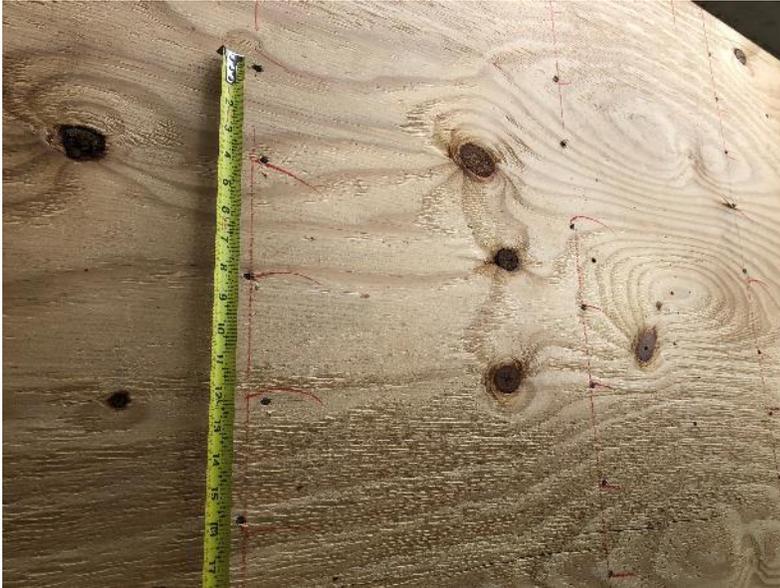
**PHOTOGRAPH #9**

**BUILDING 3  
SECTION H**

Contractor finished plywood sheathing installation. 8d nails spaced 4" OC along end studs and 6" OC along interior studs.

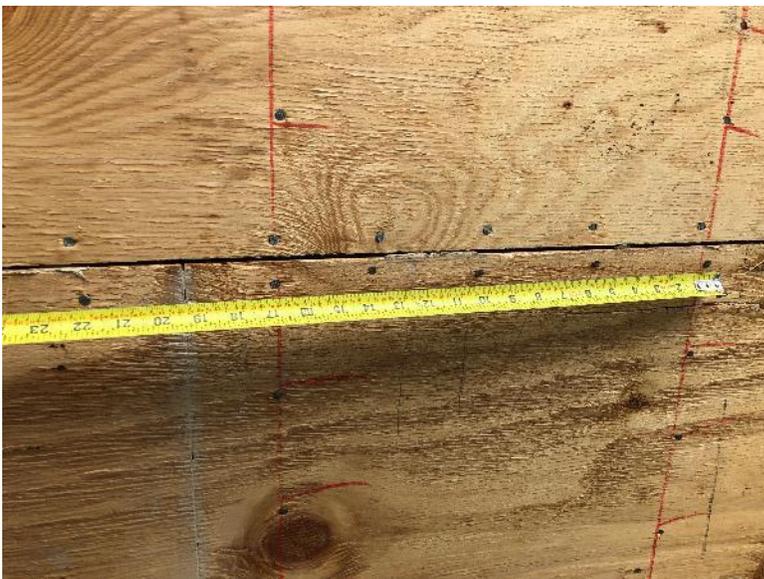
**PHOTOGRAPH #10**

**BUILDING 2  
SECTION G**

Contractor finished plywood sheathing installation. 8d nails spaced 4" OC along end studs and 6" OC along interior studs.

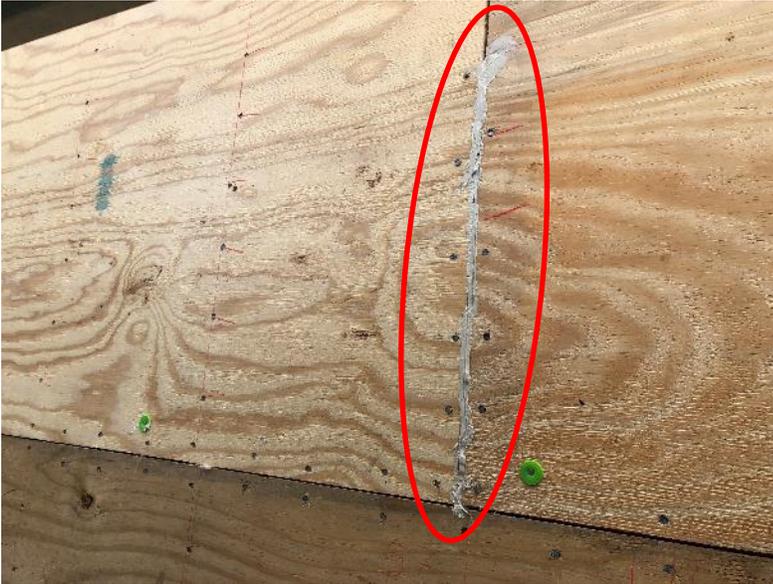
**PHOTOGRAPH #11**

**BUILDING 3  
SECTION G**

Contractor caulked gaps between plywood sheathing larger than 1/4".

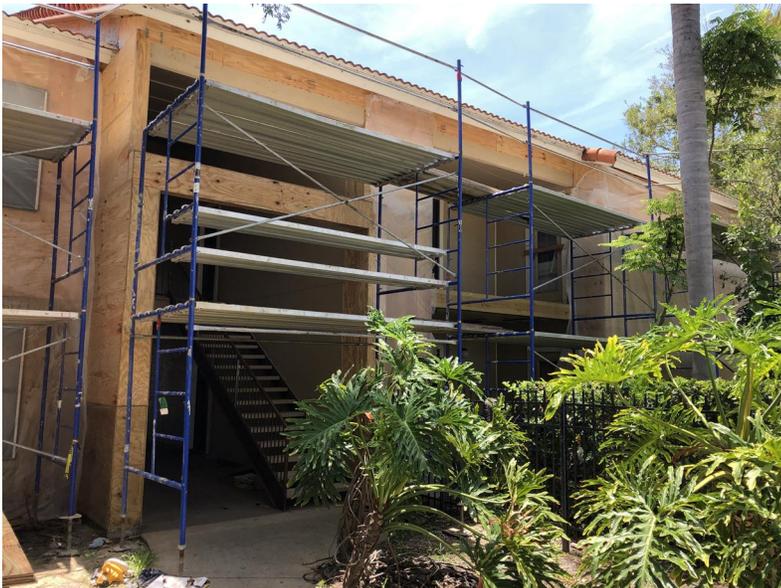
**PHOTOGRAPH #12**

**BUILDING 3  
SECTION F**

Contractor finished plywood sheathing installation at Section F.

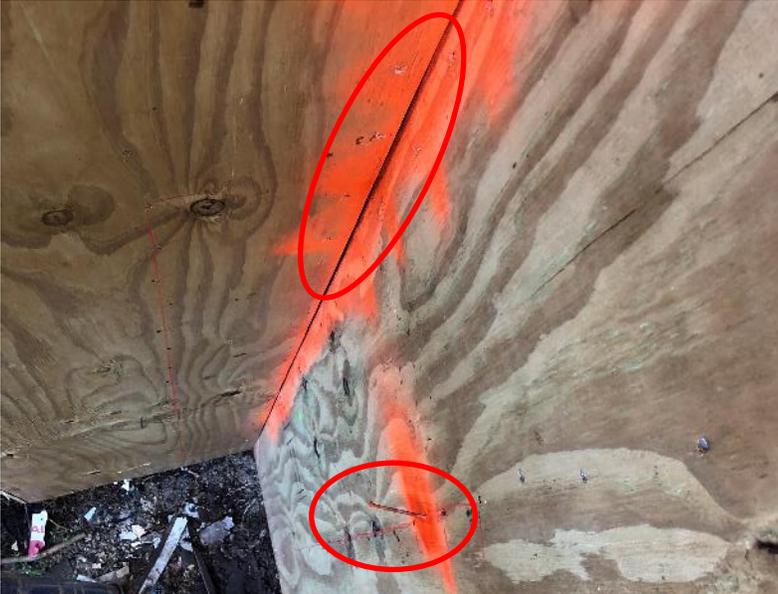
**PHOTOGRAPH #13**

**BUILDING 3  
SECTION F**

Gaps greater than 1/4" were found between plywood sheathing and partially driven nails.

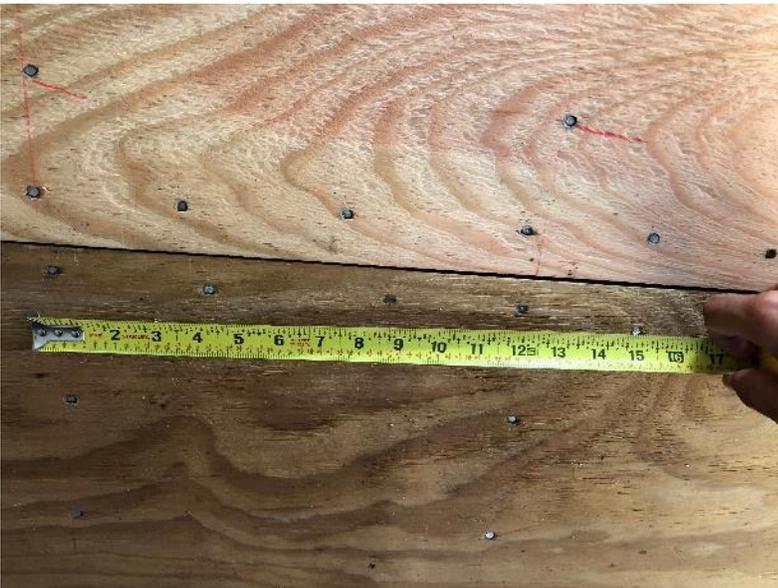
**PHOTOGRAPH #14**

**BUILDING 3  
SECTION F**

Contractor started plywood sheathing installation. 8d nails spaced 4" OC along end studs and 6" OC along interior studs.

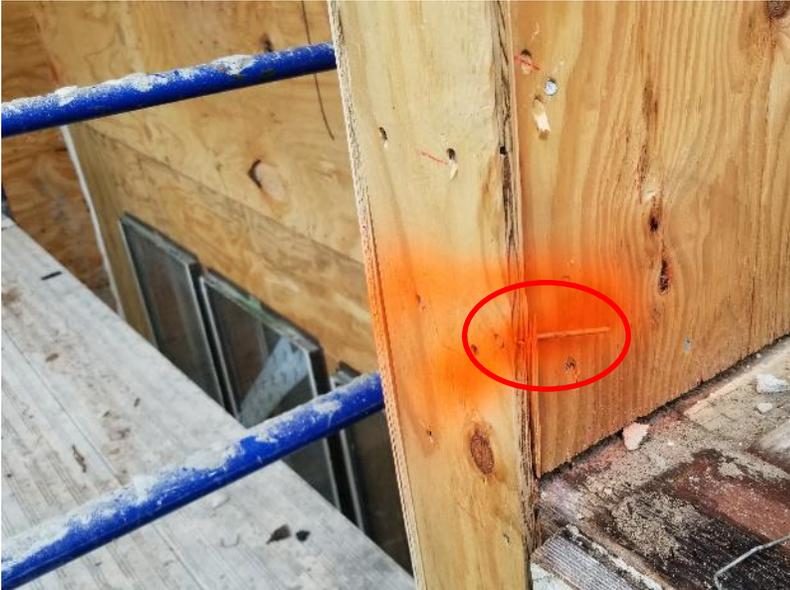
**PHOTOGRAPH #15**

**BUILDING 3  
SECTION E**

A nail was driven crooked through sheathing. Contractor to remove and replace crooked nail.

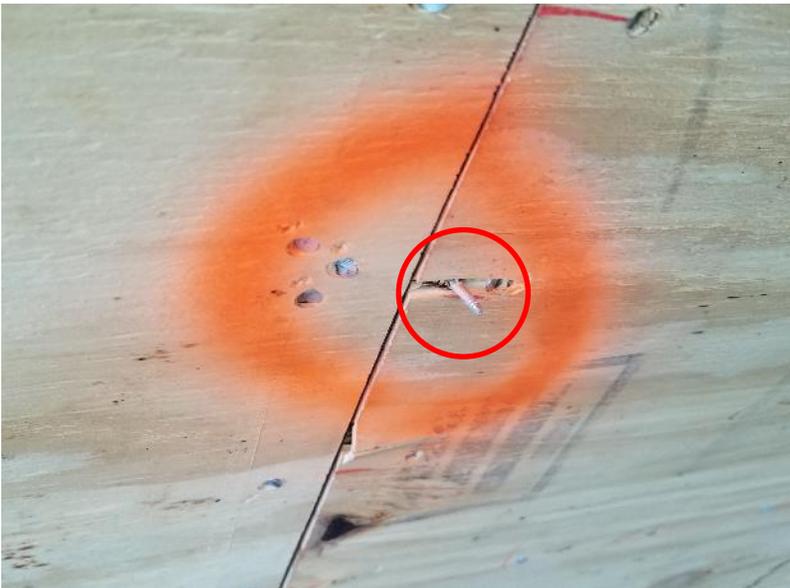
**PHOTOGRAPH #16**

**BUILDING 3  
SECTION E**

Screw was found protruding through surface of sheathing.

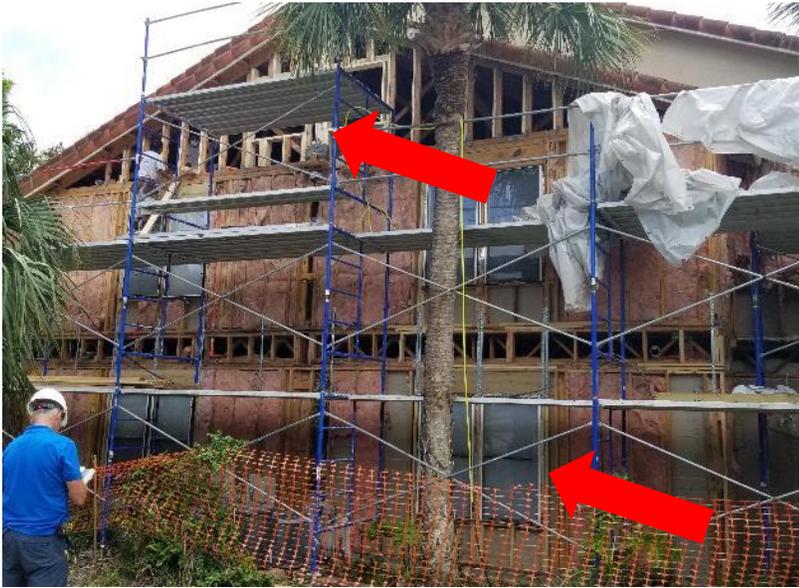
**PHOTOGRAPH #17**

**BUILDING 3  
SECTION D**

Contractor started performing framing repairs of studs, headers, and gable truss bracing.

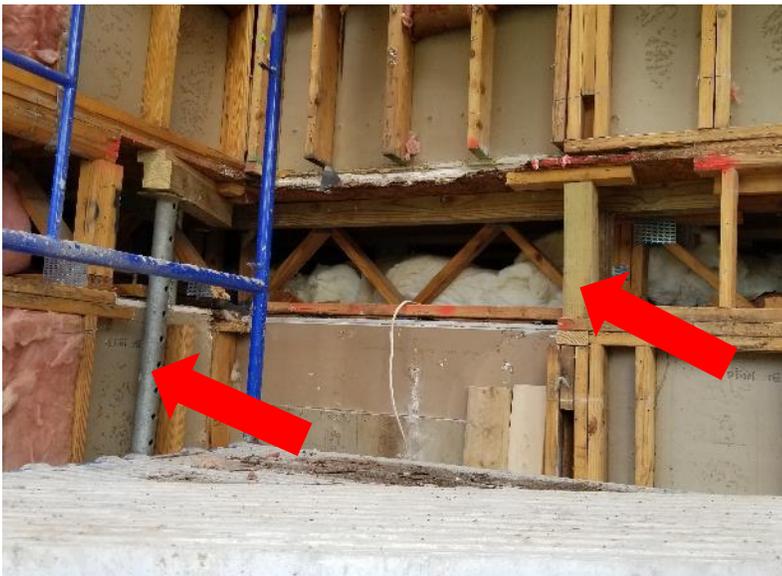
**PHOTOGRAPH #18**

**BUILDING 3  
GENERAL OVERVIEW**

Contractor installed temporary shoring due to extent of deteriorated framing and floor joist. Delta to visit site and provide engineering assistance.
