PHOTOGRAPHS

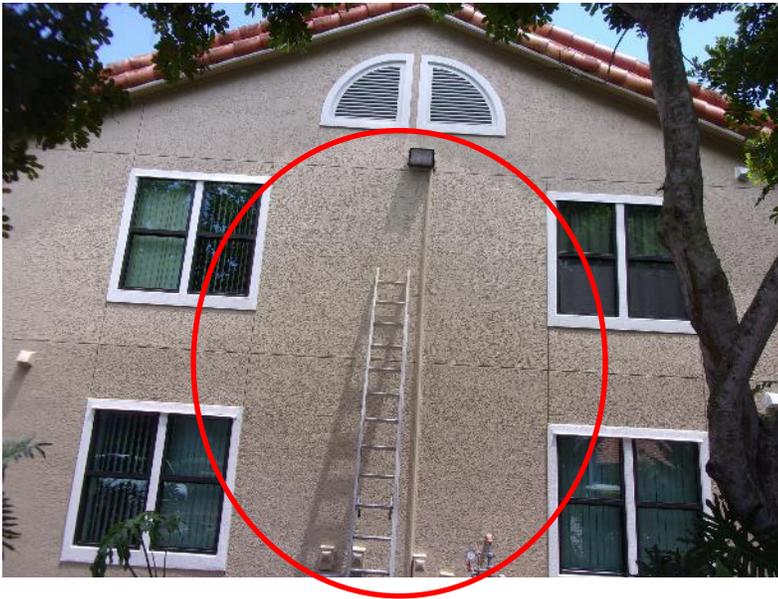
PHOTOGRAPH #1

**BUILDING 2
SECTION H**

Contractor has attached and painted electrical wiring cover and re attached A/C electrical boxes.

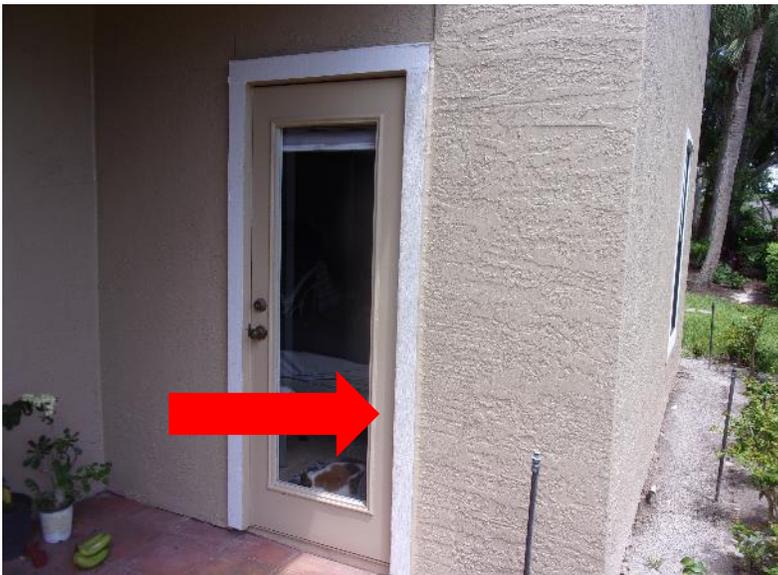
PHOTOGRAPH #2

**BUILDING 2
SECTION G**

Contractor has replaced rotted cedar door framing at patio.

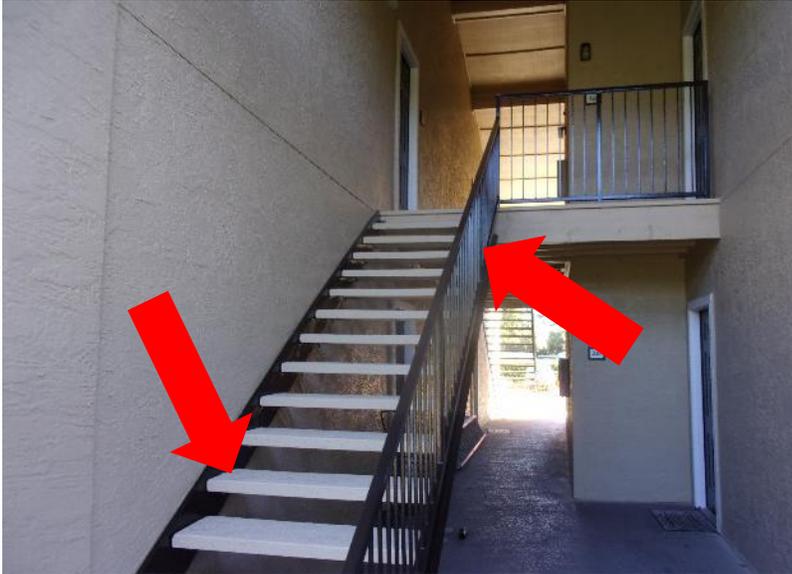
PHOTOGRAPH #3

**BUILDING 2
SECTION G**

Stair way railings and steps finish painted with Florida Paints coatings.

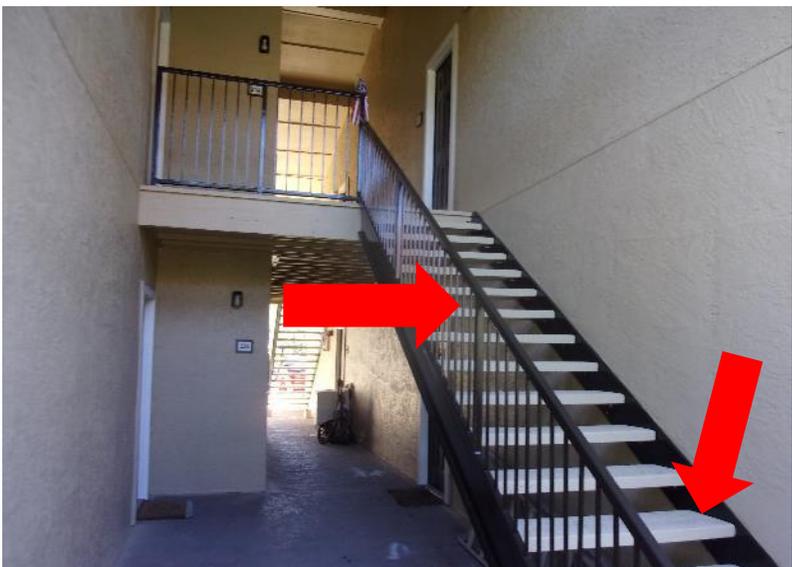
PHOTOGRAPH #4

**BUILDING 2
SECTION E**

Stair way railings and steps finish painted with Florida Paints coatings.

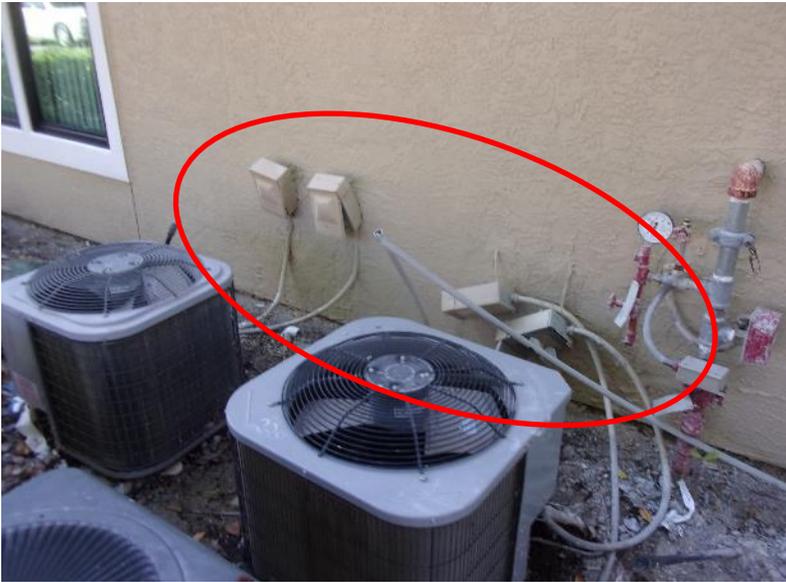
PHOTOGRAPH #5

**BUILDING 2
SECTION D**

A/C electrical boxes have not been re attached or sealed to the new stucco.

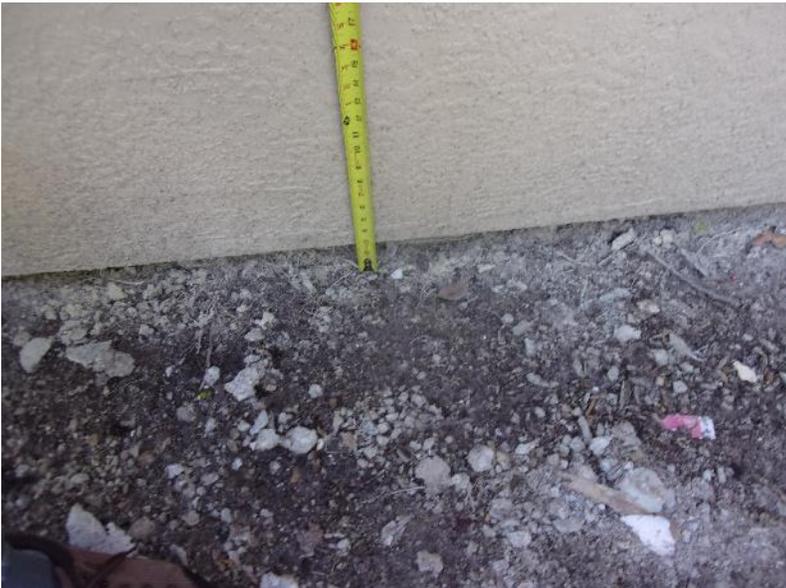
PHOTOGRAPH #6

**BUILDING 2
SECTION D**

Six-inch distance from stucco to grade per drawings has not been meet and is the responsibility of owners to be performed by others.

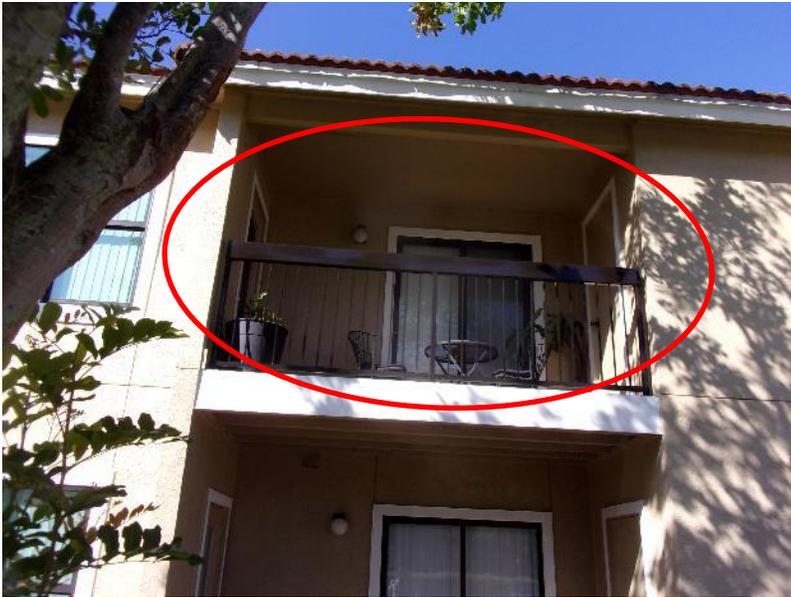
PHOTOGRAPH #7

**BUILDING 2
SECTION B**

Balcony railings have been reinstalled by anchoring to the built-up beam at railing stanchions.

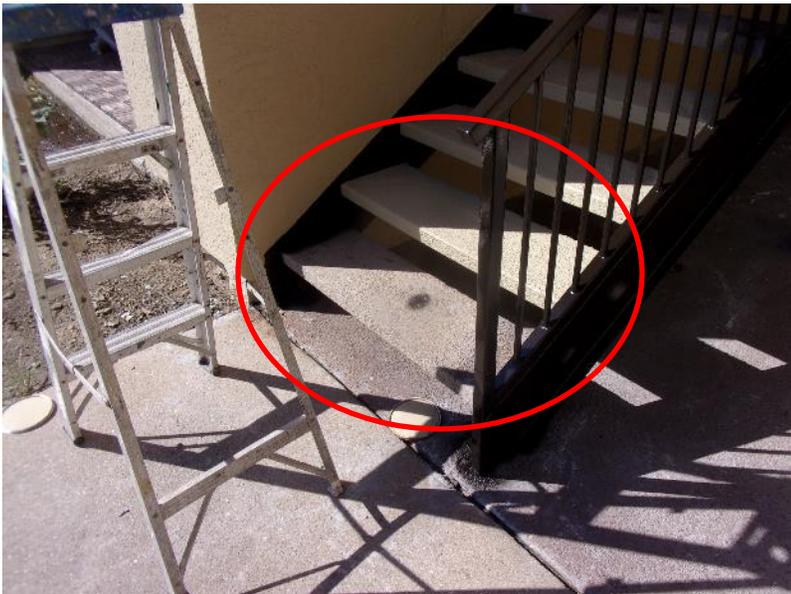
PHOTOGRAPH #8

**BUILDING 2
SECTION A**

Bottom two steps require removal, angle reinforcement welding at stringers and re installation. Contractor performing as change order repairs.

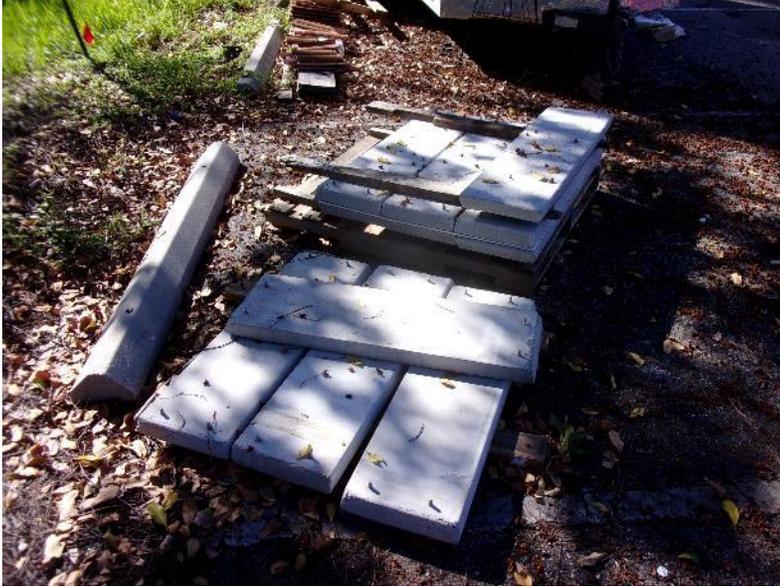
PHOTOGRAPH #9

**BUILDING 2
SECTION A**

New precast concrete steps delivered for change order repairs at stairways.

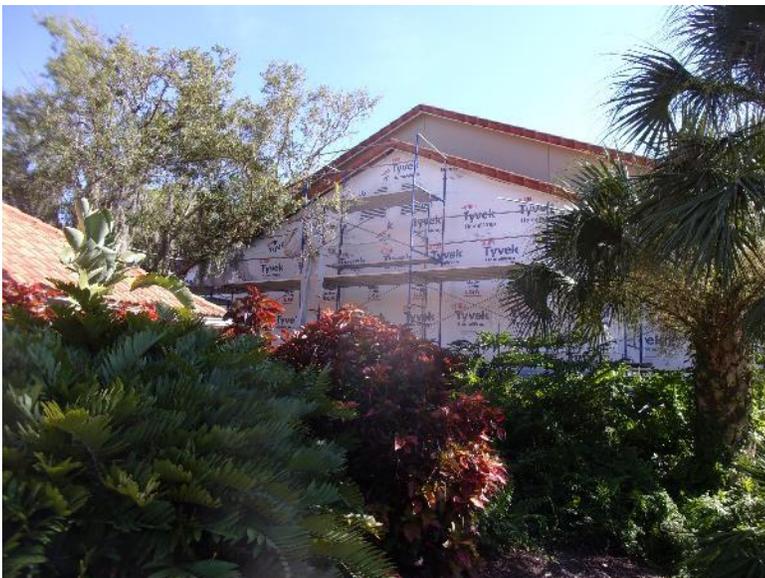
PHOTOGRAPH #10

**BUILDING 3
SECTION H**

Contractor has applied Tyvek HomeWrap over new plywood sheathing, covering window openings until windows are delivered.

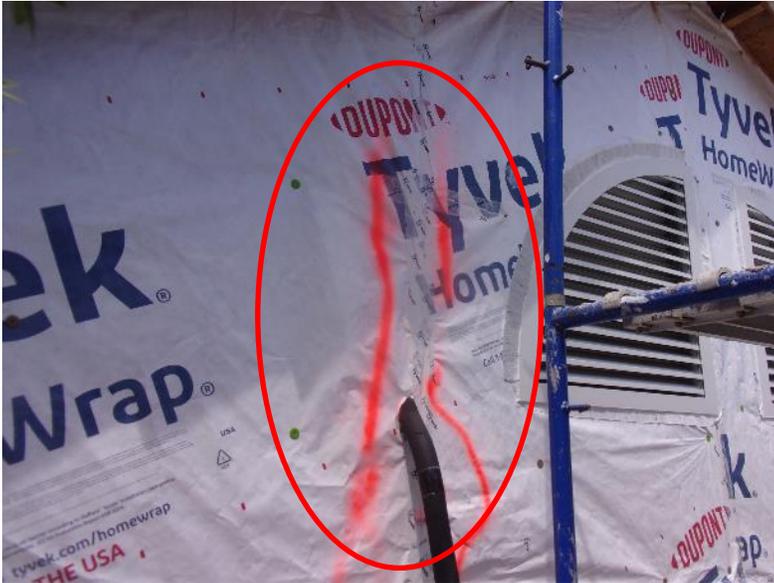
PHOTOGRAPH #11

**BUILDING 3
SECTION H**

Locations marked for corrections where seam tape improperly used at penetrations.

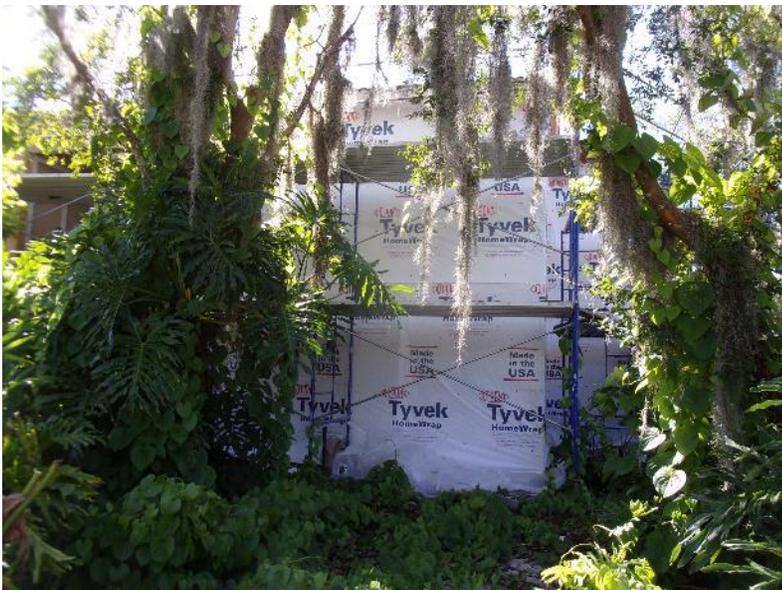
PHOTOGRAPH #12

**BUILDING 3
SECTION G**

Contractor has applied Tyvek HomeWrap over new plywood sheathing, covering window openings until windows are delivered.

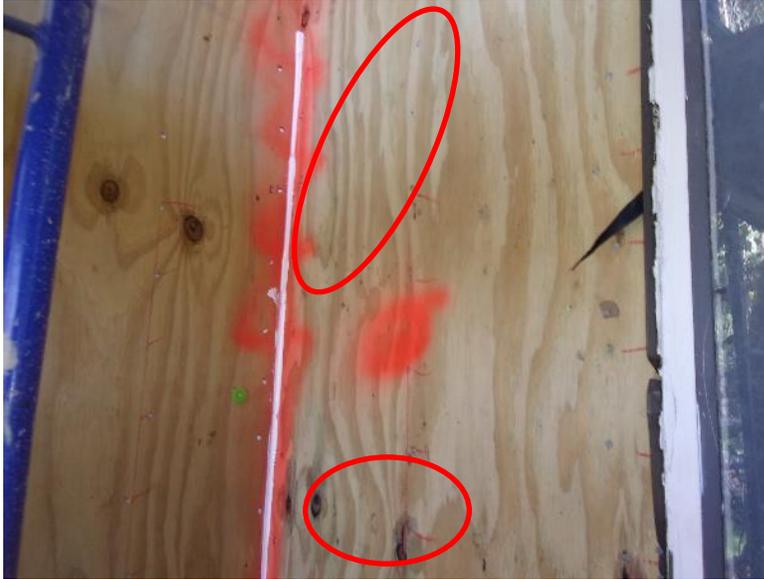
PHOTOGRAPH #13

**BUILDING 3
SECTION F**

Corrections made at gaps greater than 1/4" with sealant and partially driven nails re set.

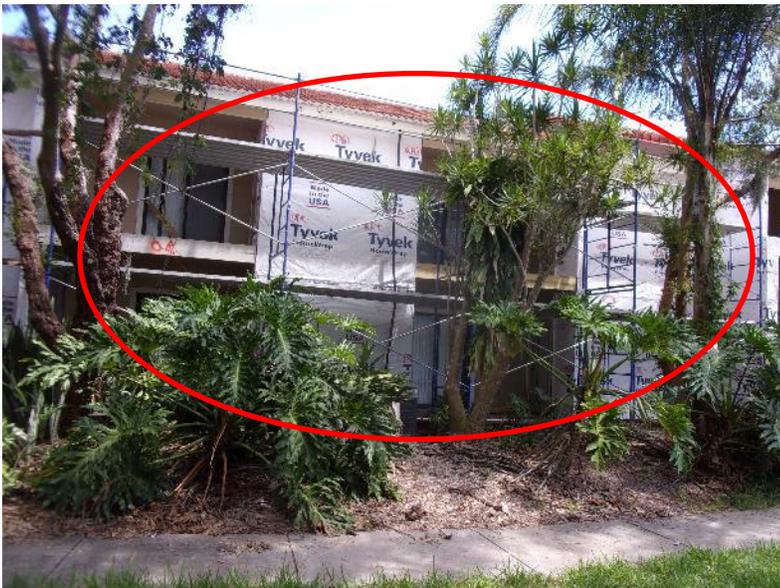
PHOTOGRAPH #14

**BUILDING 3
SECTION F**

Contractor has applied Tyvek HomeWrap over new plywood sheathing, covering window openings until windows are delivered.

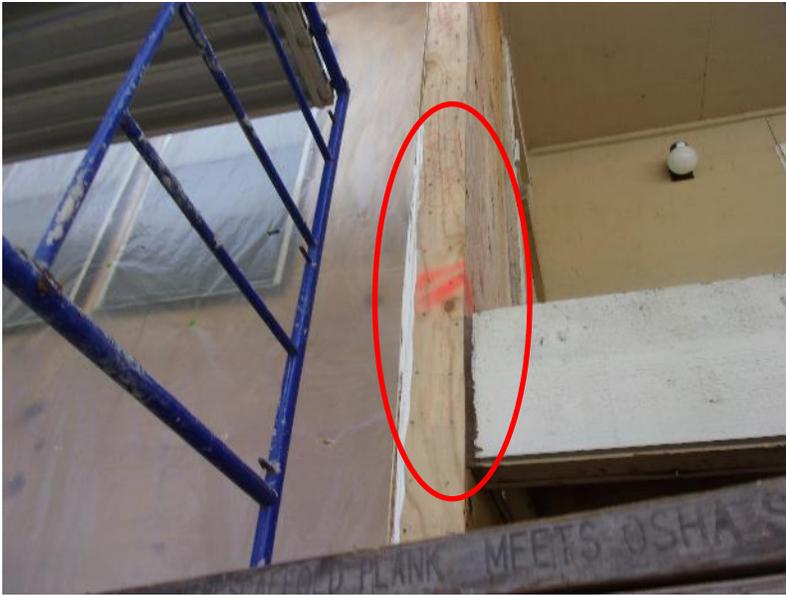
PHOTOGRAPH #15

**BUILDING 3
SECTION E**

Corrections made at gaps greater than 1/4" with sealant and nails replaced where marked.

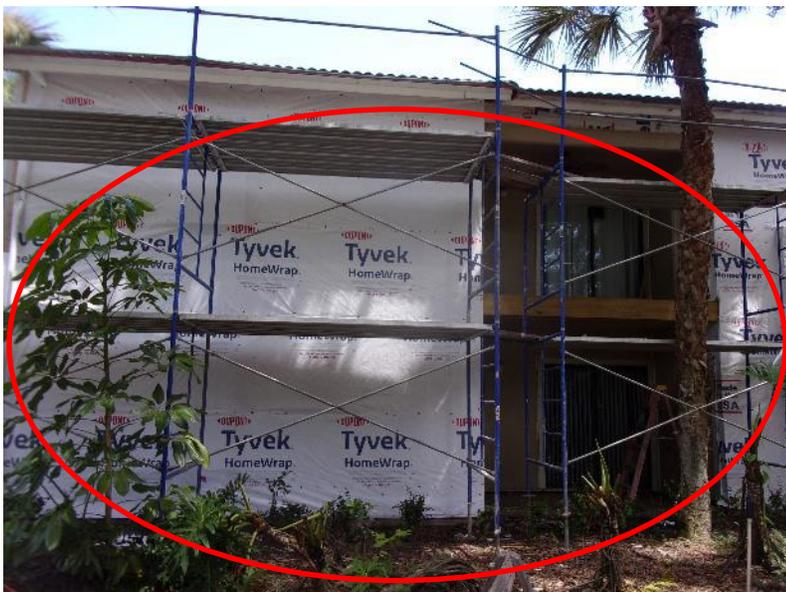
PHOTOGRAPH #16

**BUILDING 3
SECTION E**

Contractor has applied Tyvek HomeWrap over new plywood sheathing, covering window openings until windows are delivered.

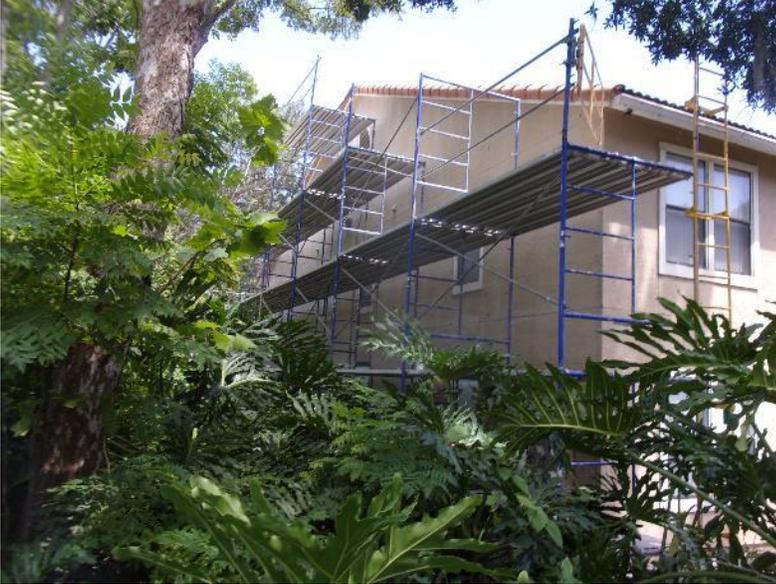
PHOTOGRAPH #17

**BUILDING 6
SECTION H**

Access scaffolding erected and stucco cutting for removal has begun.

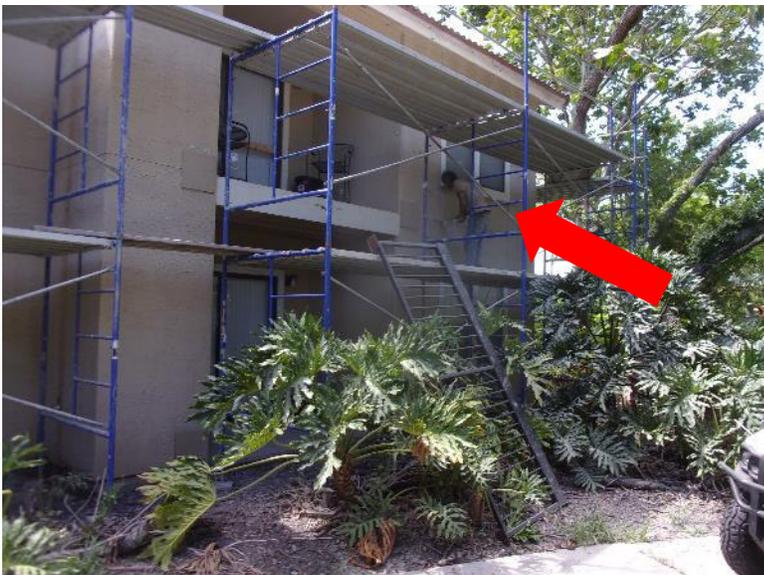
PHOTOGRAPH #18

**BUILDING 6
SECTION G**

Access scaffolding erected, balcony railing removed and stucco cutting for removal has begun.

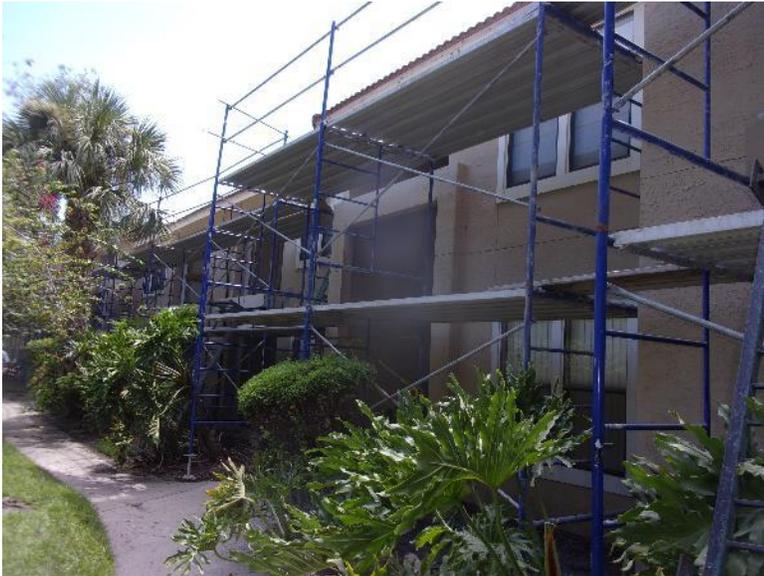
PHOTOGRAPH #19

**BUILDING 6
SECTION F**

Contractor has set up access scaffolding and construction fencing.
