PHOTOGRAPHS

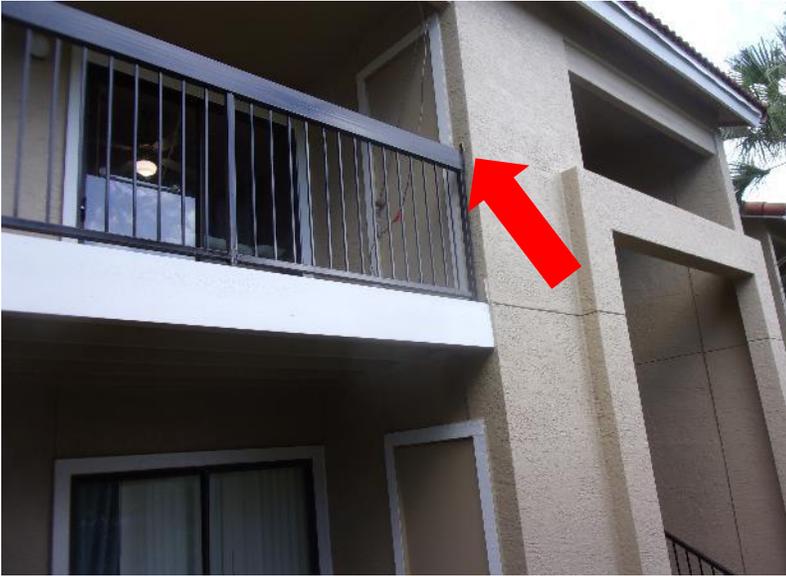
PHOTOGRAPH #1

**BUILDING 2
SECTION E**

Balcony railings welded top rail angles attached and installed through stucco to wood framing.

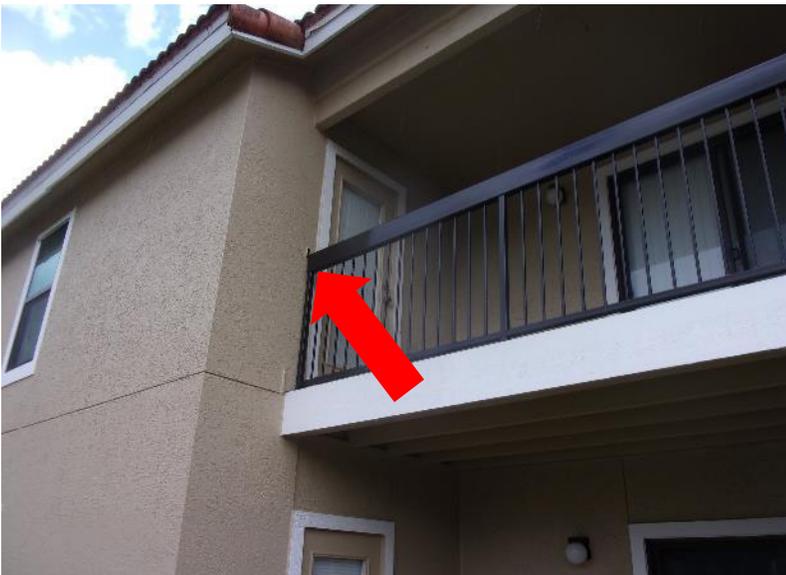
PHOTOGRAPH #2

**BUILDING 2
SECTION A**

Balcony railings welded top rail angles attached and installed through stucco to wood framing.

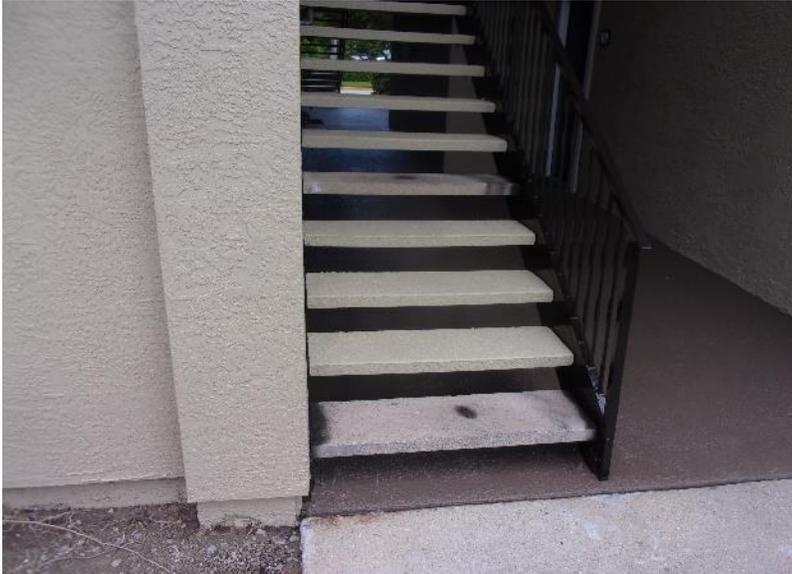
PHOTOGRAPH #3

**BUILDING 2
SECTION A**

Two stair locations have not yet been welded and replaced.

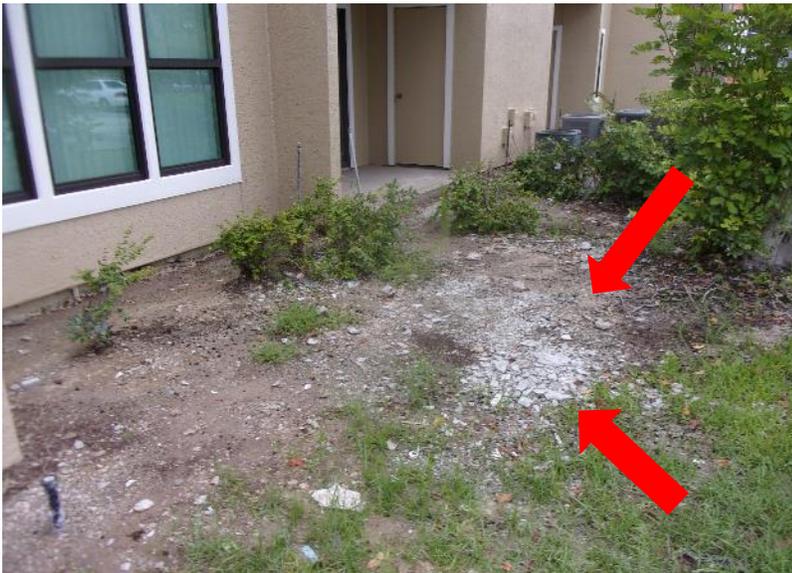
PHOTOGRAPH #4

**BUILDING 2
SECTION B**

Construction debris have not yet been removed and site final cleaned.

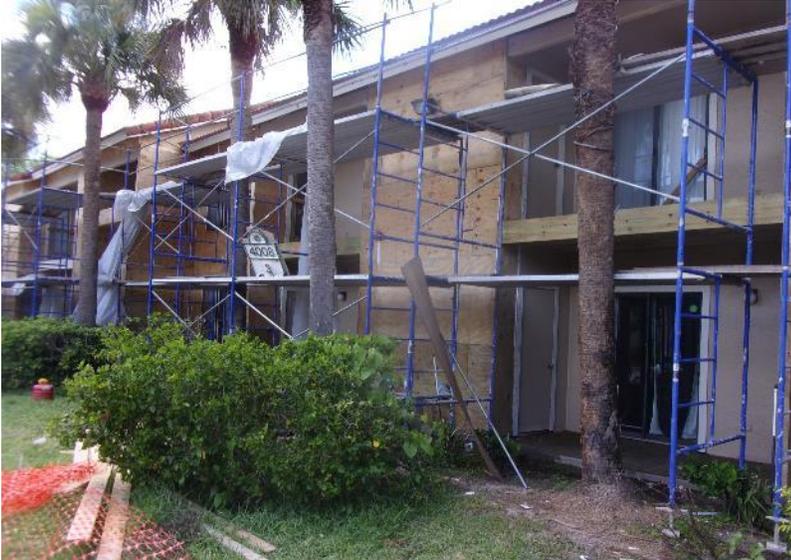
PHOTOGRAPH #5

**BUILDING 3
SECTION B**

15/32" plywood sheathing applied over new repairs.

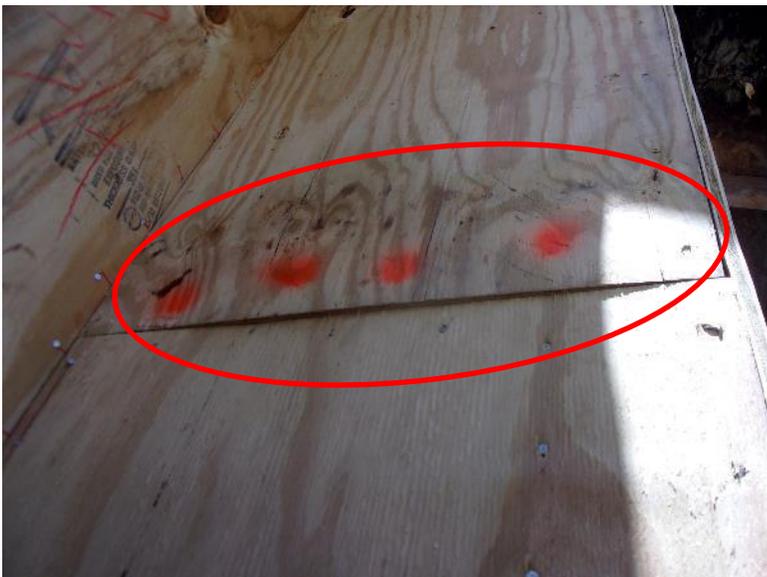
PHOTOGRAPH #6

**BUILDING 3
SECTIONS B**

Missing fasteners marked during inspection at new plywood sheathing.

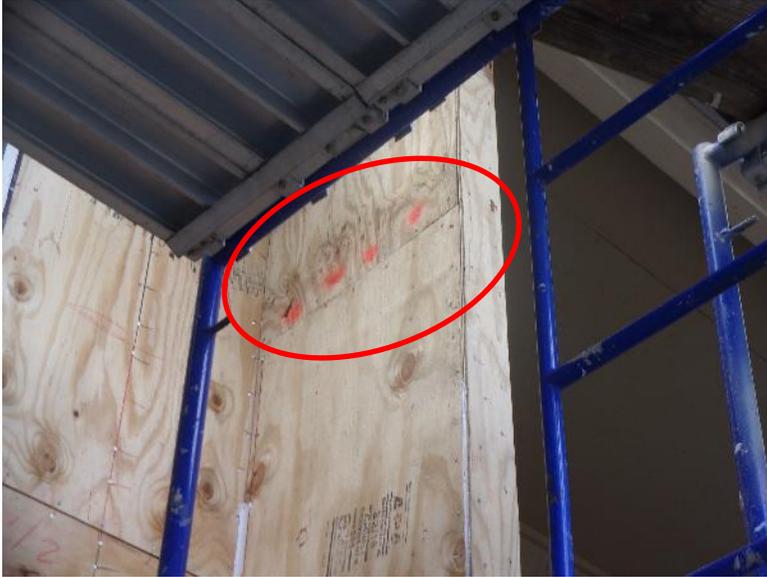
PHOTOGRAPH #7

**BUILDING 3
SECTION B**

Missing fasteners installed by contractor at new plywood sheathing.

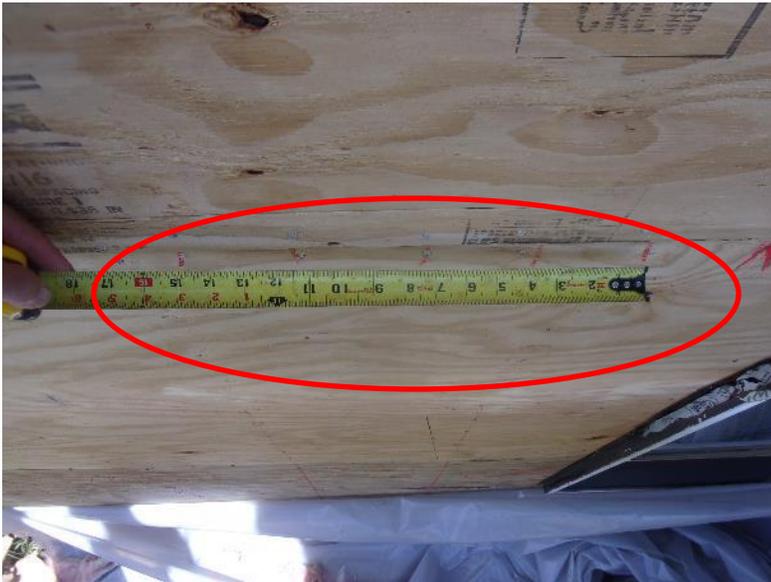
PHOTOGRAPH #8

**BUILDING 3
SECTION C**

Fastening of new sheathing to framing inspected for nail spacing at perimeters and framing studs.

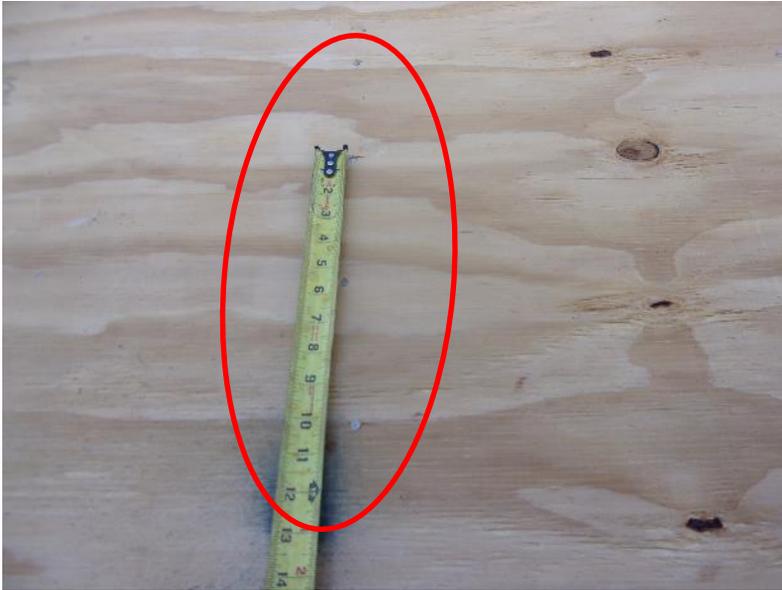
PHOTOGRAPH #9

**BUILDING 3
SECTION C**

Fastening of new sheathing to framing inspected for nail spacing at perimeters and framing studs.

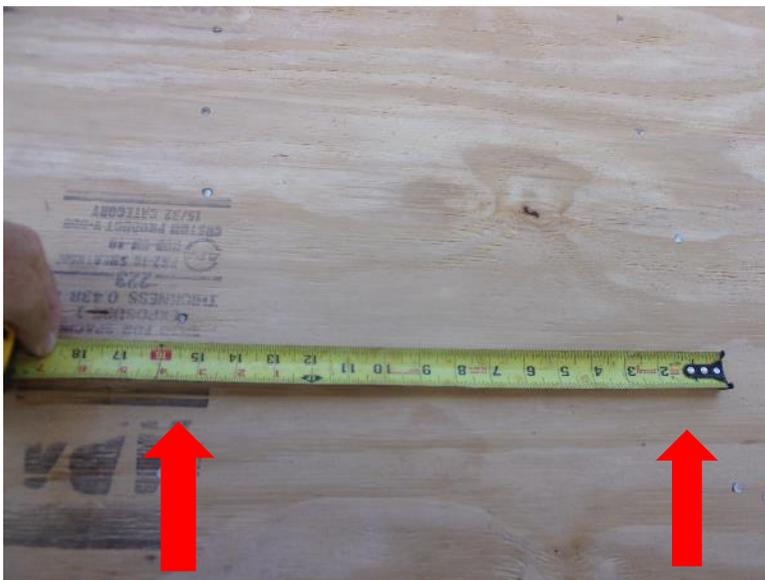
PHOTOGRAPH #10

**BUILDING 3
SECTION C**

Fastening of new sheathing to framing inspected for nail spacing at perimeters and framing studs.

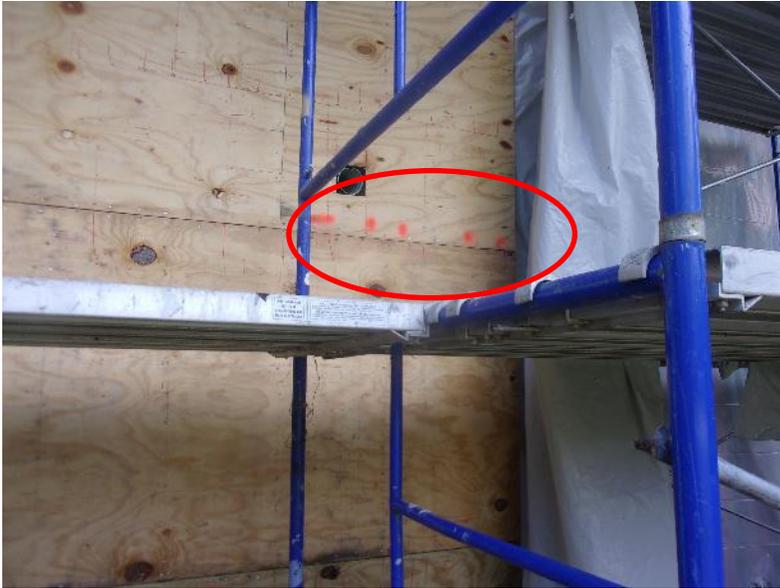
PHOTOGRAPH #11

**BUILDING 3
SECTION D**

Missing fasteners marked and corrected during inspection at new plywood sheathing.

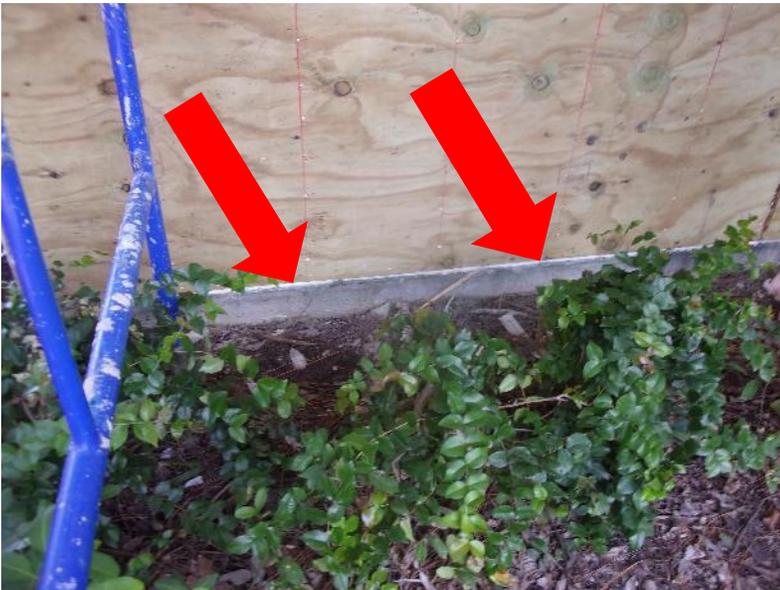
PHOTOGRAPH #12

**BUILDING 3
SECTION D**

BASF urethane sealant applied at plywood to bottom plate and existing concrete slab.

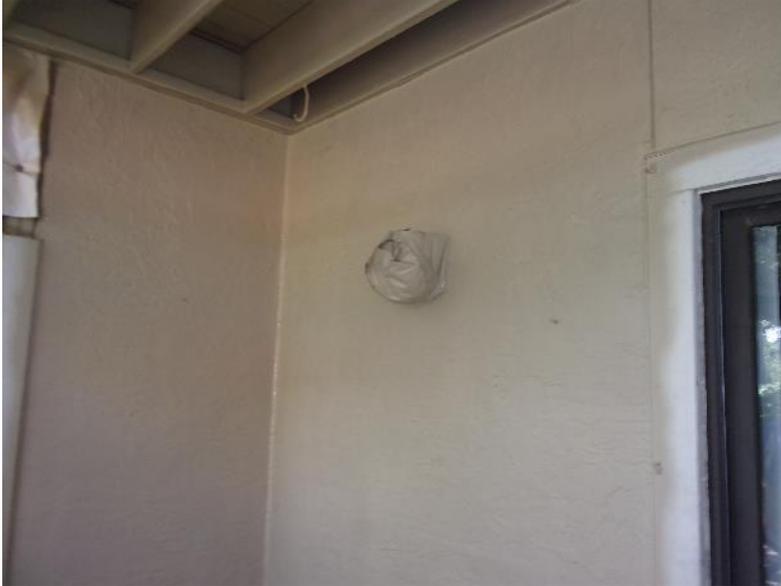
PHOTOGRAPH #13

**BUILDING 3
SECTION F**

Contractor painting patio stucco and overhead wood with Florida Paint Ultra Exterior Supercoat.

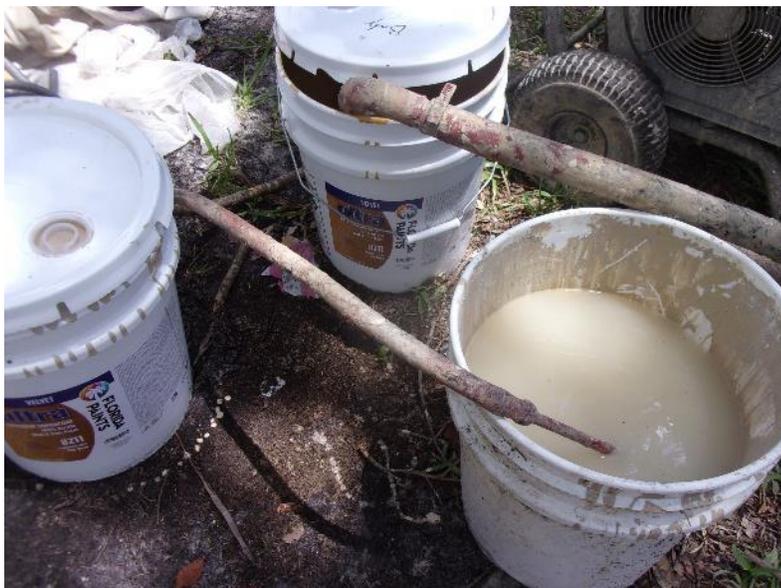
PHOTOGRAPH #14

**BUILDING 3
SECTION F**

Contractor painting patio stucco and overhead wood with Florida Paint Ultra Exterior Supercoat.

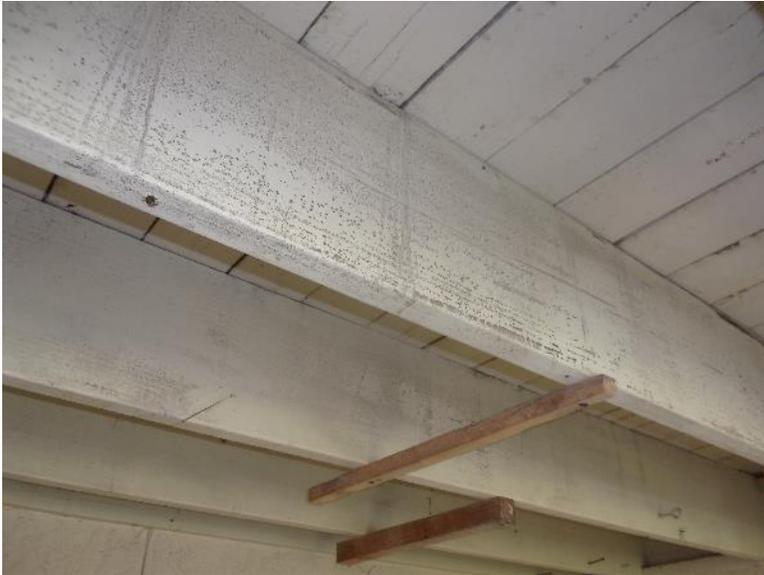
PHOTOGRAPH #15

**BUILDING 3
SECTION G**

Mildew at overhead wood where contractor was preparing to paint. Delta instructed that these surfaces require mildew and soil removal prior to painting as per specification and manufactures instructions.

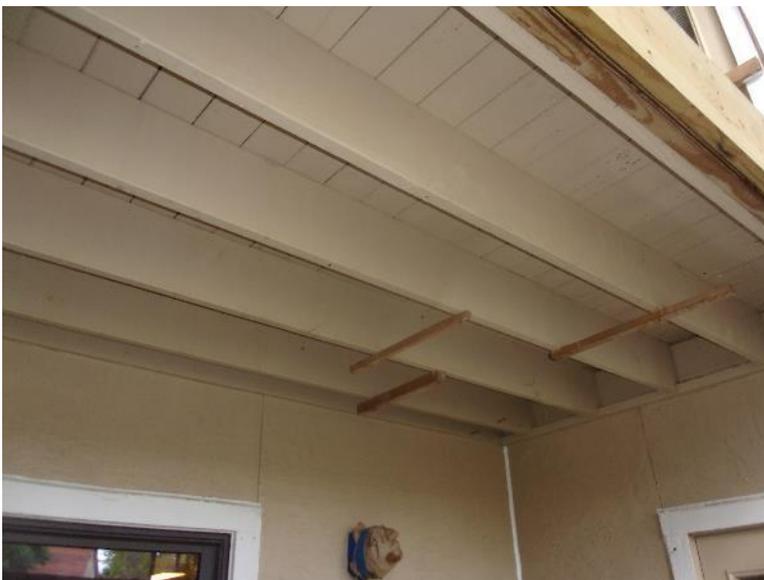
PHOTOGRAPH #16

**BUILDING 3
SECTION G**

Contractor has cleaned wood over head at patios in preparation to paint as per specifications and manufactures instructions.

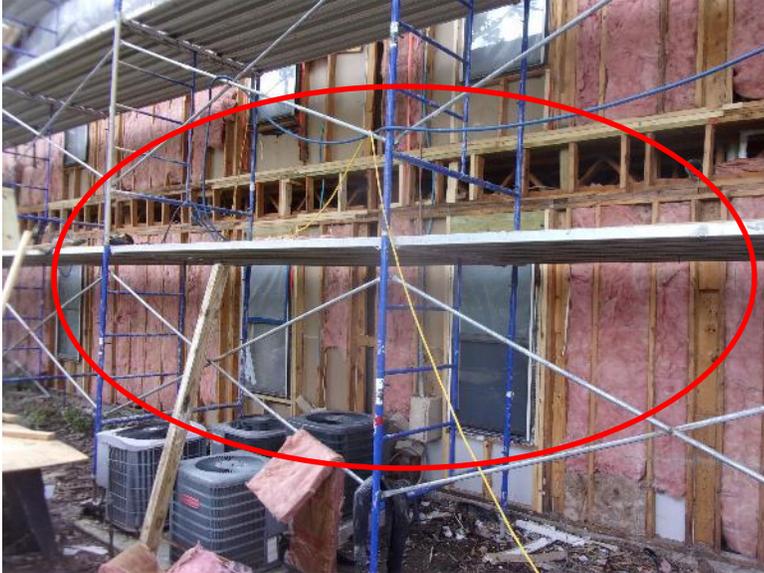
PHOTOGRAPH #17

**BUILDING 6
SECTION H**

New framing repairs at window openings,
and wall framing, quantified with
contractor.

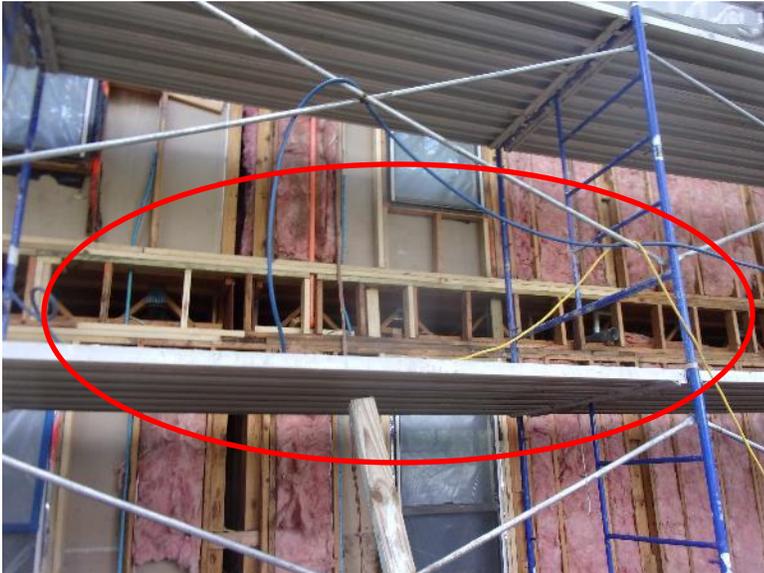
PHOTOGRAPH #18

**BUILDING 6
SECTION H**

New framing repairs at window openings,
and wall framing, quantified with
contractor.

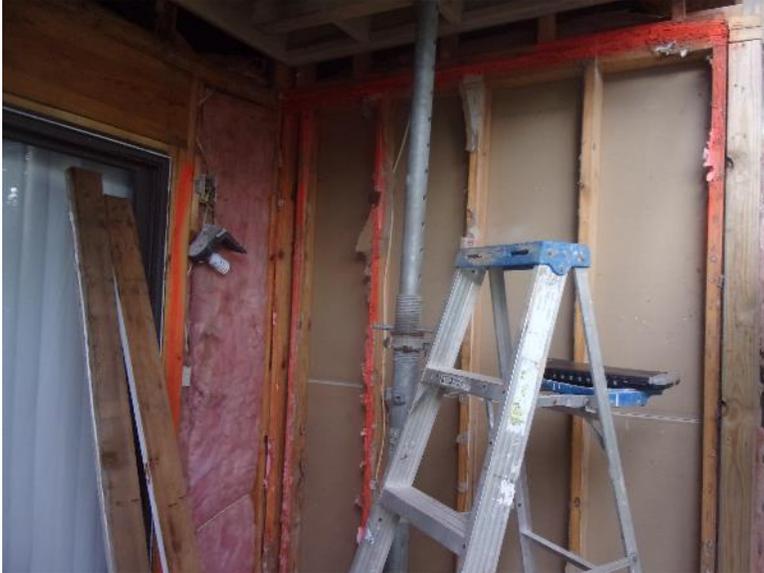
PHOTOGRAPH #19

**BUILDING 6
SECTION G- UNIT 612**

Marked termite damage extending into patio walls at **Unit # 612**.

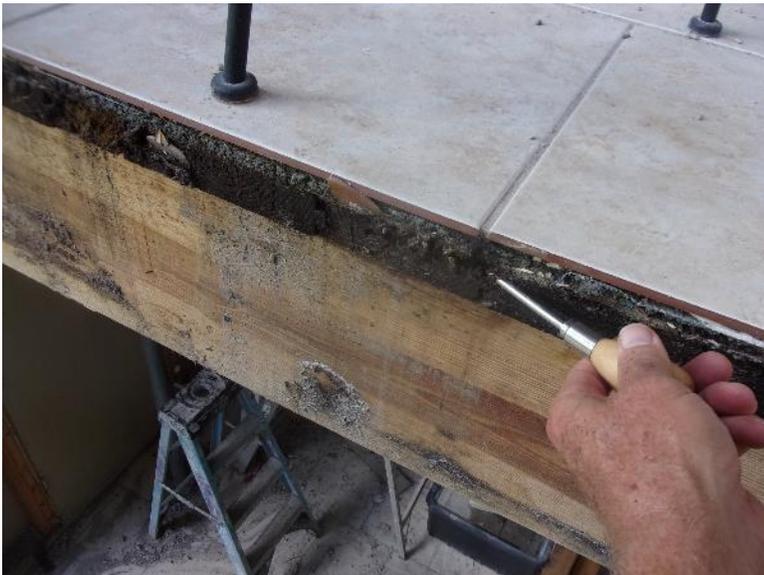
PHOTOGRAPH #20

**BUILDING 6
SECTION G- UNIT 622**

Damaged decking at balcony of **Unit # 622** will require removal of owner's tile from deck.

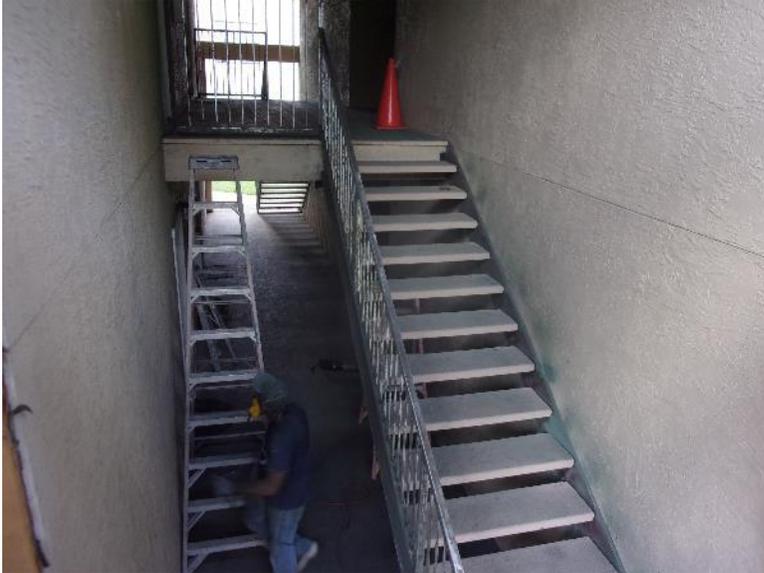
PHOTOGRAPH #21

**BUILDING 6
SECTION G**

Contractor in process of grinding rust and peeling paint from stairway railings in preparation for primer and paint.

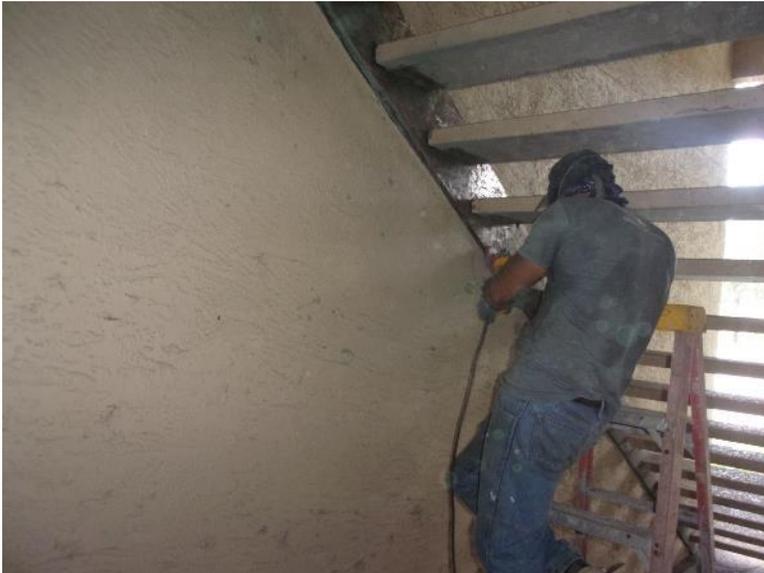
PHOTOGRAPH #22

**BUILDING 6
SECTION E**

Contractor in process of grinding rust and peeling paint from stairway railings in preparation for primer and paint
