PHOTOGRAPHS

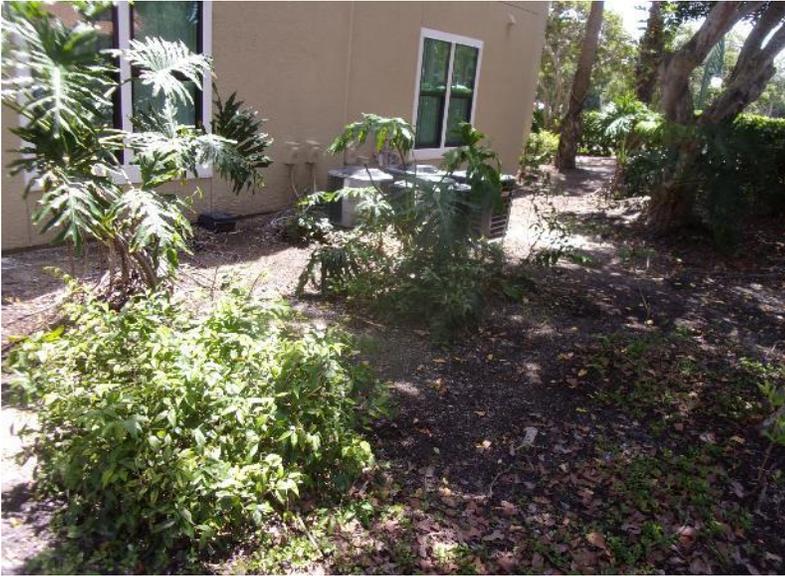
PHOTOGRAPH #1

**BUILDING 2
SECTION D**

Grounds cleaned and raked by contractor.

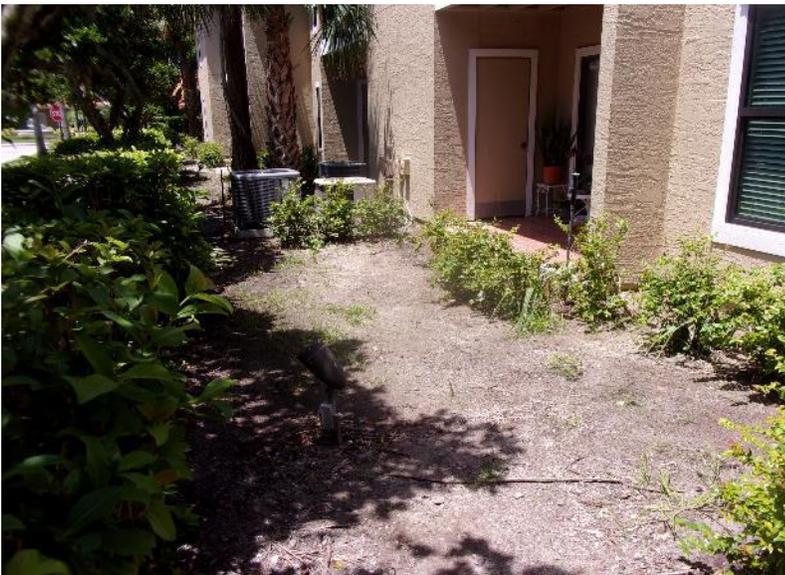
PHOTOGRAPH #2

**BUILDING 2
SECTION F**

Grounds cleaned and raked by contractor.

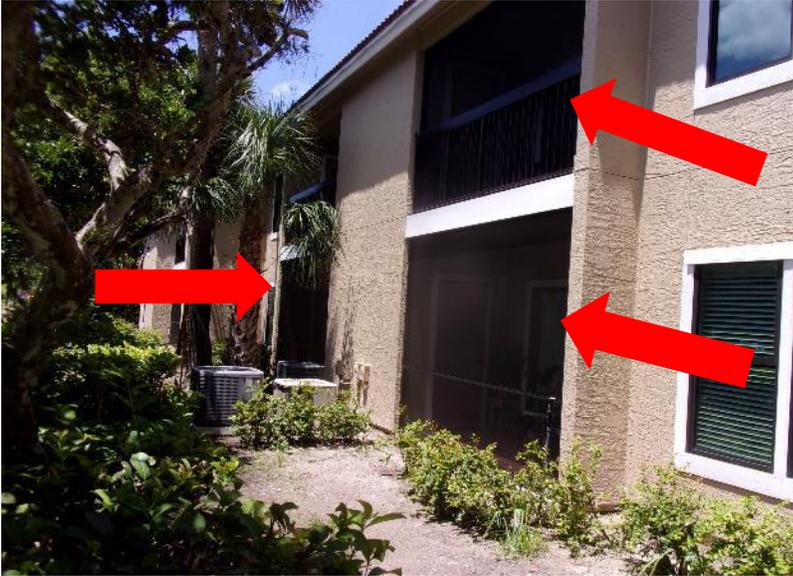
PHOTOGRAPH #3

**BUILDING 2
SECTION F**

New screen enclosures installed at all previous locations.

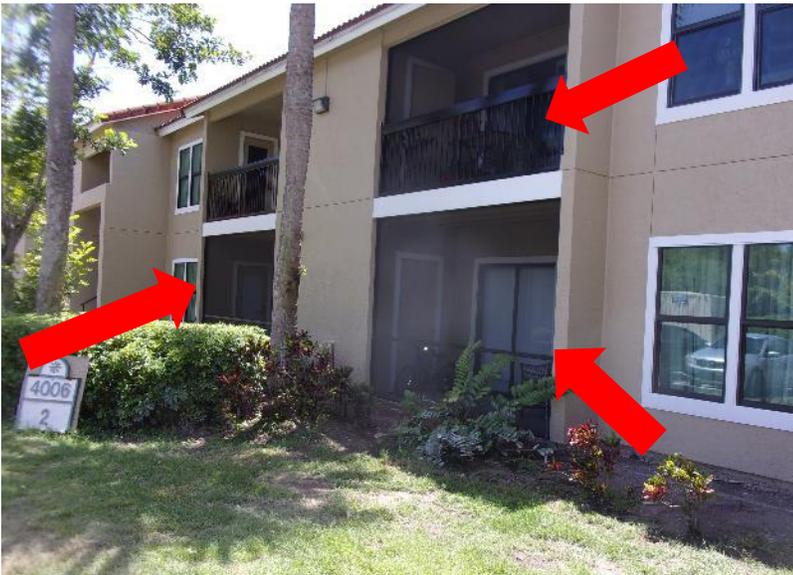
PHOTOGRAPH #4

**BUILDING 2
SECTION B**

New screen enclosures installed at all previous locations.

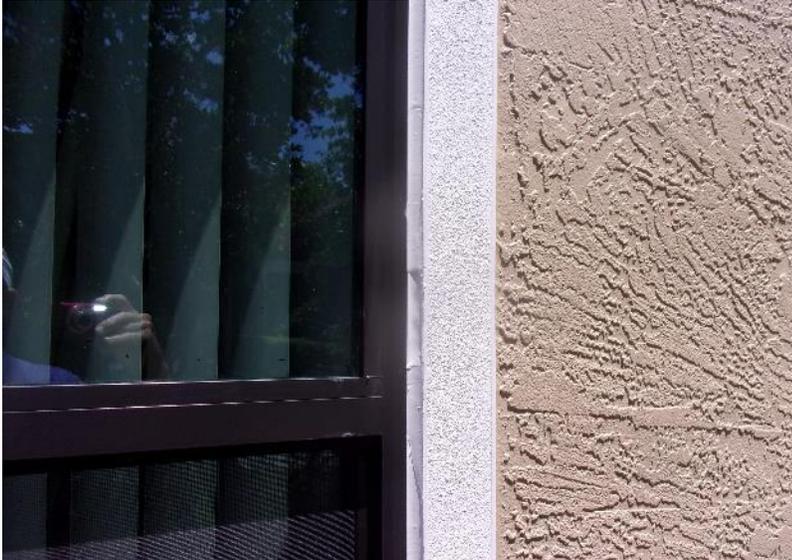
PHOTOGRAPH #5

**BUILDING 2
SECTION G**

Sealant has been replaced at window perimeter pull test location.

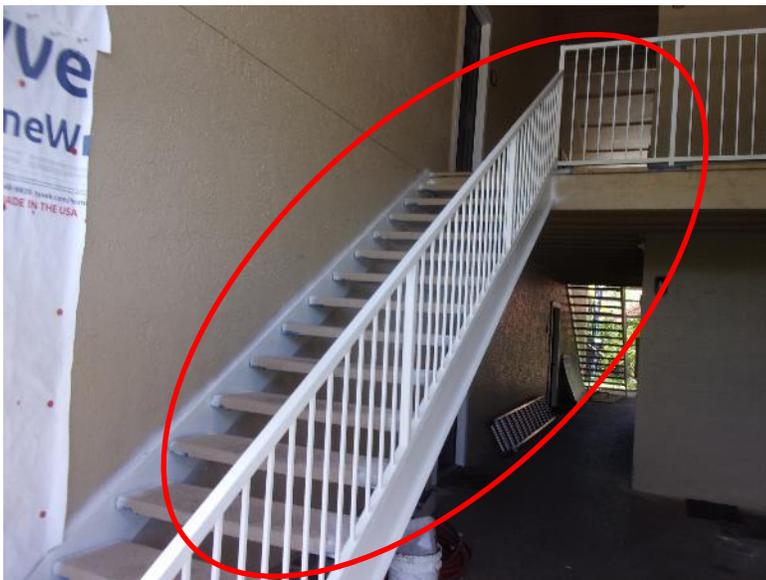
PHOTOGRAPH #6

**BUILDING 3
SECTIONS A**

Contractor has applied Encapsulon epoxy mastic primer at stair way railings and stringers.

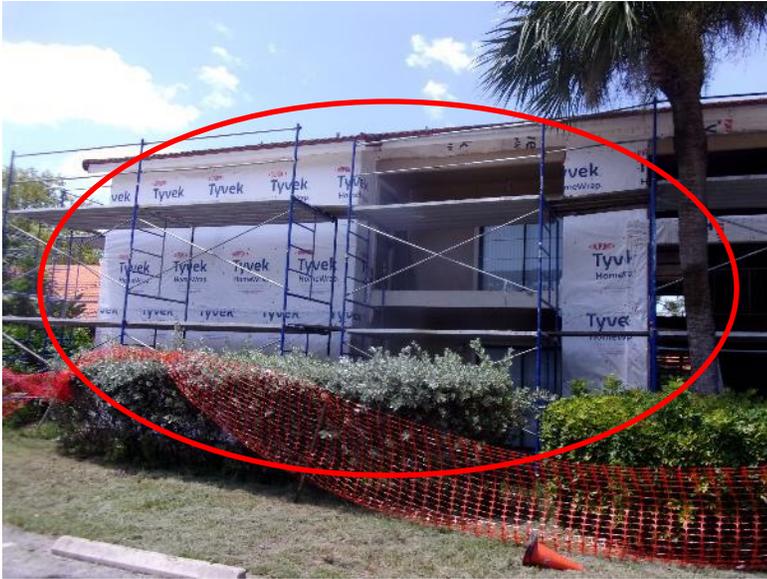
PHOTOGRAPH #7

**BUILDING 3
SECTION A**

Dupont Tyvek HomeWrap has been applied covering the window openings until windows are delivered to site.

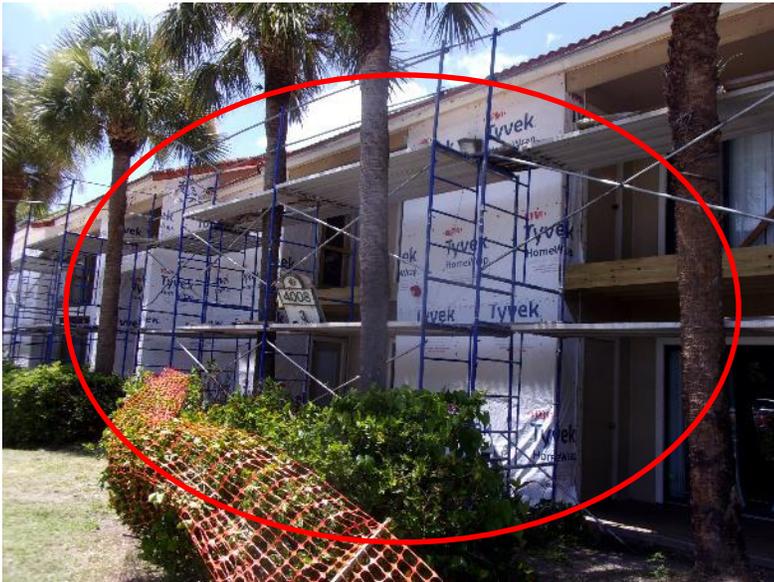
PHOTOGRAPH #8

**BUILDING 3
SECTION B**

Dupont Tyvek HomeWrap has been applied covering the window openings until windows are delivered to site.

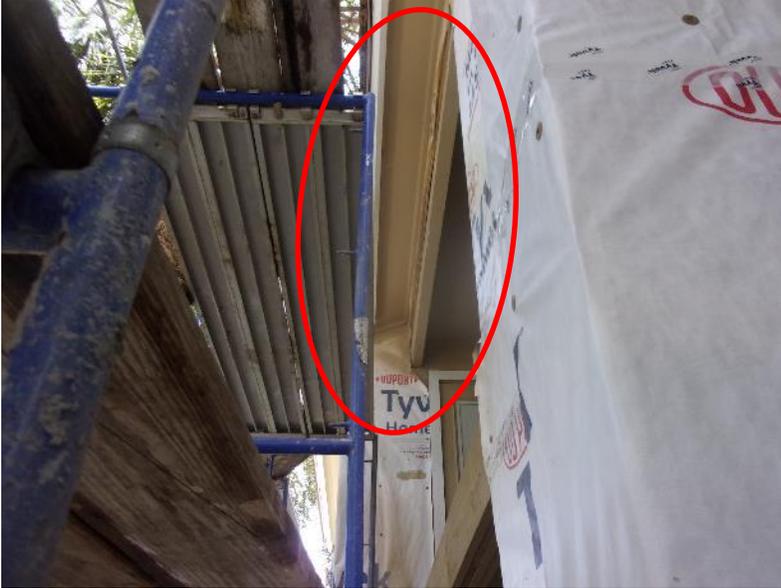
PHOTOGRAPH #9

**BUILDING 3
SECTION C**

New soffit and soffit vent has been installed and painted.

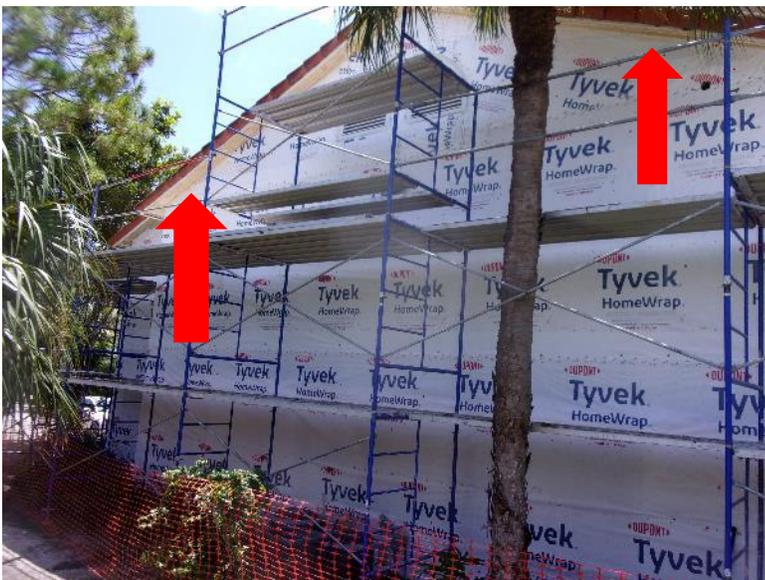
PHOTOGRAPH #10

**BUILDING 3
SECTION D**

New soffit and soffit vent has been installed at gable end.

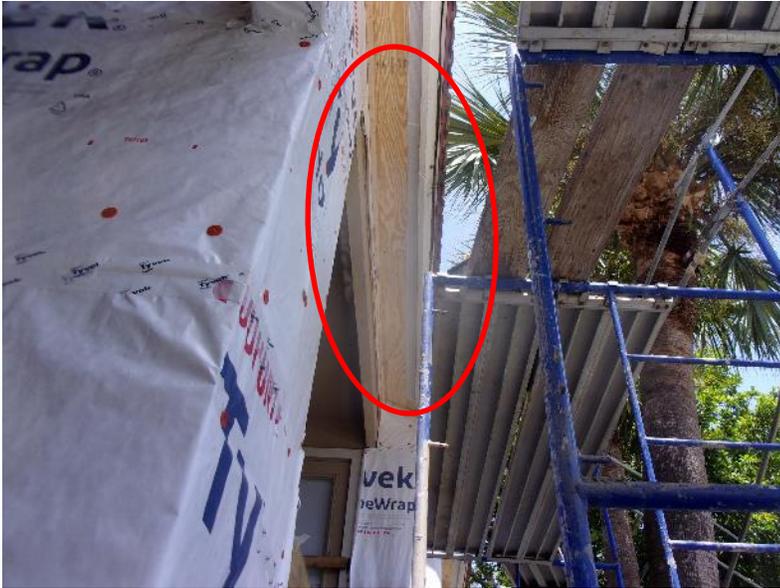
PHOTOGRAPH #11

**BUILDING 3
SECTION E**

New soffit and soffit vent has been installed.

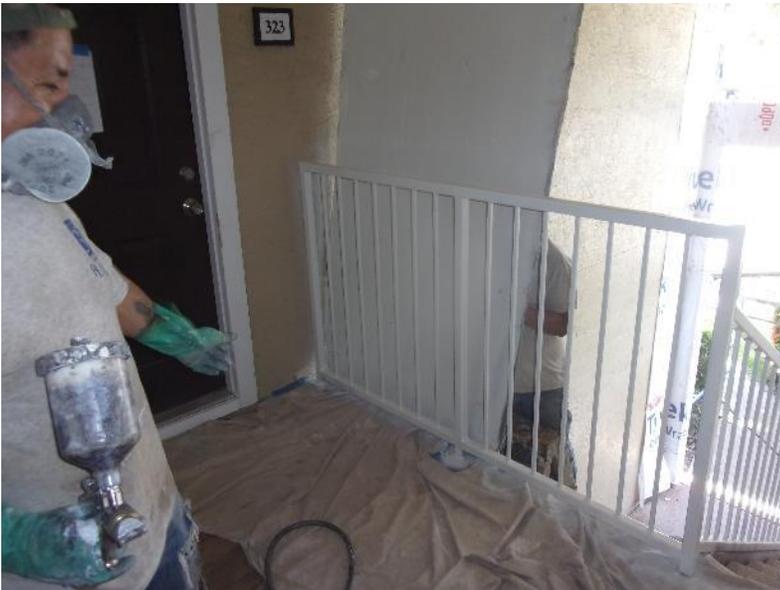
PHOTOGRAPH #12

**BUILDING 3
SECTION E**

Florida Paints Encapsulon epoxy mastic primer applied by spray application at railings.

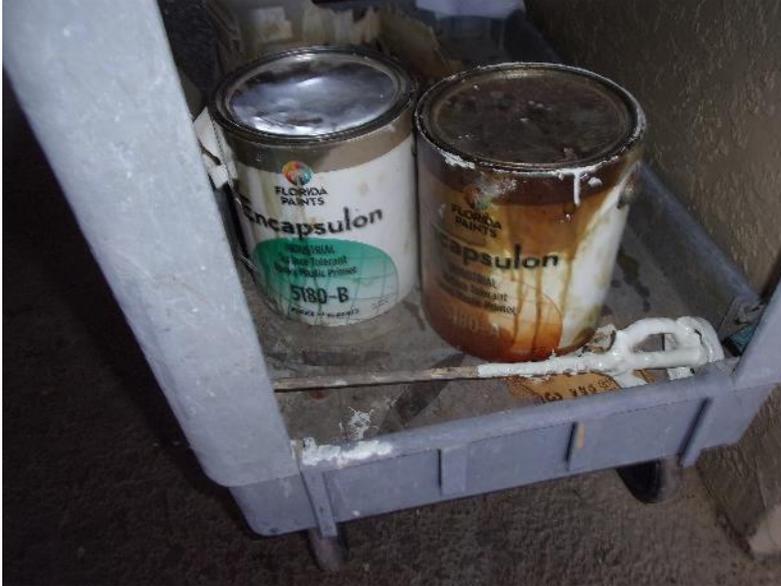
PHOTOGRAPH #13

**BUILDING 3
SECTION E**

Florida Paints Encapsulon epoxy mastic primer applied by spray application at railings.

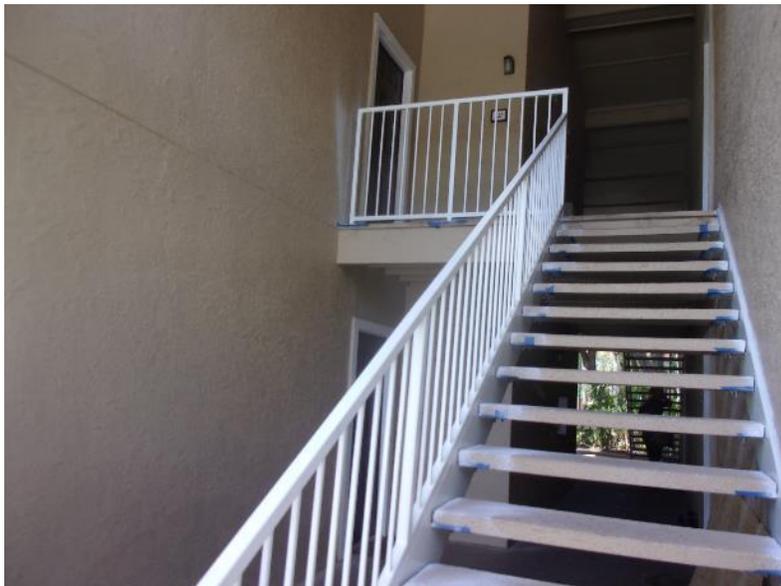
PHOTOGRAPH #14

**BUILDING 3
SECTION E**

Florida Paints Encapsulon epoxy mastic primer applied by spray application at railings.

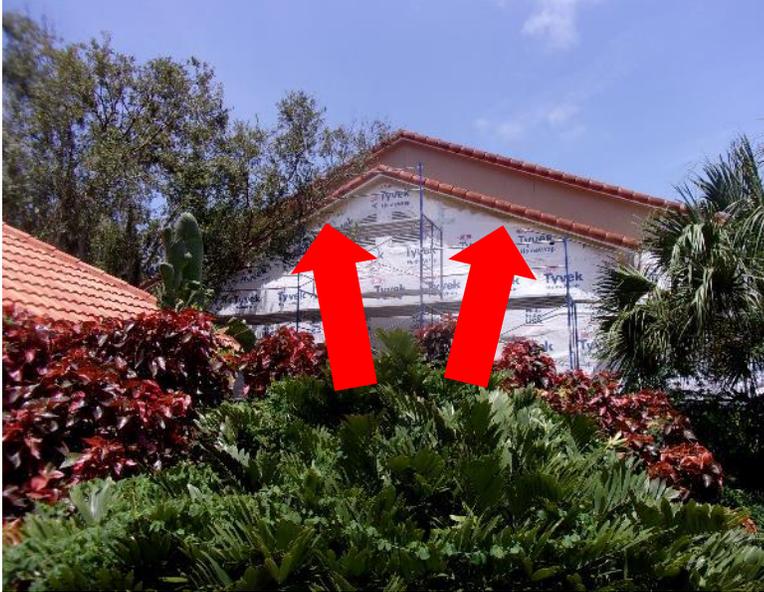
PHOTOGRAPH #15

**BUILDING 3
SECTION H**

New soffit and soffit vent has been installed and painted.

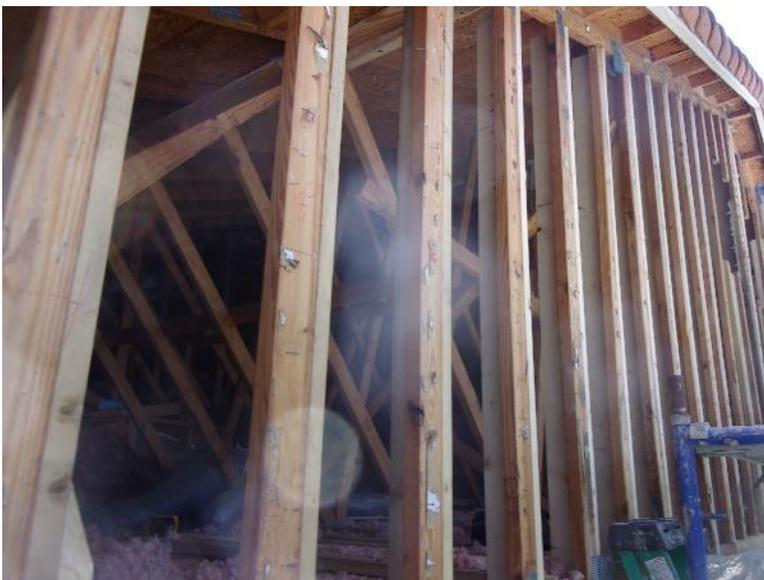
PHOTOGRAPH #16

**BUILDING 6
SECTION H**

Contractor has begun gable end reinforcement and cross bracing as per drawings and details.

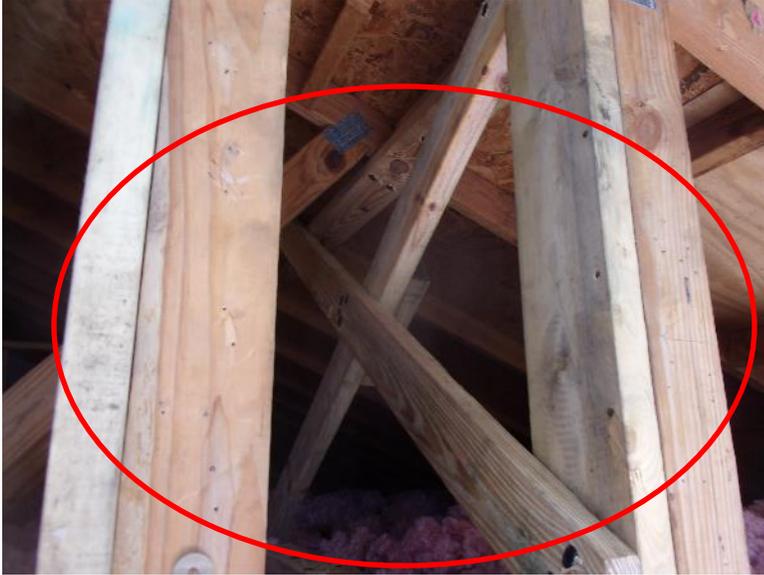
PHOTOGRAPH #17

**BUILDING 6
SECTION H**

Contractor has begun gable end reinforcement and cross bracing as per drawings and details.

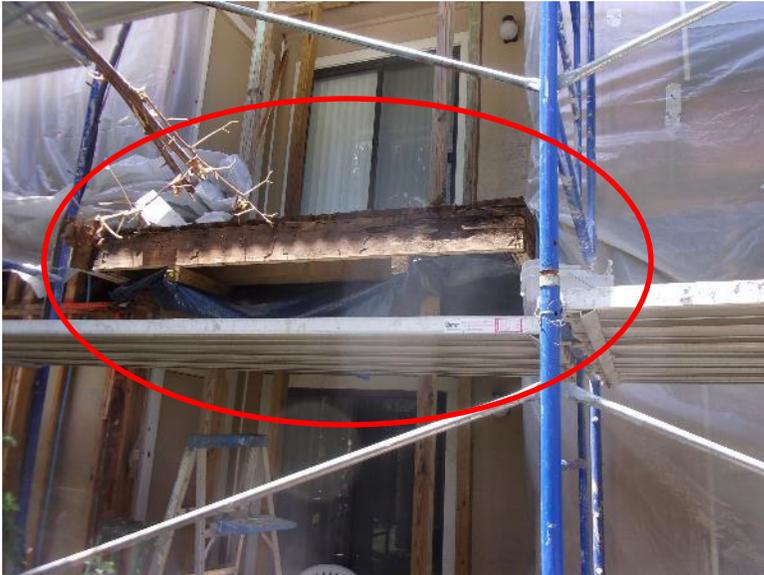
PHOTOGRAPH #18

**BUILDING 6
SECTION G- UNIT 622**

Contractor has begun removing owners tile exposing rotted deck boards.

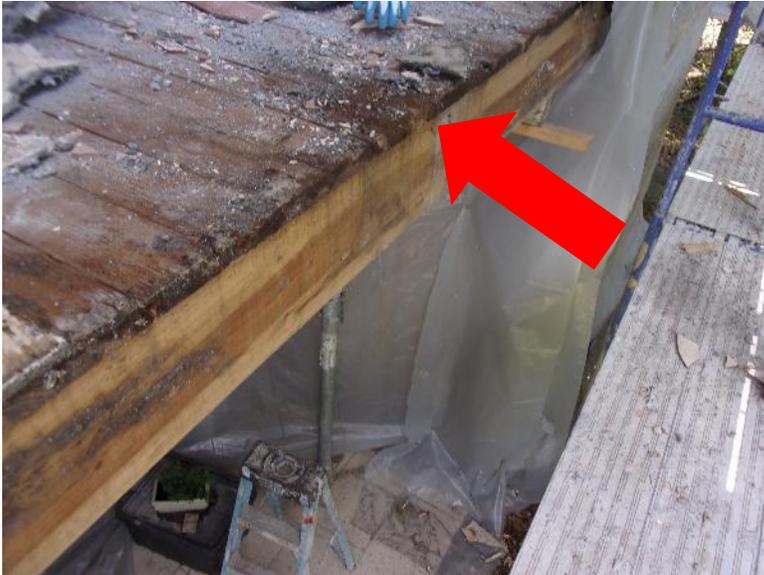
PHOTOGRAPH #19

**BUILDING 6
SECTION G- UNIT 622**

Contractor has begun removing owners tile exposing rotted deck boards.

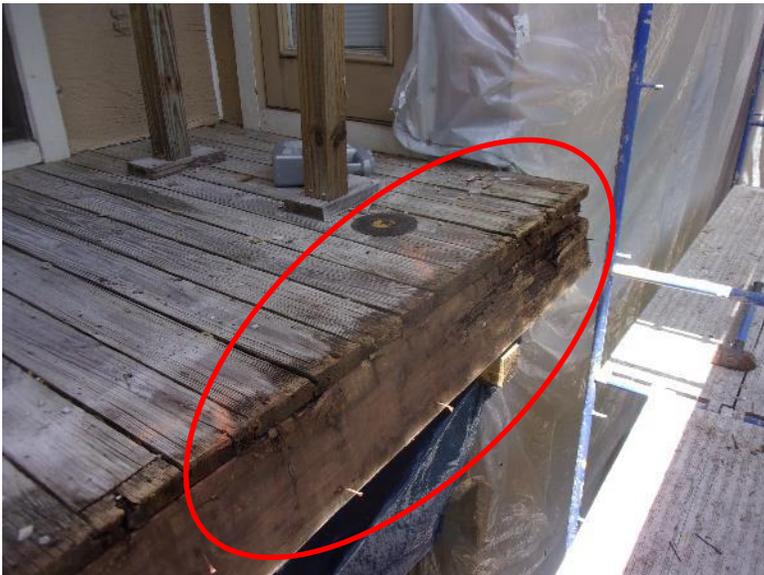
PHOTOGRAPH #20

**BUILDING 6
SECTION F**

Damaged decking at balconies will require removal and replacement of all deck boards.

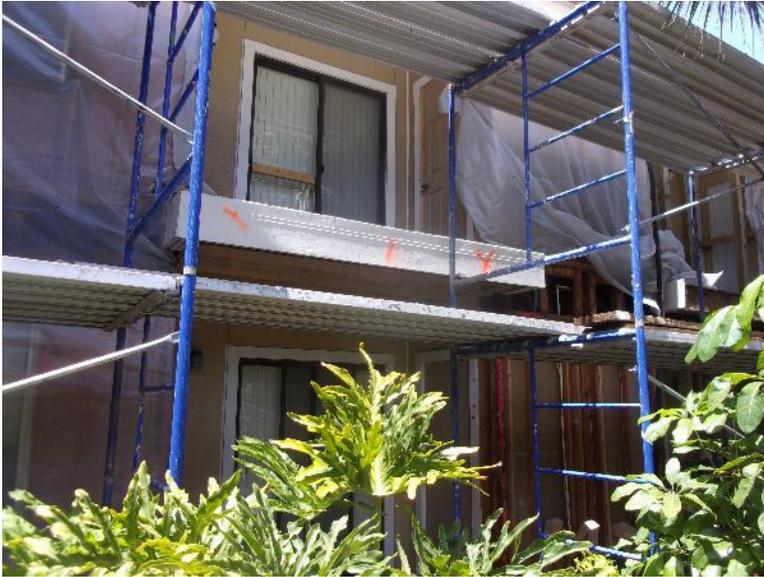
PHOTOGRAPH #21

**BUILDING 6
SECTION F**

Contractor in process of framing repairs at balconies, windows, and walls.

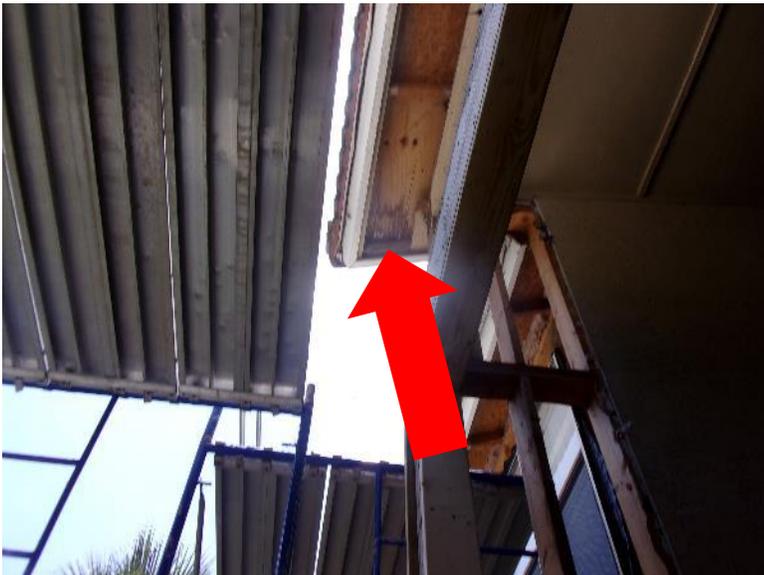
PHOTOGRAPH #22

**BUILDING 6
SECTION F**

Roofing sheathing damage above soffit to be addressed by owners roofing contractors.

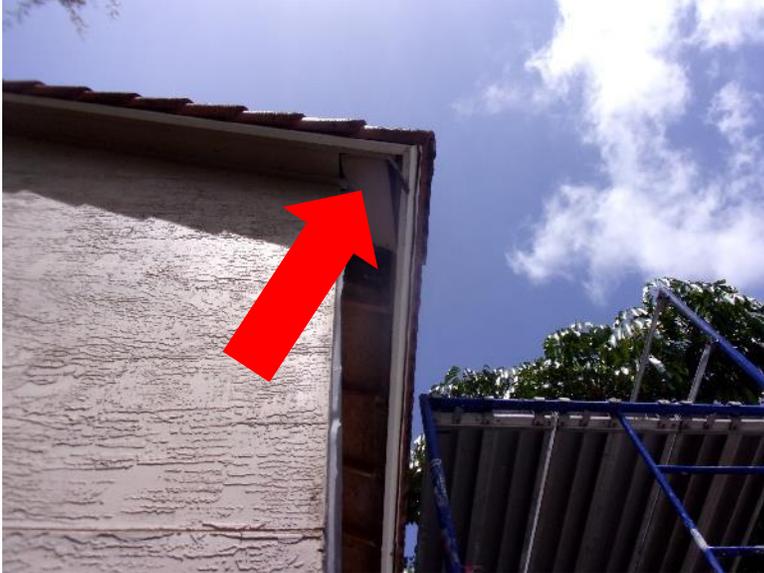
PHOTOGRAPH #23

**BUILDING 6
SECTION G**

Roofing sheathing damage above soffit to be addressed by owners roofing contractors.

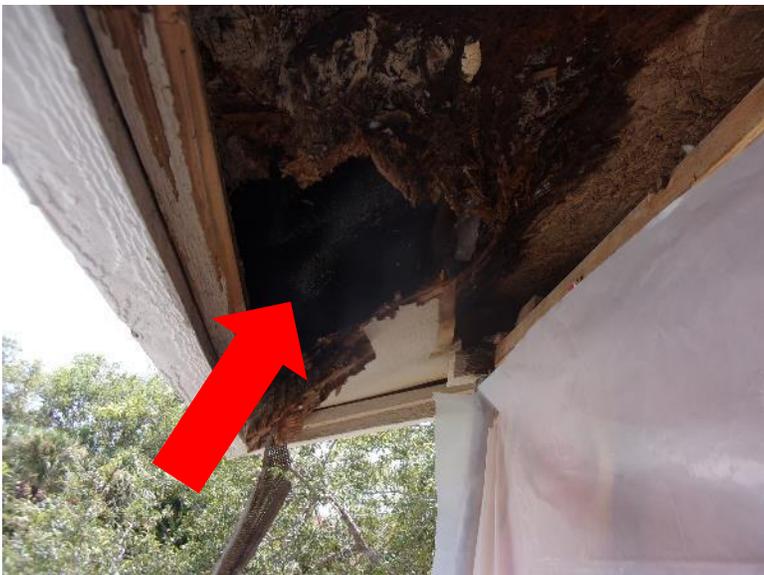
PHOTOGRAPH #24

**BUILDING 6
SECTION G**

Roofing sheathing damage above soffit to be addressed by owners roofing contractors.

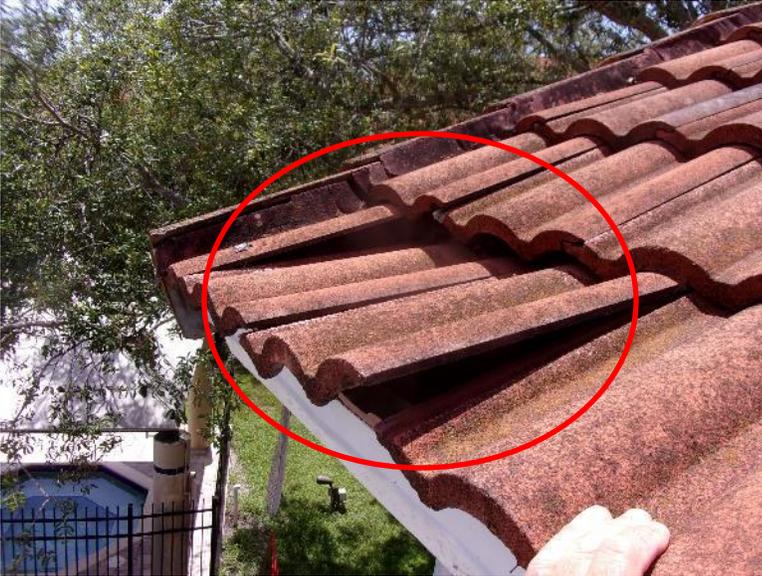
PHOTOGRAPH #25

**BUILDING 6
SECTION G**

Roofing sheathing damage above soffit to be addressed by owners roofing contractors.
