PHOTOGRAPHS

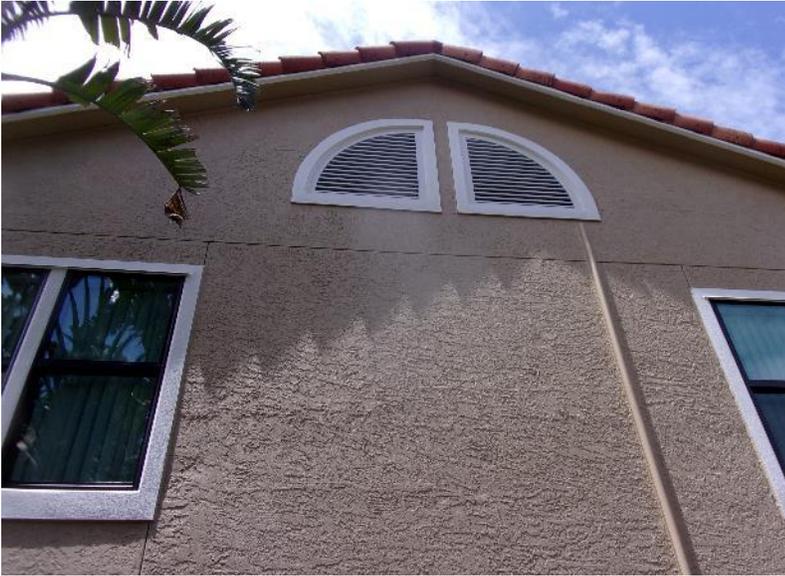
PHOTOGRAPH #1

**BUILDING 2
SECTION H**

Exterior walk through with contractor and property manager. Punch list will be provided with pictures after interior walk through is completed.

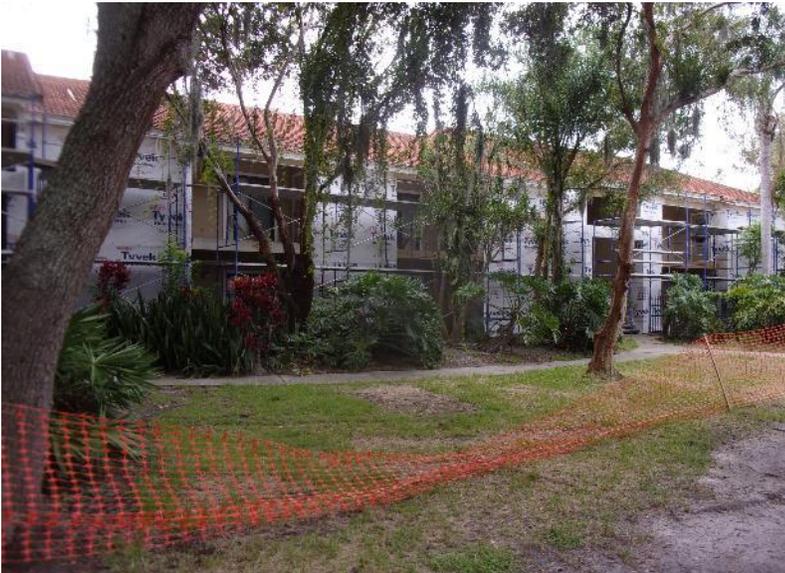
PHOTOGRAPH #2

**BUILDING 3
SECTION F**

Temporary weather proofing in place waiting for delivery of PGT windows to proceed.

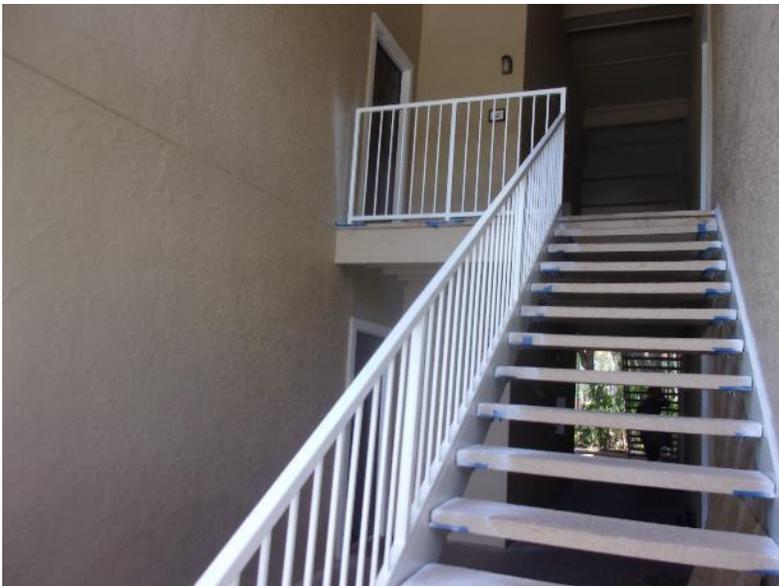
PHOTOGRAPH #14

**BUILDING 6
SECTION E**

Florida Paints Encapsulon epoxy mastic primer applied by spray application at railings.

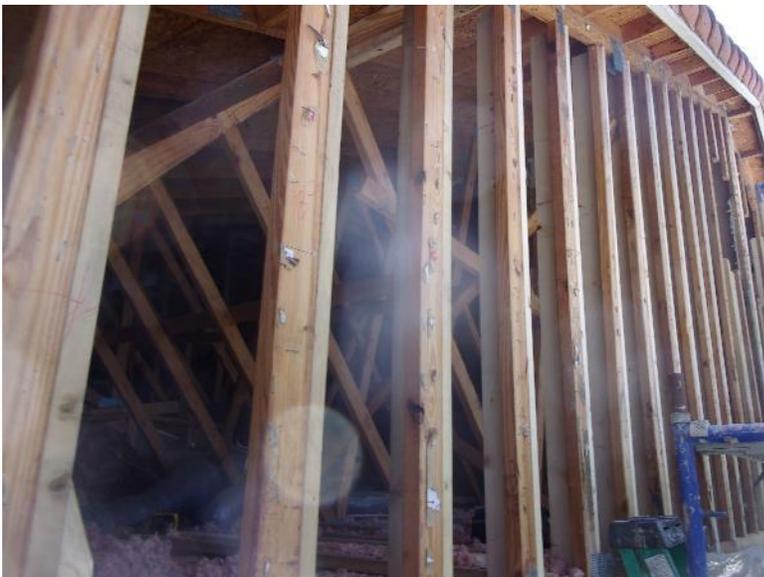
PHOTOGRAPH #16

**BUILDING 6
SECTION H**

Contractor has begun gable end reinforcement and cross bracing as per drawings and details.

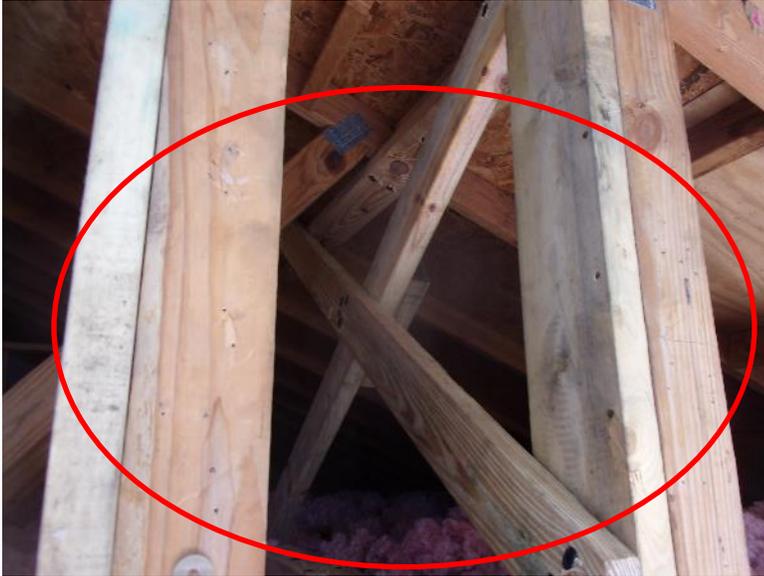
PHOTOGRAPH #17

**BUILDING 6
SECTION H**

Contractor has begun gable end reinforcement and cross bracing as per drawings and details.

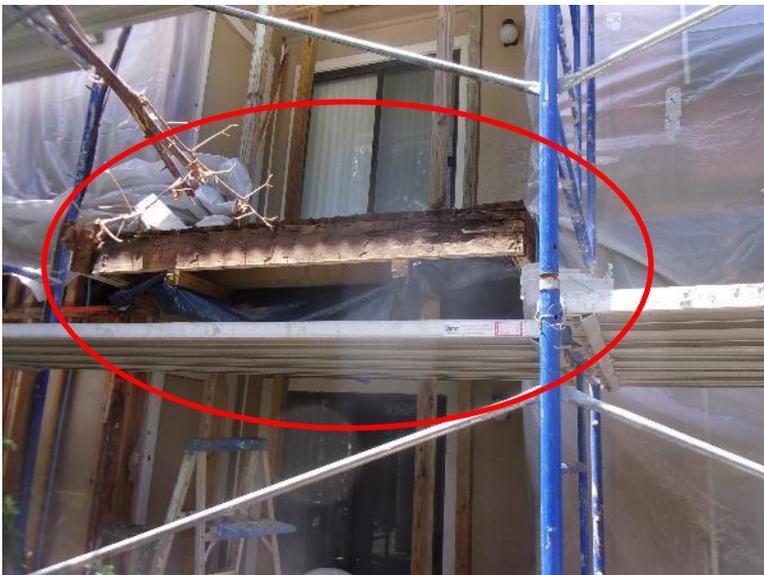
PHOTOGRAPH #18

**BUILDING 6
SECTION G- UNIT 622**

Contractor has begun removing owners tile exposing rotted deck boards.

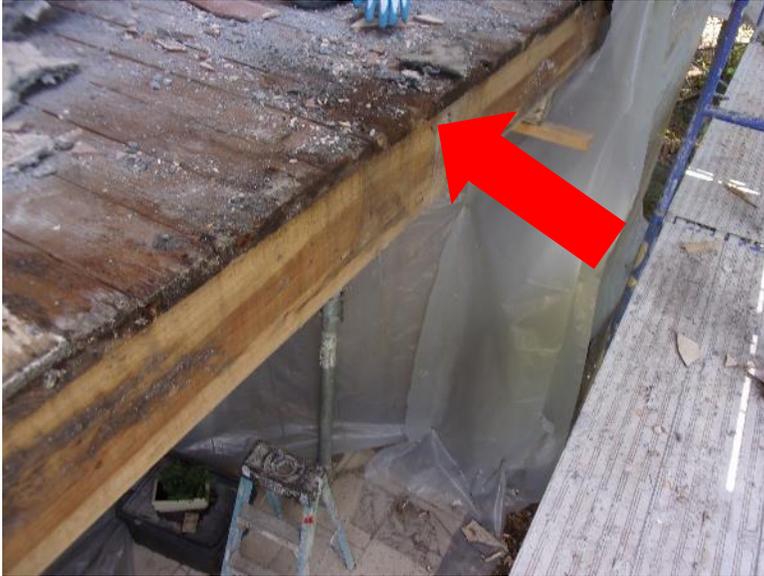
PHOTOGRAPH #19

**BUILDING 6
SECTION G- UNIT 622**

Contractor has begun removing owners tile exposing rotted deck boards.

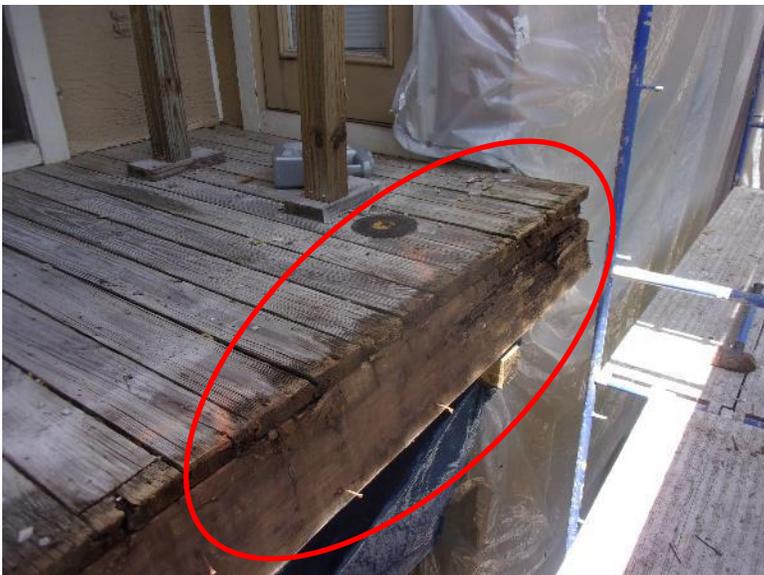
PHOTOGRAPH #20

**BUILDING 6
SECTION F**

Damaged decking at balconies will require removal and replacement of all deck boards.

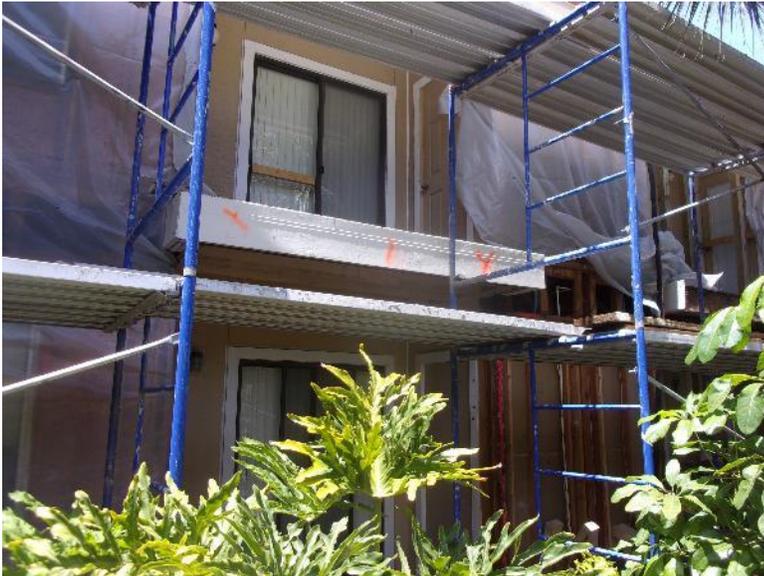
PHOTOGRAPH #21

**BUILDING 6
SECTION F**

Contractor in process of framing repairs at balconies, windows, and walls.

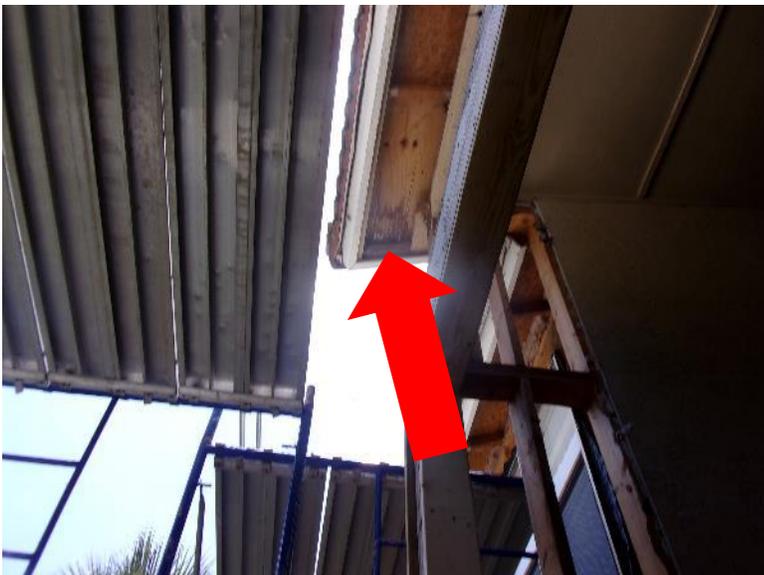
PHOTOGRAPH #22

**BUILDING 6
SECTION F**

Roofing sheathing damage above soffit to be addressed by owners roofing contractors.

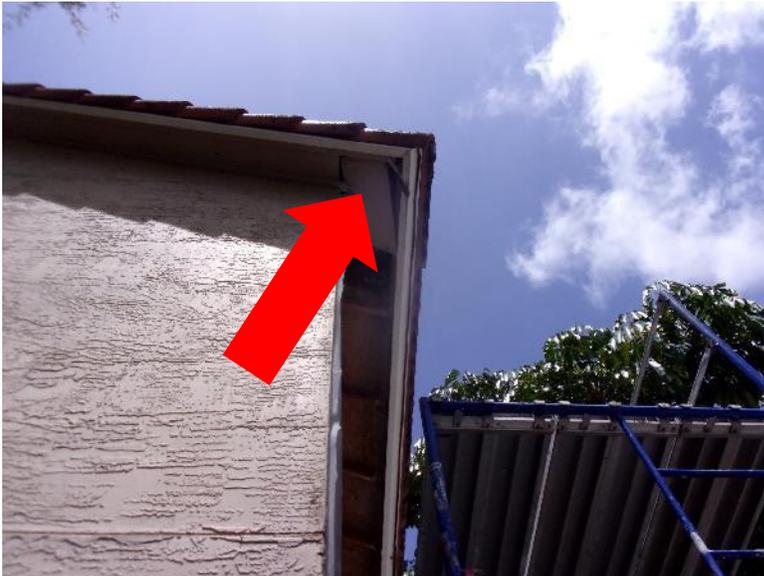
PHOTOGRAPH #23

**BUILDING 6
SECTION G**

Roofing sheathing damage above soffit to be addressed by owners roofing contractors.

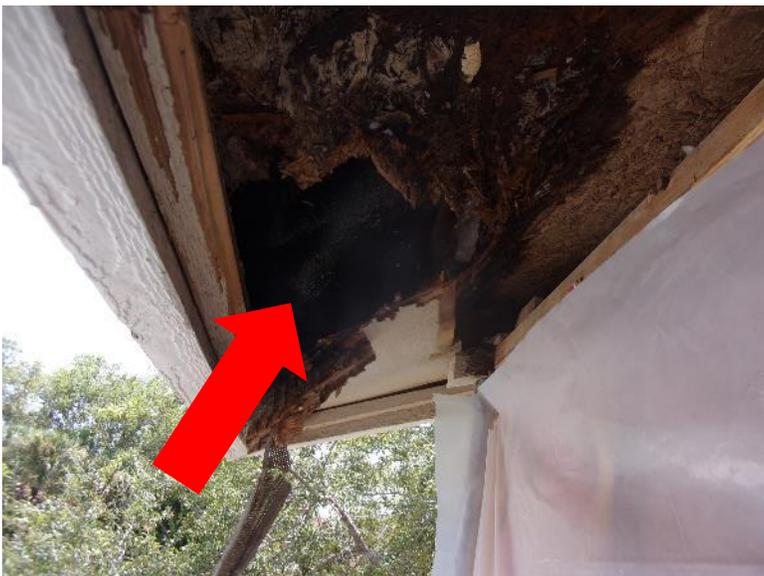
PHOTOGRAPH #24

**BUILDING 6
SECTION G**

Roofing sheathing damage above soffit to be addressed by owners roofing contractors.

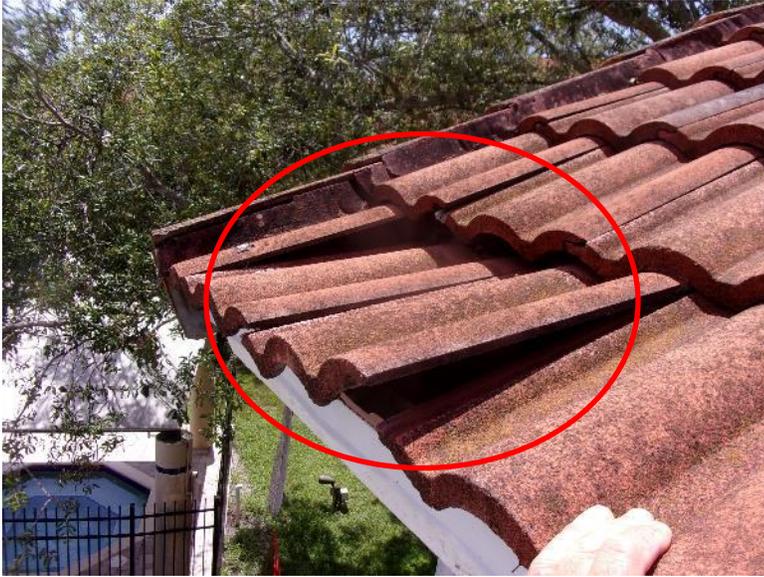
PHOTOGRAPH #25

**BUILDING 6
SECTION G**

Roofing sheathing damage above soffit to be addressed by owners roofing contractors.
