PHOTOGRAPHS

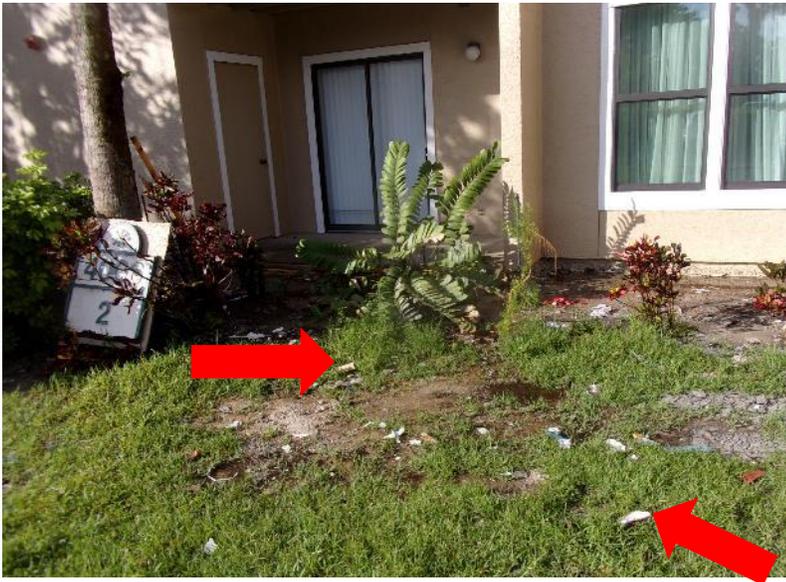
PHOTOGRAPH #1

**BUILDING 2
SECTION B**

Construction debris and trash scattered around the building. Contractor to cleanup.

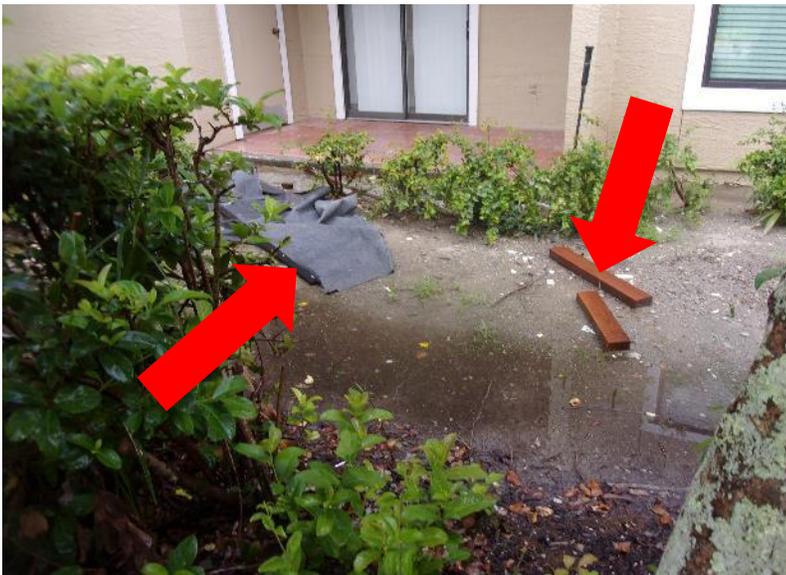
PHOTOGRAPH #2

**BUILDING 2
SECTION E**

Construction debris and trash scattered around the building. Contractor to cleanup.

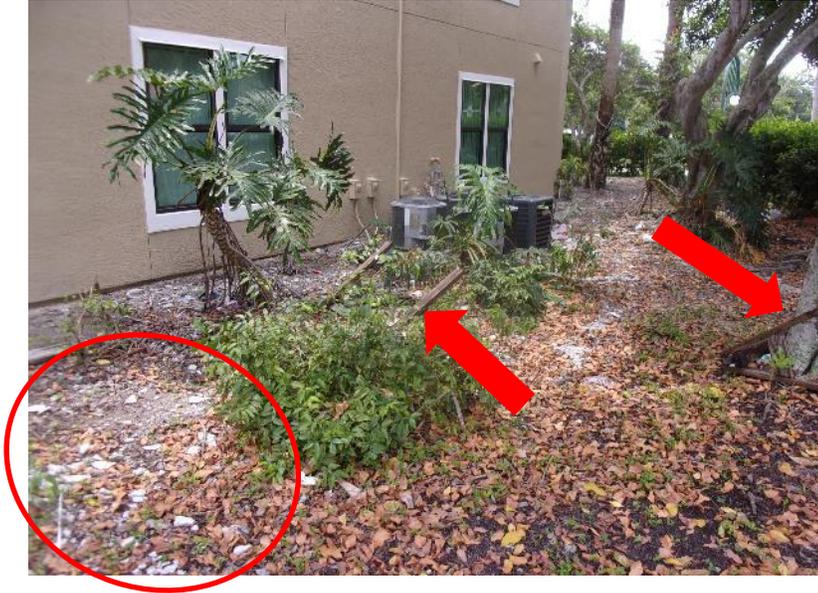
PHOTOGRAPH #3

**BUILDING 2
SECTION H**

Construction debris and trash scattered around the building. Contractor to cleanup.

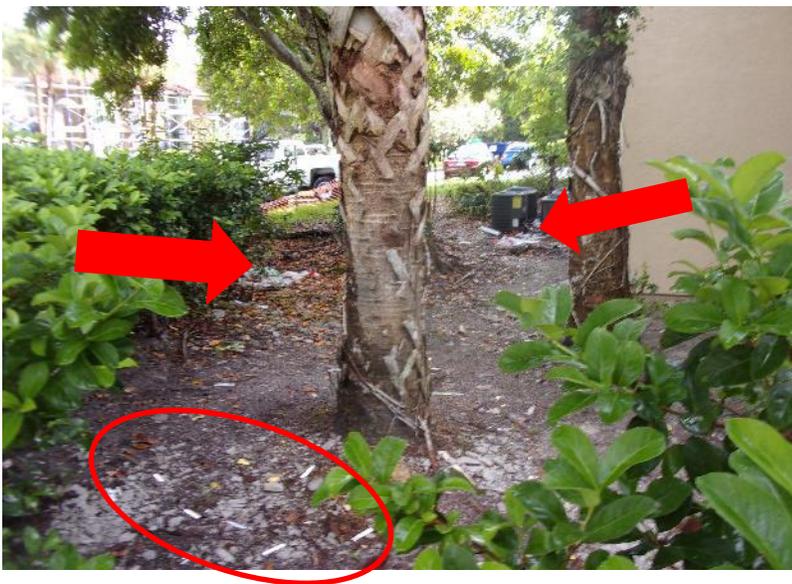
PHOTOGRAPH #4

**BUILDING 2
SECTION D**

Construction debris and trash scattered around the building. Contractor to cleanup.

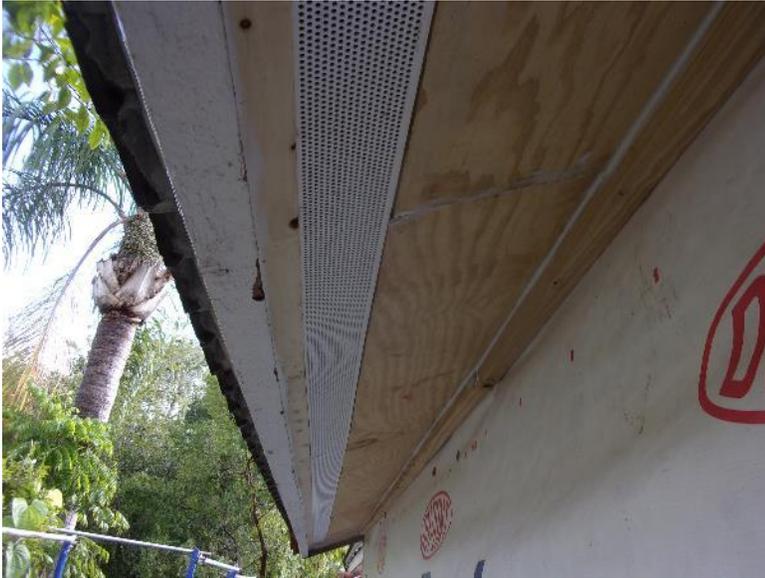
PHOTOGRAPH #5

**BUILDING 3
SECTION G**

Contractor installed new plywood soffit with vent. All seams were caulked and ready for paint.

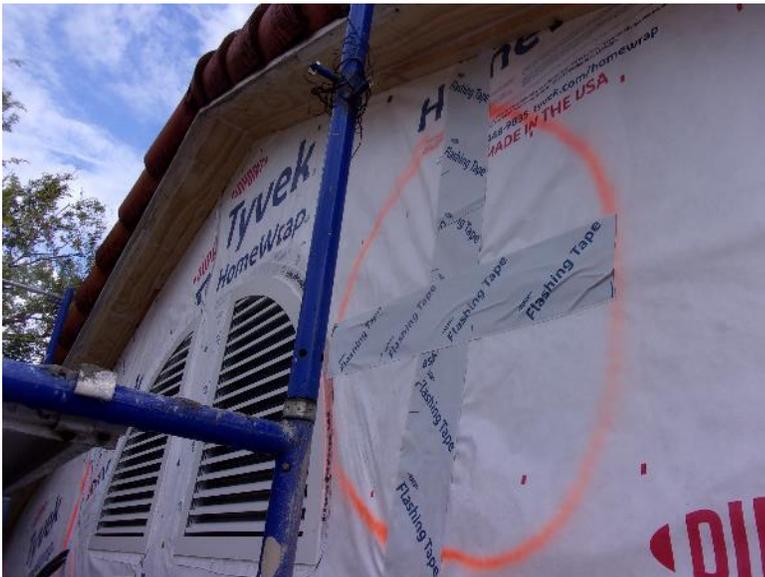
PHOTOGRAPH #6

**BUILDING 3
SECTION H**

Contractor made corrections where seam tape was improperly used at penetrations.

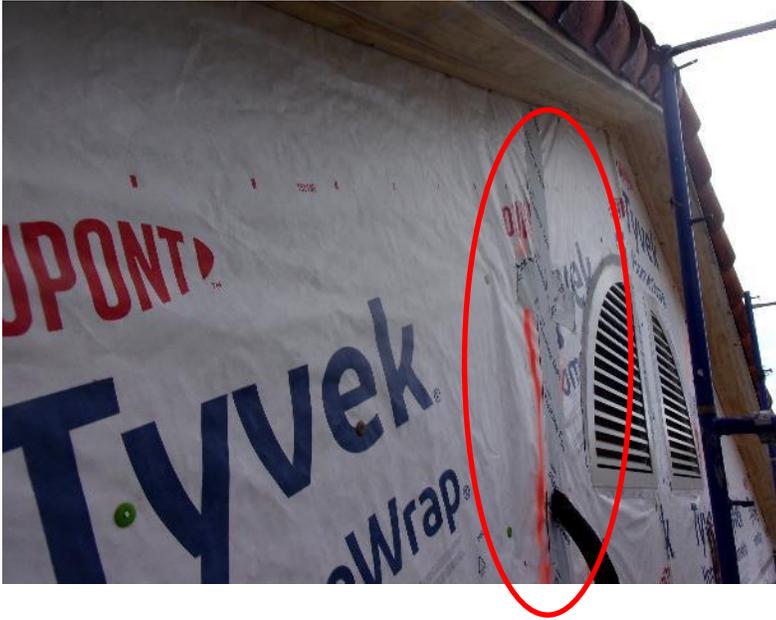
PHOTOGRAPH #7

**BUILDING 3
SECTION H**

Contractor made corrections where seam tape was improperly used at penetrations.

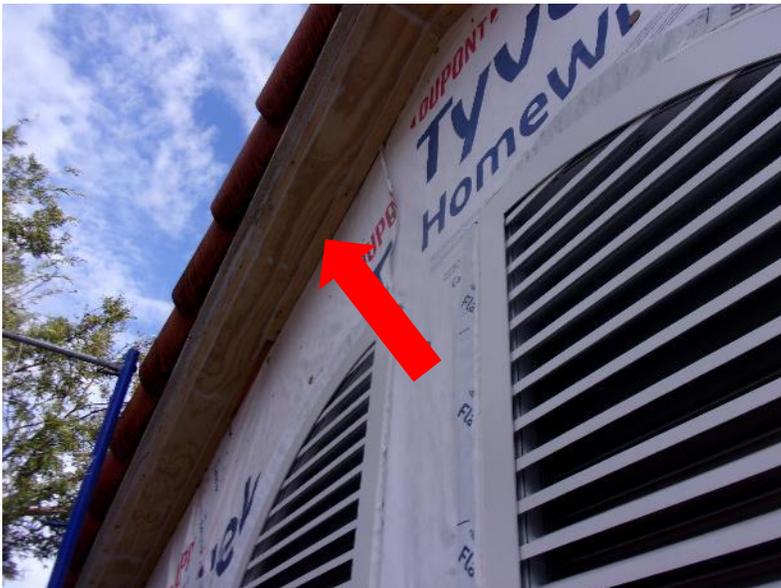
PHOTOGRAPH #8

**BUILDING 3
SECTION H**

Contractor installed new plywood soffit. All seams were caulked and ready for paint.

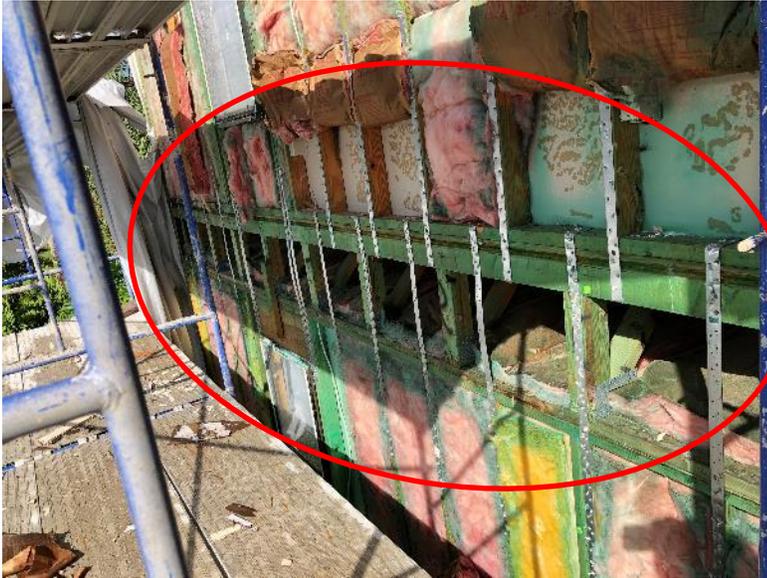
PHOTOGRAPH #9

**BUILDING 3
SECTION A**

Simpson Strong Tie connectors and straps installed as per drawings and specifications.

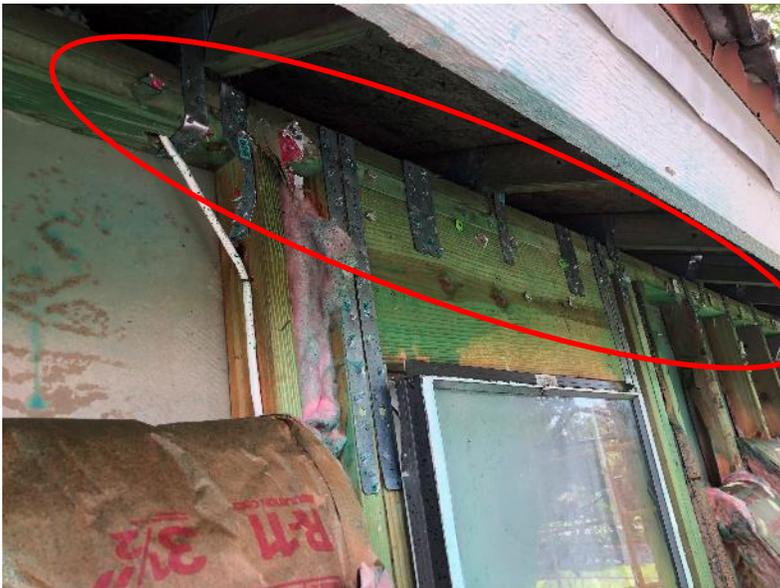
PHOTOGRAPH #10

**BUILDING 3
SECTION A**

Simpson Strong Tie connectors and straps installed as per drawings and specifications.

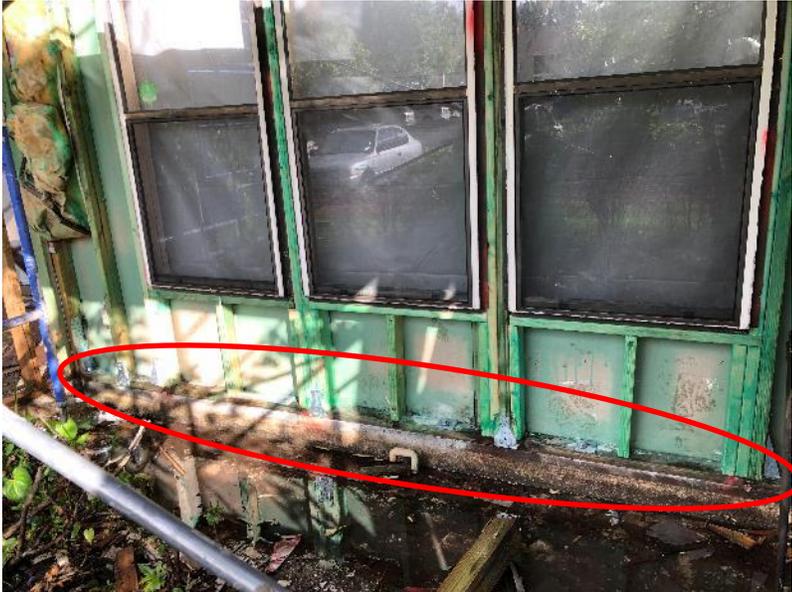
PHOTOGRAPH #11

**BUILDING 3
SECTION B**

Simpson Strong Tie connectors and anchors installed as per drawings and specifications.

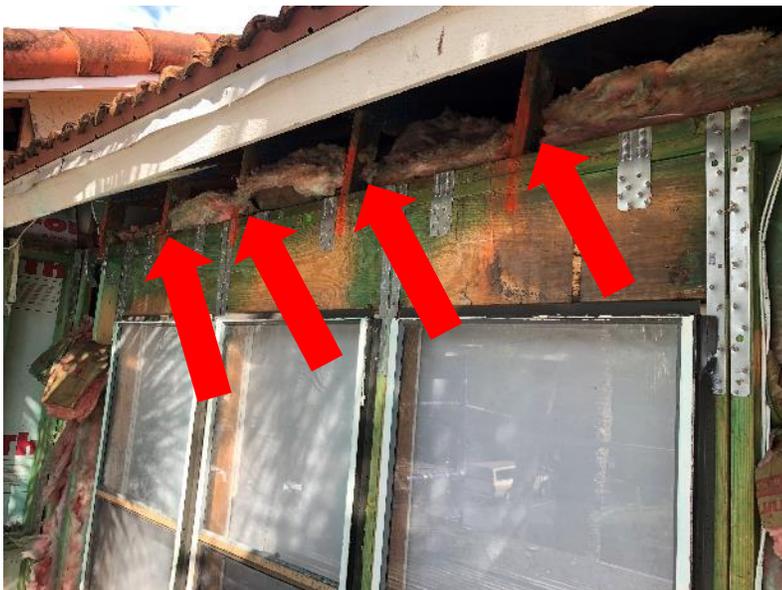
PHOTOGRAPH #12

**BUILDING 3
SECTION B**

Trusses are missing Strap 'G', located from truss to double top plate.

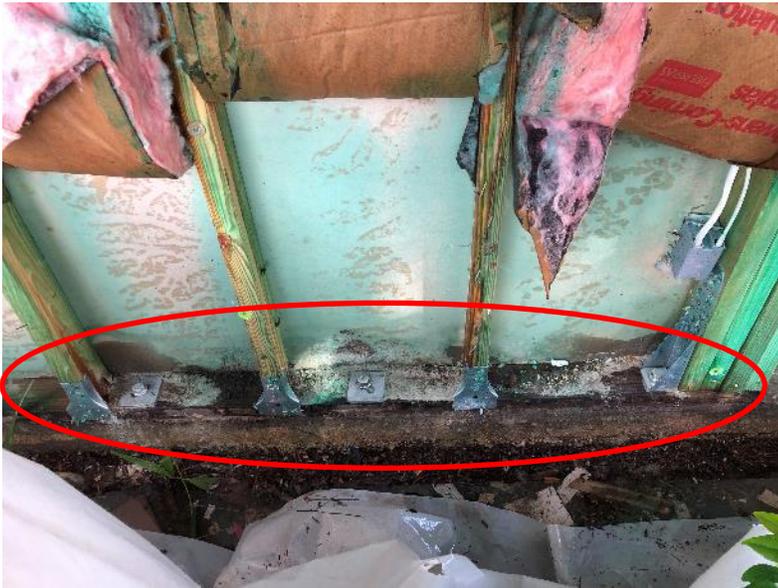
PHOTOGRAPH #13

**BUILDING 3
SECTION C**

Simpson Strong Tie connectors and anchors installed as per drawings and specifications.

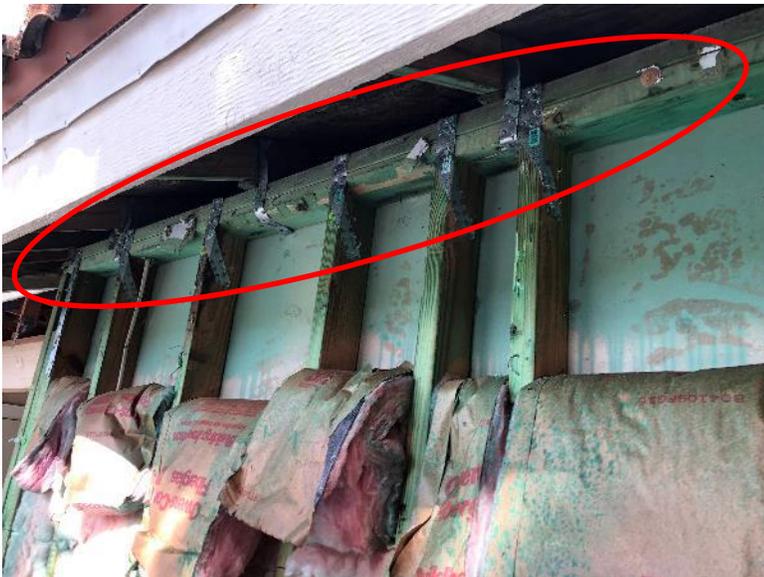
PHOTOGRAPH #14

**BUILDING 3
SECTION C**

Simpson Strong Tie connectors and straps installed as per drawings and specifications.

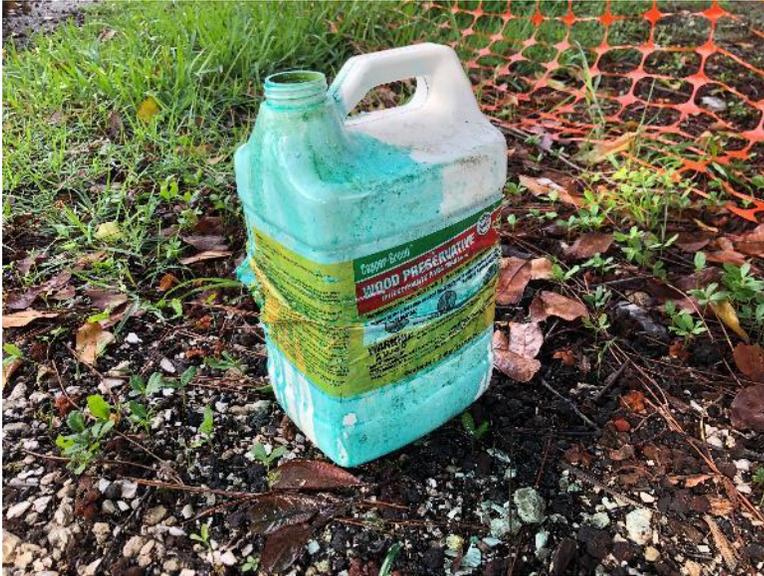
PHOTOGRAPH #15

**BUILDING 3
SECTION C**

Contractor applied Copper-Green Wood Preservative to bottom 2'-0" of framing.

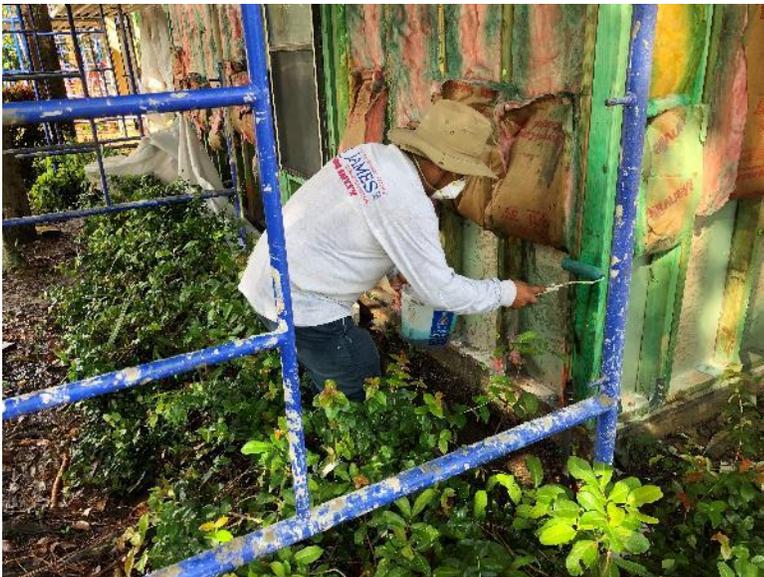
PHOTOGRAPH #16

**BUILDING 3
SECTION C**

Contractor applied Copper-Green Wood Preservative to bottom 2'-0" of framing.

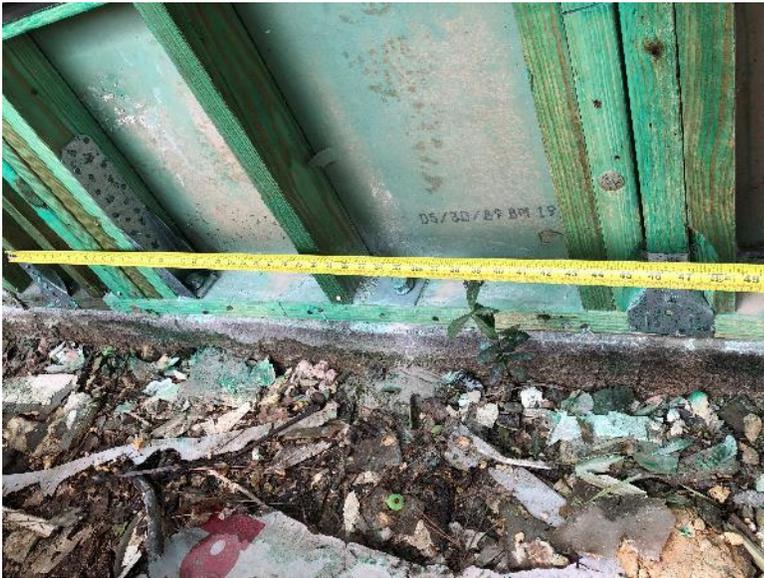
PHOTOGRAPH #17

**BUILDING 3
SECTION D**

Simpson Strong Tie connectors and anchors installed as per drawings and specifications.

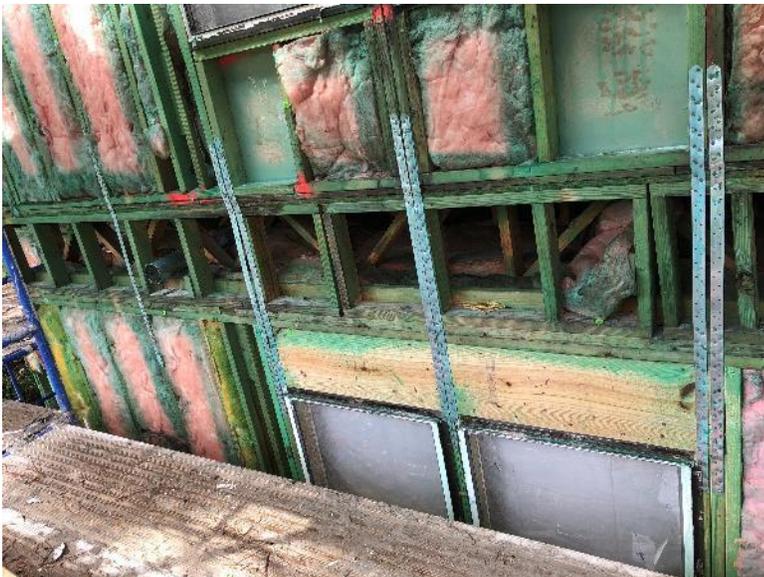
PHOTOGRAPH #18

**BUILDING 3
SECTION D**

Simpson Strong Tie connectors and straps installed as per drawings and specifications.

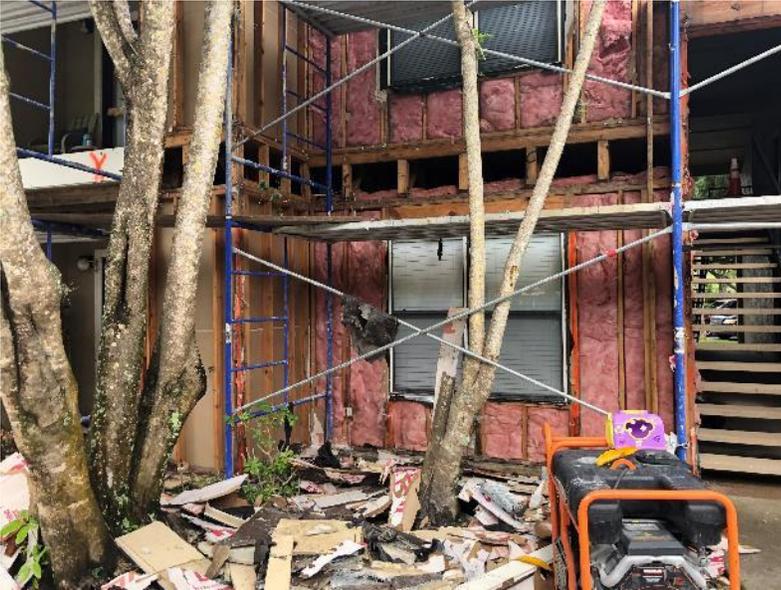
PHOTOGRAPH #19

**BUILDING 6
SECTION E**

Wood rot damage marked for repairs at stud framing and around windows.

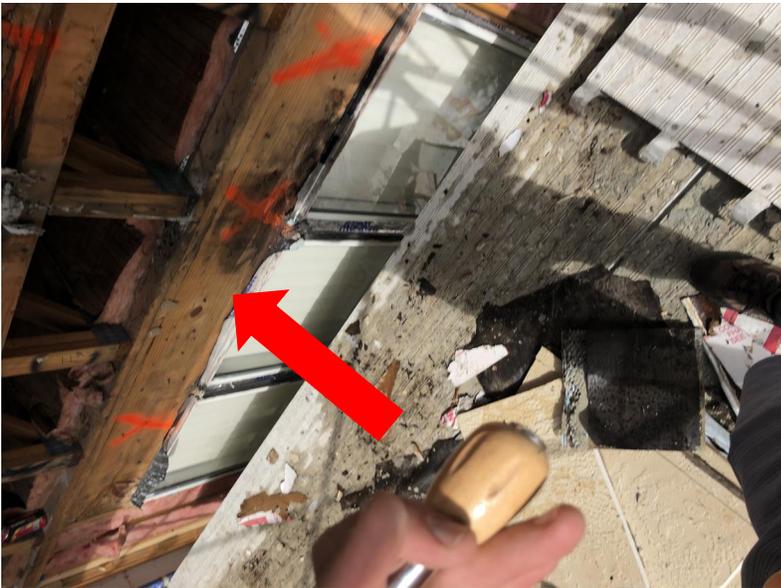
PHOTOGRAPH #20

**BUILDING 6
SECTION F**

Header above windows marked for replacement due to wood rot.

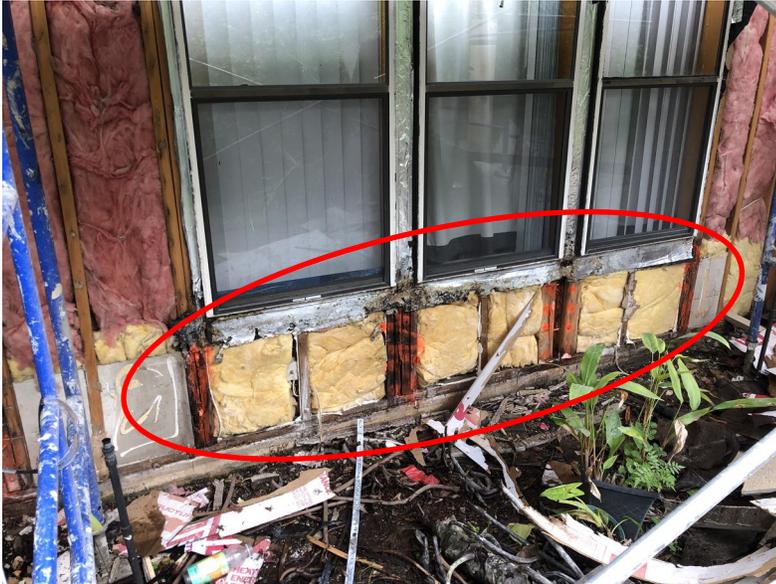
PHOTOGRAPH #21

**BUILDING 6
SECTION F**

Wood rot damage marked for repairs below windows.

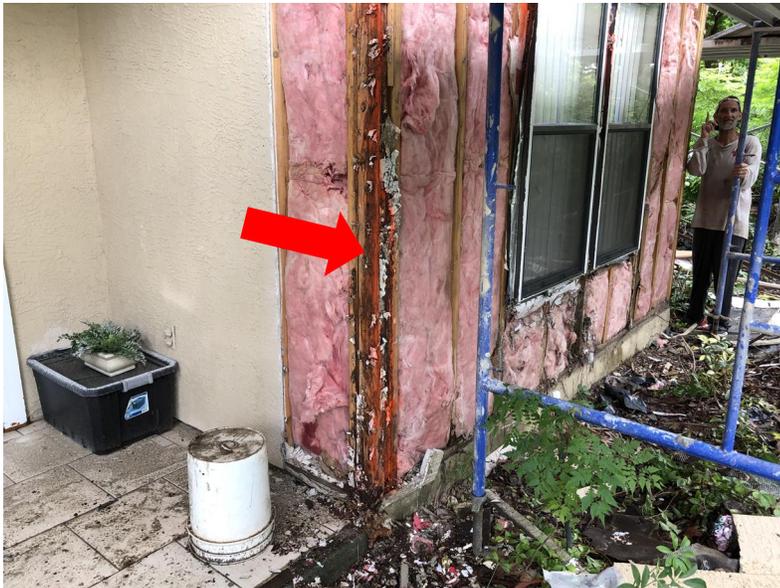
PHOTOGRAPH #22

**BUILDING 6
SECTION G**

Stud framing at balcony corner marked for repairs.

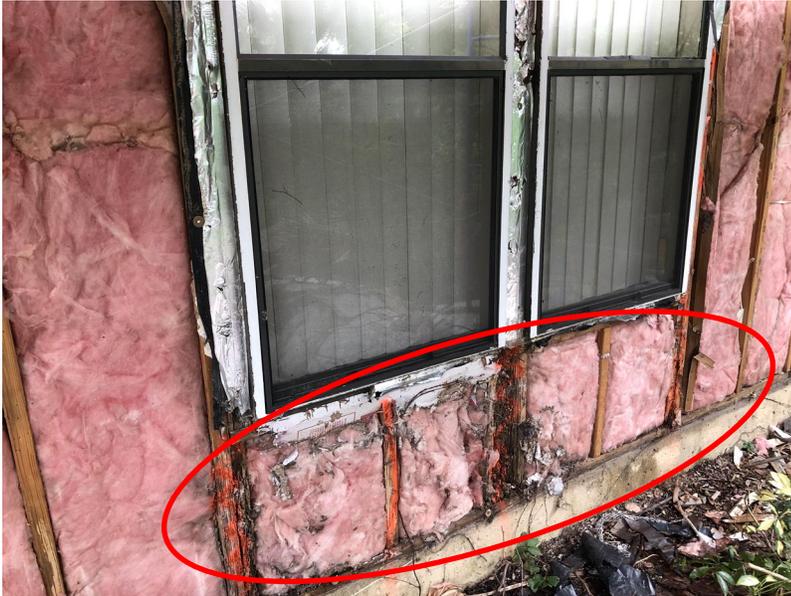
PHOTOGRAPH #23

**BUILDING 6
SECTION G**

Wood rot damage marked for repairs below windows.

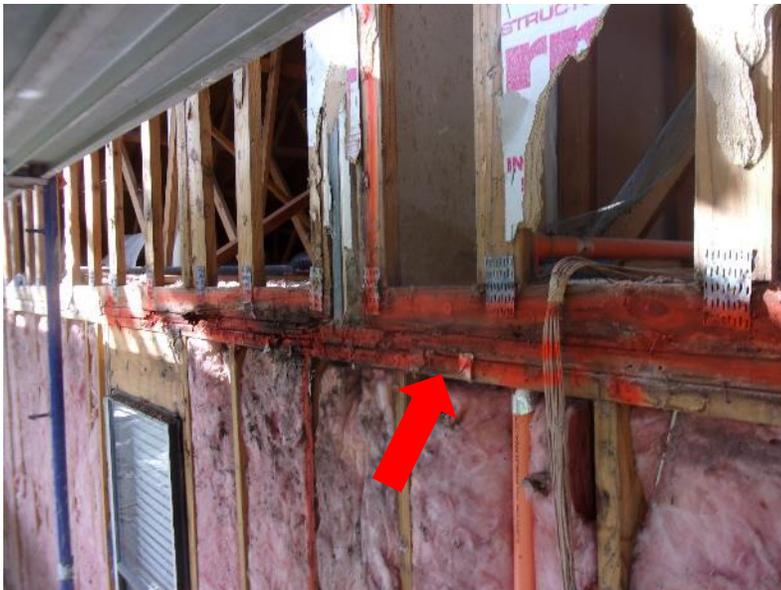
PHOTOGRAPH #24

**BUILDING 6
SECTION H**

Roof truss wood rot marked for replacement.

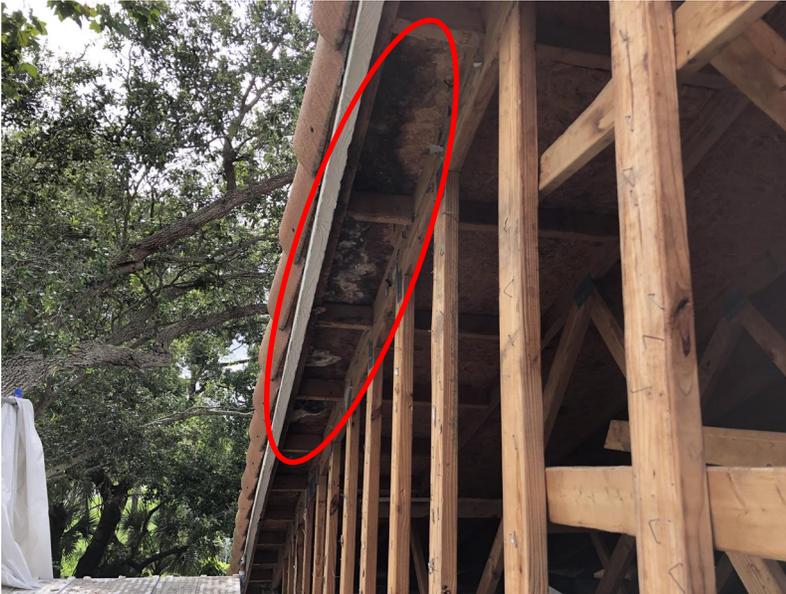
PHOTOGRAPH #25

**BUILDING 6
SECTION H**

Roofing sheathing damage and recent roofing leaks observed over soffit area. Owners to have roofing contractor perform repair.
