## PHOTOGRAPHS

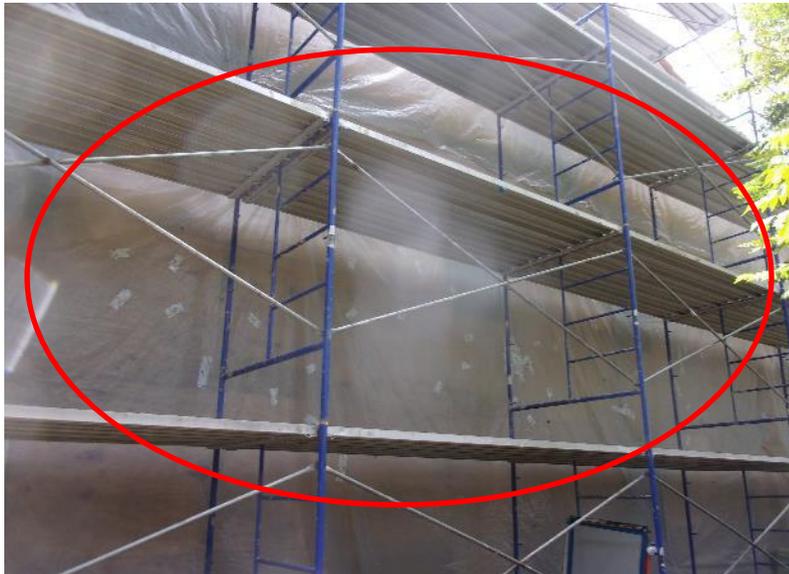
**PHOTOGRAPH #1**

### **BUILDING 6 SECTION H**

Contractor has applied new plywood sheathing, temporarily re installed old windows and covered with plastic sheeting protection while waiting for new window delivery.

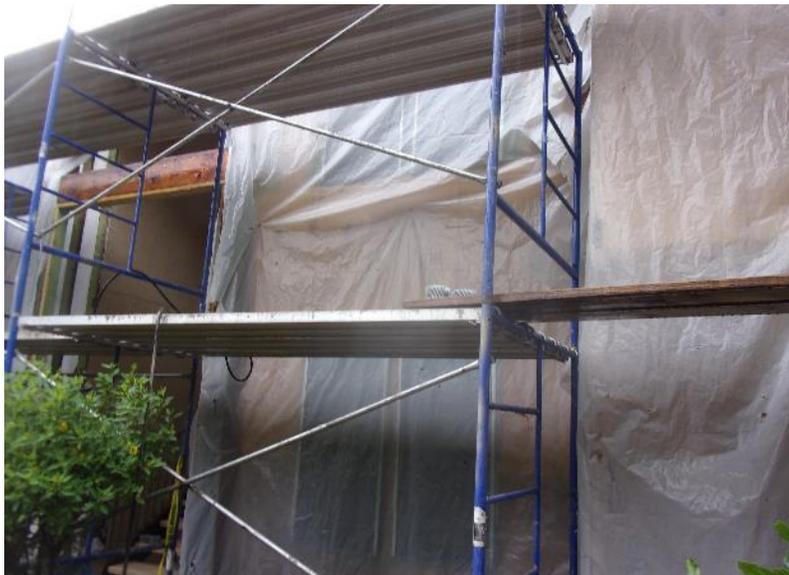
**PHOTOGRAPH #2**

### **BUILDING 6 SECTION G**

New 15/32" plywood sheathing covered with heavy plastic sheeting for weather protection.

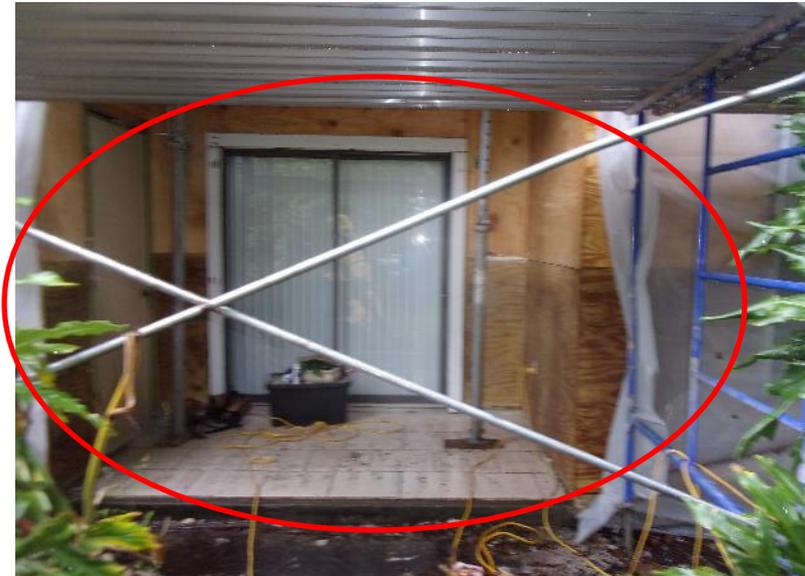
**PHOTOGRAPH #3**

**BUILDING 6  
SECTION G**

**Unit # 612** – Plywood sheathing installed at patio walls. Bottom sheet of plywood is pressure treated.

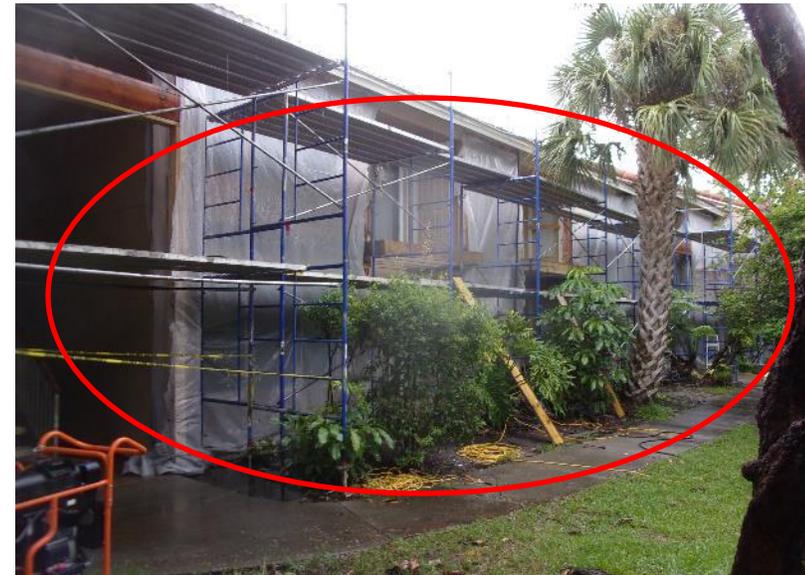
**PHOTOGRAPH #4**

**BUILDING 6  
SECTION F**

Framing repairs covered with heavy plastic sheeting for weather protection.

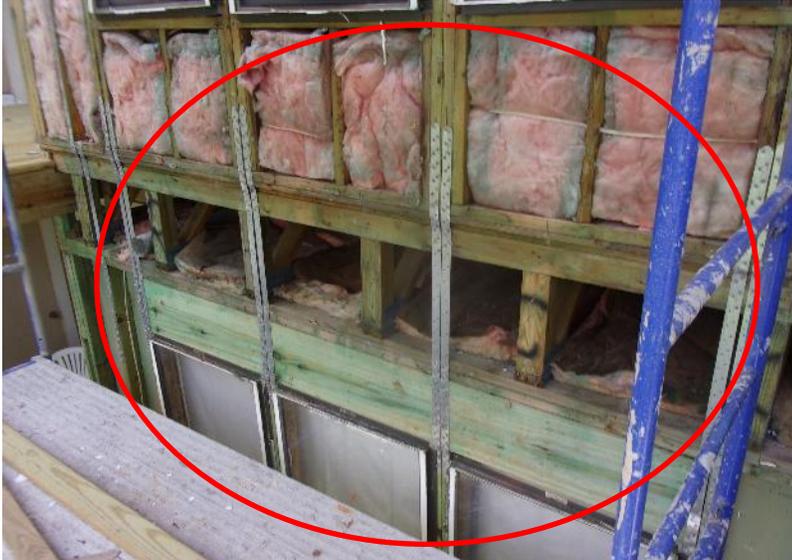
**PHOTOGRAPH #5**

**BUILDING 6  
SECTION F**

Bora - Care termite treatment applied to exterior wall framing and Simpson Strong-Tie straps installed.

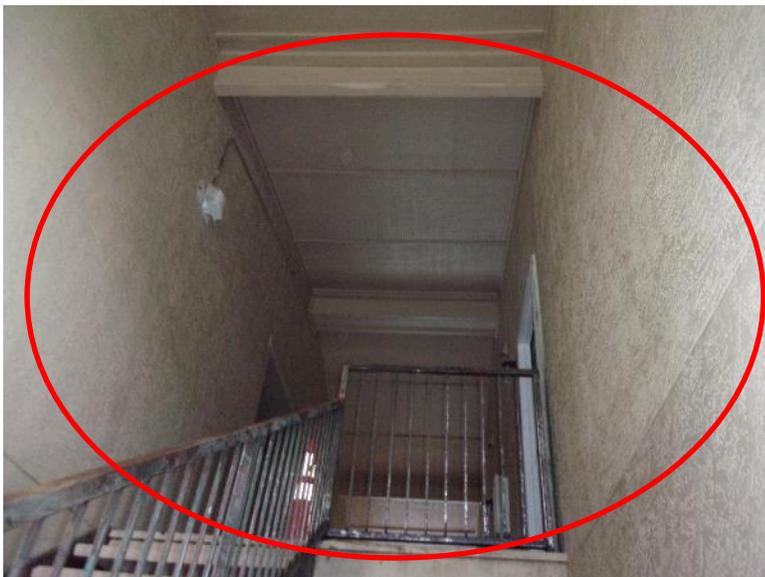
**PHOTOGRAPH #6**

**BUILDING 6  
SECTION E**

Breezeway walls and ceilings pressure cleaned in preparation for painting.

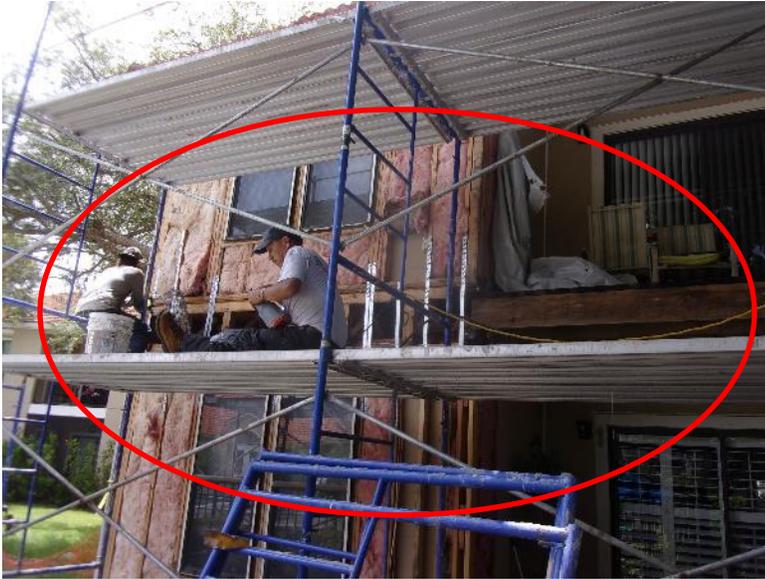
**PHOTOGRAPH #7**

**BUILDING 6  
SECTION E**

Contractor installing Simpson Strong-Tie MST-A 49 connector straps at framing studs above and below floor trusses.

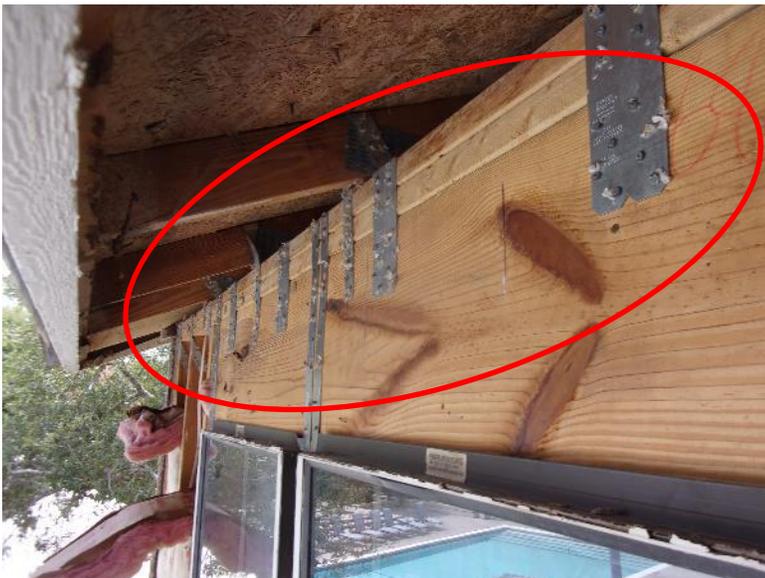
**PHOTOGRAPH #8**

**BUILDING 6  
SECTION E**

Contractor has installed Simpson Strong-Tie connectors at top plates and trusses but has not completed by adding SDWC 15600 screws.

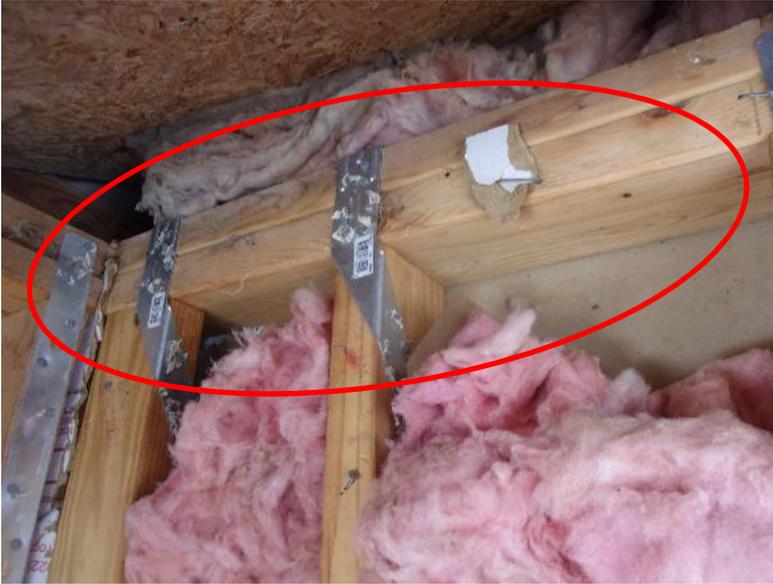
**PHOTOGRAPH #9**

**BUILDING 6  
SECTION E**

Contractor has installed Simpson Strong-Tie connectors at top plates and trusses but has not completed by adding SDWC 15600 screws.

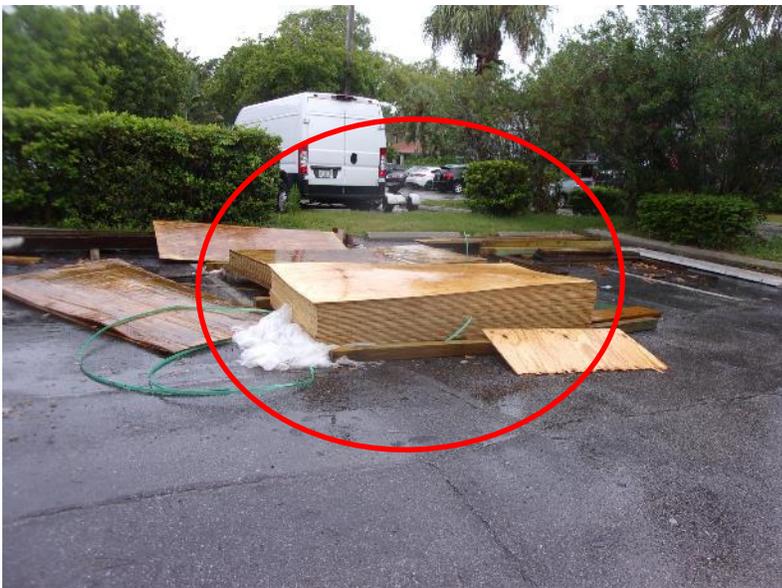
**PHOTOGRAPH #10**

**BUILDING 6  
STORAGE AREA**

Plywood stagged in parking area uncovered while raining.
