PHOTOGRAPHS

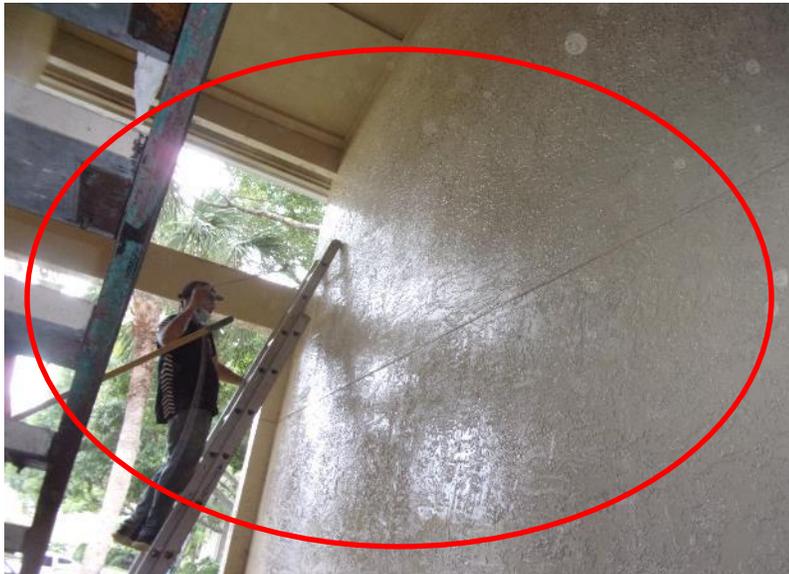
PHOTOGRAPH #1

**BUILDING 6
SECTION E**

Contractor applying Florida Paints Ultra Exterior Supercoat by spray and backtrolling application.

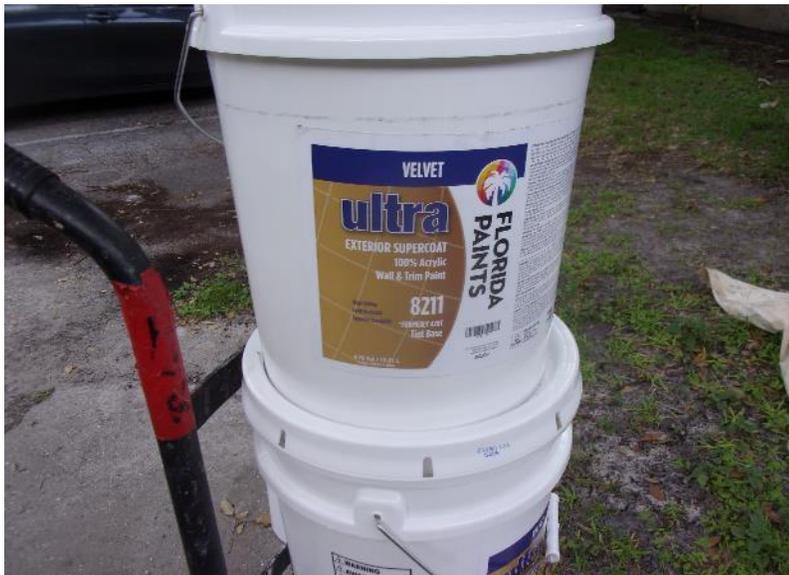
PHOTOGRAPH #2

**BUILDING 6
SECTION E**

Contractor applying Florida Paints Ultra Exterior Supercoat by spray and backtrolling application.

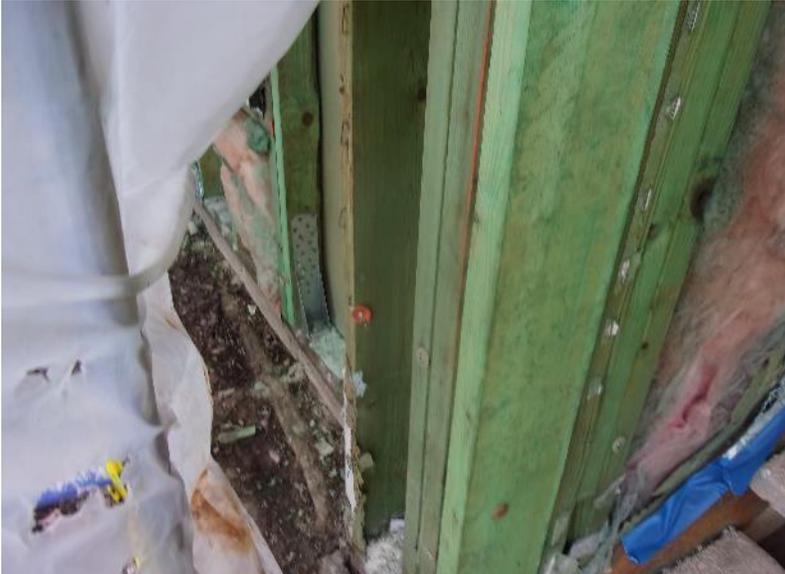
PHOTOGRAPH #3

**BUILDING 6
SECTION E**

Bora-Care termite treatment applied by pest sub-contractor at wall framing.

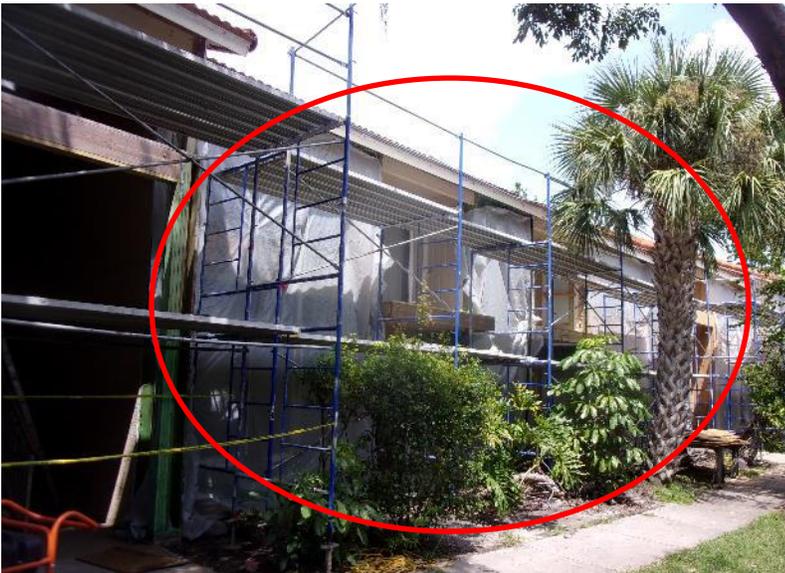
PHOTOGRAPH #4

**BUILDING 6
SECTION F**

Framing repairs at walls and balconies protected with plastic sheathing.

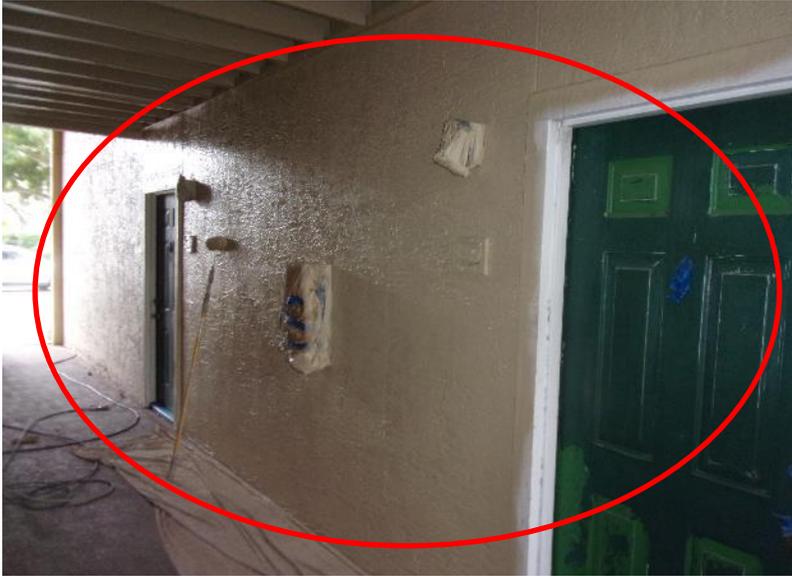
PHOTOGRAPH #5

**BUILDING 6
SECTION G**

Breezeway walls painted and front entrance doors sanded for application of primer and finish coat.

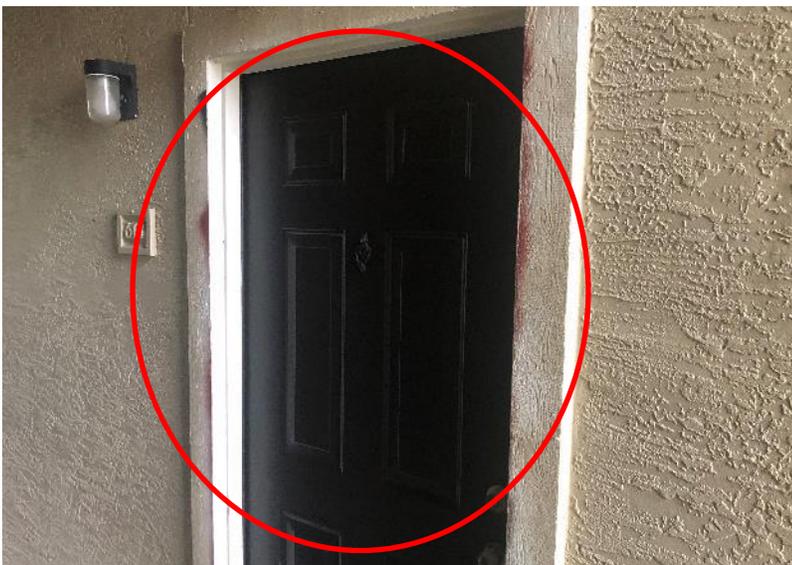
PHOTOGRAPH #6

**BUILDING 6
SECTION G**

Front doors painted with Florida Paints Allgrip Exterior Acrylic paint.

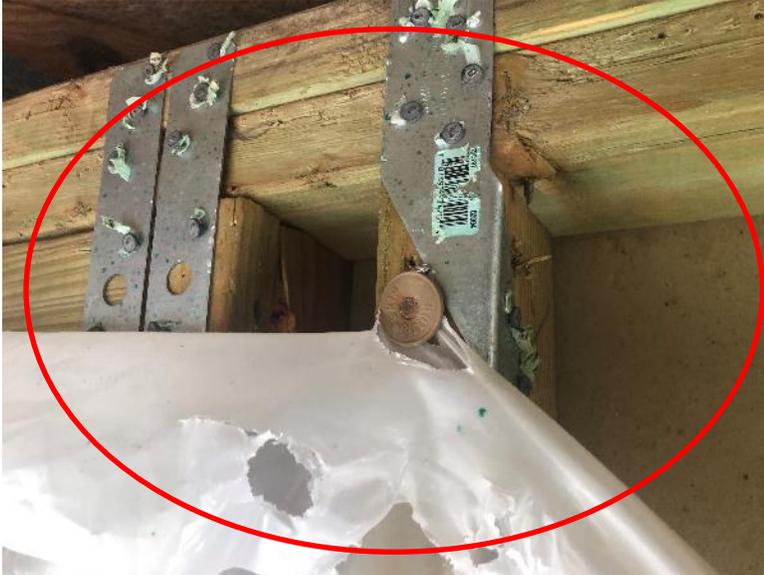
PHOTOGRAPH #7

**BUILDING 6
SECTION G**

Simpson Strong Tie SDWC 15600 screws added where missing at top plate and trusses.

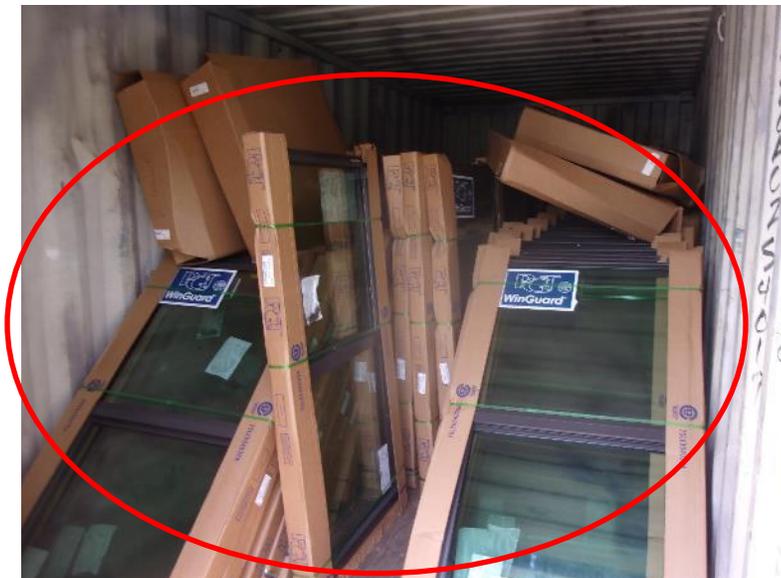
PHOTOGRAPH #8

**BUILDING 3
STORAGE AREA**

Delivery of New PGT 7700A single hung windows for buildings #6. Contractor has verified WOCDs are installed on windows for second floor.

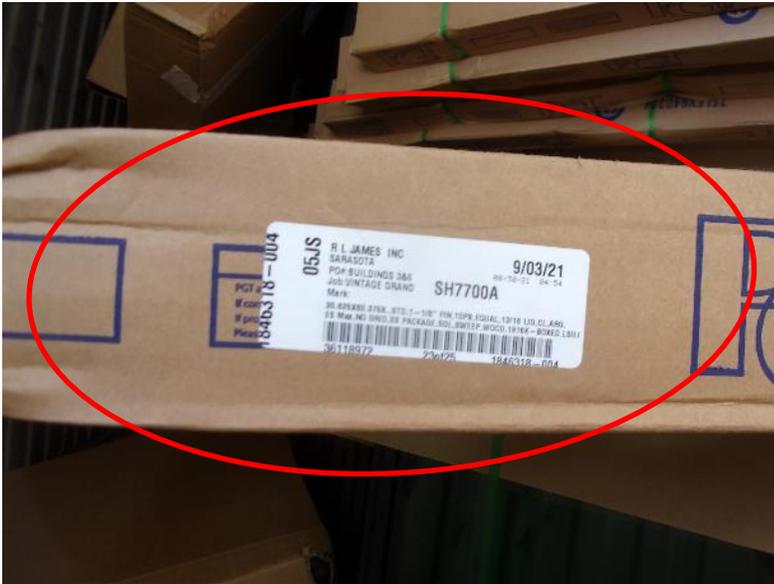
PHOTOGRAPH #9

**BUILDING 3
STORAGE AREA**

Delivery of New PGT 7700A single hung windows for buildings #6. Contractor has verified WOCDS are installed on windows for second floor.

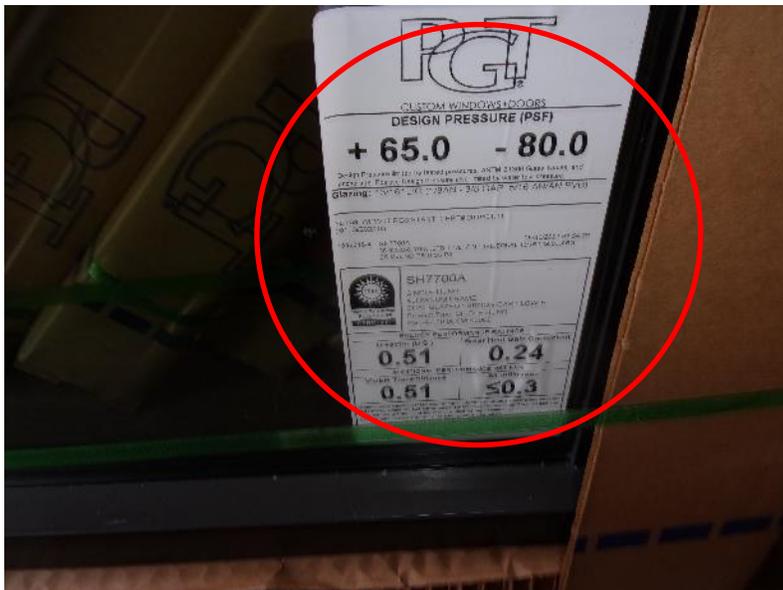
PHOTOGRAPH #10

**BUILDING 3
STORAGE AREA**

Delivery of New PGT 7700A single hung windows for buildings #6. Contractor has verified WOCDS are installed on windows for second floor.

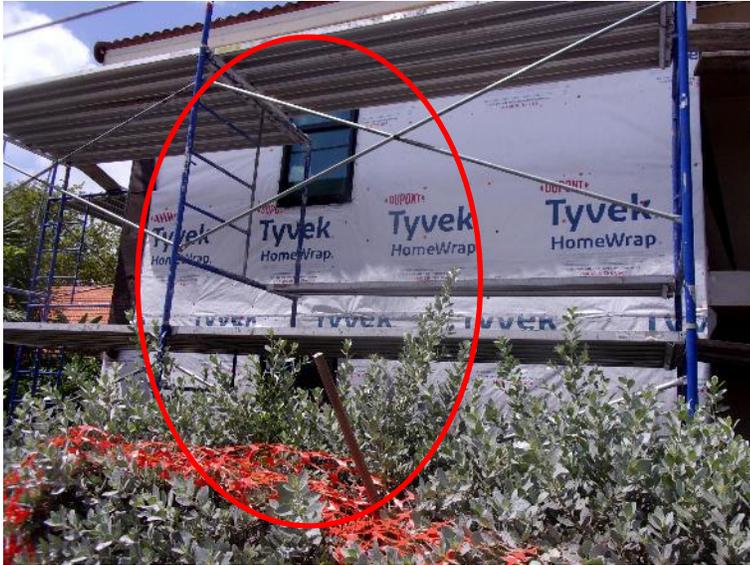
PHOTOGRAPH #11

**BUILDING 3
SECTION A**

New PGT window installed, and flashing performed with DuPont Tyvek flashing system.

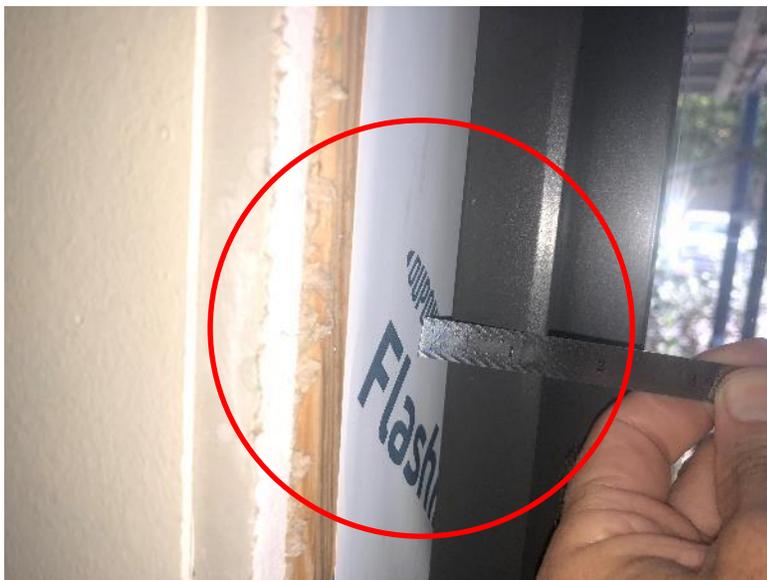
PHOTOGRAPH #12

**BUILDING 3
SECTION A**

Unit #311- Gaps from new window frame to the jambs, heads and sill are within manufactures NOC requirements for attachments.

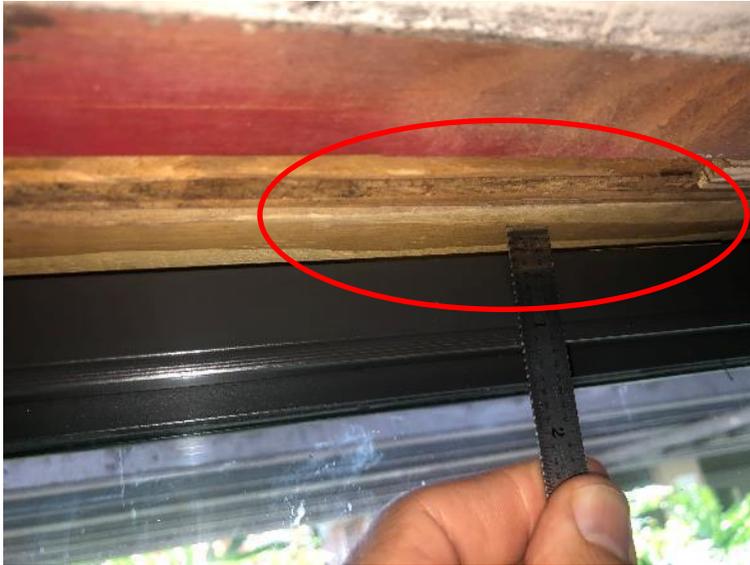
PHOTOGRAPH #13

**BUILDING 3
SECTION A**

Unit #311- Gaps from new window frame to the jambs, heads and sill are within manufactures NOC requirements for attachments.

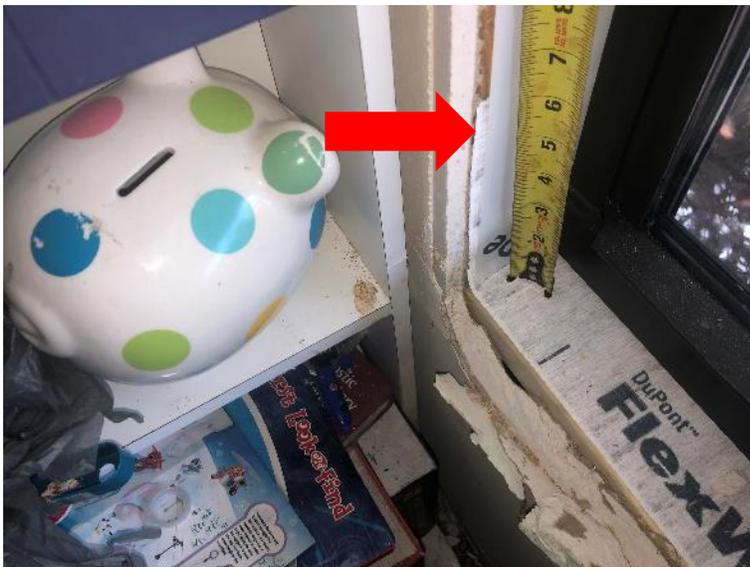
PHOTOGRAPH #14

**BUILDING 3
SECTION A**

Unit #311- New DuPont flashing at window jamb laps over sill flashing up 6" as per manufacturers recommendations and AAMA guidelines.

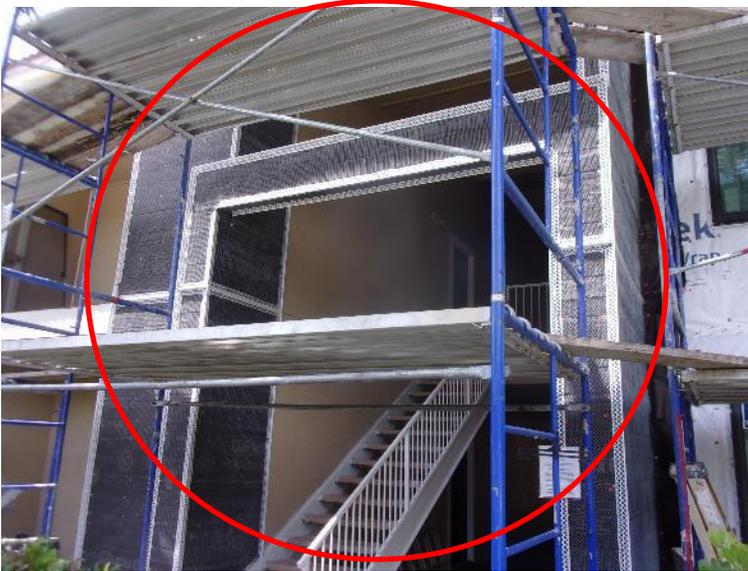
PHOTOGRAPH #15

**BUILDING 3
SECTION A**

Stucco Sub-contractor has begun to install water resistant barrier, metal lath and stucco accessories.

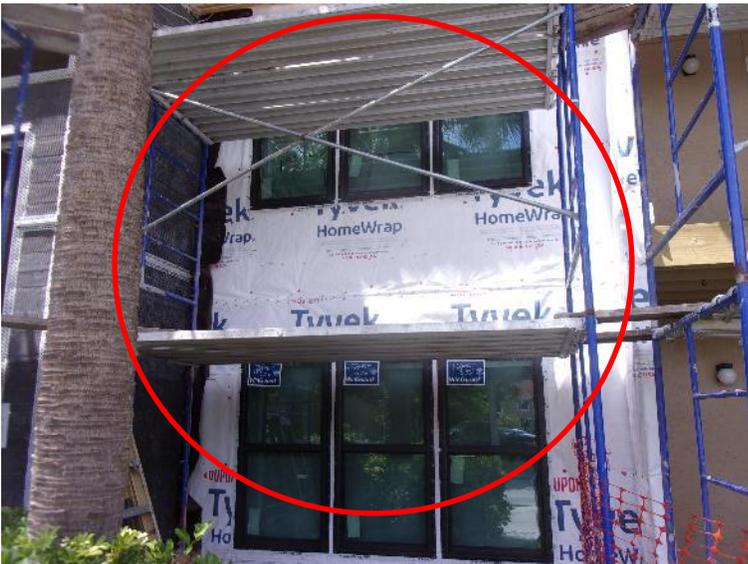
PHOTOGRAPH #16

**BUILDING 3
SECTION B**

New PGT window installed, and flashing performed with DuPont Tyvek flashing system.

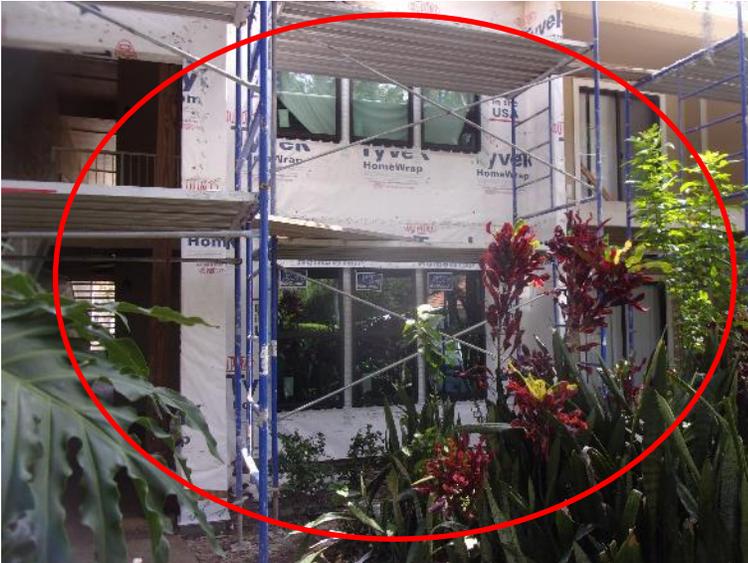
PHOTOGRAPH #17

**BUILDING 3
SECTION C**

New PGT window installed, and flashing performed with DuPont Tyvek flashing system.

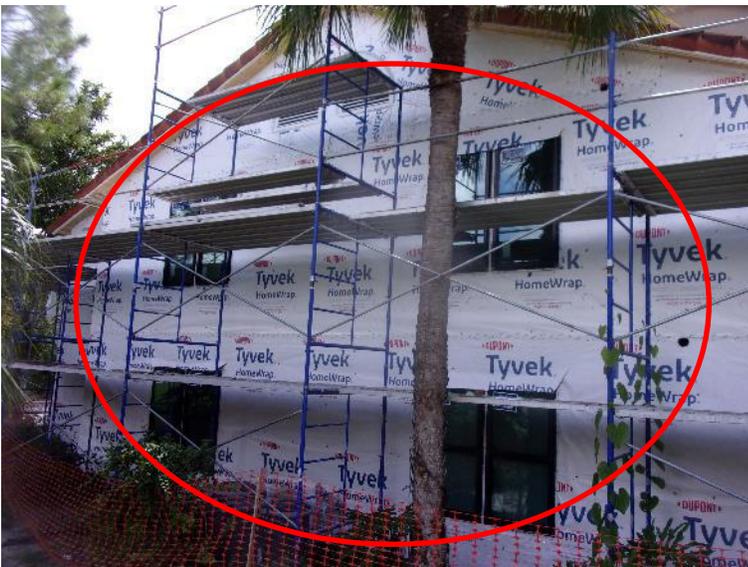
PHOTOGRAPH #18

**BUILDING 3
SECTION D**

New PGT window installed, and flashing performed with DuPont Tyvek flashing system.

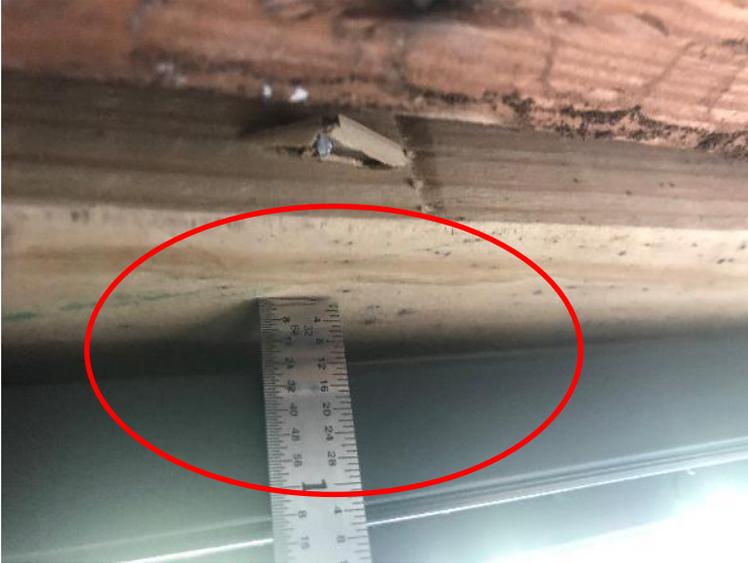
PHOTOGRAPH #19

**BUILDING 3
SECTION D**

Unit #318- Gaps from new window frame to the head framing are not within manufactures NOC requirements for attachments.

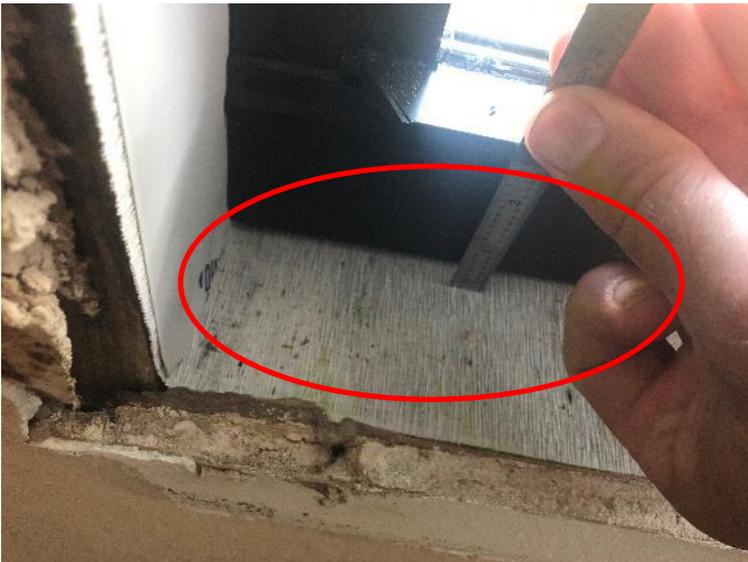
PHOTOGRAPH #20

**BUILDING 3
SECTION D**

Unit #318- Gaps from new window frame to the jambs and sill are within manufactures NOC requirements for attachments.

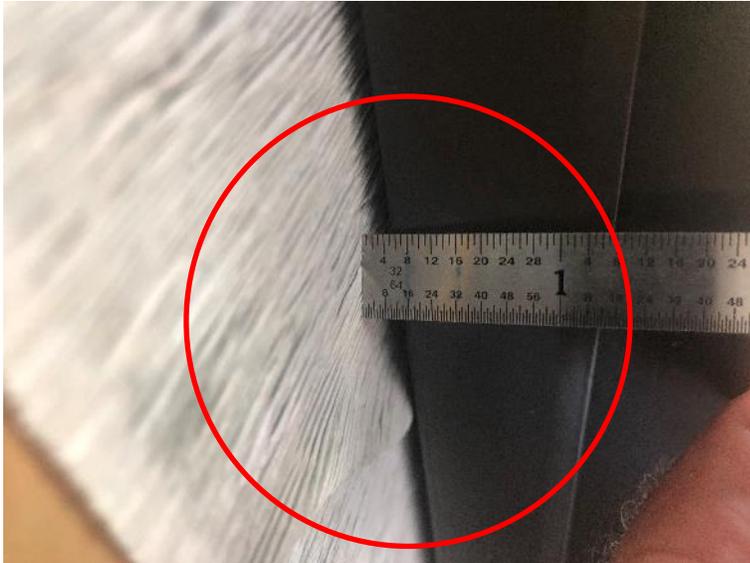
PHOTOGRAPH #21

**BUILDING 3
SECTION D**

Gaps from new window frame to the
jamb and sill are within manufactures
NOC requirements for attachments.

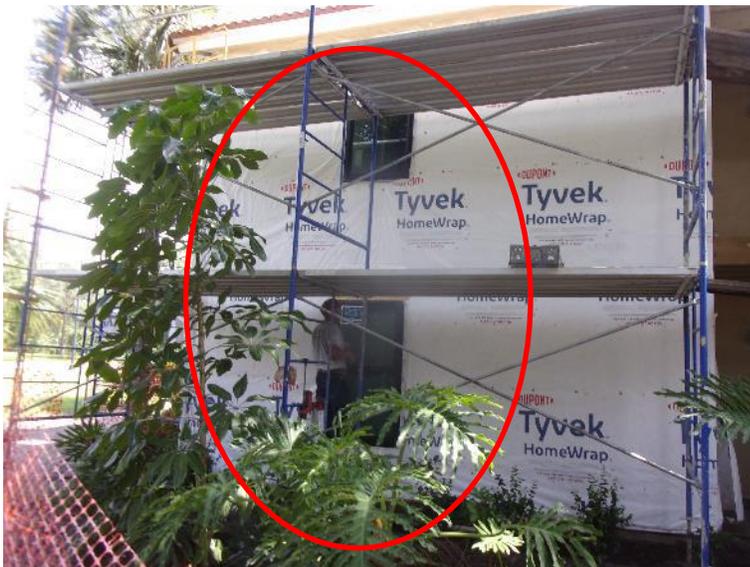
PHOTOGRAPH #22

**BUILDING 3
SECTION E**

New PGT window installed, and flashing
performed with DuPont Tyvek flashing
system.

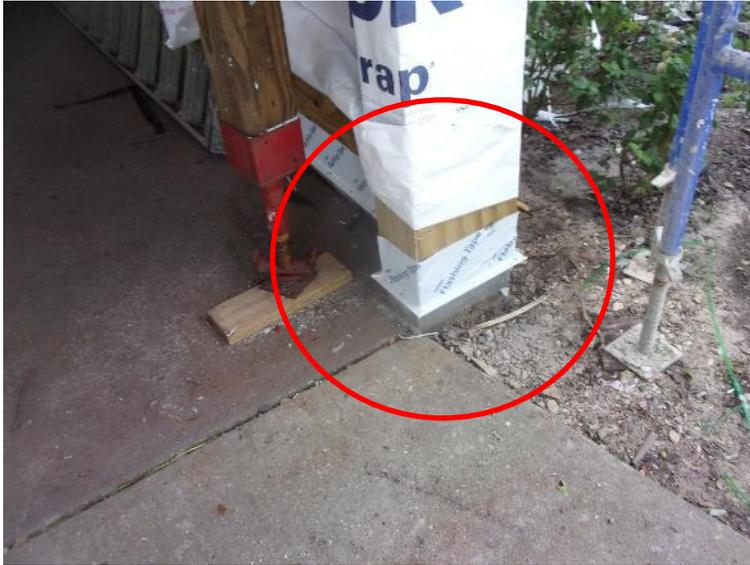
PHOTOGRAPH #23

**BUILDING 3
SECTION E**

Weep screed vinyl accessory attached to base of sheathing and flashed with Dupont Straight Flashing.

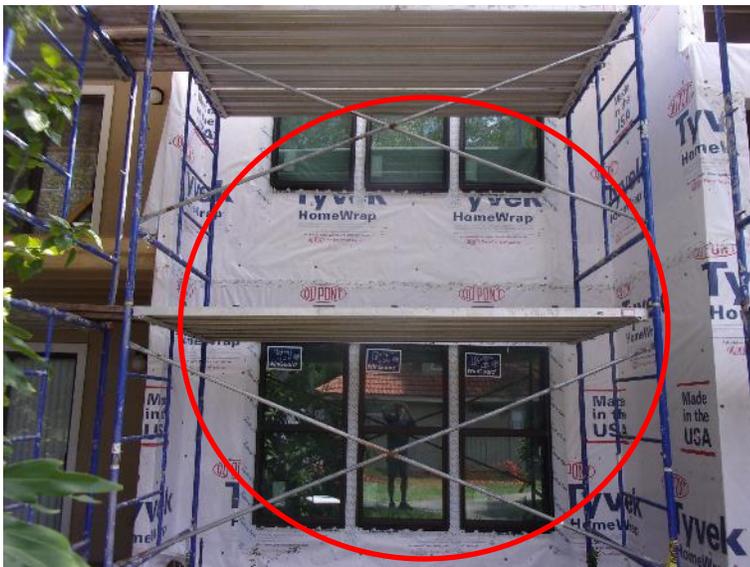
PHOTOGRAPH #24

**BUILDING 3
SECTION F**

New PGT window installed, and flashing performed with DuPont Tyvek flashing system.

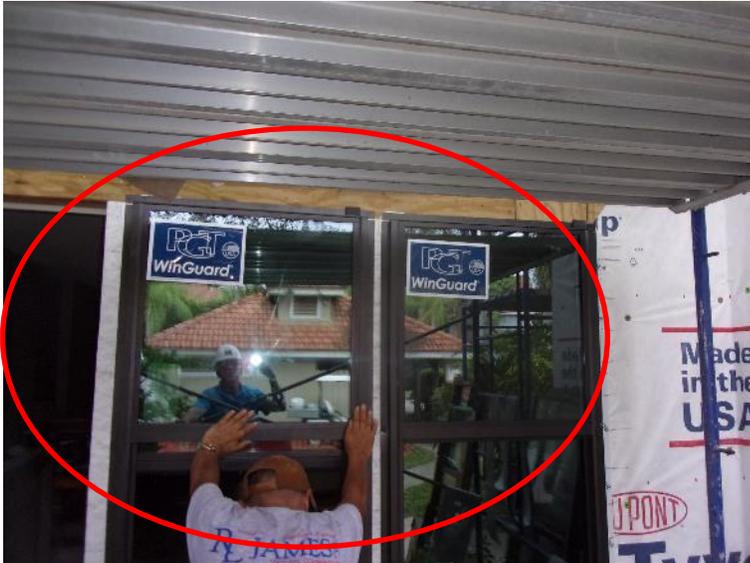
PHOTOGRAPH #25

**BUILDING 3
SECTION F**

Contractor in process of installing New PGT windows with DuPont Tyvek flashing system.

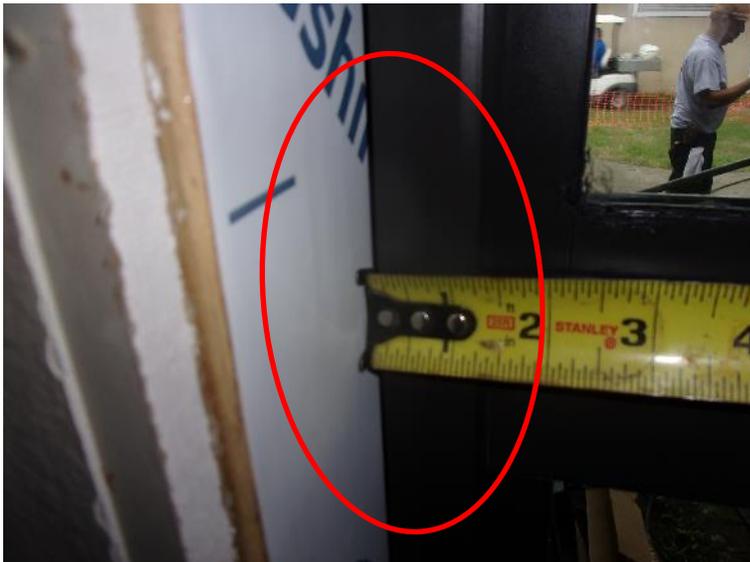
PHOTOGRAPH #26

**BUILDING 3
SECTION F**

Gaps from new window frame to the jambs, heads and sill are within manufactures NOC requirements for attachments.

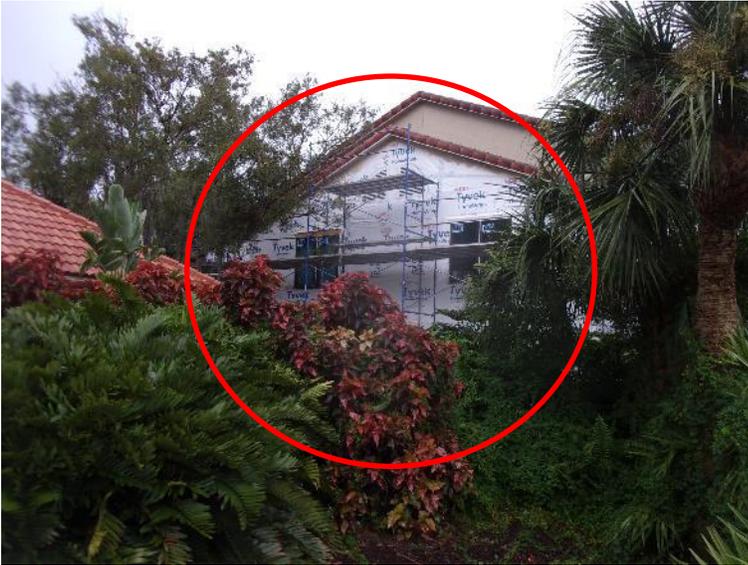
PHOTOGRAPH #27

**BUILDING 3
SECTION H**

New PGT window installed, and flashing performed with DuPont Tyvek flashing system.

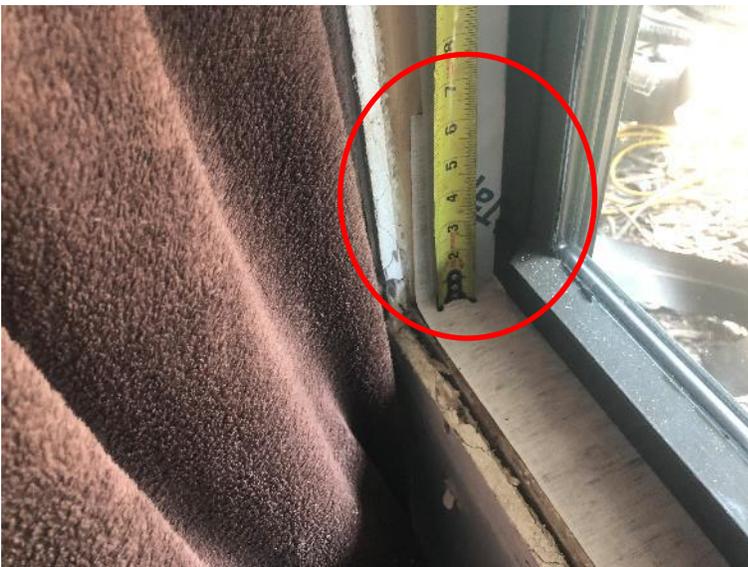
PHOTOGRAPH #28

**BUILDING 3
SECTION H**

Unit #312- New DuPont flashing at window jamb laps over sill flashing up 6" as per manufacturers recommendations and AAMA guidelines.

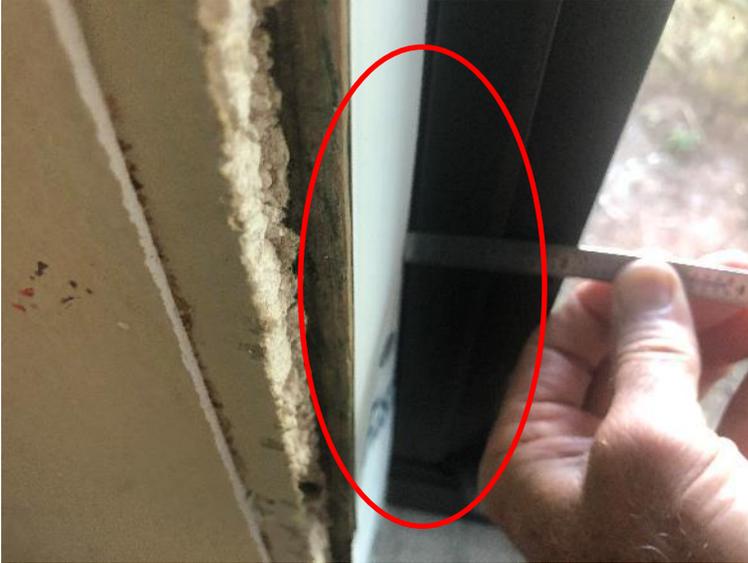
PHOTOGRAPH #29

**BUILDING 3
SECTION H**

Unit #312- Gaps from new window frame to the jambs and sill are within manufactures NOC requirements for attachments.

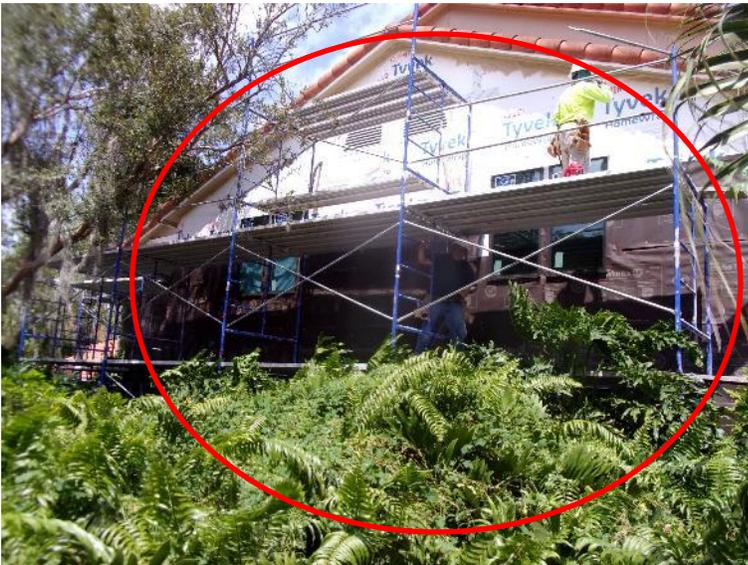
PHOTOGRAPH #30

**BUILDING 3
SECTION H**

Stucco Sub-contractor has begun to install Jumbo Tex Super 60 water resistant barrier.

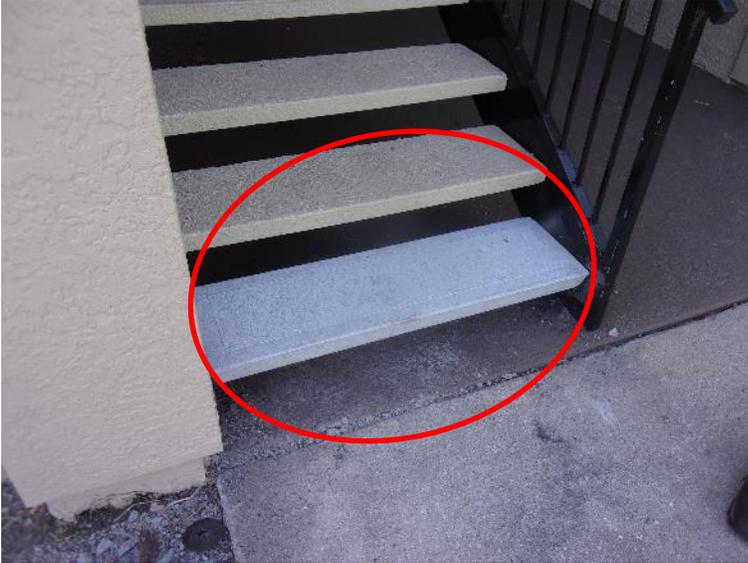
PHOTOGRAPH #31

**BUILDING 2
SECTION A**

Stair way repair completed with new concrete stair pad and welded steel angles.

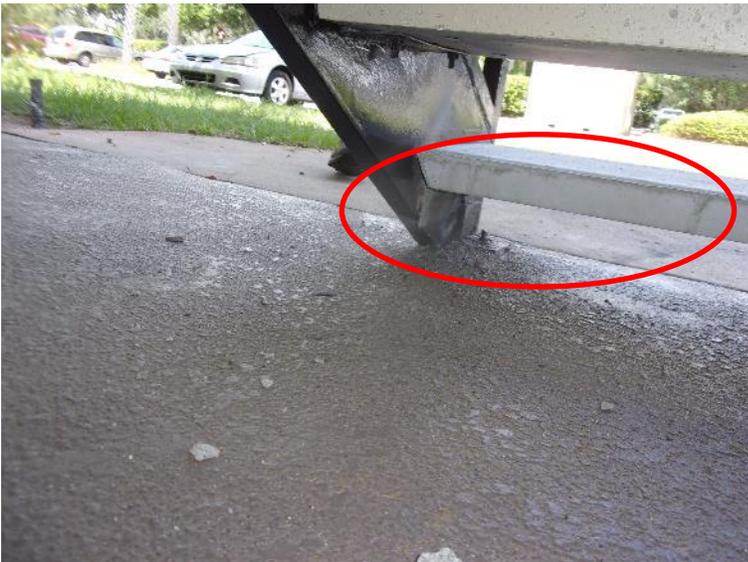
PHOTOGRAPH #32

**BUILDING 2
SECTION A**

Stair way repair completed with new concrete stair pad and welded steel angles.
