PHOTOGRAPHS

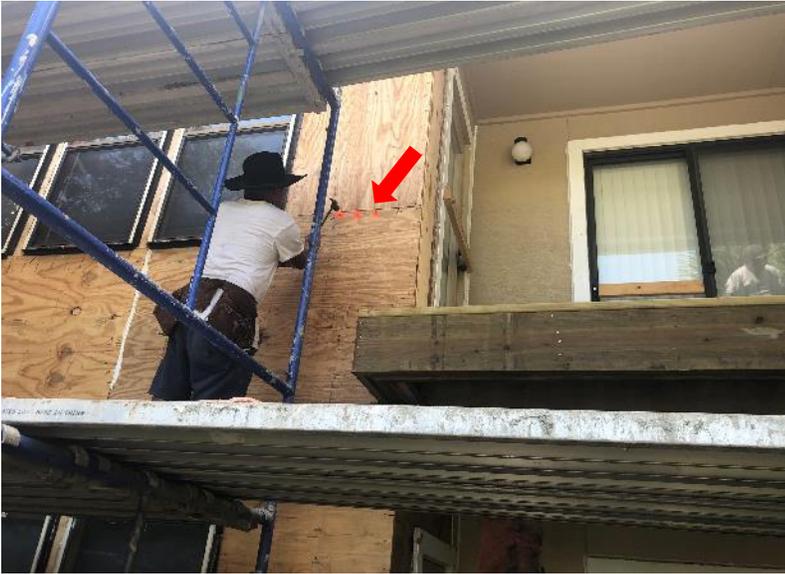
PHOTOGRAPH #1

BUILDING 6 SECTION F

Contractor made corrections where marked and installed plywood sheathing using 8d nails spaced at 4" on-center per contract drawings.

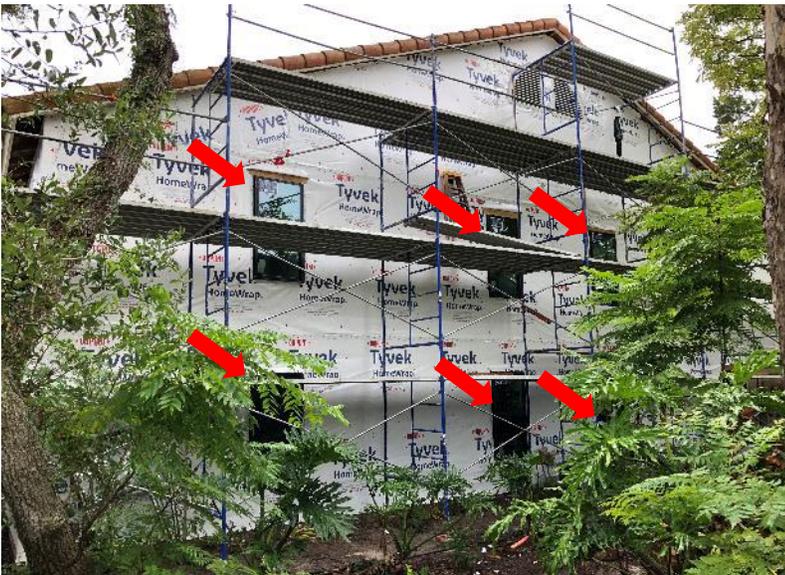
PHOTOGRAPH #2

BUILDING 6 SECTION H

Contractor installed PGT windows and verified WOCDS are installed on windows for second floor.

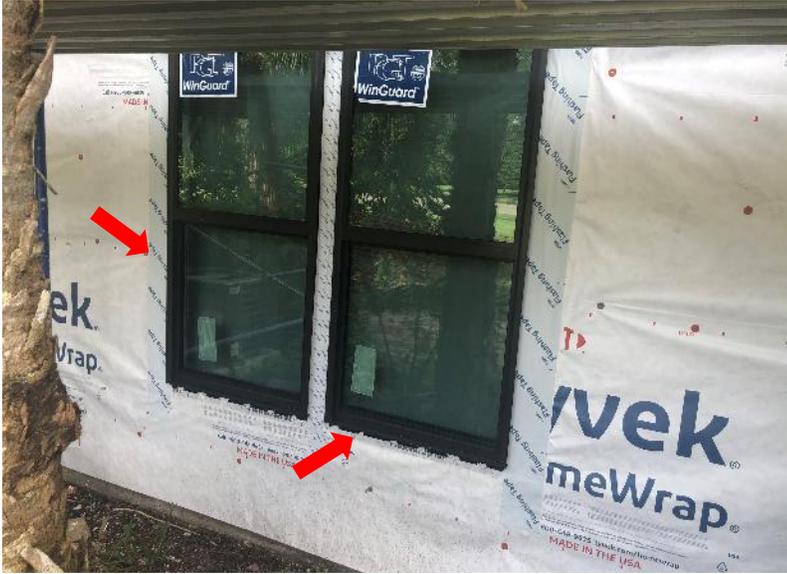
PHOTOGRAPH #3

**BUILDING 3
SECTION D**

Contractor installed Dupont jamb flashing and sill FlexWrap per the construction drawings.

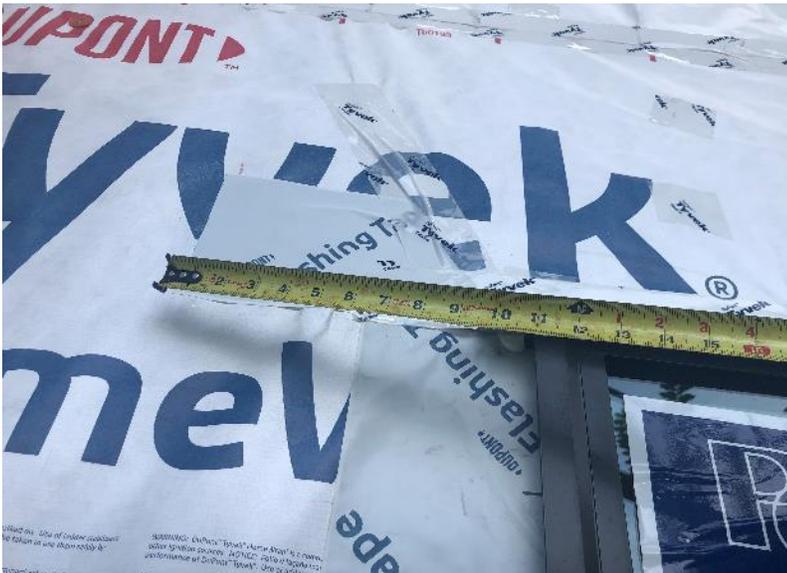
PHOTOGRAPH #4

**BUILDING 3
SECTION D**

Contractor installed Dupont Flashing Tape at window head and extended 12".

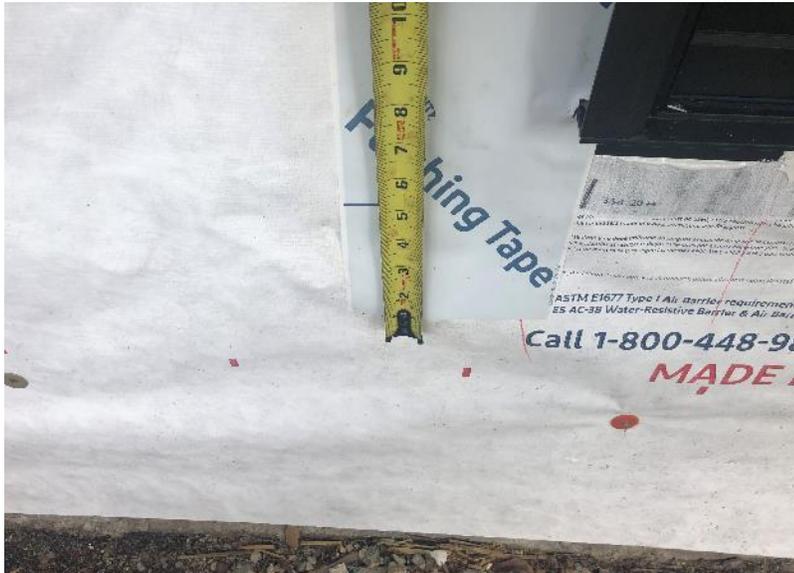
PHOTOGRAPH #5

**BUILDING 3
SECTION D**

Contractor installed Dupont Flashing Tape at window and extended 6" below.

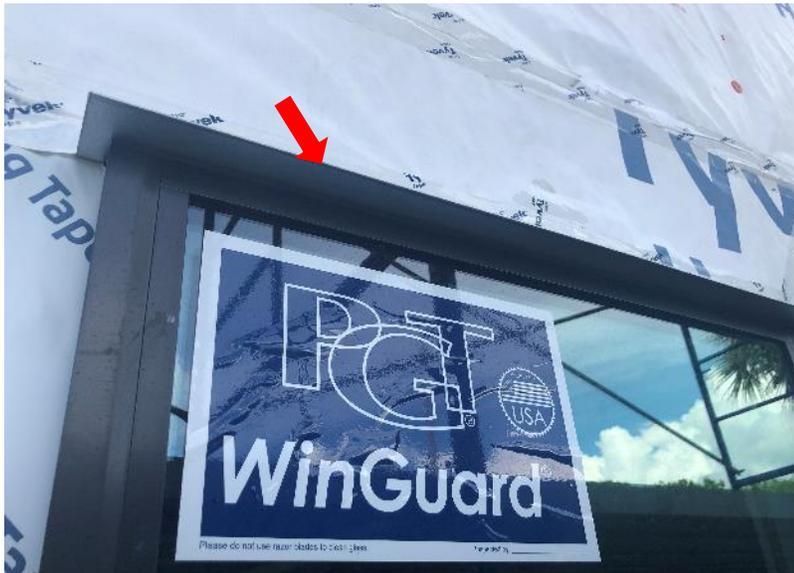
PHOTOGRAPH #6

**BUILDING 3
SECTION D**

Contractor installed L-flashing behind Tyvek with sealant per the construction drawings.

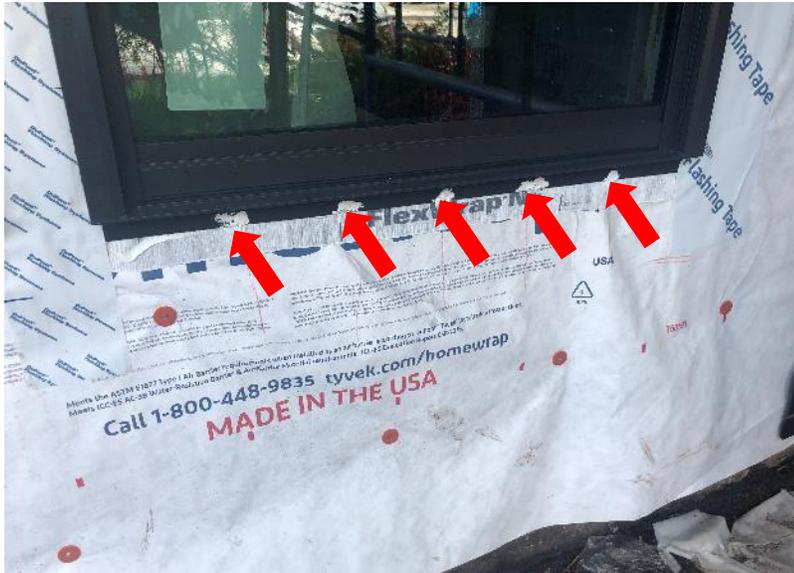
PHOTOGRAPH #7

**BUILDING 3
SECTION D**

Contractor installed windows and covered fasteners with sealant.

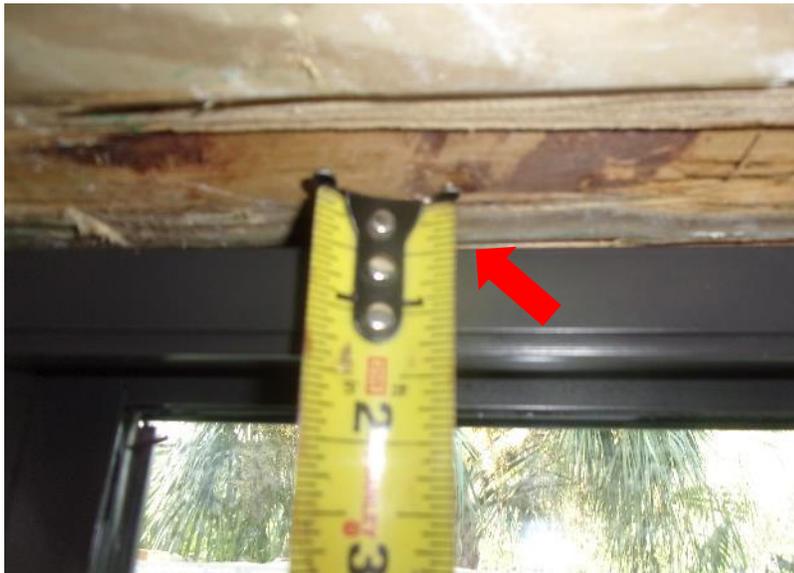
PHOTOGRAPH #8

**BUILDING 3
SECTION D**

Unit #317- Gaps from new window frame to the head framing are not within manufactures NOC requirements for attachments and require correction.

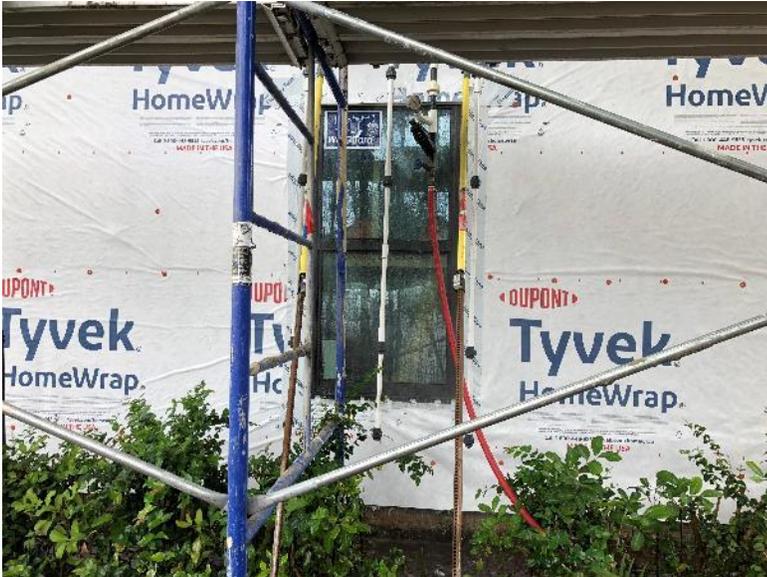
PHOTOGRAPH #9

**BUILDING 3
SECTION C**

Unit #317 – Water testing performed by independent water testing agency (at side bedroom single window) in accordance with AAMA 502. Test passed with no water intrusion.

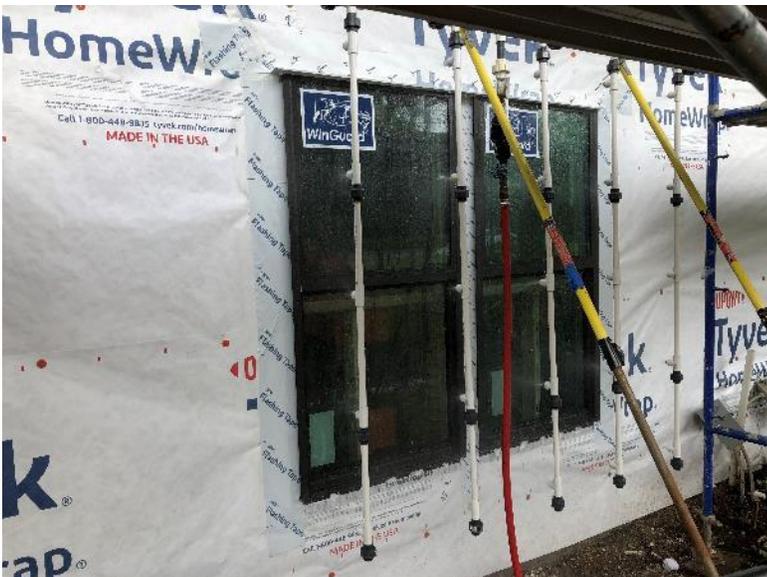
PHOTOGRAPH #10

**BUILDING 3
SECTION D**

Unit #317 – Water testing performed by independent water testing agency (at rear bedroom double window) in accordance with AAMA 502. Test passed with no water intrusion.

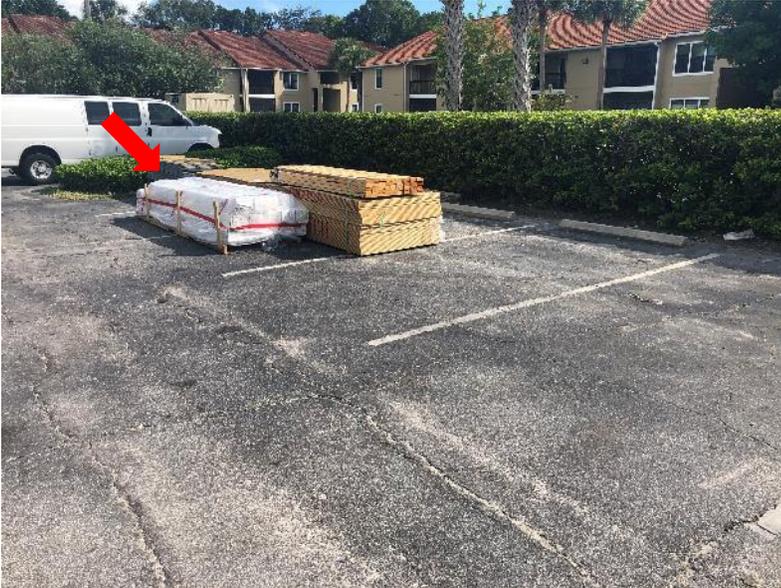
PHOTOGRAPH #11

**BUILDING 3
STORAGE AREA**

Contractor received delivery of approved AMICO Self Furred lath 3.4 lbs., galvanized.

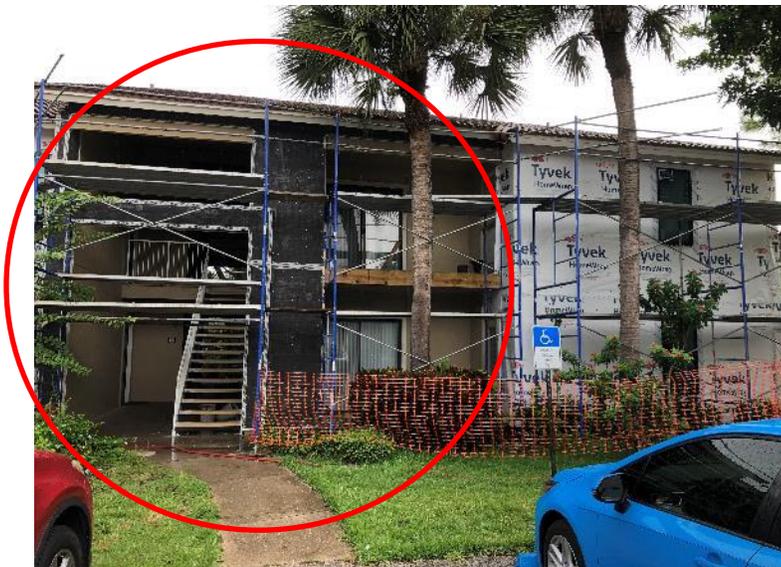
PHOTOGRAPH #12

**BUILDING 3
SECTION C**

Stucco Sub-contractor has begun to install water resistant barrier, metal lath and stucco accessories.

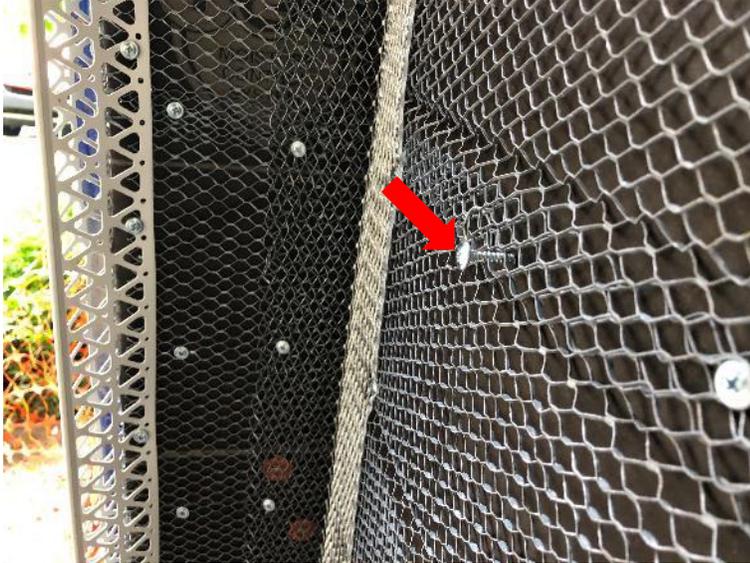
PHOTOGRAPH #13

**BUILDING 3
SECTION C**

Partially screwed fastener next to tie wire. Fasteners shall be installed at stud locations.

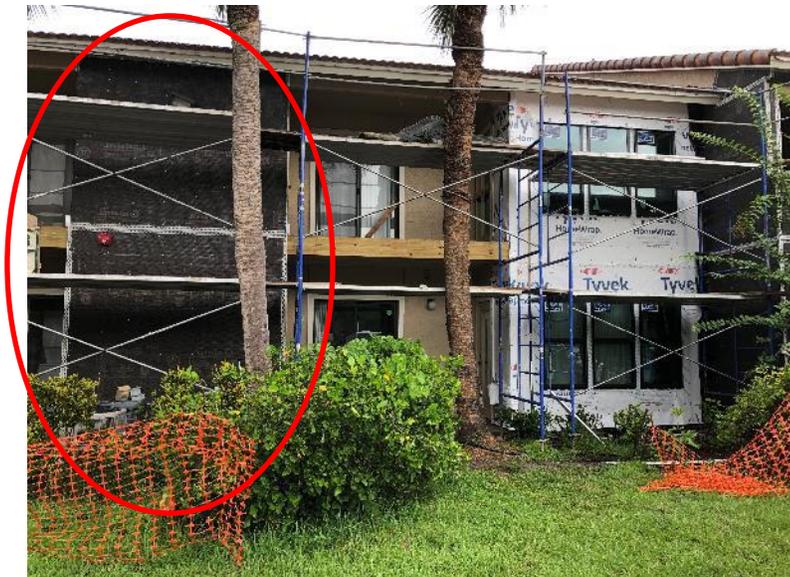
PHOTOGRAPH #14

**BUILDING 3
SECTION B**

Stucco Sub-contractor has begun to install water resistant barrier, metal lath and stucco accessories.

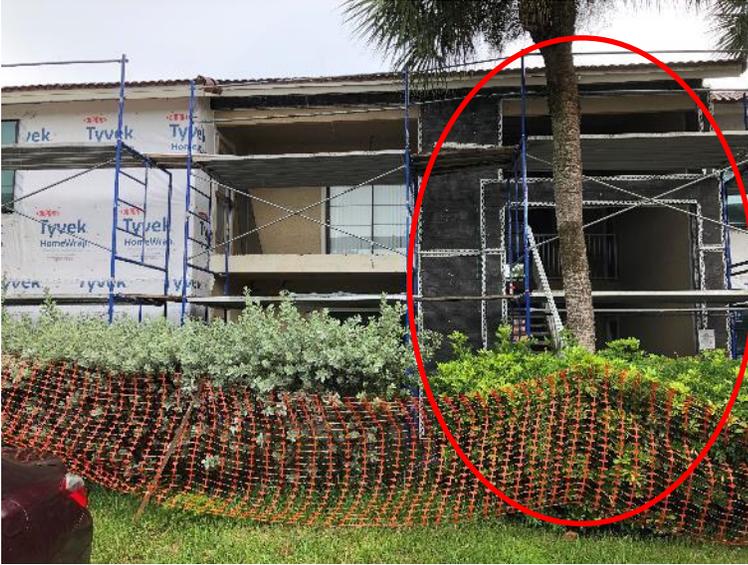
PHOTOGRAPH #15

**BUILDING 3
SECTION A**

Stucco Sub-contractor has begun to install water resistant barrier, metal lath and stucco accessories.

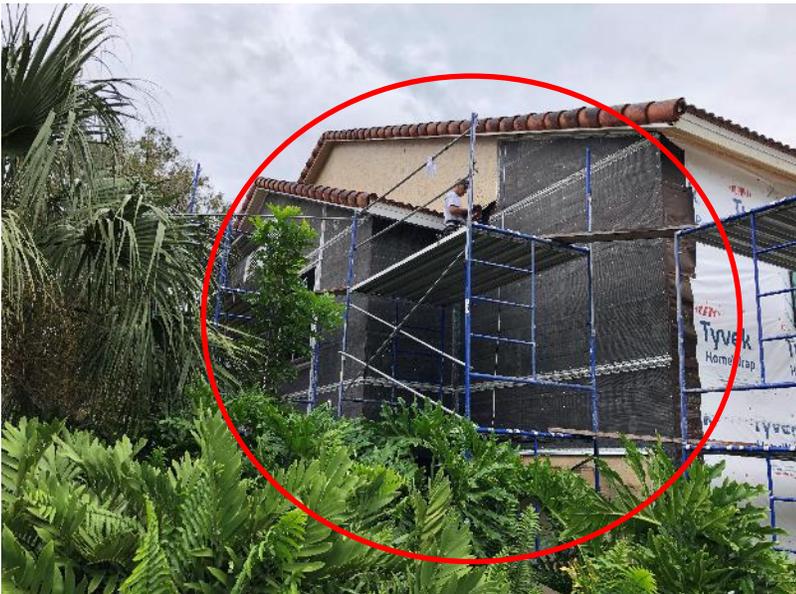
PHOTOGRAPH #16

**BUILDING 3
SECTION H**

Stucco Sub-contractor has begun to install water resistant barrier, metal lath and stucco accessories.

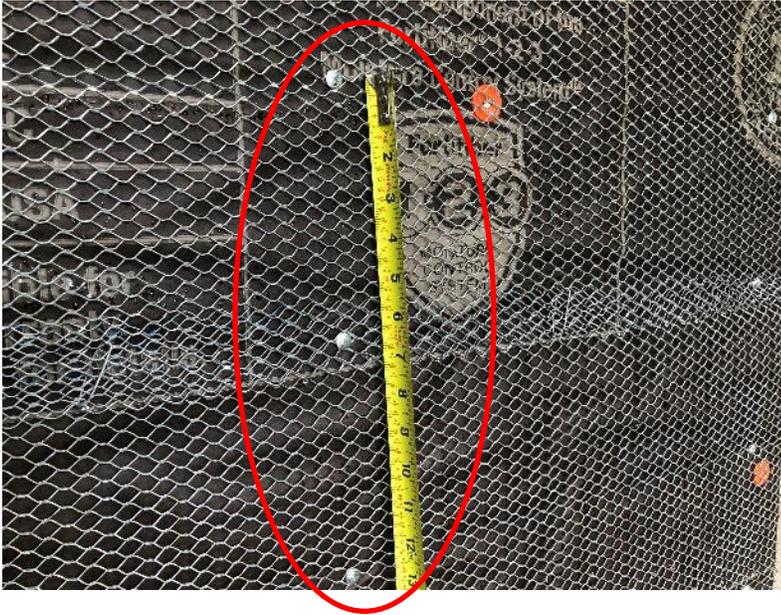
PHOTOGRAPH #17

**BUILDING 3
SECTION H**

Stucco Sub-contractor has installed lath with fasteners 6" on-center.

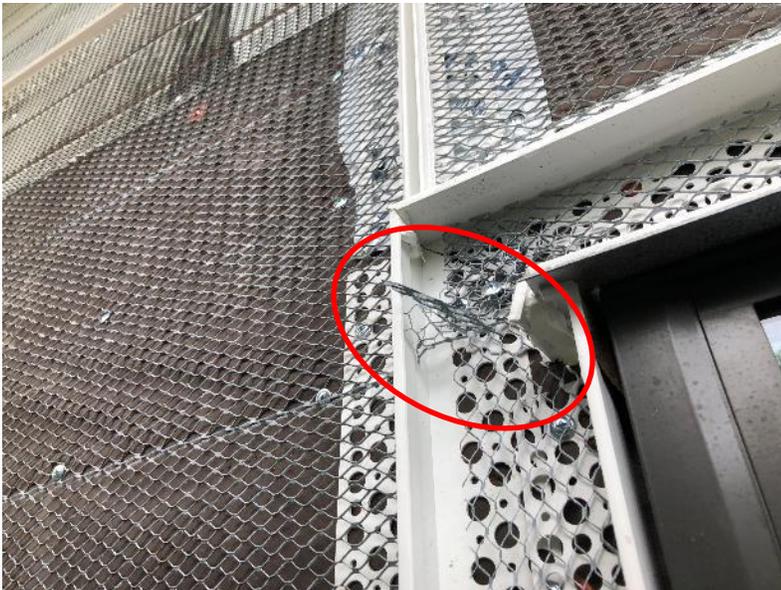
PHOTOGRAPH #18

**BUILDING 3
SECTION H**

Lath is sticking out from wall. Stucco Sub-contractor to fasten lath flush with accessory.

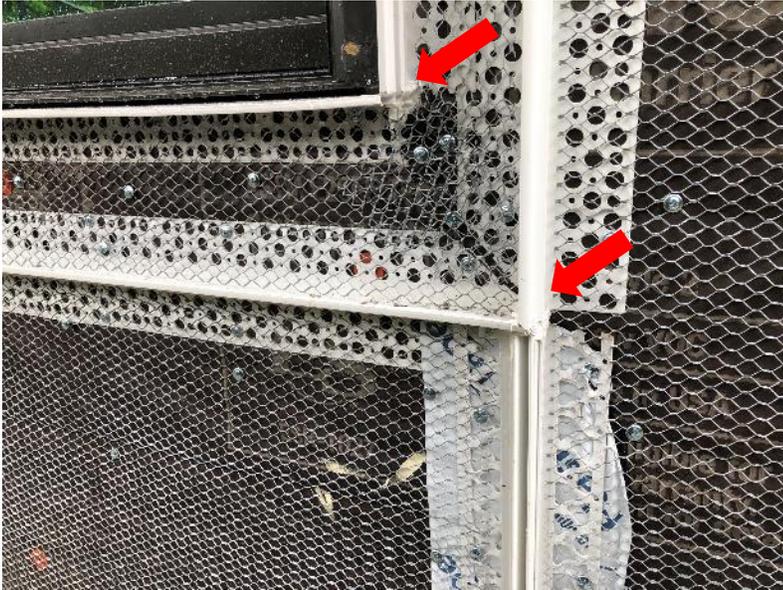
PHOTOGRAPH #19

**BUILDING 3
SECTION H**

Stucco Sub-contractor installed sealant at stucco accessory intersections.

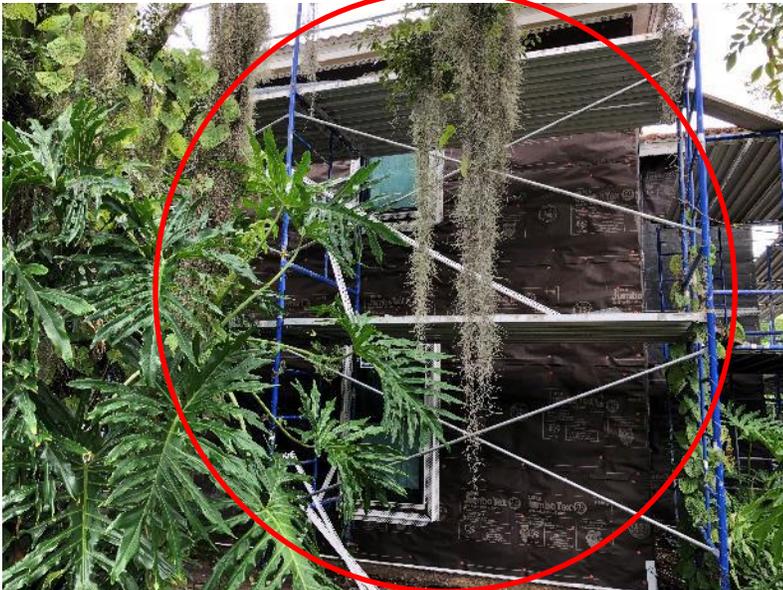
PHOTOGRAPH #20

**BUILDING 3
SECTION G**

Stucco Sub-contractor has begun to install Jumbo Tex Super 60 water resistant barrier and stucco accessories.

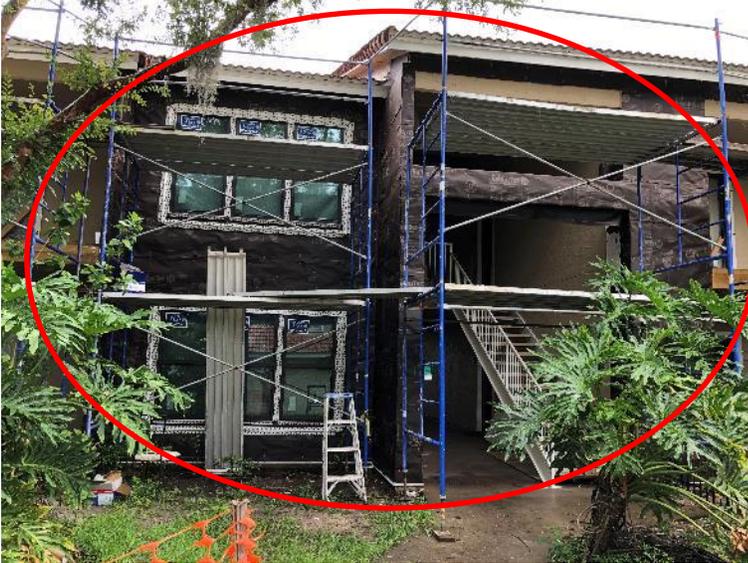
PHOTOGRAPH #21

**BUILDING 3
SECTION F**

Stucco Sub-contractor has begun to install Jumbo Tex Super 60 water resistant barrier and stucco accessories.
