**PHOTOGRAPHS**

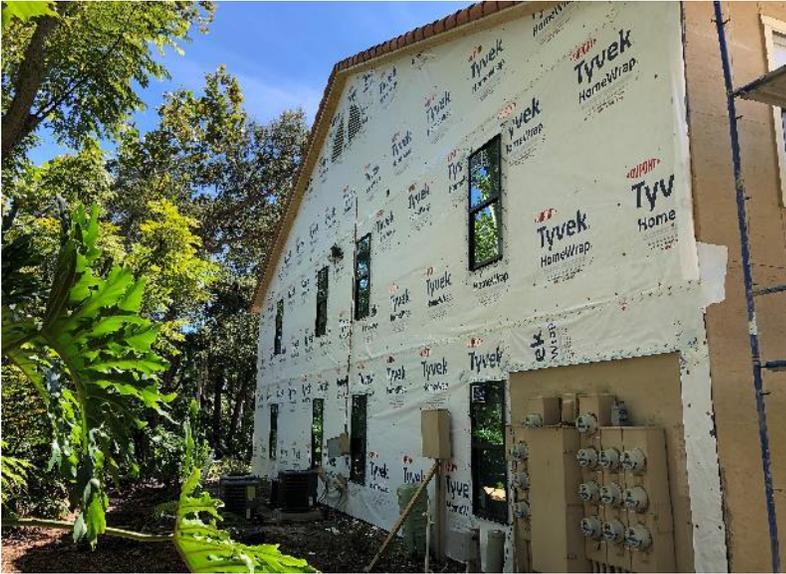
**PHOTOGRAPH #1**

**BUILDING 6  
SECTIONS E-H**

Contractor relocated scaffolding to the remaining elevations to start stucco removal.

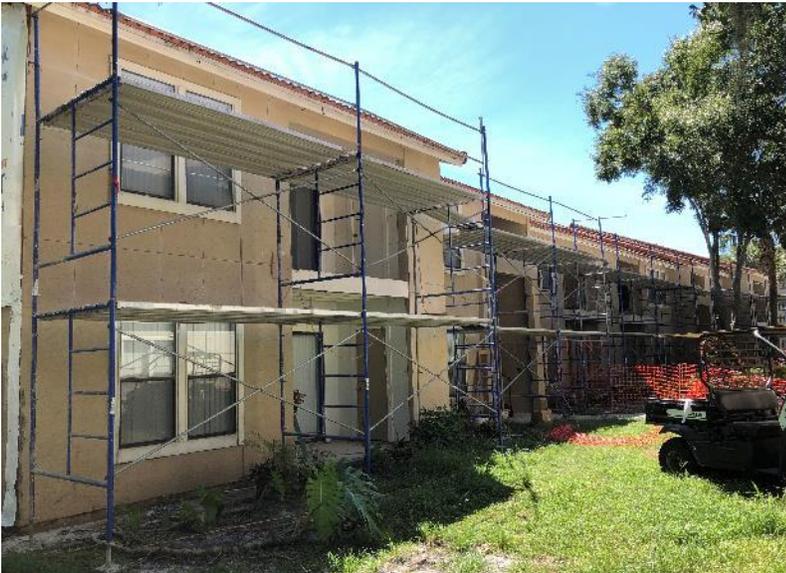
**PHOTOGRAPH #2**

**BUILDING 6  
SECTIONS A-D**

Contractor relocated scaffolding to the remaining elevations to start stucco removal.

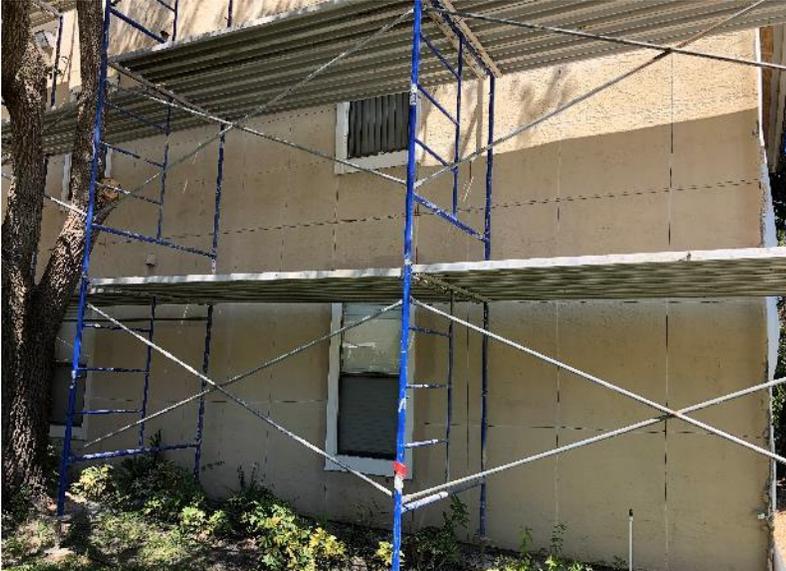
**PHOTOGRAPH #3**

**BUILDING 6  
SECTIONS A-D**

Contractor began saw cutting stucco to remove in sections.

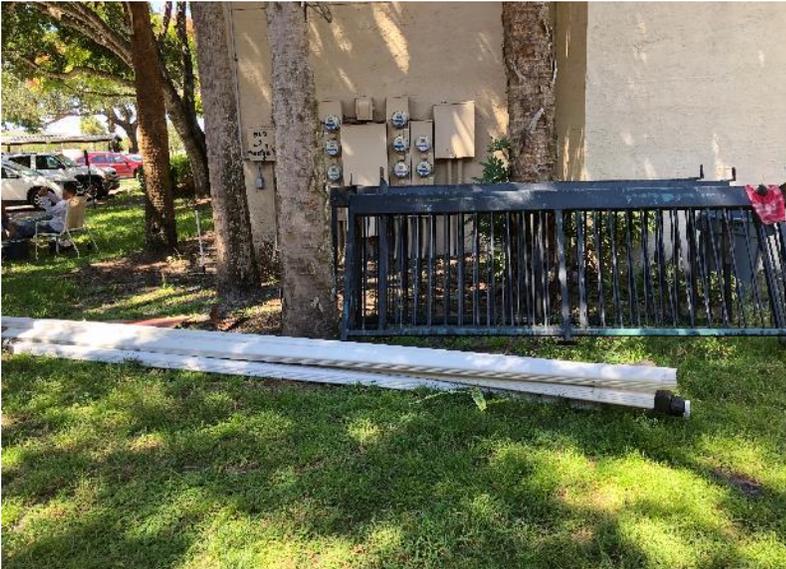
**PHOTOGRAPH #4**

**BUILDING 6  
SECTION A-D**

Downspouts and balcony railing were removed and stored on-site for stucco and framing repairs.

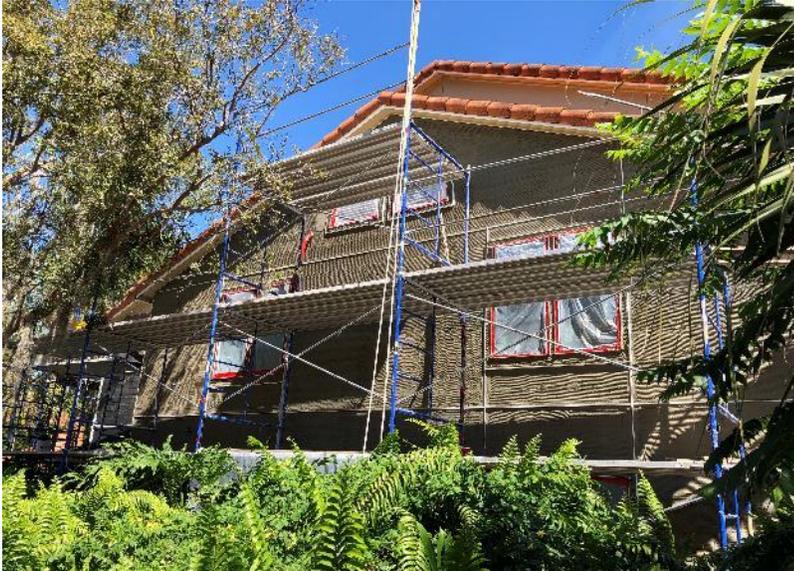
**PHOTOGRAPH #5**

**BUILDING 3  
SECTION H**

Stucco Sub-contractor began stucco scratch coat installation.

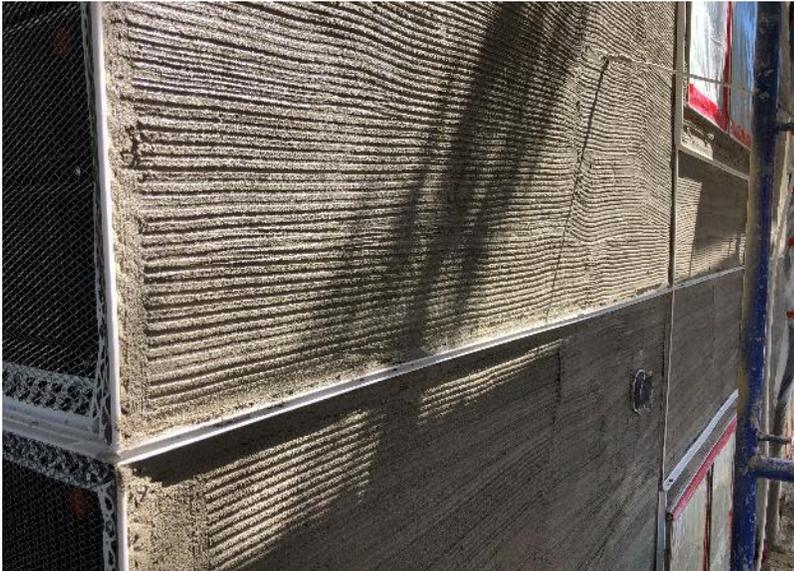
**PHOTOGRAPH #6**

**BUILDING 3  
SECTION H**

Stucco Sub-contractor began stucco scratch coat installation.

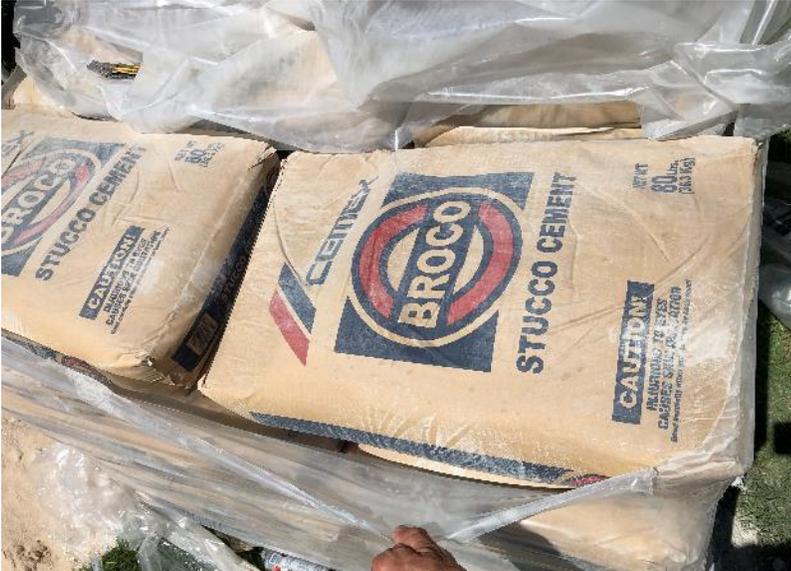
**PHOTOGRAPH #7**

**BUILDING 3  
SECTION H**

Stucco Sub-contractor used approved Cemex Broco Stucco Cement to mix stucco on-site.

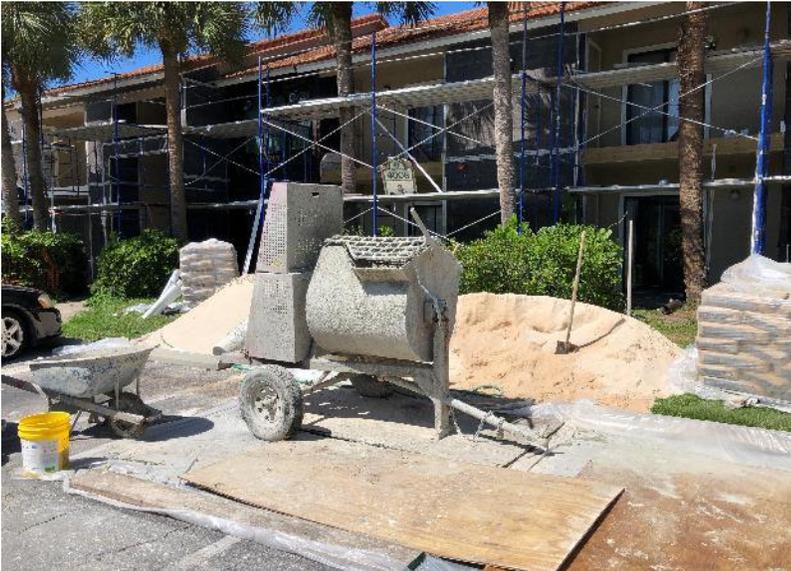
**PHOTOGRAPH #8**

**BUILDING 3  
SECTION H**

Stucco Sub-contractor used approved Cemex Broco Stucco Cement to mix stucco on-site.

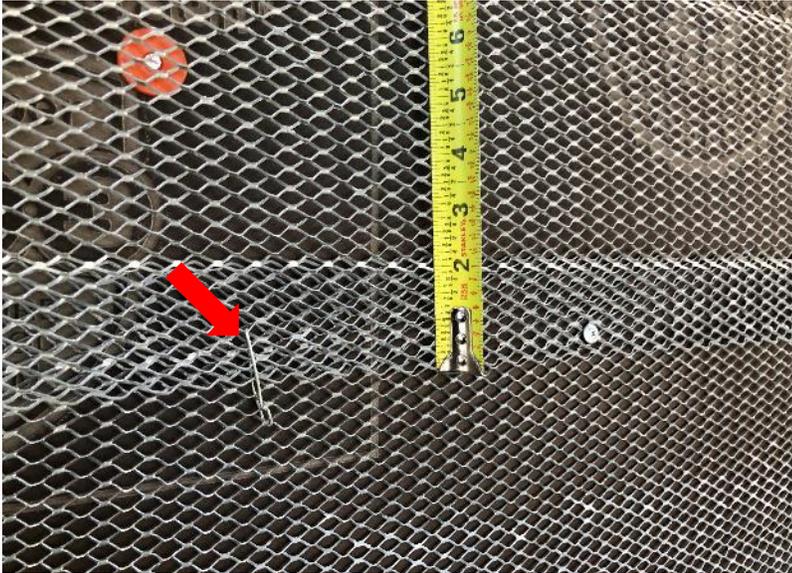
**PHOTOGRAPH #9**

**BUILDING 3  
SECTION F**

Stucco Sub-contractor overlapped lath 2" minimum per the construction drawings and installed tie wire between fasteners.

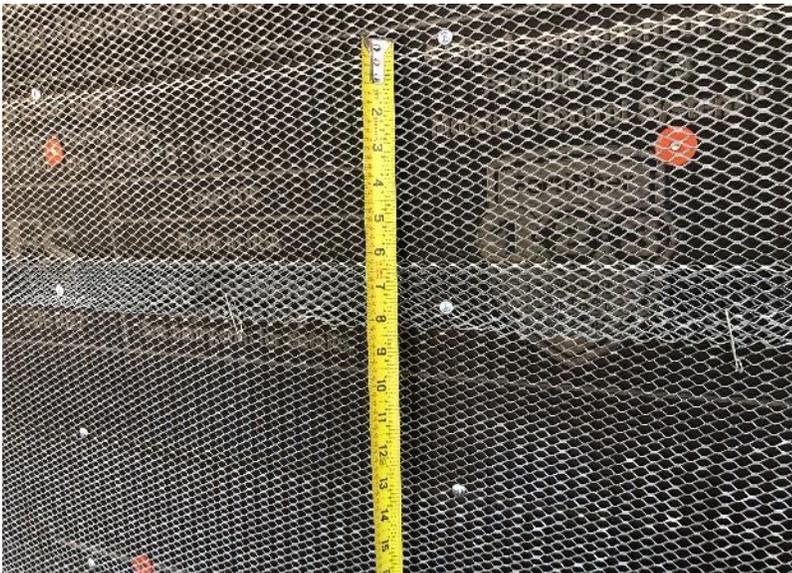
**PHOTOGRAPH #10**

**BUILDING 3  
SECTION F**

Lath fasteners are spaced 6" on-center.

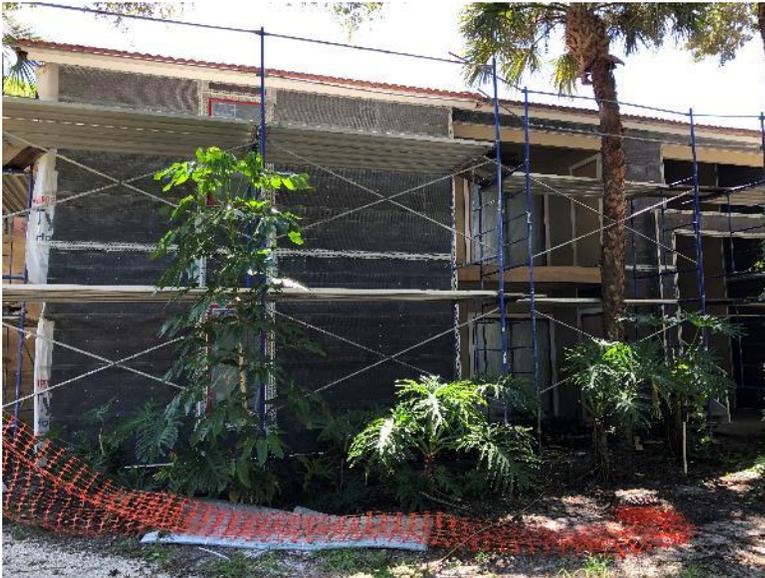
**PHOTOGRAPH #11**

**BUILDING 3  
SECTION E**

Stucco Sub-contractor installed lath and accessories over Weather-Resistive Barrier.

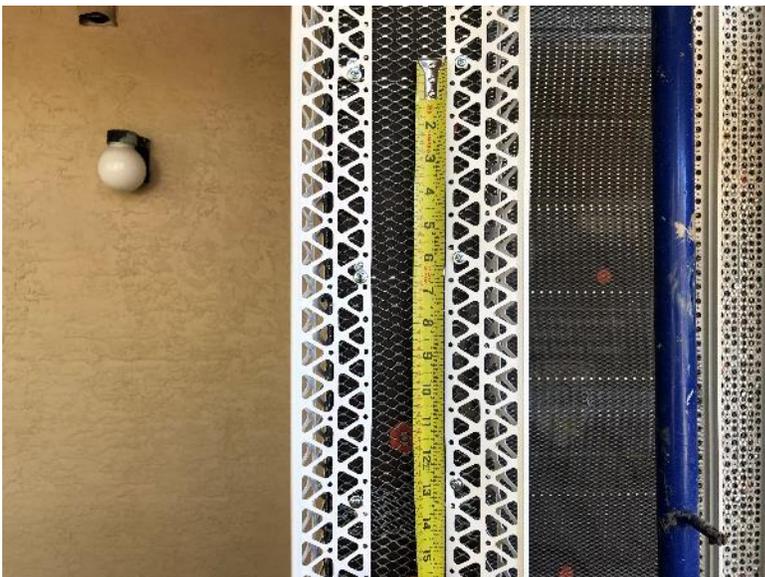
**PHOTOGRAPH #12**

**BUILDING 3  
SECTION E**

Stucco accessories are fastened within 7" on-center.

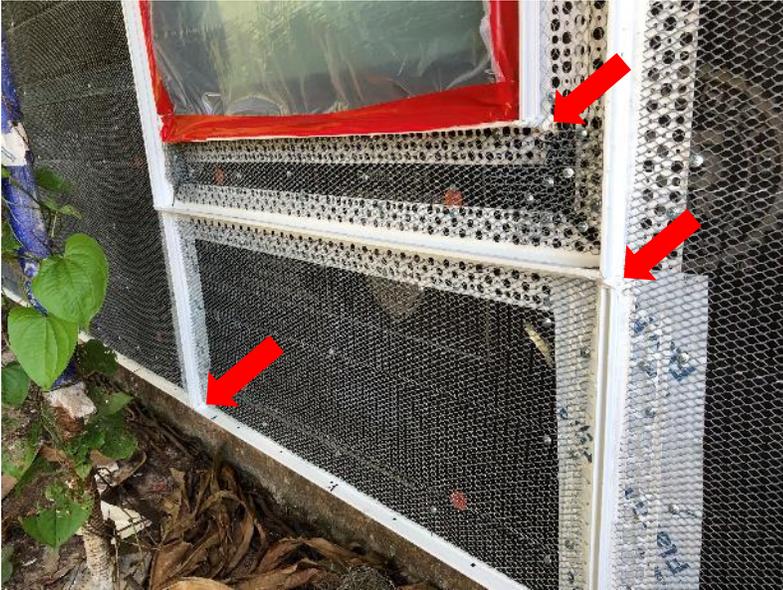
**PHOTOGRAPH #13**

**BUILDING 3  
SECTION E**

MasterSeal NP 150 sealant was applied to accessory ends, corners, and intersections.

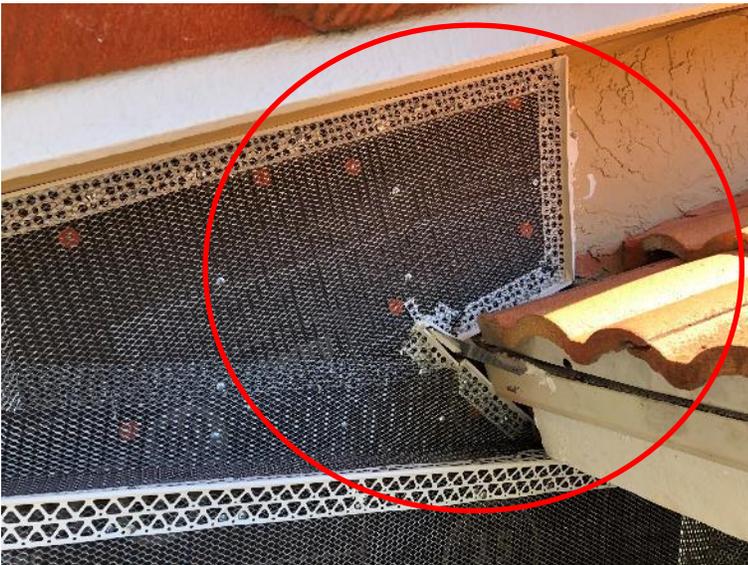
**PHOTOGRAPH #14**

**BUILDING 3  
SECTION E**

Kickout flashing and accessories have been installed per the contract drawings.

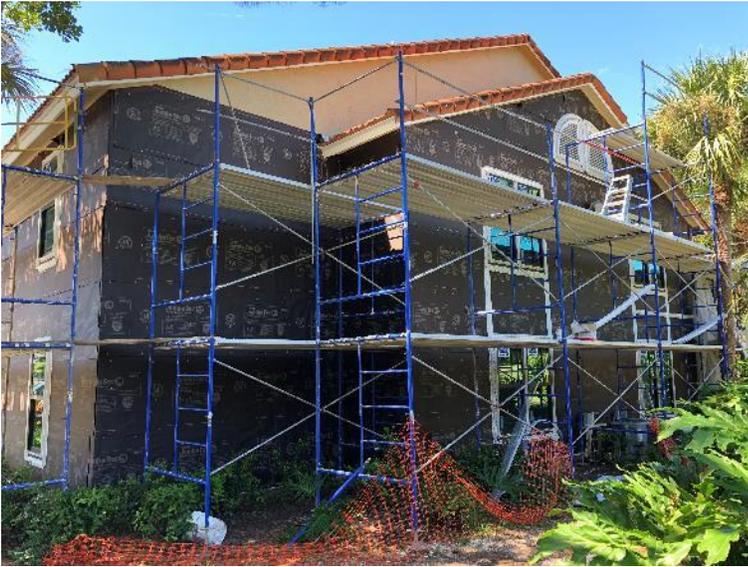
**PHOTOGRAPH #15**

**BUILDING 3  
SECTION D**

Stucco Sub-contractor installing Super JumboTex 60 Minute Weather-Resistive Barrier.

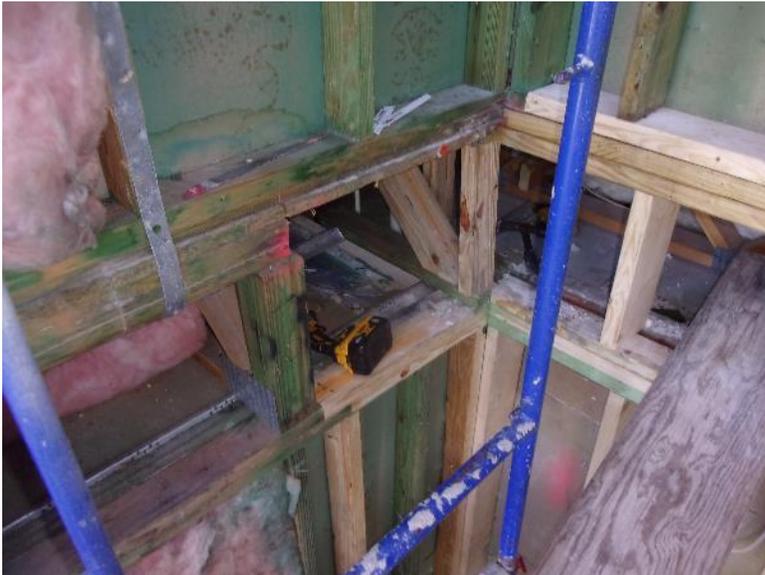
**PHOTOGRAPH #16**

**BUILDING 3  
SECTION D**

Damaged truss repairs to second floor truss is in progress per ESI #1.

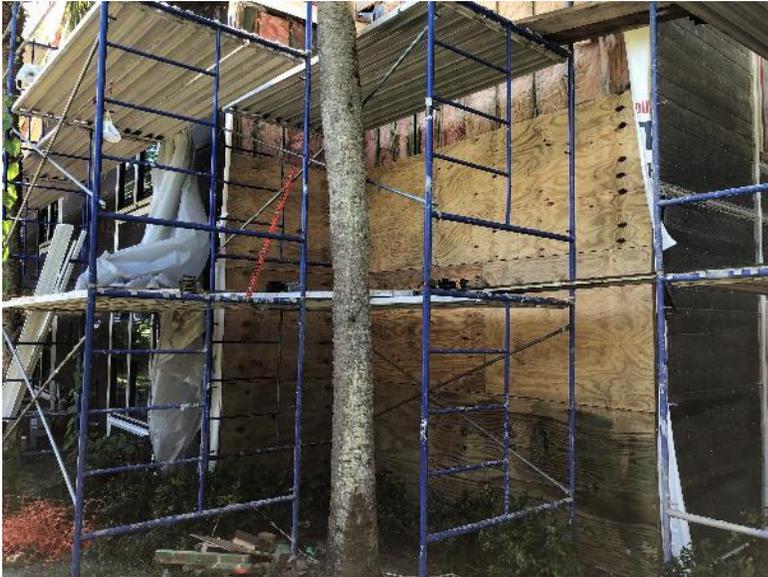
**PHOTOGRAPH #17**

**BUILDING 3  
SECTION D**

Contractor installing sheathing using 4d nails spaced at 4" on-center per contract drawings.

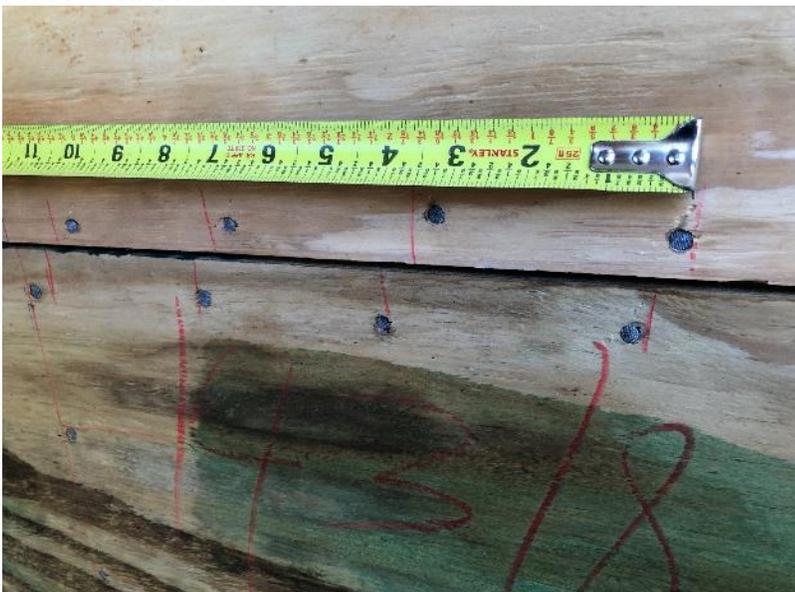
**PHOTOGRAPH #18**

**BUILDING 3  
SECTION D**

Contractor installed remaining sheathing using 4d nails spaced at 4" on-center per contract drawings.

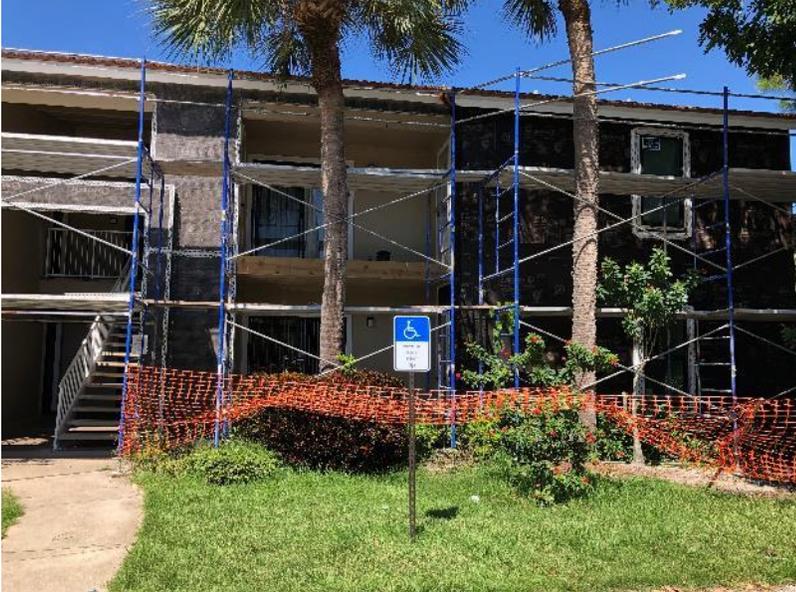
**PHOTOGRAPH #19**

**BUILDING 3  
SECTION C**

Stucco Sub-contractor installed Super JumboTex 60 Minute Weather-Resistive Barrier with 2" horizontal overlap and 6" minimum vertical overlap.

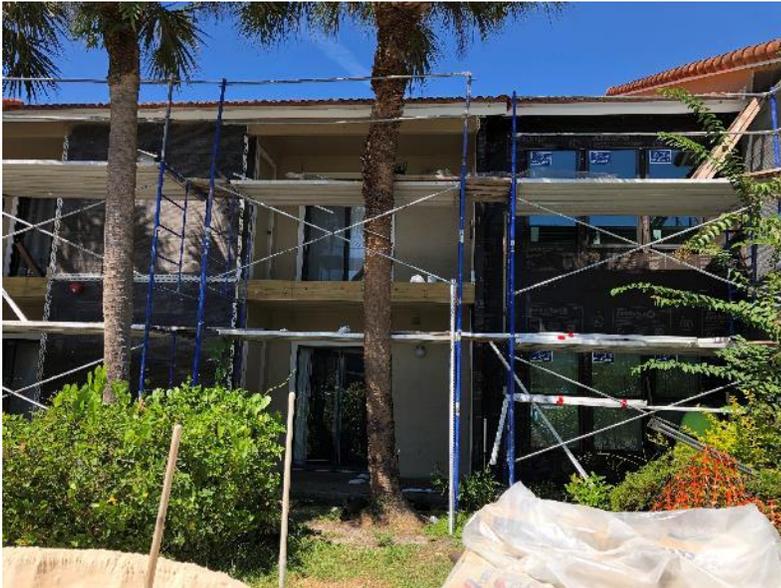
**PHOTOGRAPH #20**

**BUILDING 3  
SECTION B**

Stucco Sub-contractor installing Super JumboTex 60 Minute Weather-Resistive Barrier and stucco accessories.

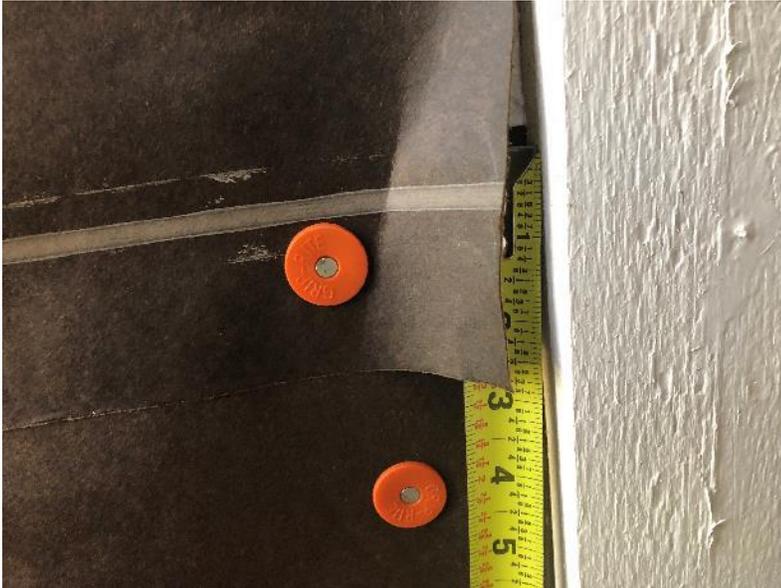
**PHOTOGRAPH #21**

**BUILDING 3  
SECTION B**

Stucco Sub-contractor provided over 2" horizontal overlap and 6" minimum vertical overlap.

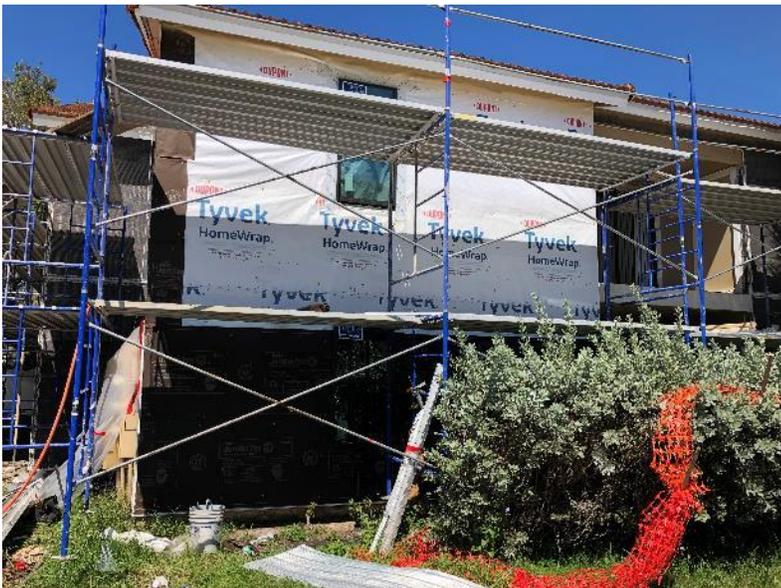
**PHOTOGRAPH #22**

**BUILDING 3  
SECTION A**

Stucco Sub-contractor installing Super JumboTex 60 Minute Weather-Resistive Barrier.
