## PHOTOGRAPHS

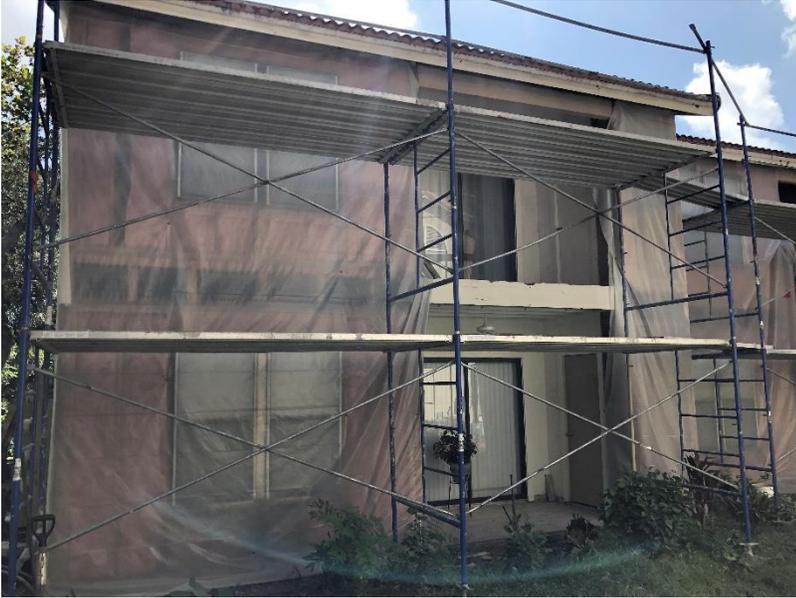
**PHOTOGRAPH #1**

### **BUILDING 6 SECTION A**

Contractor removed stucco on Section A and covered with plastic.

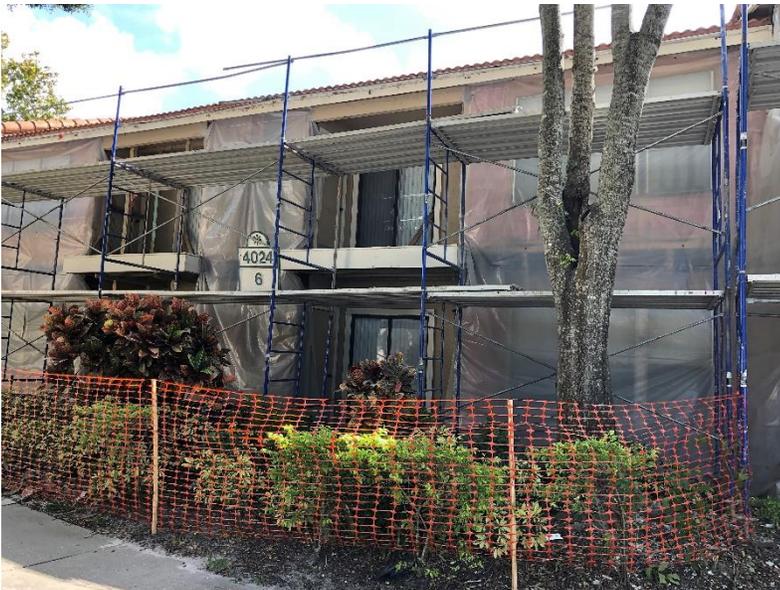
**PHOTOGRAPH #2**

### **BUILDING 6 SECTION B**

Contractor removed stucco on Section B and covered with plastic.

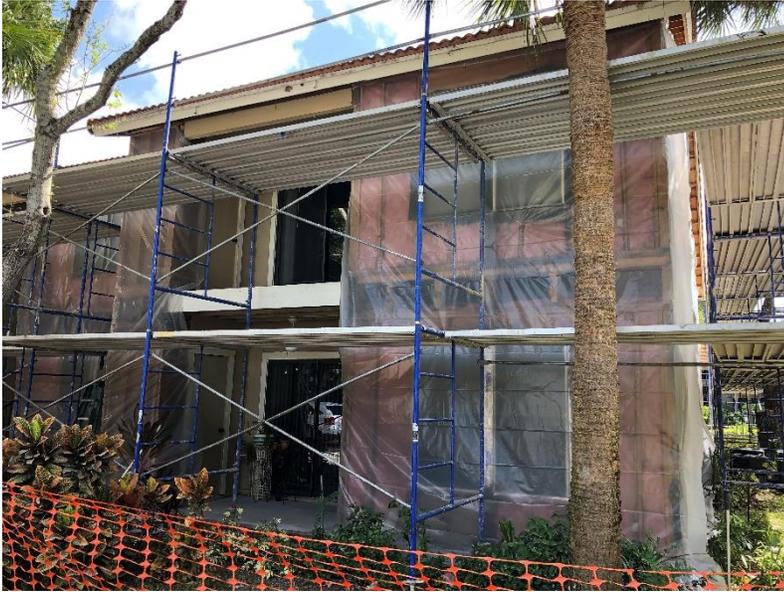
**PHOTOGRAPH #3**

**BUILDING 6  
SECTION C**

Contractor removed stucco on Section C and covered with plastic.

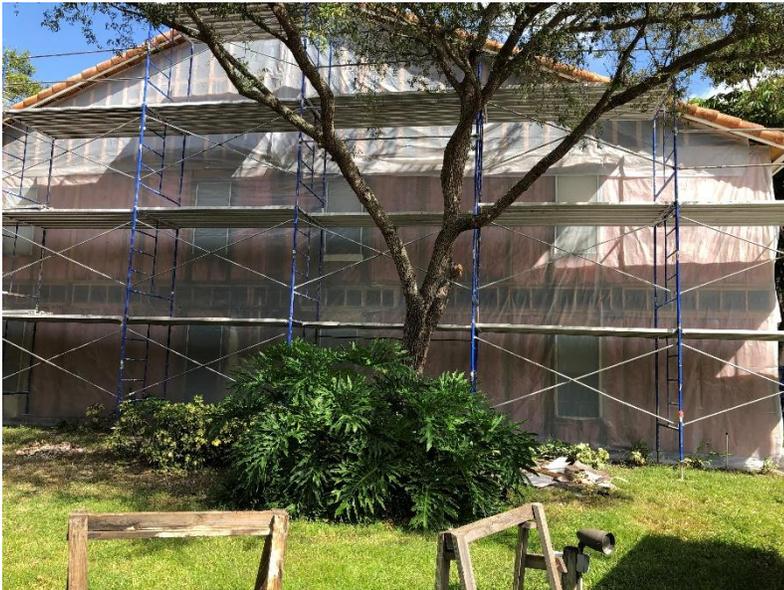
**PHOTOGRAPH #4**

**BUILDING 6  
SECTION D**

Contractor removed stucco on Section D and covered with plastic.

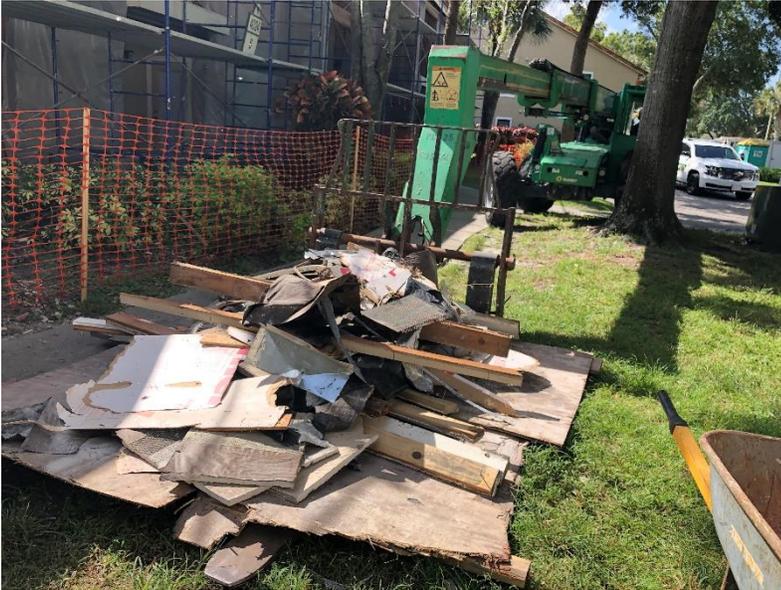
**PHOTOGRAPH #5**

**BUILDING 6  
SECTION A-D**

Contractor disposed stucco and debris from Sections A-D.

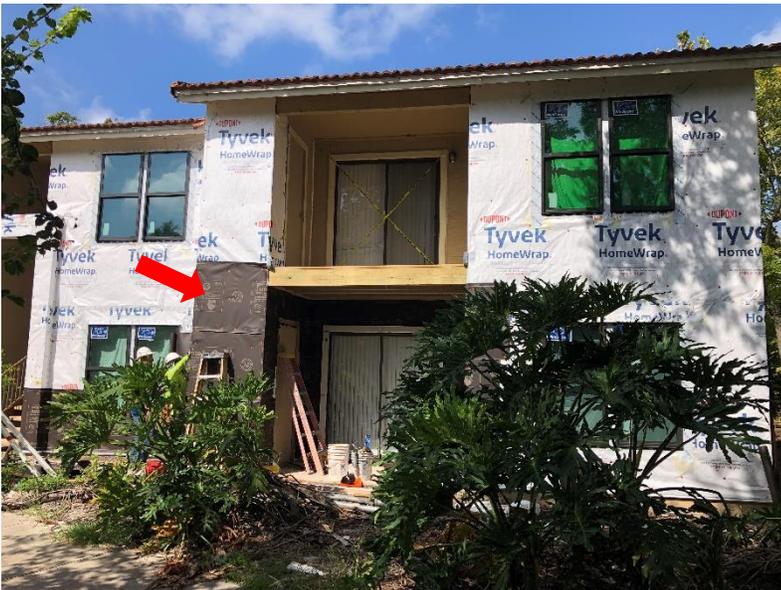
**PHOTOGRAPH #6**

**BUILDING 6  
SECTION G**

Stucco Sub-contractor installing Super JumboTex 60 Minute Weather-Resistive Barrier.

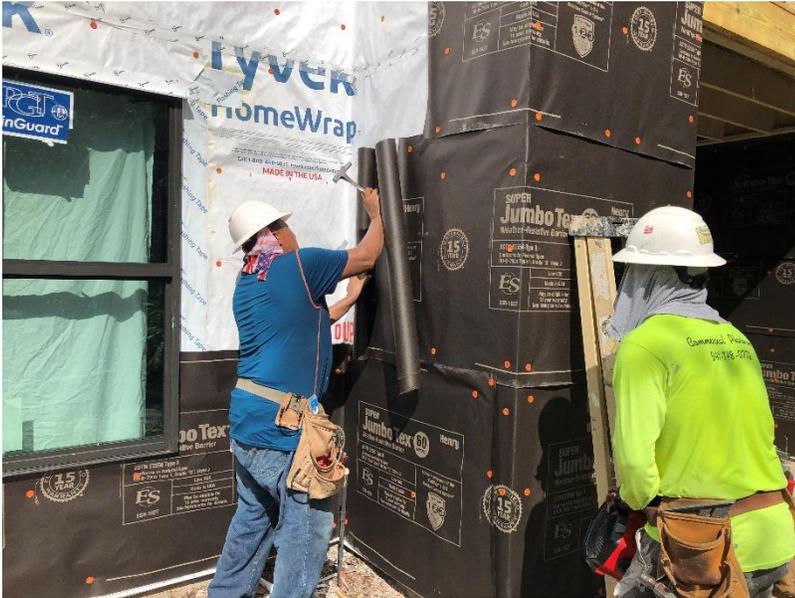
**PHOTOGRAPH #7**

**BUILDING 6  
SECTION G**

Stucco Sub-contractor installing Super JumboTex 60 Minute Weather-Resistive Barrier.

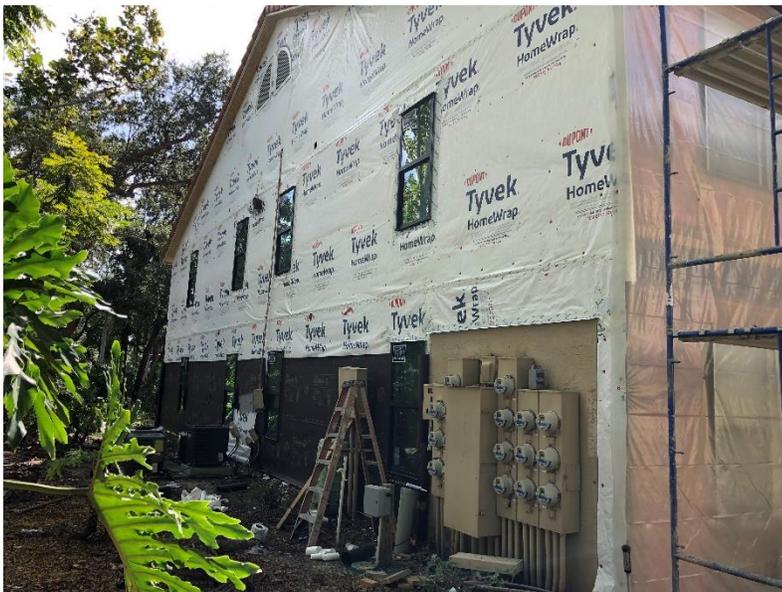
**PHOTOGRAPH #8**

**BUILDING 6  
SECTION H**

Stucco Sub-contractor installing Super JumboTex 60 Minute Weather-Resistive Barrier.

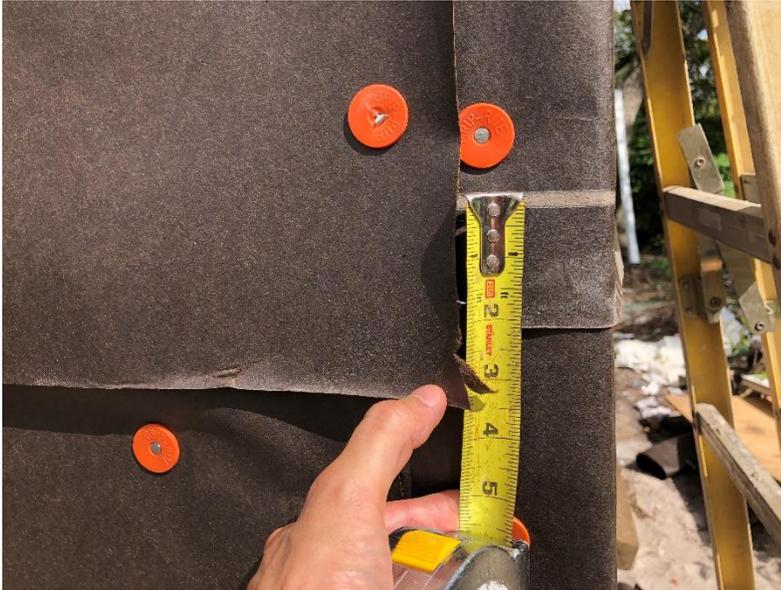
**PHOTOGRAPH #9**

**BUILDING 6  
SECTION H**

Stucco Sub-contractor provided over 2" horizontal overlap and 6" minimum vertical overlap.

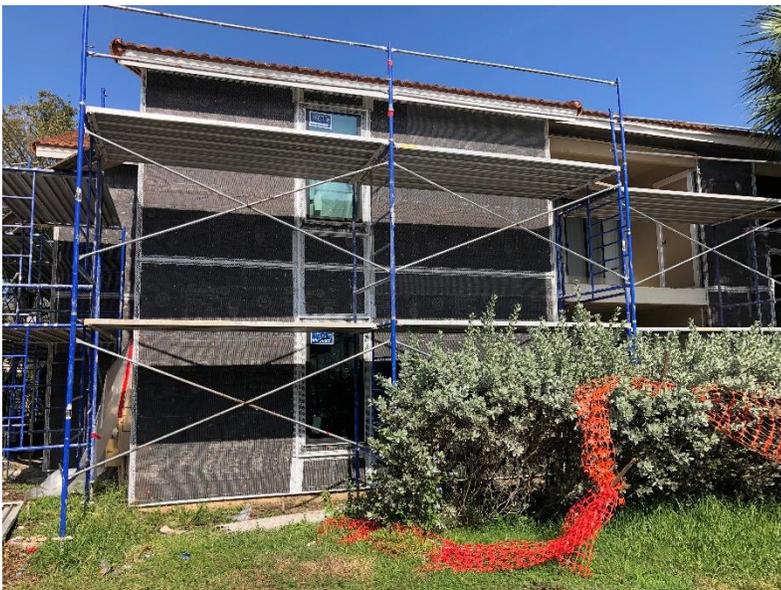
**PHOTOGRAPH #10**

**BUILDING 3  
SECTION A**

Stucco Sub-contractor installed lath and accessories over Weather-Resistive Barrier.

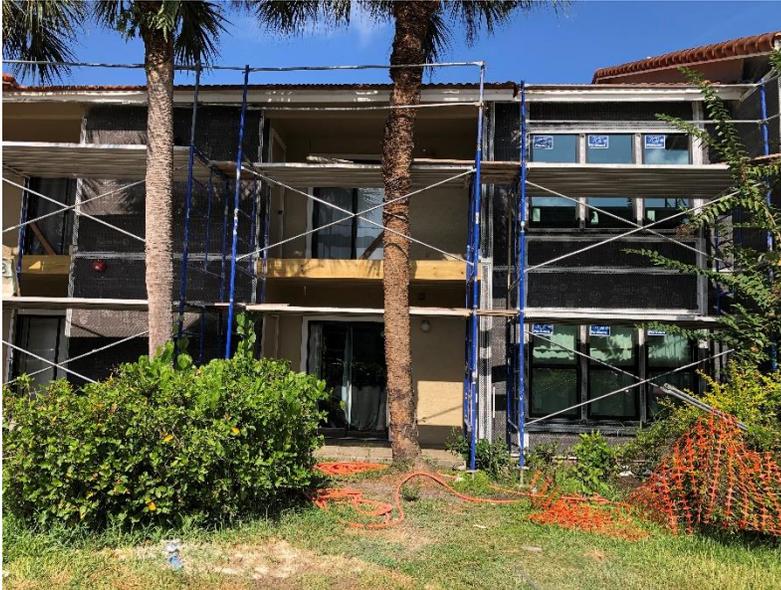
**PHOTOGRAPH #11**

**BUILDING 3  
SECTION B**

Stucco Sub-contractor installed lath and accessories over Weather-Resistive Barrier.

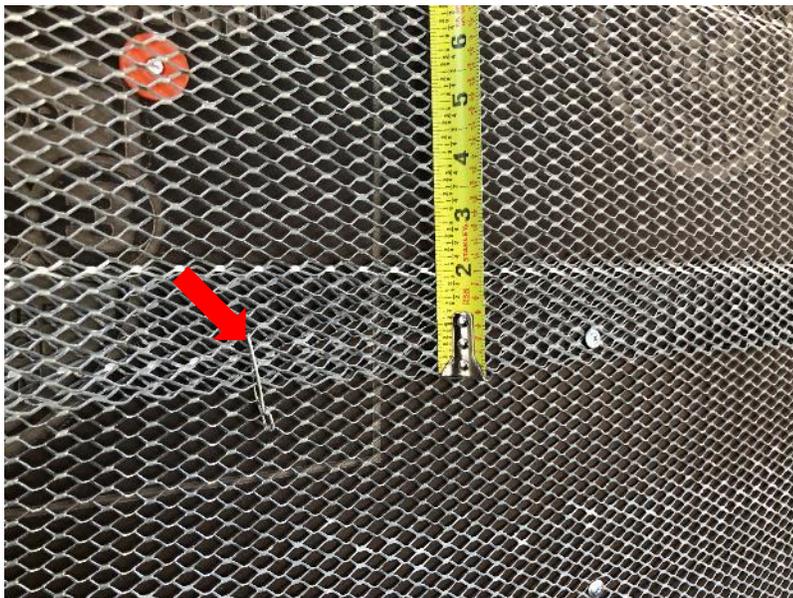
**PHOTOGRAPH #12**

**BUILDING 3  
SECTION B**

Stucco Sub-contractor overlapped lath 2" minimum per the construction drawings and installed tie wire between fasteners.

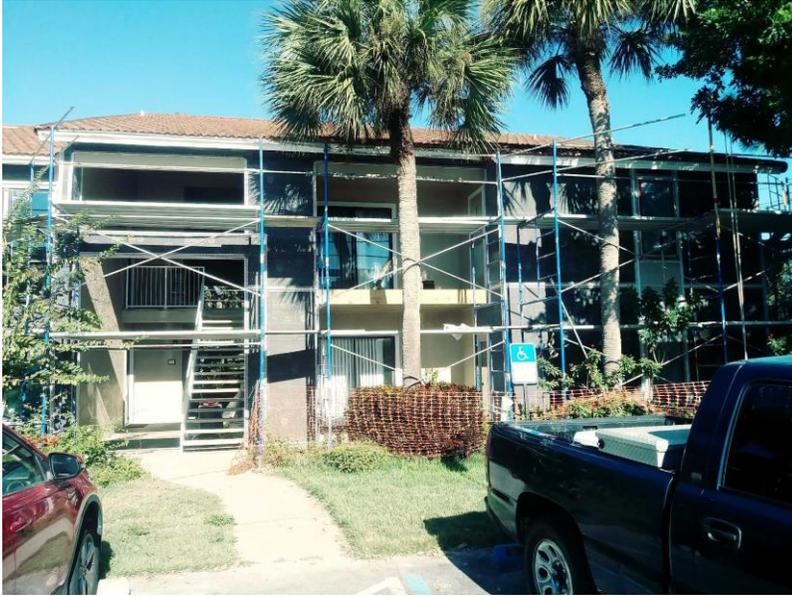
**PHOTOGRAPH #13**

**BUILDING 3  
SECTION C**

Stucco Sub-contractor installed lath and accessories over Weather-Resistive Barrier.

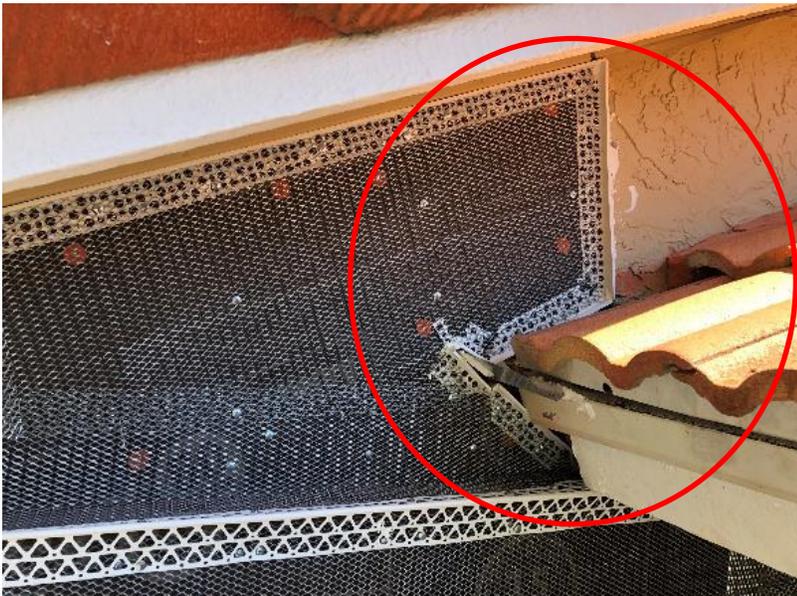
**PHOTOGRAPH #14**

**BUILDING 3  
SECTION C**

Kickout flashing and accessories have been installed per the contract drawings.

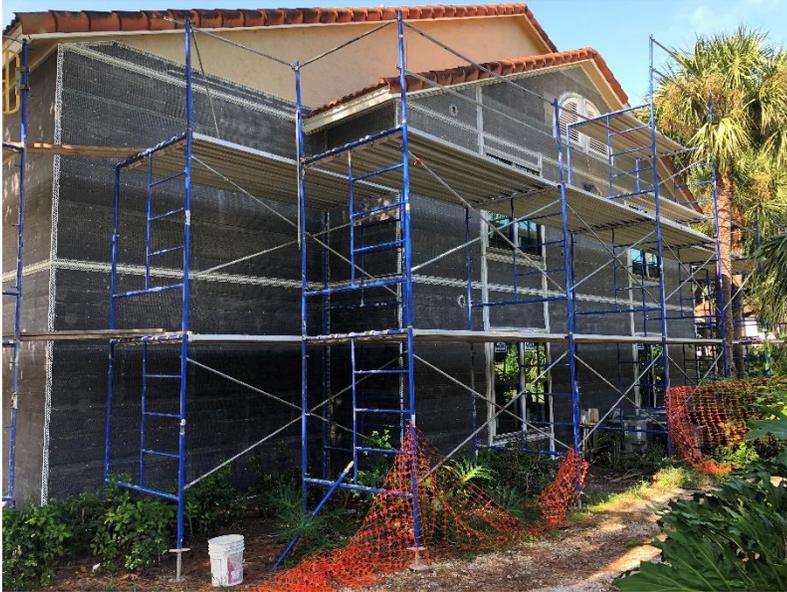
**PHOTOGRAPH #15**

**BUILDING 3  
SECTION D**

Stucco Sub-contractor installed lath and accessories over Weather-Resistive Barrier.

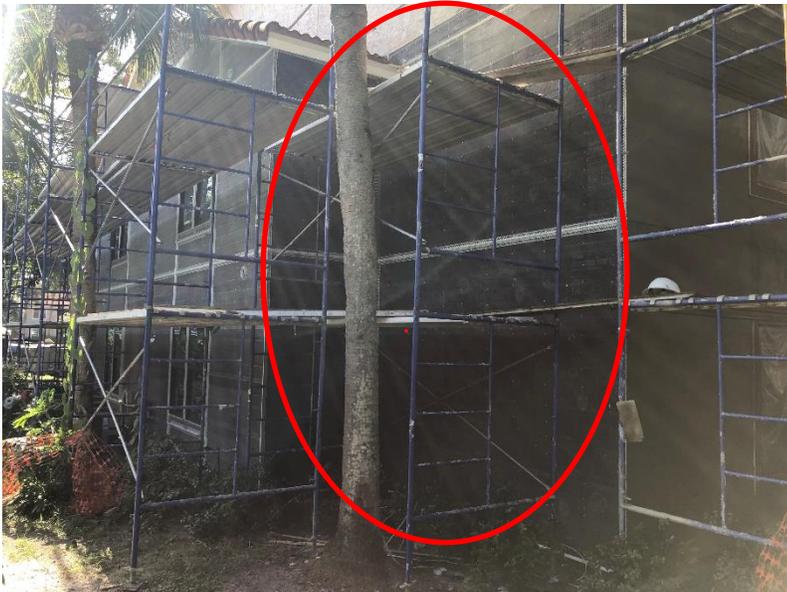
**PHOTOGRAPH #16**

**BUILDING 3  
SECTION D**

Stucco Sub-contractor installed lath and accessories over Section D area that required truss repairs.

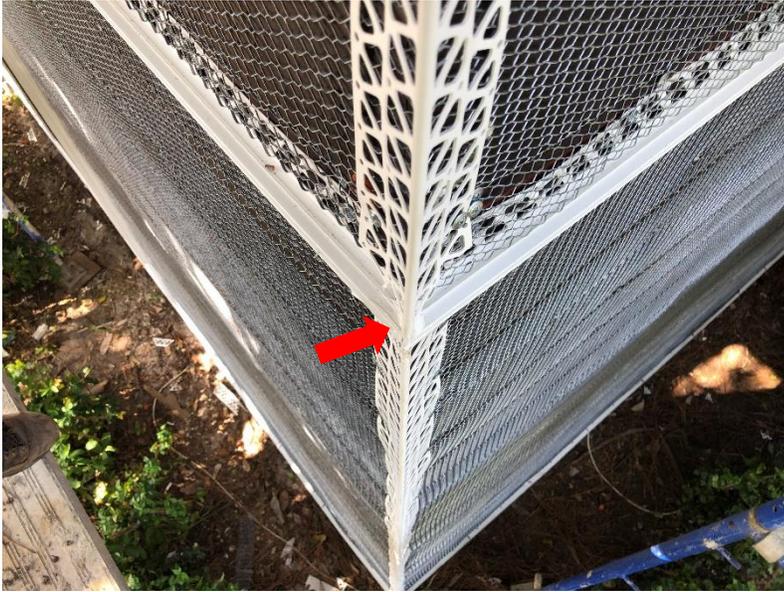
**PHOTOGRAPH #17**

**BUILDING 3  
SECTION D**

MasterSeal NP 150 sealant was applied to accessory ends, corners, and intersections.

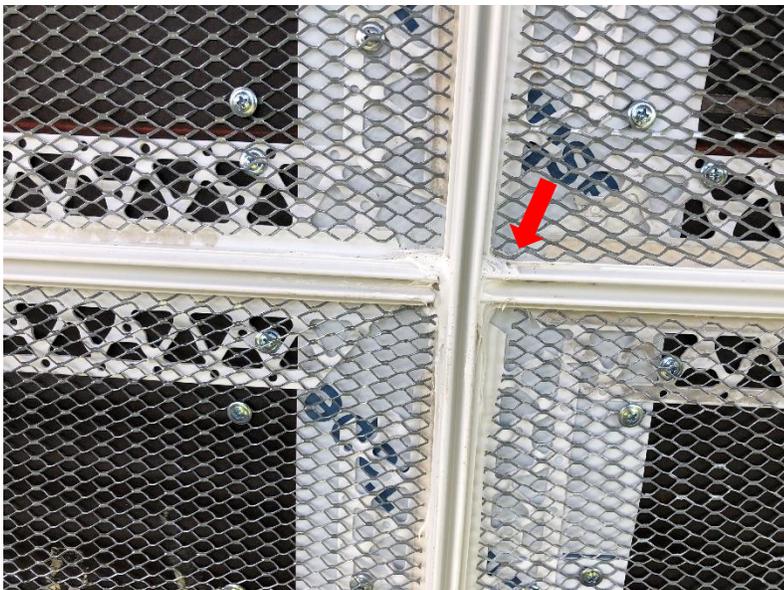
**PHOTOGRAPH #18**

**BUILDING 3  
SECTION D**

MasterSeal NP 150 sealant was applied to accessory ends, corners, and intersections.

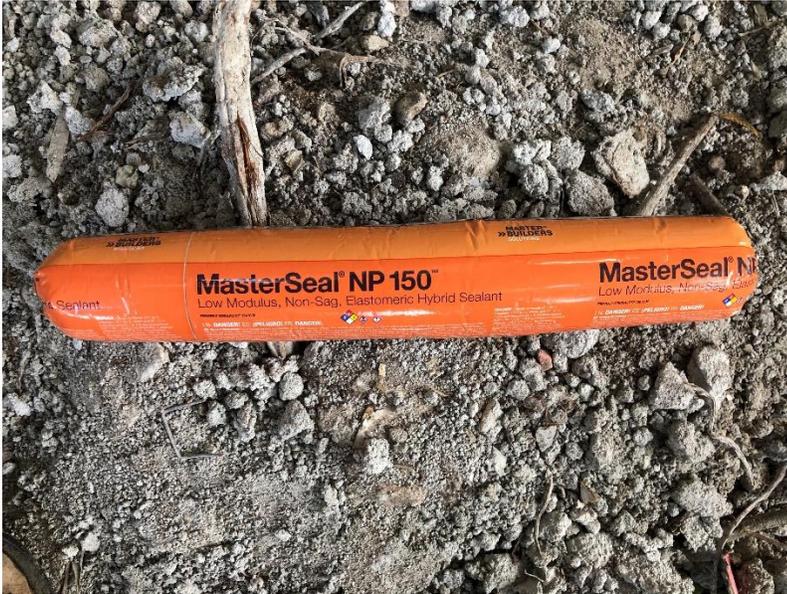
**PHOTOGRAPH #19**

**BUILDING 3  
SECTION D**

MasterSeal NP 150 sealant was applied to accessory ends, corners, and intersections.

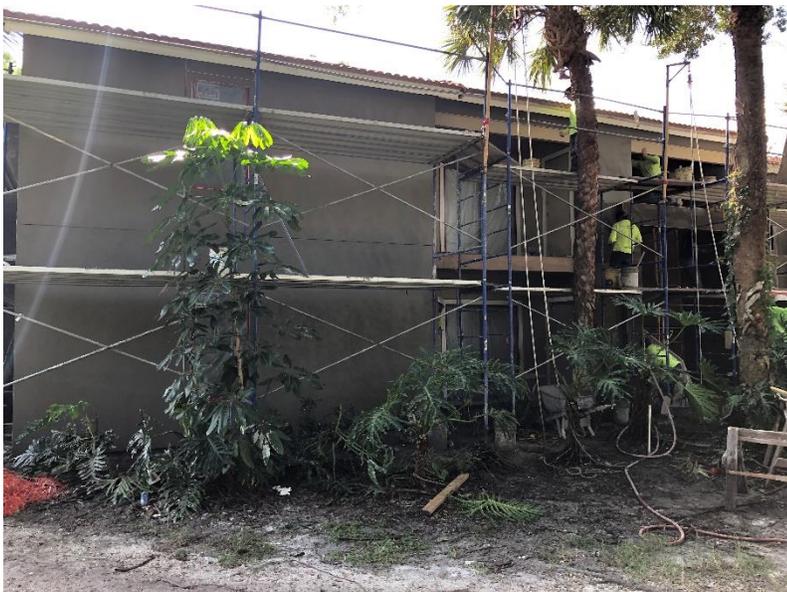
**PHOTOGRAPH #20**

**BUILDING 3  
SECTION E**

Stucco Sub-contractor applied scratch coat and brown coat.

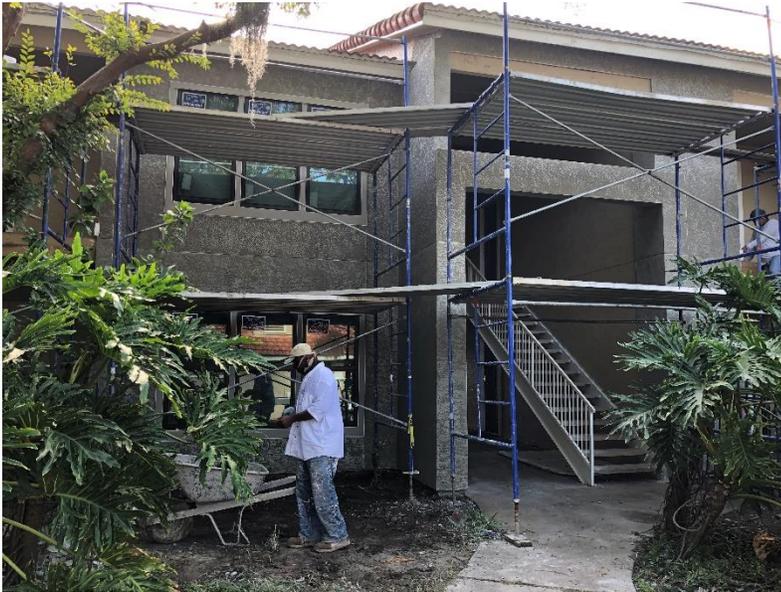
**PHOTOGRAPH #21**

**BUILDING 3  
SECTION F**

Stucco Sub-contractor applied stucco final coat.

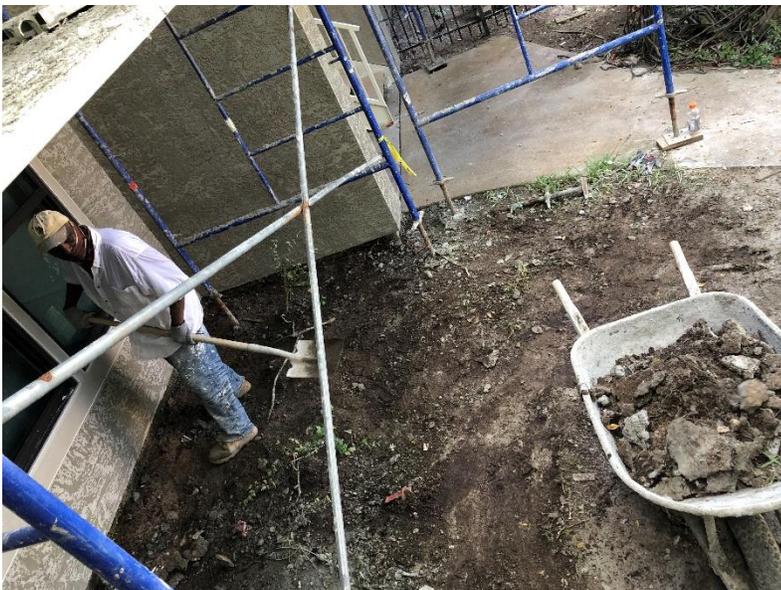
**PHOTOGRAPH #22**

**BUILDING 3  
SECTION F**

Contractor cleaned construction debris and trash from landscaped areas.

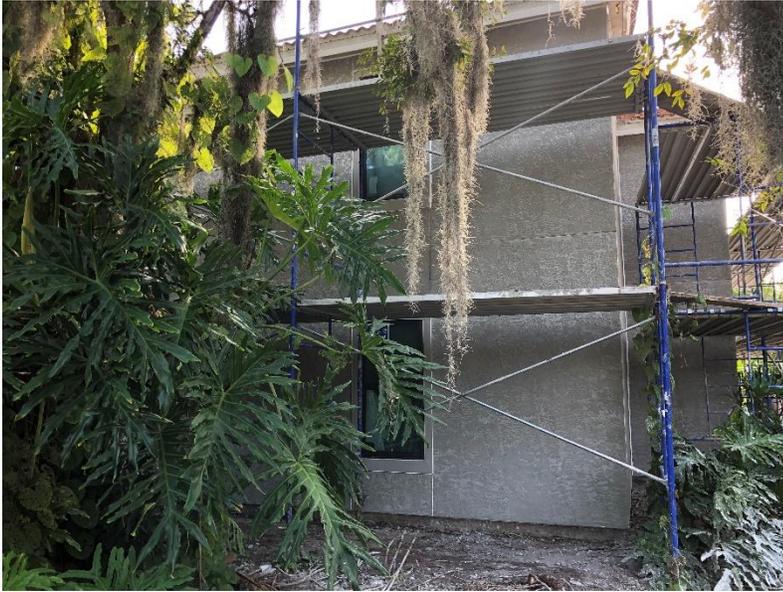
**PHOTOGRAPH #23**

**BUILDING 3  
SECTION G**

Stucco Sub-contractor applied stucco final coat.

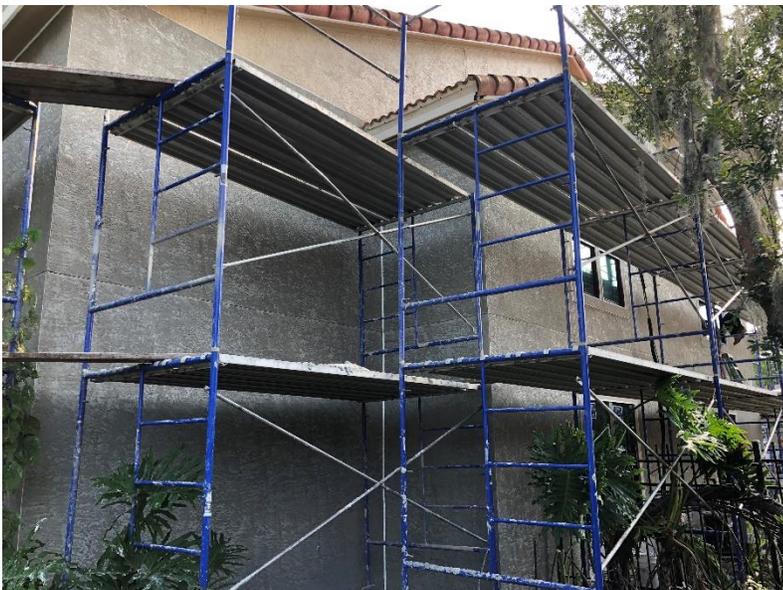
**PHOTOGRAPH #24**

**BUILDING 3  
SECTION H**

Stucco Sub-contractor applied final coat.

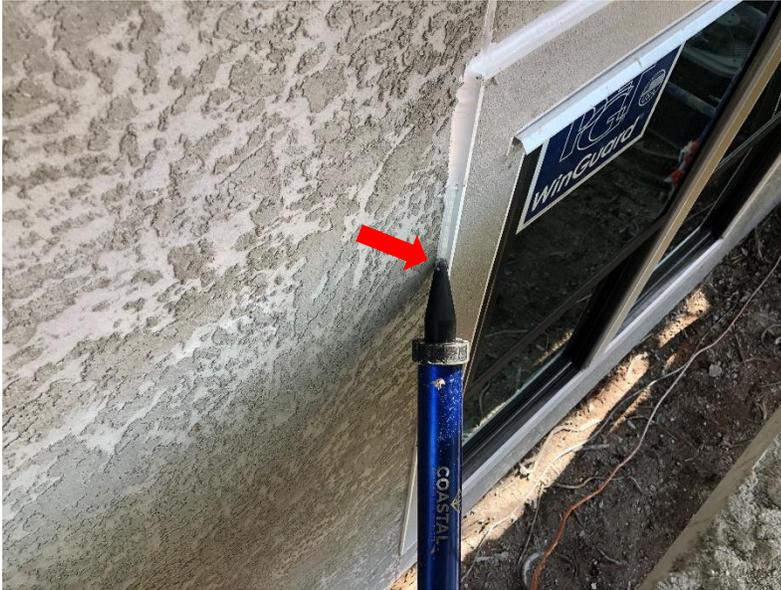
**PHOTOGRAPH #25**

**BUILDING 3  
SECTION H**

Stucco Sub-contractor applied MasterSeal NP 150 sealant around windows and inside stucco corners.

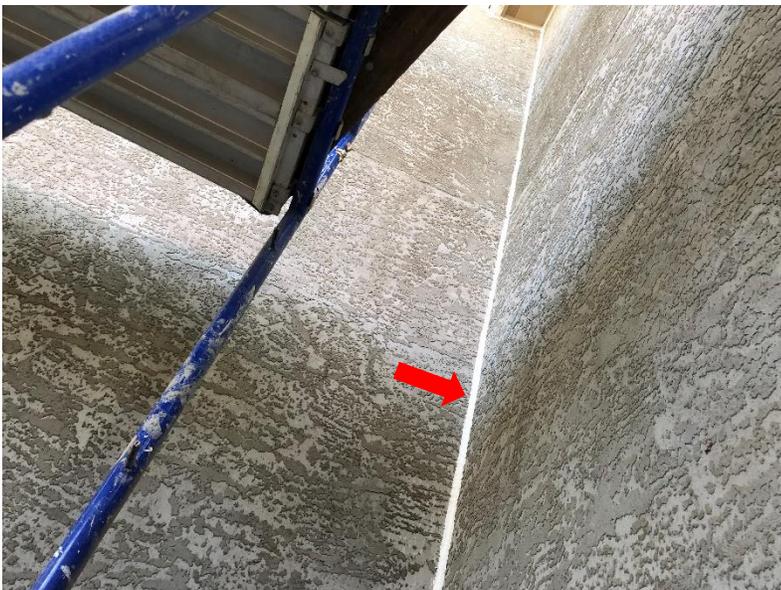
**PHOTOGRAPH #26**

**BUILDING 3  
SECTION H**

Stucco Sub-contractor applied MasterSeal NP 150 sealant around windows and inside stucco corners.

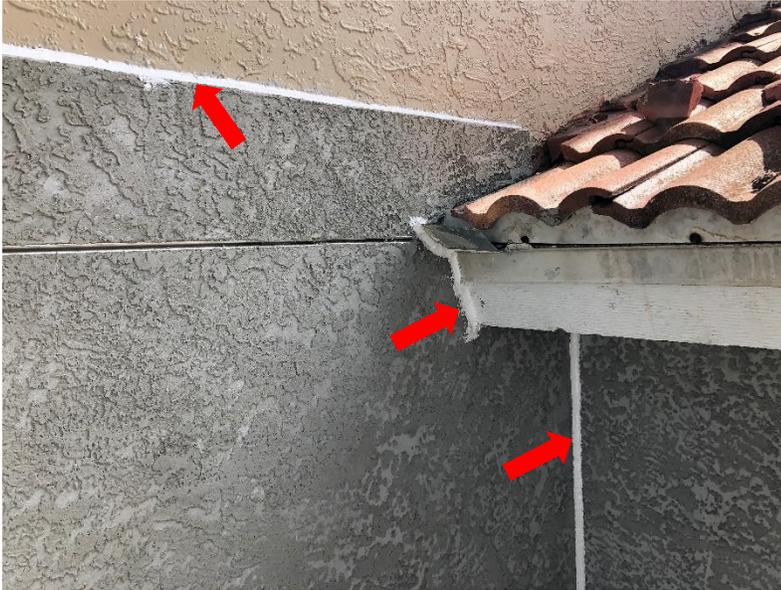
**PHOTOGRAPH #27**

**BUILDING 3  
SECTION H**

Stucco Sub-contractor applied MasterSeal NP 150 sealant around windows and inside stucco corners.

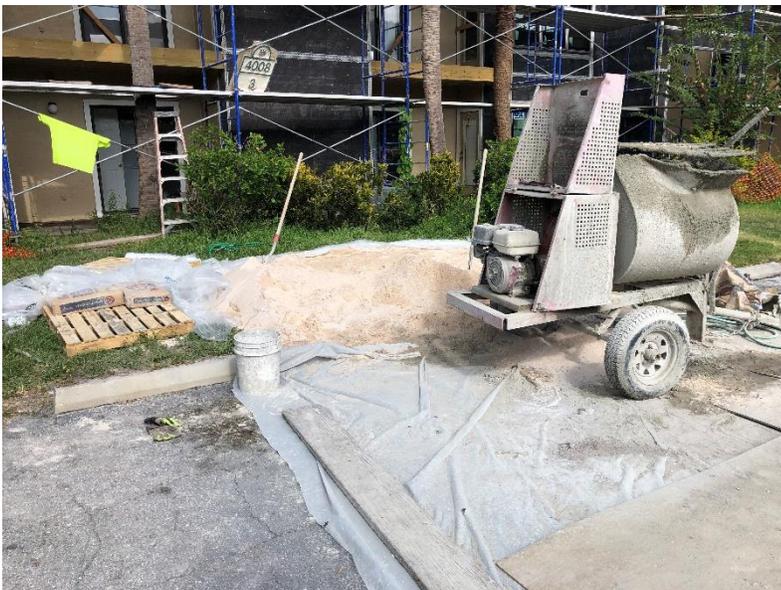
**PHOTOGRAPH #28**

**BUILDING 3  
SECTIONS E-H**

Stucco Sub-contractor used approved Cemex Broco Stucco Cement to mix stucco on-site.

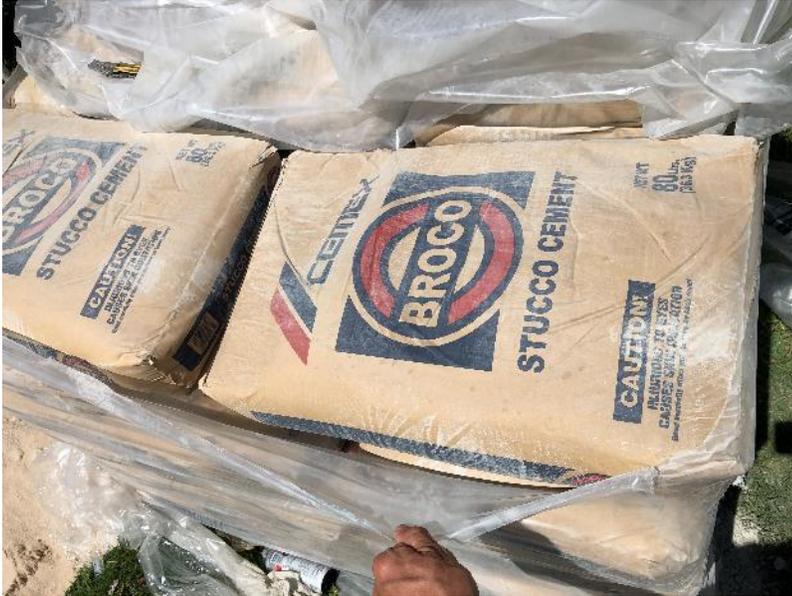
**PHOTOGRAPH #29**

**BUILDING 3  
SECTIONS E-H**

Stucco Sub-contractor used approved Cemex Broco Stucco Cement to mix stucco on-site.
