PHOTOGRAPHS

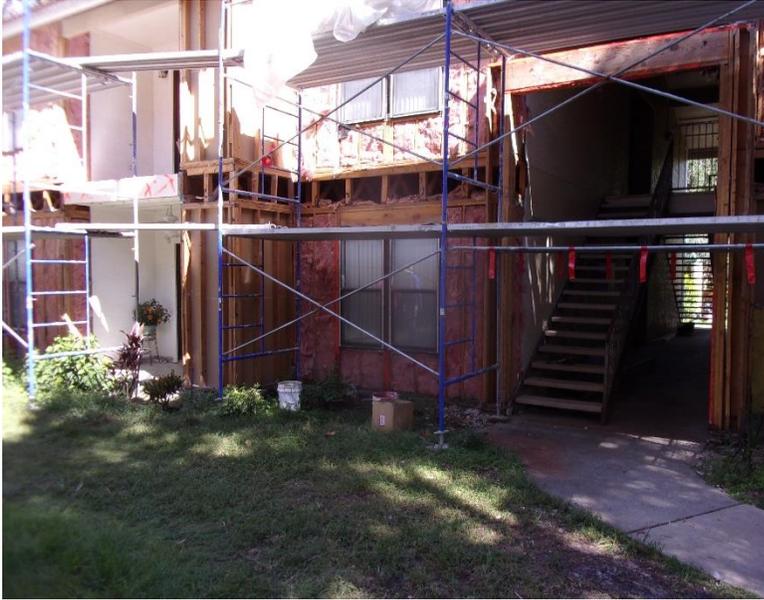
PHOTOGRAPH #1

BUILDING 6 SECTION A

Damaged framing identified and marked for repairs.

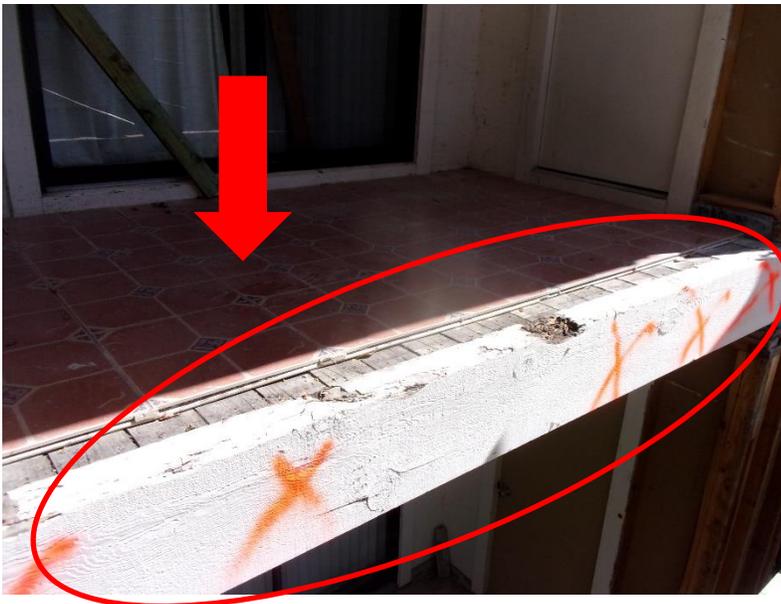
PHOTOGRAPH #2

BUILDING 6 SECTION A

Original cedar beam marked to be replaced. Owners has covered balcony deck with tile system.

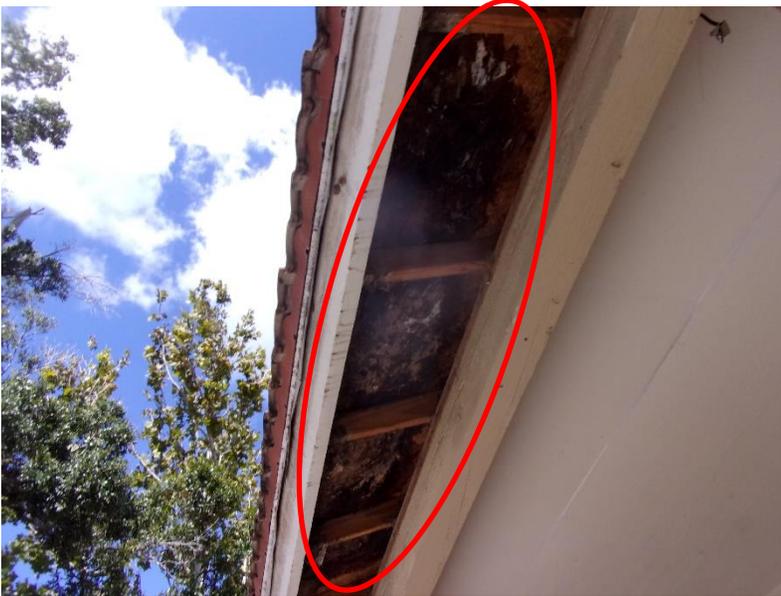
PHOTOGRAPH #3

**BUILDING 6
SECTION A**

Roof sheathing damaged from leaks will require removal and replacement by owners roofing contractor.

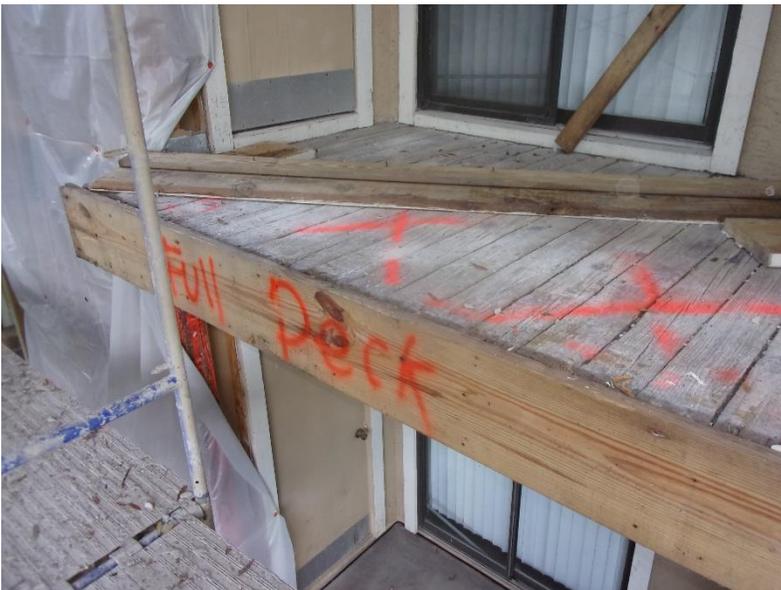
PHOTOGRAPH #4

**BUILDING 6
SECTION B**

Built up beam and balcony deck boards marked for replacement.

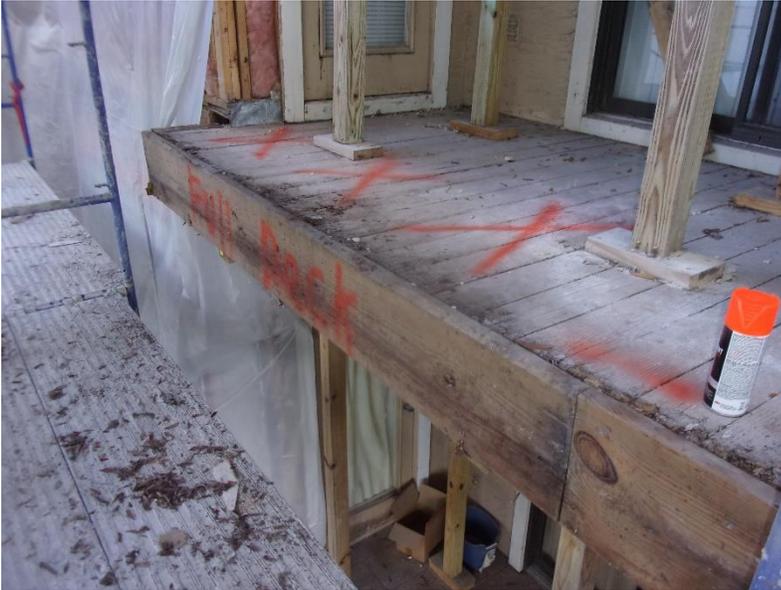
PHOTOGRAPH #5

**BUILDING 6
SECTION B**

Built up beam and balcony deck boards marked for replacement.

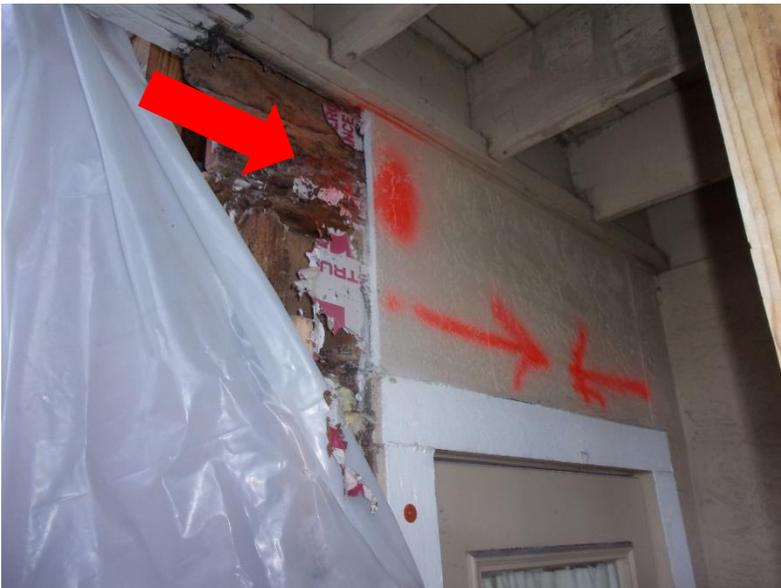
PHOTOGRAPH #6

**BUILDING 6
SECTION B**

Additional stucco marked for removal to inspect damaged beam and framing.

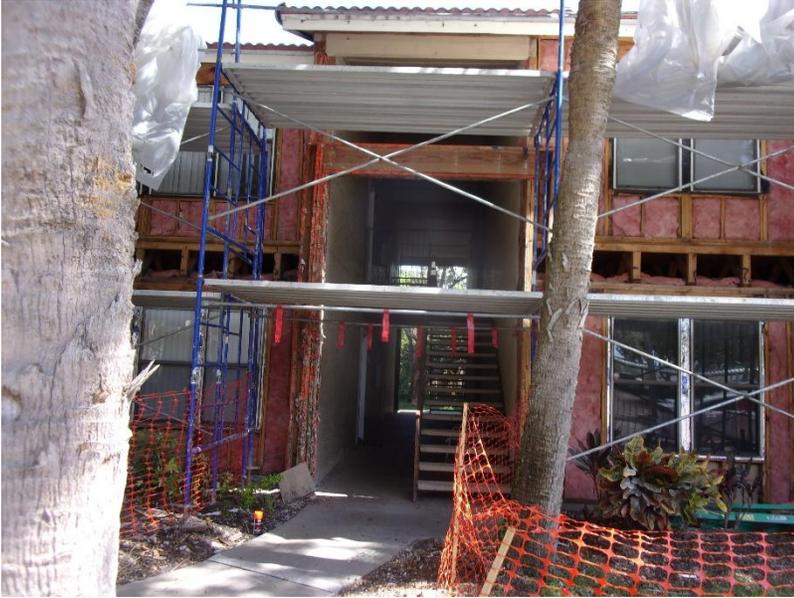
PHOTOGRAPH #7

**BUILDING 6
SECTION C**

Damaged framing identified and marked for repairs.

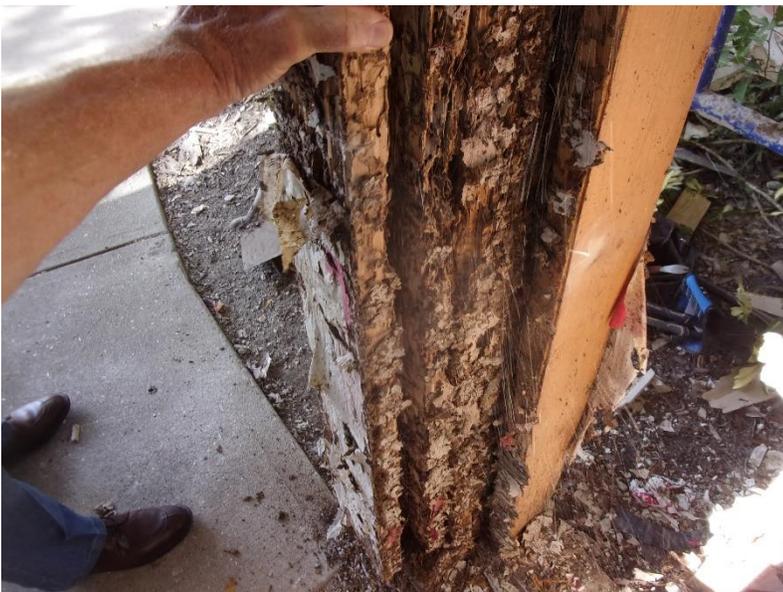
PHOTOGRAPH #8

**BUILDING 6
SECTION C**

Extensive termite damage at breezeway columns marked for repairs.

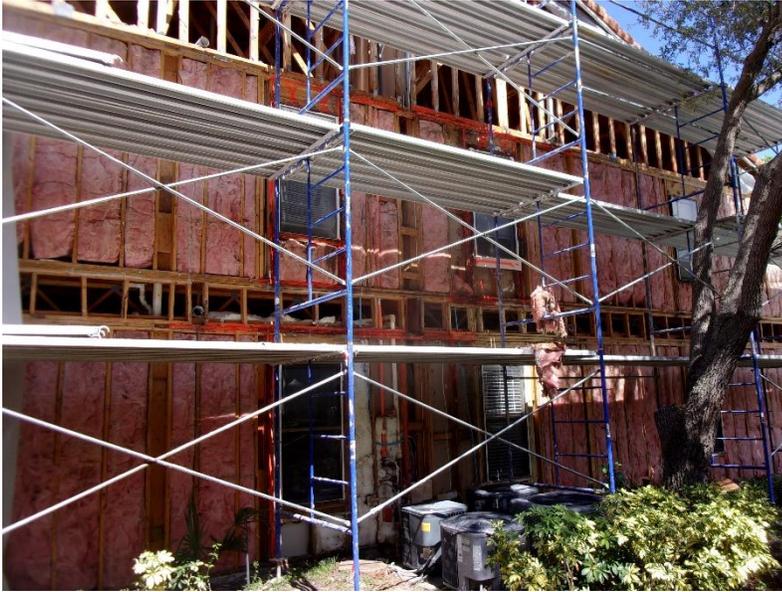
PHOTOGRAPH #9

**BUILDING 6
SECTION D**

Damaged framing identified and marked for repairs.

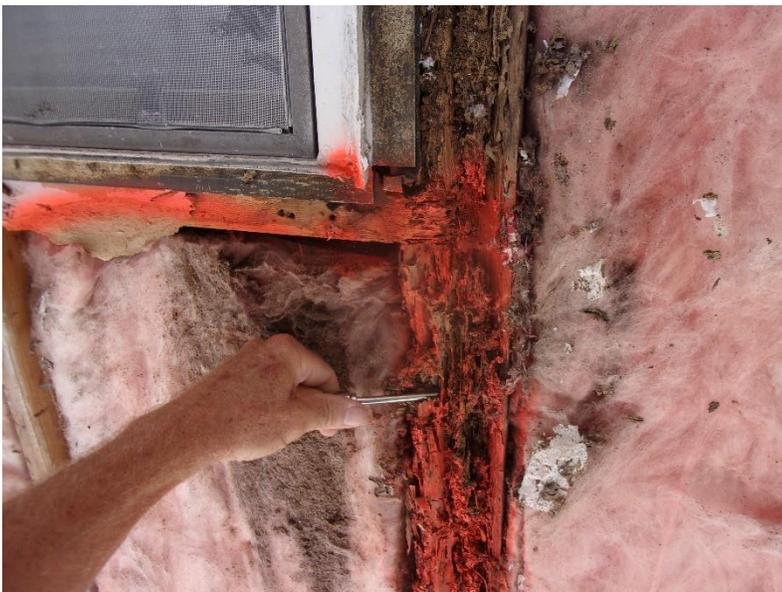
PHOTOGRAPH #10

**BUILDING 6
SECTION D**

Extensive termite damage at window framing studs marked for repairs.

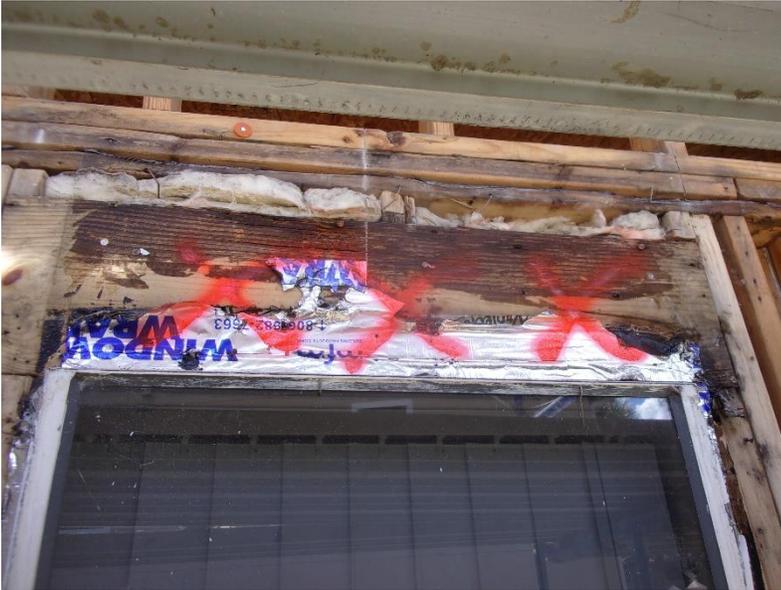
PHOTOGRAPH #11

**BUILDING 6
SECTION D**

Damaged window headers marked for removal and replacement.

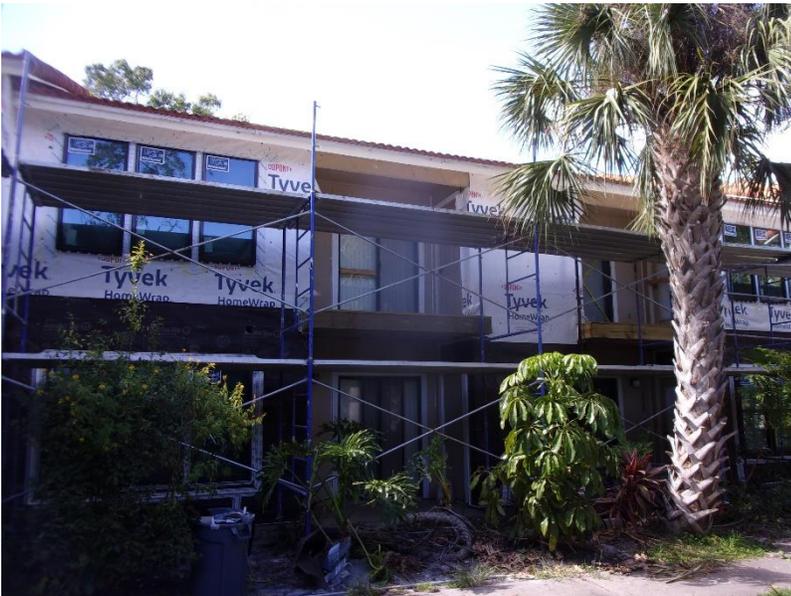
PHOTOGRAPH #12

**BUILDING 6
SECTION E, F & G**

Contractor re-erected scaffolding for access to complete repairs.

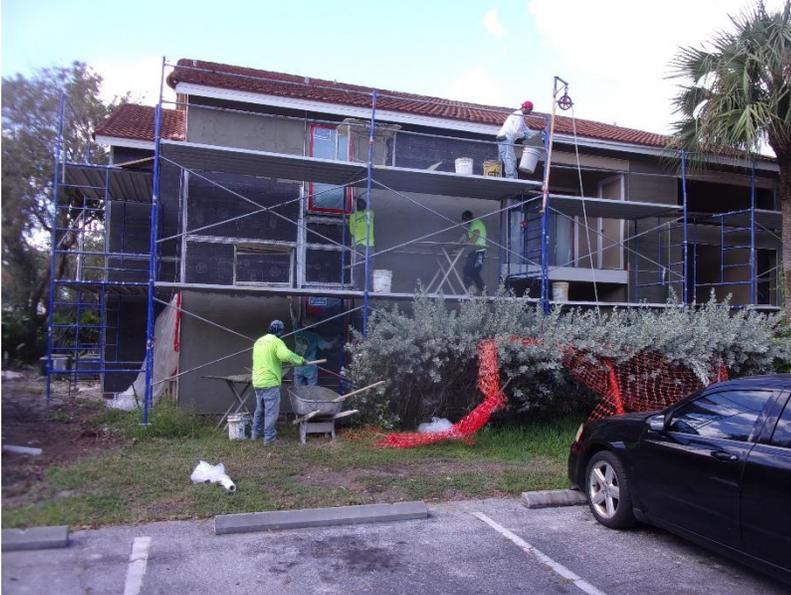
PHOTOGRAPH #13

**BUILDING 3
SECTION A**

Stucco Sub-contractor applying scratch coat of stucco.

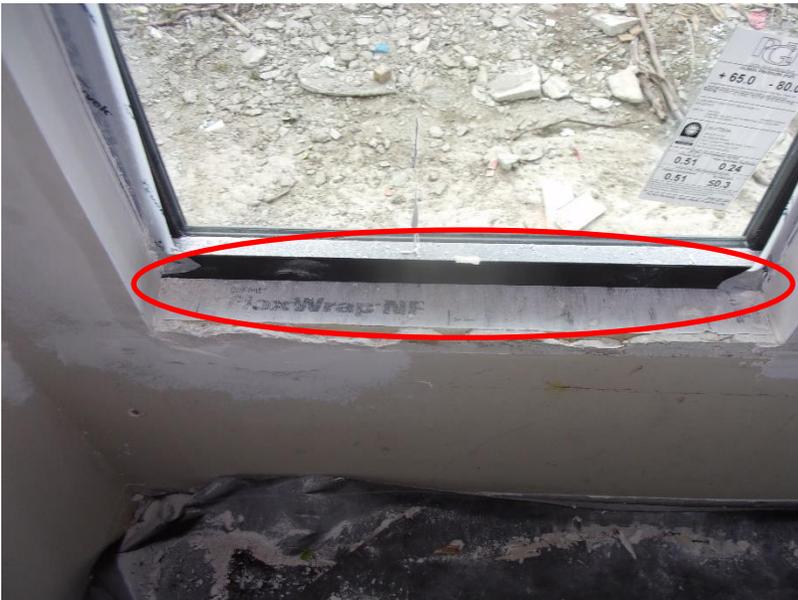
PHOTOGRAPH #14

**BUILDING 3
SECTION A-UNIT #311**

Interior sealant has not been applied as required before installing new drywall at window perimeters.

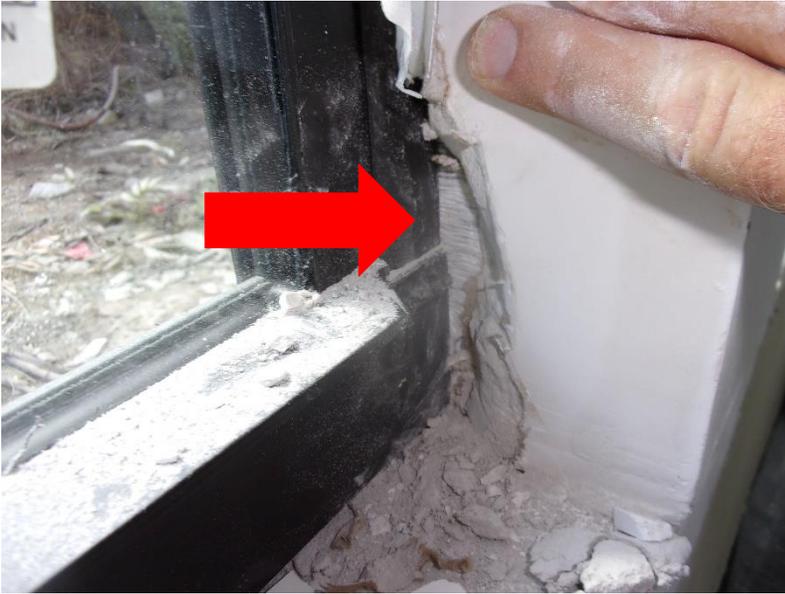
PHOTOGRAPH #15

**BUILDING 3
SECTION A-UNIT #311**

Drywall removal at window jamb verifies absence of sealant required before drywall application.

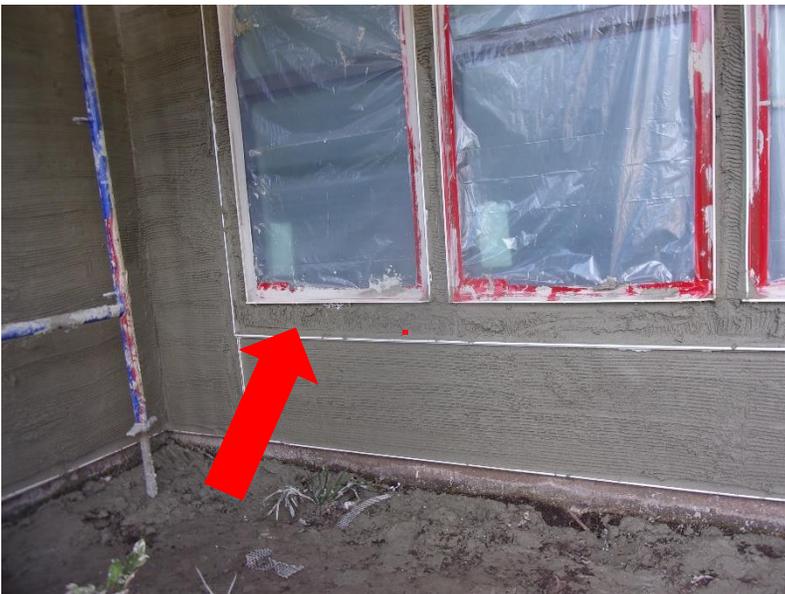
PHOTOGRAPH #16

**BUILDING 3
SECTION B**

Stucco Sub-contractor missed full scratch coat application at bottom of window band.

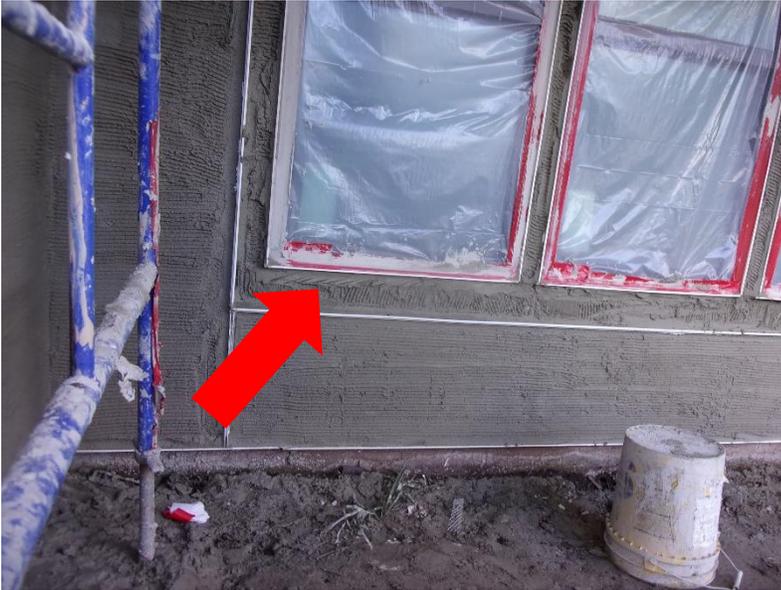
PHOTOGRAPH #17

**BUILDING 3
SECTION B**

Stucco Sub-contractor corrected scratch coat application at bottom of window band when pointed out by Delta.

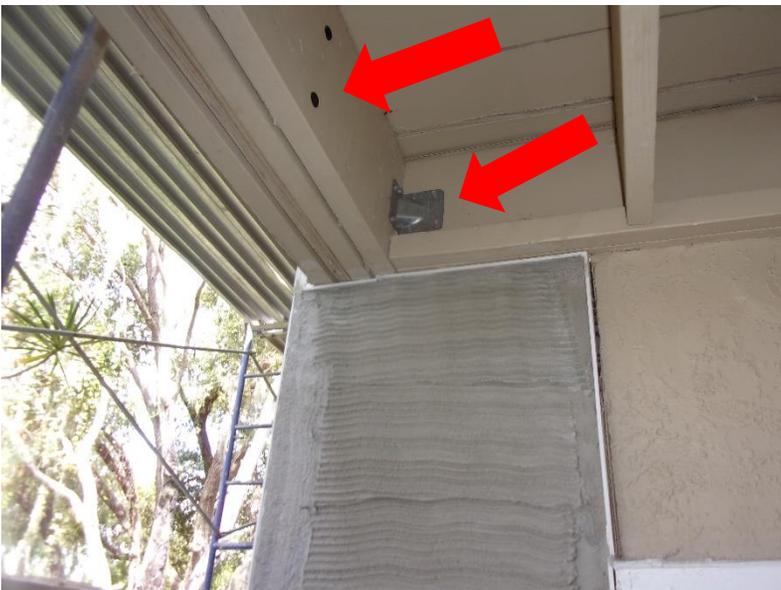
PHOTOGRAPH #18

**BUILDING 3
SECTION B**

Simpson Strong-Tie # HSLQ37 shear clip and SDW22458 screws installed at balcony built up beam as per drawings and specifications.

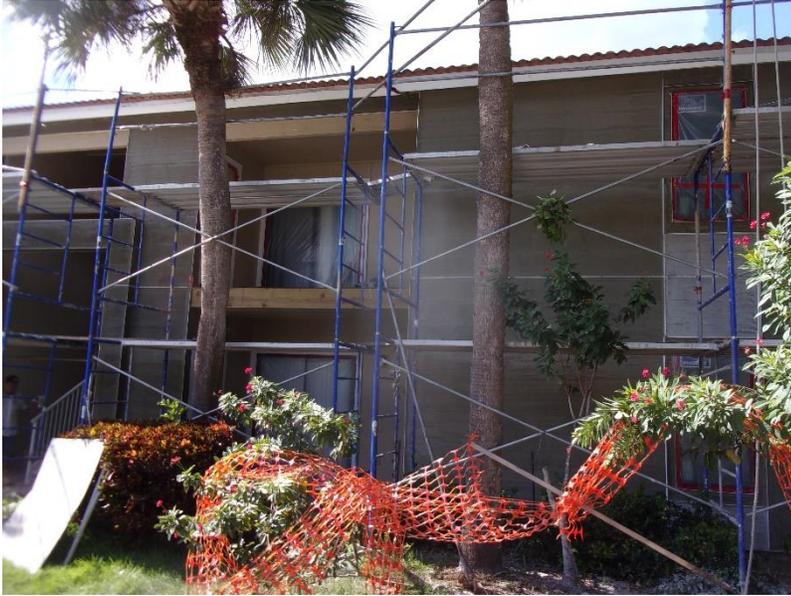
PHOTOGRAPH #19

**BUILDING 3
SECTION C**

Stucco sub-contractor has applied scratch coat and begun brown coat.

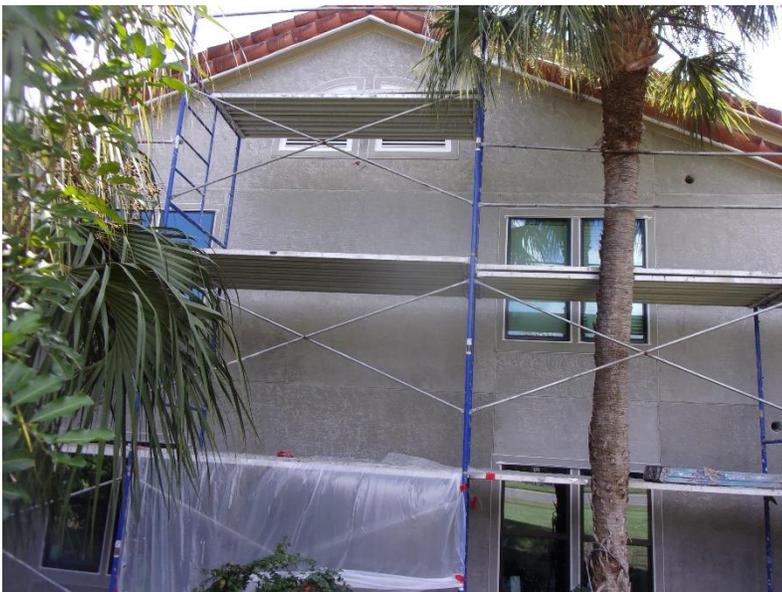
PHOTOGRAPH #20

**BUILDING 3
SECTION D**

Stucco sub-contractor has applied full three coat 7/8" stucco system.

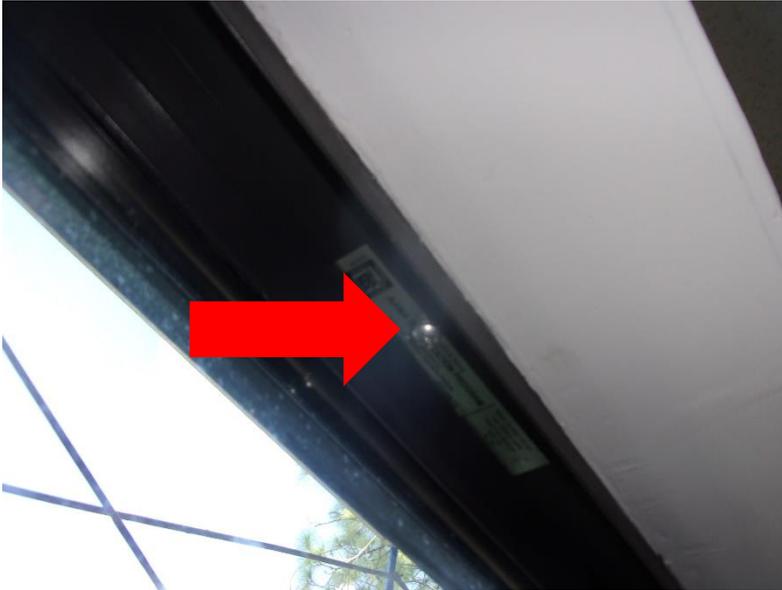
PHOTOGRAPH #21

**BUILDING 3
SECTION D-UNIT #317**

Contractor has made corrections at windows by applying #12 SMS screw at head location as per PGT Letter by Lynn Miller PE dated 9.17.2020. addressing the condition.

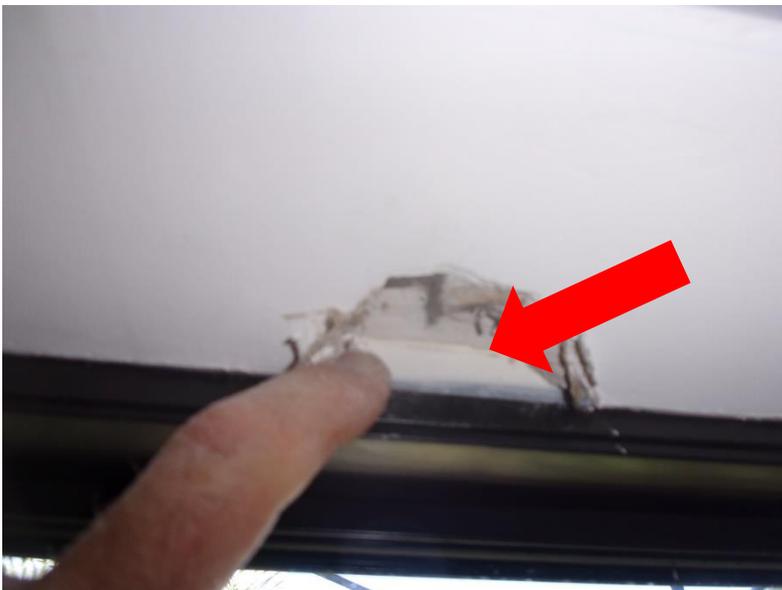
PHOTOGRAPH #22

**BUILDING 3
SECTION D-UNIT #317**

Delta removed drywall to verify interior perimeter sealant was applied prior to drywall installation.

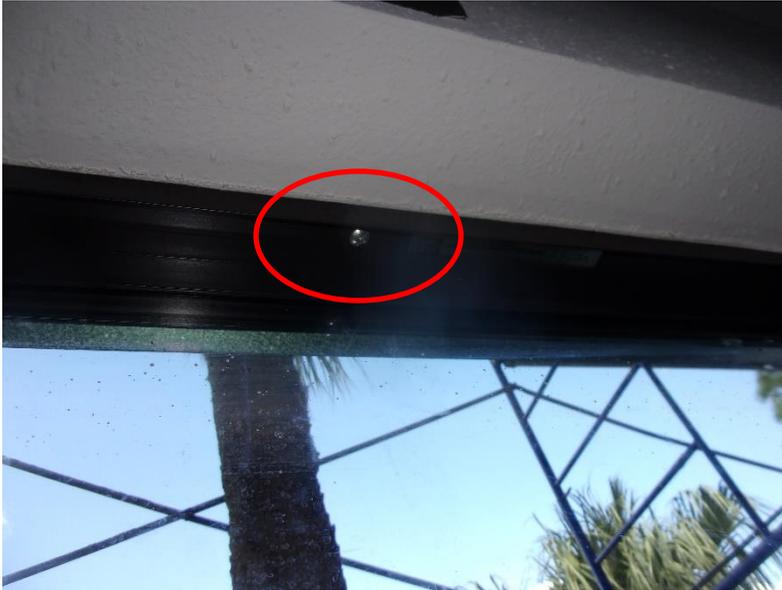
PHOTOGRAPH #23

**BUILDING 3
SECTION D-UNIT #318**

Contractor has made corrections at windows by applying #12 SMS screw at head location as per PGT Letter by Lynn Miller PE dated 9.17.2020. addressing the condition.

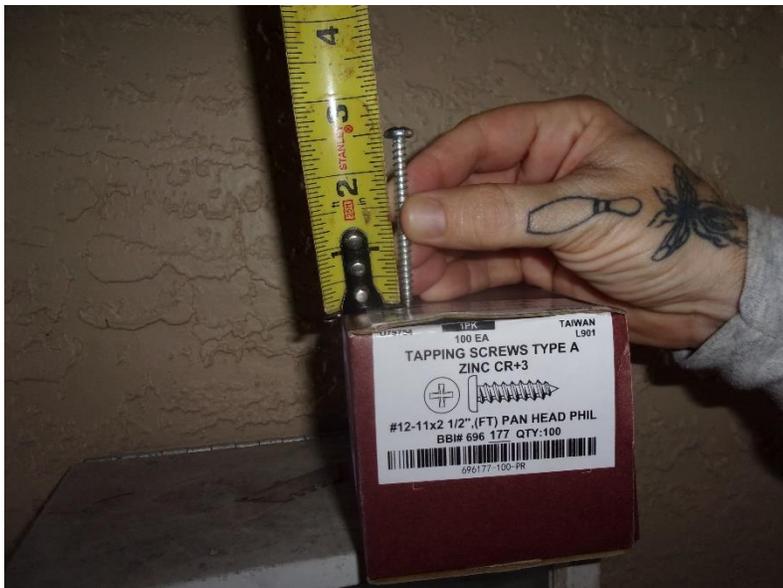
PHOTOGRAPH #24

**BUILDING 3
SECTION D-UNIT #318**

Contractor has made corrections at windows by applying #12 SMS screw at head location as per PGT Letter by Lynn Miller PE dated 9.17.2020. addressing the condition

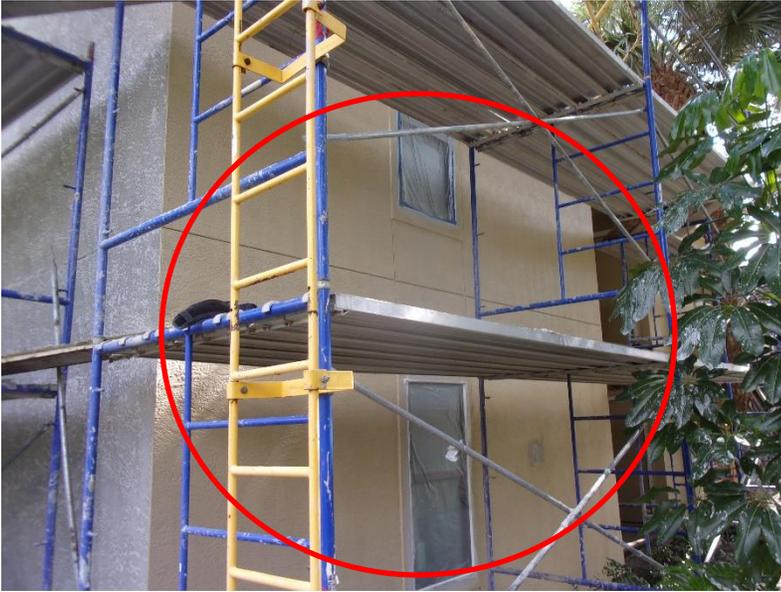
PHOTOGRAPH #25

**BUILDING 3
SECTION E**

Contractor has applied SunFlex Masonry Acrylic exterior primer to new stucco.

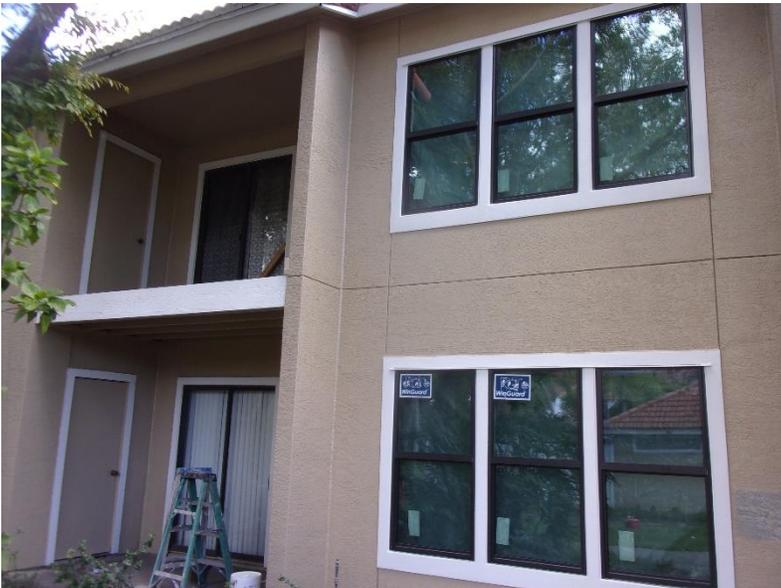
PHOTOGRAPH #26

**BUILDING 3
SECTION F**

Contractor has applied Florida Paints Ultra Exterior Supercoat to new stucco.

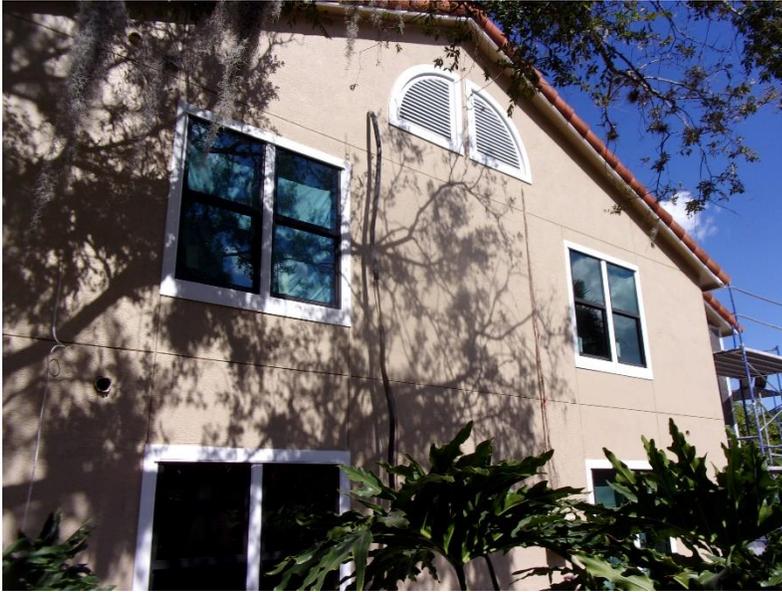
PHOTOGRAPH #27

**BUILDING 3
SECTION H**

Contractor has applied Florida Paints Ultra Exterior Supercoat to new stucco.

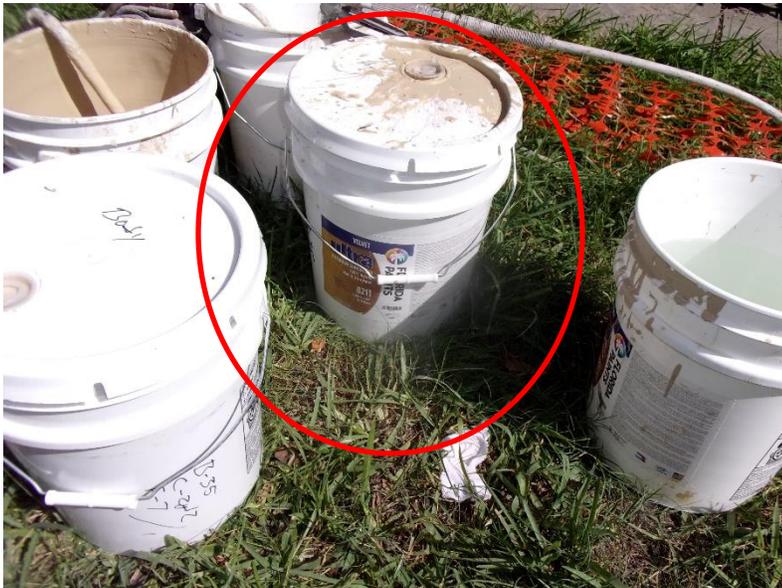
PHOTOGRAPH #28

**BUILDING 3
SECTIONS H**

Contractor has applied Florida Paints Ultra Exterior Supercoat to new stucco.
