PHOTOGRAPHS

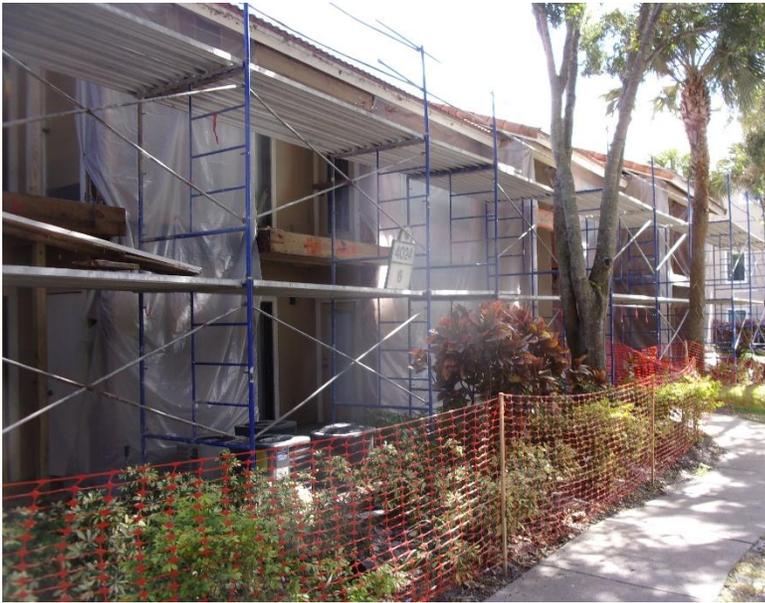
PHOTOGRAPH #1

BUILDING 6 SECTION A, B & C

Walls opened for repairs have been covered with heavy plastic for weather protection during repairs.

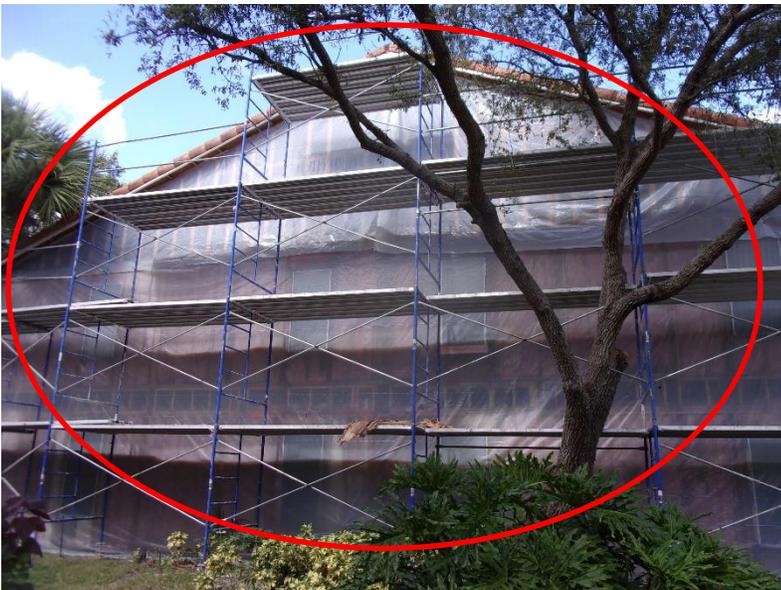
PHOTOGRAPH #2

BUILDING 6 SECTION D

Walls opened for repairs have been covered with heavy plastic for weather protection during repairs.

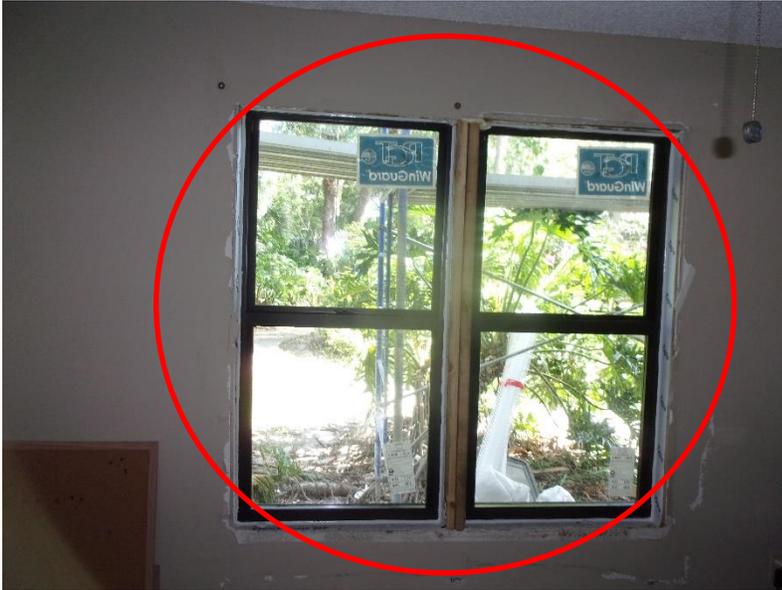
PHOTOGRAPH #3

**BUILDING 6
SECTION G- UNIT 612**

Independent Testing Agency performed AAMA 502 water infiltration testing at bedroom double window with passing results and no leaks.

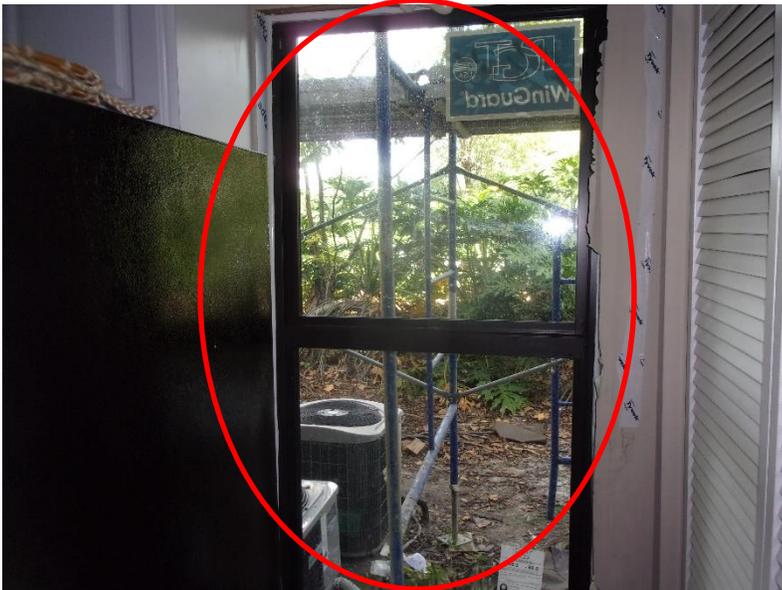
PHOTOGRAPH #4

**BUILDING 6
SECTION H-UNIT 612**

Independent Testing Agency performed AAMA 502 water infiltration testing at kitchen single window with failing results, leaking at lower perimeter wood framing member.

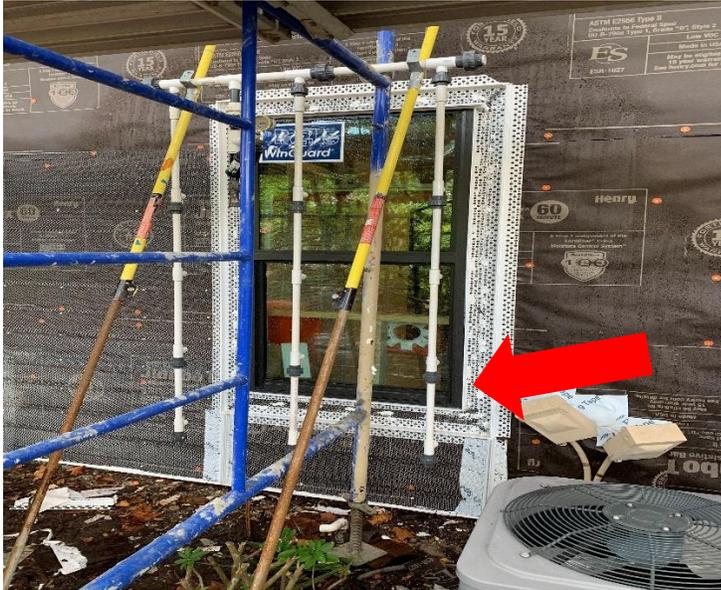
PHOTOGRAPH #5

**BUILDING 6
SECTION H-UINT 612**

Independent Testing Agency performed AAMA 502 water infiltration testing at kitchen single window with failing results, leaking at lower perimeter wood framing member.

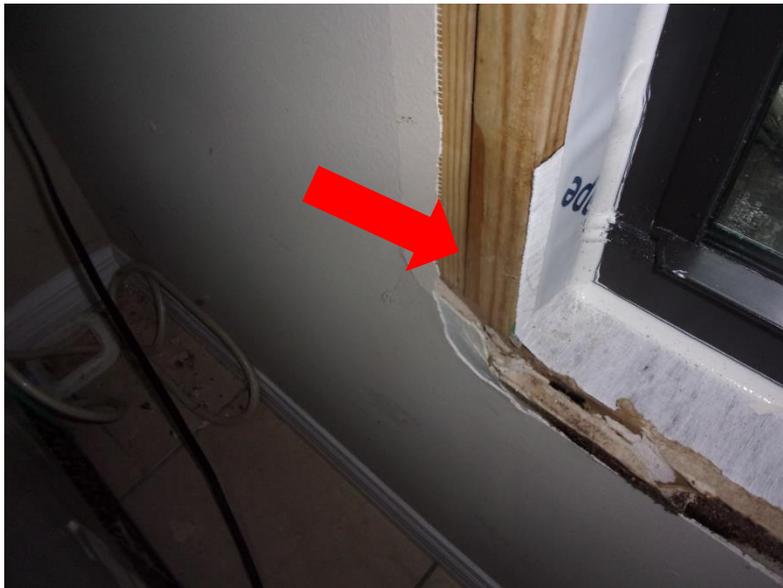
PHOTOGRAPH #6

**BUILDING 6
SECTION H-UINT 612**

Independent Testing Agency performed AAMA 502 water infiltration testing at kitchen single window with failing results, leaking at lower perimeter wood framing member.

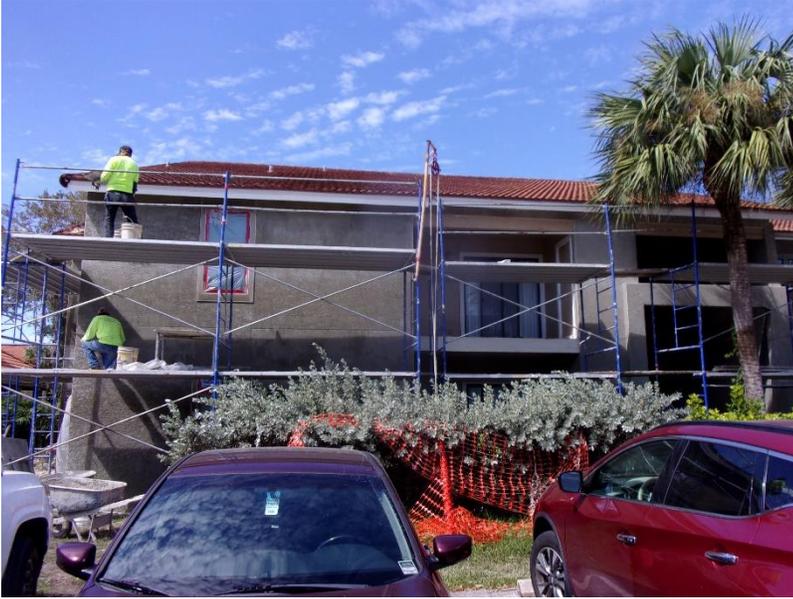
PHOTOGRAPH #7

**BUILDING 3
SECTION A**

Stucco sub-contractor applying skip trowel texture finish coat of stucco.

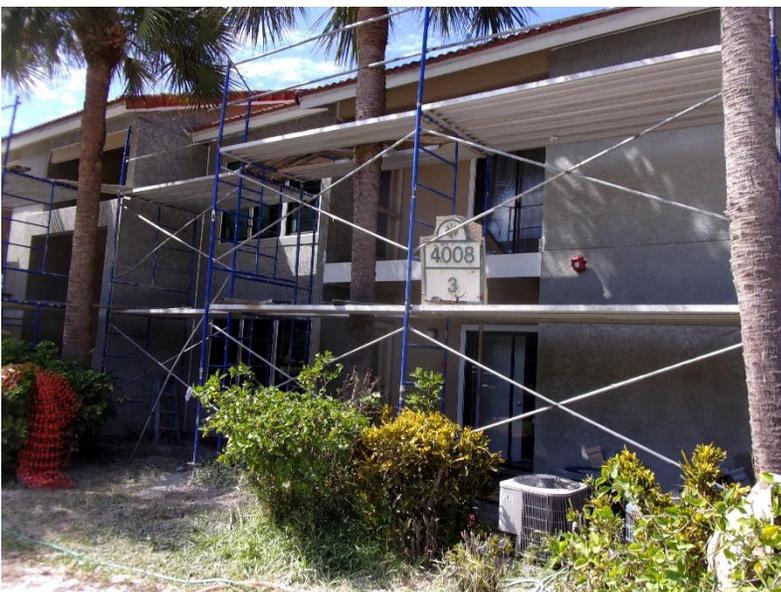
PHOTOGRAPH #8

**BUILDING 3
SECTION B**

Three coat 7/8" stucco application applied as per specifications.

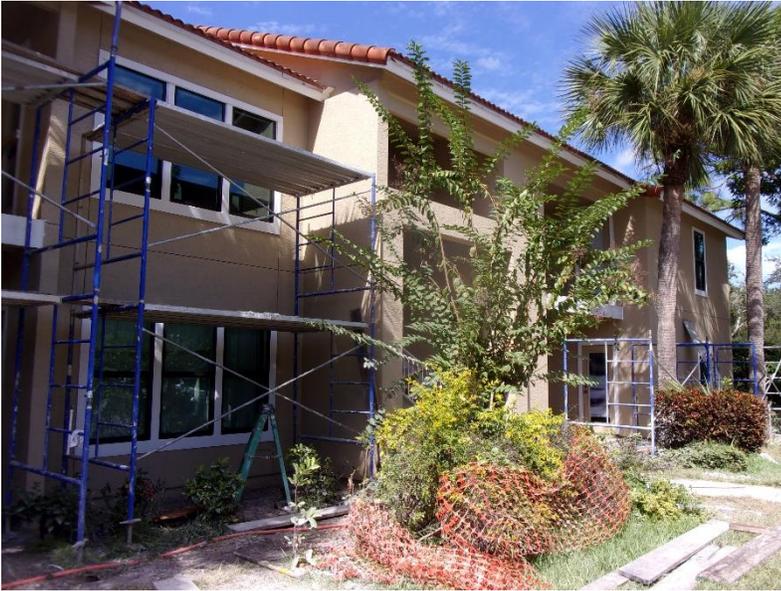
PHOTOGRAPH #9

**BUILDING 3
SECTION C**

Finish trim painting has been performed and access scaffolding is being removed.

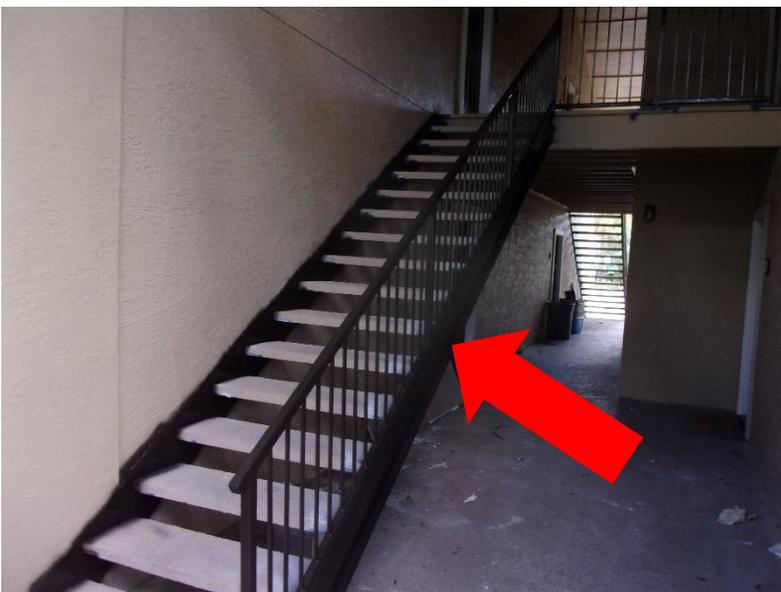
PHOTOGRAPH #10

**BUILDING 3
SECTION C**

Florida Paints Sundeavor high performance urethan enamel applied to walkway railings.

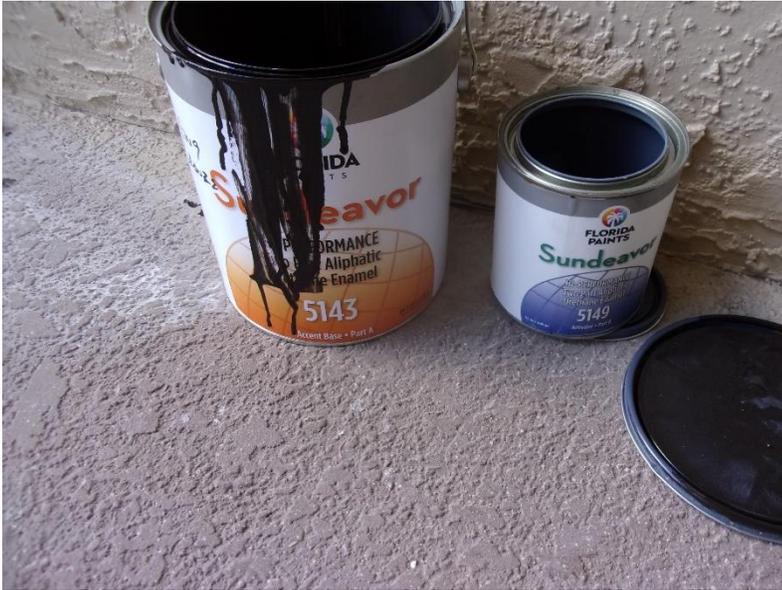
PHOTOGRAPH #11

**BUILDING 3
SECTION C**

Florida Paints Sundeavor high performance urethane enamel applied to walkway railings.

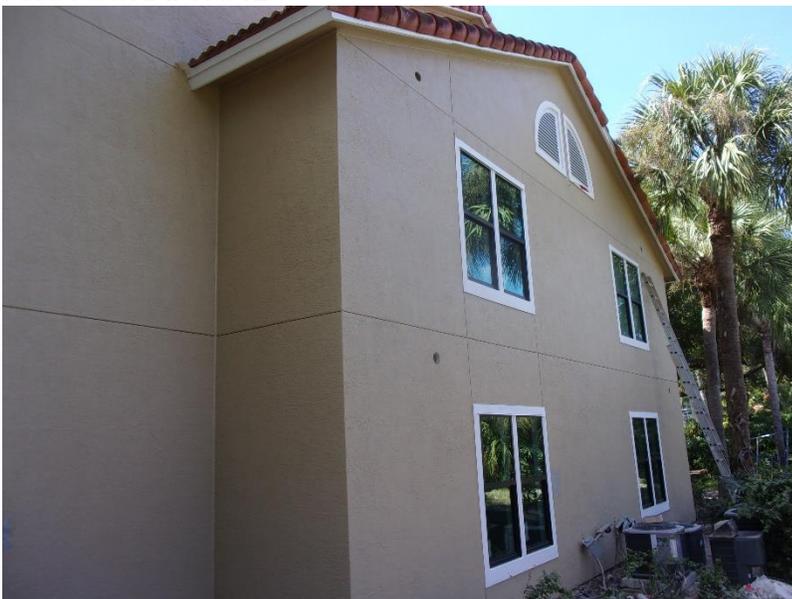
PHOTOGRAPH #12

**BUILDING 3
SECTION D**

Finish trim painting has been performed and access scaffolding has been removed.

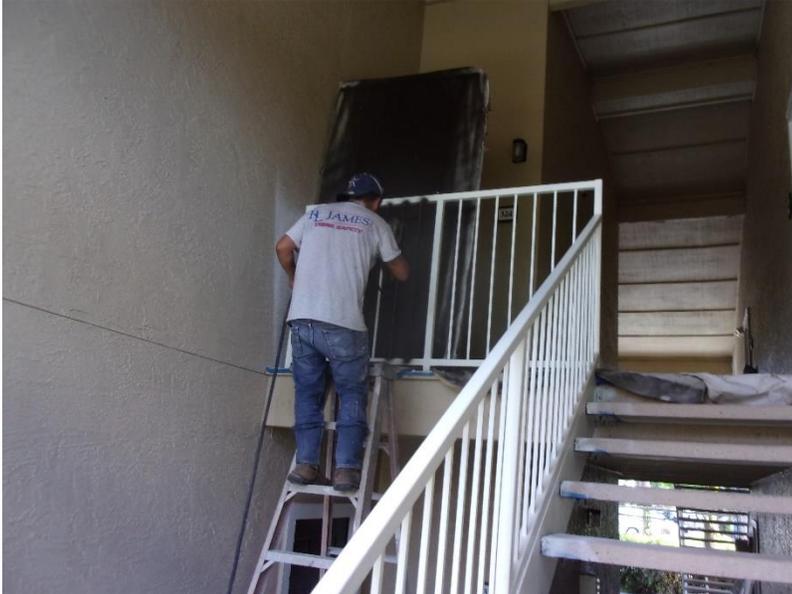
PHOTOGRAPH #13

**BUILDING 3
SECTION E**

Florida Paints Sundeavor high performance urethan enamel, being spray applied to walkway railings.

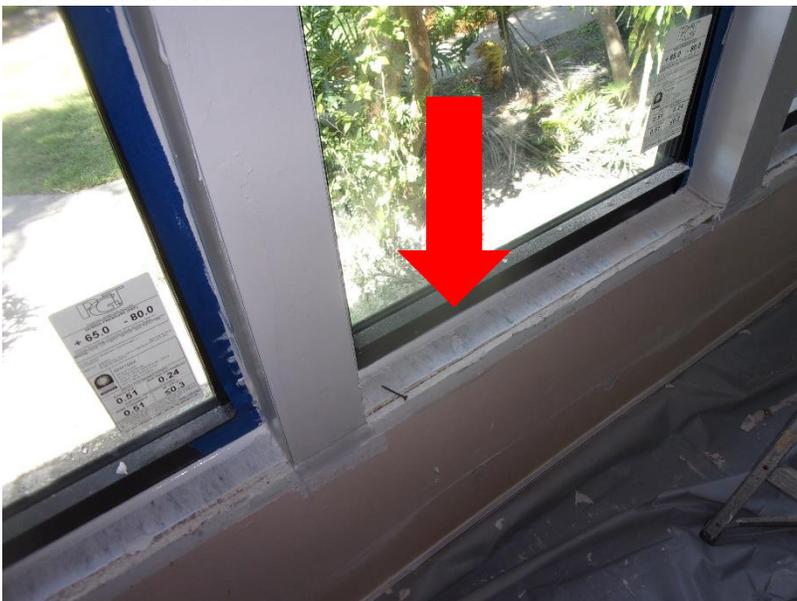
PHOTOGRAPH #14

**BUILDING 3
SECTION F-UNIT #324**

Interior sealant has been applied as required before installing new drywall at window perimeters.

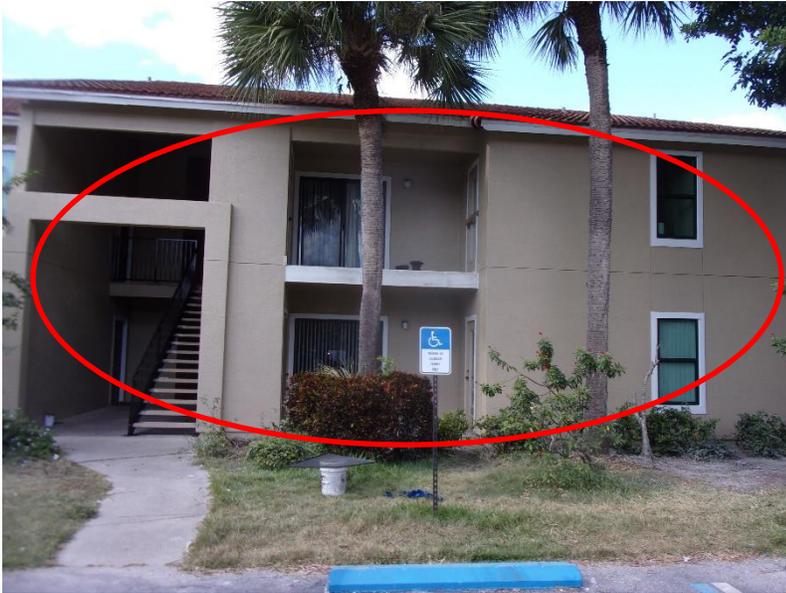
PHOTOGRAPH #15

**BUILDING 3
SECTION G**

Finish trim painting has been performed and access scaffolding has been removed.

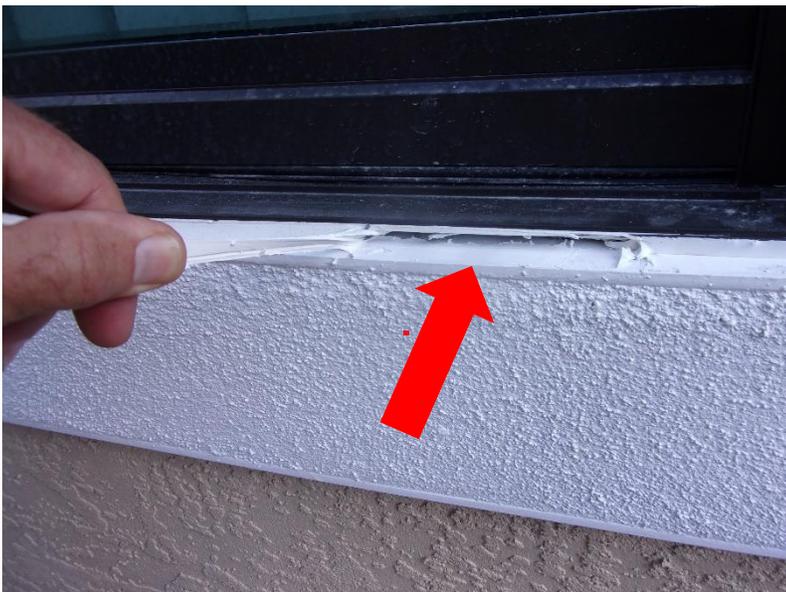
PHOTOGRAPH #16

**BUILDING 3
SECTION G**

Adhesion pull test of BASF MasterSeal sealant performed and passed at window perimeter.

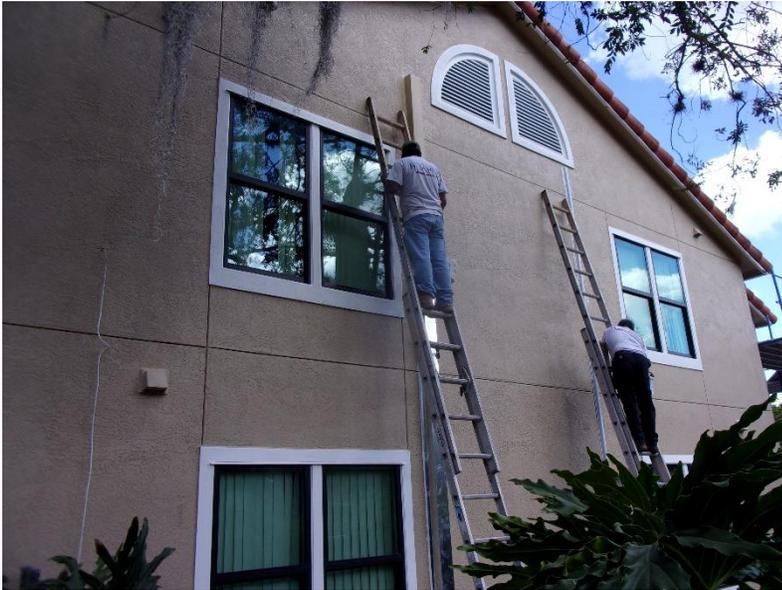
PHOTOGRAPH #17

**BUILDING 3
SECTION H**

Contractor performing trim painting and new chase cover installation at gable end wall.

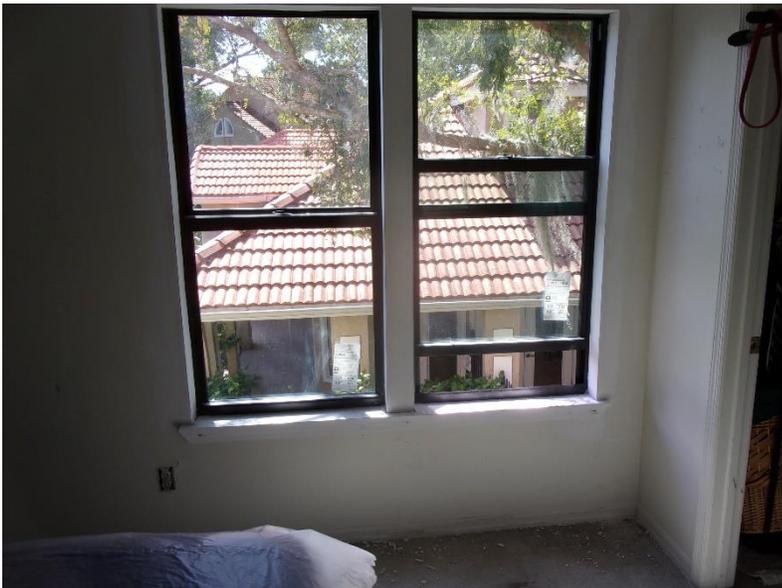
PHOTOGRAPH #18

**BUILDING 3
SECTION H- UINT 322**

Interior drywall and windowsill repairs have been performed at new window location.

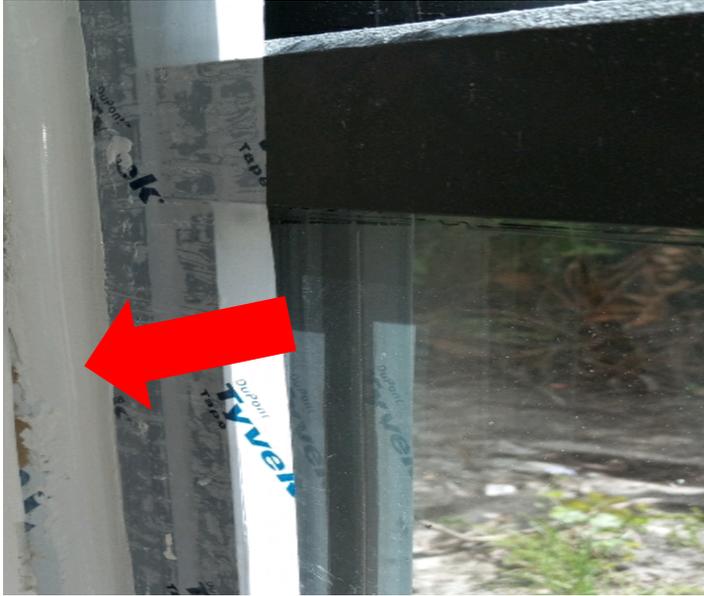
PHOTOGRAPH #19

**BUILDING 3
SECTION H- UINT 311**

Drywall was removed and Interior sealant has been applied as required before re installing drywall at window perimeters.
