## PHOTOGRAPHS

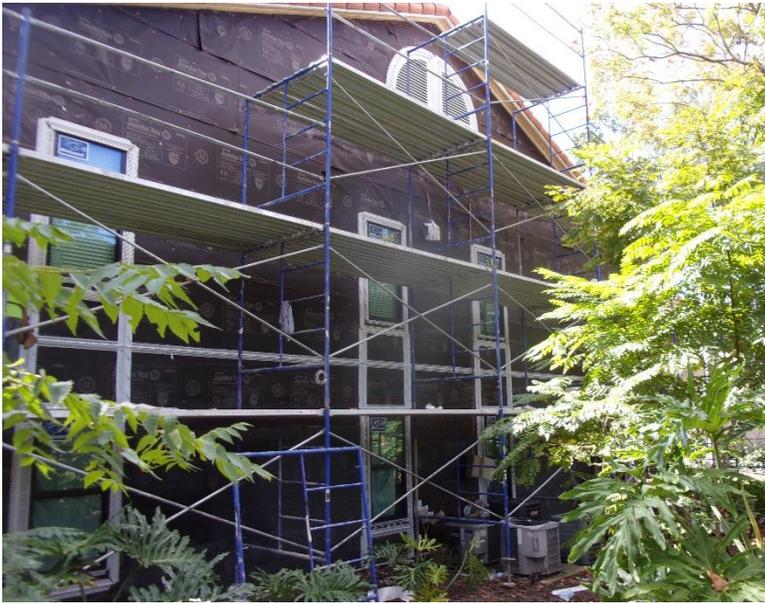
PHOTOGRAPH #1

### BUILDING 6 SECTION H

Jumbo Tex super 60 WRB applied and stucco accessories in progress.

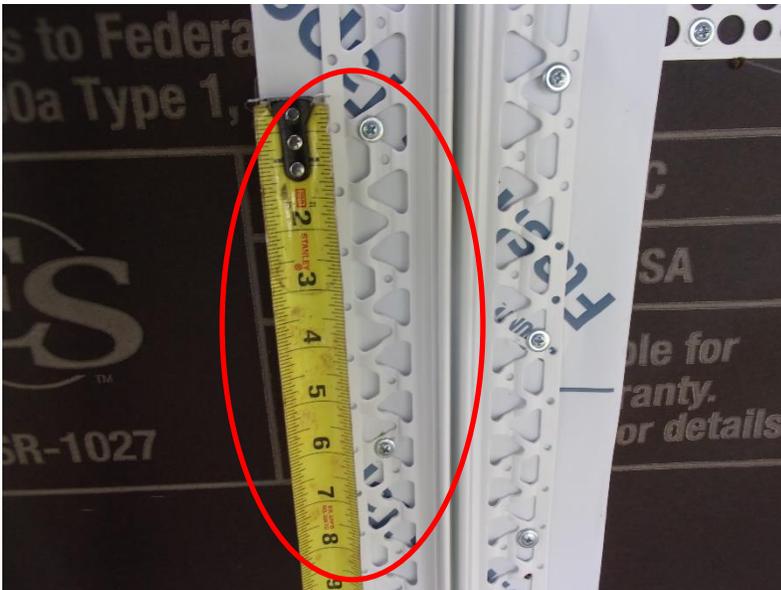
PHOTOGRAPH #2

### BUILDING 6 SECTION F

Vinyl stucco joints attached over Dupont flashing at 7" intervals as per specifications.

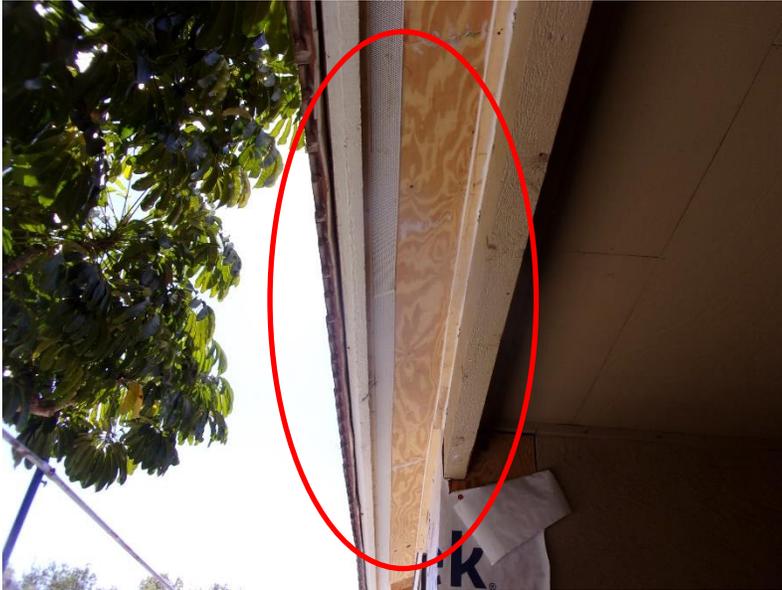
**PHOTOGRAPH #3**

**BUILDING 6  
SECTION F**

New soffit and soffit vent installed and prepared for prime and painting.

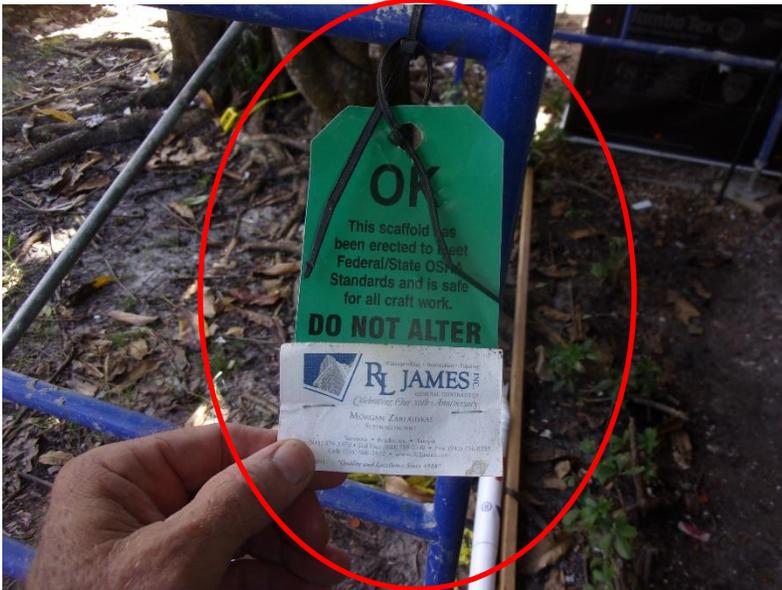
**PHOTOGRAPH #4**

**BUILDING 6  
SECTION E**

Contractor has approved erecting of access scaffold as per safety program process.

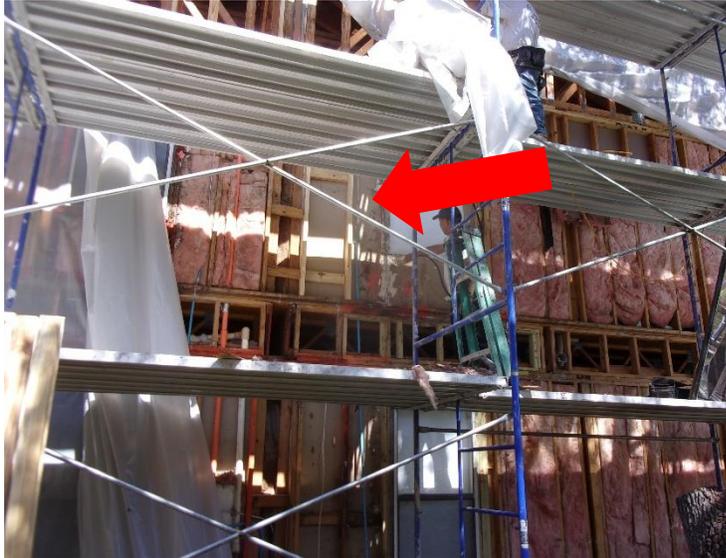
**PHOTOGRAPH #5**

**BUILDING 6  
SECTION D**

Framing repairs have begun at wall studs and window openings with 2"X4" southern yellow pine.

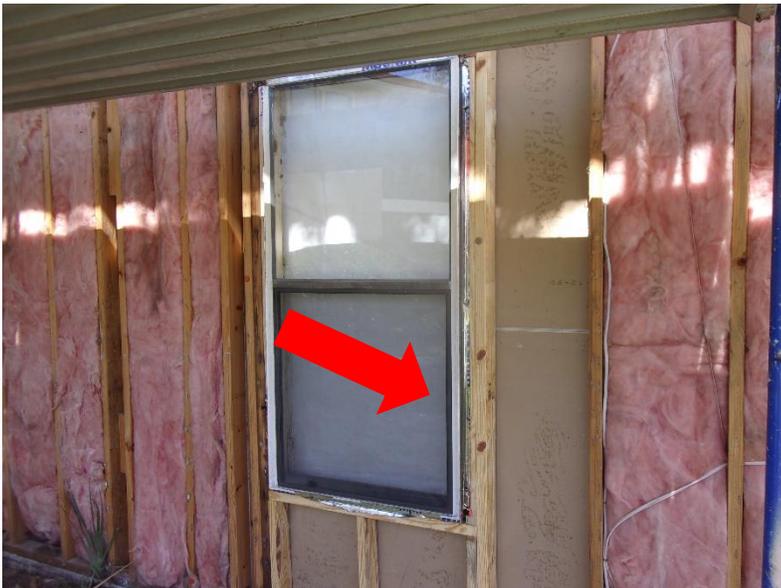
**PHOTOGRAPH #6**

**BUILDING 6  
SECTION D**

Window opening repairs performed at jams, sills, and jacks.

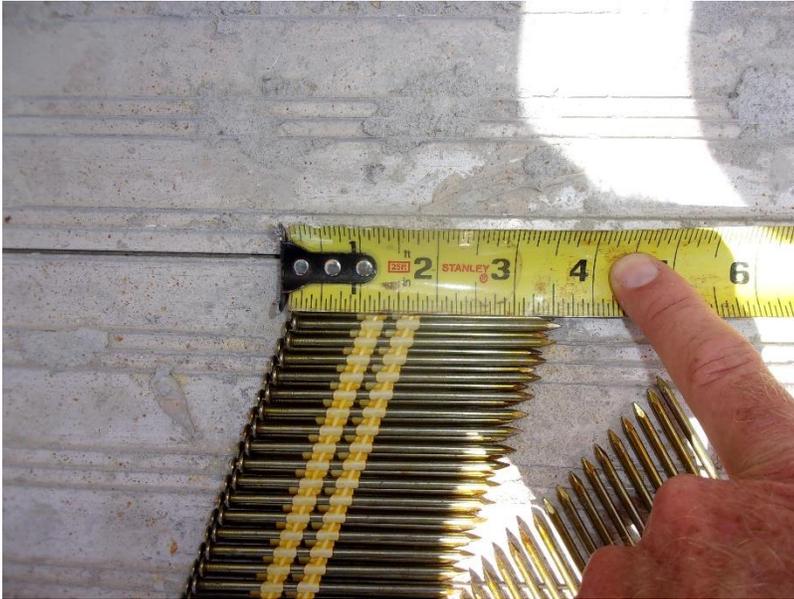
**PHOTOGRAPH #7**

**BUILDING 6  
SECTION D**

3 1/2" 16P framing nails used for framing repairs as per drawings.

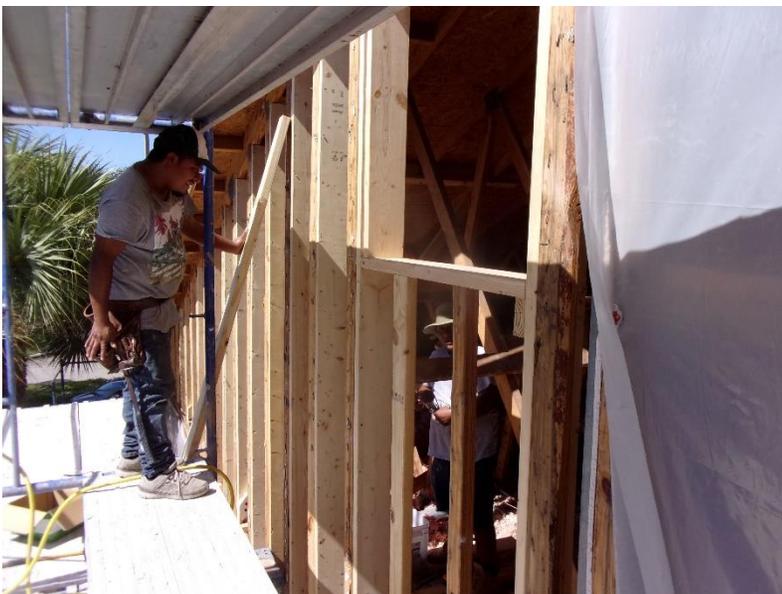
**PHOTOGRAPH #8**

**BUILDING 6  
SECTION D**

Gable end structural support framing in progress as per drawings.

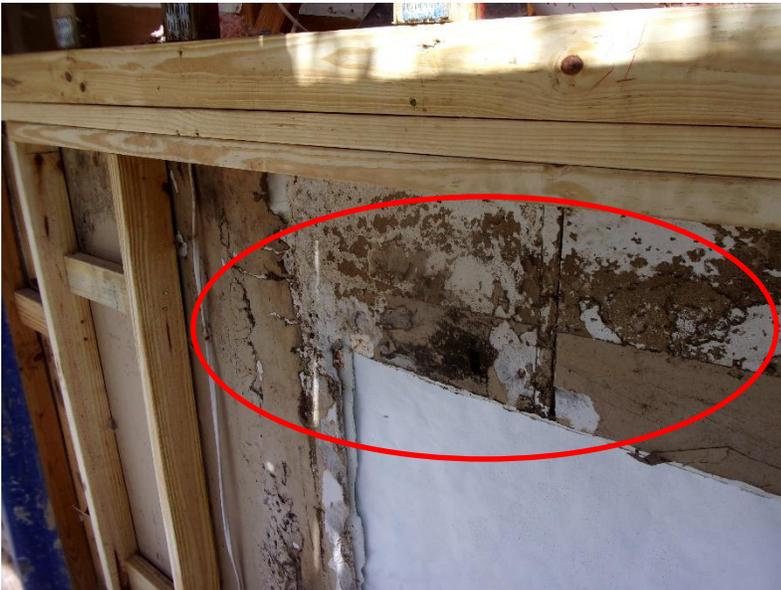
**PHOTOGRAPH #9**

**BUILDING 6  
SECTION D**

Drywall damage identified at **Unit #628** will require removal and replacement.

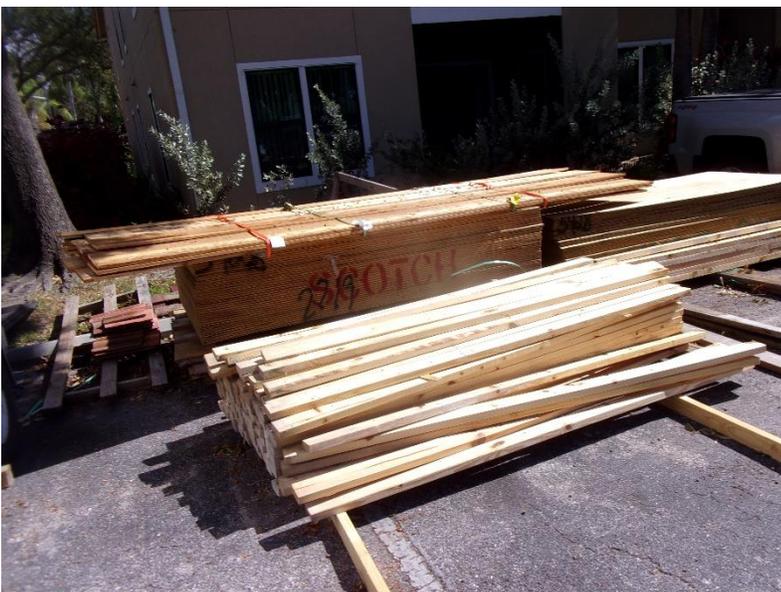
**PHOTOGRAPH #10**

**BUILDING 6  
STORAGE AREA**

Sheathing plywood and wood framing materials delivered.

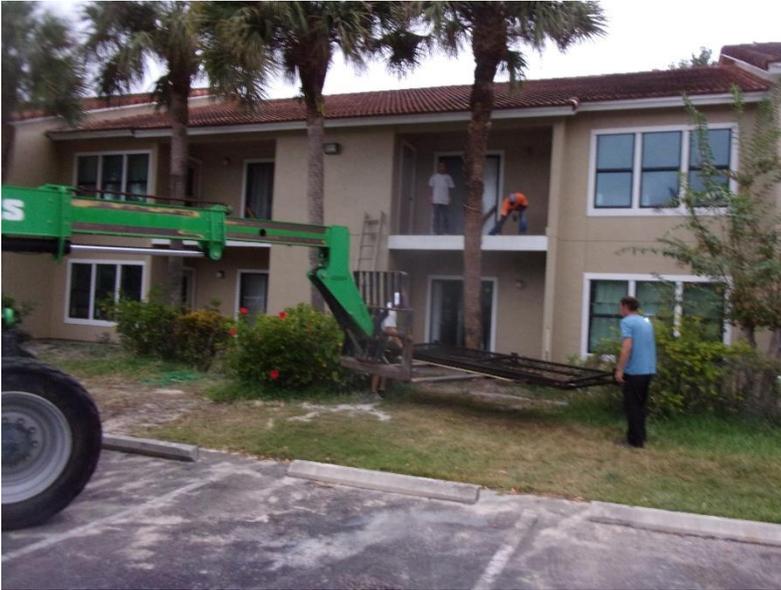
**PHOTOGRAPH #11**

**BUILDING 3  
SECTION B**

Newly painted balcony railings placed upon balconies for installation.

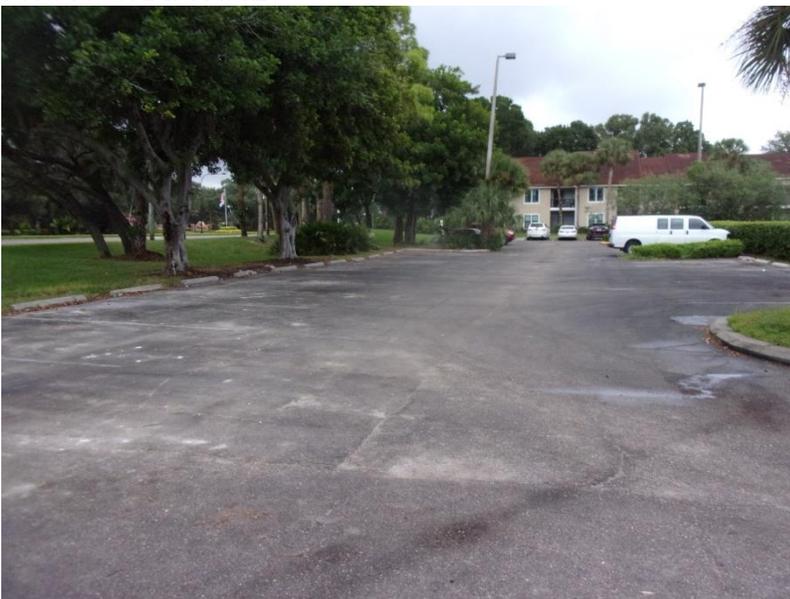
**PHOTOGRAPH #12**

**BUILDING 3  
STORAGE AREA**

Storage and laydown area at parking lot has been cleared out and re-opened for tenants parking.

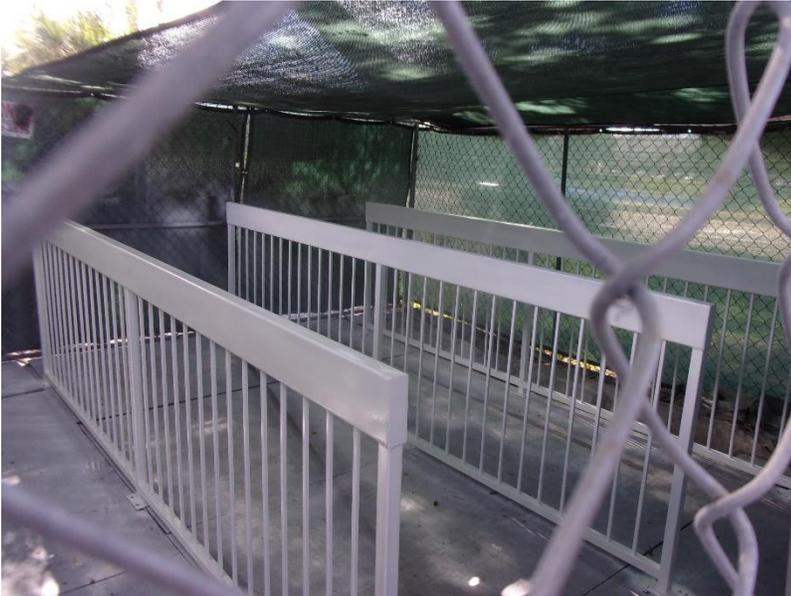
**PHOTOGRAPH #13**

**BUILDING 3  
STORAGE AREA**

Florida Paints Encapsulon Epoxy Mastic Primer applied to balcony railings.

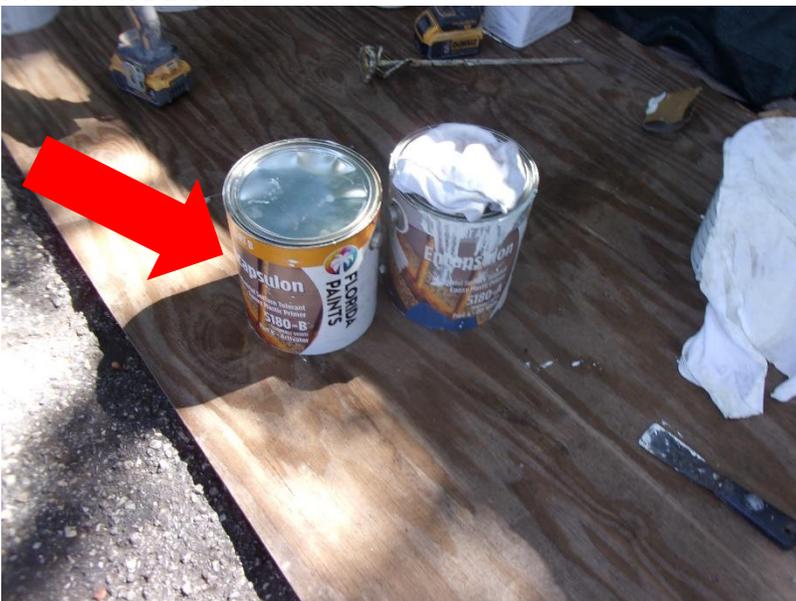
**PHOTOGRAPH #14**

**BUILDING 3  
STORAGE AREA**

Florida Paints Encapsulon Epoxy Mastic Primer applied to balcony railings.

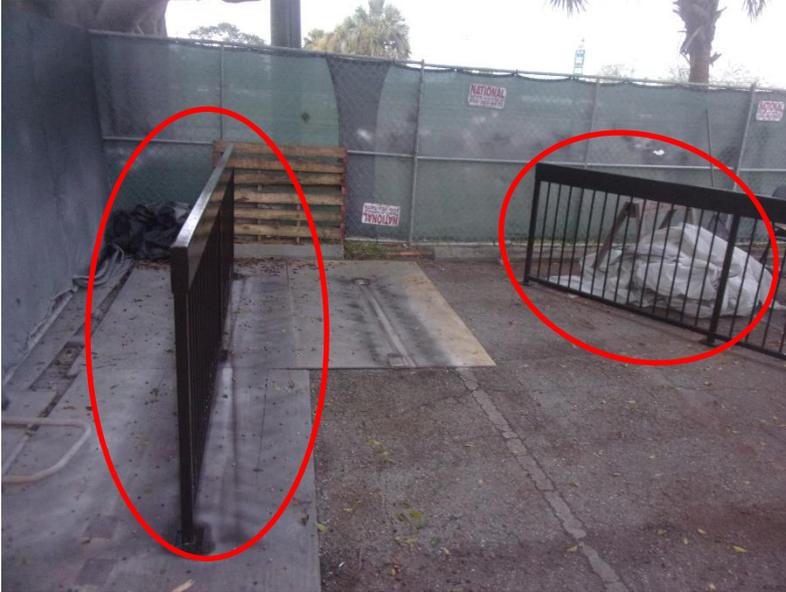
**PHOTOGRAPH #15**

**BUILDING 3  
STORAGE AREA**

Florida Paints Sundeavor high  
performance urethan enamel, spray  
applied to balcony railings.
