PHOTOGRAPHS

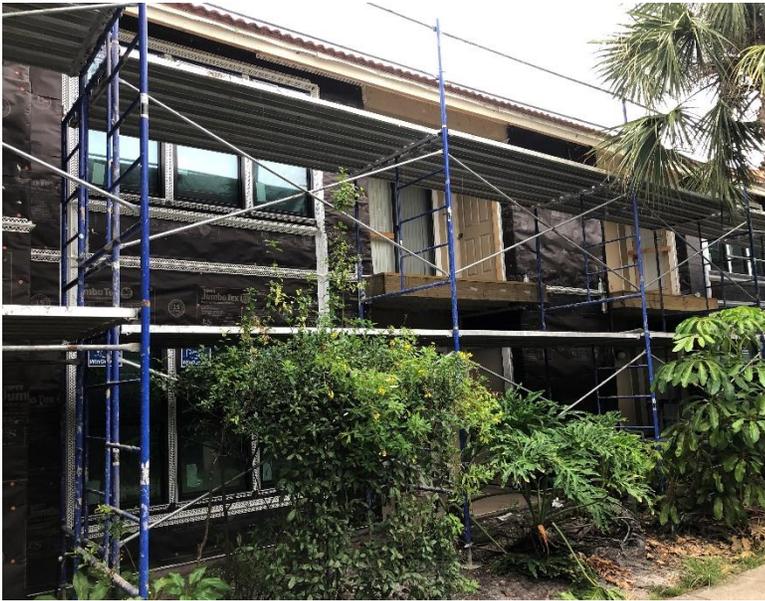
PHOTOGRAPH #1

BUILDING 6 SECTION F

Jumbo Tex super 60 WRB applied and stucco accessories in progress.

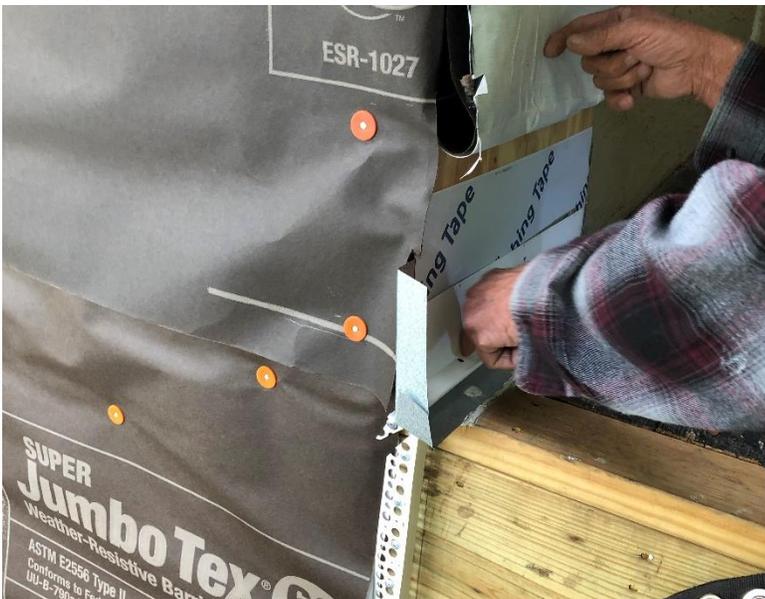
PHOTOGRAPH #2

BUILDING 6 SECTION F

Contractor installing kick-out flashing at balconies per contract drawings, Detail A/S-6.3.

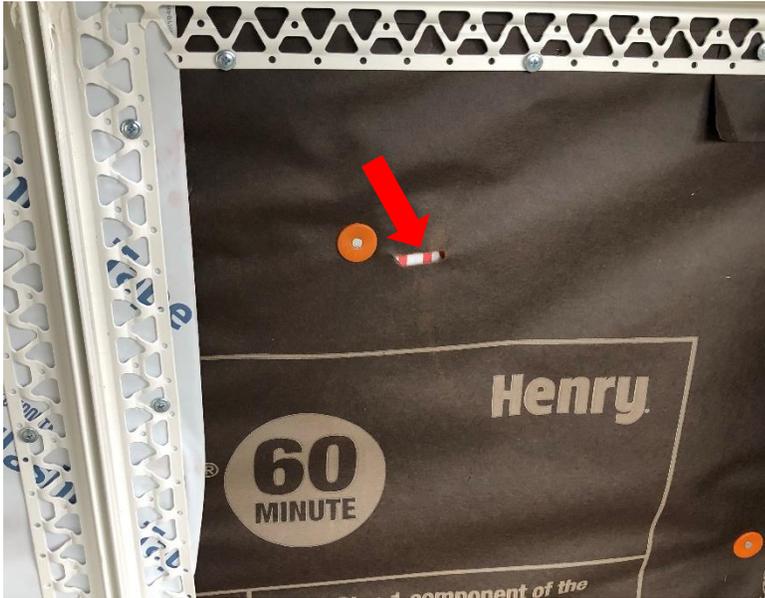
PHOTOGRAPH #3

**BUILDING 6
SECTION F**

Holes and tears in Super JumpTex shall be covered with Tyvek tape prior to lath installation.

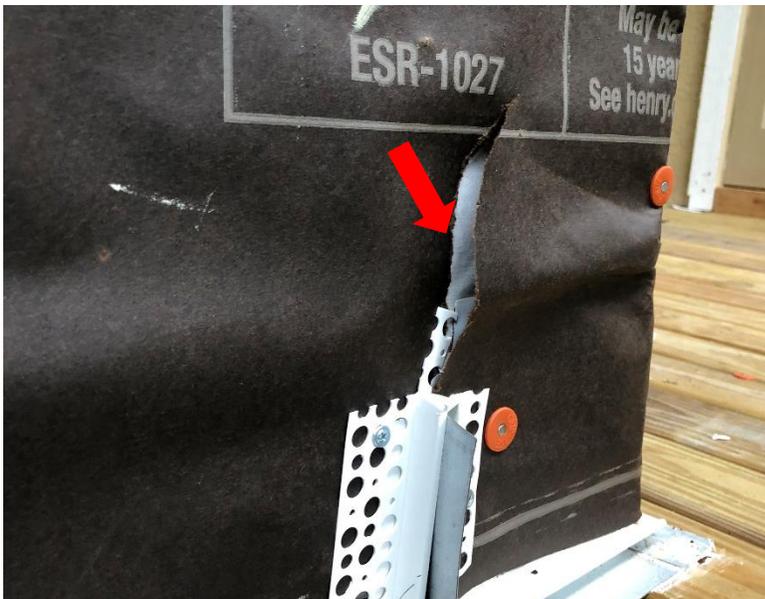
PHOTOGRAPH #4

**BUILDING 6
SECTION F**

Holes and tears in Super JumpTex shall be covered with Tyvek tape prior to lath installation.

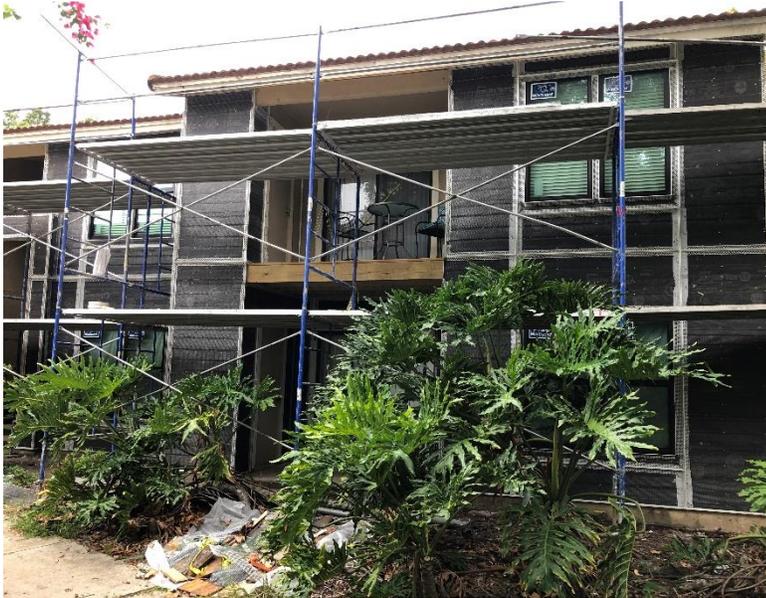
PHOTOGRAPH #5

**BUILDING 6
SECTION G**

Stucco accessories and wire lath were installed per the drawings and specifications and is ready for scratch coat.

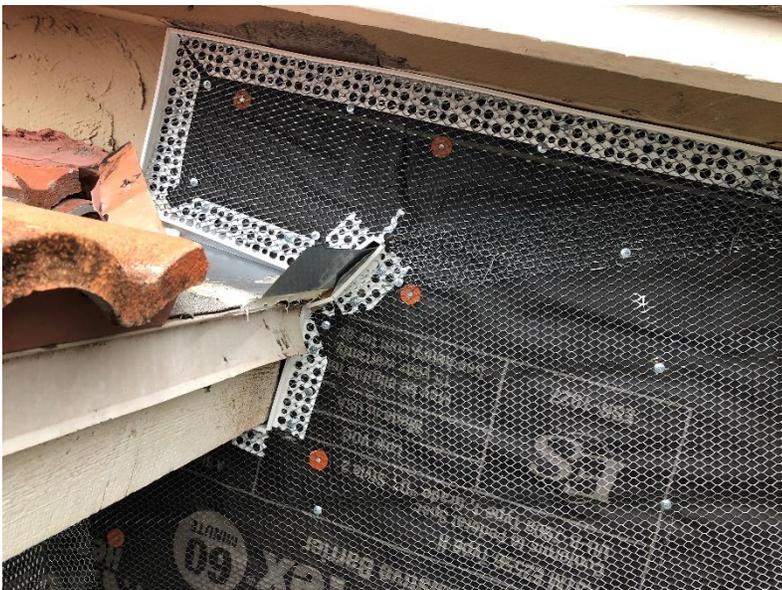
PHOTOGRAPH #6

**BUILDING 6
SECTION G**

Kickout flashing and accessories have been installed per the contract drawings.

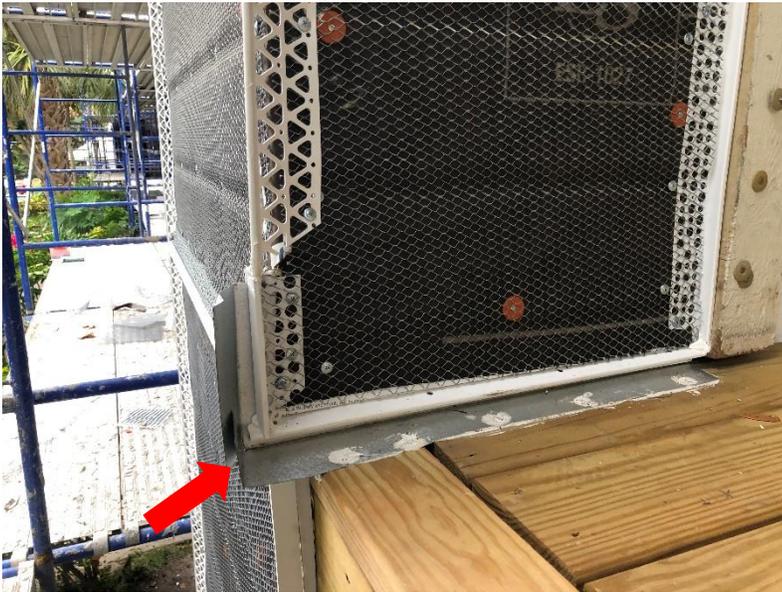
PHOTOGRAPH #7

**BUILDING 6
SECTION G**

Kickout flashing and accessories have been installed with the flashing lap backwards. Contractor to fix flashing lap.

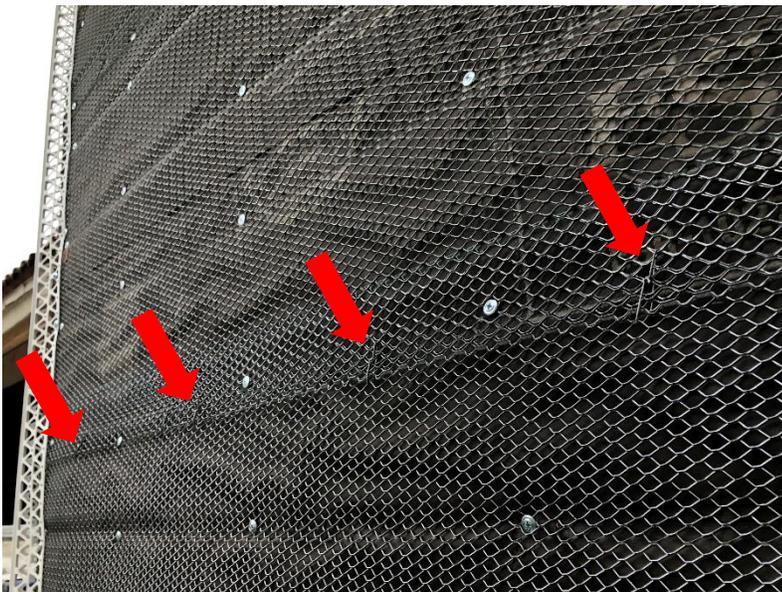
PHOTOGRAPH #8

**BUILDING 6
SECTION G**

Stucco Sub-contractor lath 2" minimum per the construction drawings and installed tie wire between fasteners.

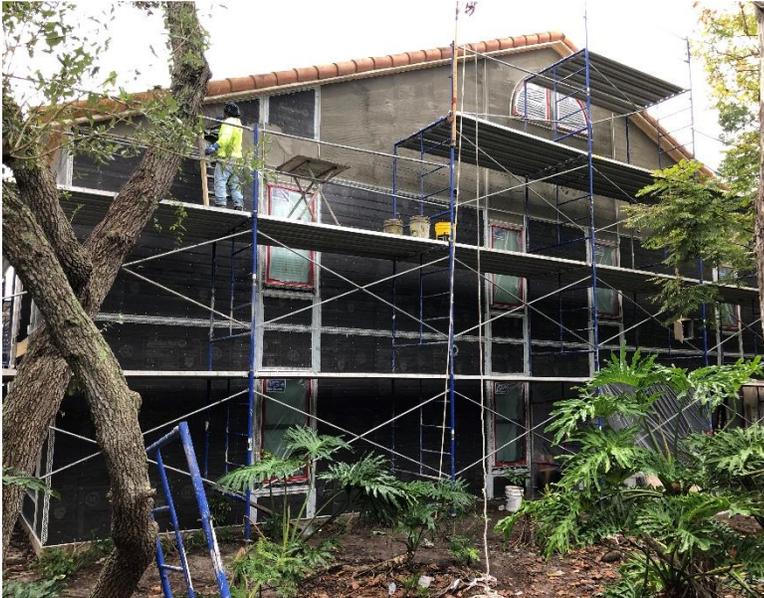
PHOTOGRAPH #9

**BUILDING 6
SECTION H**

Stucco accessories and wire lath were installed per the drawings and specifications and is ready for scratch coat.

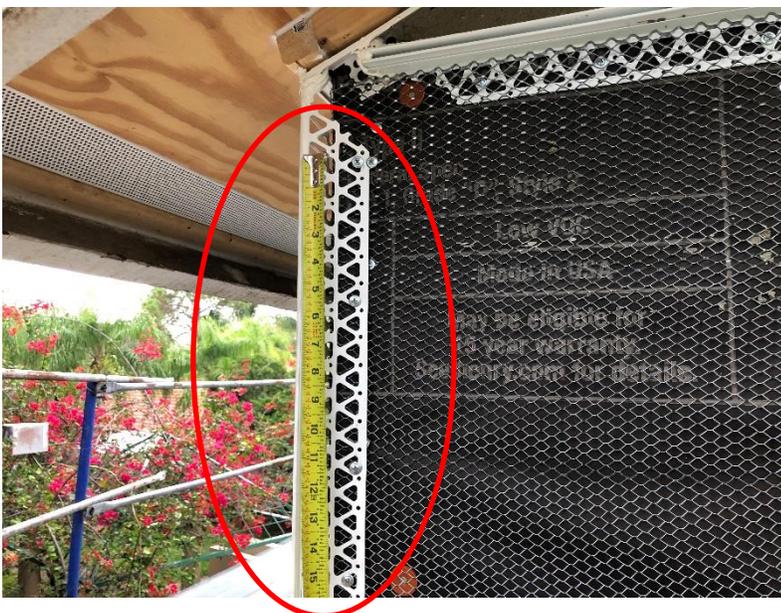
PHOTOGRAPH #10

**BUILDING 6
SECTION H**

Vinyl stucco accessories attached at 7" intervals per the specifications.

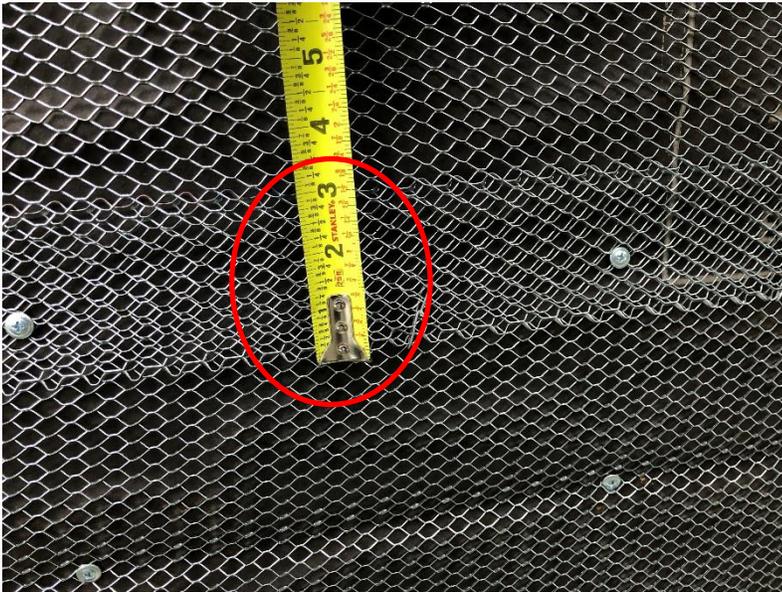
PHOTOGRAPH #11

**BUILDING 6
SECTION H**

Stucco Sub-contractor lath 2" minimum per the construction drawings and installed tie wire between fasteners.

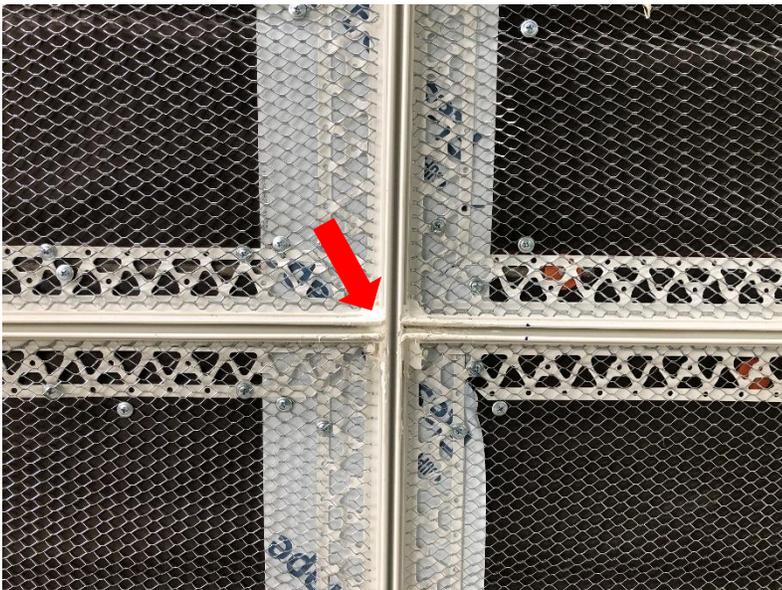
PHOTOGRAPH #12

**BUILDING 6
SECTION H**

MasterSeal NP 150 sealant was applied to accessory ends, corners, and intersections.

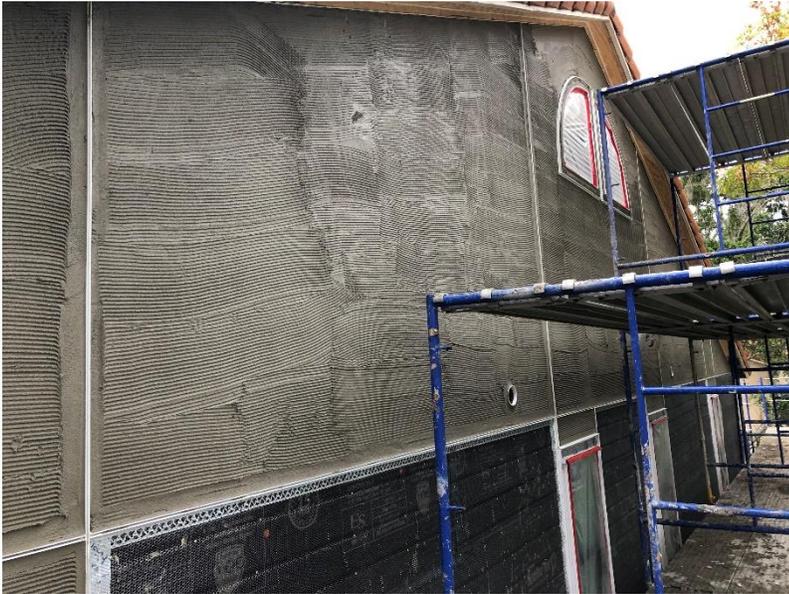
PHOTOGRAPH #13

**BUILDING 6
SECTION H**

Stucco Sub-contractor began scratch coat application.

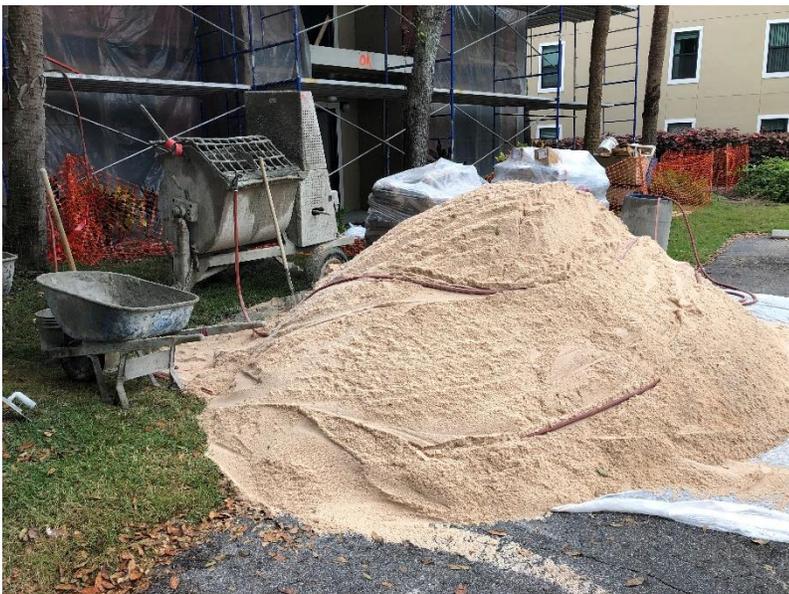
PHOTOGRAPH #14

**BUILDING 6
SECTION H**

Stucco Sub-contractor mixed approved Cemex Broco Stucco Cement with sand on-site.

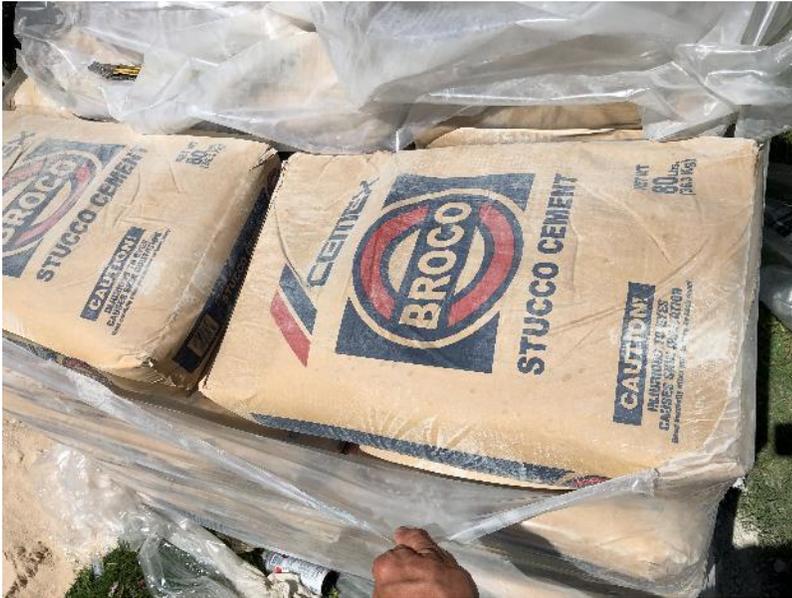
PHOTOGRAPH #15

**BUILDING 6
SECTION H**

Stucco Sub-contractor mixed approved Cemex Broco Stucco Cement with sand on-site.

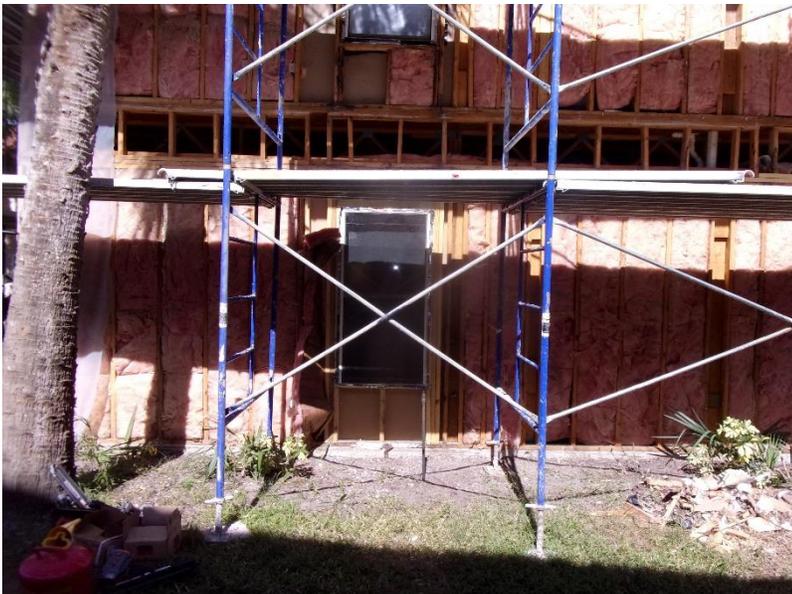
PHOTOGRAPH #16

**BUILDING 6
SECTION A**

Framing repairs in progress at wall studs and window openings with 2"X4" southern yellow pine.

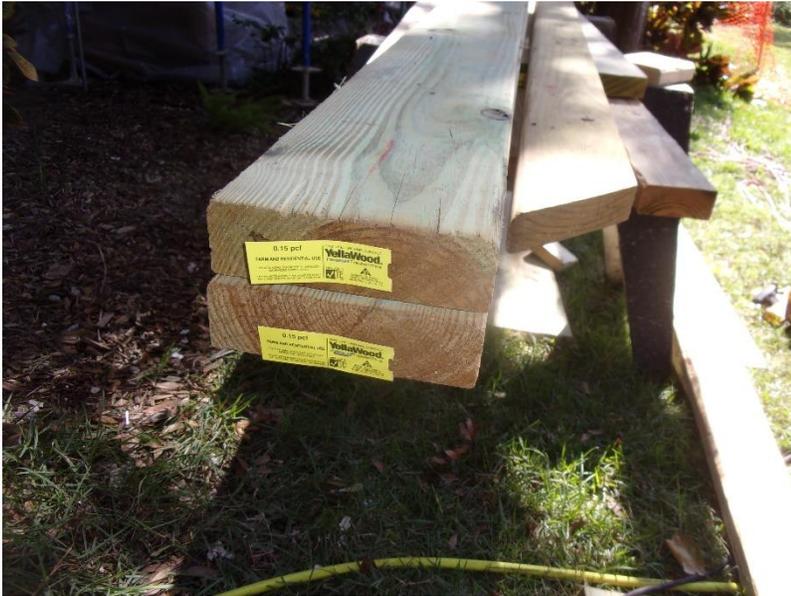
PHOTOGRAPH #17

**BUILDING 6
SECTION A**

2"X6" pressure treated studs for breezeway column repairs.

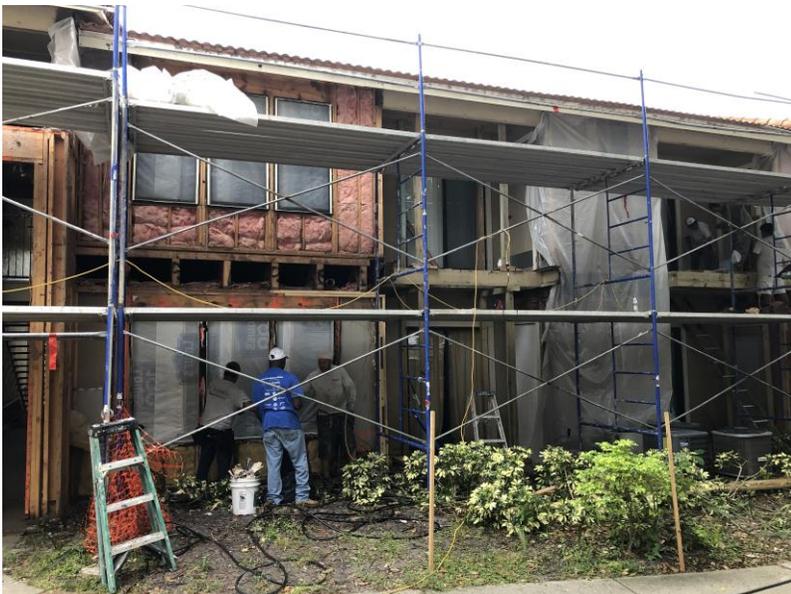
PHOTOGRAPH #18

**BUILDING 6
SECTION B**

Framing repairs in progress at wall studs and window openings with 2"X4" southern yellow pine.

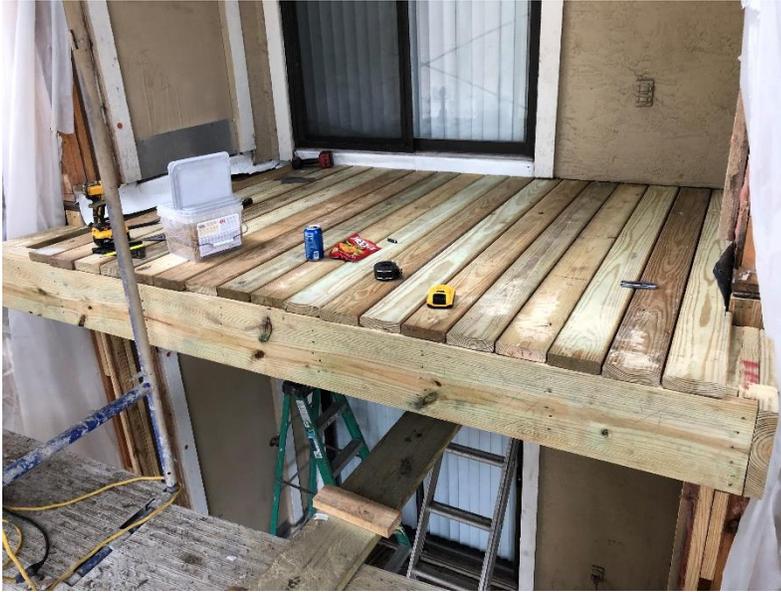
PHOTOGRAPH #19

**BUILDING 6
SECTION B**

Deteriorated floorboards and balcony framing were removed and replaced with new southern yellow pine. New floorboards are pressure treated 2"x6".

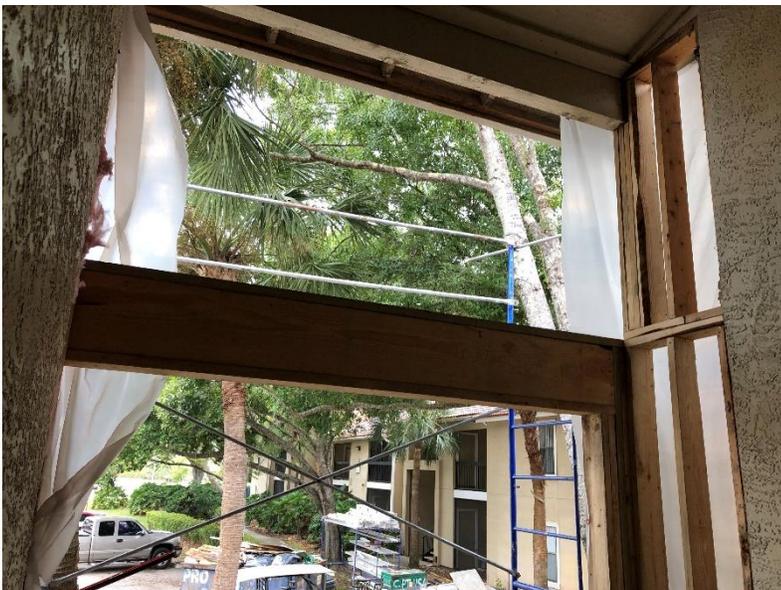
PHOTOGRAPH #20

**BUILDING 6
SECTION B**

Damaged box beam at breezeway and adjacent framing were replaced.

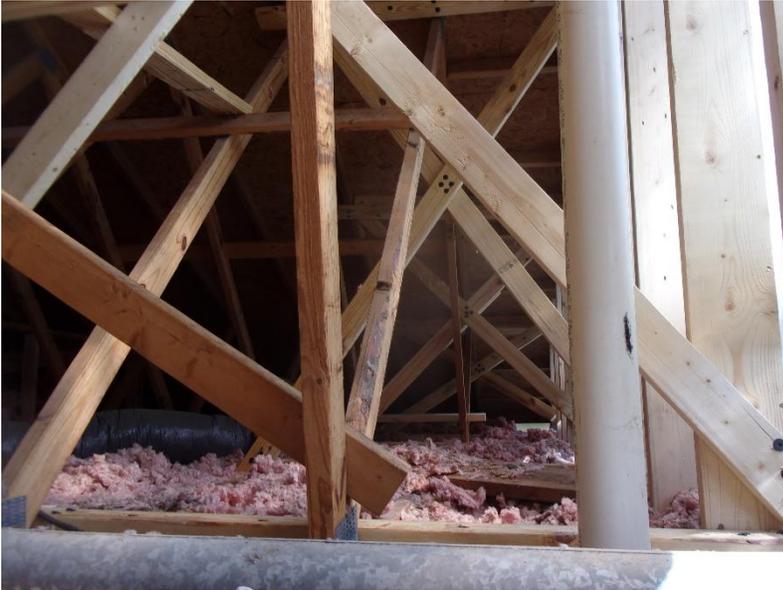
PHOTOGRAPH #21

**BUILDING 6
SECTION D**

Gable end reinforcement and cross bracing were installed per drawings and details.

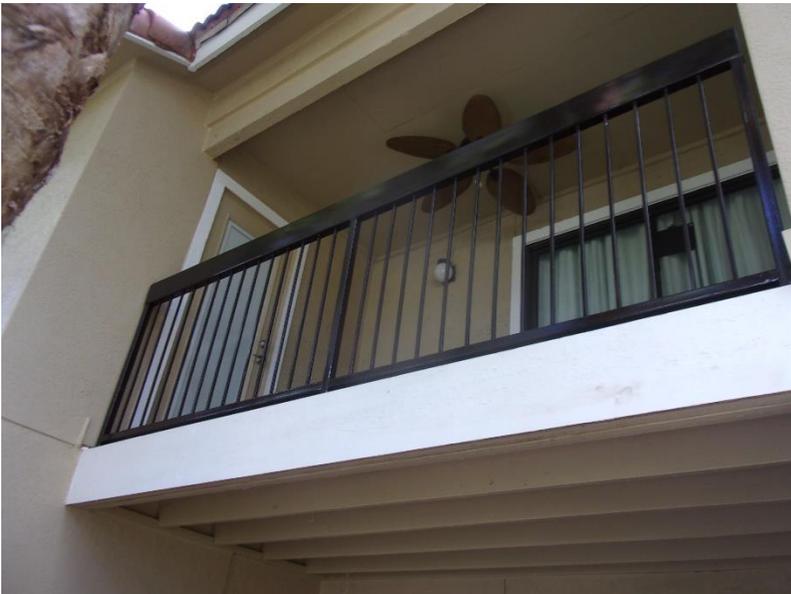
PHOTOGRAPH #22

**BUILDING 3
SECTION F**

Contractor coated and installed balcony railings.

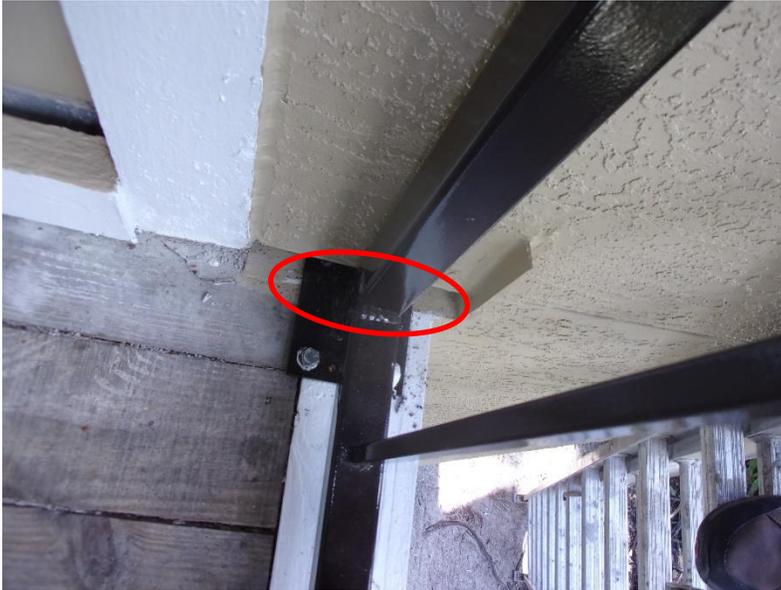
PHOTOGRAPH #23

**BUILDING 3
SECTION F**

Contractor to install remaining lag bolts in balcony railing base.

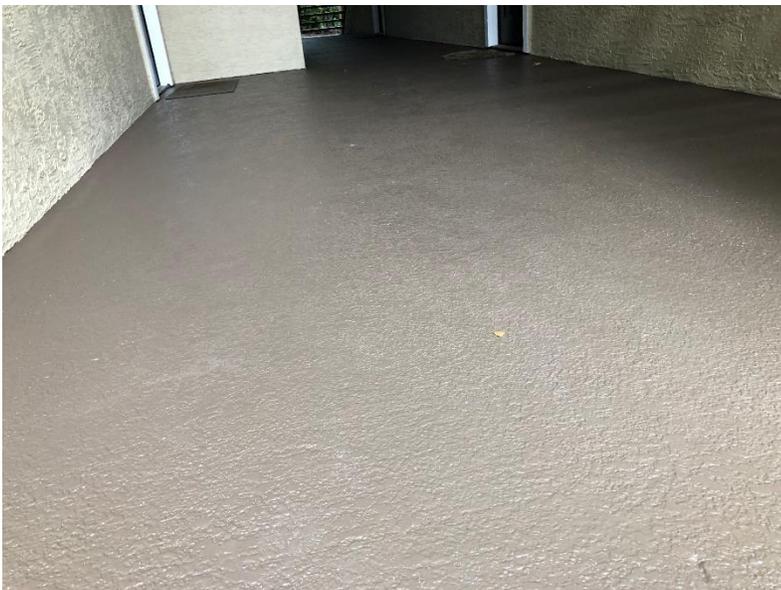
PHOTOGRAPH #24

**BUILDING 3
SECTION F**

Contractor applied Florida Paints
TropiCrete Waterborne Epoxy Floor
Coating.

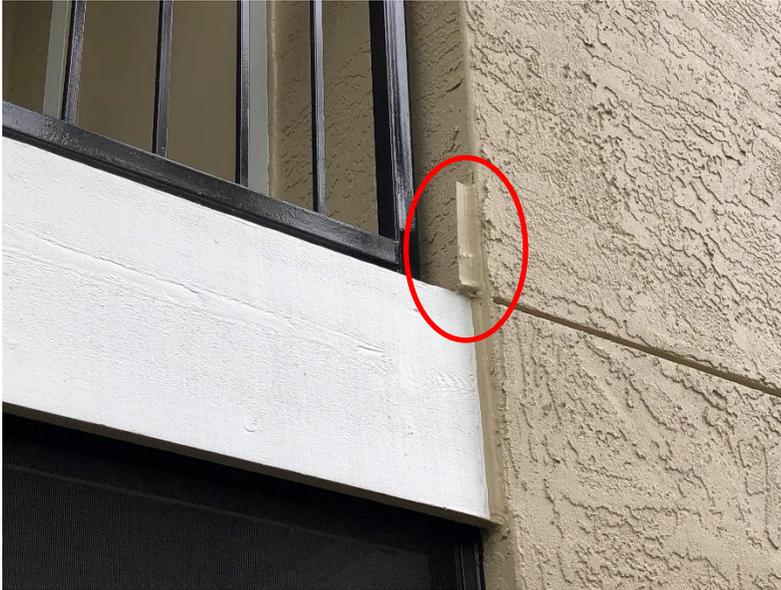
PHOTOGRAPH #25

**BUILDING 2
SECTION F**

Contractor adjusted kick-out flashing per punchlist item request.
