PHOTOGRAPHS

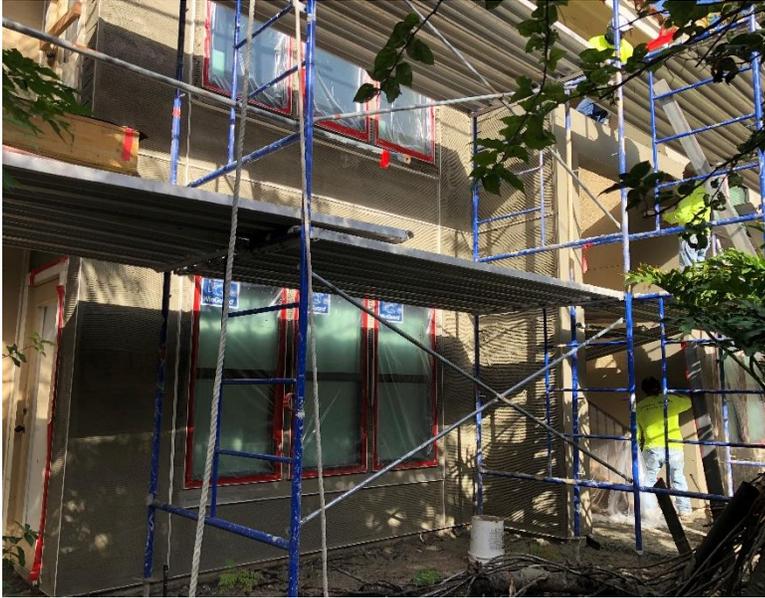
PHOTOGRAPH #1

BUILDING 6 SECTION F

Stucco Sub-contractor began scratch coat application.

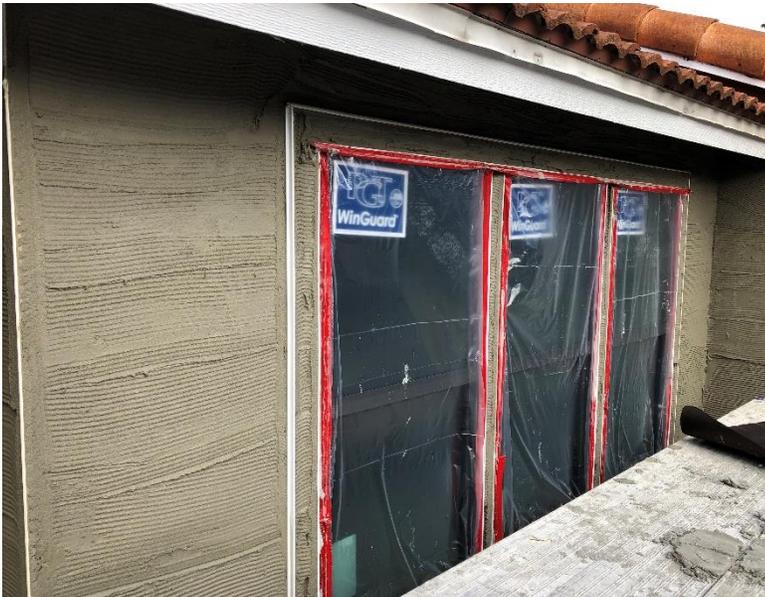
PHOTOGRAPH #2

BUILDING 6 SECTION F

Stucco Sub-contractor began scratch coat application.

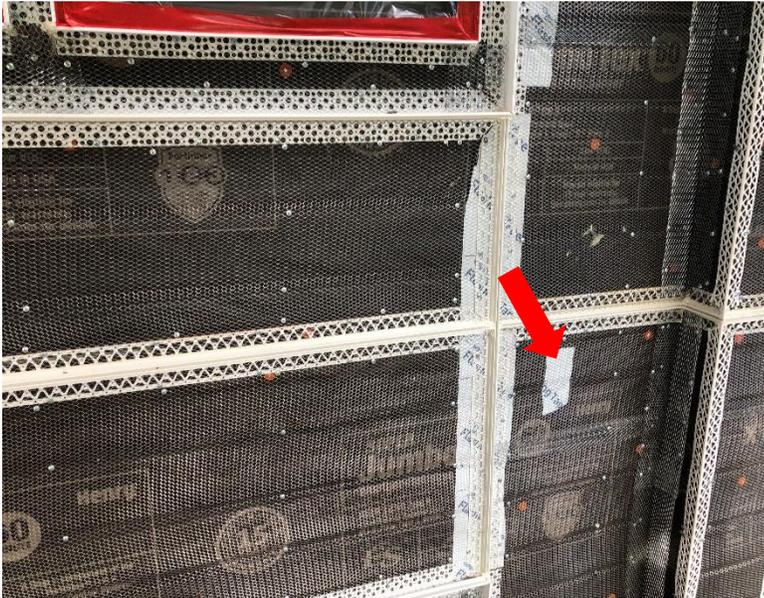
PHOTOGRAPH #3

**BUILDING 6
SECTION F**

Contractor covered holes and tears in Super JumboTex with Tyvek tape prior to lath installation.

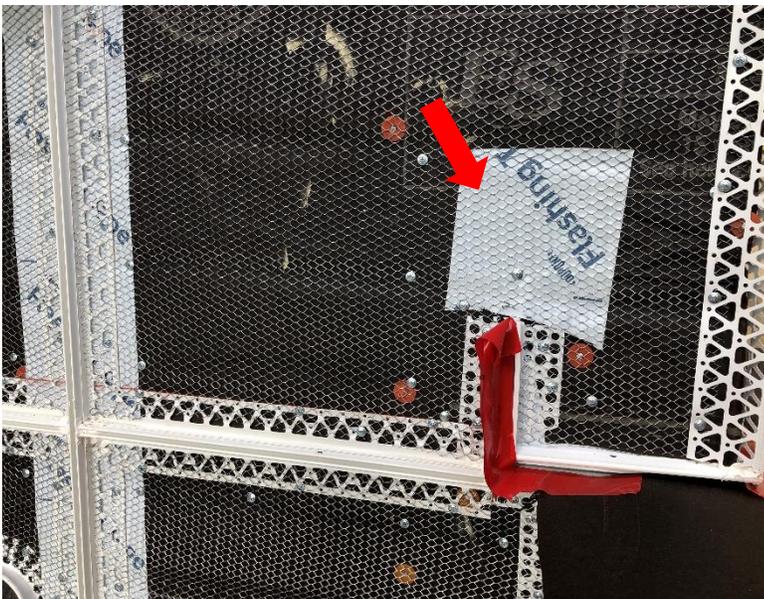
PHOTOGRAPH #4

**BUILDING 6
SECTION F**

Contractor covered holes and tears in Super JumboTex with Tyvek tape prior to lath installation.

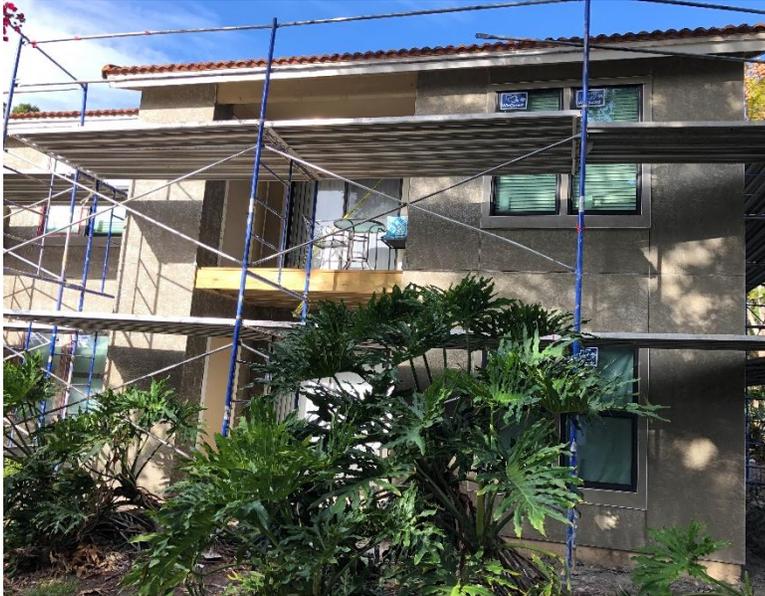
PHOTOGRAPH #5

**BUILDING 6
SECTION G**

Stucco Sub-contractor applied, stucco scratch coat, brown coat, and finish coats.

pH testing to be done by manufacturer representative to approve coating application.

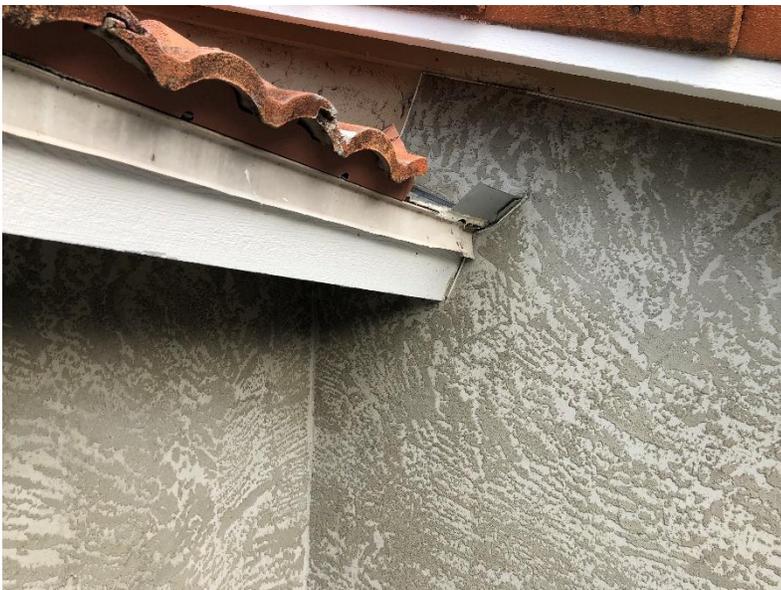
PHOTOGRAPH #6

**BUILDING 6
SECTION G**

Stucco Sub-contractor applied, stucco scratch coat, brown coat, and finish coats.

pH testing to be done by manufacturer representative to approve coating application.

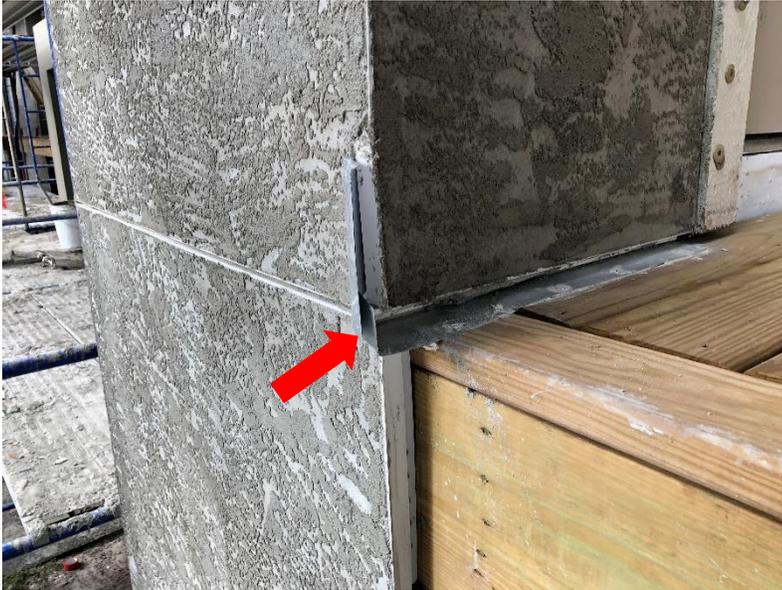
PHOTOGRAPH #7

**BUILDING 6
SECTION G**

Kickout flashing and accessories have been installed with the flashing lap backwards. Contractor to fix flashing lap.

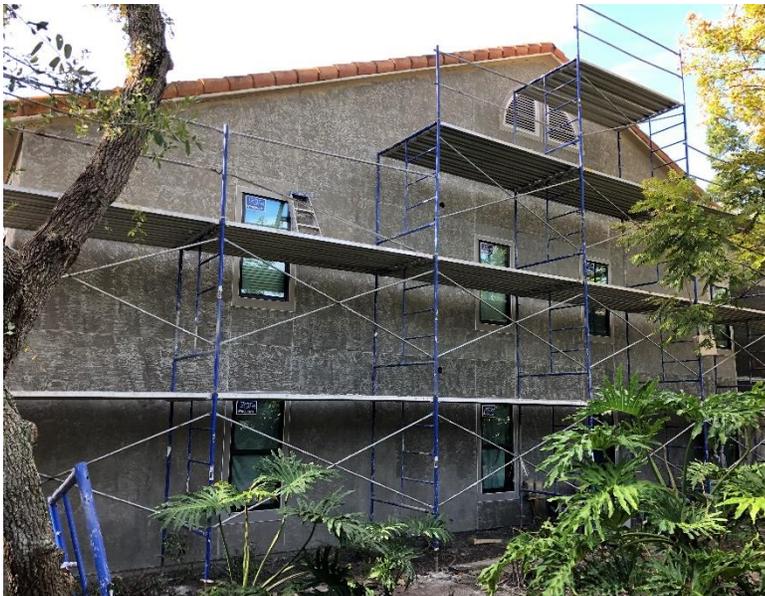
PHOTOGRAPH #8

**BUILDING 6
SECTION H**

Stucco Sub-contractor applied, stucco scratch coat, brown coat, and finish coats.

pH testing to be done by manufacturer representative to approve coating application.

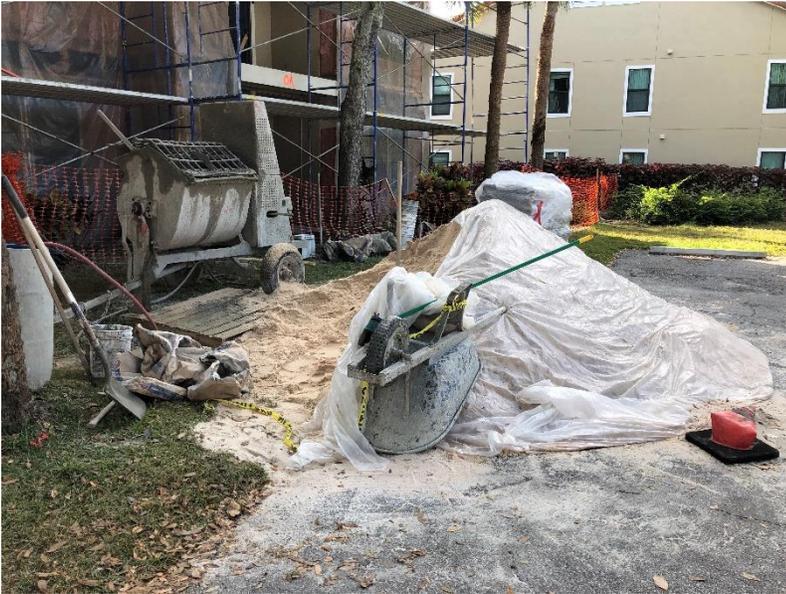
PHOTOGRAPH #9

**BUILDING 6
SECTION H**

Stucco Sub-contractor mixed approved Cemex Broco Stucco Cement with sand on-site.

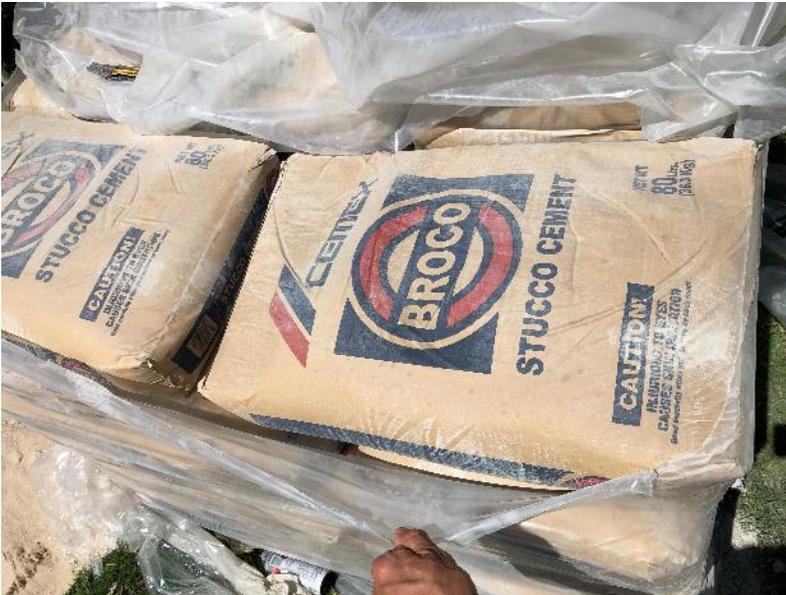
PHOTOGRAPH #10

**BUILDING 6
SECTION H**

Stucco Sub-contractor mixed approved Cemex Broco Stucco Cement with sand on-site.

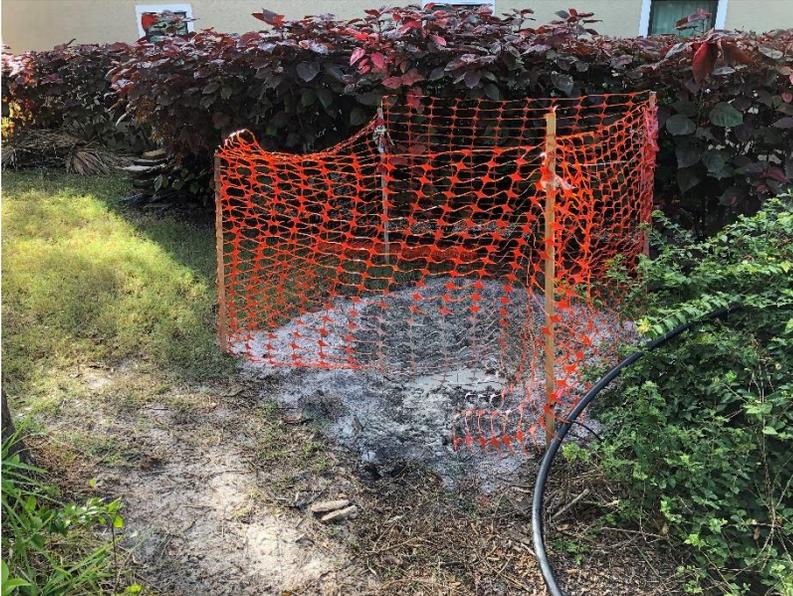
PHOTOGRAPH #11

**BUILDING 6
SECTION D**

Stucco Sub-contractor cleanout location.

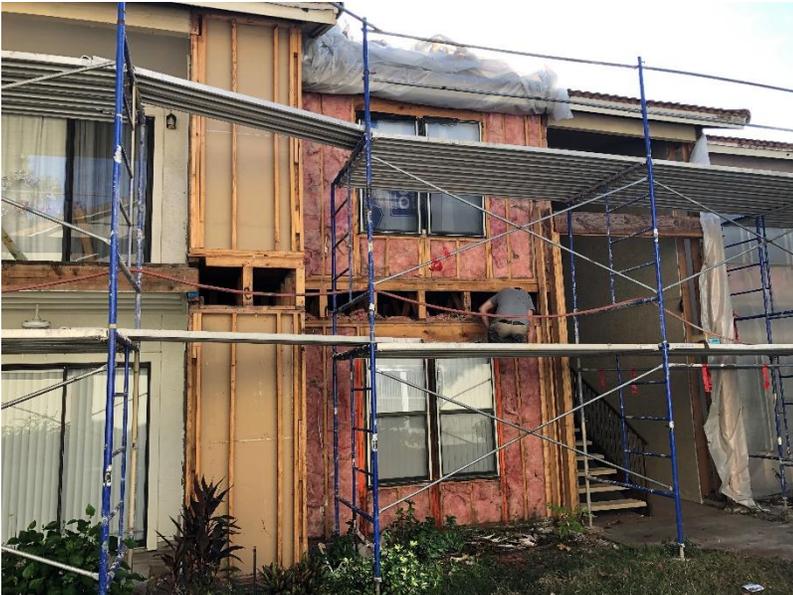
PHOTOGRAPH #12

**BUILDING 6
SECTION A**

Framing repairs in progress at wall studs and window openings with 2"X4" southern yellow pine.

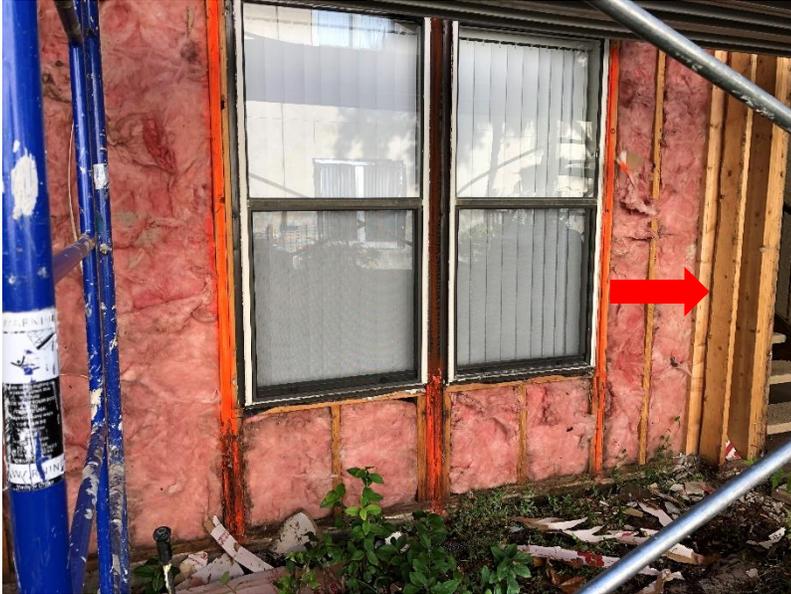
PHOTOGRAPH #13

**BUILDING 6
SECTION A**

Contractor is replacing damaged stud framing that was marked for repair.

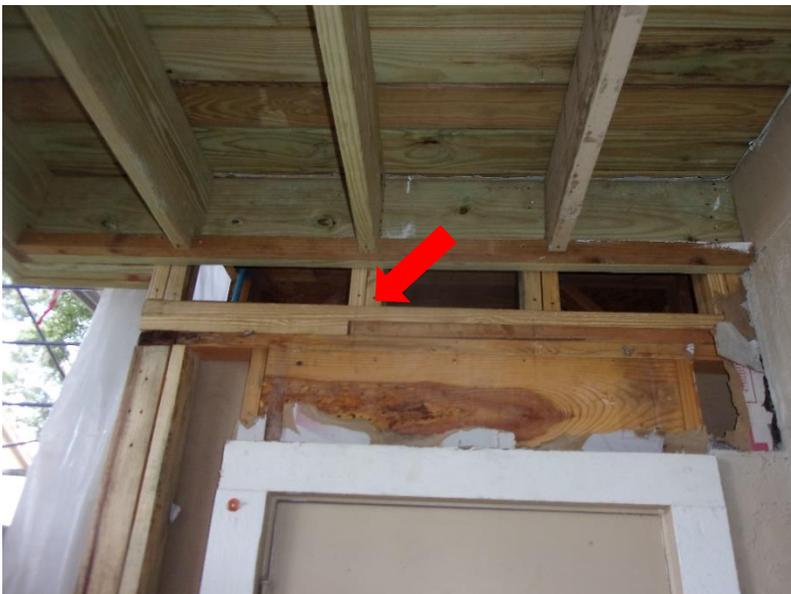
PHOTOGRAPH #14

**BUILDING 6
SECTION A**

Contractor replaced damaged stud framing adjacent to balconies.

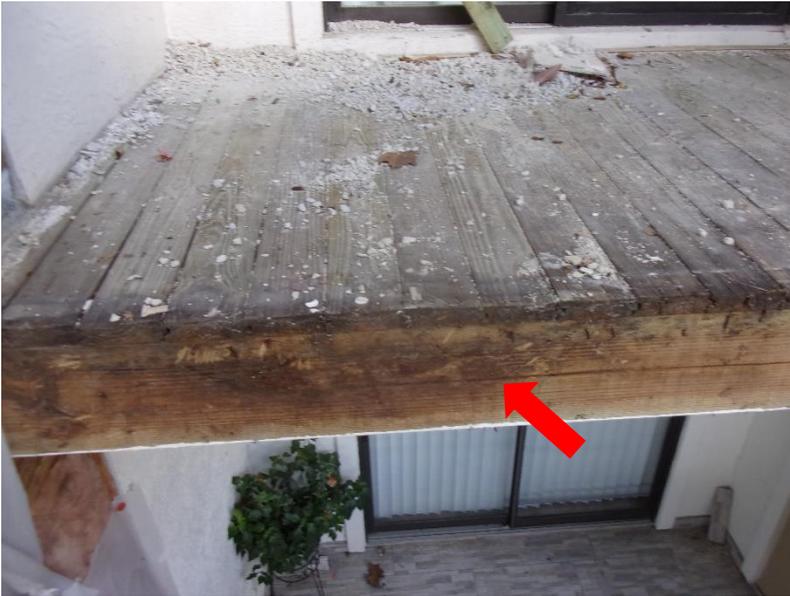
PHOTOGRAPH #15

**BUILDING 6
SECTION A**

Removal of tile has exposed a rotten deck beam that needs to be replaced. Deck boards do not.

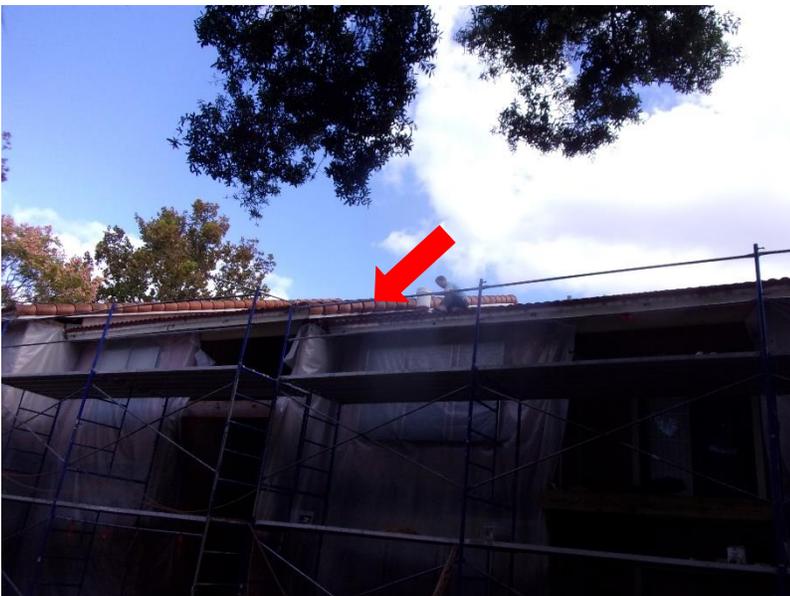
PHOTOGRAPH #16

**BUILDING 6
SECTION A**

Contractor applied Florida Paints Exterior Supercoat to soffit.

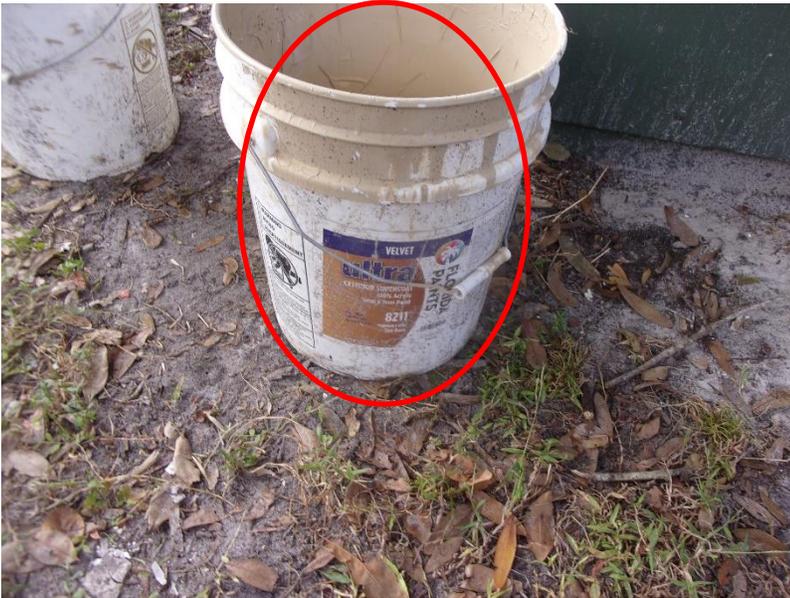
PHOTOGRAPH #17

**BUILDING 6
SECTION A**

Contractor applied Florida Paints Exterior Supercoat to soffit.

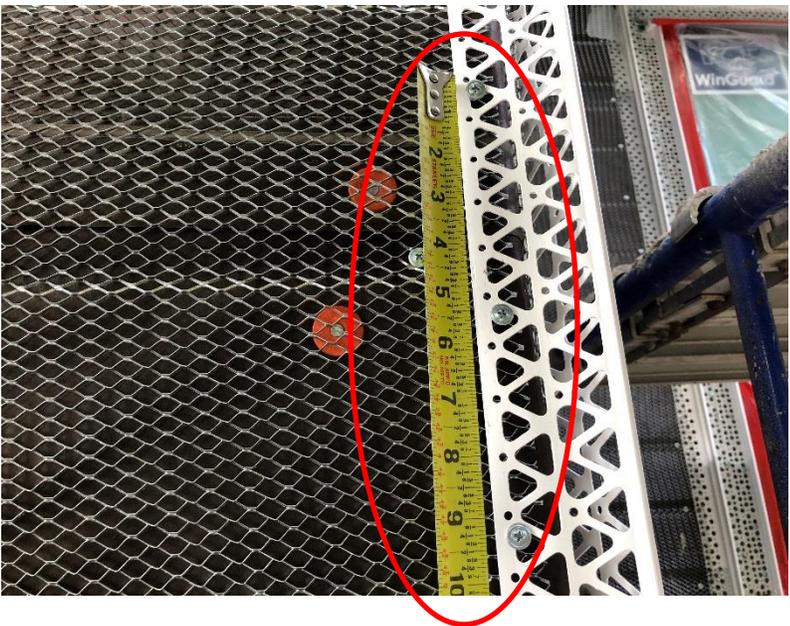
PHOTOGRAPH #18

**BUILDING 6
SECTION E**

Vinyl stucco accessories attached at 7" intervals per the specifications.

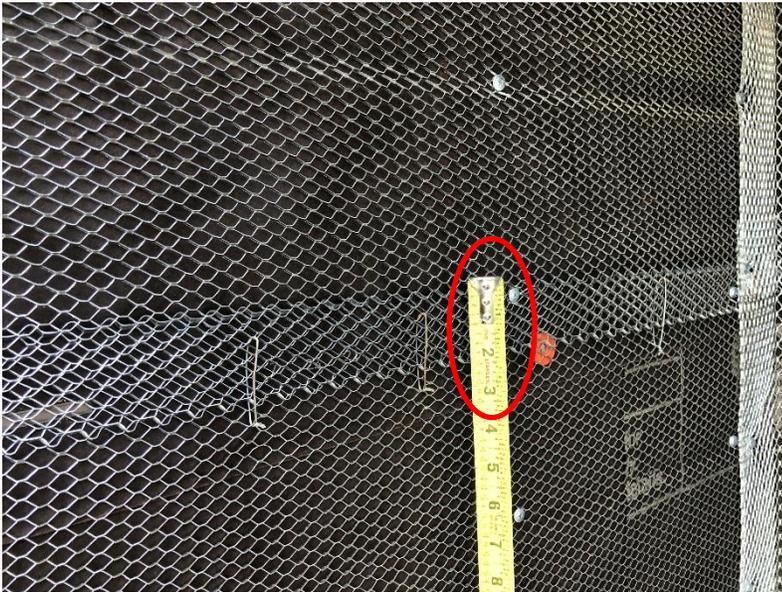
PHOTOGRAPH #19

**BUILDING 6
SECTION E**

Stucco Sub-contractor lath 2" minimum per the construction drawings and installed tie wire between fasteners.

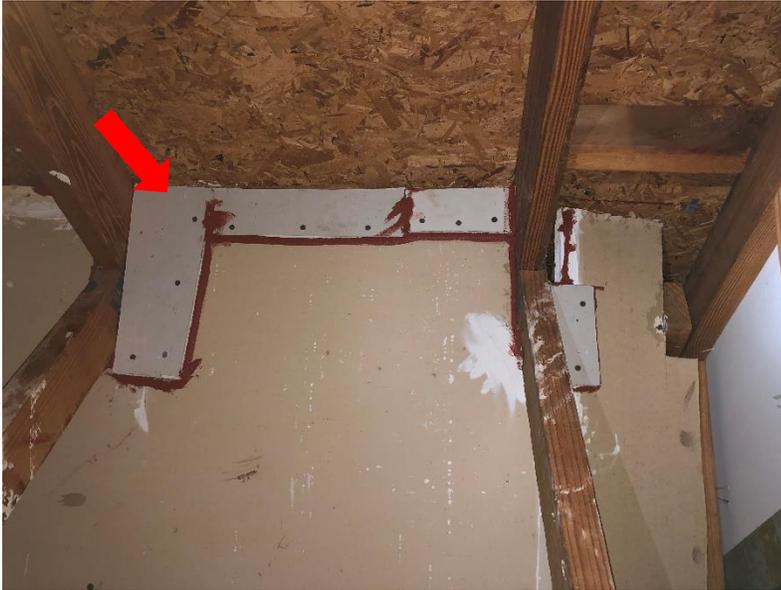
PHOTOGRAPH #21

**BUILDING 3
UNIT 325**

Contractor installed 5/8" Type X fire rated gypsum board at penetrations within the existing fire walls. Screws were 6" on-center and perimeter was sealed with 3M CP 25WB+ Fire Barrier Sealant.

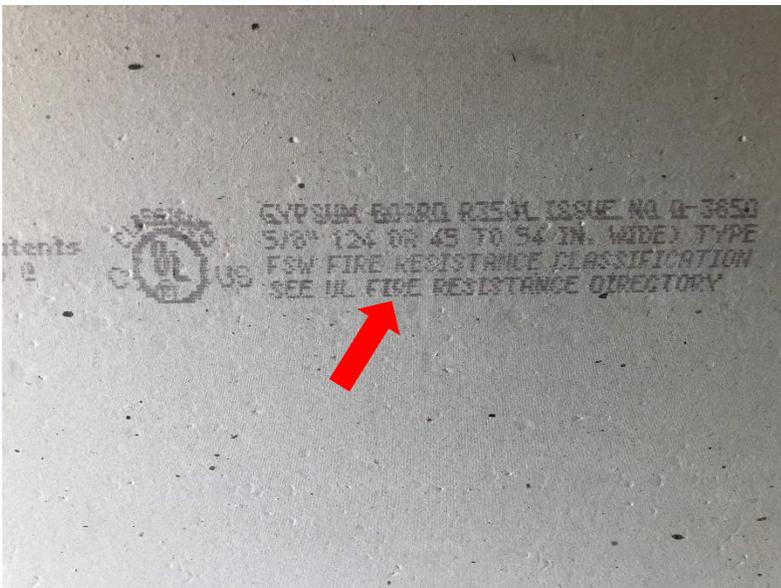
PHOTOGRAPH #22

**BUILDING 3
UNIT 325**

Contractor installed 5/8" Type X fire rated gypsum board at penetrations within the existing fire walls. Screws were 6" on-center and perimeter was sealed with 3M CP 25WB+ Fire Barrier Sealant.

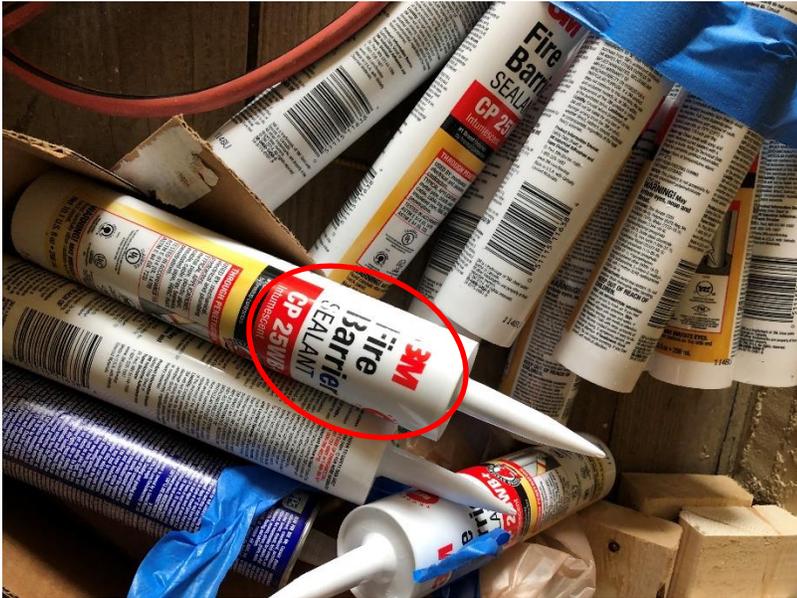
PHOTOGRAPH #23

**BUILDING 3
UNIT 325**

Contractor installed 5/8" Type X fire rated gypsum board at penetrations within the existing fire walls. Screws were 6" on-center and perimeter was sealed with 3M CP 25WB+ Fire Barrier Sealant.

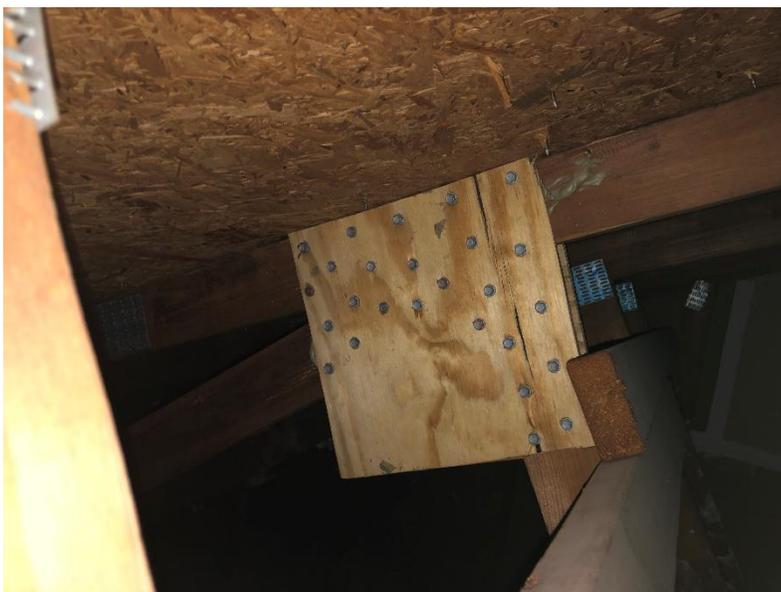
PHOTOGRAPH #24

**BUILDING 3
UNIT 325**

Contractor installed 15/32" plywood gusset plated glued and screwed with #10 wood screws were installed per gusset repair detail.

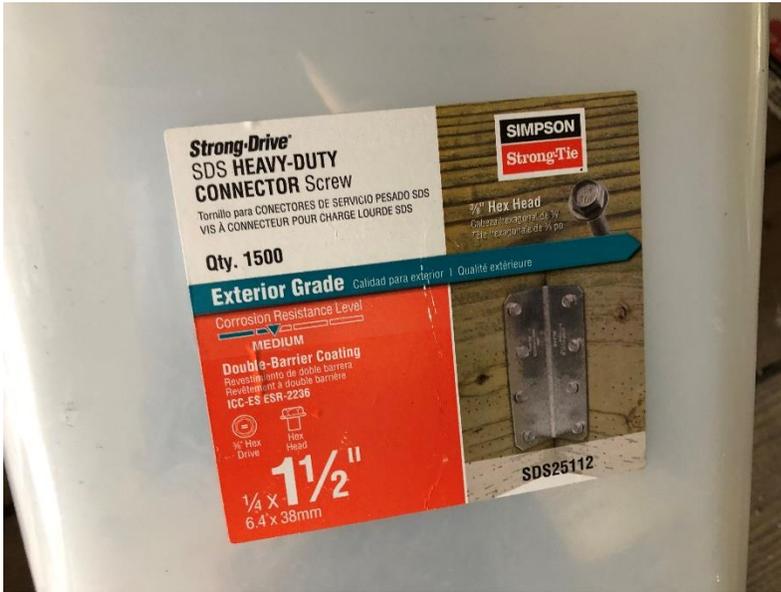
PHOTOGRAPH #25

**BUILDING 3
UNIT 325**

Contractor installed 15/32" plywood gusset plated glued and screwed with #10 wood screws were installed per gusset repair detail.

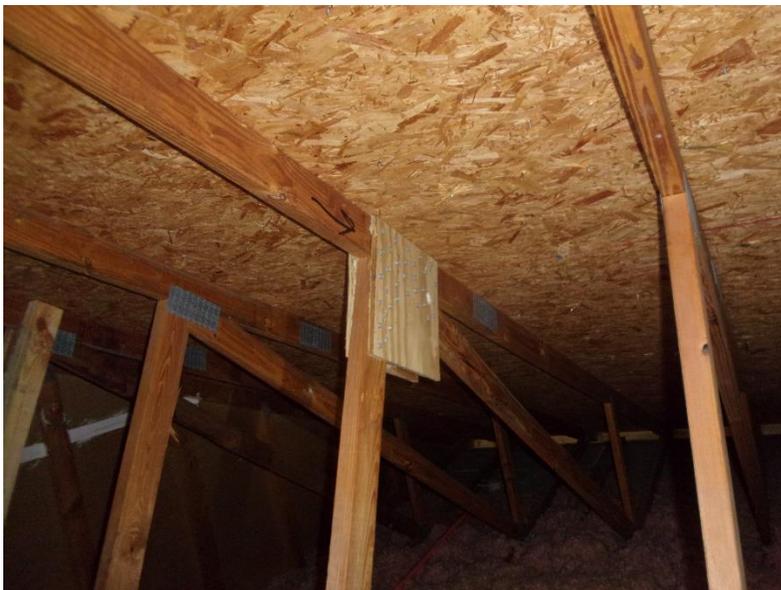
PHOTOGRAPH #26

**BUILDING 3
UNIT 326**

Contractor installed 15/32" plywood gusset plated glued and screwed with #10 wood screws were installed per gusset repair detail.
