PHOTOGRAPHS

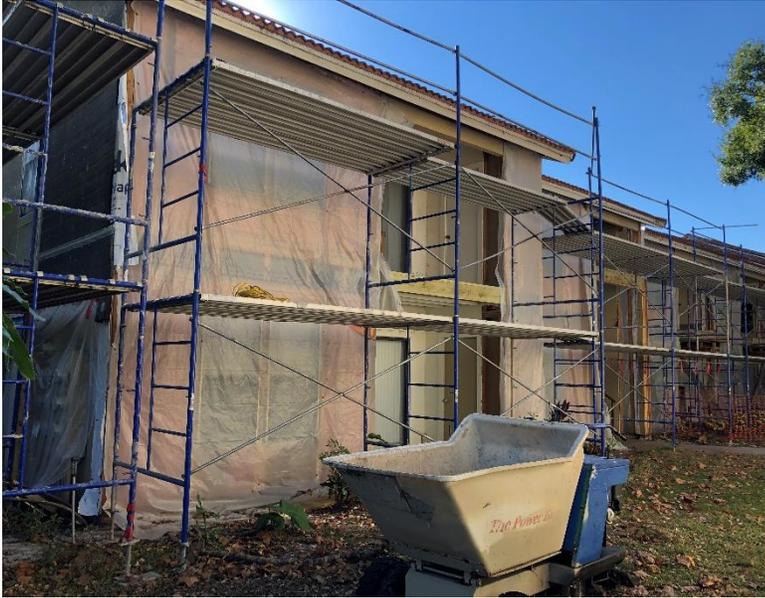
PHOTOGRAPH #1

BUILDING 6 SECTION A-D

Framing repairs completed. Contractor to start Simpson connector and strap installation.

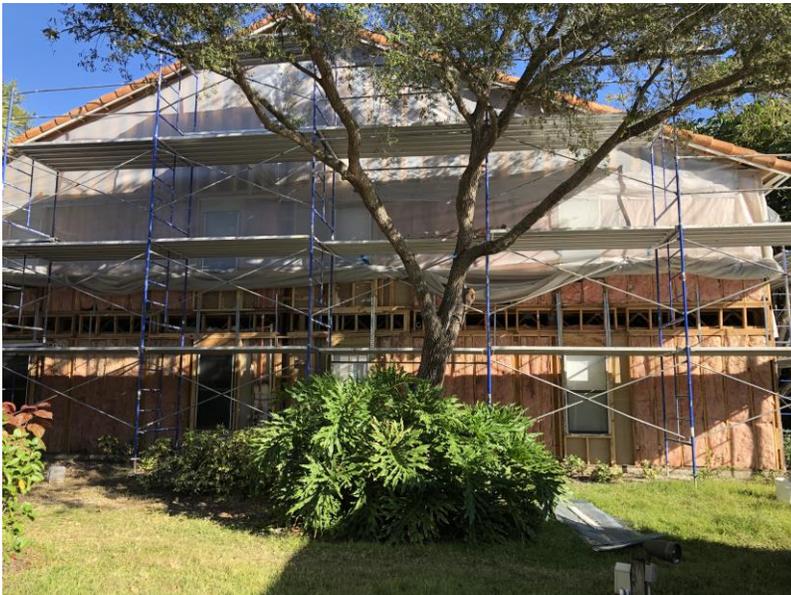
PHOTOGRAPH #2

BUILDING 6 SECTION A-D

Framing repairs completed. Contractor to start Simpson connector and strap installation.

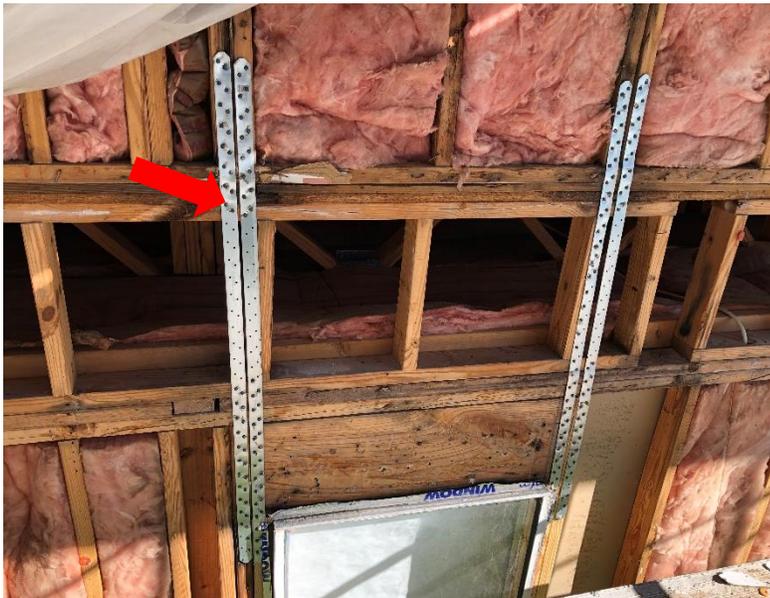
PHOTOGRAPH #3

**BUILDING 6
SECTION D**

Simpson Strong Tie connector straps types D and E were installed with 10d nails per drawings and specifications.

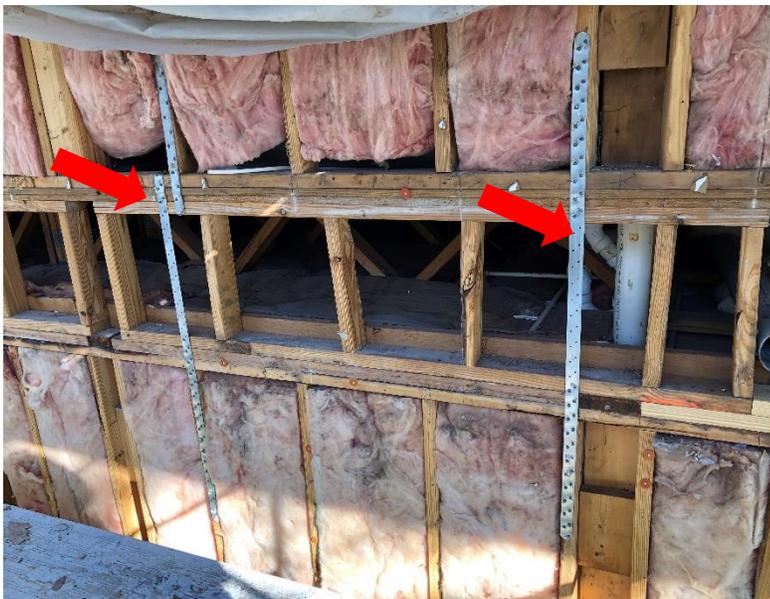
PHOTOGRAPH #4

**BUILDING 6
SECTION D**

Simpson Strong Tie connector straps types D and E were installed with 10d nails per drawings and specifications.

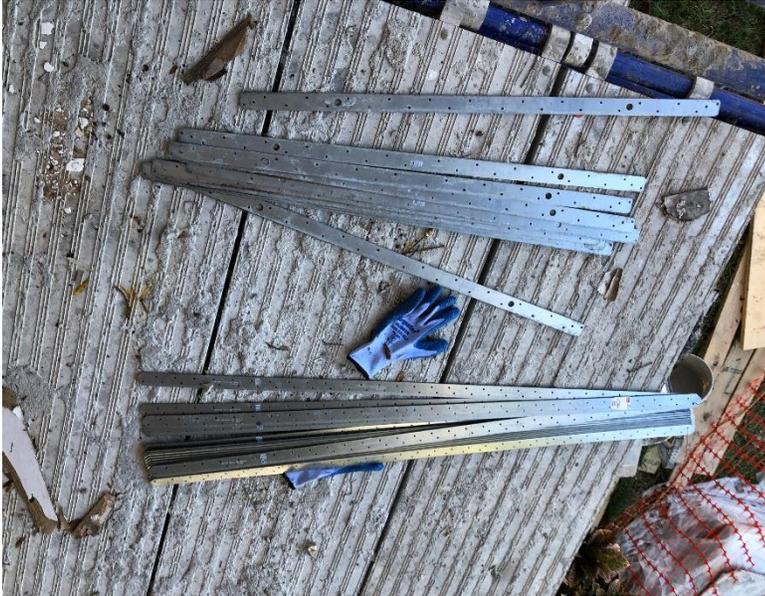
PHOTOGRAPH #5

**BUILDING 6
SECTION G**

Simpson Strong Tie connector straps types D and E were installed with 10d nails per drawings and specifications.

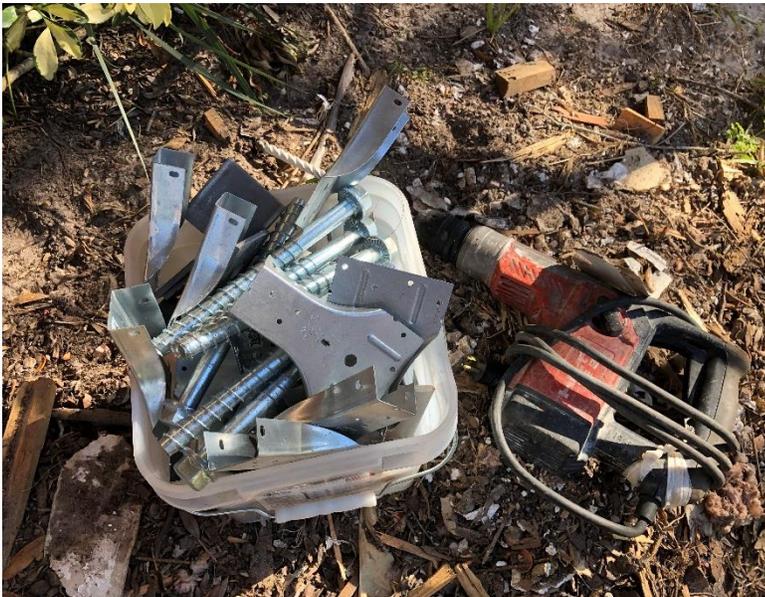
PHOTOGRAPH #6

**BUILDING 6
SECTION D**

Contractor is preparing to install Simpson Strong Tie connectors to bottom plate.

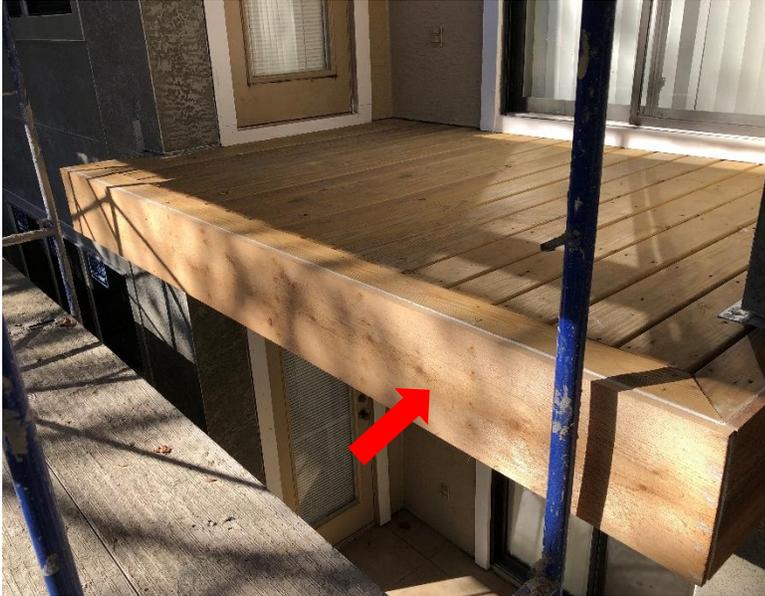
PHOTOGRAPH #7

**BUILDING 6
SECTION F**

1x12 rough sawn cedar trim board was attached to balcony edge per drawings and specifications.

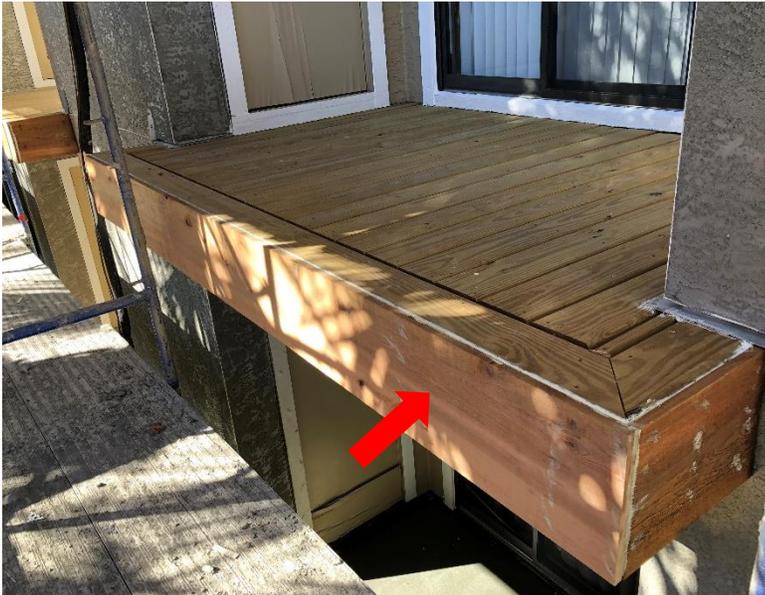
PHOTOGRAPH #8

**BUILDING 6
SECTION F**

1x12 rough sawn cedar trim board was attached to balcony edge per drawings and specifications.

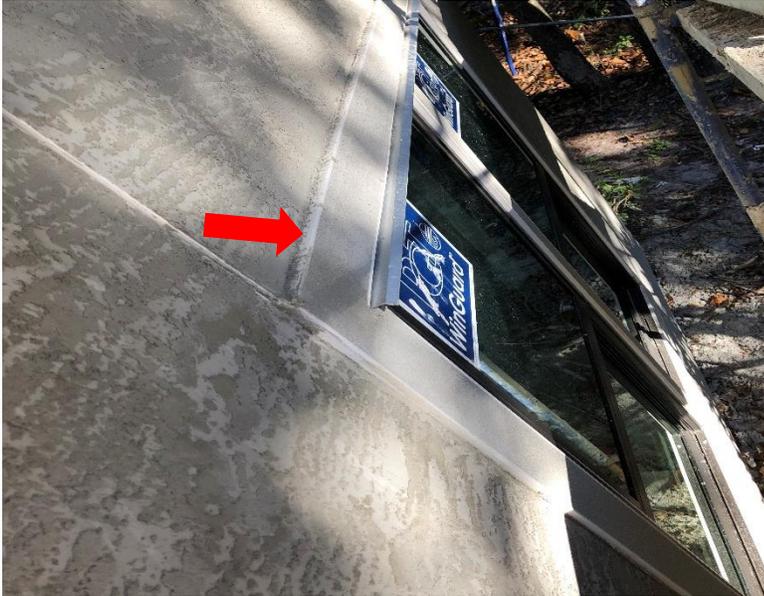
PHOTOGRAPH #9

**BUILDING 6
SECTION G**

Contractor to apply MasterSeal 150 sealant around windows.

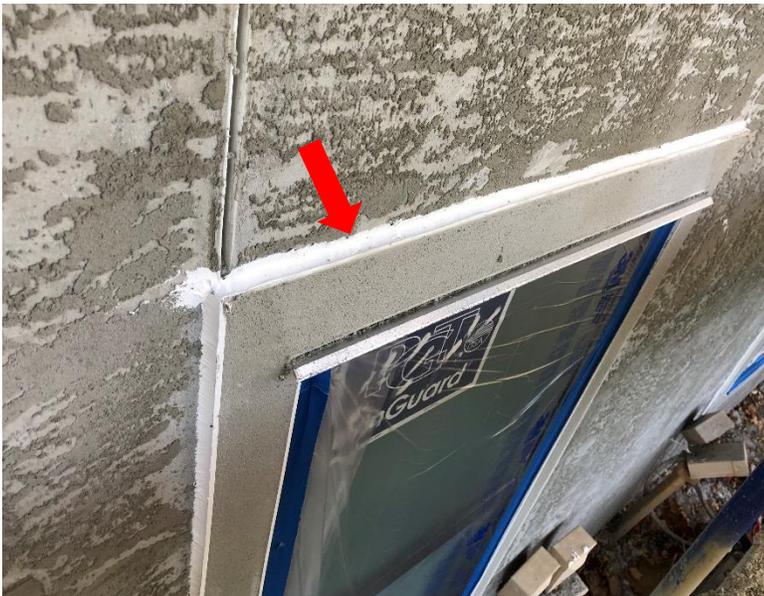
PHOTOGRAPH #10

**BUILDING 6
SECTION H**

MasterSeal 150 sealant was applied around windows.

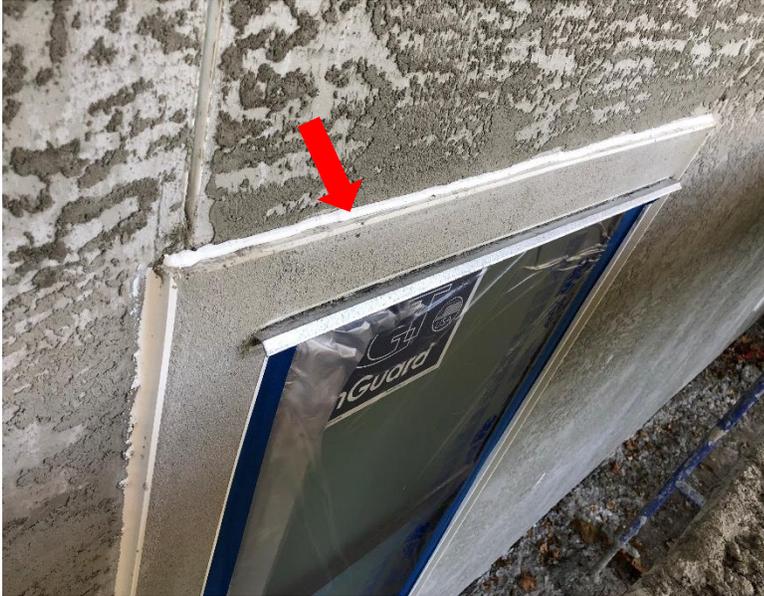
PHOTOGRAPH #11

**BUILDING 6
SECTION H**

Contractor applied a bead of MasterSeal 150 sealant and did not tool flush.

Contractor to remove, reapply, and tool sealant per manufacturer's instructions.

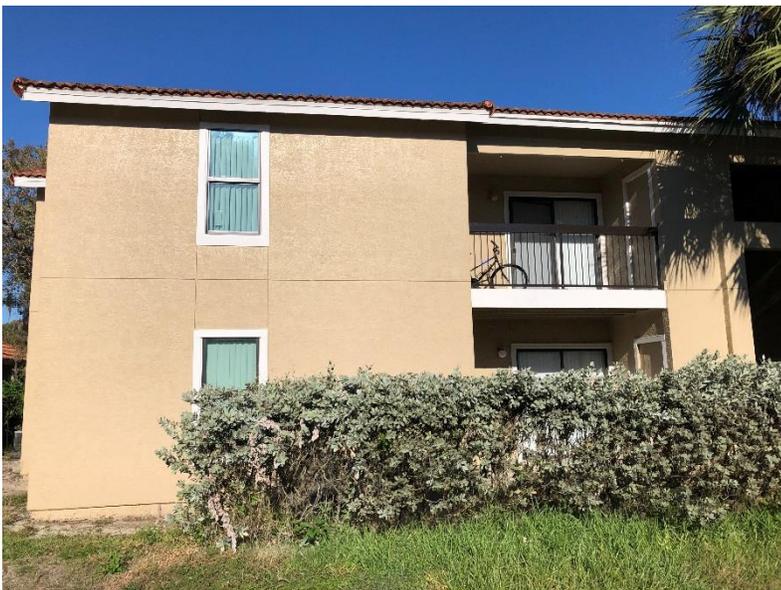
PHOTOGRAPH #12

**BUILDING 3
SECTION A-H**

The exterior of Building 3 was reviewed for completion with contractor.

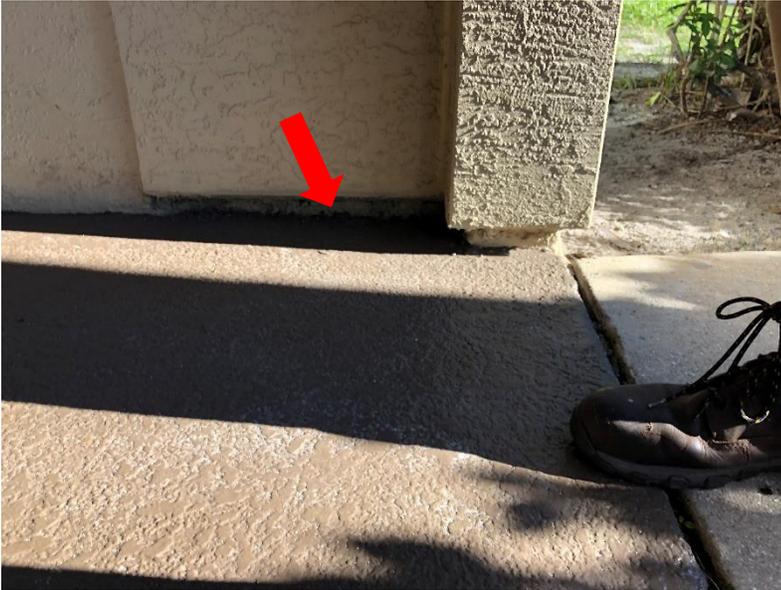
PHOTOGRAPH #13

**BUILDING 3
SECTION A**

Trim and touch-up at bottom of breezeway column.

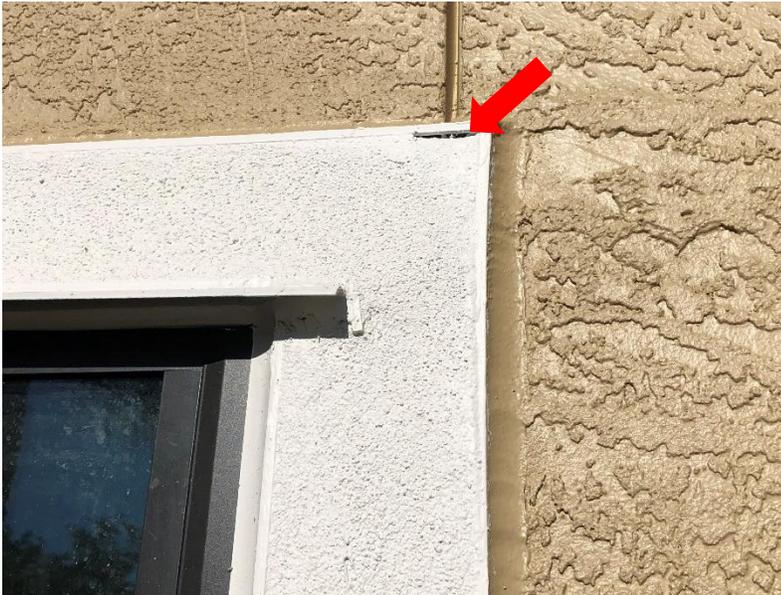
PHOTOGRAPH #14

**BUILDING 3
SECTION B**

Opening at window trim to be sealed.

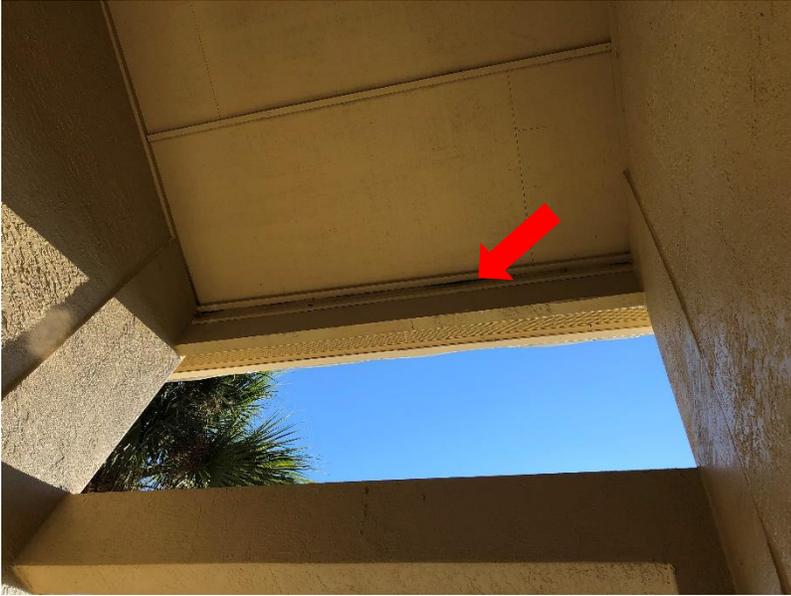
PHOTOGRAPH #15

**BUILDING 3
SECTION C**

Gaps located at the top of breezeway.
Contractor to seal gaps.

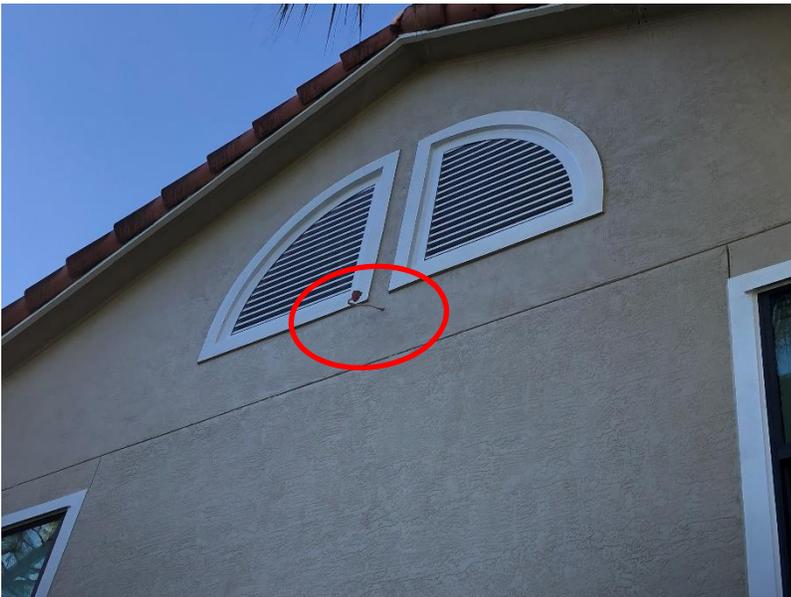
PHOTOGRAPH #16

**BUILDING 3
SECTION D**

Missing light fixture. Contractor to install.

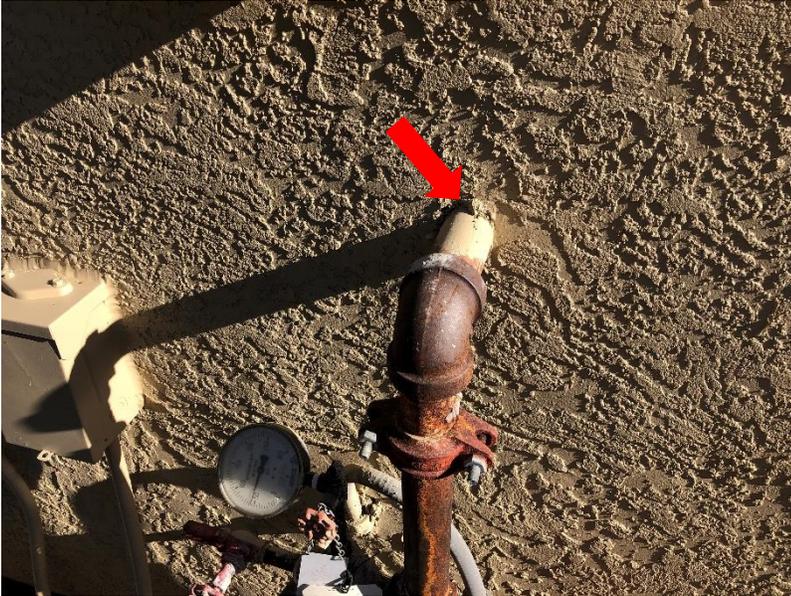
PHOTOGRAPH #17

**BUILDING 3
SECTION H**

Wall penetration is missing sealant.
Contractor to apply sealant.
