PHOTOGRAPHS

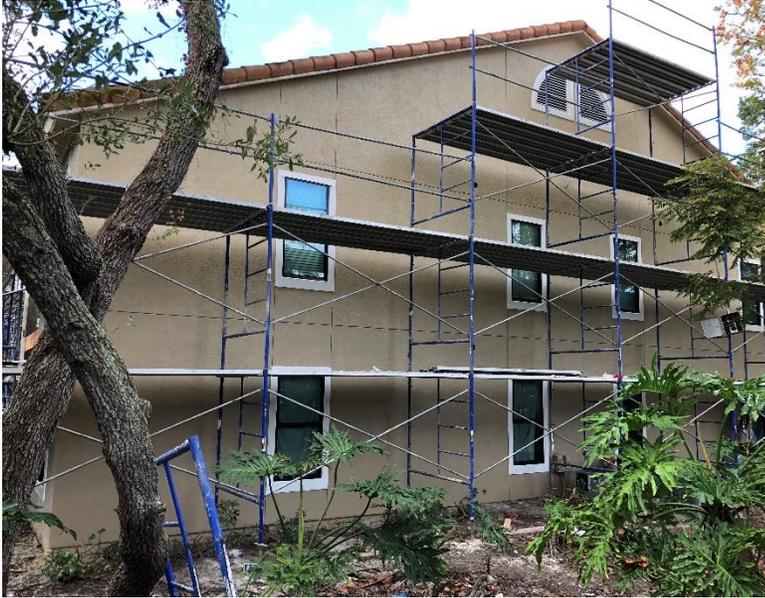
PHOTOGRAPH #1

BUILDING 6 SECTION H

Florida Paints SunFlex acrylic primer and Ultra Exterior Supercoat applied to new stucco surfaces.

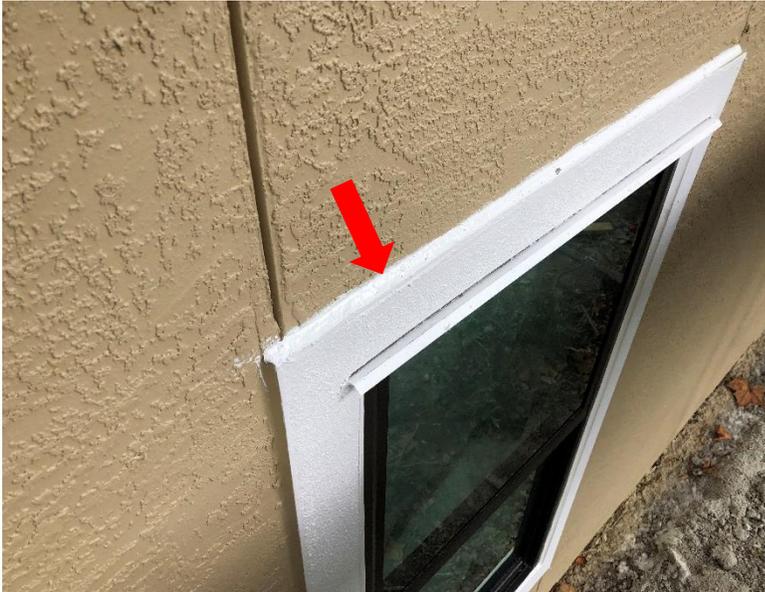
PHOTOGRAPH #2

BUILDING 6 SECTION H

Contractor removed and replaced bead of MasterSeal 150 sealant that was not tooled flush.

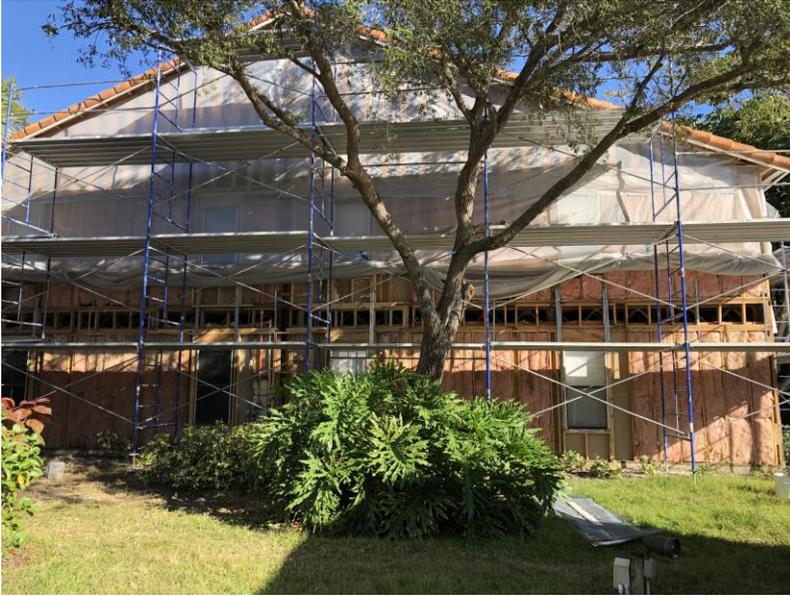
PHOTOGRAPH #3

**BUILDING 6
SECTION A-D**

Framing repairs completed. Contractor to start Simpson connector and strap installation.

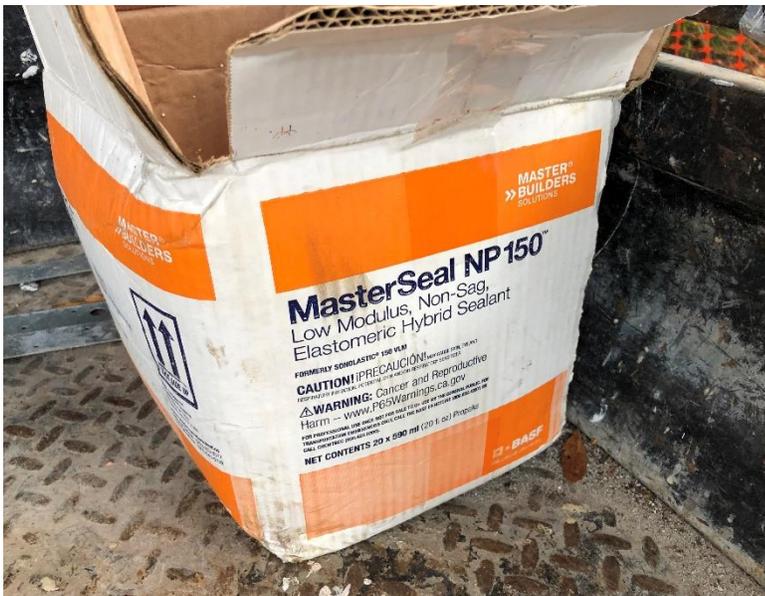
PHOTOGRAPH #4

**BUILDING 6
SECTION E-G**

Contractor applied MasterSeal NP 150 sealant around windows and inside stucco corners.

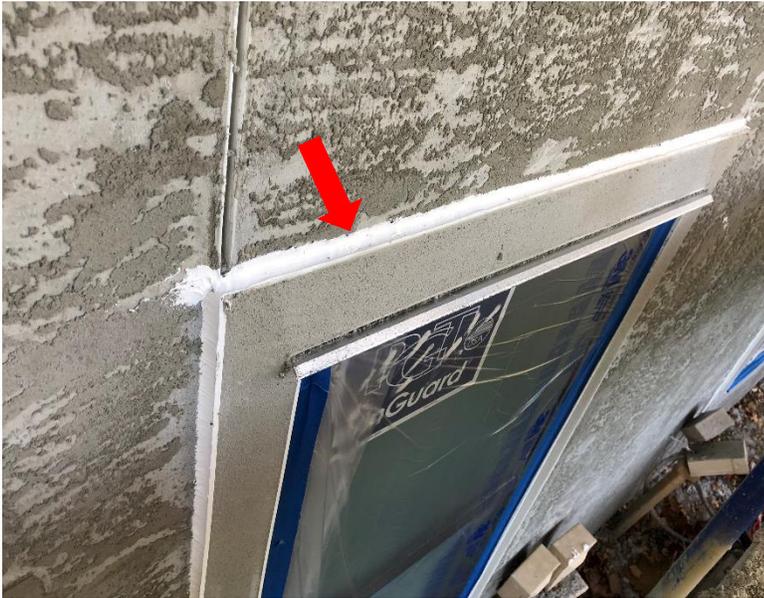
PHOTOGRAPH #5

**BUILDING 6
SECTION H**

Stucco Sub-contractor applied MasterSeal NP 150 sealant around windows and inside stucco corners.

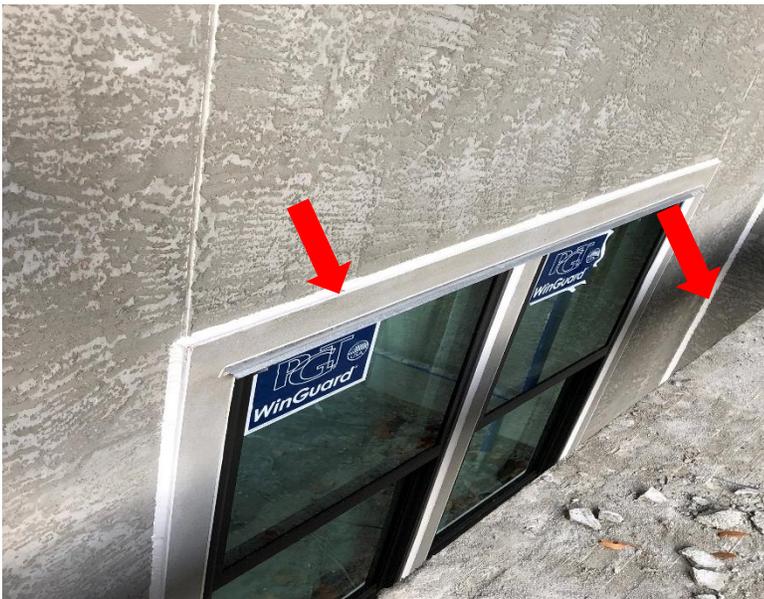
PHOTOGRAPH #6

**BUILDING 6
SECTION E-G**

Contractor applied MasterSeal NP 150 sealant around windows and inside stucco corners.

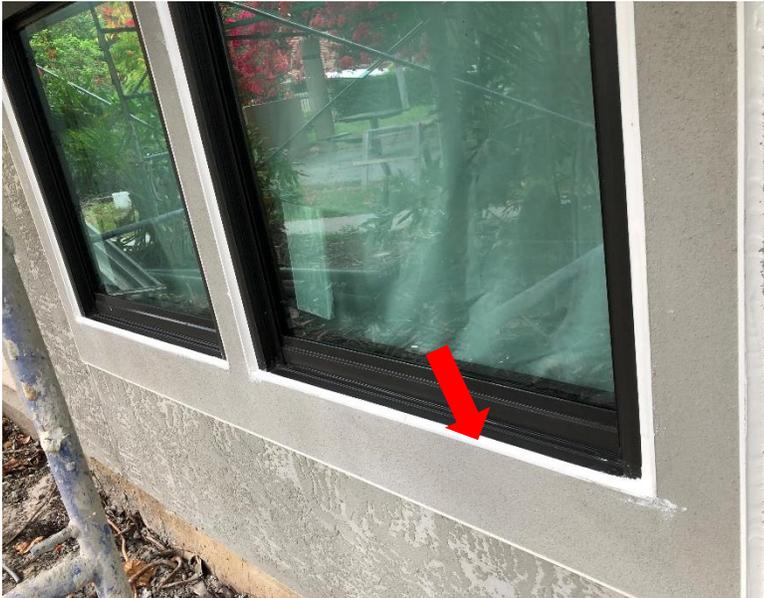
PHOTOGRAPH #7

**BUILDING 6
SECTION E-G**

Contractor applied MasterSeal NP 150 sealant around windows and inside stucco corners.

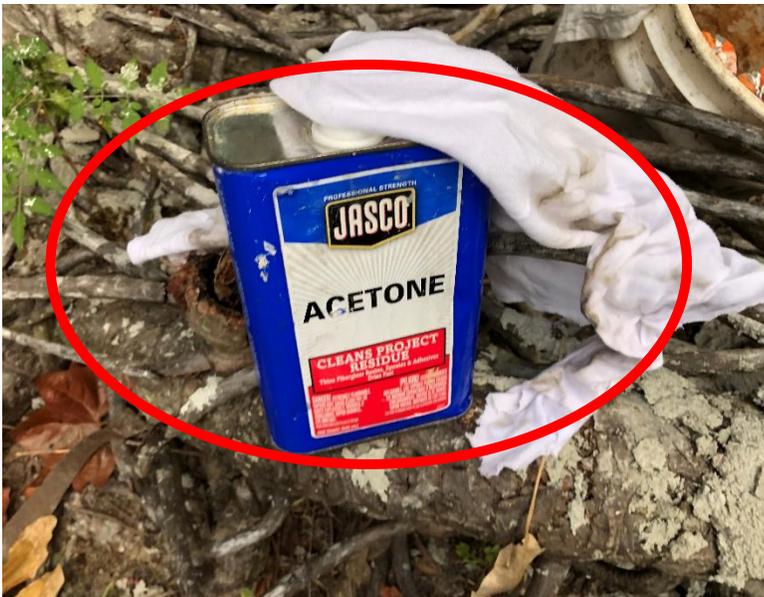
PHOTOGRAPH #8

**BUILDING 6
SECTION E-G**

Contractor cleaned windows locations to receive sealant with Acetone and a clean rag.

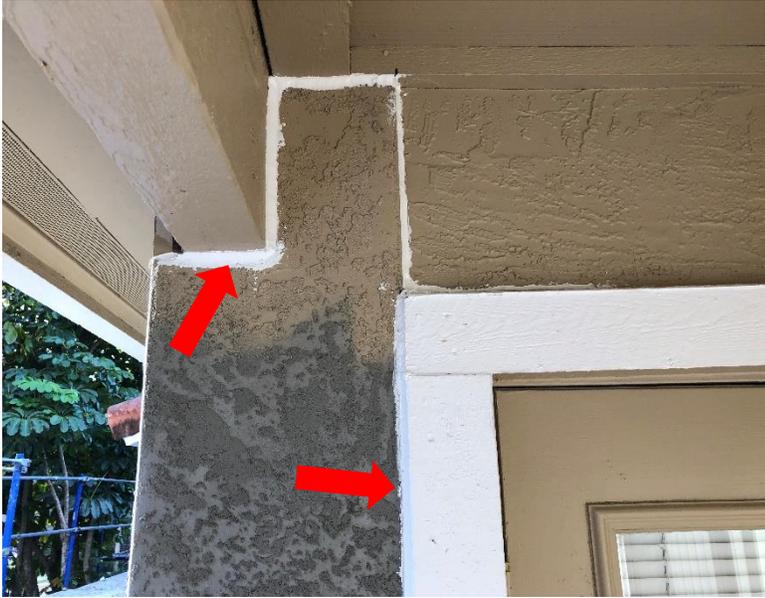
PHOTOGRAPH #9

**BUILDING 6
SECTION E-G**

Contractor applied MasterSeal NP 150 sealant around windows and inside stucco corners.

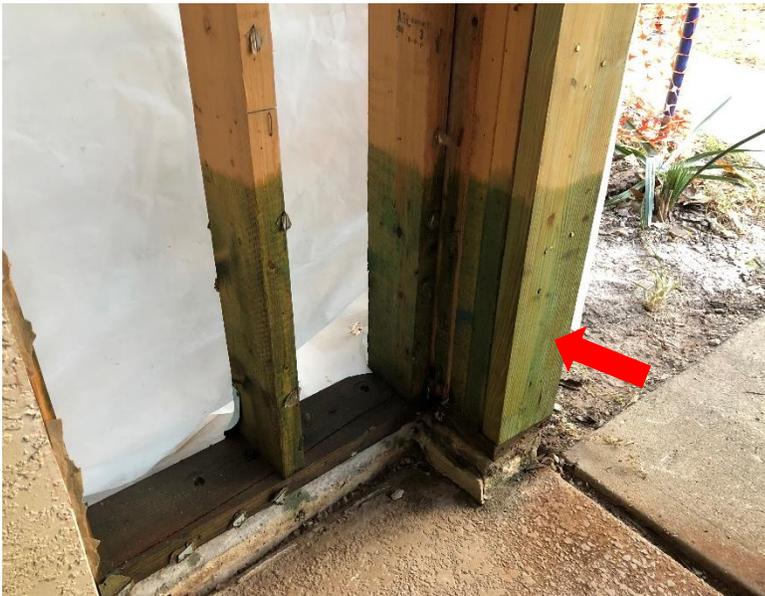
PHOTOGRAPH #10

**BUILDING 6
SECTION A-D**

Contractor applied Copper Green Wood Preservative to the bottom 24" of framing.

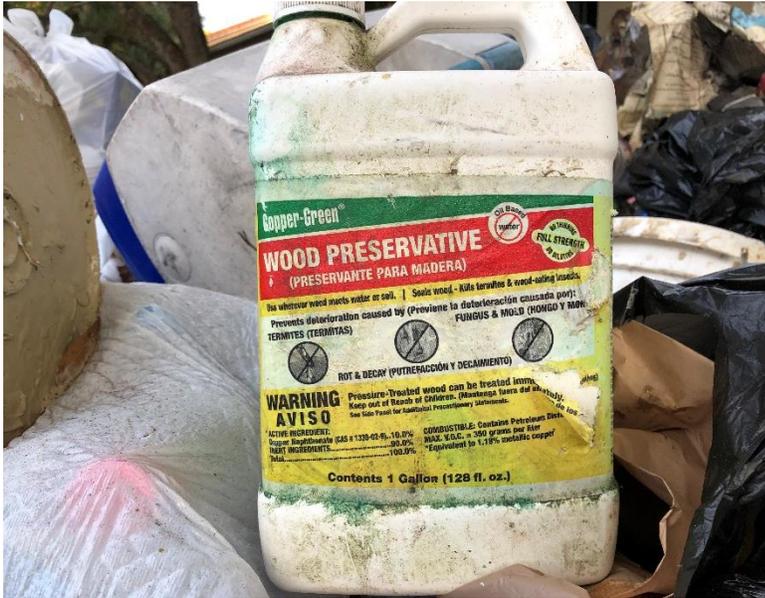
PHOTOGRAPH #11

**BUILDING 6
SECTION A-D**

Contractor applied Copper Green Wood Preservative to the bottom 24" of framing.

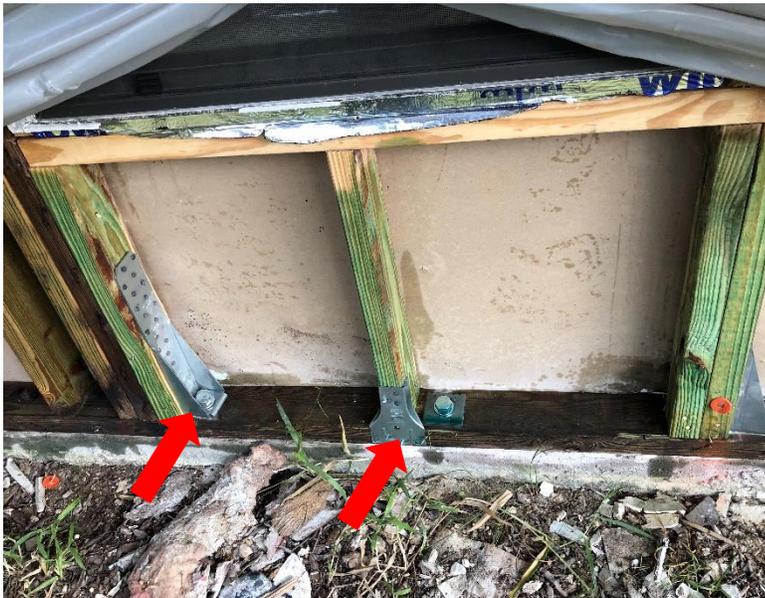
PHOTOGRAPH #12

**BUILDING 6
SECTION D**

Simpson Strong Titen HD Anchors and connector Type B - bearing wall stud to bottom plates were installed with 10d nails per drawings and specifications.

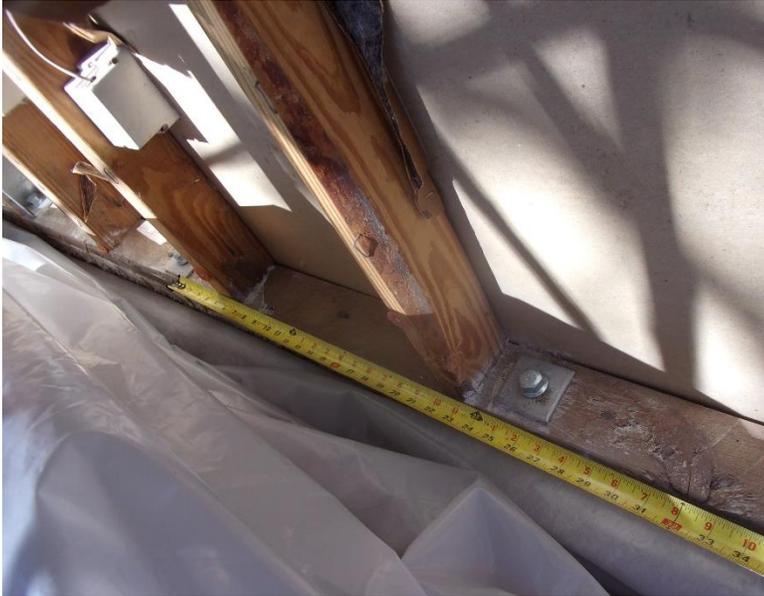
PHOTOGRAPH #13

**BUILDING 6
SECTION D**

5/8" diameter Simpson Strong Titen HD Anchors with base plate installed at 24" on-center per contract drawings and specifications.

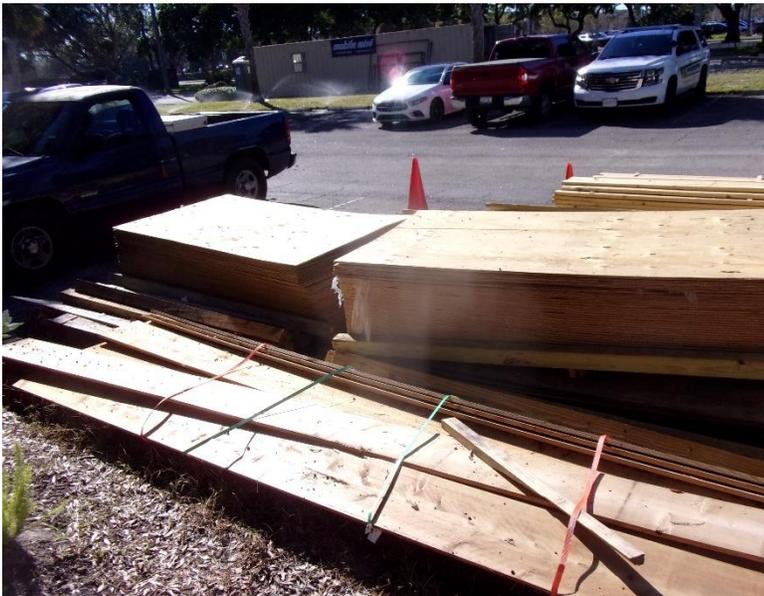
PHOTOGRAPH #14

**BUILDING 6
SECTION A-D**

Contractor received sheathing material for elevations A through D.

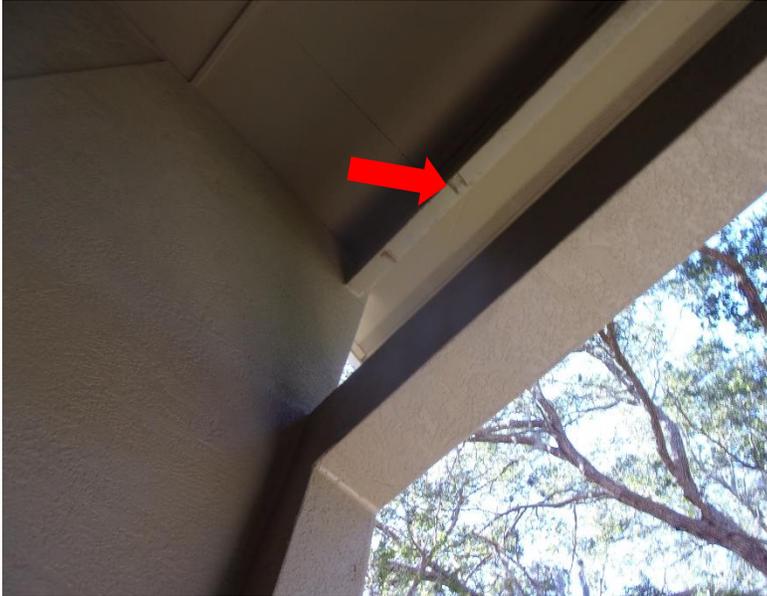
PHOTOGRAPH #15

**BUILDING 3
BREEZEWAY**

Scuff marks on underside of beam at breezeway to be painted.

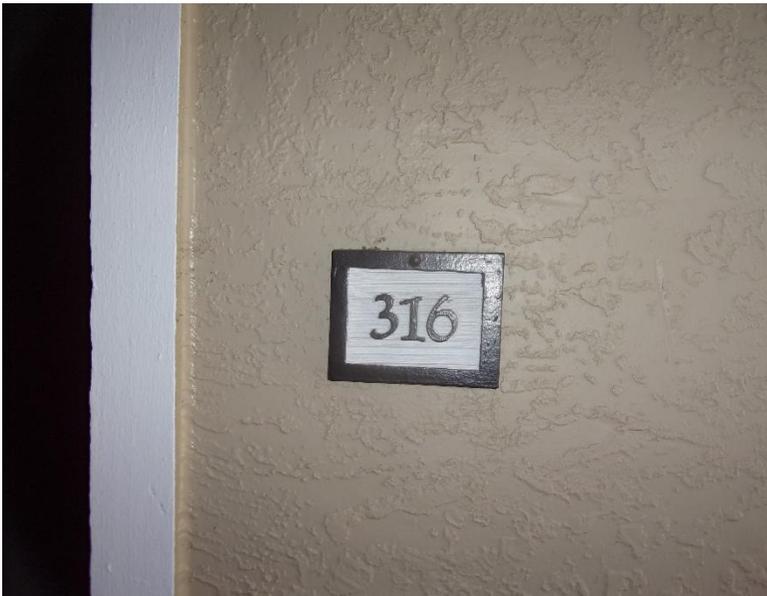
PHOTOGRAPH #16

**BUILDING 3
UNIT 316**

Attic repairs to Unit 316 were not performed due to inaccessibility.
