PHOTOGRAPHS

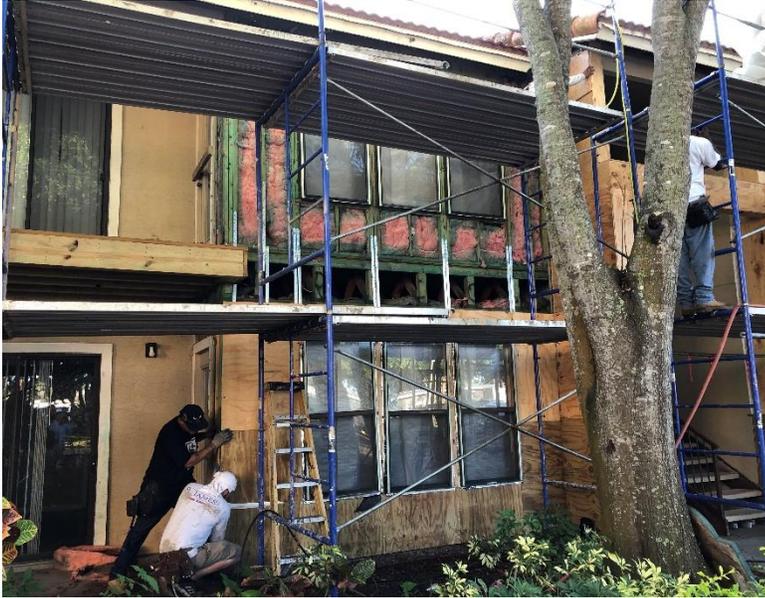
PHOTOGRAPH #1

BUILDING 6 SECTION B

Contractor installing 15/32" exterior rated plywood sheathing with 8d common nails spaced at 4" on-center.

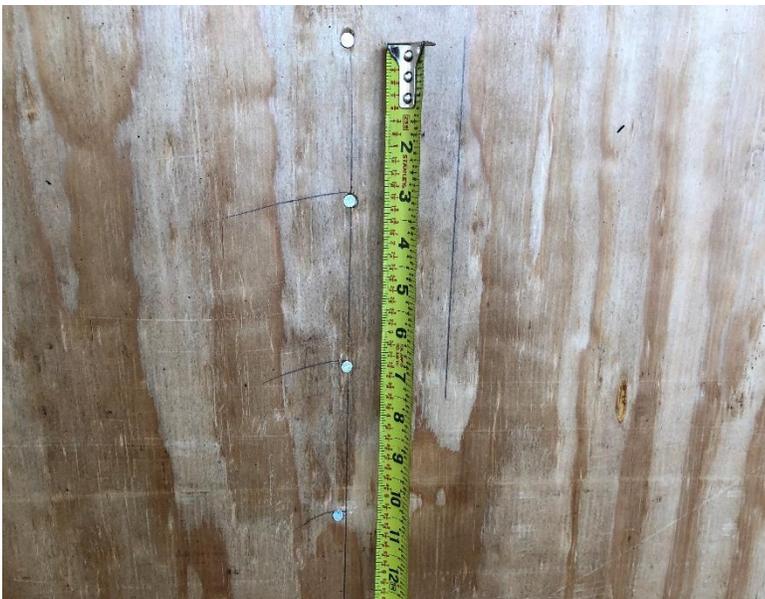
PHOTOGRAPH #2

BUILDING 6 SECTION C

Contractor installing 15/32" exterior rated plywood sheathing with 8d common nails spaced at 4" on-center.

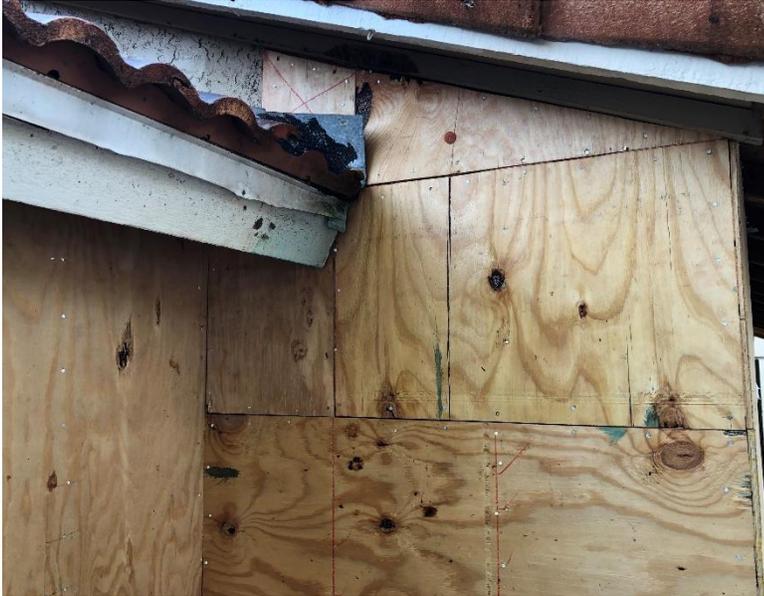
PHOTOGRAPH #3

**BUILDING 6
SECTION C**

Contractor installing 15/32" exterior rated plywood sheathing with 8d common nails spaced at 4" on-center.

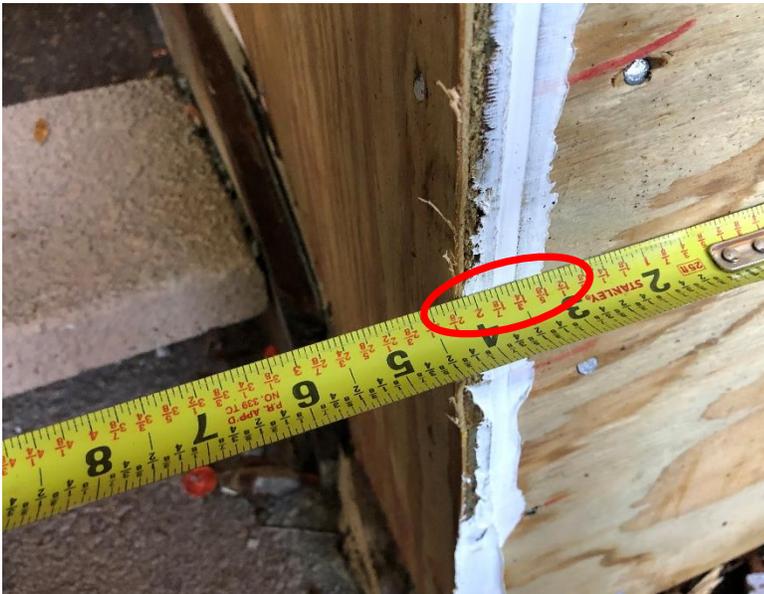
PHOTOGRAPH #4

**BUILDING 6
SECTION B**

BASF Urethane Sealant was applied to gaps larger than 1/8".

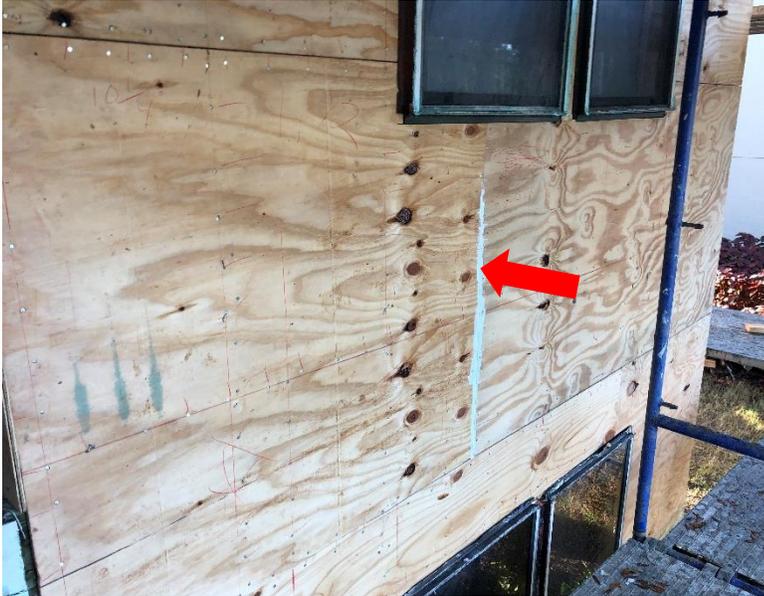
PHOTOGRAPH #5

**BUILDING 6
SECTION C**

BASF Urethane Sealant was applied to gaps larger than 1/8".

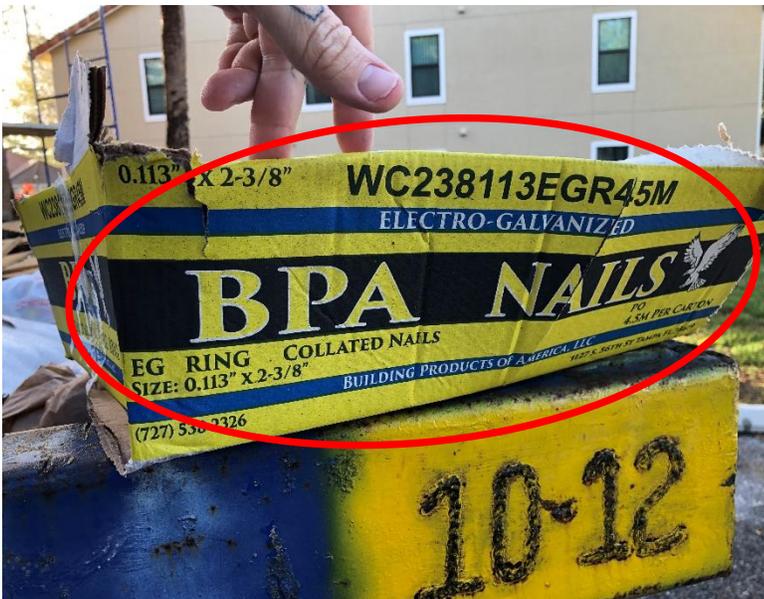
PHOTOGRAPH #6

**BUILDING 6
SECTION C**

BPA galvanized nails .113\" x 2-3/8\" were used for sheathing installation.

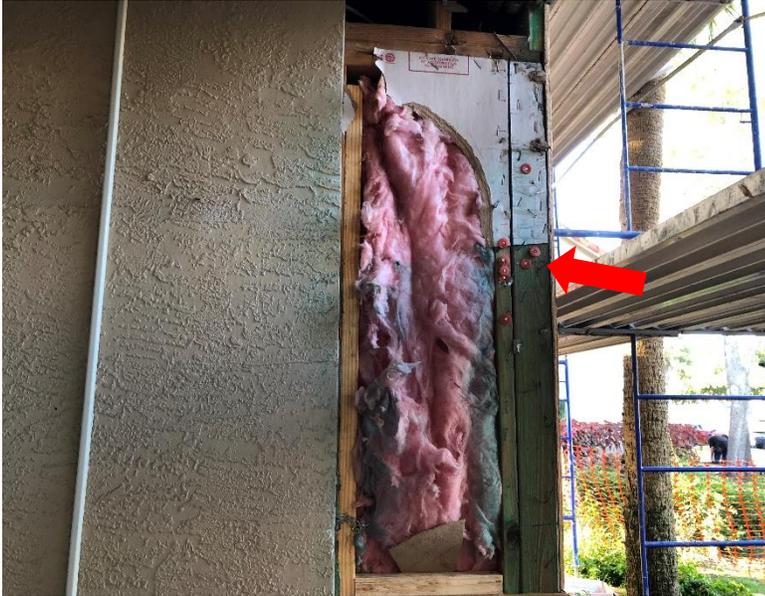
PHOTOGRAPH #7

**BUILDING 6
SECTION C**

Nails and staples to be removed prior to sheathing installation.

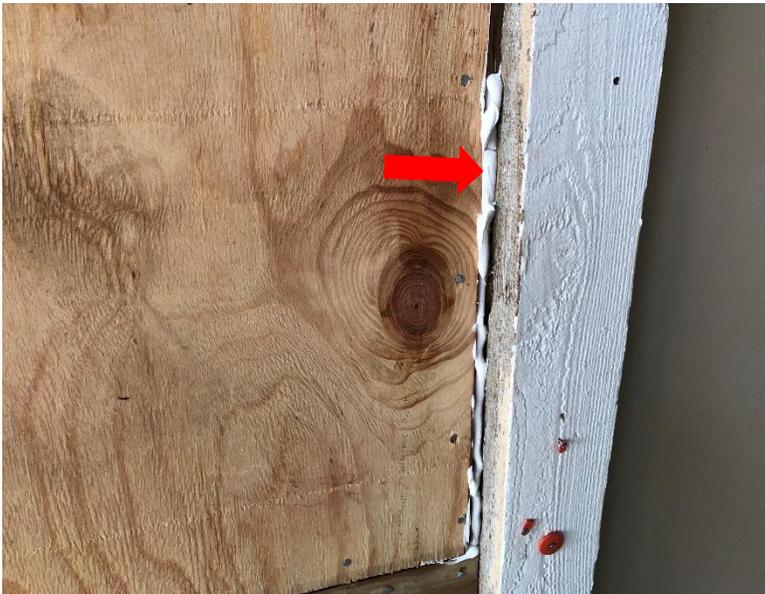
PHOTOGRAPH #8

**BUILDING 6
SECTION C**

Contractor applied BASF sealant to gap adjacent to balcony door frame and did not tool flush.

Contractor to remove cured sealant bead, reapply, and tool smooth.

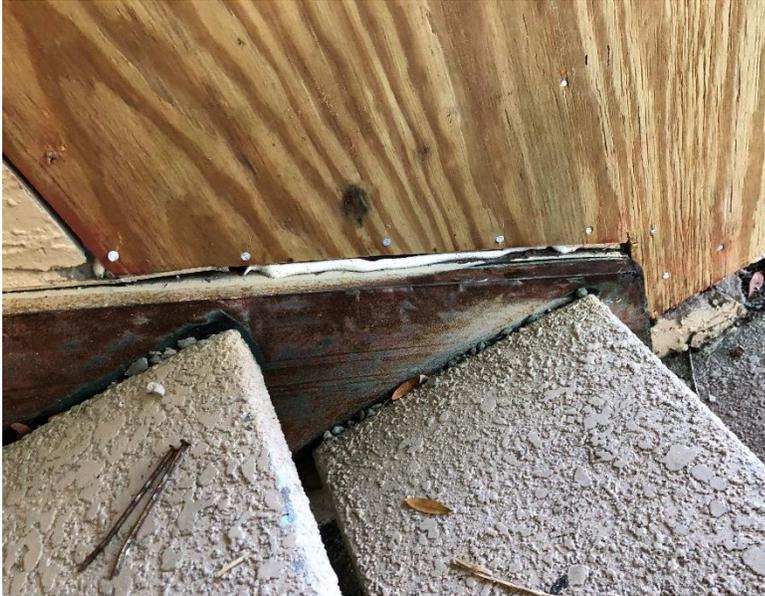
PHOTOGRAPH #9

**BUILDING 6
SECTION C**

Contractor applied BASF sealant to gap adjacent to balcony door frame and did not tool flush.

Contractor to remove cured sealant bead, reapply, and tool smooth.

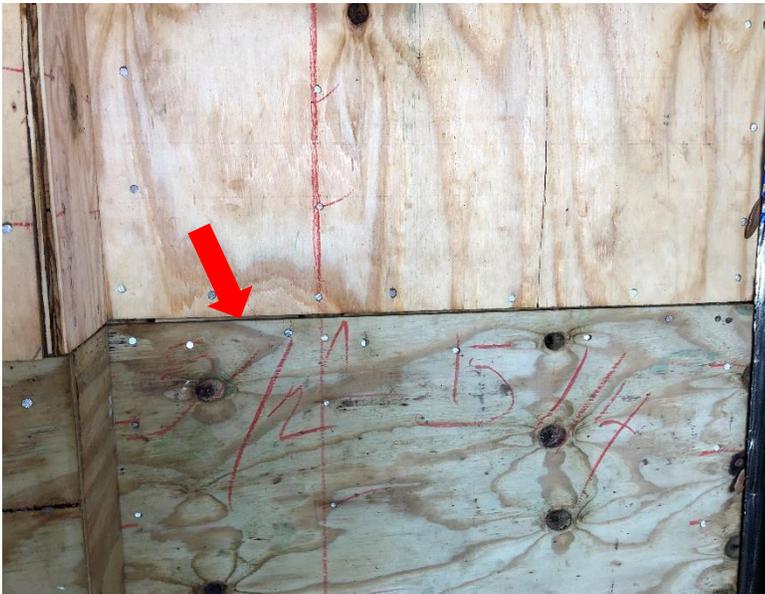
PHOTOGRAPH #10

**BUILDING 6
SECTION C**

BASF Urethane Sealant to be applied to gaps larger than 1/8".

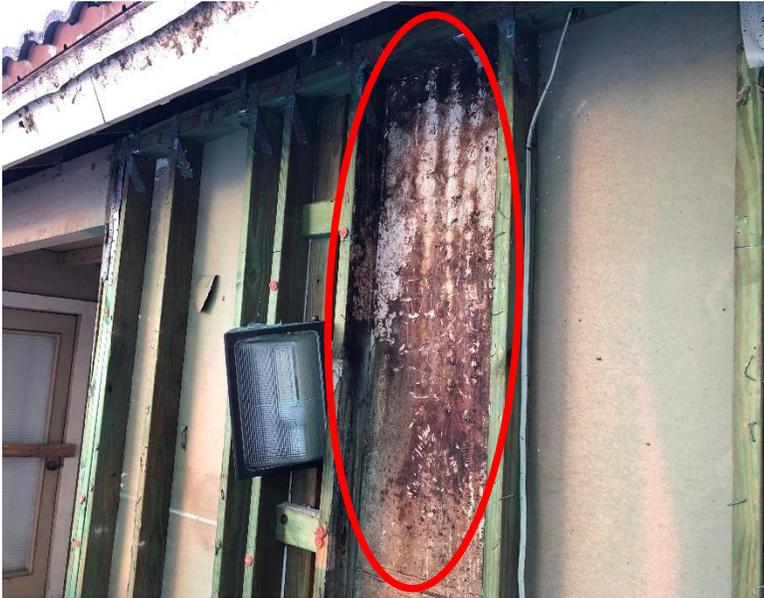
PHOTOGRAPH #11

**BUILDING 6
SECTION B**

Contractor completely removed beehive and debris.

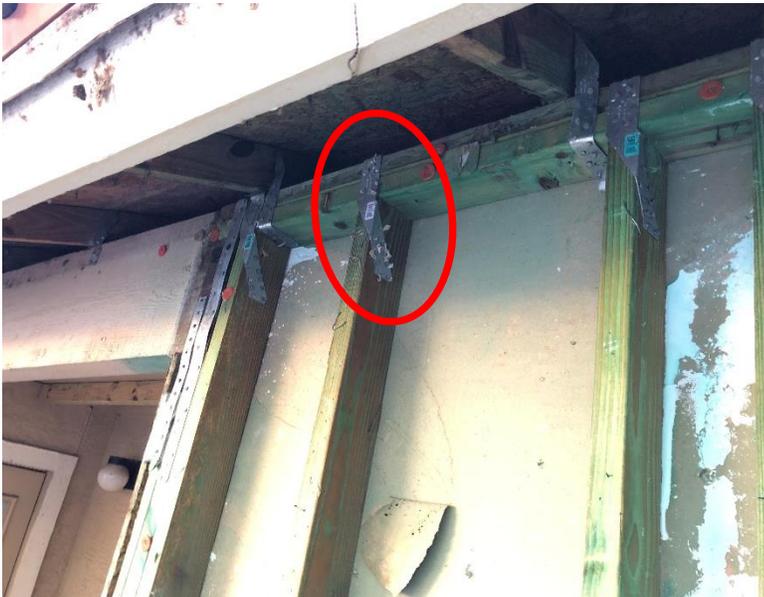
PHOTOGRAPH #12

**BUILDING 6
SECTION B**

Contractor added missing TSP strap from stud to top plate.

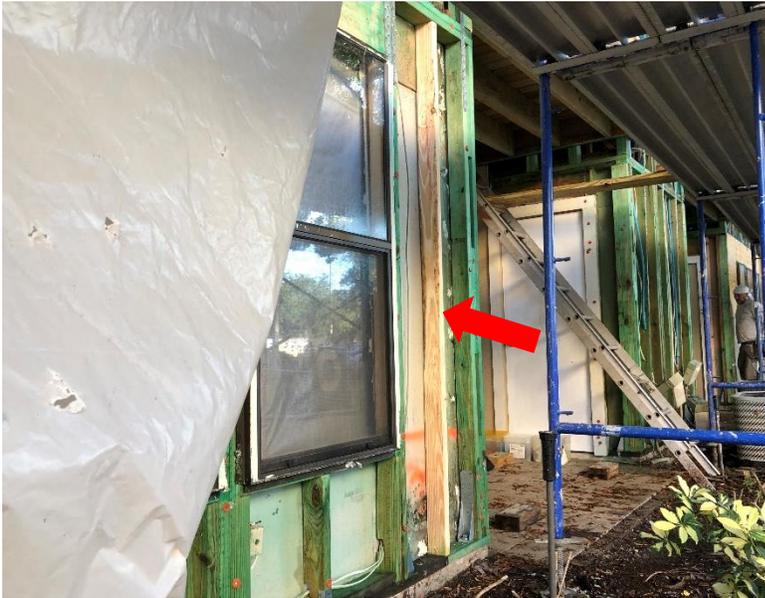
PHOTOGRAPH #13

**BUILDING 6
SECTION B**

Contractor added intermediate stud where the studs were spaced greater than 16" on-center.

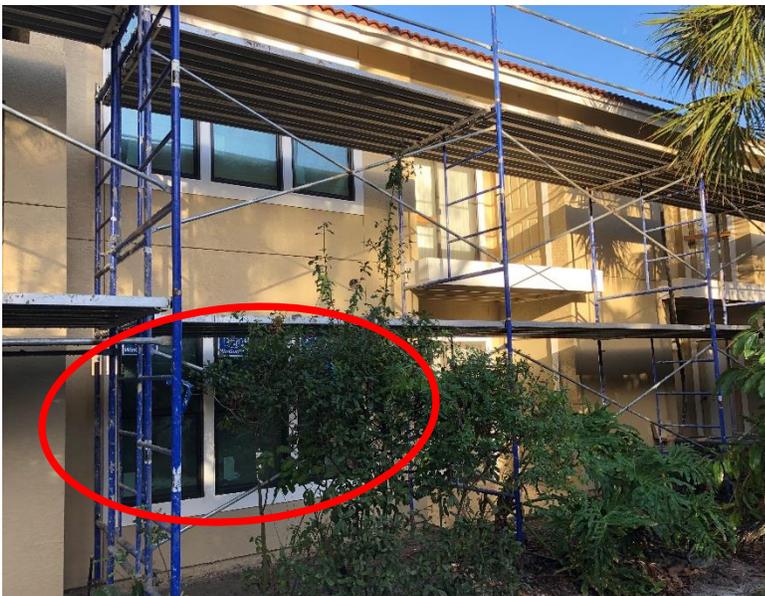
PHOTOGRAPH #14

**BUILDING 6
SECTION F**

Contractor covered sealant to paint window trim before sealant fully cured. The plastic covering has embedded in the sealant.

Contractor to remove, clean, and reapply sealant at this window.

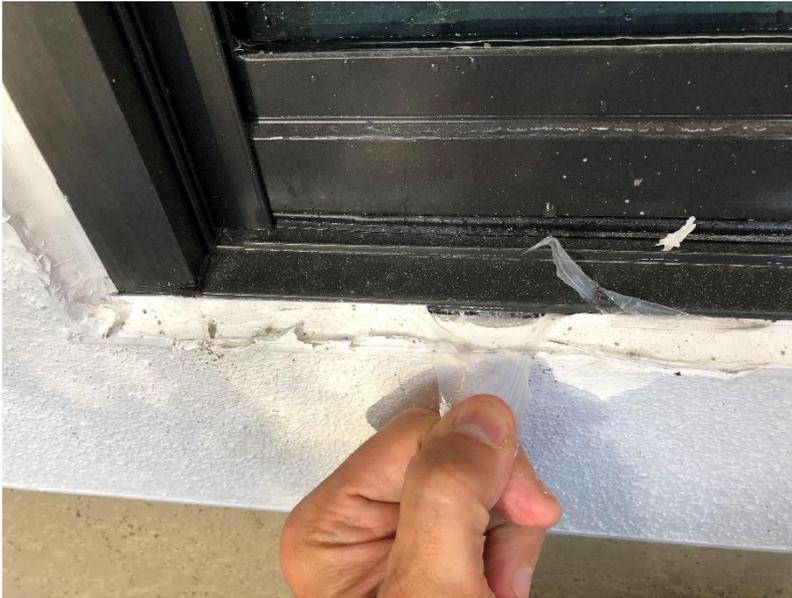
PHOTOGRAPH #15

**BUILDING 6
SECTION F**

Contractor covered sealant to paint window trim before sealant fully cured. The plastic covering has embedded in the sealant.

Contractor to remove, clean, and reapply sealant at this window.

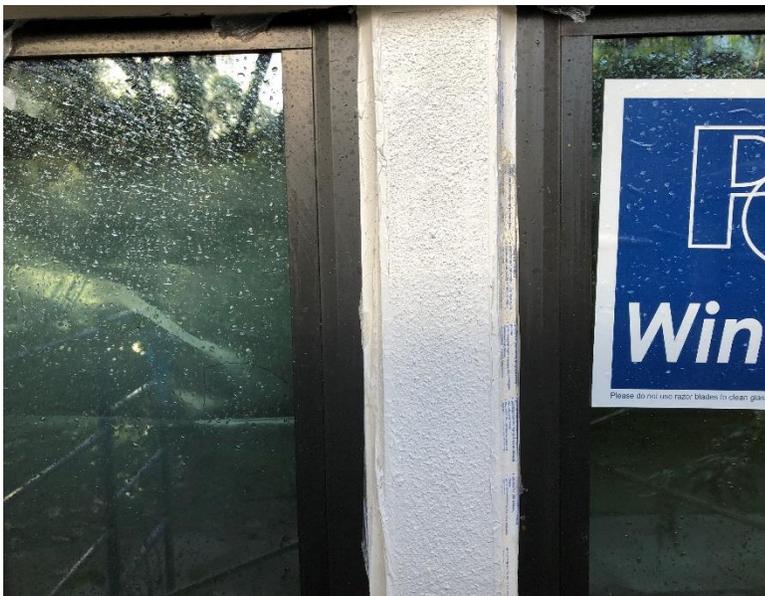
PHOTOGRAPH #16

**BUILDING 6
SECTION F**

Contractor covered sealant to paint window trim before sealant fully cured. The plastic covering has embedded in the sealant.

Contractor to remove, clean, and reapply sealant at this window.

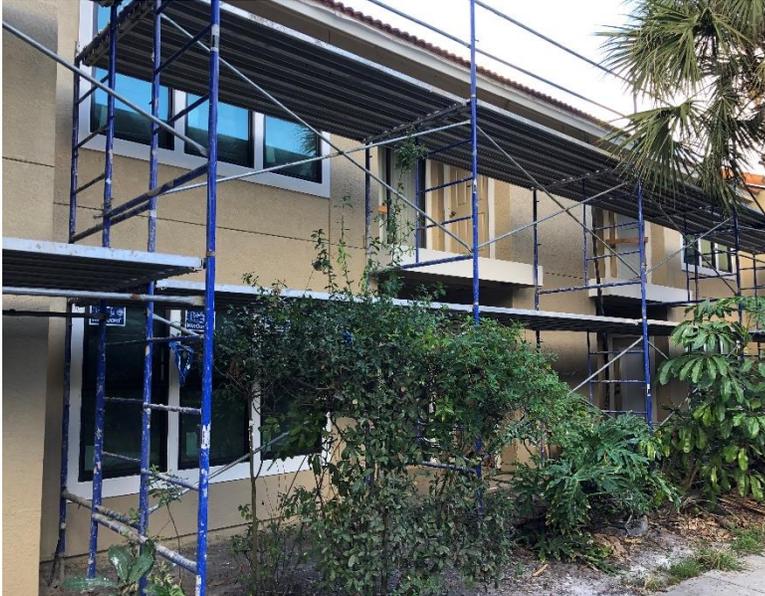
PHOTOGRAPH #17

**BUILDING 6
SECTION F**

Contractor applied two coats of paint to window trim and balcony edges.

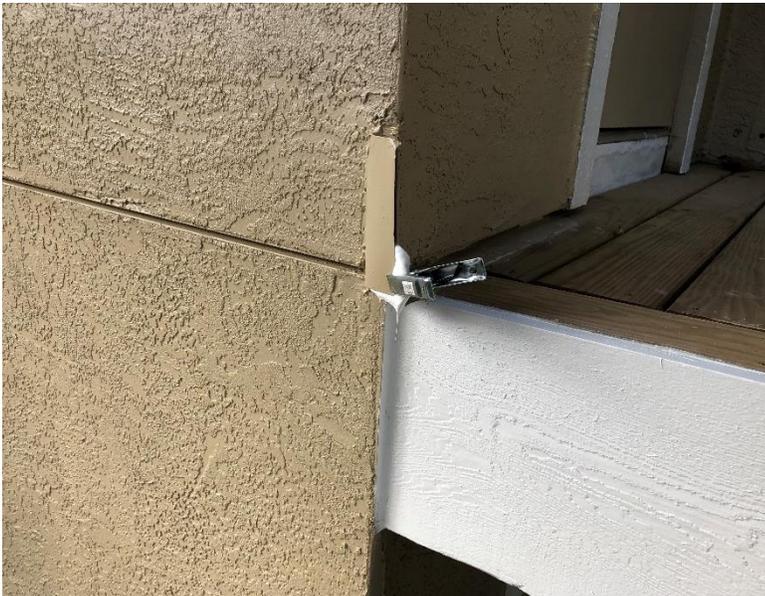
PHOTOGRAPH #18

**BUILDING 6
SECTION F**

Sealant applied to kick-out flashing and excess to be trimmed.

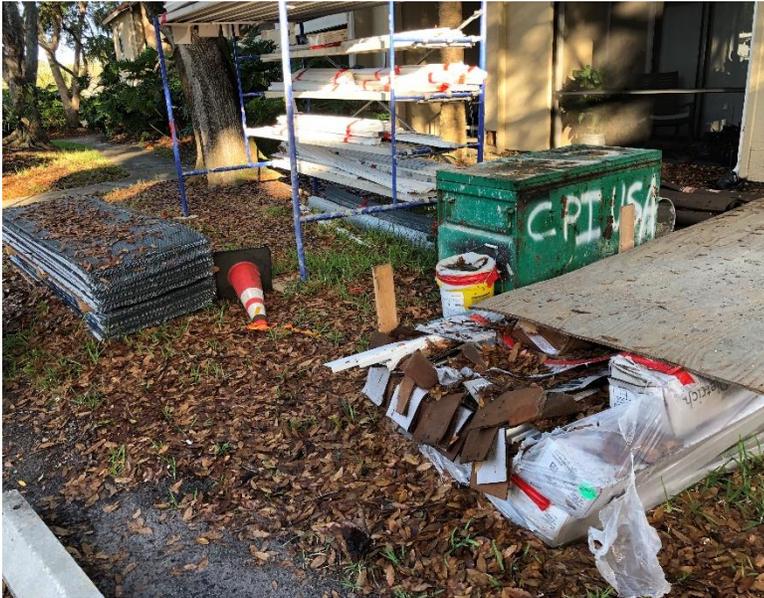
PHOTOGRAPH #19

**BUILDING 6
STORAGE**

Construction materials are not covered from weather and protected from theft.

Contractor to cover and protect building material on-site.

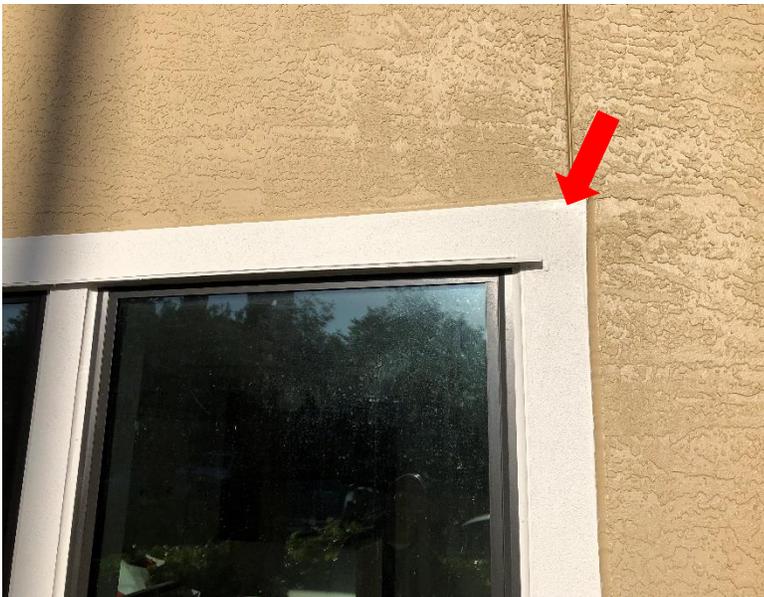
PHOTOGRAPH #20

**BUILDING 3
SECTION B**

Contractor applied MasterSeal NP-1 Sealant to small hole in window trim.

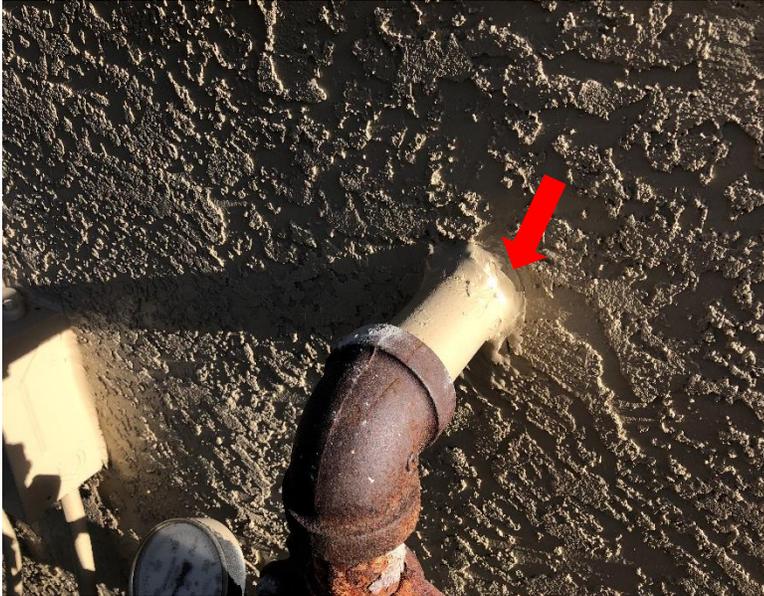
PHOTOGRAPH #21

**BUILDING 3
SECTION H**

Contractor applied sealant around pipe at wall penetration.
