### PHOTOGRAPHS

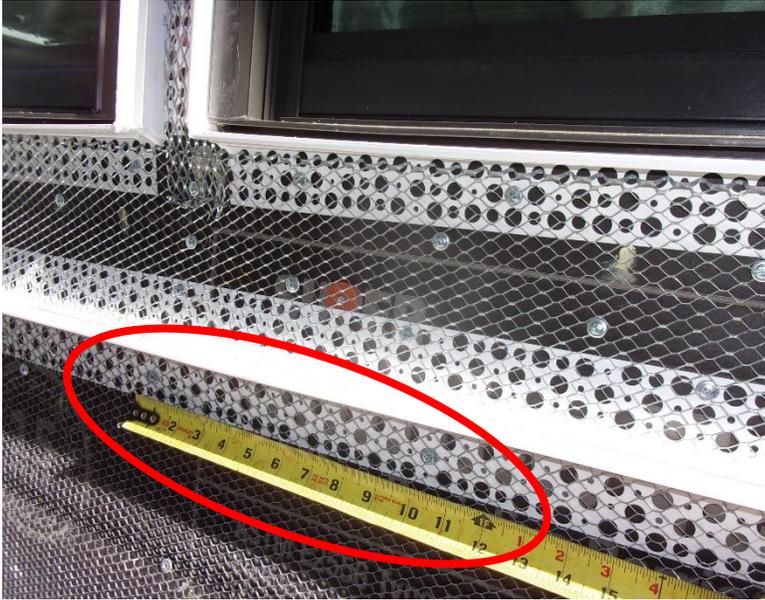
**PHOTOGRAPH #1**

#### **BUILDING 6 SECTION A**

Sub-contractor lacked fasteners at attachment of vinyl accessories. Specification requires attachment at minimum of 7" O.C.

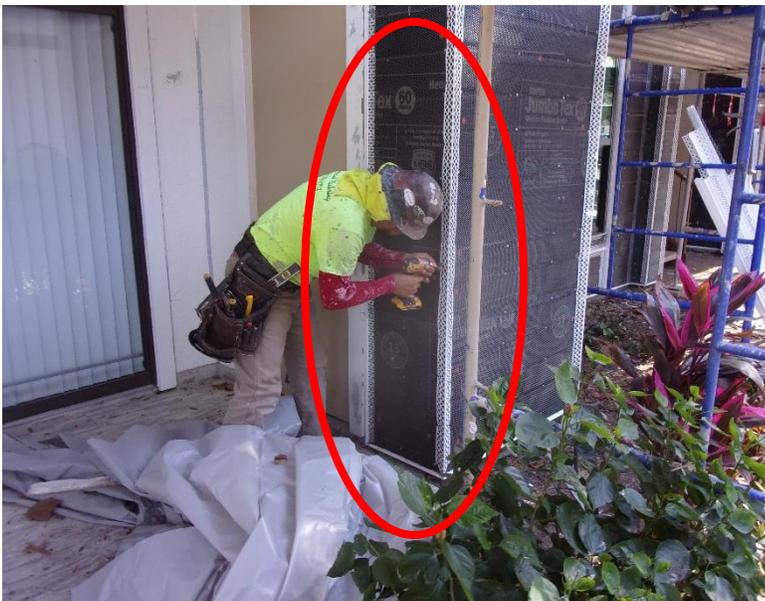
**PHOTOGRAPH #2**

#### **BUILDING 6 SECTION A**

Contractor adding missing fasteners at vinyl stucco accessories to meet the specified minimum of 7" O.C.

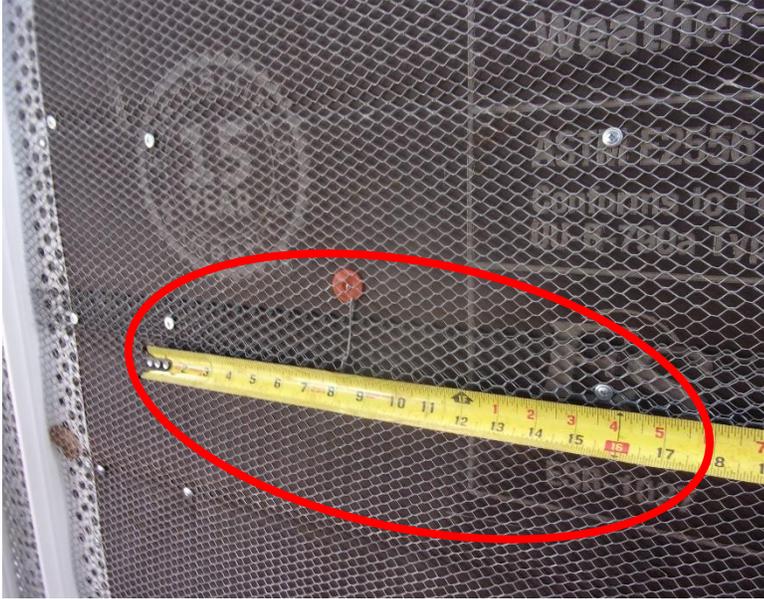
**PHOTOGRAPH #3**

**BUILDING 6  
SECTION A**

Sub-contractor has attached metal lathing to framing studs at 16" O.C. and provided tie wire connections at lathing overlaps.

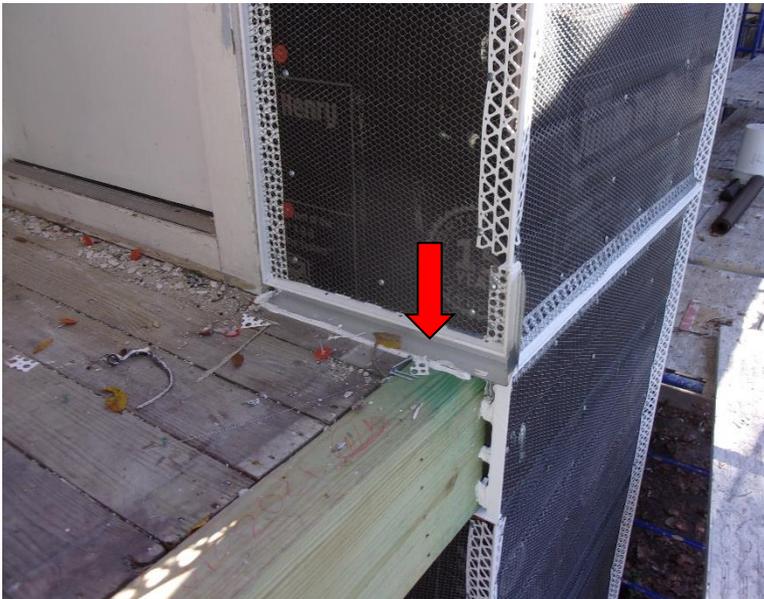
**PHOTOGRAPH #4**

**BUILDING 6  
SECTION A**

New galvanized kick out flashing installed and sealed at deck repairs as per drawings.

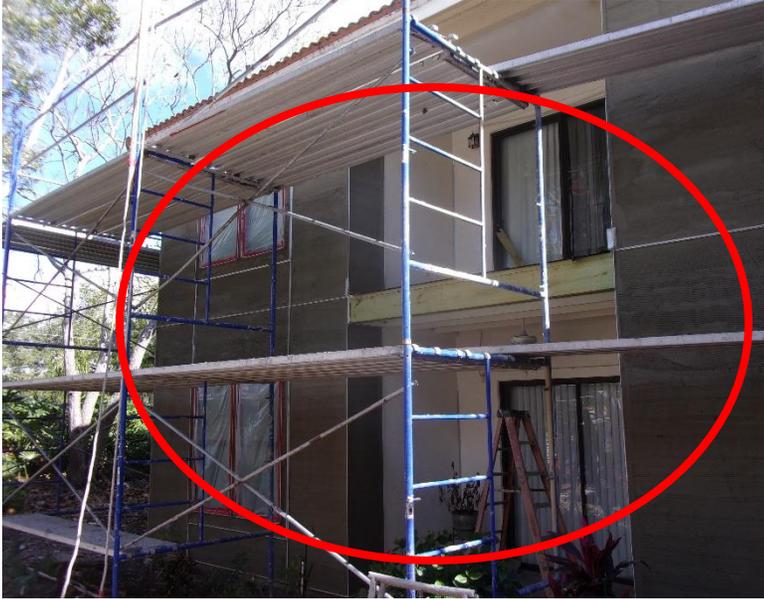
**PHOTOGRAPH #5**

**BUILDING 6  
SECTION A**

Sub-contractor has applied scratch coat of three coat 7/8" stucco system as per specifications.

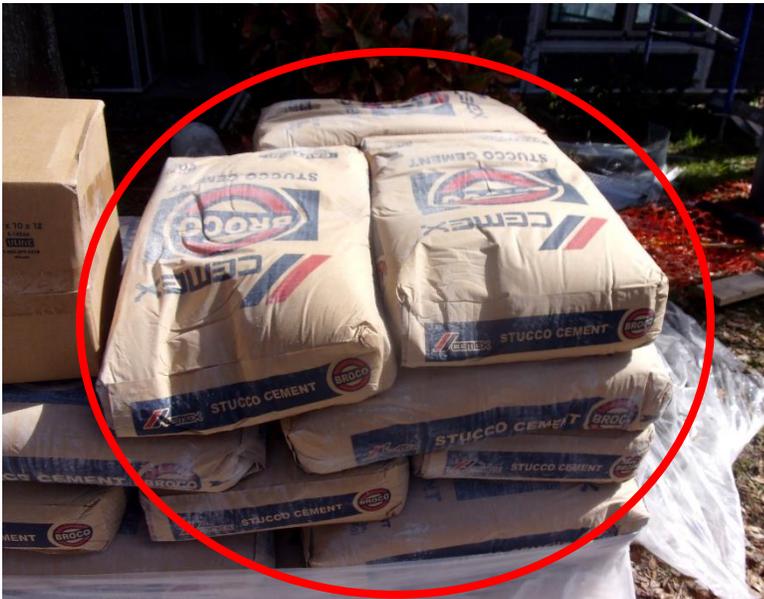
**PHOTOGRAPH #6**

**BUILDING 6  
SECTION A**

CEMEX BROCO stucco cement bag mix used for three coat 7/8" stucco system.

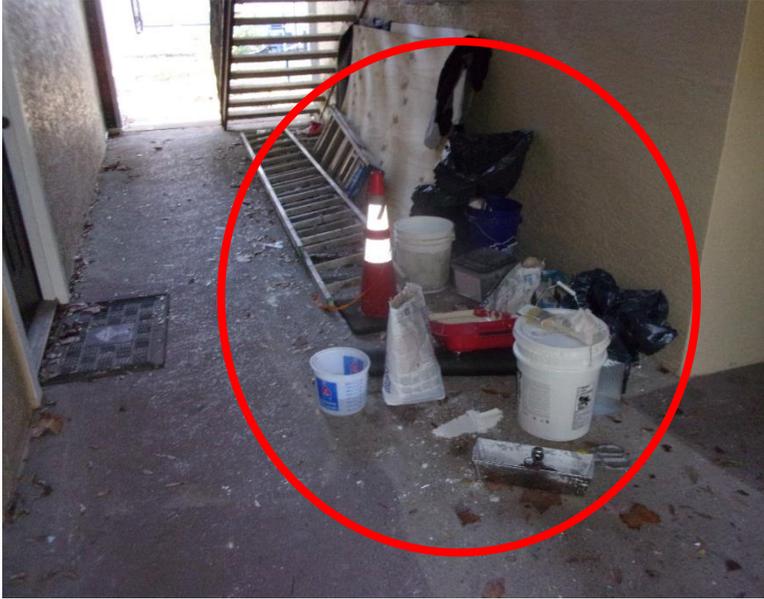
**PHOTOGRAPH #7**

**BUILDING 6  
SECTION A**

Contractors repair materials and equipment in breezeway walk path.

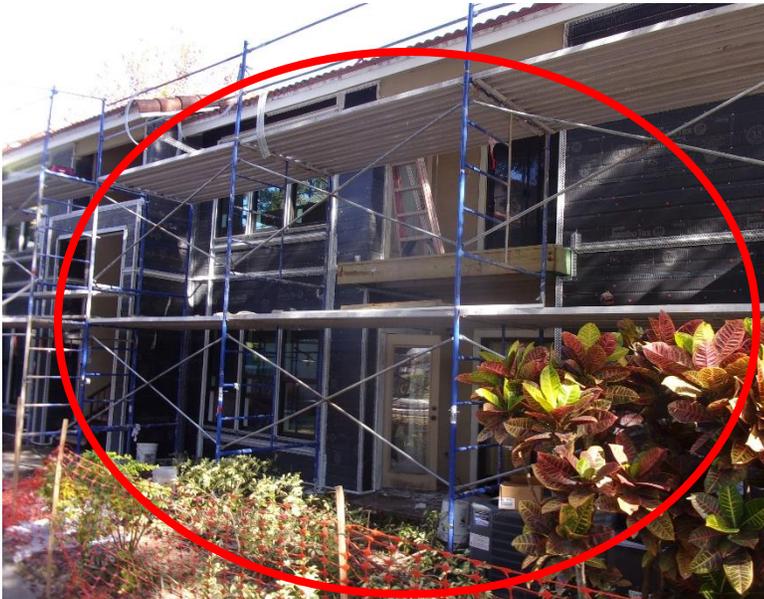
**PHOTOGRAPH #8**

**BUILDING 6  
SECTION B**

Sub-contractor has installed vinyl stucco accessories and metal lathing for application of new stucco.

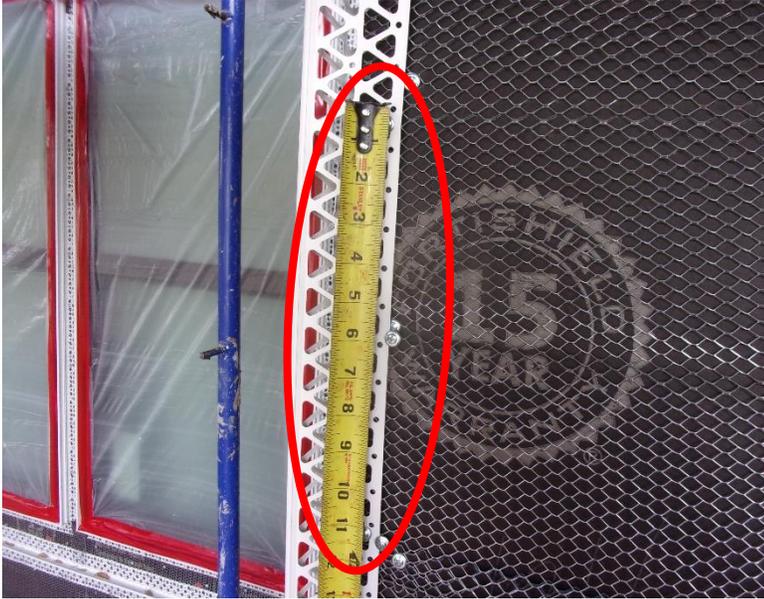
**PHOTOGRAPH #9**

**BUILDING 6  
SECTION B**

Stucco accessories fastened with self-tapping screws at minimum 7" O.C.as per drawings and specifications.

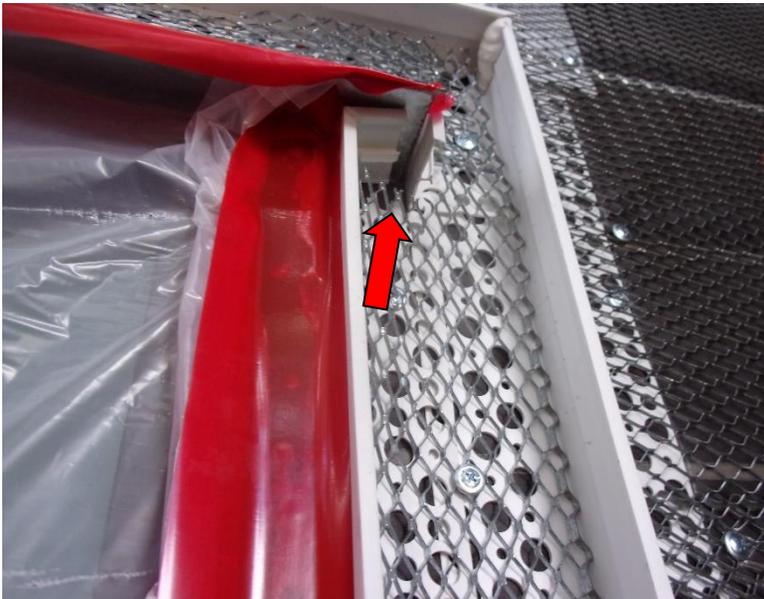
**PHOTOGRAPH #10**

**BUILDING 6  
SECTION B**

Sealant missing butt joints and transitions of vinyl accessories.

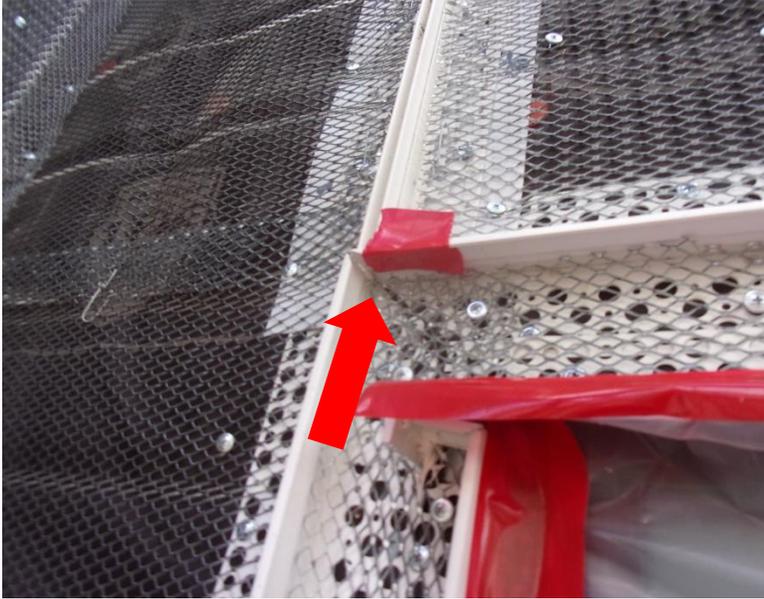
**PHOTOGRAPH #11**

**BUILDING 6  
SECTION B**

Missing sealants at butt joints and transitions of vinyl accessories corrected by sub-contractor.

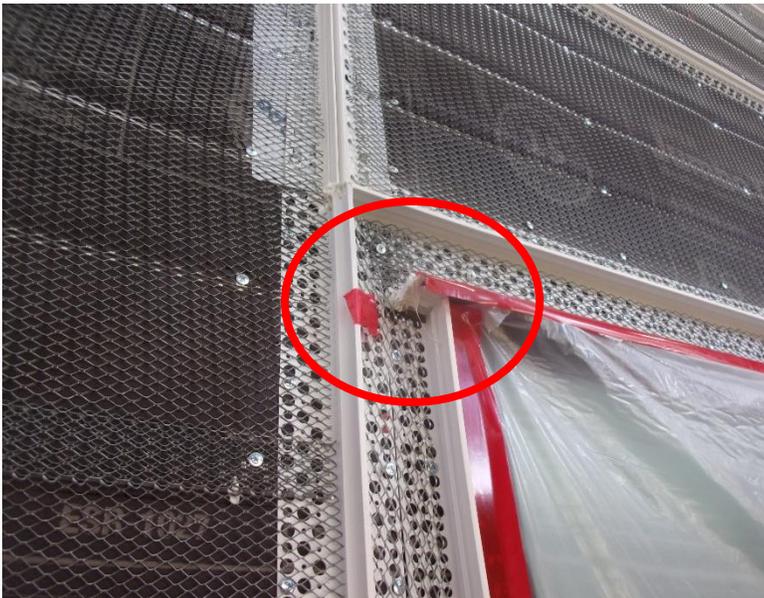
**PHOTOGRAPH #12**

**BUILDING 6  
SECTION B**

Missing sealants at butt joints and transitions of vinyl accessories corrected by sub-contractor.

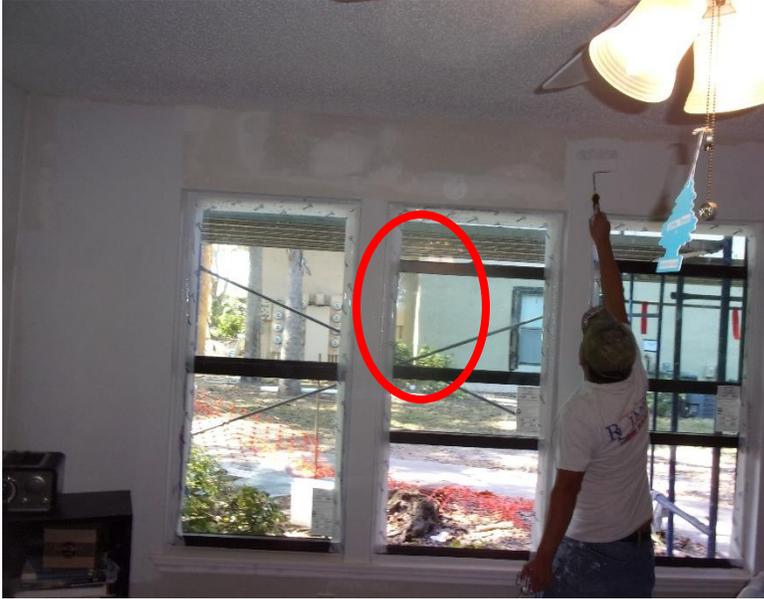
**PHOTOGRAPH #13**

**BUILDING 6  
SECTION B**

**Unit #613-** Drywall taping and finishing in progress at new PGT windows.

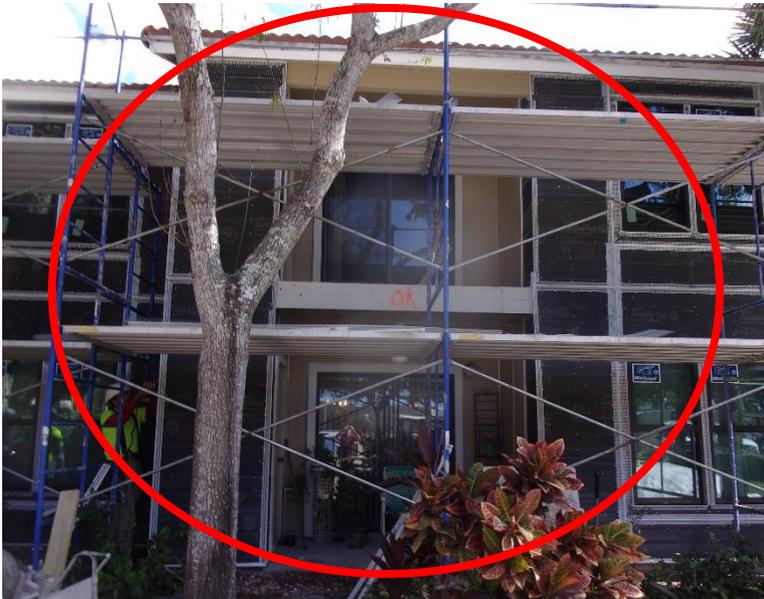
**PHOTOGRAPH #14**

**BUILDING 6  
SECTION C**

Sub-contractor in process of installing vinyl stucco accessories and metal lathing for application of new stucco.

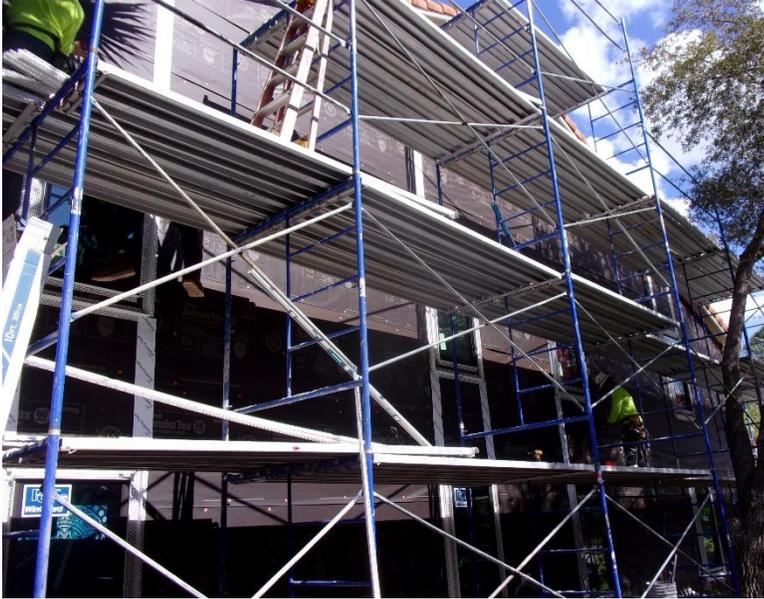
**PHOTOGRAPH #15**

**BUILDING 6  
SECTION D**

Jumbo Tex super 60 water resistant barrier applied and new stucco accessory installation in progress.

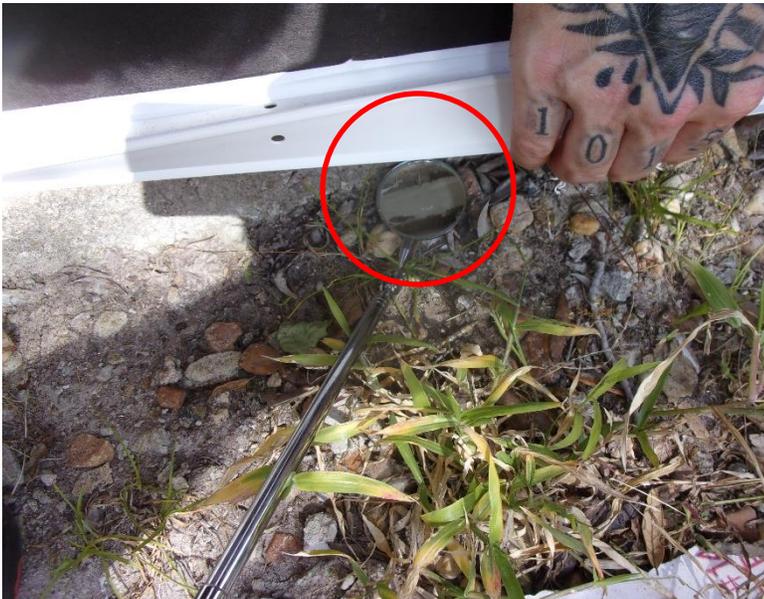
**PHOTOGRAPH #16**

**BUILDING 6  
SECTION D**

Sealant installed at base plate to concrete foundation as per drawings from ESI #1 alternate #3.

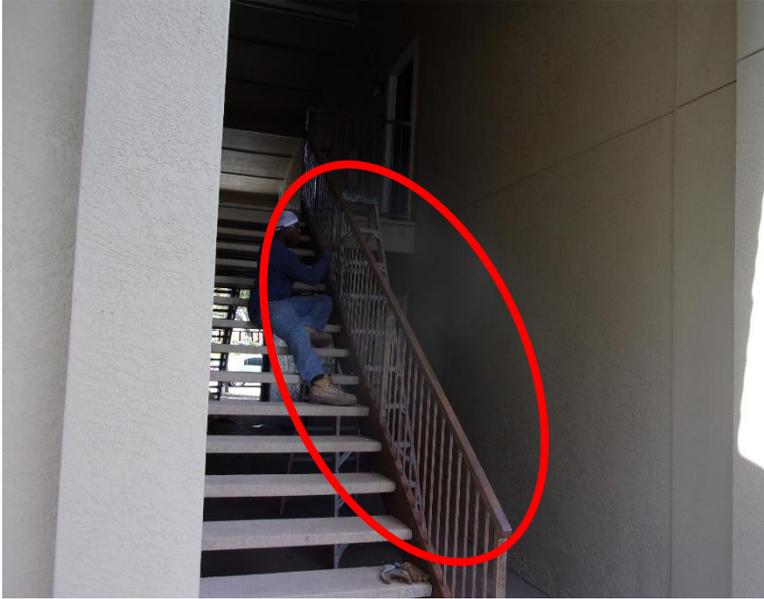
**PHOTOGRAPH #17**

**BUILDING 6  
SECTION E- BREEZEWAY**

Removal of loose paint and rust at  
stairway railing in progress.

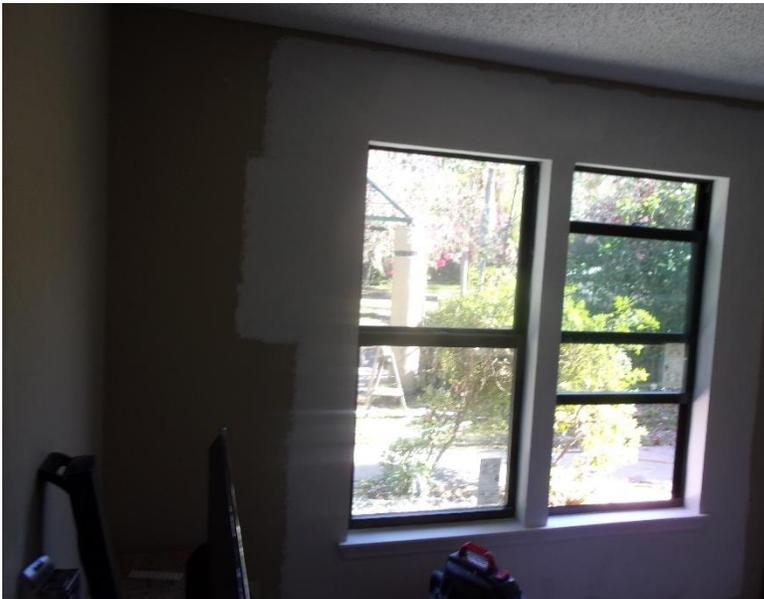
**PHOTOGRAPH #18**

**BUILDING 6  
SECTION G**

**Unit #612-** Drywall taping and finishing in  
progress at new PGT windows.
