PHOTOGRAPHS

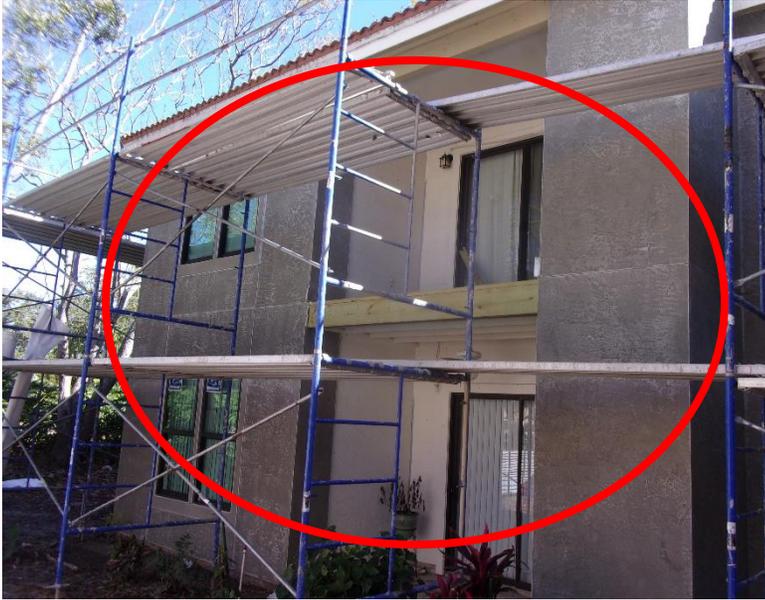
PHOTOGRAPH #1

BUILDING 6 SECTION A

Sub-contractor has applied three coat 7/8" stucco system as per specifications.

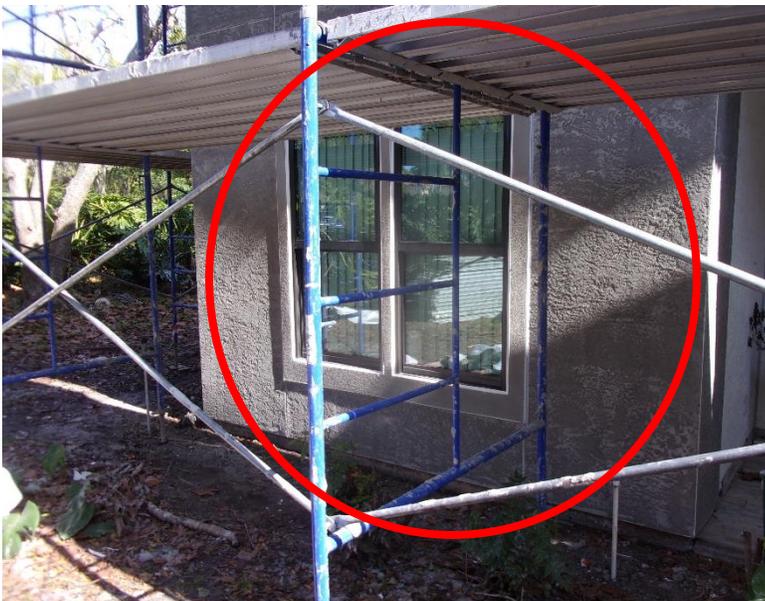
PHOTOGRAPH #2

BUILDING 6 SECTION A

Contractor has begun to apply BASF Masterseal 150 Hybrid sealant at windows.

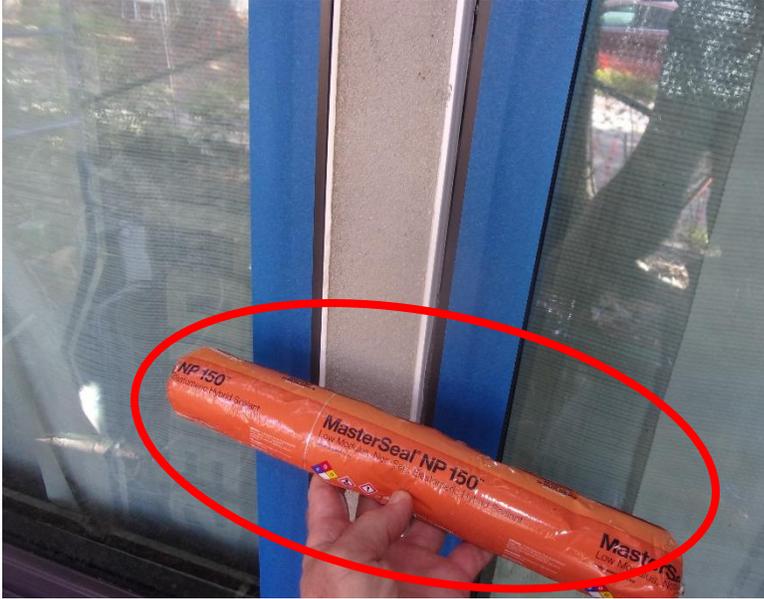
PHOTOGRAPH #3

**BUILDING 6
SECTION A**

Contractor preparing to apply Masterseal NP 150 at wind perimeters.

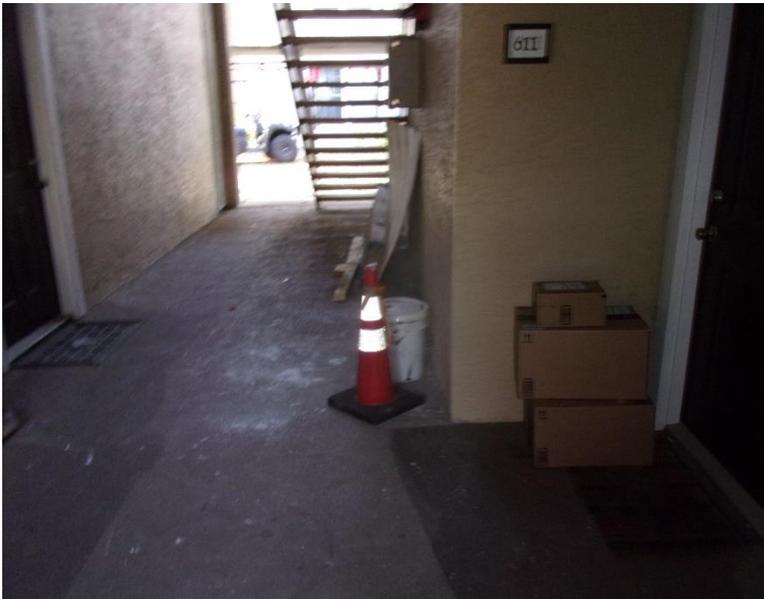
PHOTOGRAPH #4

**BUILDING 6
SECTION A**

Repair materials and equipment moved out of walk path and safety cones placed for pedestrian awareness.

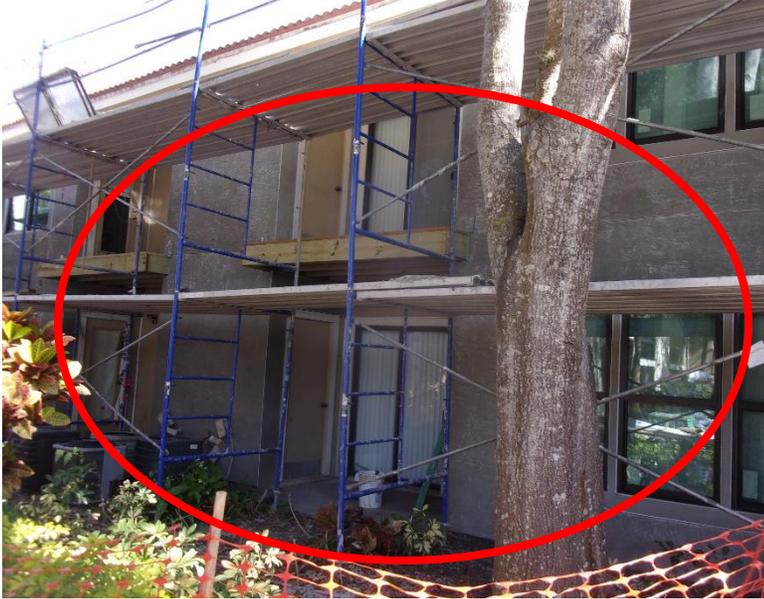
PHOTOGRAPH #5

**BUILDING 6
SECTION B**

Sub-contractor has applied three coat 7/8" stucco system as per specifications.

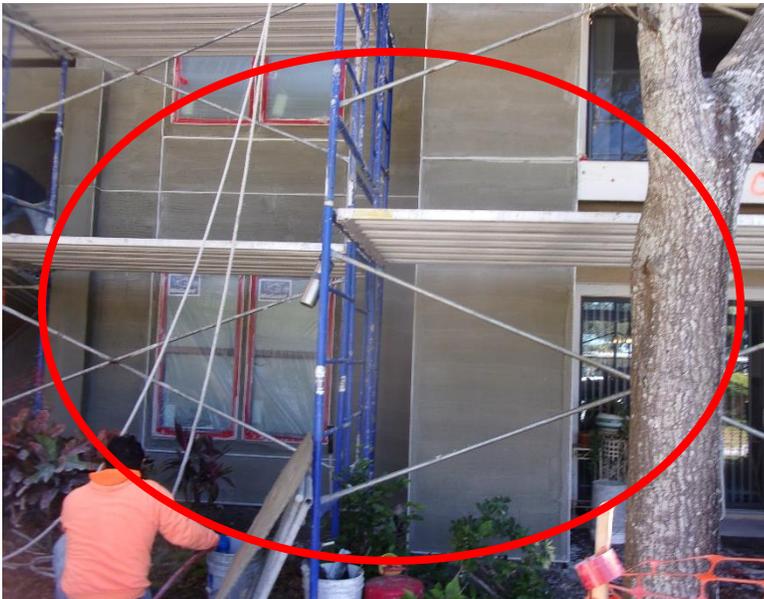
PHOTOGRAPH #6

**BUILDING 6
SECTION C**

Sub-contractor has protected windows and applied scratch coat of stucco as per specifications.

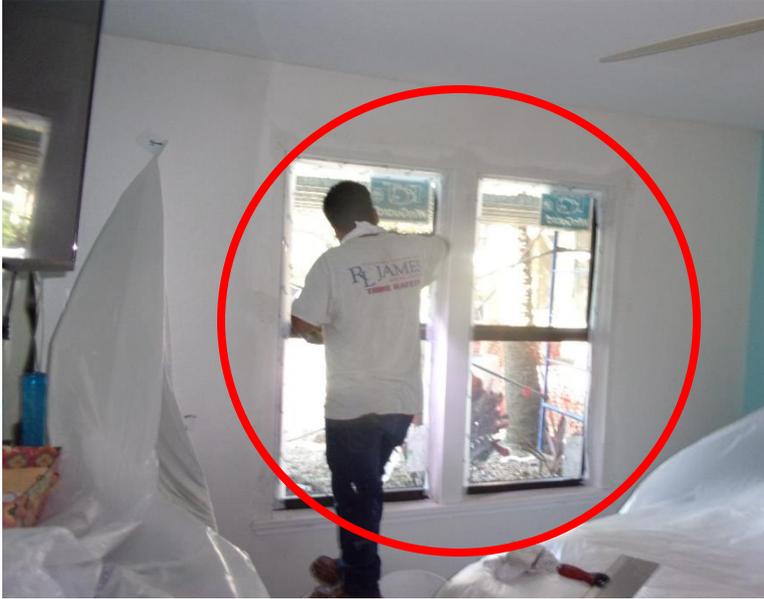
PHOTOGRAPH #7

**BUILDING 6
SECTION C**

Unit #617- Drywall repairs and texture in progress at new windows.

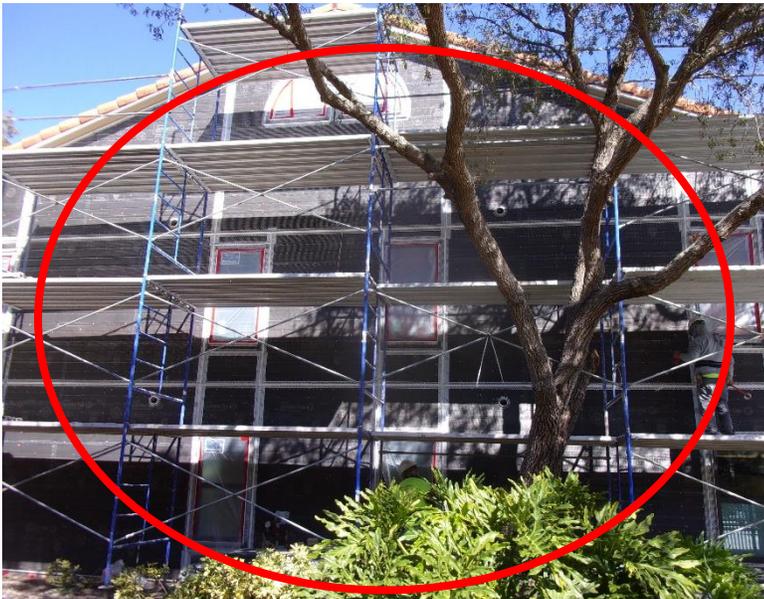
PHOTOGRAPH #8

**BUILDING 6
SECTION D**

Sub-contractor has installed vinyl stucco accessories and metal lathing for application of new stucco.

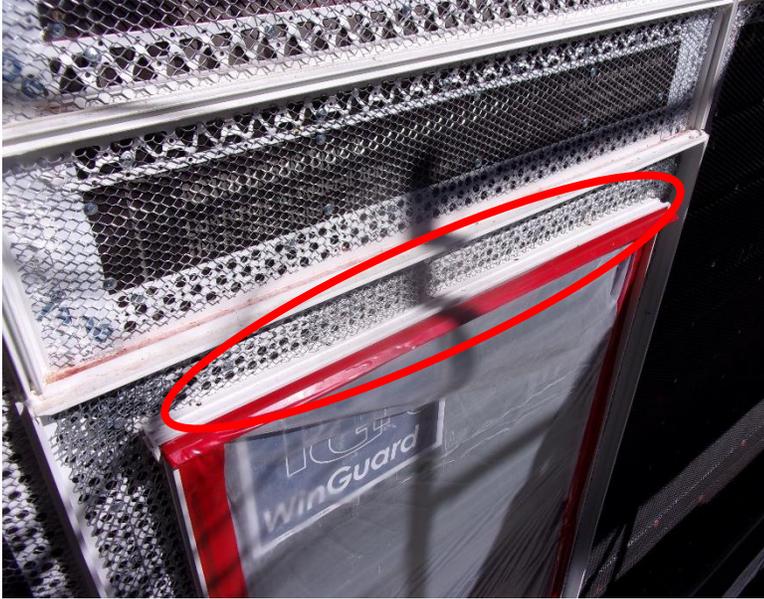
PHOTOGRAPH #9

**BUILDING 6
SECTION D**

Stucco accessories at head of new windows provides weep screed holes through stucco stop as per drawings and specifications.

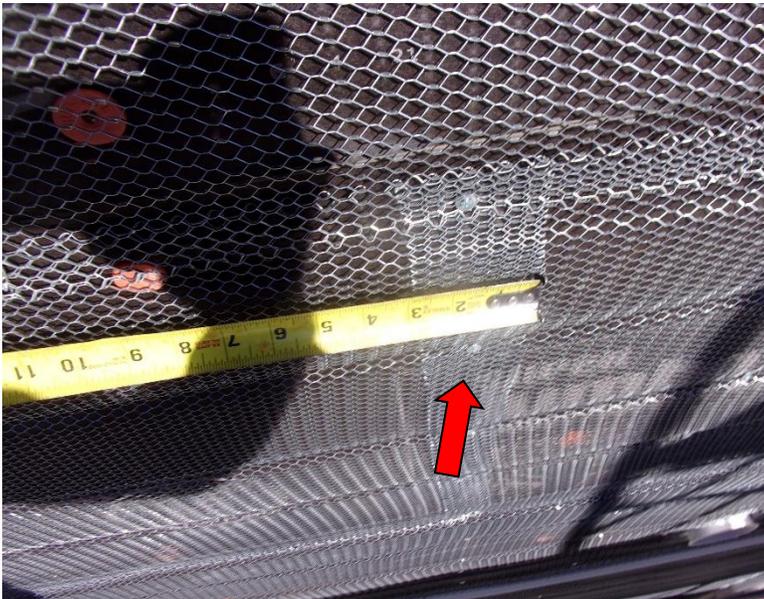
PHOTOGRAPH #10

**BUILDING 6
SECTION D**

Metal lathing overlaps meet minimum requirements per ASTM and PM specifications.

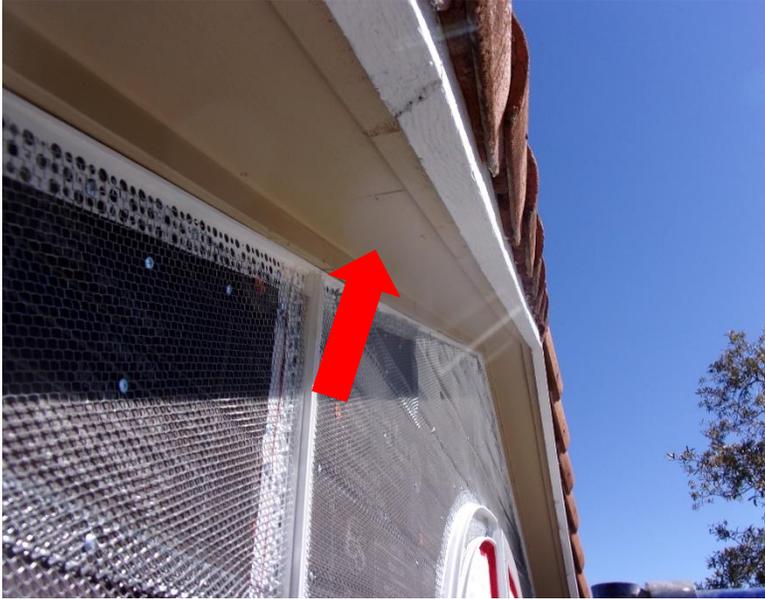
PHOTOGRAPH #11

**BUILDING 6
SECTION D**

New wood soffit at gable end wall installed and painted prior to application of new stucco.

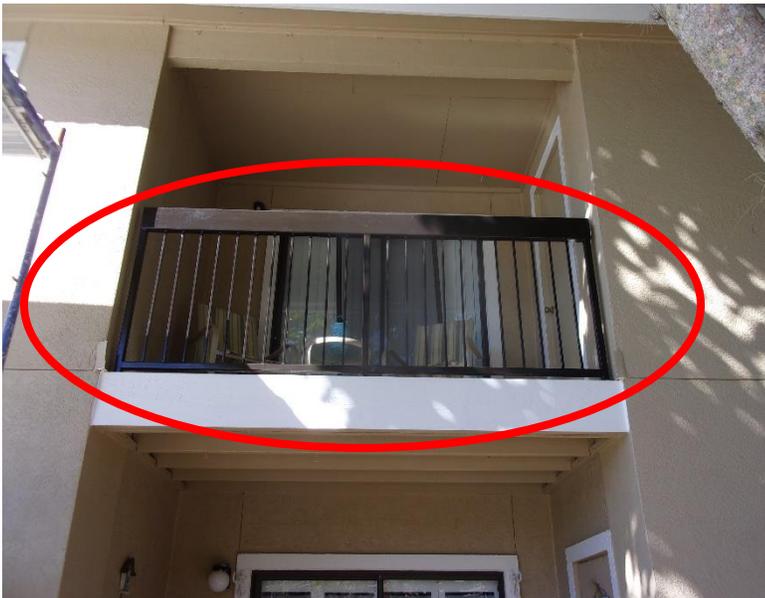
PHOTOGRAPH #12

**BUILDING 6
SECTION E**

Steel balcony railings have been repainted and re attached to balcony built up beams with 3/8" x 4" galvanized lag screws.

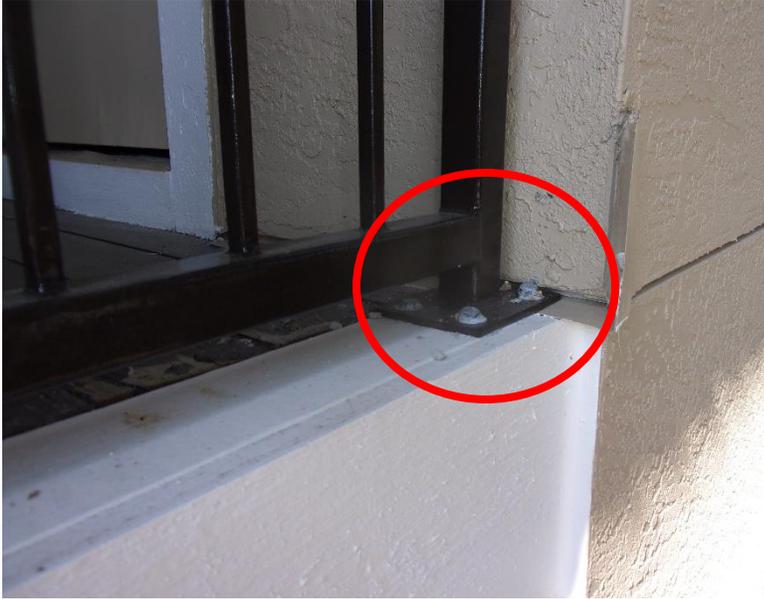
PHOTOGRAPH #13

**BUILDING 6
SECTION E**

Steel balcony railings have been repainted and re attached to balcony built up beams with 3/8" x 4" galvanized lag screw.

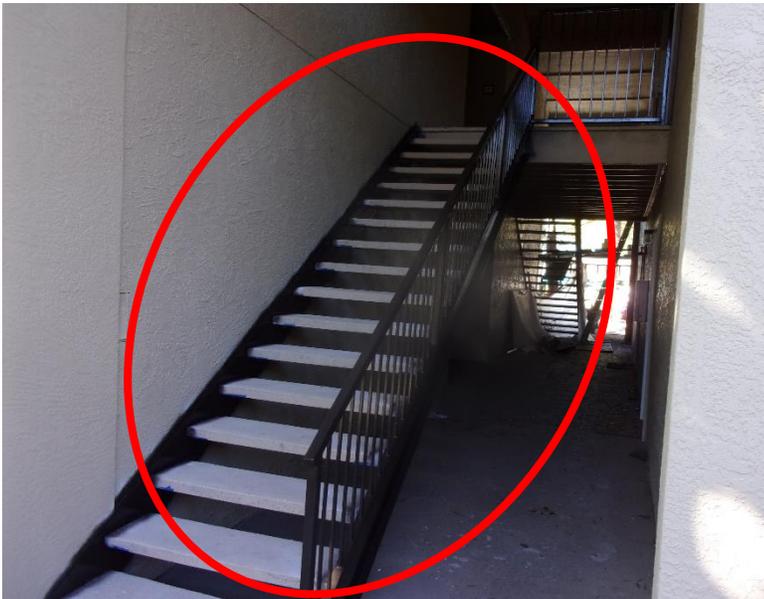
PHOTOGRAPH #14

**BUILDING 6
SECTION E**

Stairway railing finish coated with Florida Paints High-Performance two-part urethane enamel.

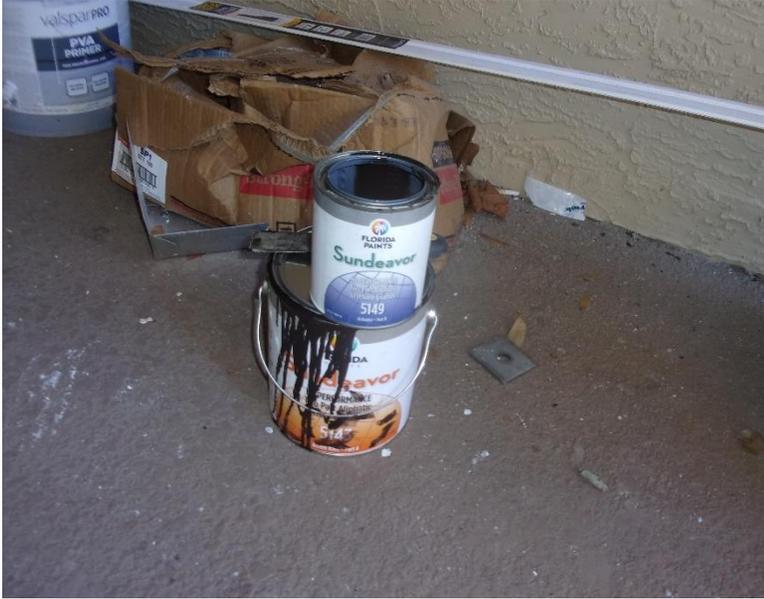
PHOTOGRAPH #15

**BUILDING 6
SECTION E**

Stairway railing finish coated with Florida Paints High-Performance two-part urethane enamel.

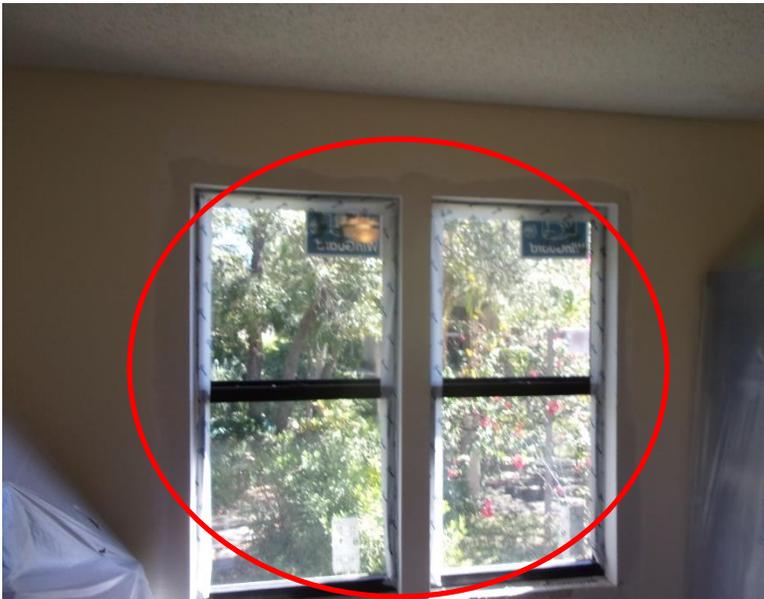
PHOTOGRAPH #16

**BUILDING 6
SECTION G**

Unit #624- Interior sealant detail and drywall repairs in progress at new windows.

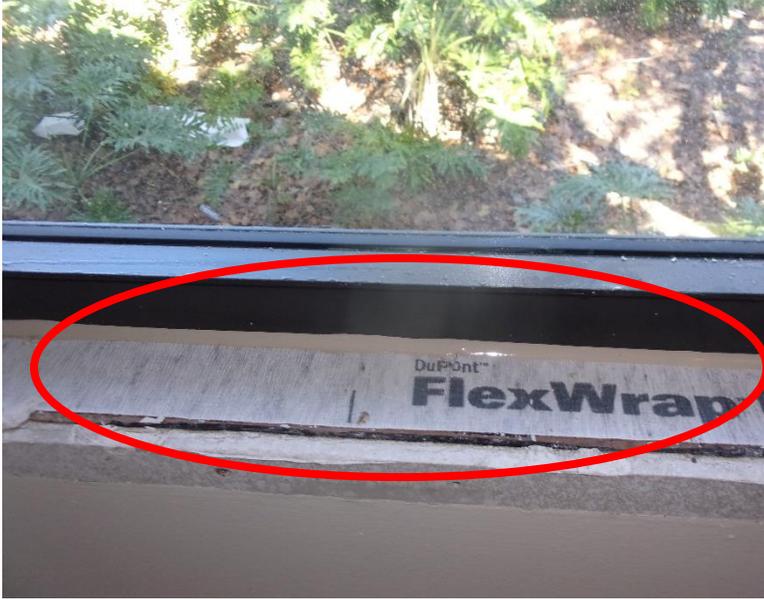
PHOTOGRAPH #17

**BUILDING 6
SECTION G**

Unit #624- Interior sealant applied from new window to Dupont FlexWrap as per drawings and manufacturers requirements.
