PHOTOGRAPHS

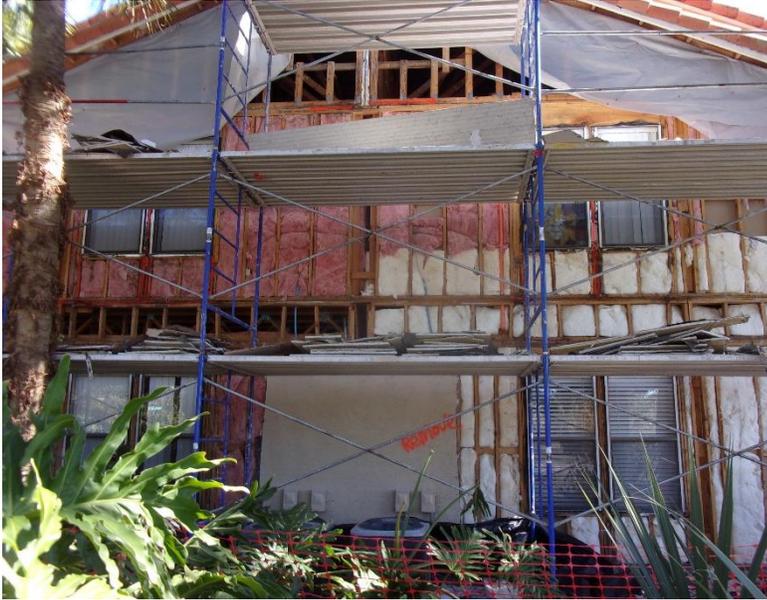
PHOTOGRAPH #1

BUILDING 7 SECTION H

Exterior walls removed for inspection and marking of wood repairs required.

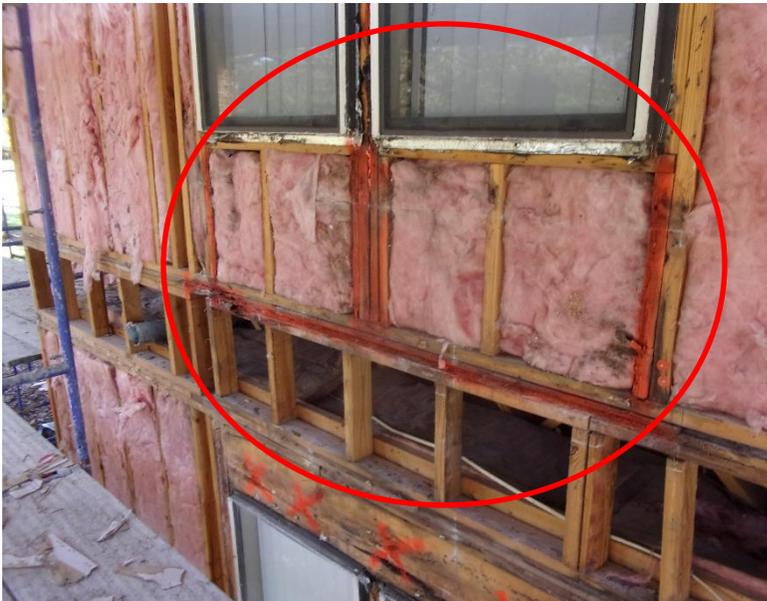
PHOTOGRAPH #2

BUILDING 7 SECTION H

Damaged framing marked for repairs at window framing, jacks, and plates.

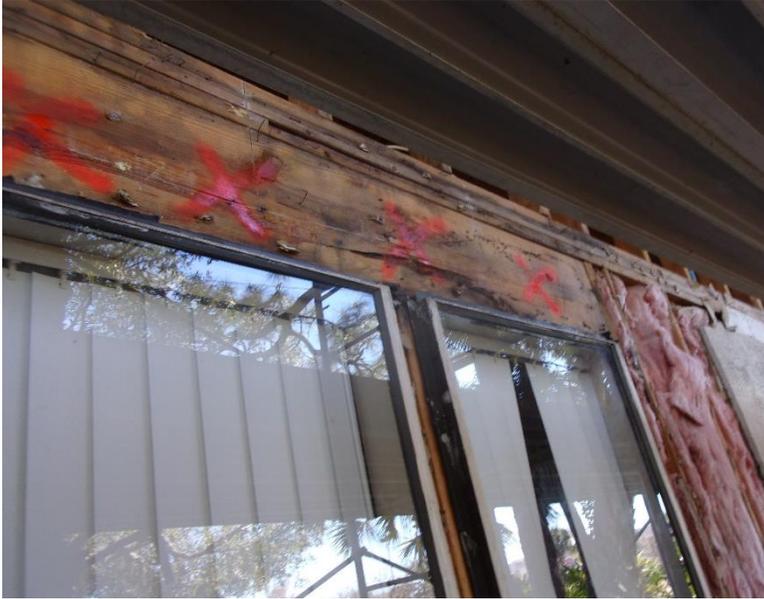
PHOTOGRAPH #3

**BUILDING 7
SECTION H**

Damaged double window headers marked for replacement.

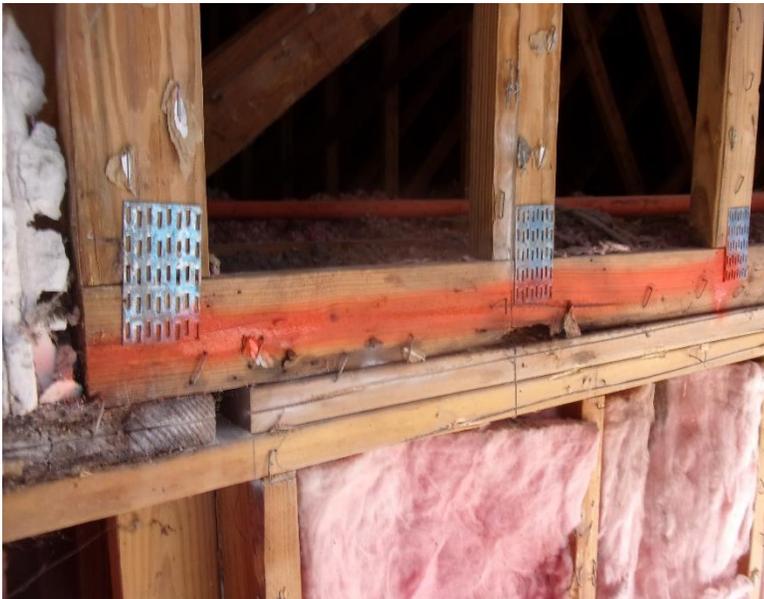
PHOTOGRAPH #4

**BUILDING 7
SECTION H**

Damaged roof truss marked for repair at gable end wall.

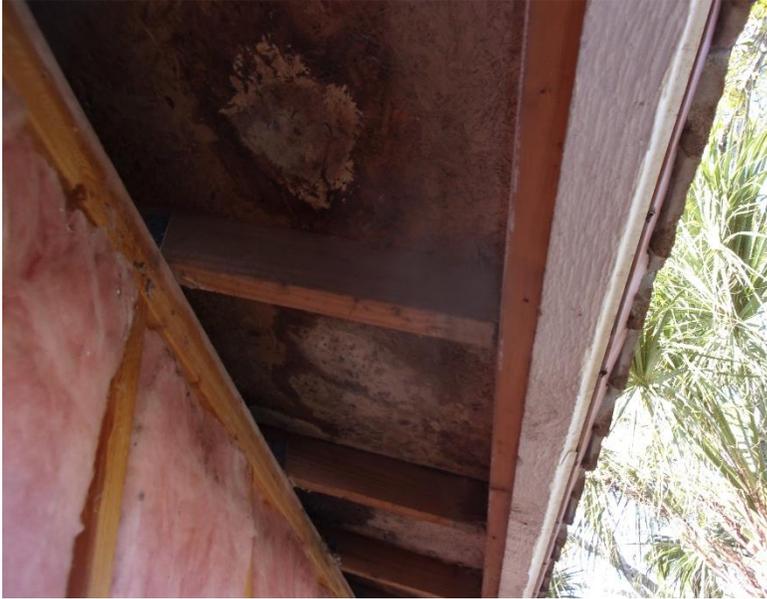
PHOTOGRAPH #5

**BUILDING 7
SECTION H**

Previous and current leaks have damaged roof sheathing. Owners to have repairs done by others.

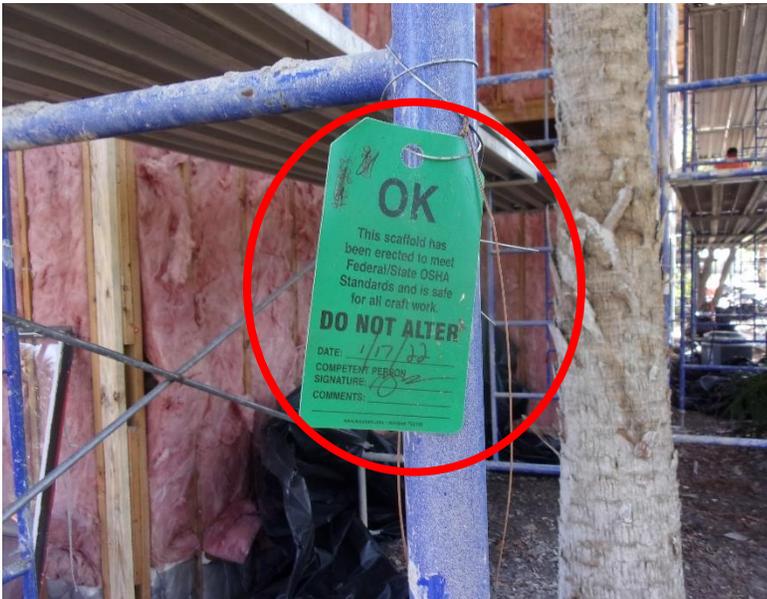
PHOTOGRAPH #6

**BUILDING 7
SECTION H**

Contractor's erection and inspection tag (requiring inspection and competent persons approval before scaffolding is use) is in place.

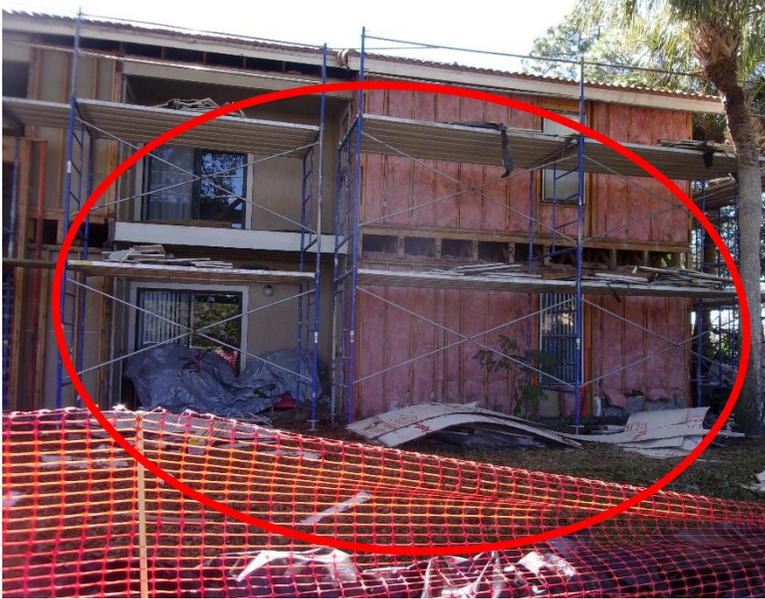
PHOTOGRAPH #7

**BUILDING 7
SECTION G**

Exterior walls removed for inspection and marking of wood repairs required.

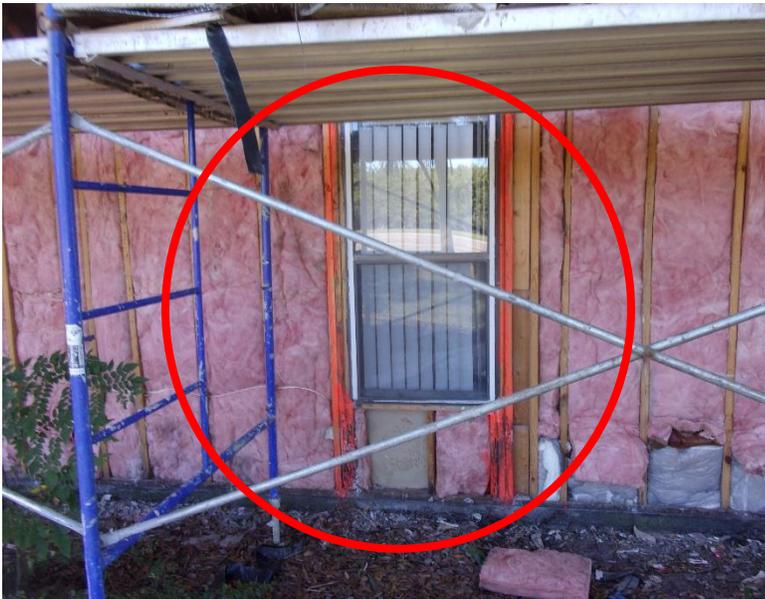
PHOTOGRAPH #8

**BUILDING 7
SECTION G**

Damaged framing marked for repairs at window framing and jacks.

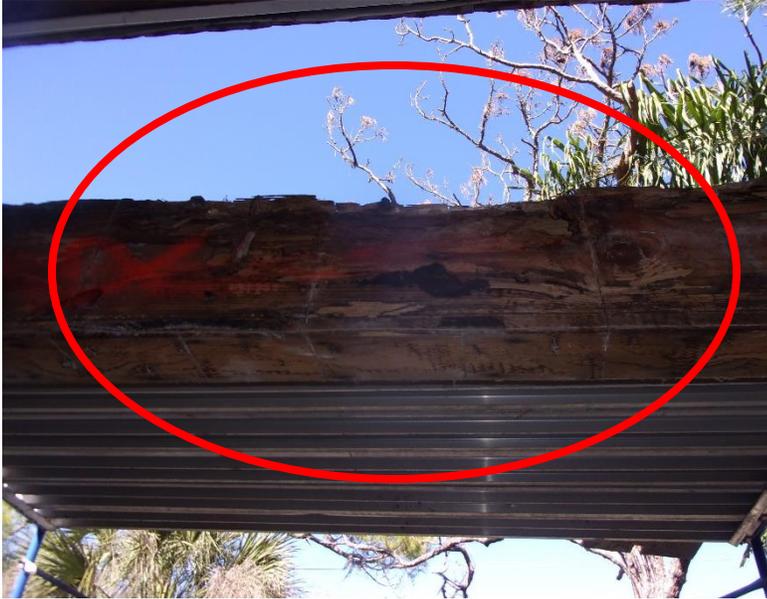
PHOTOGRAPH #9

**BUILDING 7
SECTION G**

Breezeway beam damaged by wood rot and termites marked for replacement.

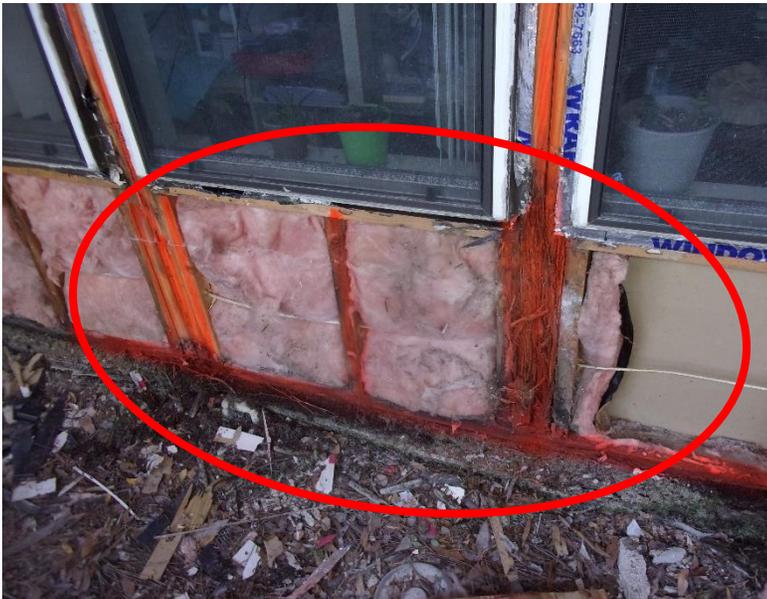
PHOTOGRAPH #10

**BUILDING 7
SECTION F**

Damaged framing marked for repairs at window framing, jacks, and plates.

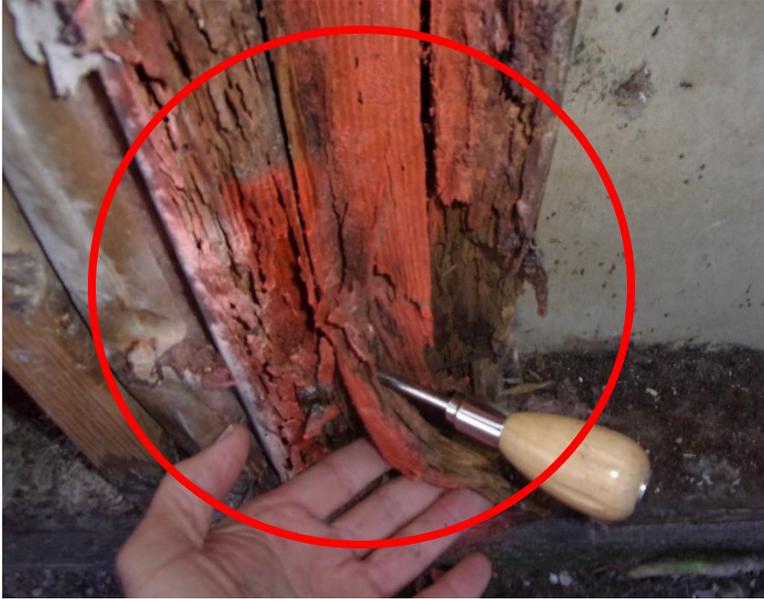
PHOTOGRAPH #11

**BUILDING 7
SECTION F**

Wood framing studs damaged by wood rot and termites marked for replacement.

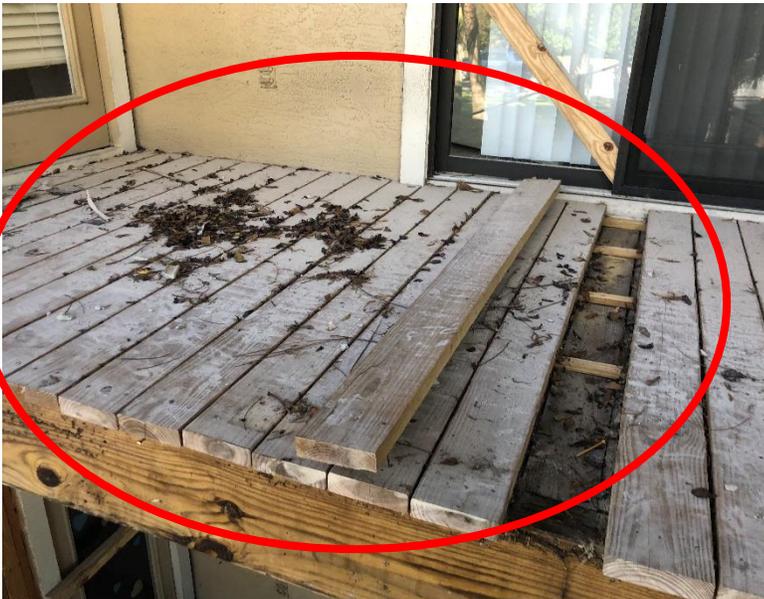
PHOTOGRAPH #12

**BUILDING 7
SECTION F**

Unit #726- Owners have covered wood decking at balcony with additional decking.

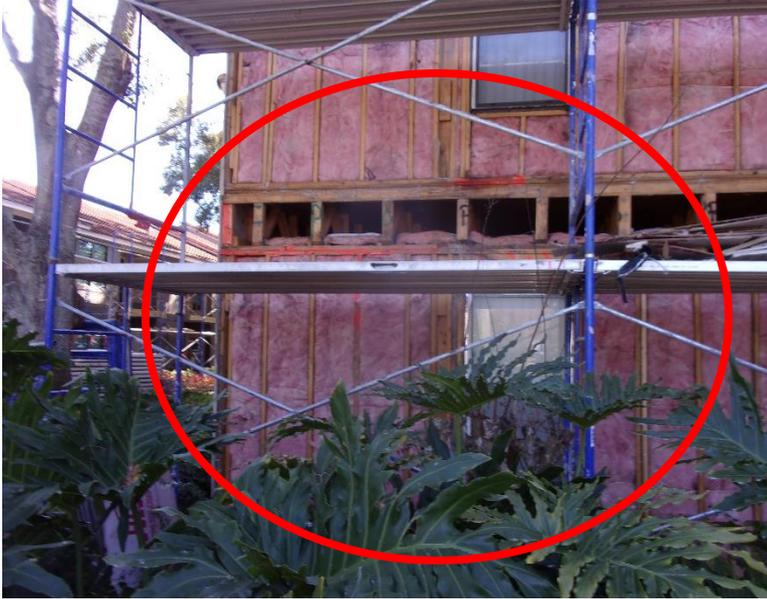
PHOTOGRAPH #13

**BUILDING 7
SECTION E**

Exterior walls removed for inspection and marking of wood repairs required.

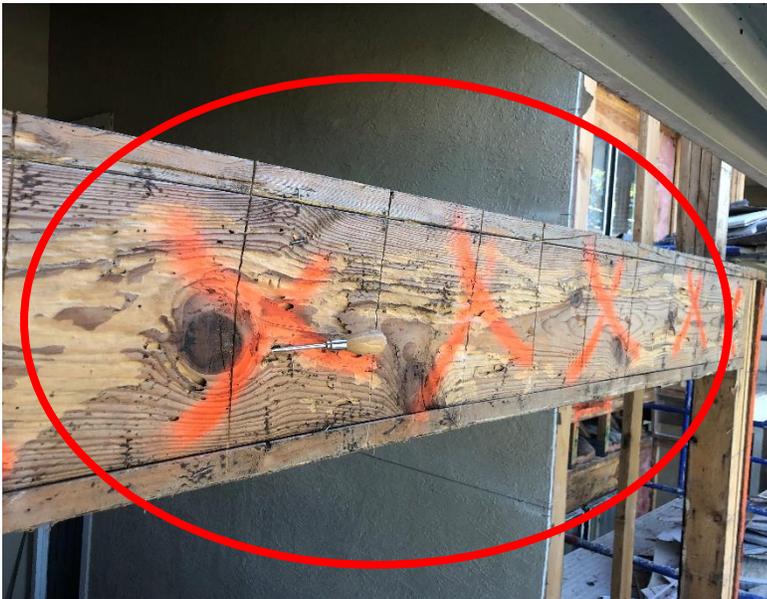
PHOTOGRAPH #14

**BUILDING 7
SECTION E**

Breezeway beam damaged termites marked for replacement.

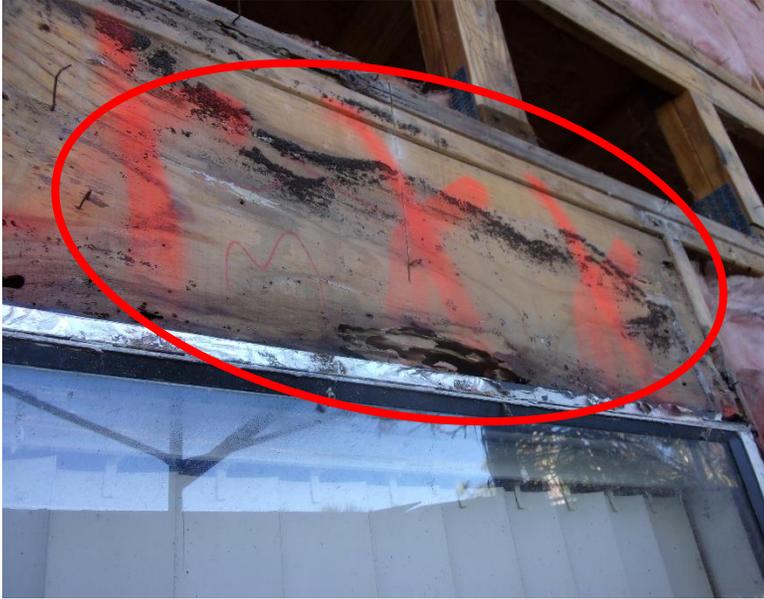
PHOTOGRAPH #15

**BUILDING 7
SECTION E**

Damaged single window header marked for replacement.
