**PHOTOGRAPHS**

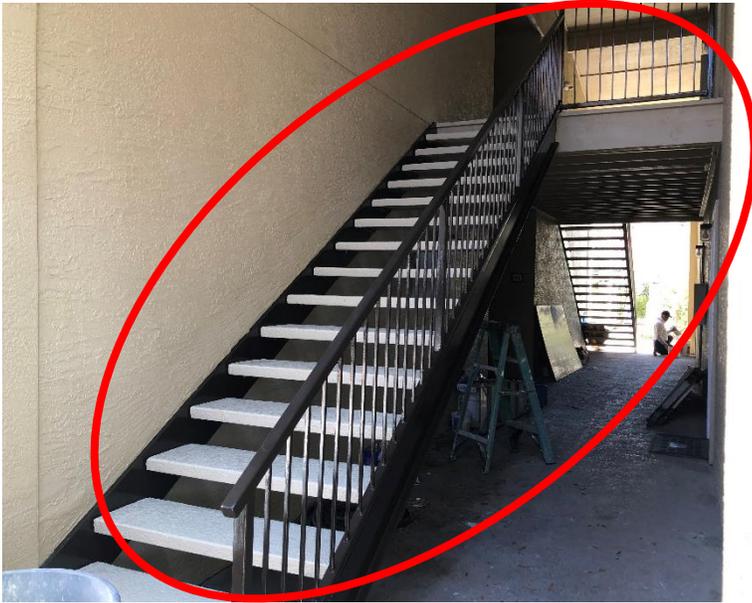
**PHOTOGRAPH #1**

**BUILDING 6  
SECTION A**

Breezeway Railings primed and finish painted. Contractor touched up paint on walls from Breezeway Railings paint overspray. (Typical all Breezeways)

Breezeway Stair Treads finish painted with Florida Paints TropiCrete (6920).

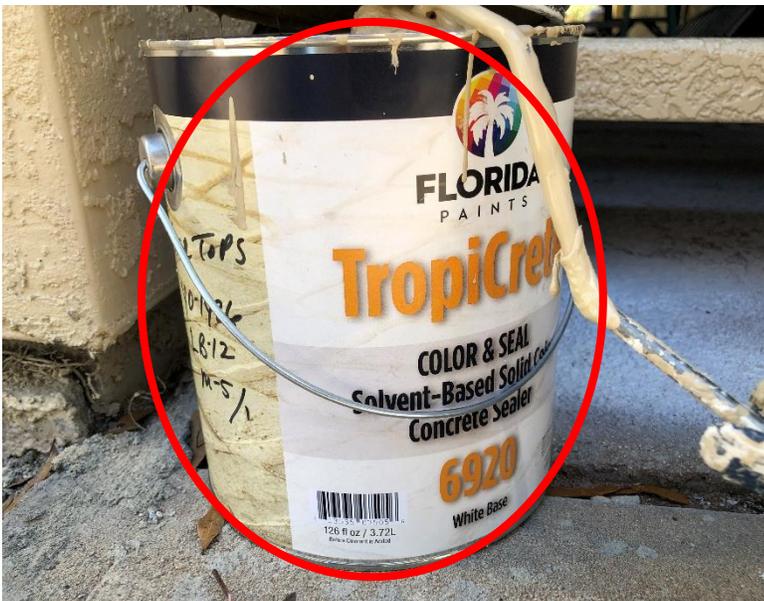
**PHOTOGRAPH #2**

**BUILDING 6  
SECTION A**

Breezeway Stair Treads finish painted with Florida Paints TropiCrete (6920).

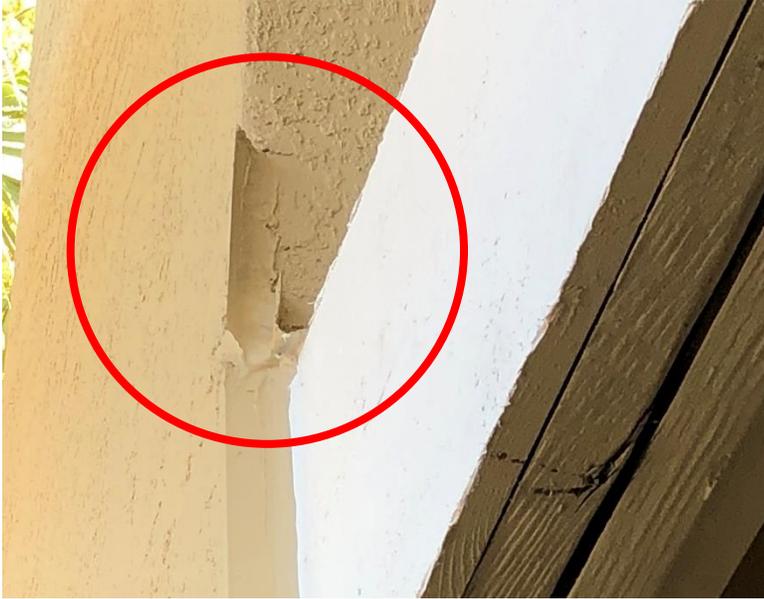
**PHOTOGRAPH #3**

**BUILDING 6  
SECTION A**

Kickout-Flashing for 2<sup>nd</sup> Story Balcony is not lapped correctly, and needs resealed for proper installation (typical item).

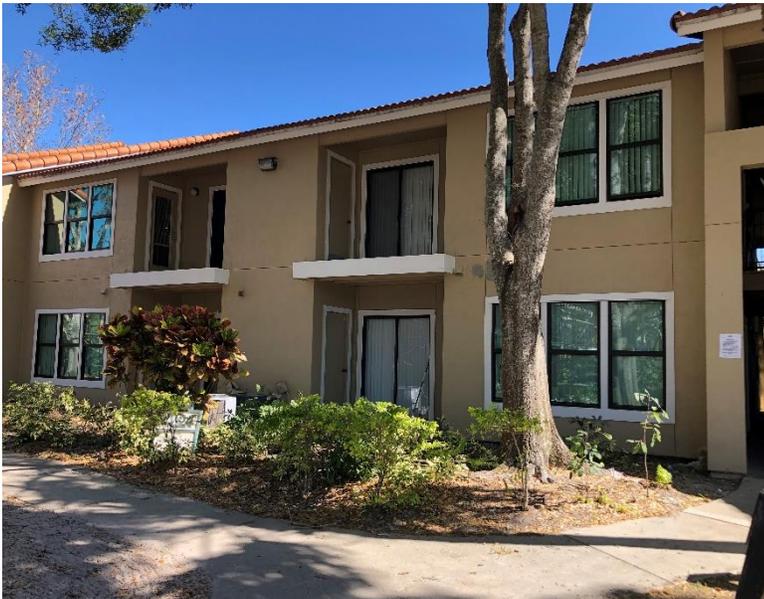
**PHOTOGRAPH #4**

**BUILDING 6  
SECTION B**

New stucco finish painted with Florida Paints Ultra Exterior SuperCoat 100% Acrylic paint and scaffolding removed.

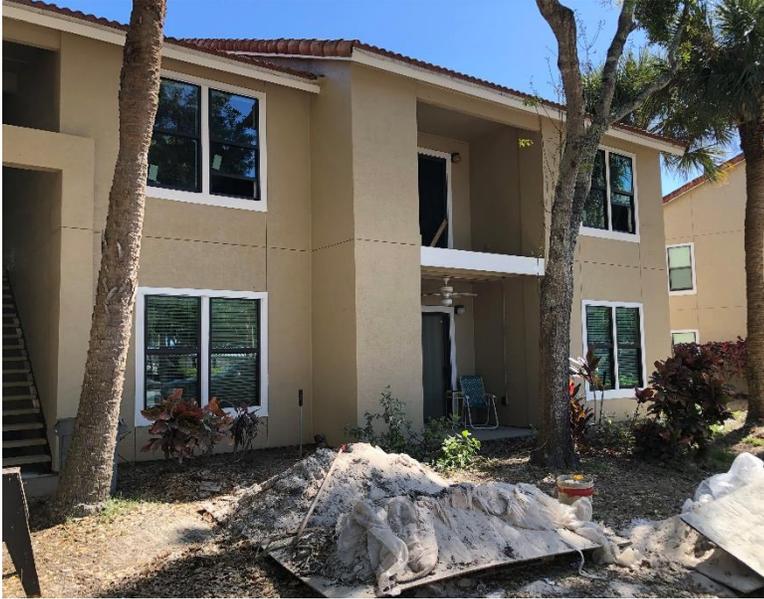
**PHOTOGRAPH #5**

**BUILDING 6  
SECTION C**

New stucco finish painted with Florida Paints Ultra Exterior SuperCoat 100% Acrylic paint and scaffolding removed.

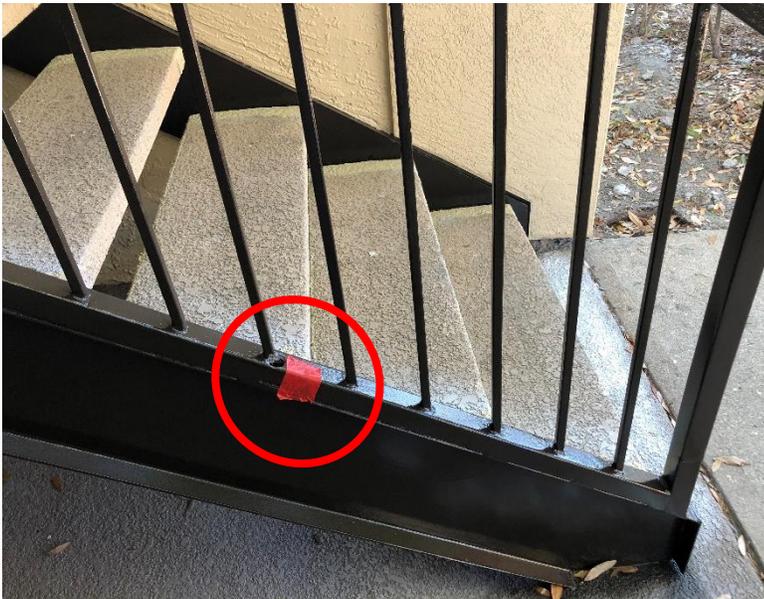
**PHOTOGRAPH #6**

**BUILDING 6  
SECTION C**

Contractor to properly repair (by welding repair) damaged stairway stringer location at Breezeway Railing.

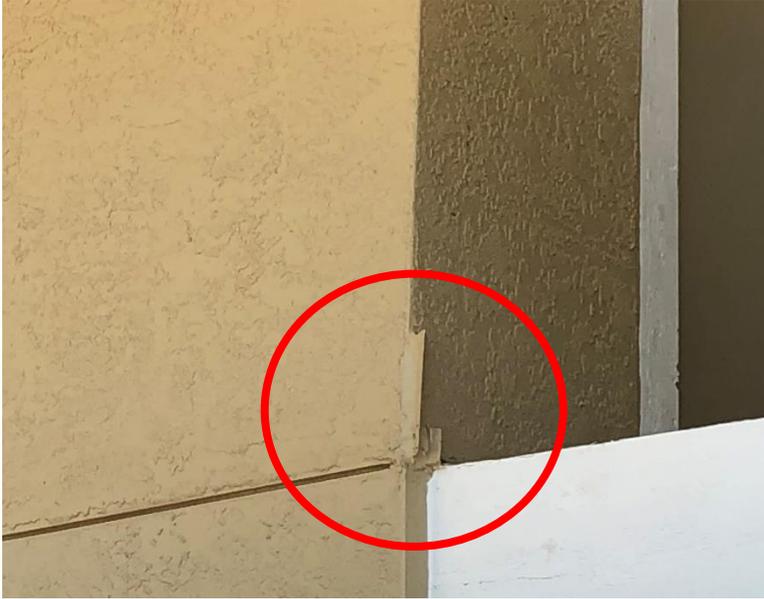
**PHOTOGRAPH #7**

**BUILDING 6  
SECTION C**

Kickout-Flashing for 2<sup>nd</sup> Story Balcony is not lapped correctly, and needs resealed for proper installation (typical item).

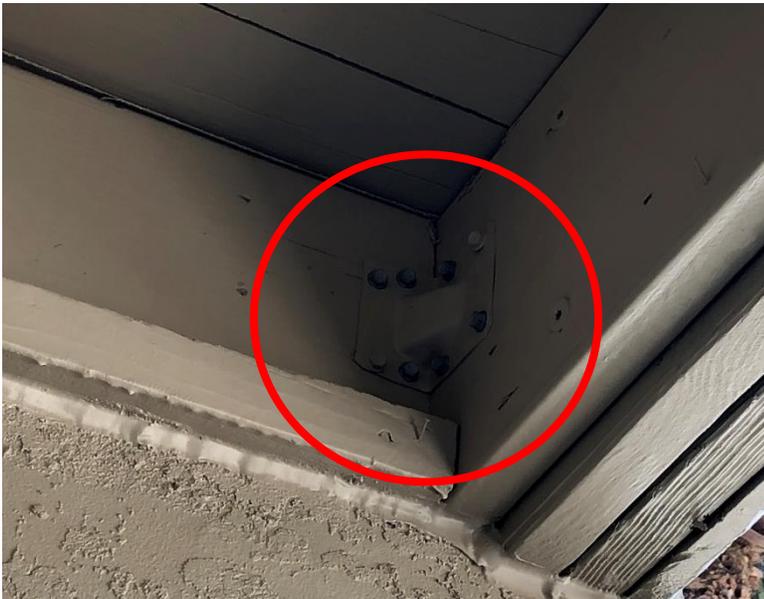
**PHOTOGRAPH #8**

**BUILDING 6  
SECTION C**

Contractor installed missing Bracket Fasteners under the 2<sup>nd</sup> Story Balcony Deck.

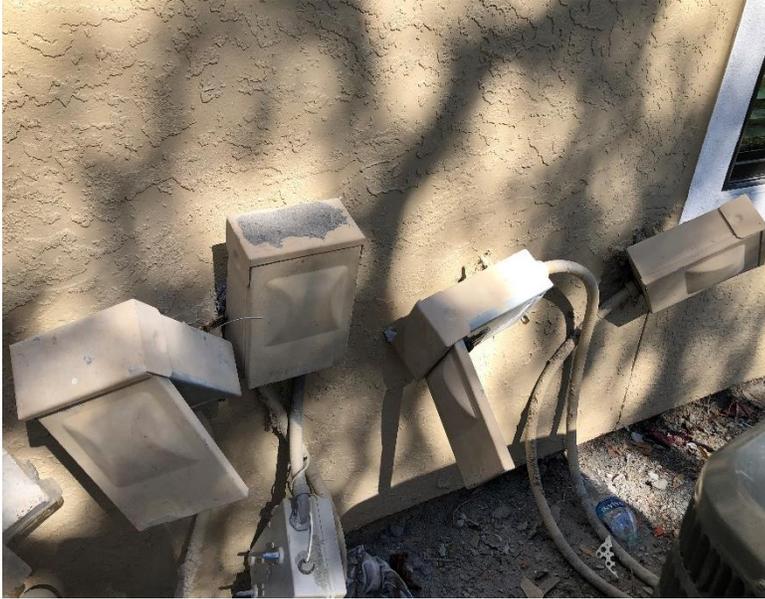
**PHOTOGRAPH #9**

**BUILDING 6  
SECTION D**

Electrical Boxes to be fastened to wall and properly sealed.

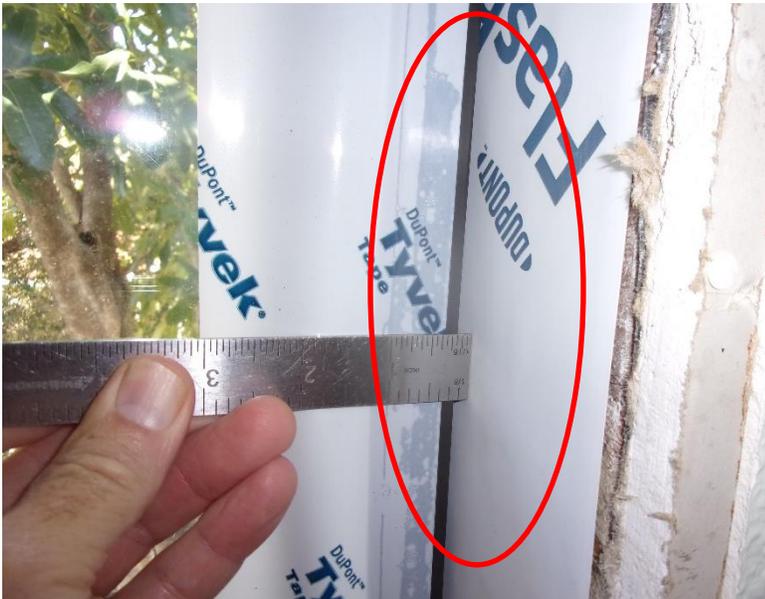
**PHOTOGRAPH #10**

**BUILDING 6  
SECTION E**

**Unit #628** - Window in has less than  $\frac{1}{4}$ " gap around new window frame installation.

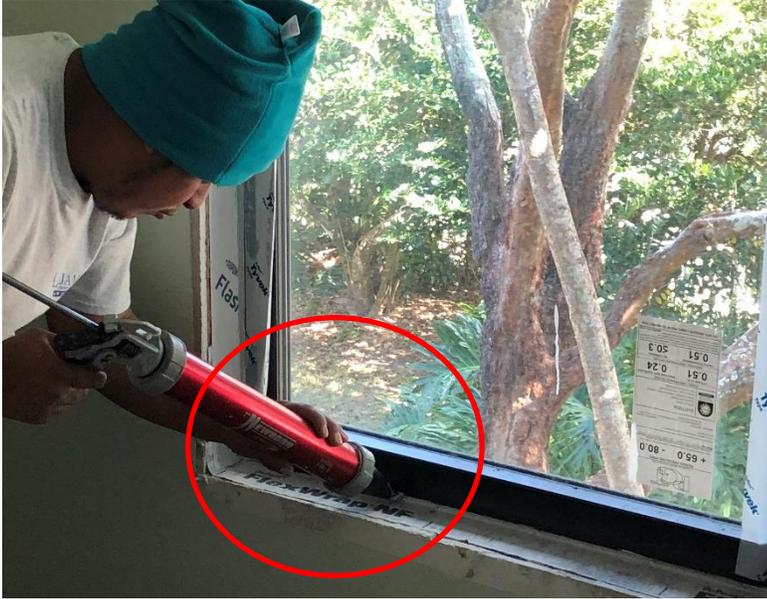
**PHOTOGRAPH #11**

**BUILDING 6  
SECTION E**

**Unit #628** - Contractor installing NP 150 Sealant around the interior perimeter of the new window installation.

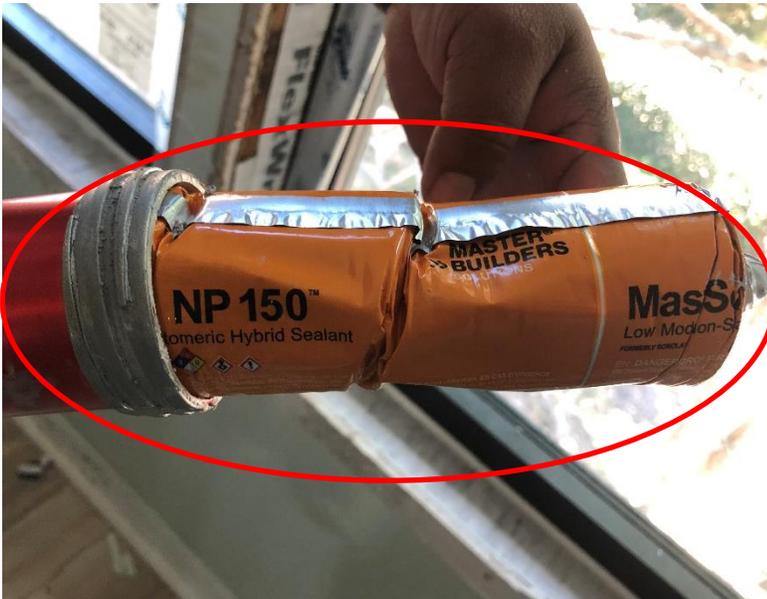
**PHOTOGRAPH #12**

**BUILDING 6  
SECTION E**

**Unit #628** - Contractor installing NP 150 Sealant around the interior perimeter of the new window installation.

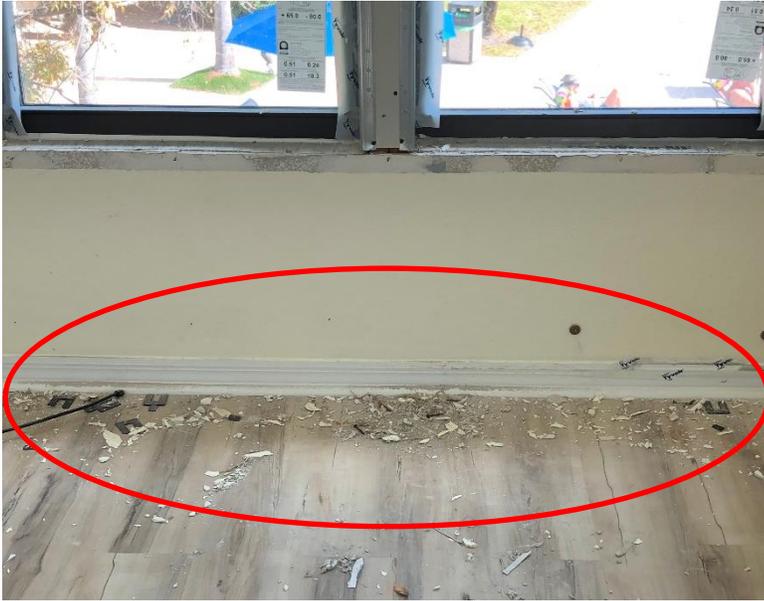
**PHOTOGRAPH #13**

**BUILDING 6  
SECTION E**

**Unit #628** - Contractor to clean up all debris from window installation, and to proactively protect all adjacent existing materials, including flooring (typical item).

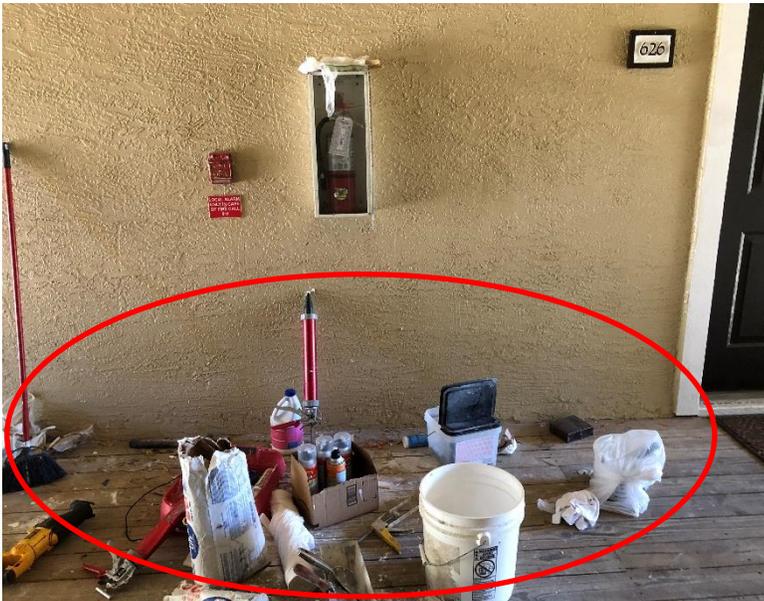
**PHOTOGRAPH #14**

**BUILDING 6  
SECTION E**

Contractor to clean up all debris from construction, and to proactively protect existing materials (typical item).

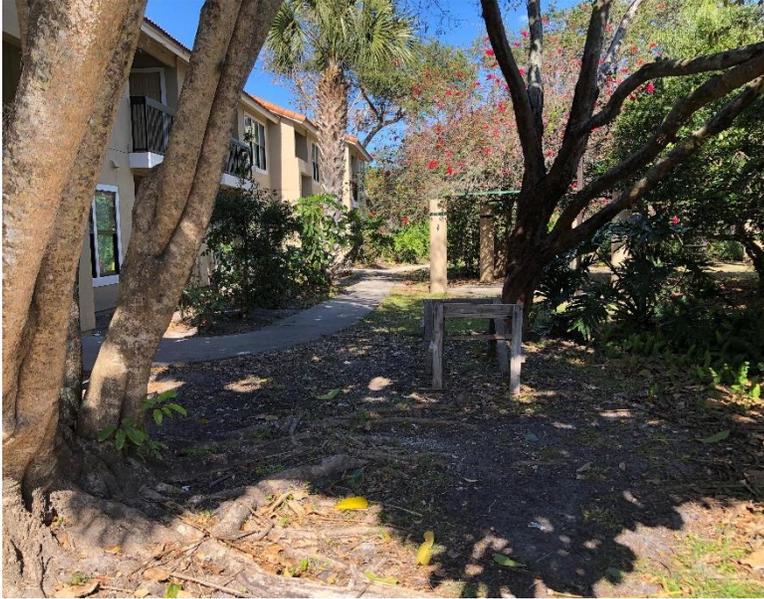
**PHOTOGRAPH #15**

**BUILDING 6  
SECTION F**

Construction area has been cleaned of trash and construction debris.

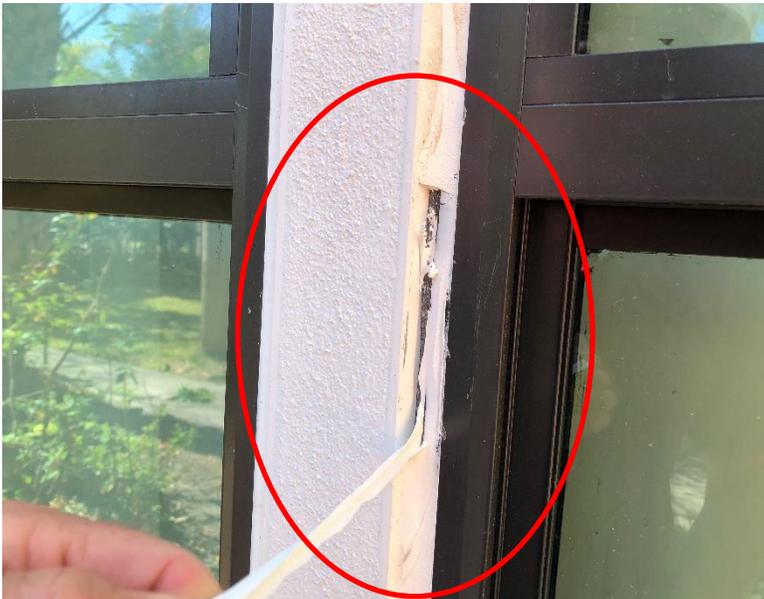
**PHOTOGRAPH #16**

**BUILDING 6  
SECTION F**

Double-Window sealant Pull Test conducted. Sealant performed well passing adhesion test per project manual protocol.

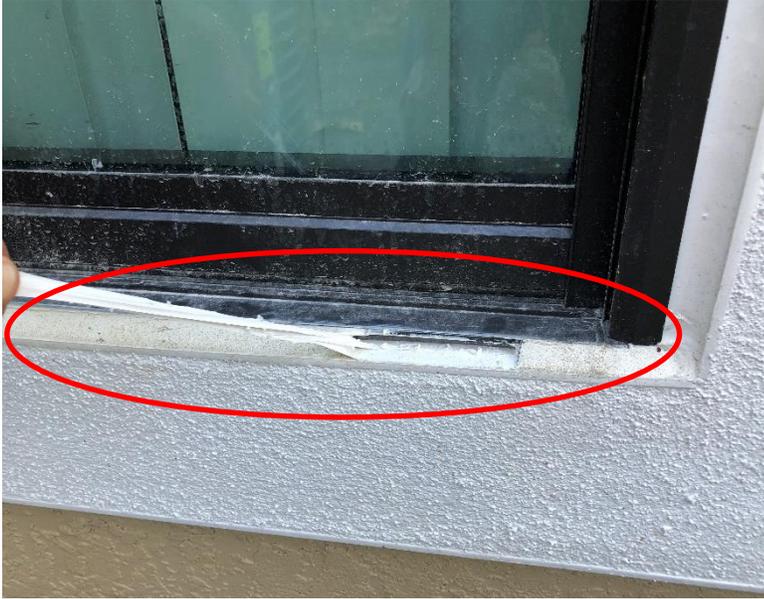
**PHOTOGRAPH #17**

**BUILDING 6  
SECTION H**

Single-Window sealant Pull Test conducted. Sealant performed well passing adhesion test per project manual protocol.
