PHOTOGRAPHS

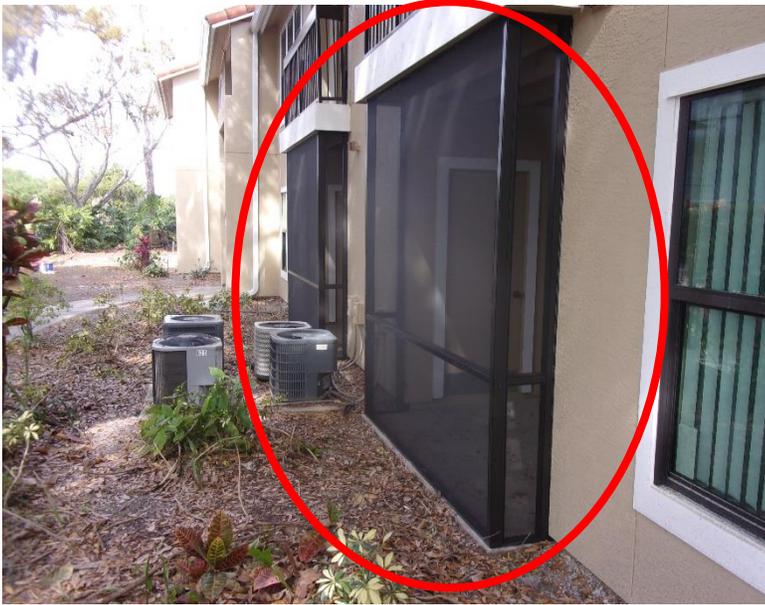
PHOTOGRAPH #1

**BUILDING 6
SECTION F**

Contractor installing new bronze aluminum screen enclosures where previously existed at owner's lanai (typical).

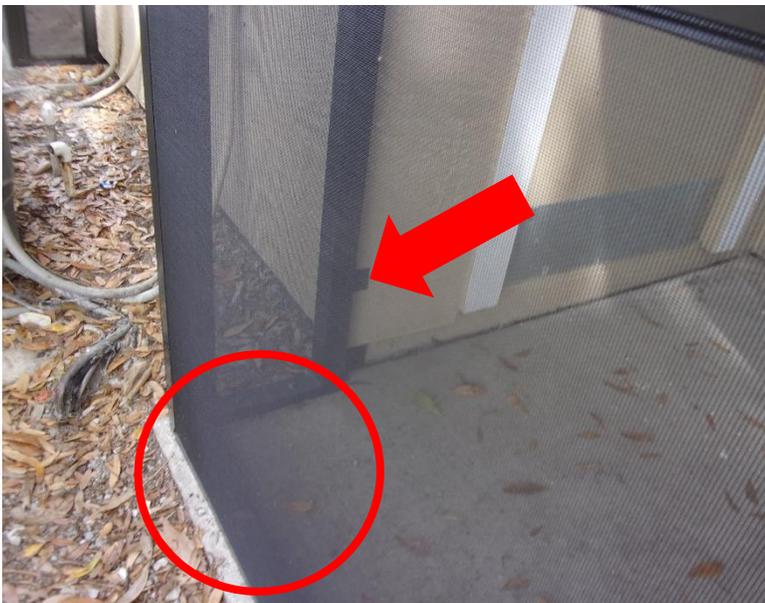
PHOTOGRAPH #2

**BUILDING 6
SECTION F**

New aluminum screen enclosure fastened at concrete slab with stainless steel fasteners and sealed with BASF urethane sealant. Angle bracing attached to framing trough stucco at vertical post (typical).

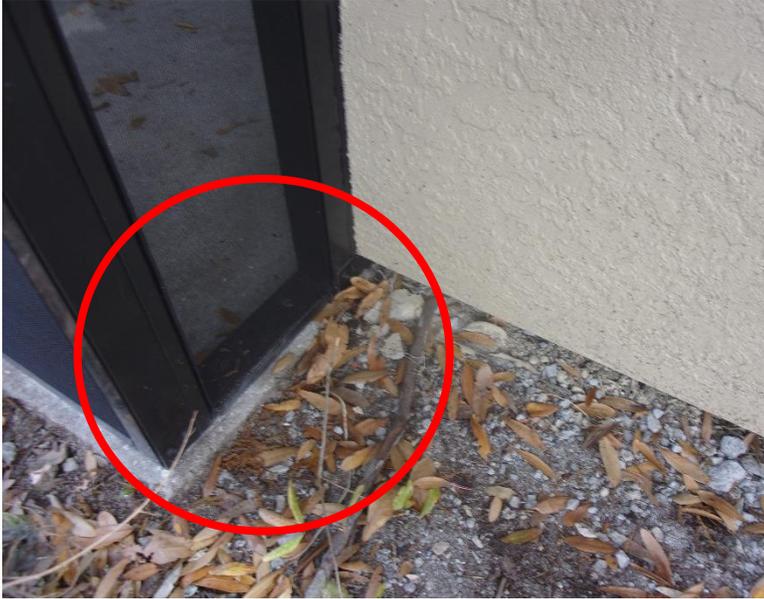
PHOTOGRAPH #3

**BUILDING 6
SECTION F**

New aluminum screen enclosure fastened at concrete slab with stainless steel fasteners and sealed with BASF urethane sealant (typical).

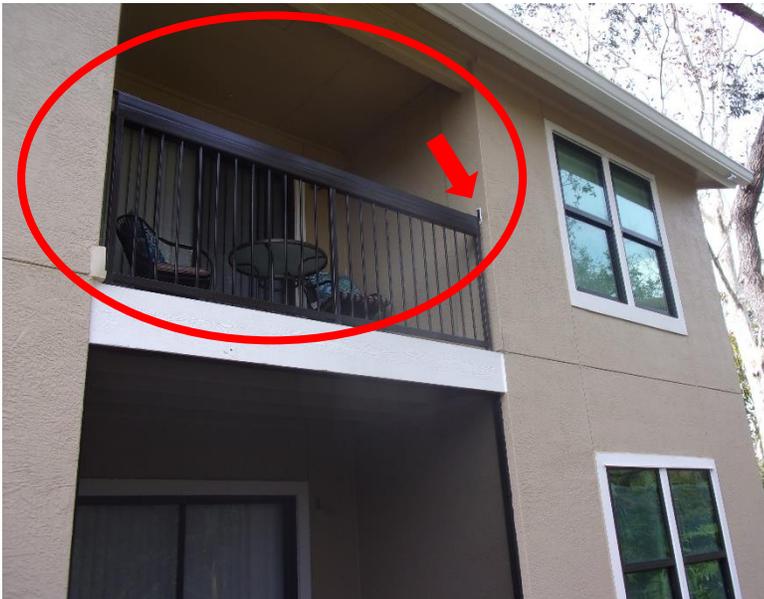
PHOTOGRAPH #4

**BUILDING 6
SECTION G**

Contractor installed brackets to attach balcony railing to walls (typical).

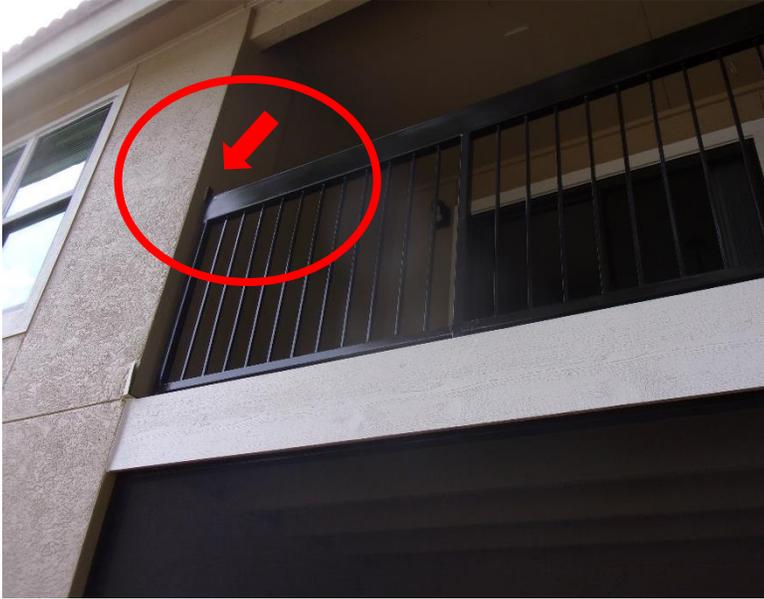
PHOTOGRAPH #5

**BUILDING 6
SECTION G**

Contractor installed brackets to attach balcony railing to walls (typical).

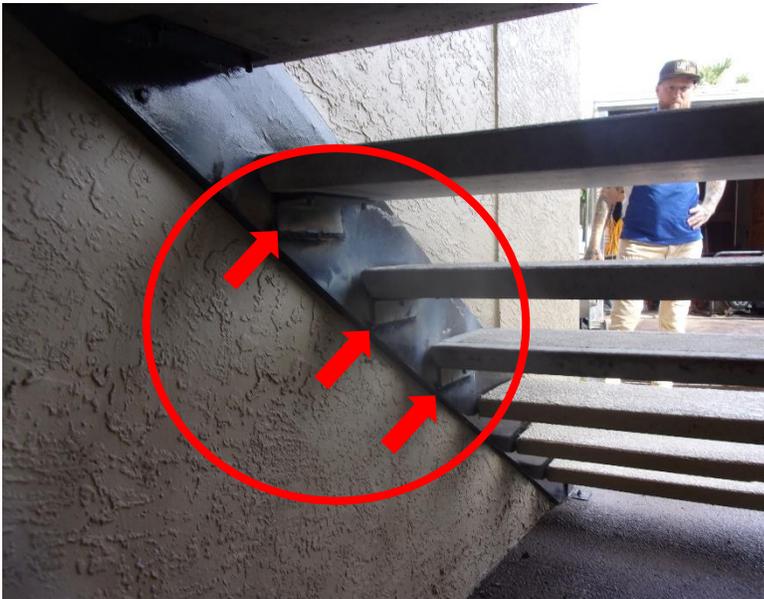
PHOTOGRAPH #6

**BUILDING 3
SECTION C**

Sub-Contractor welding new steel support angle under three new stair pads and marked for repairs.

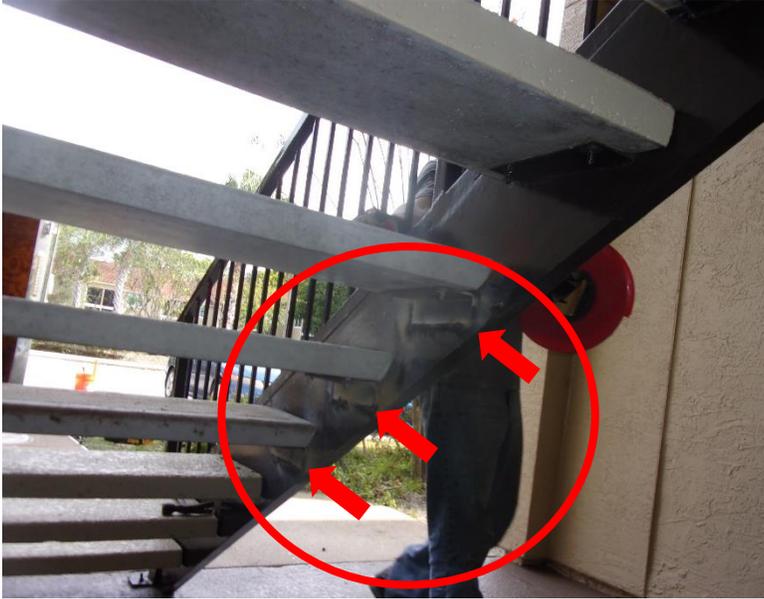
PHOTOGRAPH #7

**BUILDING 3
SECTION C**

Sub-Contractor welding new steel support angle under three new stair pads and marked for repairs.

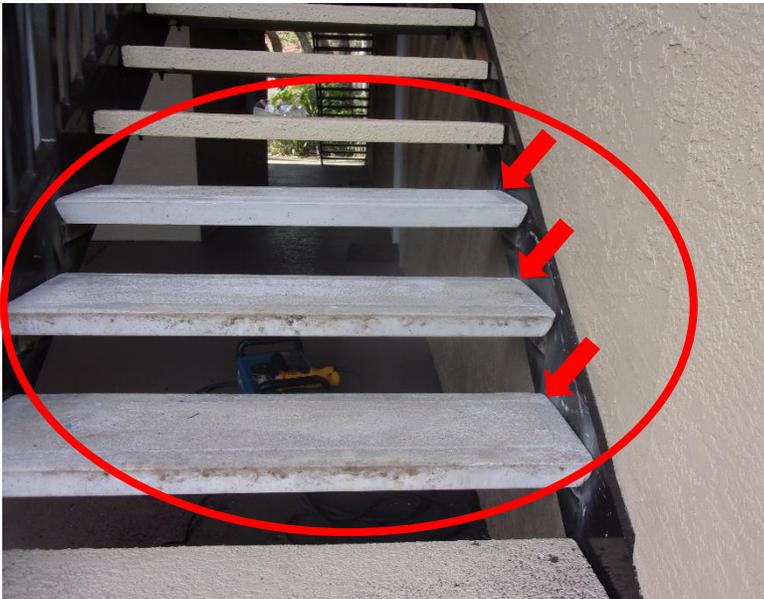
PHOTOGRAPH #8

**BUILDING 3
SECTION C**

Sub-Contractor welding new steel angles support under three new stair pads and marked for repairs.
