PHOTOGRAPHS

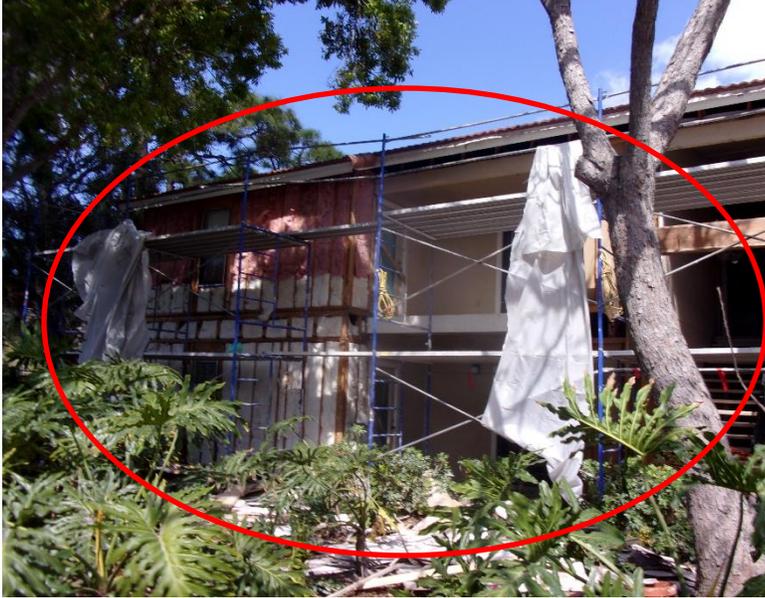
PHOTOGRAPH #1

BUILDING 7 SECTION A

Delta inspected wood framing conditions and marked for repairs.

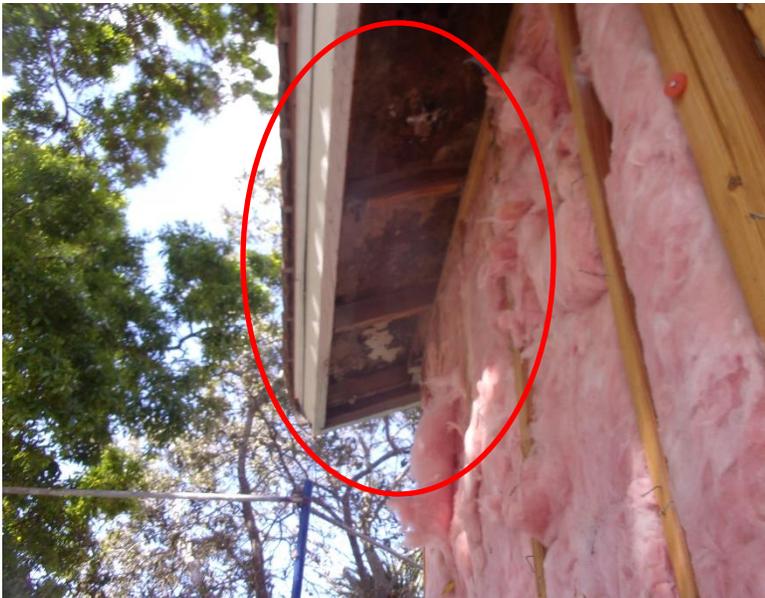
PHOTOGRAPH #2

BUILDING 7 SECTION A

Previous and current leaks have damaged roof sheathing. Owners to have repairs done by others.

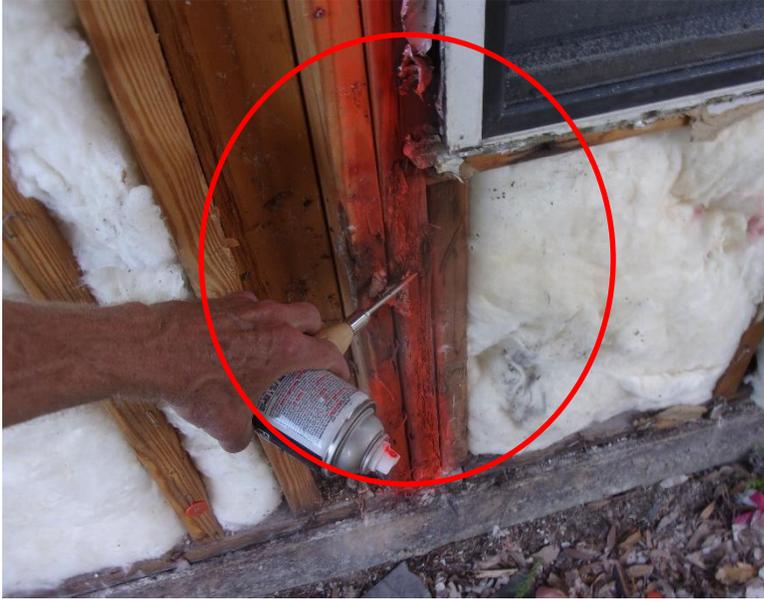
PHOTOGRAPH #3

**BUILDING 7
SECTION A**

Damage at lower window framing and jacks marked for repairs.

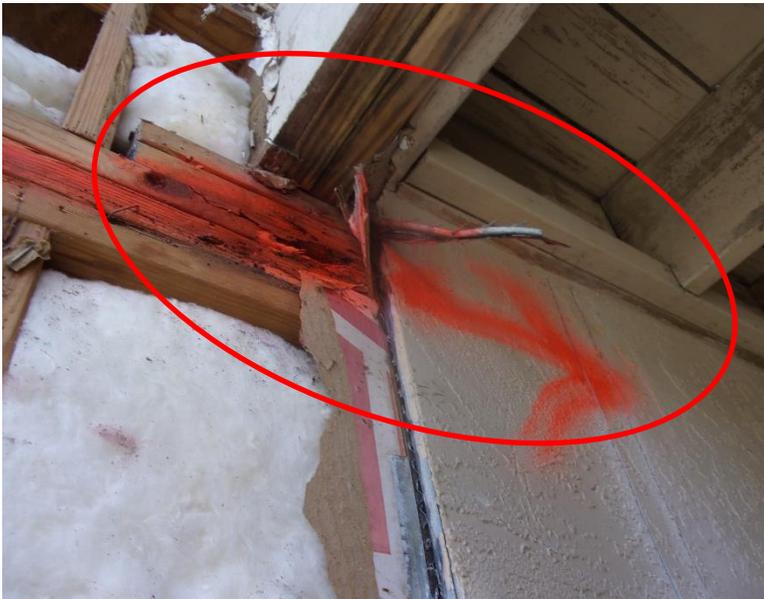
PHOTOGRAPH #4

**BUILDING 7
SECTION A**

Top plate and blocking marked for repairs. Additional stucco removal required into balcony wall for inspection and marking of damage framing.

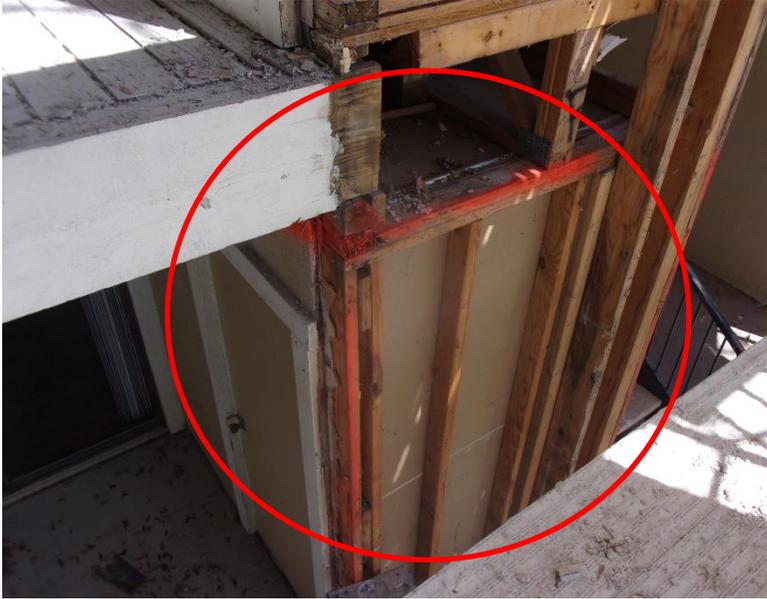
PHOTOGRAPH #5

**BUILDING 7
SECTION A**

Framing studs, top plate and blocking marked for repairs below balcony.

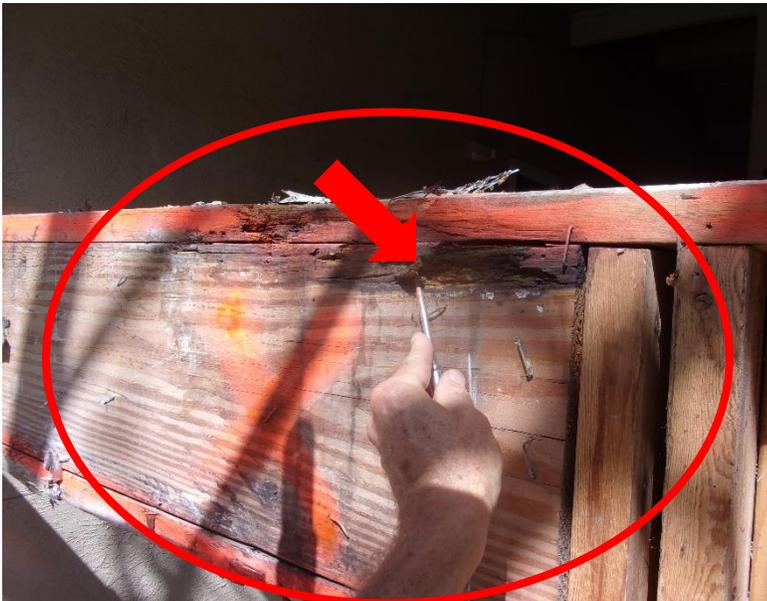
PHOTOGRAPH #6

**BUILDING 7
SECTION A**

Box beam at breezeway damage marked for repairs.

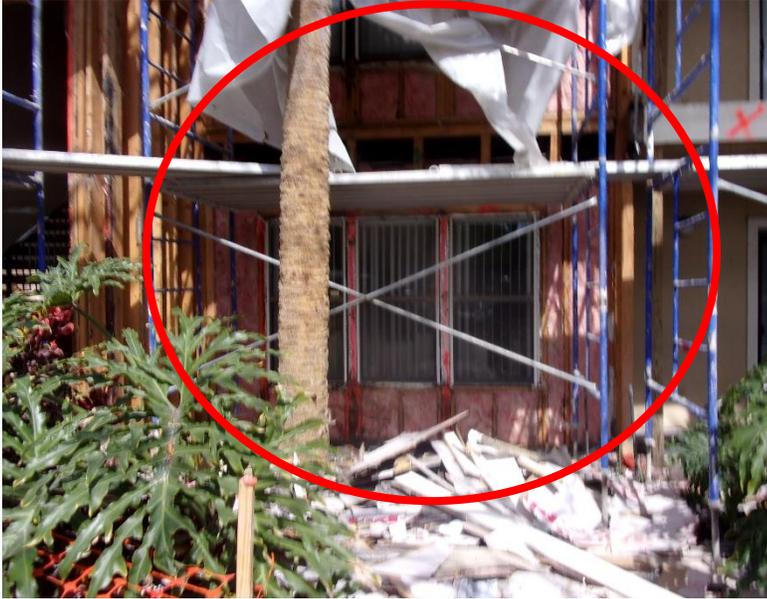
PHOTOGRAPH #7

**BUILDING 7
SECTION B**

Delta inspected wood framing conditions and marked for repairs.

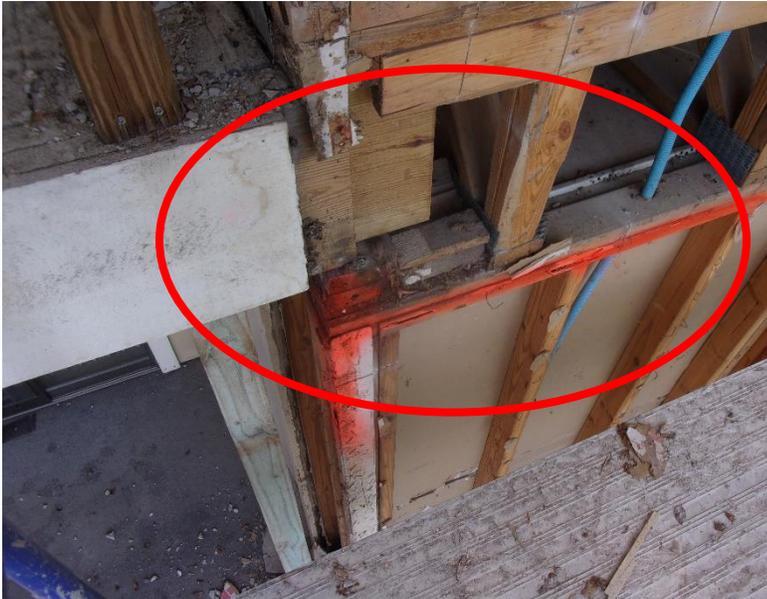
PHOTOGRAPH #8

**BUILDING 7
SECTION B**

Framing studs, top plate and blocking marked for repairs below balcony.

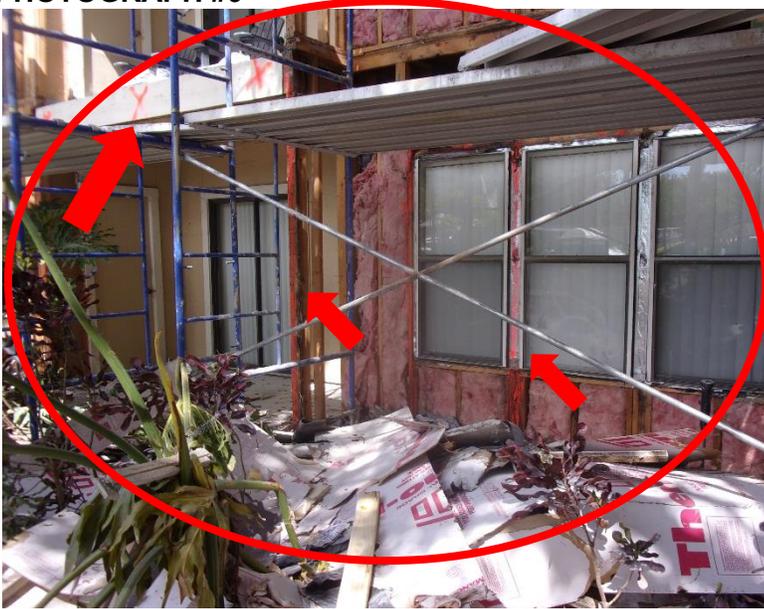
PHOTOGRAPH #9

**BUILDING 7
SECTION B**

Balcony built up beam, support framing and window framing damage marked for repairs.

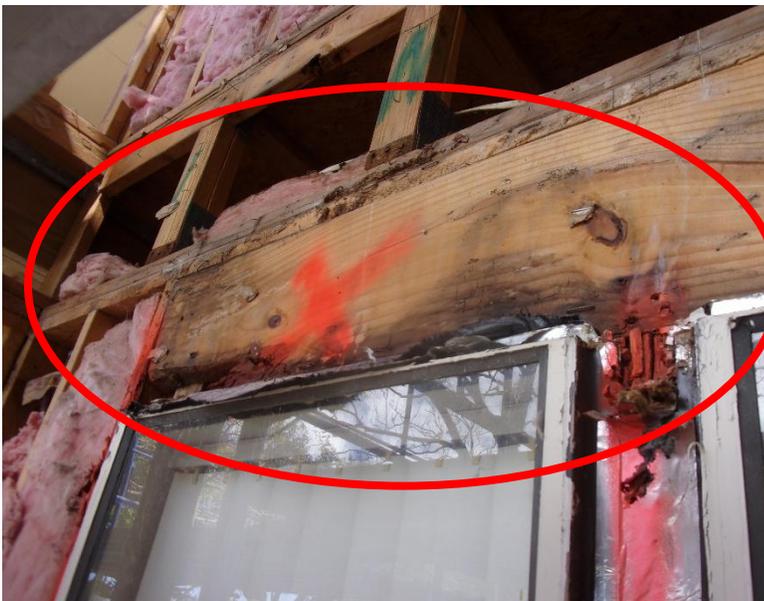
PHOTOGRAPH #10

**BUILDING 7
SECTION B**

Window header inspected and marked for removal and replacement.

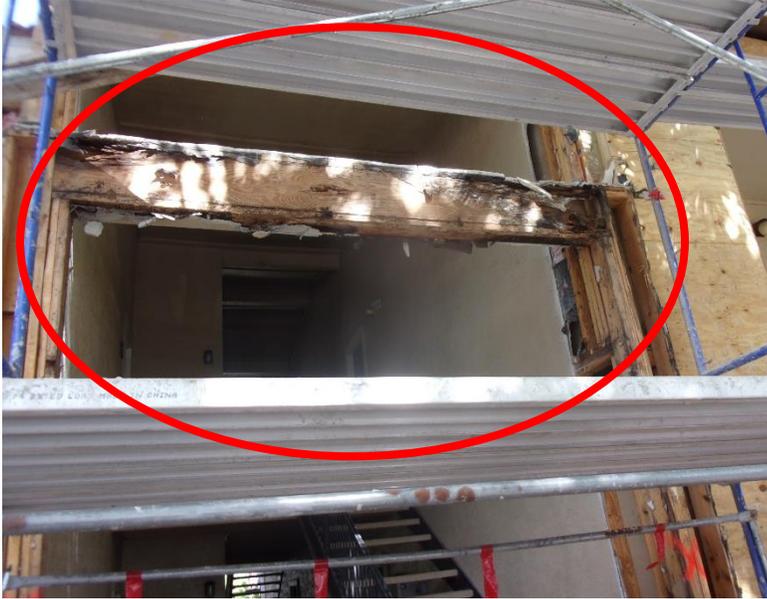
PHOTOGRAPH #11

**BUILDING 7
SECTION C**

Full breezeway box beam and supports marked for replace.

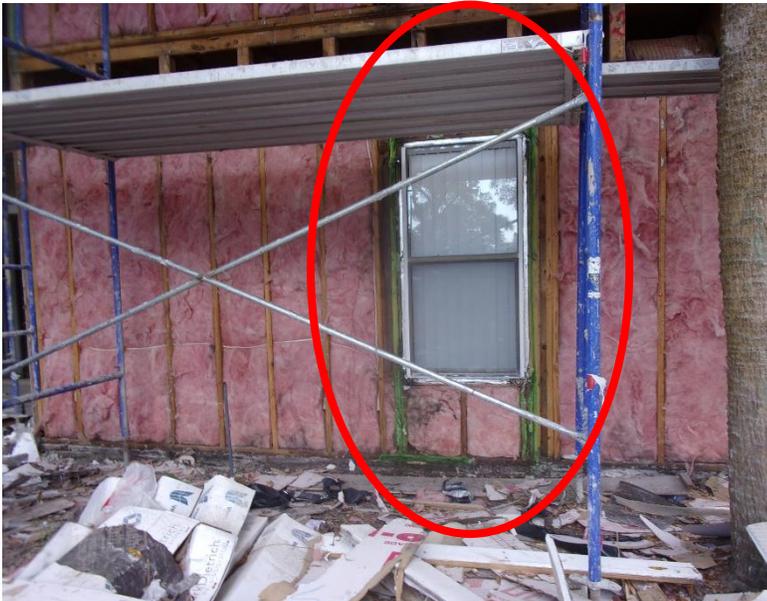
PHOTOGRAPH #12

**BUILDING 7
SECTION C**

Damaged window framing and base plate marked for repairs.

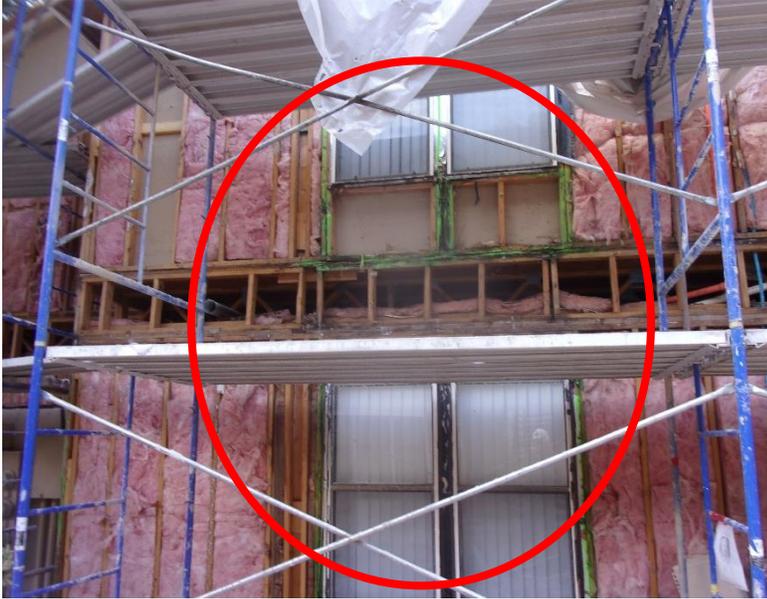
PHOTOGRAPH #13

**BUILDING 7
SECTION D**

Delta inspected wood framing conditions and marked for repairs.

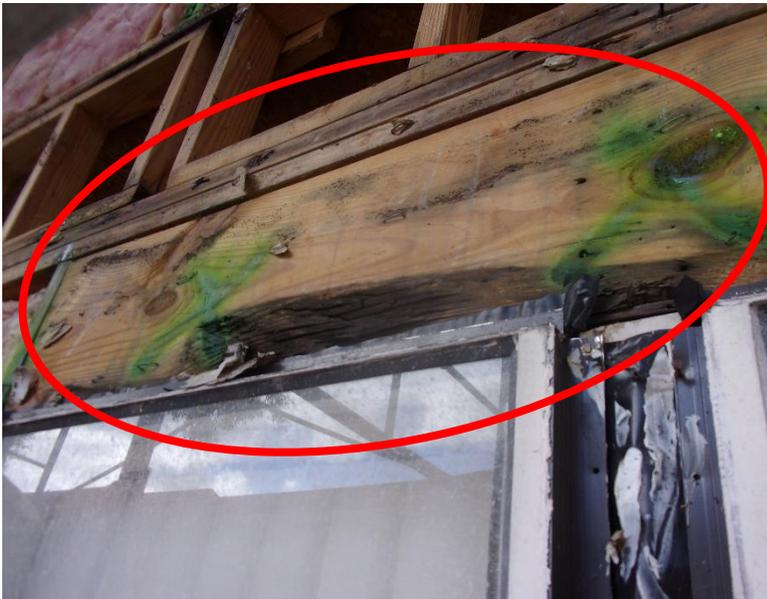
PHOTOGRAPH #14

**BUILDING 7
SECTION D**

Window header inspected and marked for removal and replacement.

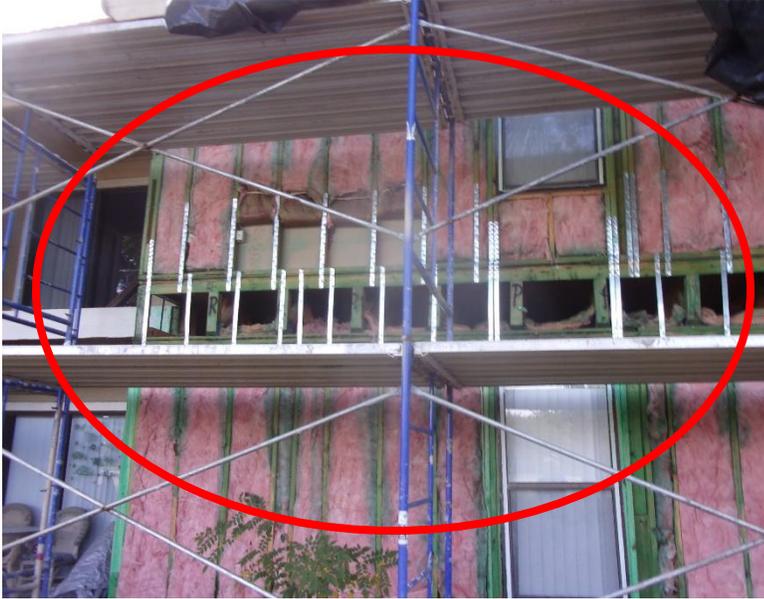
PHOTOGRAPH #15

**BUILDING 7
SECTION E**

Simpson Strong Tie connectors and straps attached at each stud of bearing wall. Bora care Termite treatment applied at all wall framing.

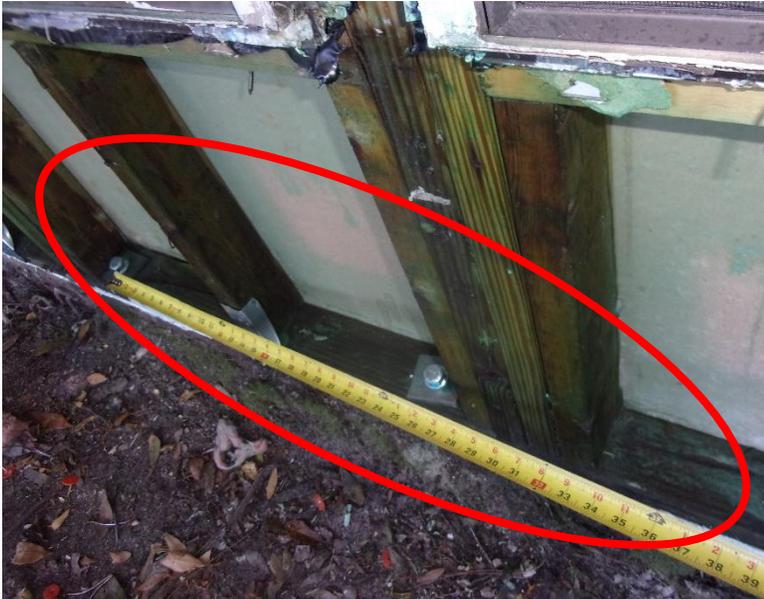
PHOTOGRAPH #16

**BUILDING 7
SECTION F**

Simpson Connector (Strong-Tie 5/8" x 8" Titen HD Anchors) installed 24" on-center max.

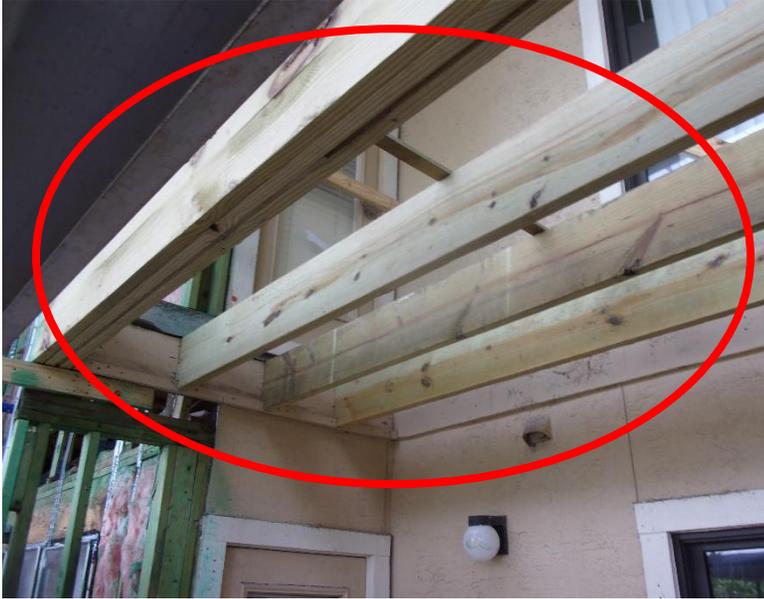
PHOTOGRAPH #17

**BUILDING 7
SECTION F**

Contractor replacing (at no cost to the owners) decking and ledgers mistakenly removed at balconies that were not marked for repairs.

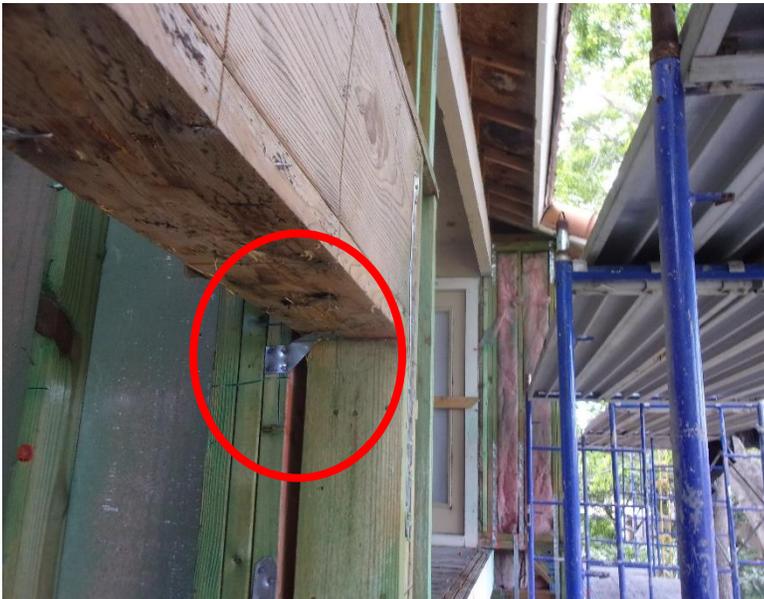
PHOTOGRAPH #18

**BUILDING 7
SECTION G**

Contractor has installed Simpson Connector (H3) to connect Breezeway Box Beam to adjacent stud, above and below the Box Beam, as per drawings and specifications.

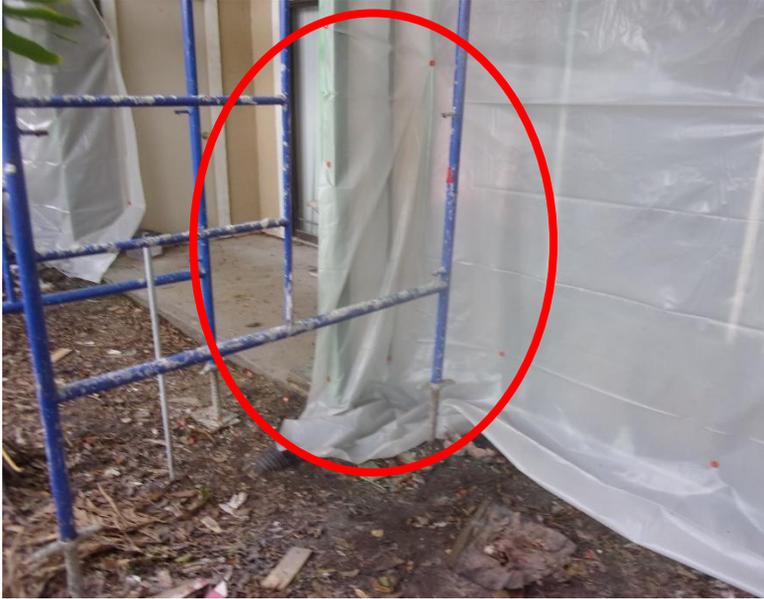
PHOTOGRAPH #19

**BUILDING 7
SECTION G**

Plastic protection has been applied and secured as required to fully secured and covering all open wall locations for weather protection.

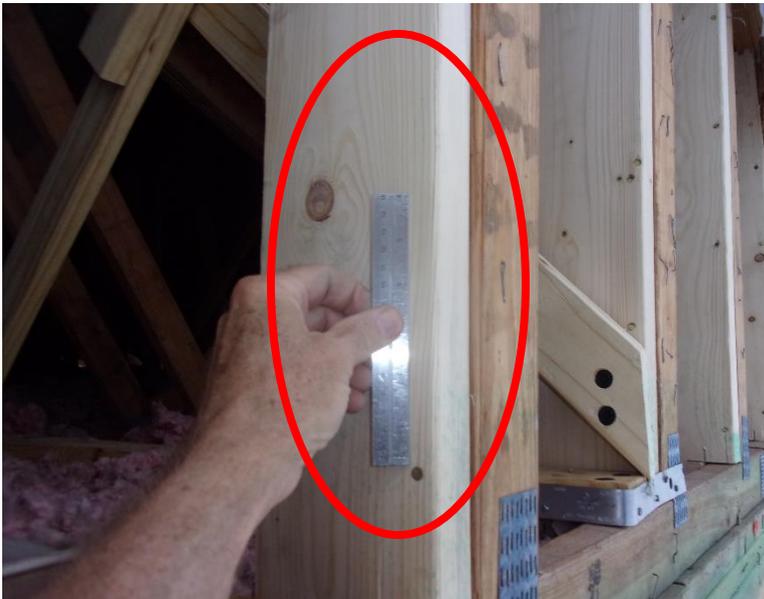
PHOTOGRAPH #20

**BUILDING 7
SECTION H**

L-SCAB reinforcement framing at gable end is not fastened as per specifications with 10d nails 6" O.C...
