PHOTOGRAPHS

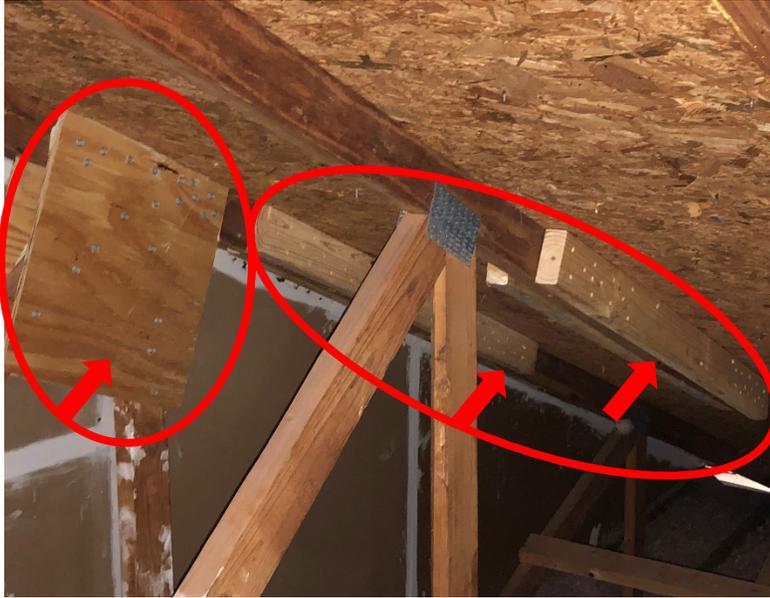
PHOTOGRAPH #1

**BUILDING 6
UNIT 621 - ATTIC**

Contractor has performed truss scab repairs and gusset plate repairs.

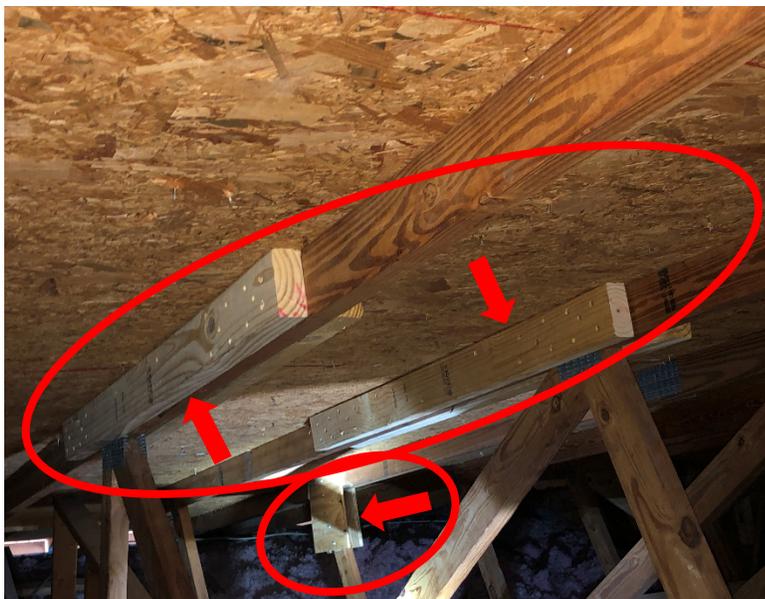
PHOTOGRAPH #2

**BUILDING 6
UNIT 621 - ATTIC**

Contractor has performed truss scab repairs.

Larger gusset plate is needed with more screws, as per the drawings. Reported to contractor.

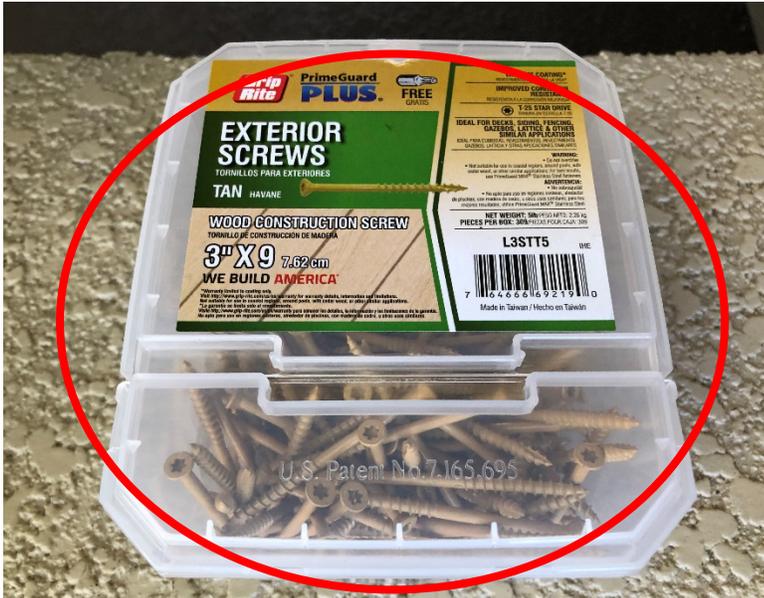
PHOTOGRAPH #3

**BUILDING 6
UNIT 621 - ATTIC**

Wood Construction Screw used for truss scab repairs.

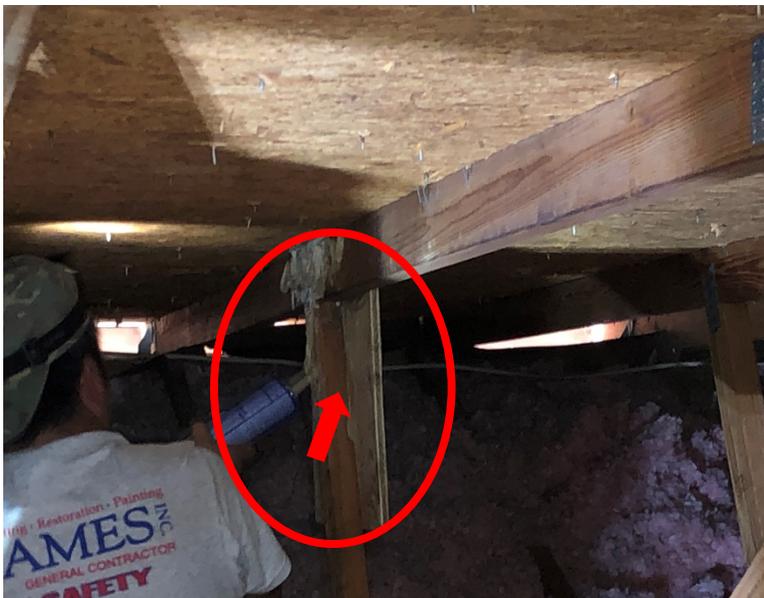
PHOTOGRAPH #4

**BUILDING 6
UNIT 621 - ATTIC**

Contractor installing Liquid Nails for gusset plate repairs.

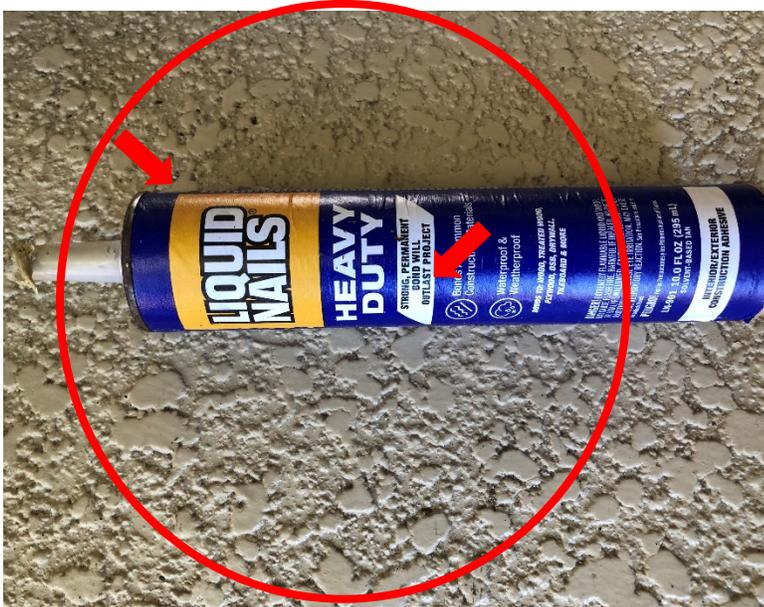
PHOTOGRAPH #5

**BUILDING 6
UNIT 621 - ATTIC**

Liquid Nails used for gusset plate repairs.

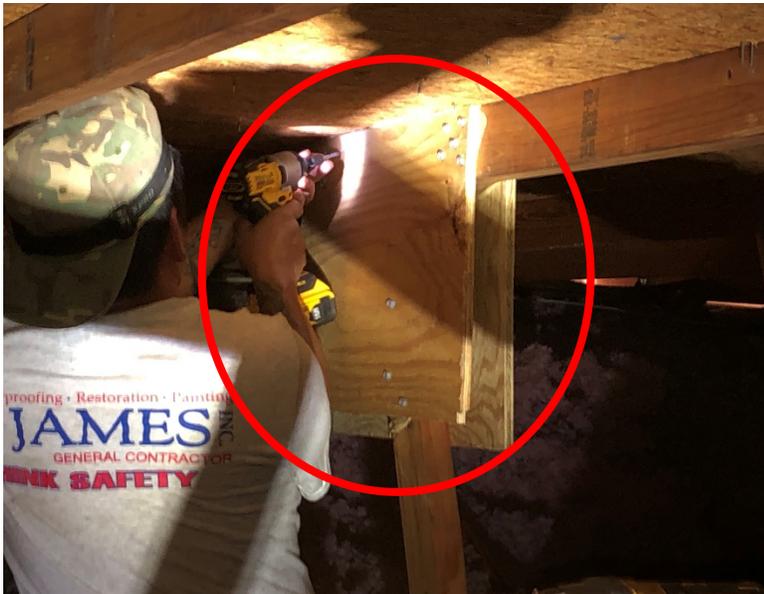
PHOTOGRAPH #6

**BUILDING 6
UNIT 621 - ATTIC**

Contractor has performed gusset plate repairs.

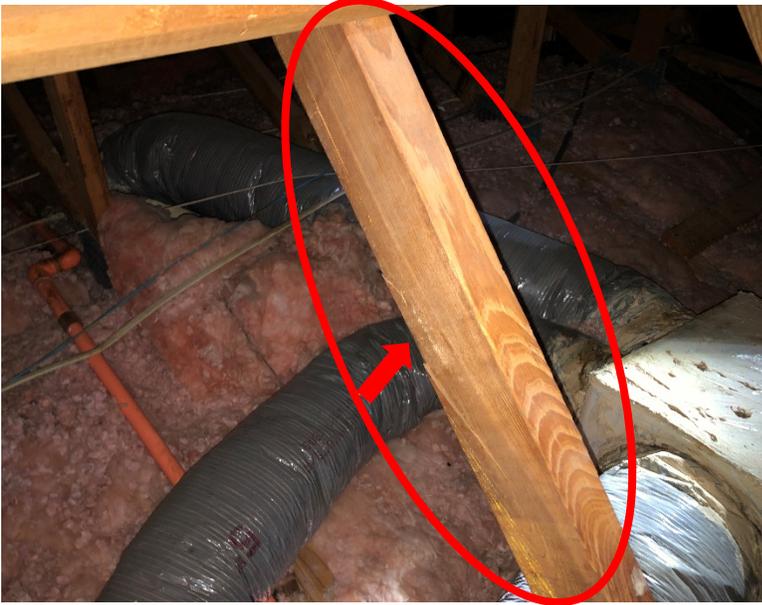
PHOTOGRAPH #7

**BUILDING 6
UNIT 621 - ATTIC**

Recently found damaged truss member.
Contractor to perform truss scab repairs.

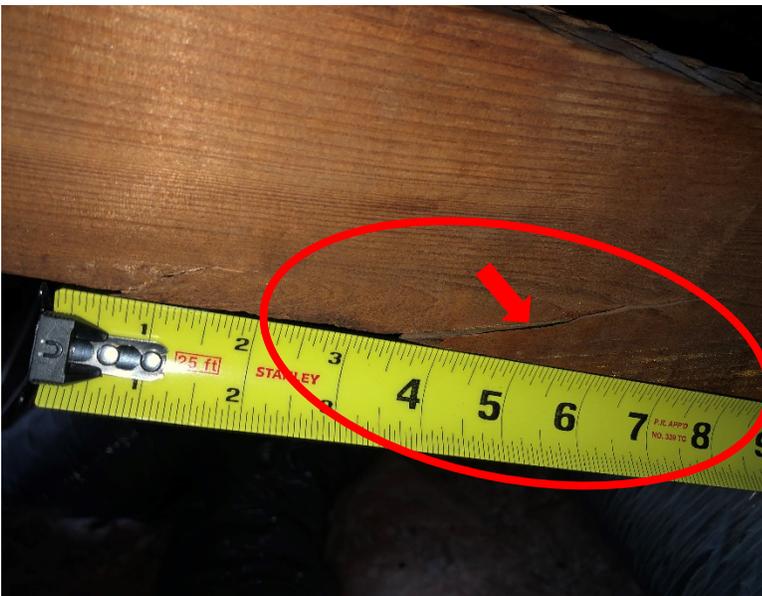
PHOTOGRAPH #8

**BUILDING 6
UNIT 621 - ATTIC**

Recently found damaged truss member.
Contractor to perform truss scab repairs.

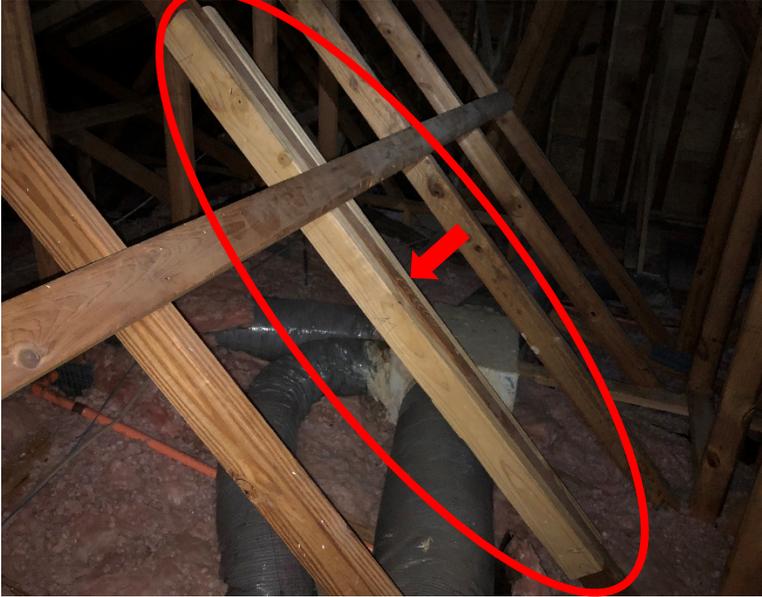
PHOTOGRAPH #9

**BUILDING 6
UNIT 621 - ATTIC**

Contractor has performed truss scab repairs on recently found damaged truss member.

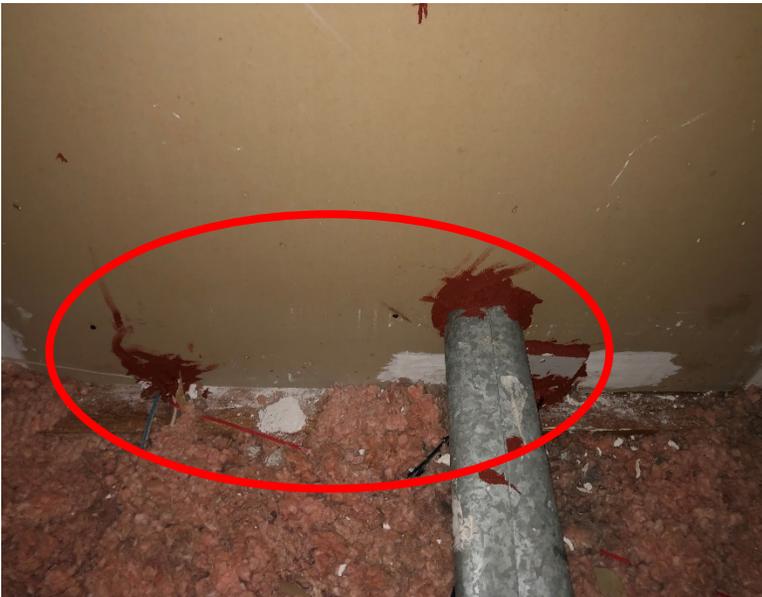
PHOTOGRAPH #10

**BUILDING 6
UNIT 623 - ATTIC**

3M Fire Barrier sealant applied at fire wall penetrations and fire wall repairs.

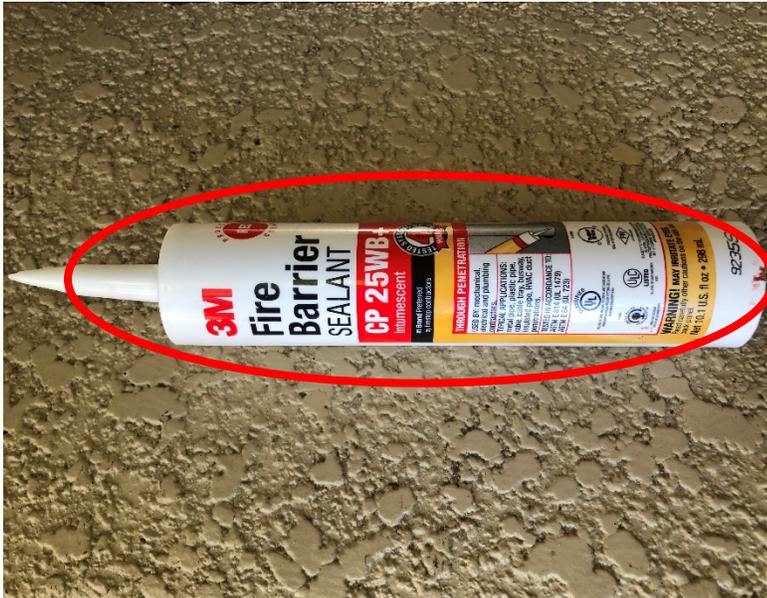
PHOTOGRAPH #11

**BUILDING 6
UNIT 623 - ATTIC**

3M Fire Barrier sealant applied at fire wall penetrations and fire wall repairs.

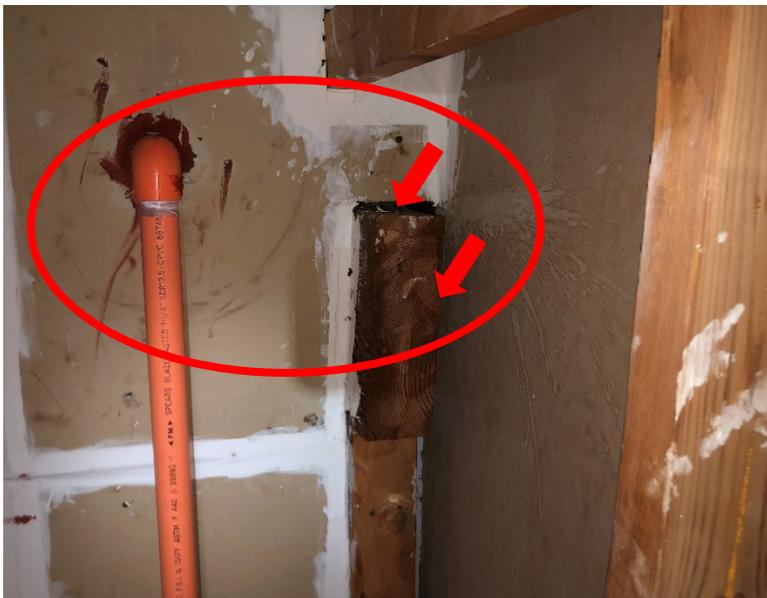
PHOTOGRAPH #12

**BUILDING 6
UNIT 623 - ATTIC**

3M Fire Barrier sealant applied at fire wall penetrations and fire wall repairs.

Fire wall repair incomplete around wooden beam in fire wall. Reported to Contractor.

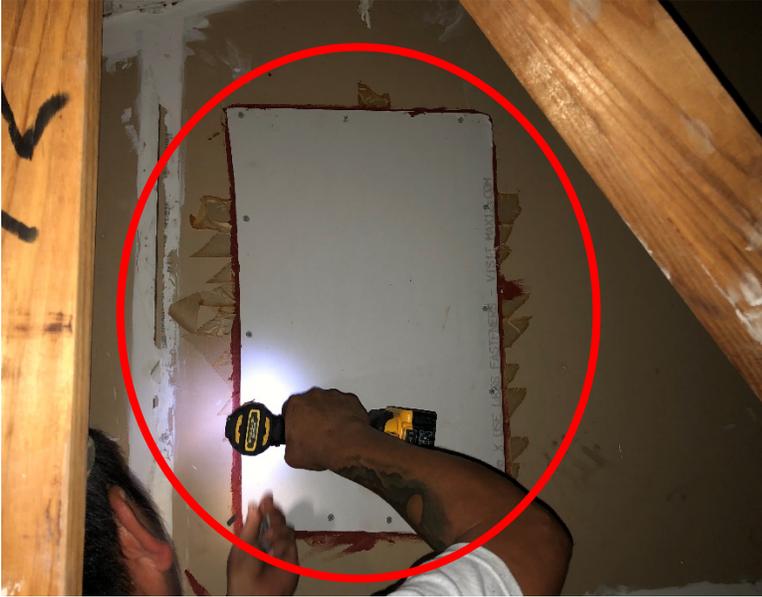
PHOTOGRAPH #13

**BUILDING 6
UNIT 623 - ATTIC**

Screws were added to fire wall repair to conform with 6" on-center spacing requirement.

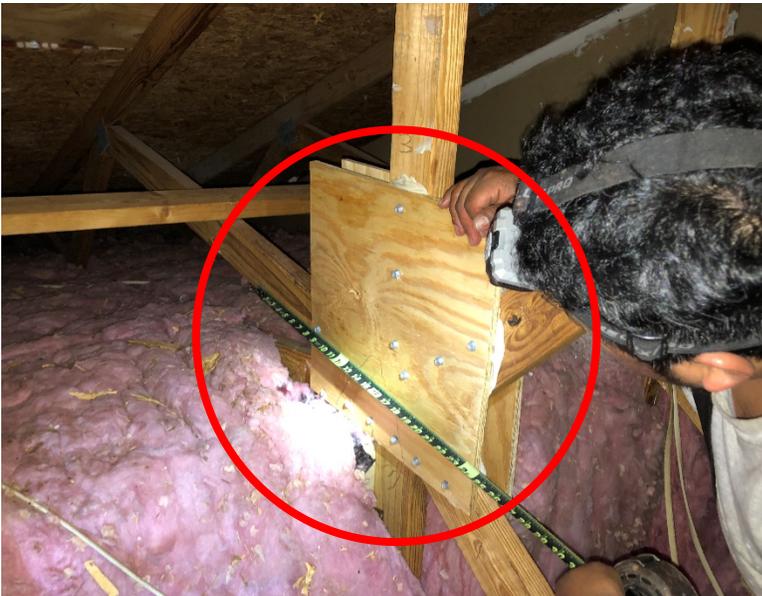
PHOTOGRAPH #14

**BUILDING 6
UNIT 623 - ATTIC**

Larger gusset plate is needed with more screws, as per the drawings. Reported to contractor.

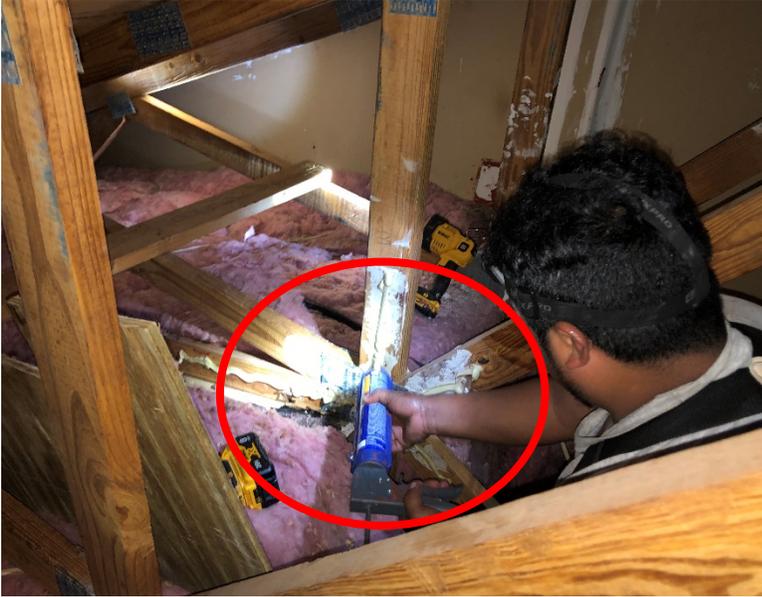
PHOTOGRAPH #15

**BUILDING 6
UNIT 623 - ATTIC**

Contractor installing Liquid Nails for gusset plate repairs.

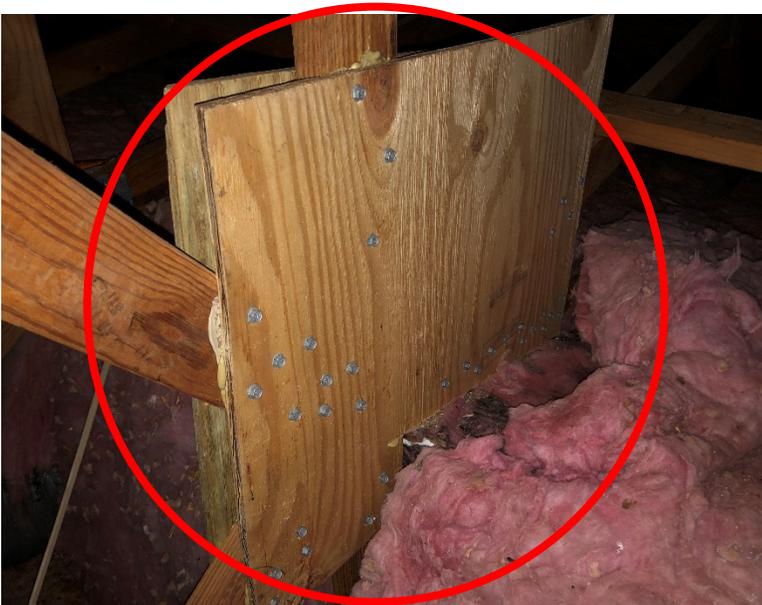
PHOTOGRAPH #16

**BUILDING 6
UNIT 623 - ATTIC**

Contractor has performed gusset plate repairs in the location that required a larger gusset plate.

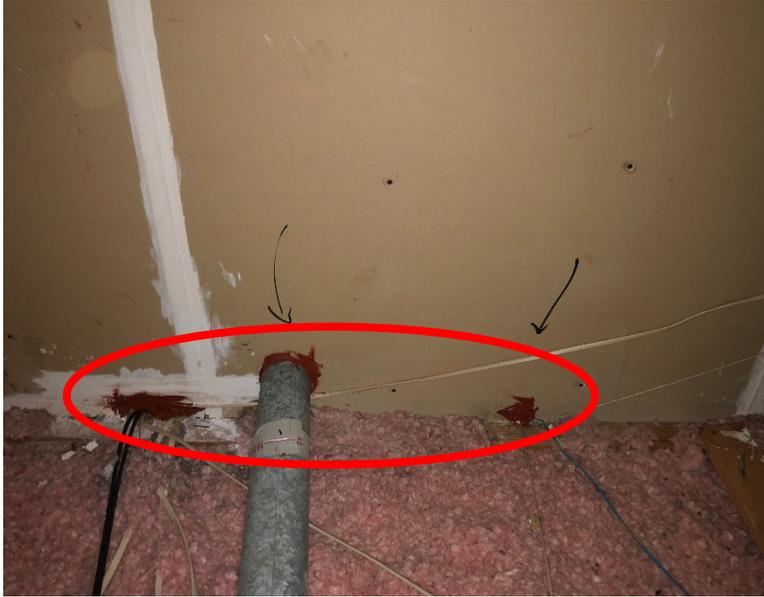
PHOTOGRAPH #17

**BUILDING 6
UNIT 625 - ATTIC**

3M Fire Barrier sealant applied at fire wall repairs.

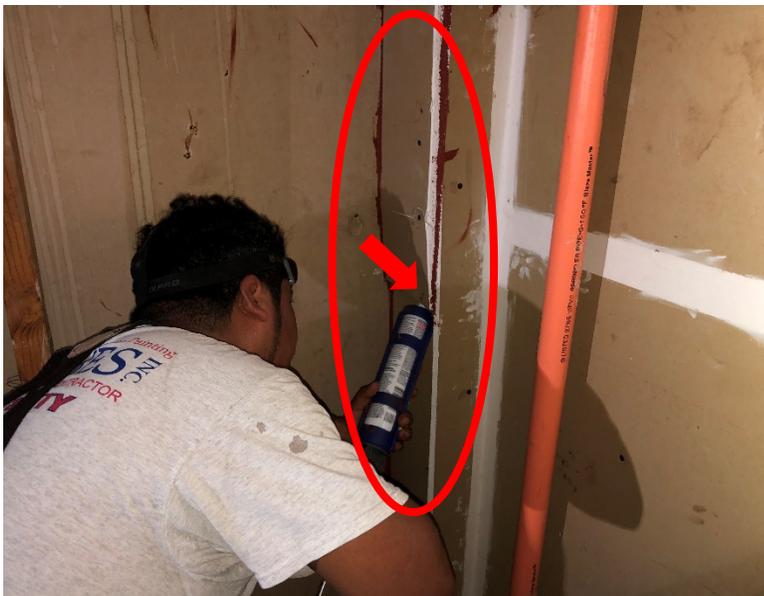
PHOTOGRAPH #18

**BUILDING 6
UNIT 625 - ATTIC**

3M Fire Barrier sealant applied at fire wall repairs.

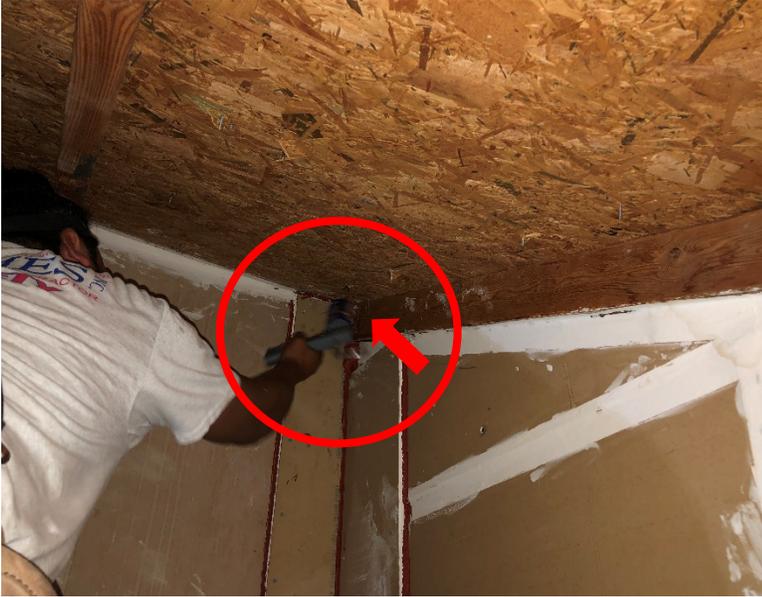
PHOTOGRAPH #19

**BUILDING 6
UNIT 625 - ATTIC**

3M Fire Barrier sealant applied at fire wall repairs.

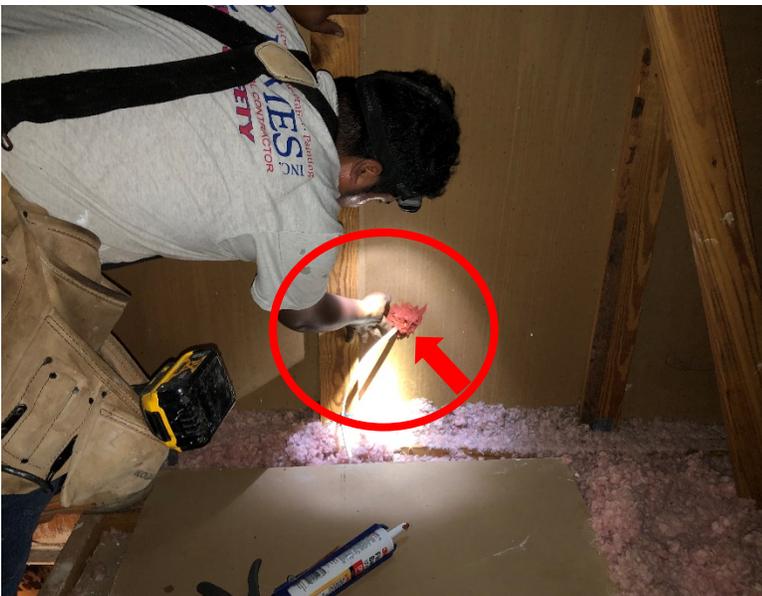
PHOTOGRAPH #20

**BUILDING 6
UNIT 626 - ATTIC**

3M Fire Barrier sealant applied at fire wall repairs.

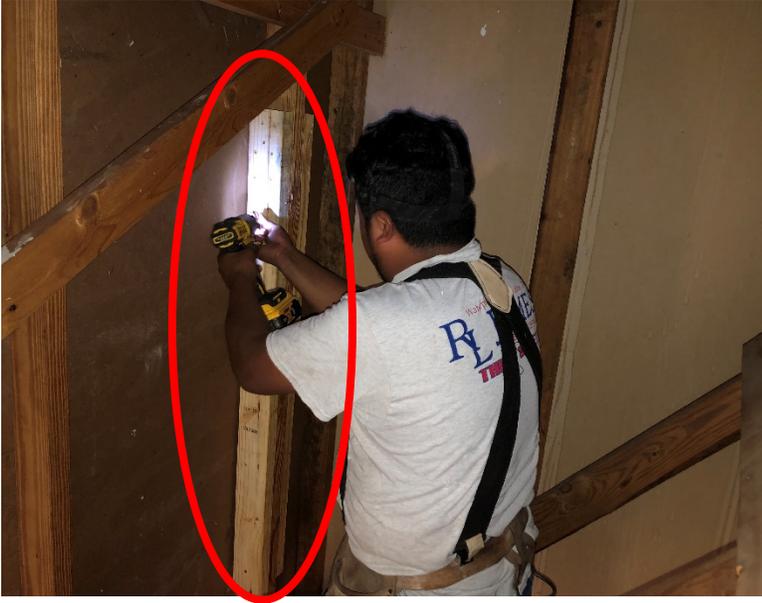
PHOTOGRAPH #21

**BUILDING 6
UNIT 626 - ATTIC**

Contractor has performed truss scab repairs.

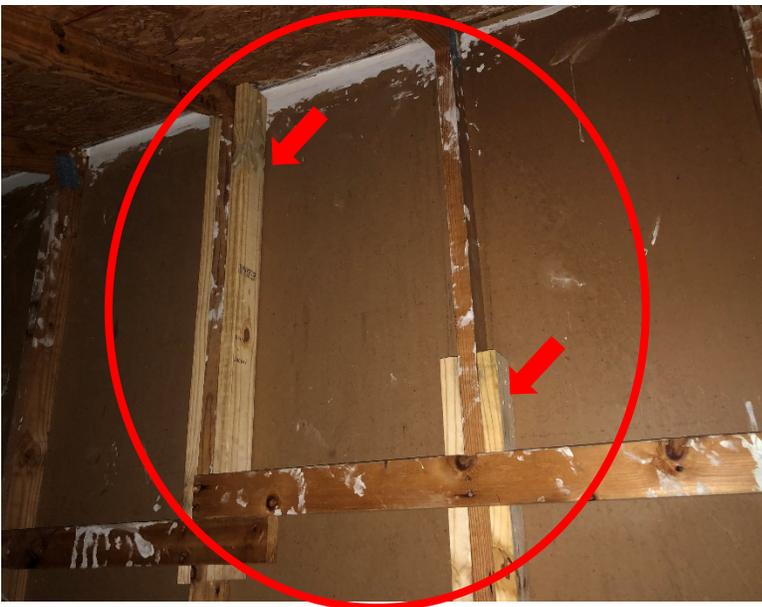
PHOTOGRAPH #22

**BUILDING 6
UNIT 626 - ATTIC**

Contractor has performed truss scab repairs.

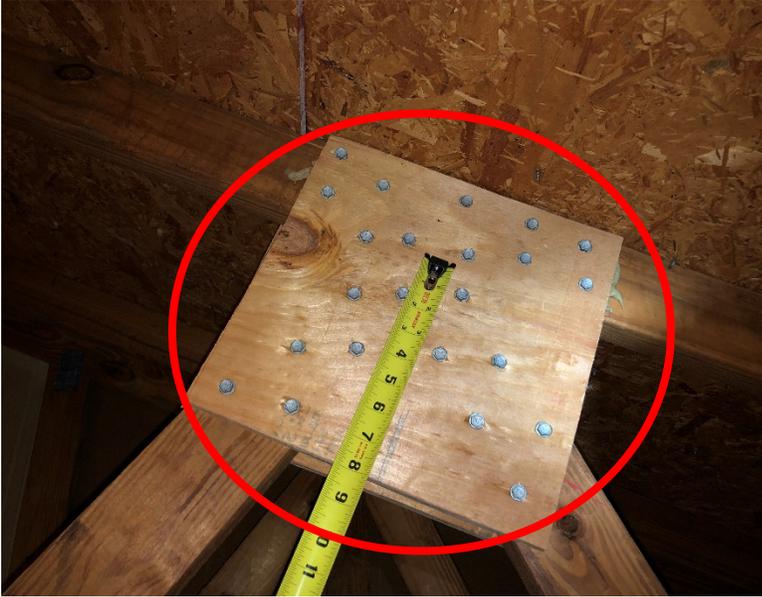
PHOTOGRAPH #23

**BUILDING 6
UNIT 626 - ATTIC**

Contractor has performed gusset plate repairs.

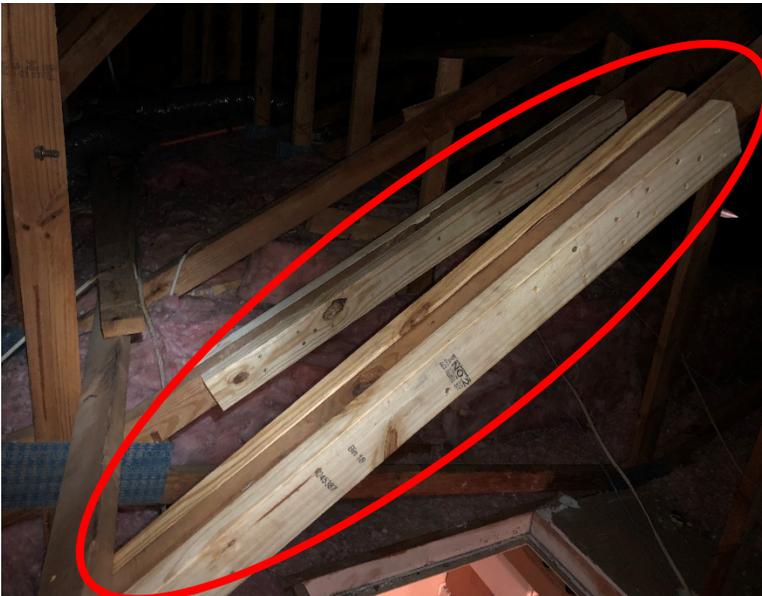
PHOTOGRAPH #24

**BUILDING 6
UNIT 627 - ATTIC**

Contractor has performed truss scab repairs.

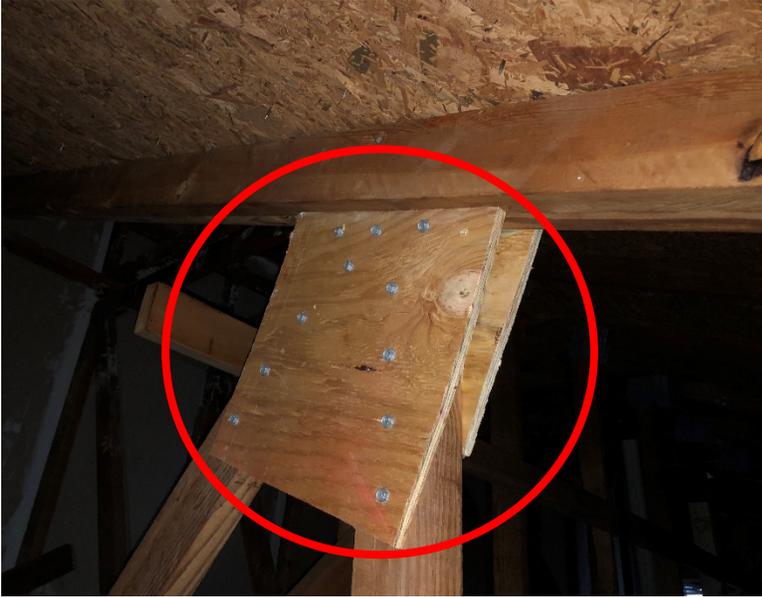
PHOTOGRAPH #25

**BUILDING 6
UNIT 627 - ATTIC**

Larger gusset plate is needed with more screws, as per the drawings. Reported to contractor.

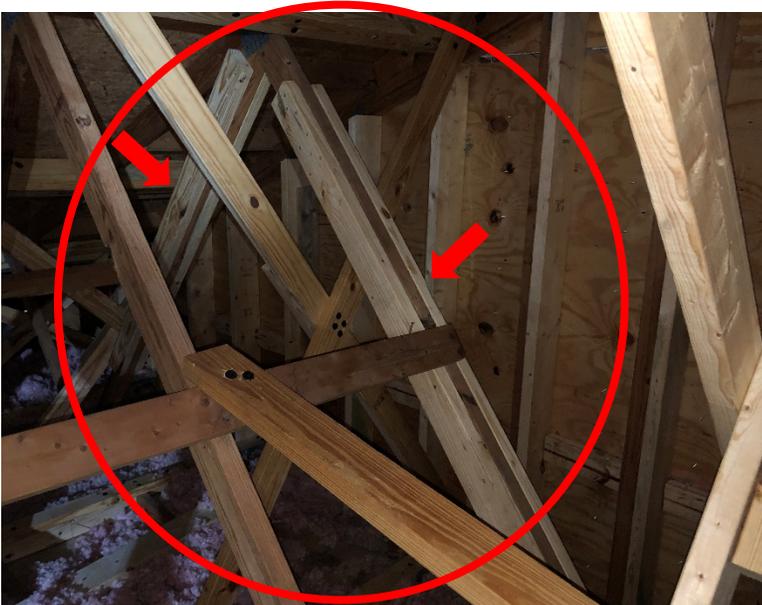
PHOTOGRAPH #26

**BUILDING 6
UNIT 628 - ATTIC**

Contractor has performed truss scab repairs.
