PHOTOGRAPHS

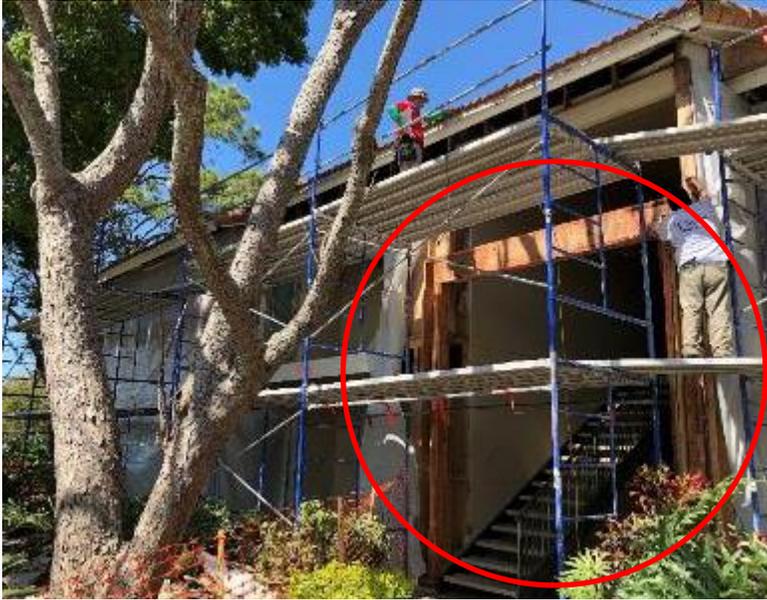
PHOTOGRAPH #1

BUILDING 7 SECTION A

Contractor preparing breezeway box beam and supports to be replaced.

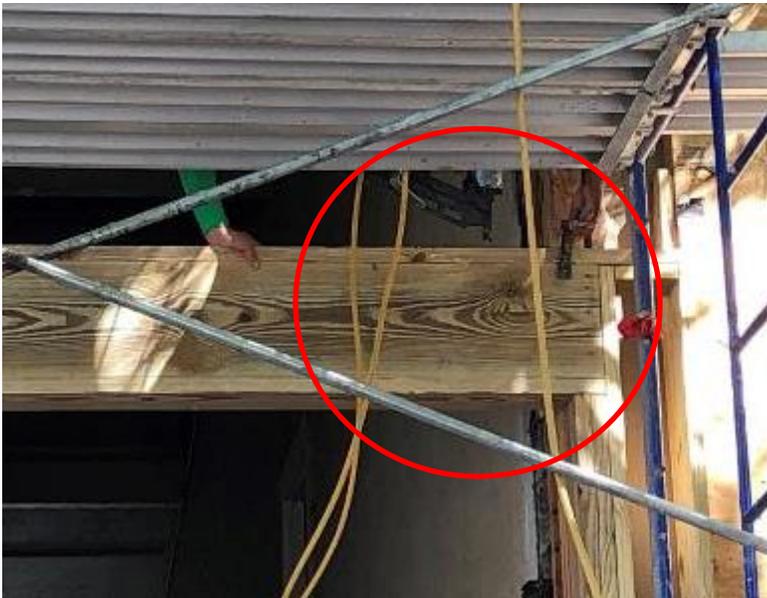
PHOTOGRAPH #2

BUILDING 7 SECTION C

Breezeway box beam and supports are being replaced.

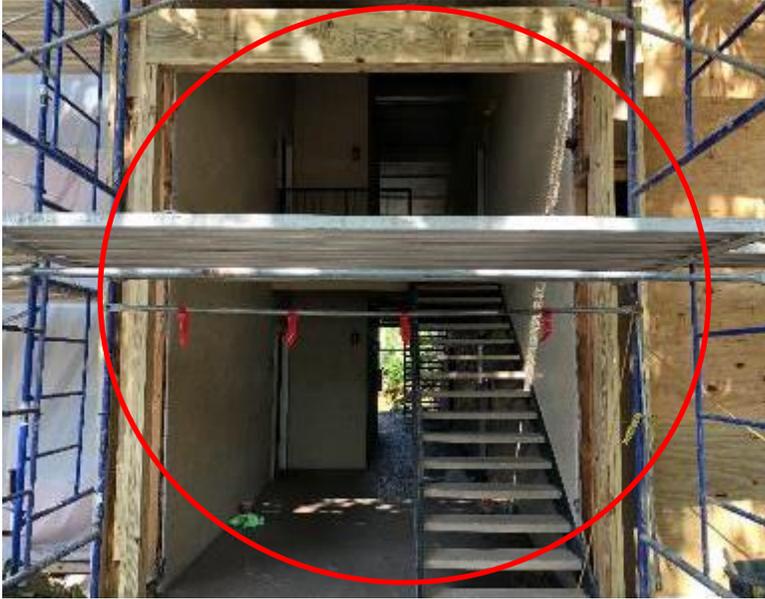
PHOTOGRAPH #3

**BUILDING 7
SECTION C**

Breezeway box beam and supports have been replaced as per drawings and specifications.

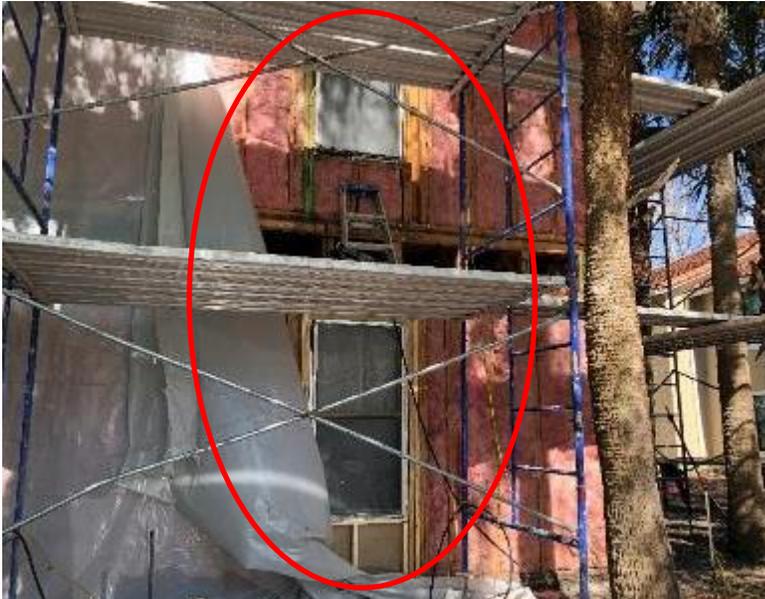
PHOTOGRAPH #4

**BUILDING 7
SECTION C**

Framing repairs in progress at wall studs and window openings with 2"X4" southern yellow pine.

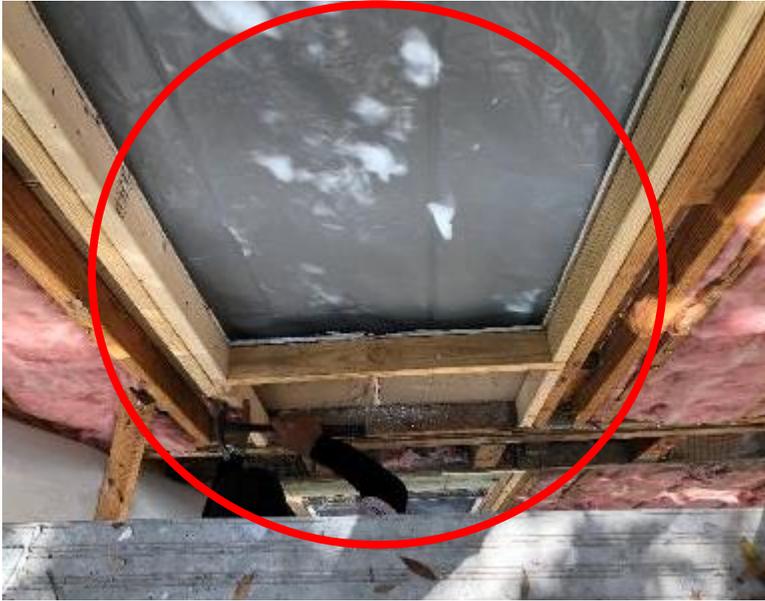
PHOTOGRAPH #5

**BUILDING 7
SECTION C**

Framing repairs in progress at wall studs and window openings with 2"X4" southern yellow pine.

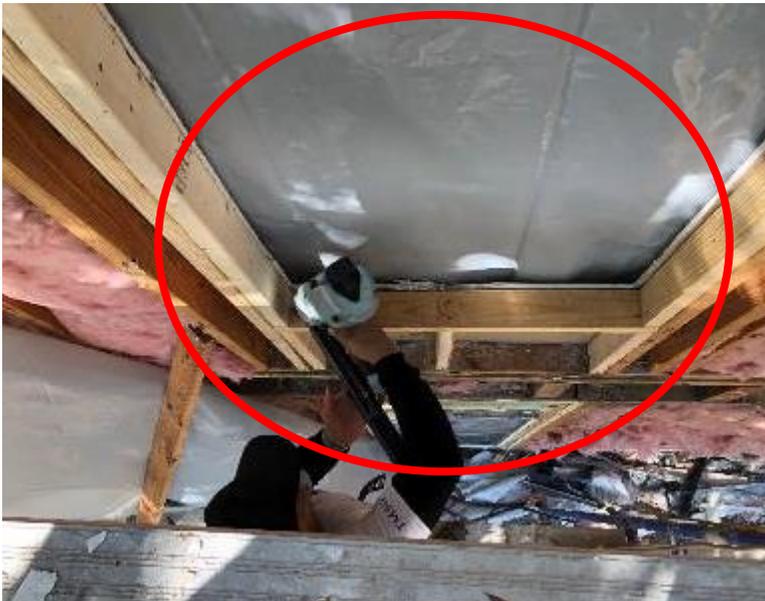
PHOTOGRAPH #6

**BUILDING 7
SECTION C**

Framing repairs in progress at wall studs and window openings with 2"X4" southern yellow pine.

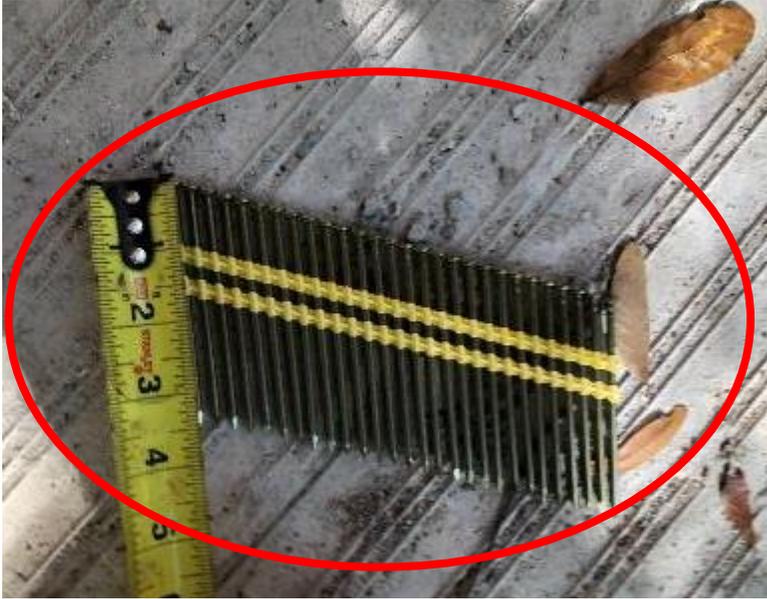
PHOTOGRAPH #7

**BUILDING 7
SECTION C**

3 1/2" 16P framing nails used for framing repairs as per drawings.

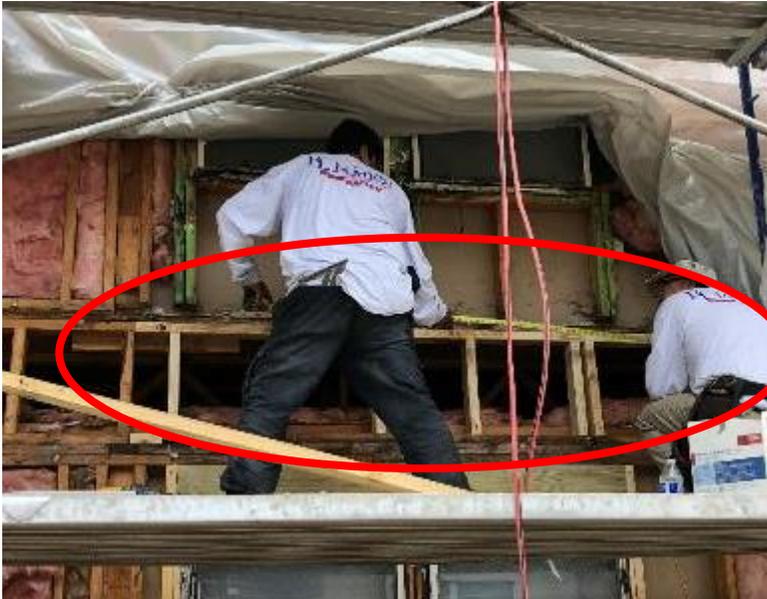
PHOTOGRAPH #8

**BUILDING 7
SECTION D**

Sub Floor Framing repairs at long gable wall in progress at second with 2"X4" southern yellow pine.

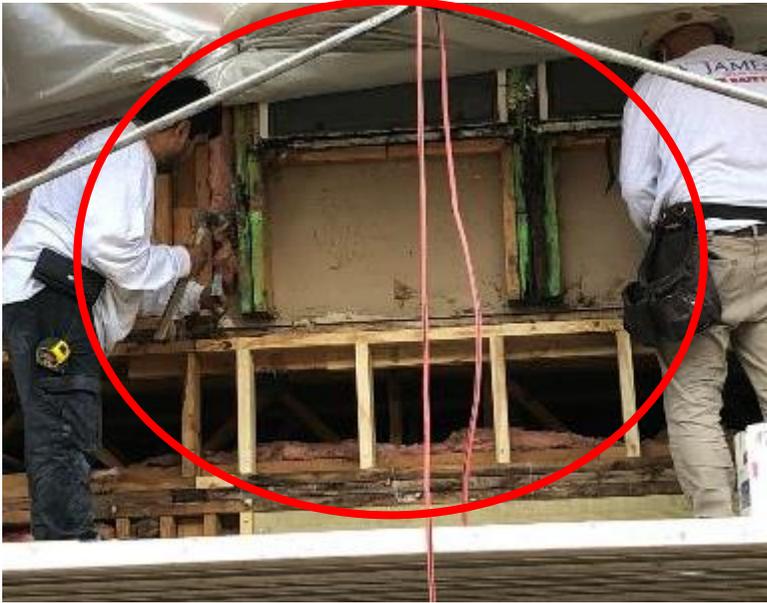
PHOTOGRAPH #9

**BUILDING 7
SECTION D**

Sub Floor Framing repairs at long gable wall in progress at second with 2"X4" southern yellow pine.

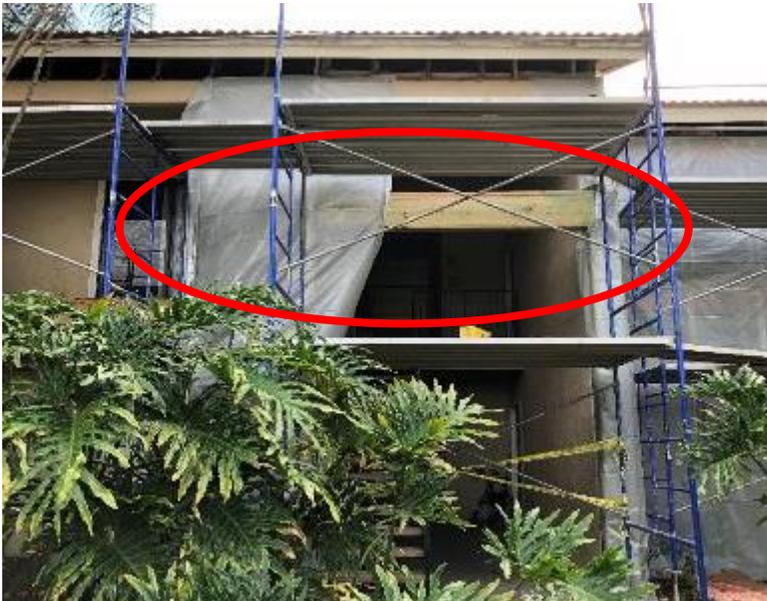
PHOTOGRAPH #10

**BUILDING 7
SECTION E**

Breezeway box beam and supports replaced as per drawings and specifications.

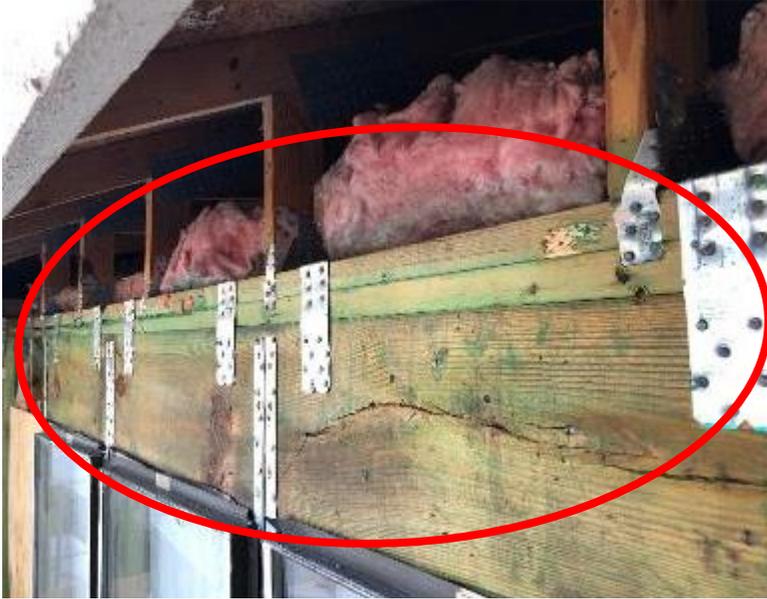
PHOTOGRAPH #11

**BUILDING 7
SECTION F**

Simpson Strong Tie connectors, straps, and screws were installed per drawings and specifications.

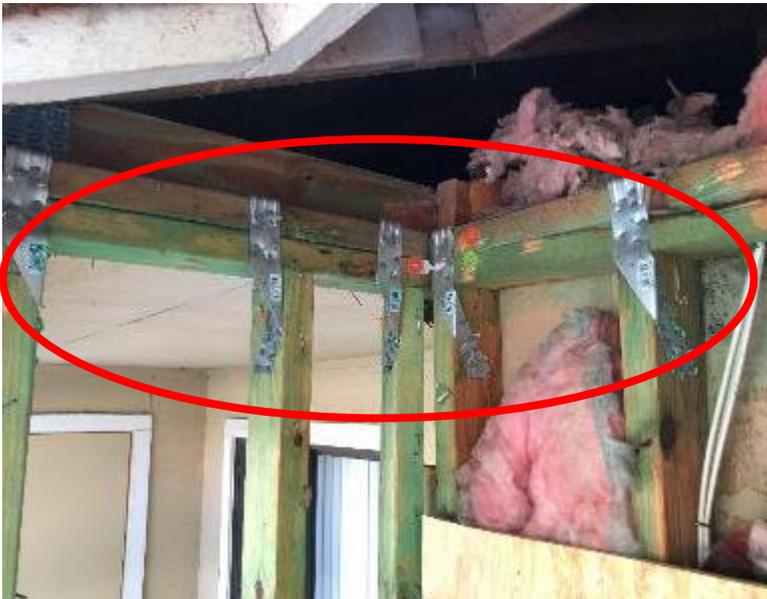
PHOTOGRAPH #12

**BUILDING 7
SECTION F**

Simpson Strong Tie connectors, straps, and screws were installed per drawings and specifications.

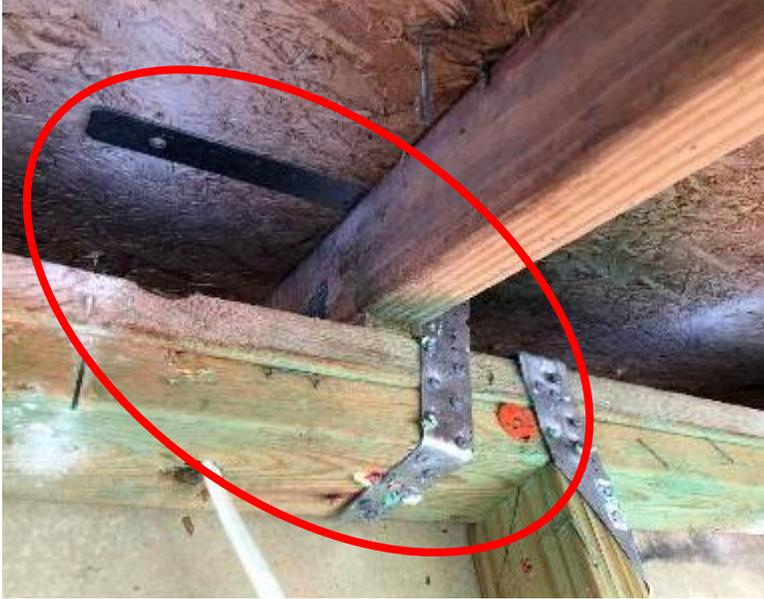
PHOTOGRAPH #13

**BUILDING 7
SECTION F**

Contractor to make corrections on Simpson Strong Tie strap not properly fastened to truss.

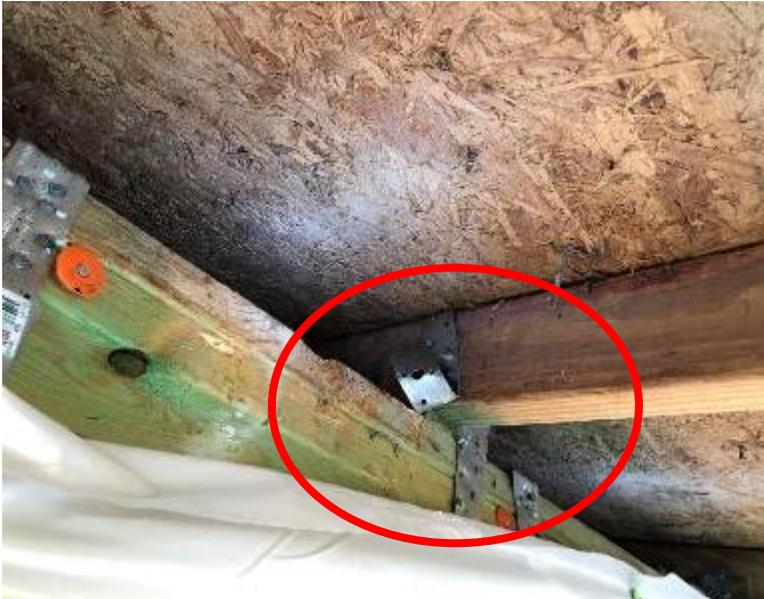
PHOTOGRAPH #14

**BUILDING 7
SECTION F**

Contractor made corrections on Simpson Strong Tie strap where not fastened to truss.

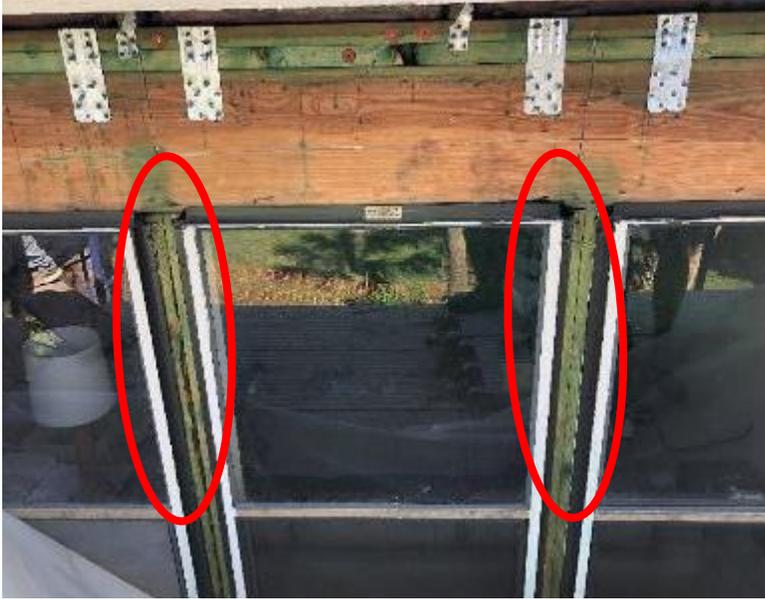
PHOTOGRAPH #15

**BUILDING 7
SECTION F**

Simpson Strong-Tie MTS straps to be installed in between windows and attaching to the header.

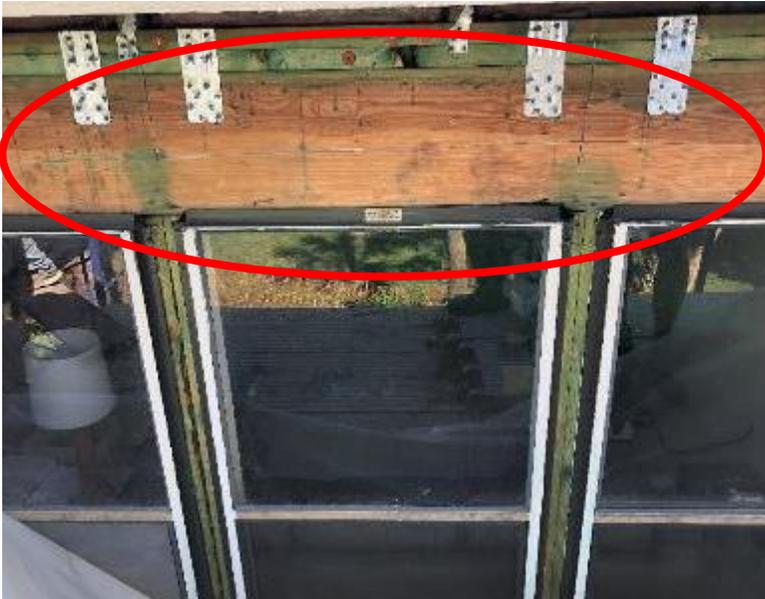
PHOTOGRAPH #16

**BUILDING 7
SECTION F**

Contractor to apply termite wood treatment over all framing.

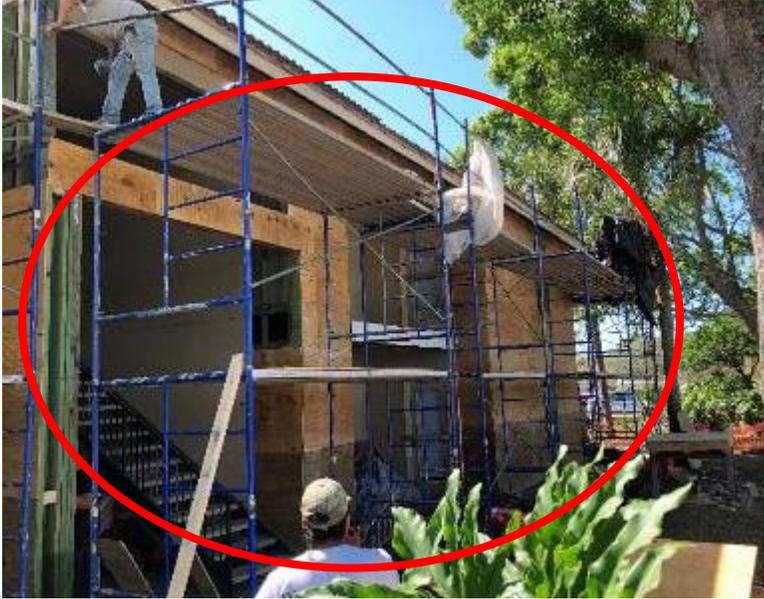
PHOTOGRAPH #17

**BUILDING 7
SECTION G**

15/32" exterior rated plywood sheathing installed with 8d common nails spaced at 4" on-center.

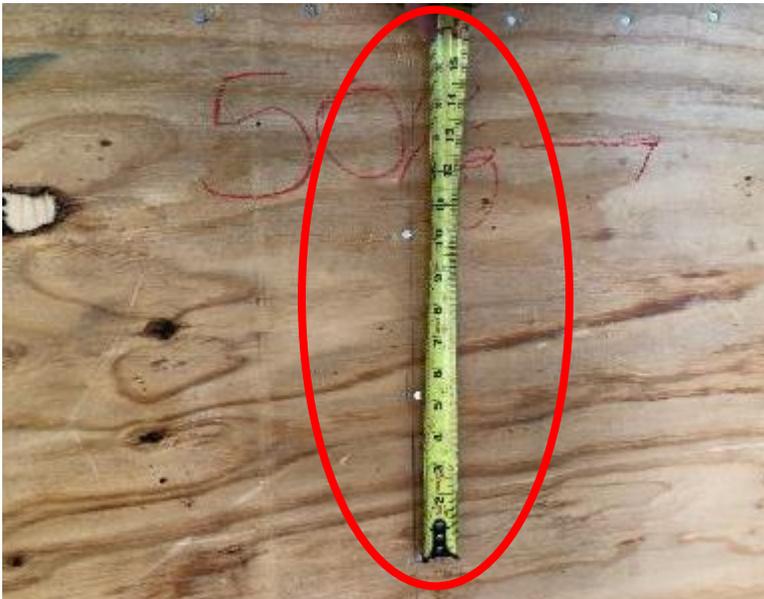
PHOTOGRAPH #18

**BUILDING 7
SECTION G**

15/32" exterior rated plywood sheathing installed with 8d common nails spaced at 4" on-center.

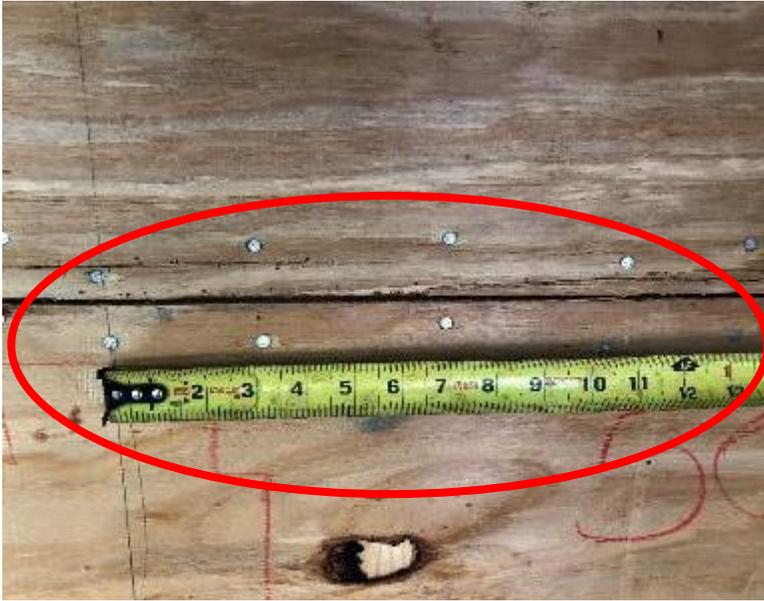
PHOTOGRAPH #19

**BUILDING 7
SECTION G**

15/32" exterior rated plywood sheathing installed with 8d common nails spaced at 4" on-center.

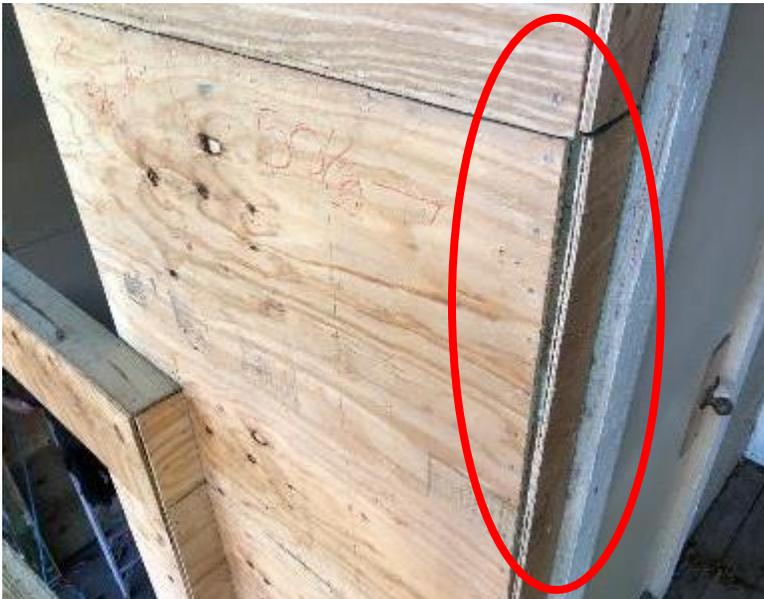
PHOTOGRAPH #20

**BUILDING 7
SECTION G**

BASF Urethane Sealant to be applied at gaps larger than 1/8".

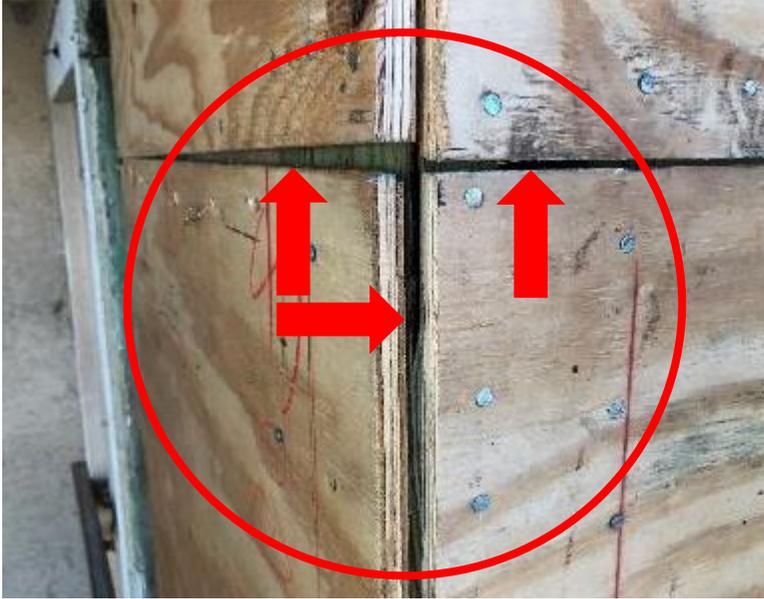
PHOTOGRAPH #21

**BUILDING 7
SECTION G**

BASF Urethane Sealant to be applied at gaps larger than 1/8".

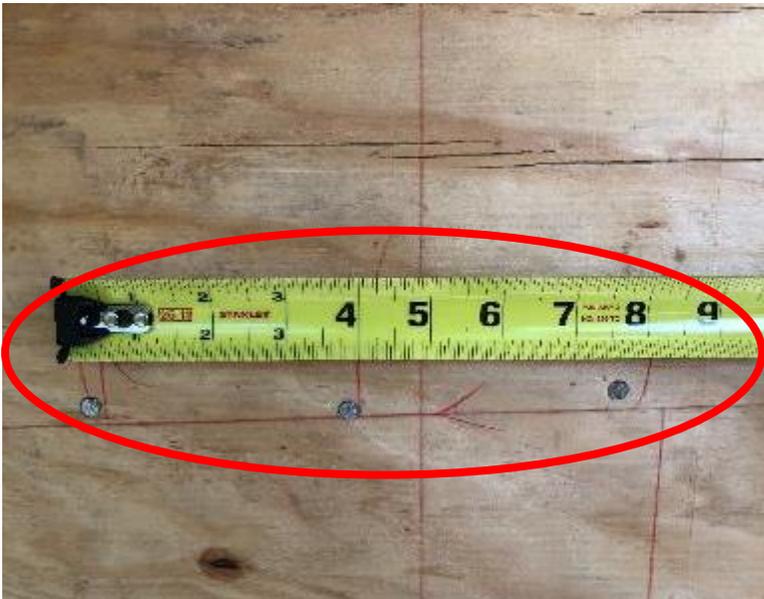
PHOTOGRAPH #22

**BUILDING 7
SECTION H**

15/32" exterior rated plywood sheathing installed with 8d common nails spaced at 4" on-center.

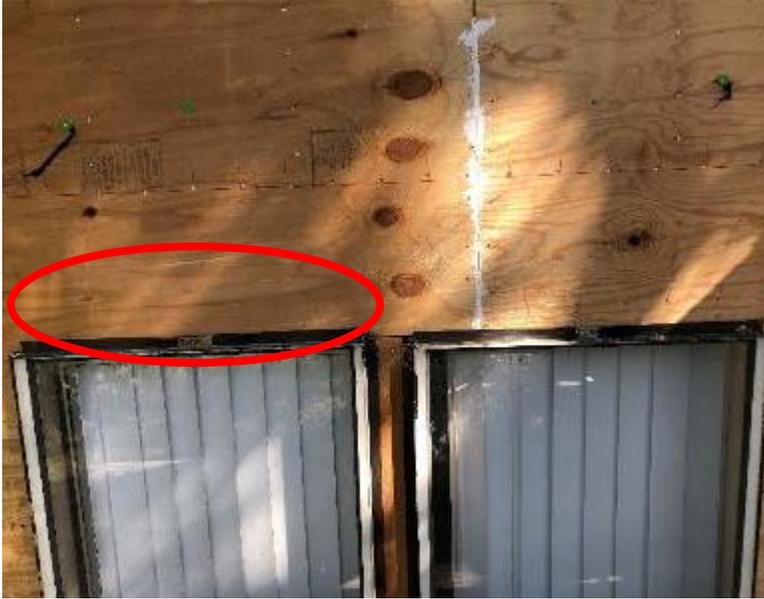
PHOTOGRAPH #23

**BUILDING 7
SECTION H**

Contractor to nail exterior rated 15/32" plywood sheathing with 8d common nails spaced at 4" on-center. Nails missed at this location.

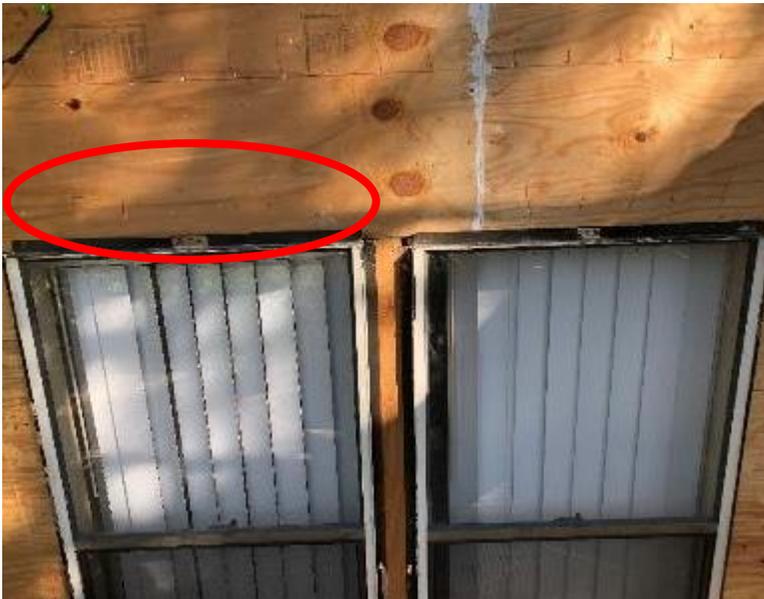
PHOTOGRAPH #24

**BUILDING 7
SECTION H**

Nails missed have been installed at exterior rated 15/32" plywood sheathing with 8d common nails spaced at 4" on-center.

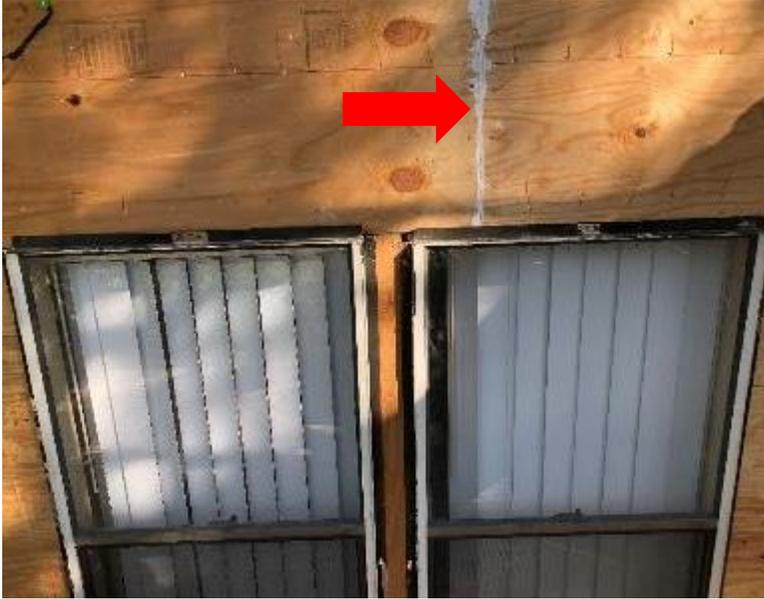
PHOTOGRAPH #25

**BUILDING 7
SECTION H**

BASF Urethane Sealant was applied at gaps larger than 1/8".

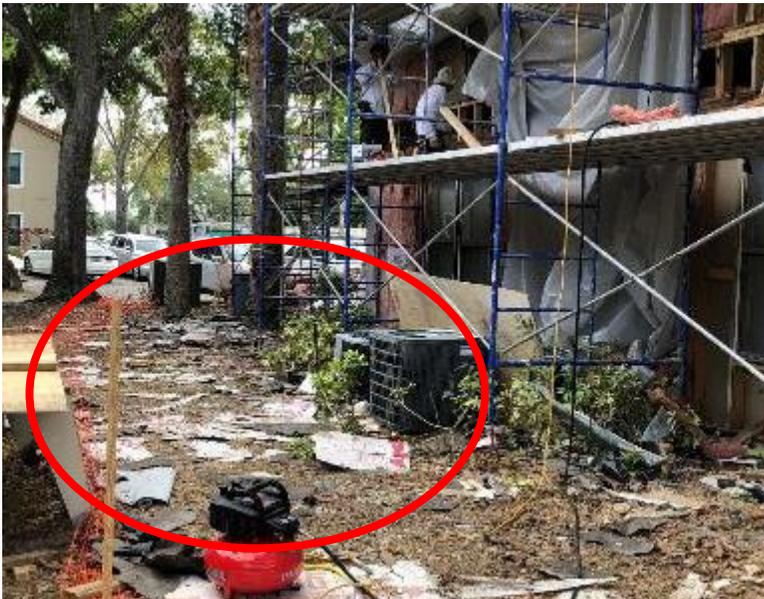
PHOTOGRAPH #26

**BUILDING 7
BUILDING PERIMETER**

Contractor to clean up the stucco and preexisting sheathing material that was removed during demolition.

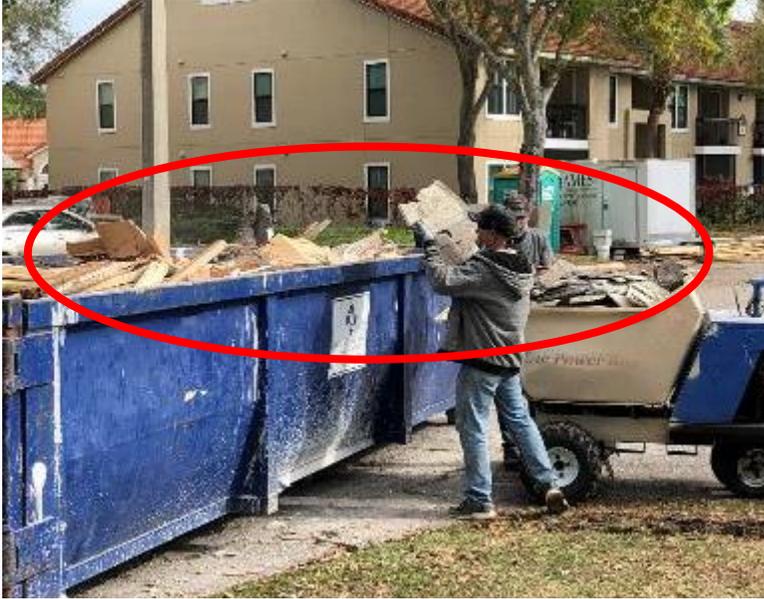
PHOTOGRAPH #27

**BUILDING 7
BUILDING PERIMETER**

Contractor is cleaning up the stucco and preexisting sheathing material that was removed during demolition.

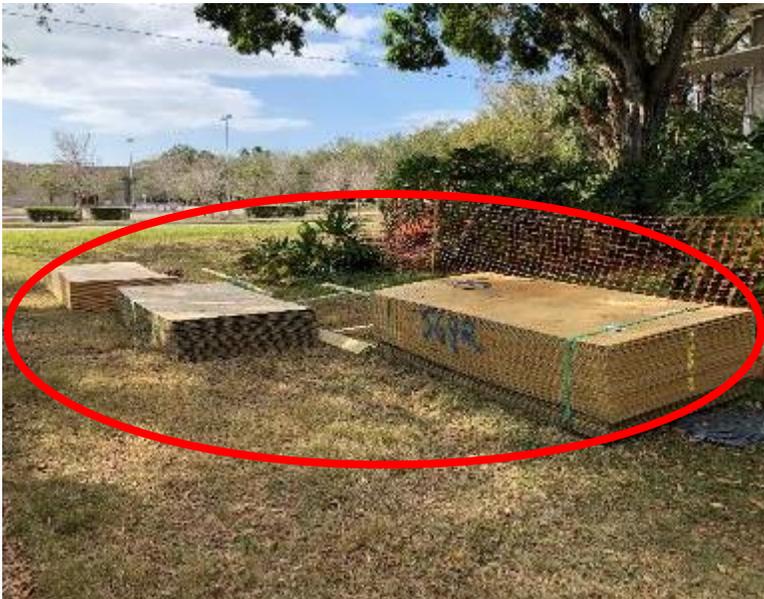
PHOTOGRAPH #28

**BUILDING 7
BUILDING PERIMETER**

15/32" exterior rated plywood sheathing stored on-site.

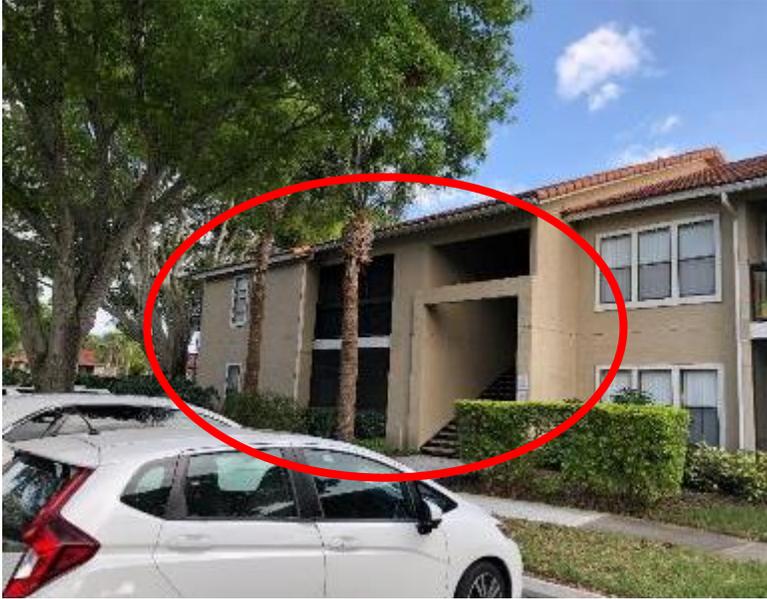
PHOTOGRAPH #29

**BUILDING 8
SECTION A**

Existing conditions of Building. Contractor has begun work on Building Sections E through H.

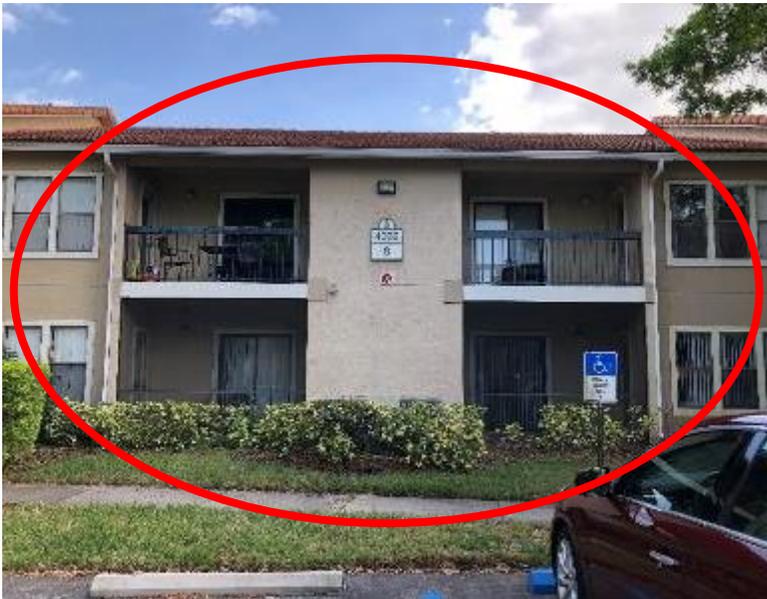
PHOTOGRAPH #30

**BUILDING 8
SECTION B**

Existing conditions of Building. Contractor has begun work on Building Sections E through H.

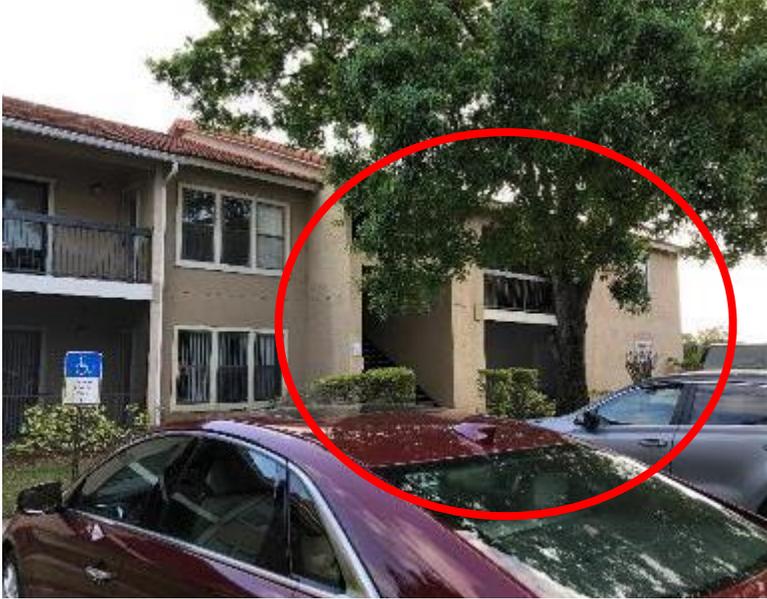
PHOTOGRAPH #31

**BUILDING 8
SECTION C**

Existing conditions of Building. Contractor has begun work on Building Sections E through H.

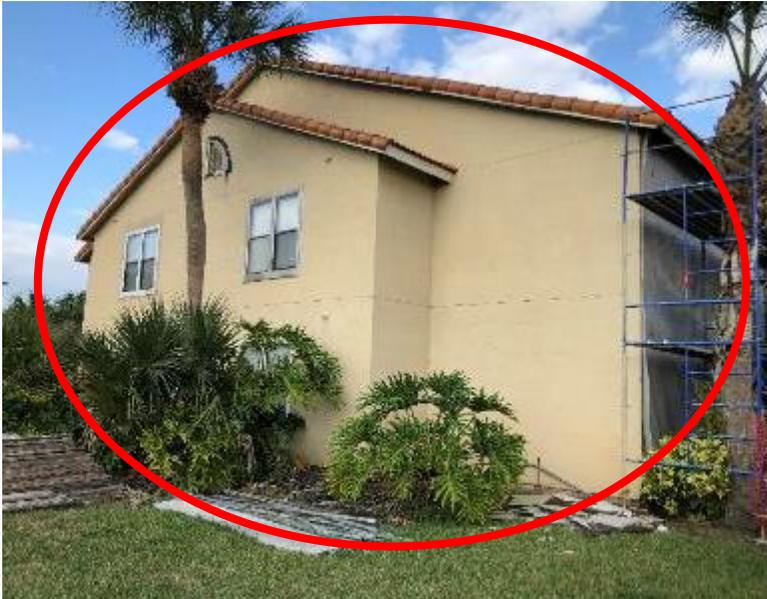
PHOTOGRAPH #32

**BUILDING 8
SECTION D**

Existing conditions of Building. Contractor has begun work on Building Sections E through H.

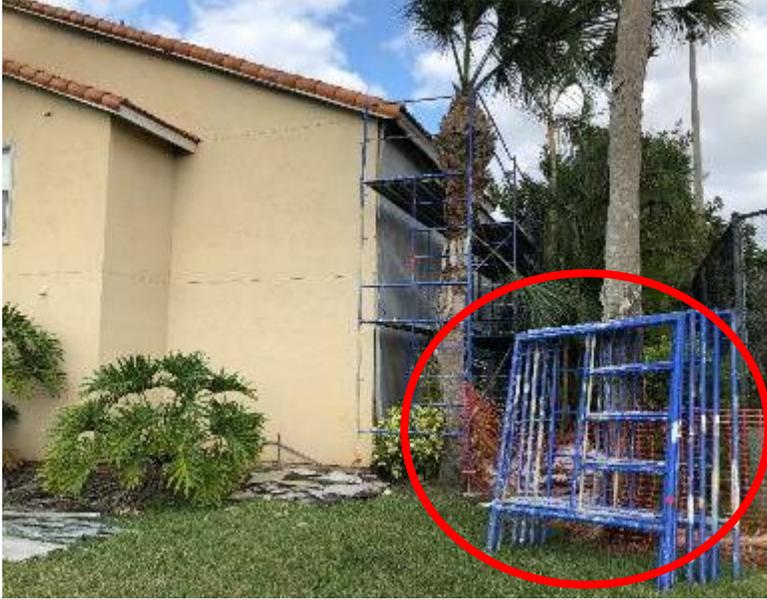
PHOTOGRAPH #33

**BUILDING 8
SECTION E**

Contractor installed construction perimeter plastic fencing in place, designating hard-hat areas.

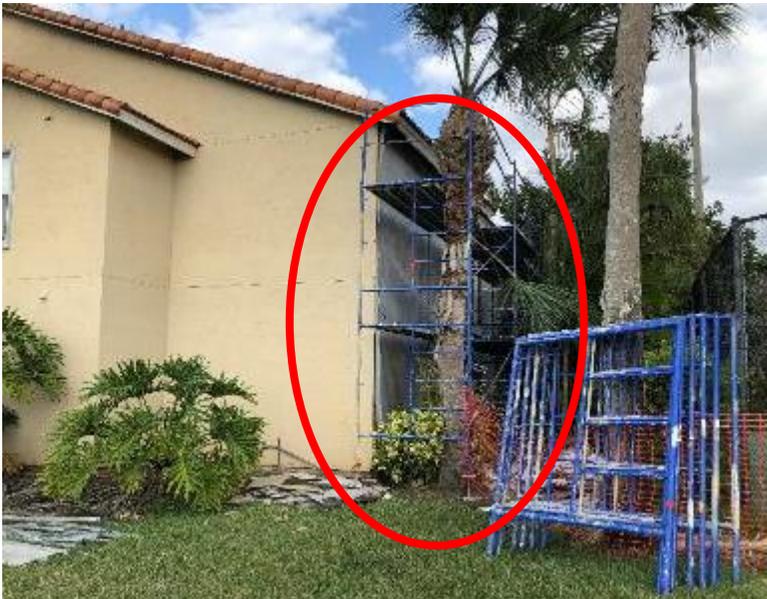
PHOTOGRAPH #34

**BUILDING 8
SECTION E**

Contractor installed scaffolding for Building Sections E through H. Contractor has begun demolition by removal of stucco and preexisting sheathing.

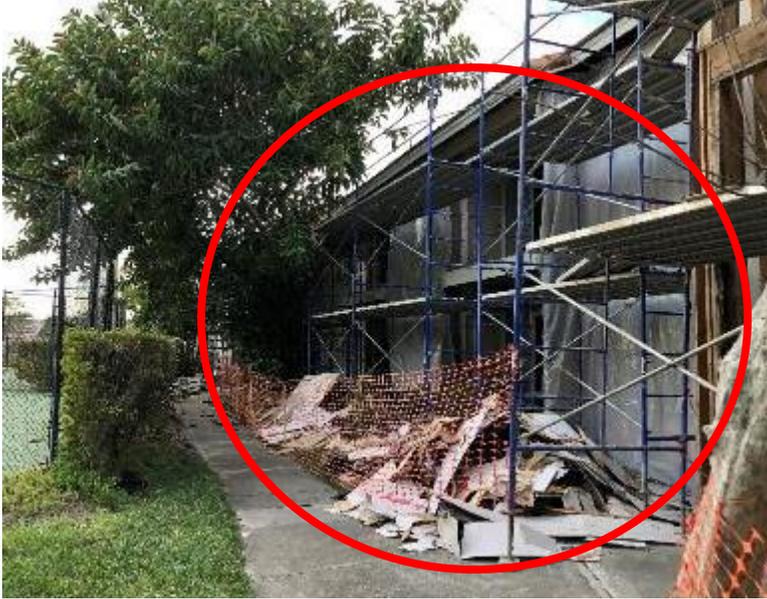
PHOTOGRAPH #35

**BUILDING 8
SECTION F**

Contractor installed scaffolding for Building Sections E through H. Contractor has begun demolition by removal of stucco and preexisting sheathing.

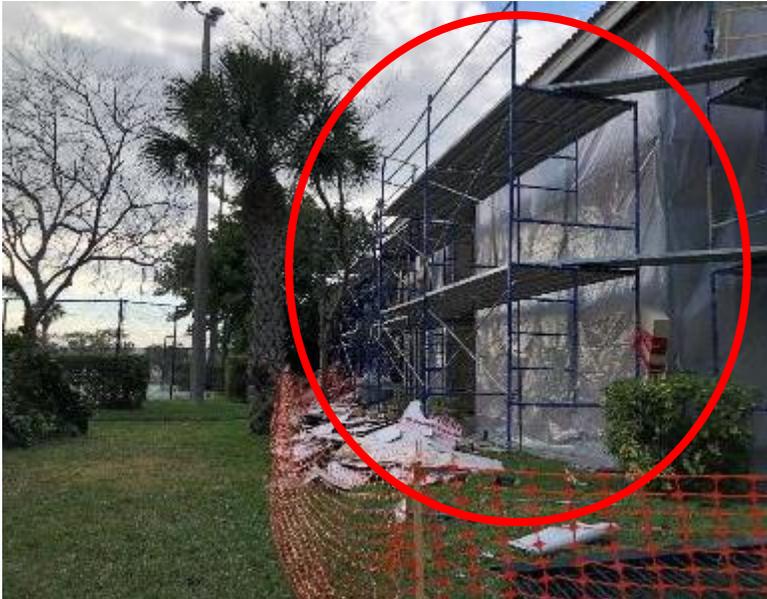
PHOTOGRAPH #36

**BUILDING 8
SECTION G**

Contractor installed scaffolding for Building Sections E through H. Contractor has begun demolition by removal of stucco and preexisting sheathing.

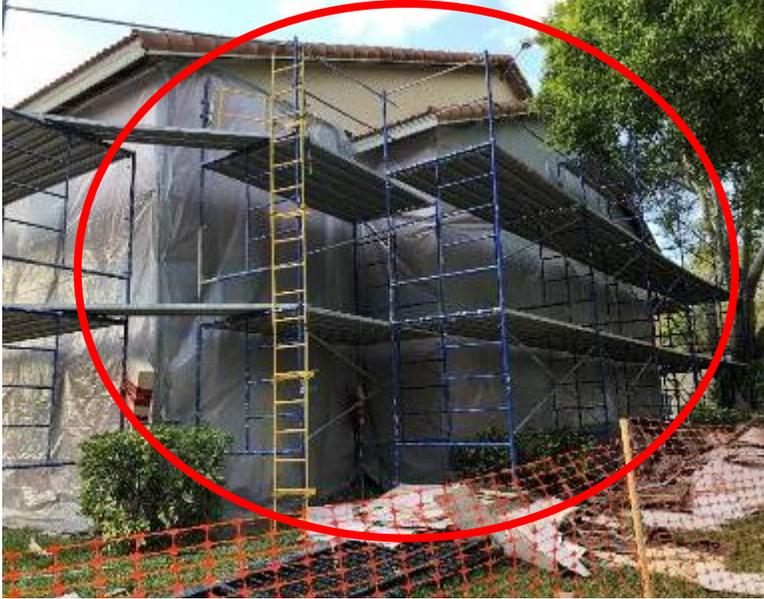
PHOTOGRAPH #37

**BUILDING 8
SECTION H**

Contractor installed scaffolding for Building Sections E through H. Contractor has begun demolition by removal of stucco and preexisting sheathing.
