PHOTOGRAPHS

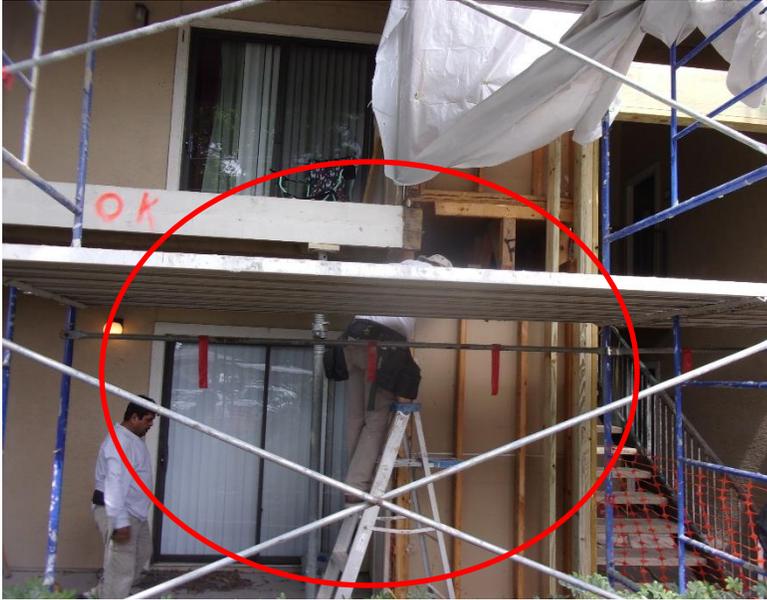
PHOTOGRAPH #1

BUILDING 7 SECTION A

Contractor proceeding with damage repairs at balcony support and wall framing.

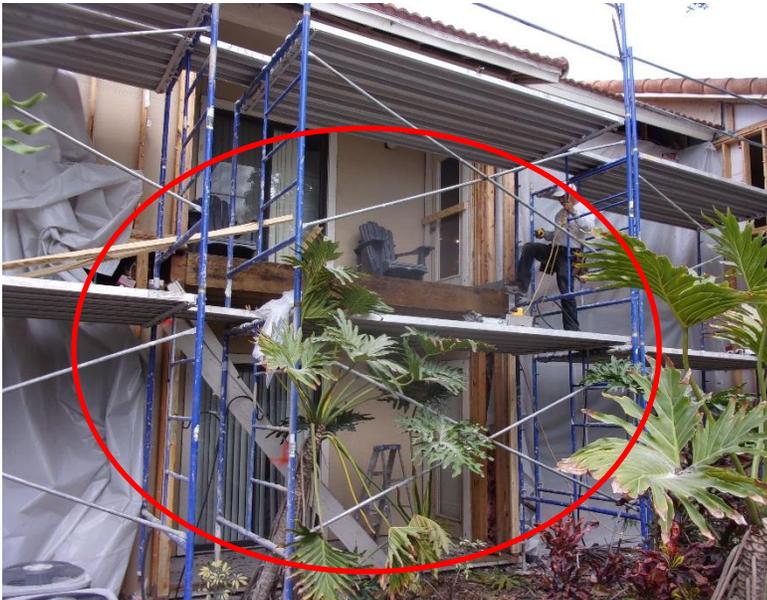
PHOTOGRAPH #2

BUILDING 7 SECTION B

Contractor proceeding with damage repairs at balcony support and wall framing.

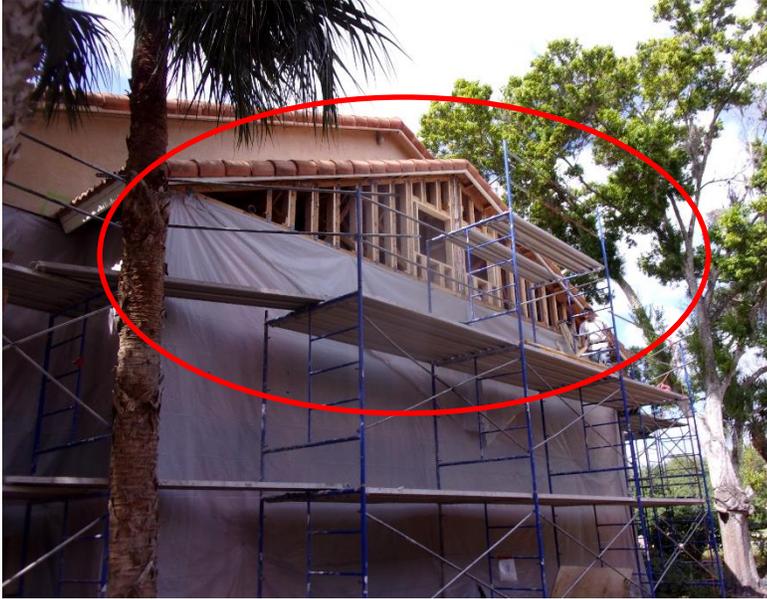
PHOTOGRAPH #3

**BUILDING 7
SECTION D**

Gable end reinforcement repairs in progress.

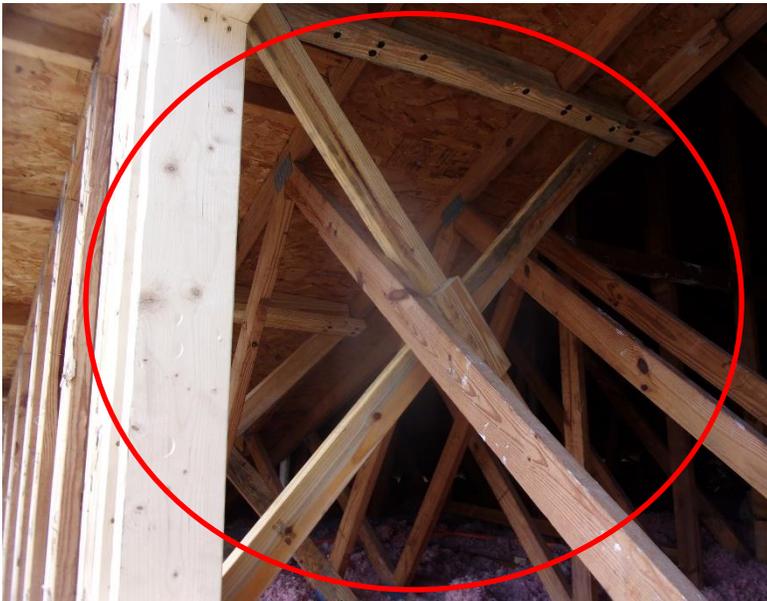
PHOTOGRAPH #4

**BUILDING 7
SECTION D**

Gable end reinforcement repairs in progress.

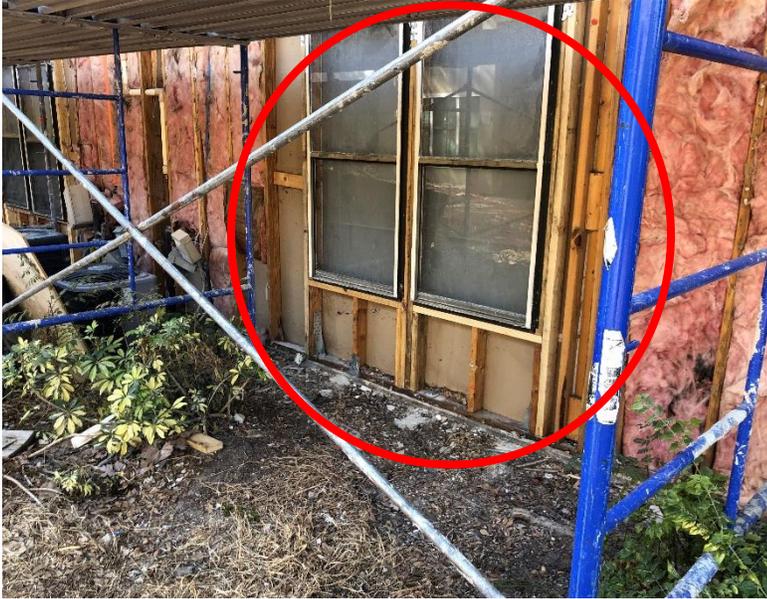
PHOTOGRAPH #5

**BUILDING 7
SECTION D**

Window opening and wall framing repairs in progress with 2"X4" southern yellow pine.

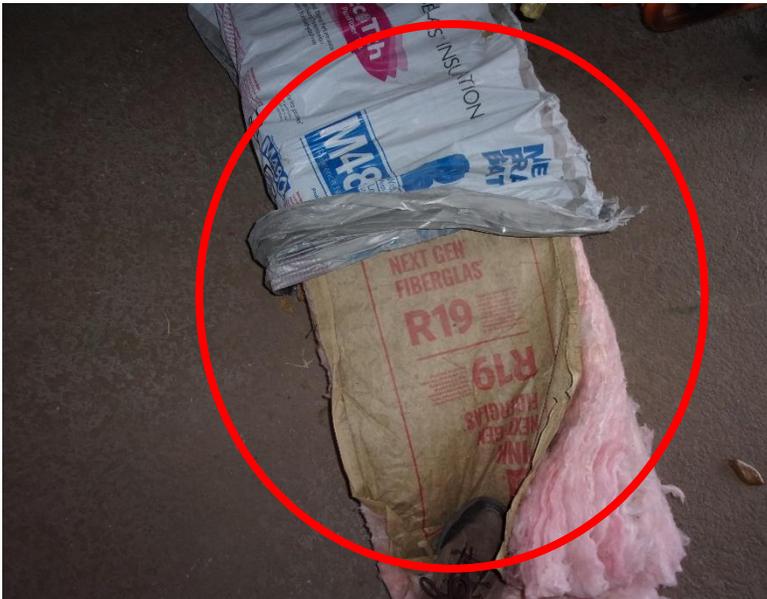
PHOTOGRAPH #6

**BUILDING 7
SECTION D**

Contractor installing new R19 insulation where missing or damaged.

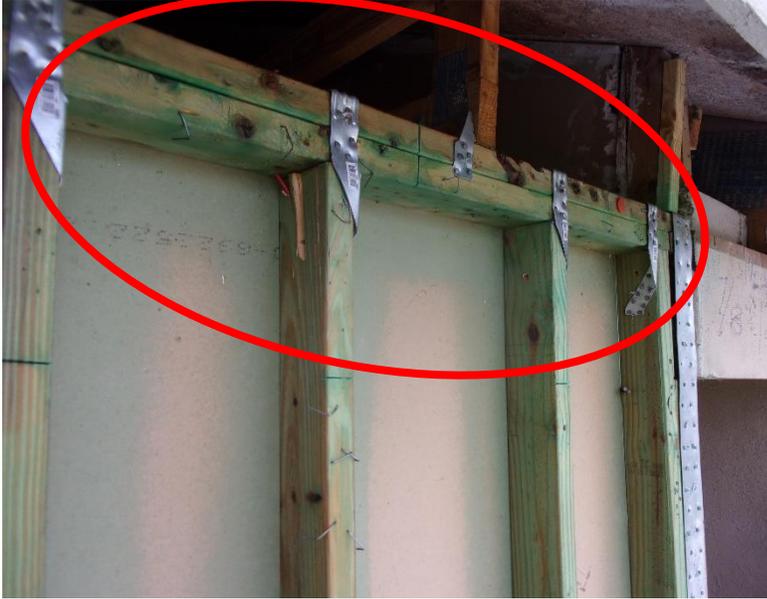
PHOTOGRAPH #7

**BUILDING 7
SECTION E**

New Simpson Strong -Tie connectors with SDWC15600 screws installed at top plates and trusses.

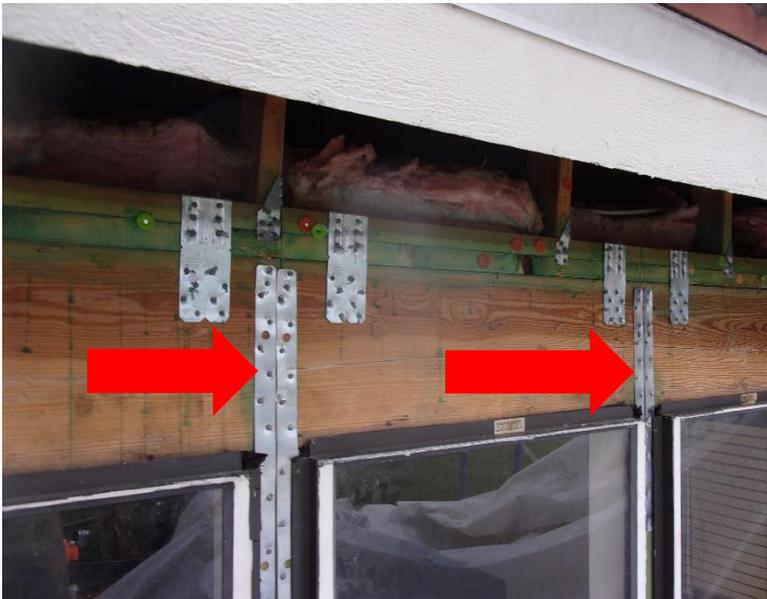
PHOTOGRAPH #8

**BUILDING 8
SECTION F**

Simpson Strong -Tie straps installed between windows where previously missing.

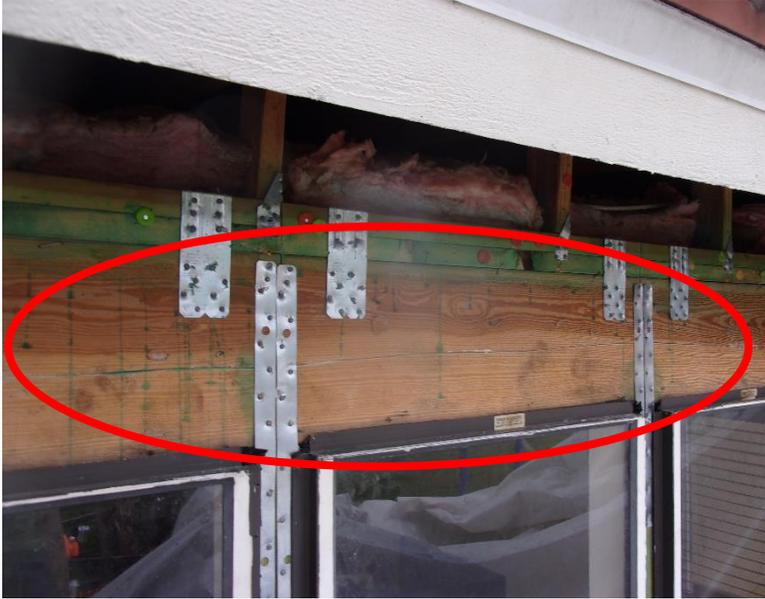
PHOTOGRAPH #9

**BUILDING 7
SECTION F**

Window header framing does not have required termite treatment

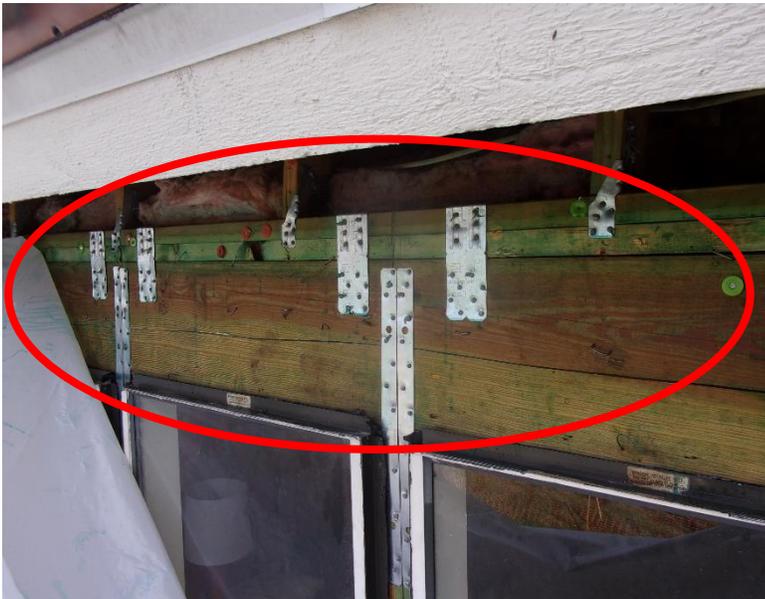
PHOTOGRAPH #10

**BUILDING 7
SECTION F**

Contractor has hand applied termite treatment were missing at window header.

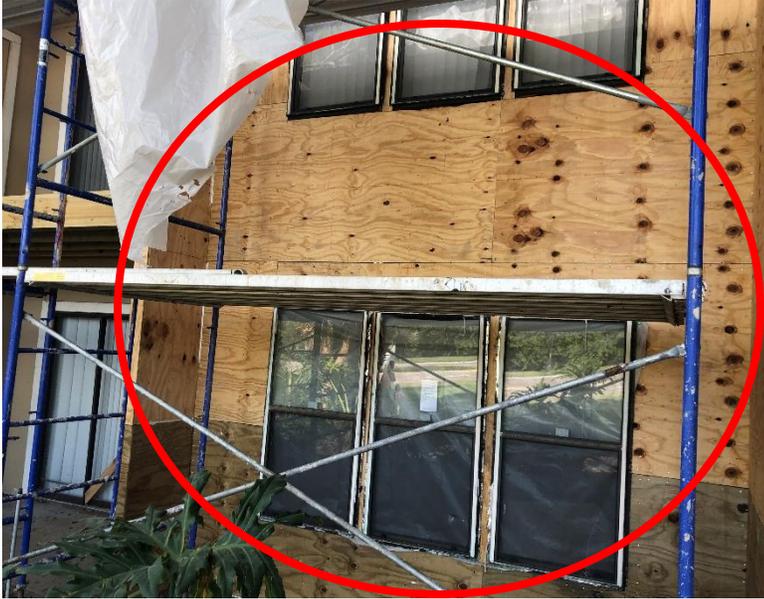
PHOTOGRAPH #11

**BUILDING 7
SECTION F**

New 15/32" plywood sheathing attached to framing. Bottom row of 4' X 8' sheet of plywood is pressure treated as per specification requirements.

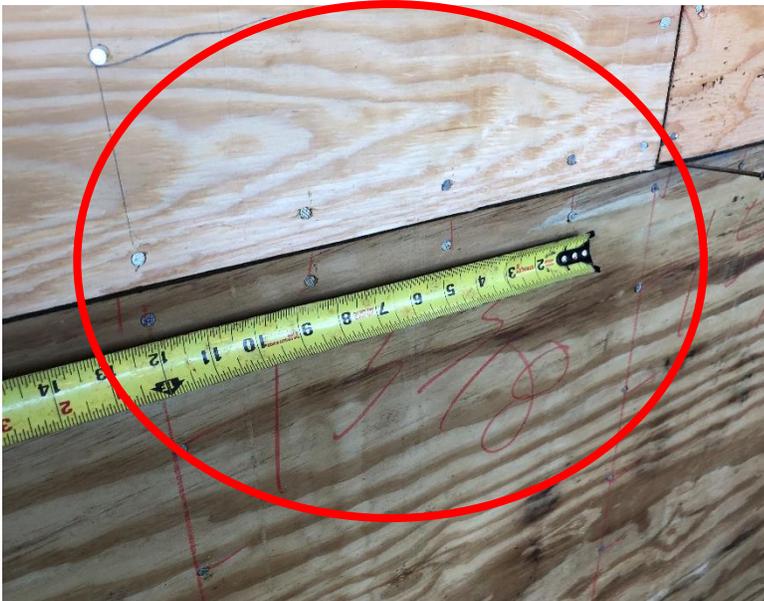
PHOTOGRAPH #12

**BUILDING 7
SECTION F**

New sheathing attachments at perimeters are as per drawings and specifications at 4" O.C.

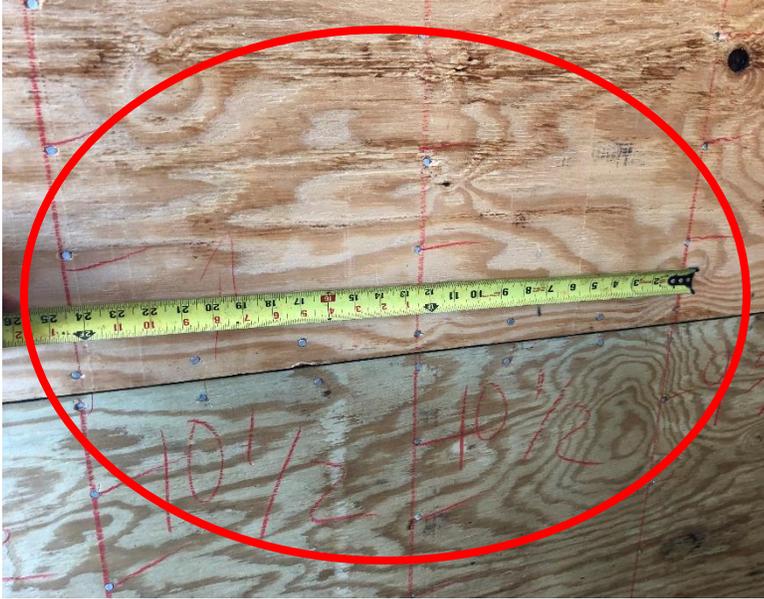
PHOTOGRAPH #13

**BUILDING 7
SECTION F**

New sheathing attached at wall framing as per drawings and specifications at minimum 16" attachments.

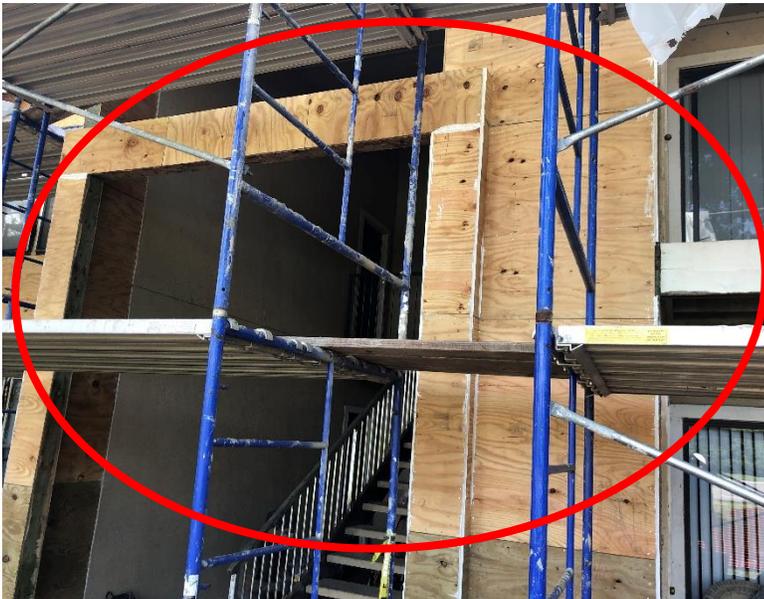
PHOTOGRAPH #14

**BUILDING 7
SECTION G**

New 15/32" plywood sheathing attached to framing. Bottom row of 4' X 8' sheet of plywood is pressure treated as per specification requirements.

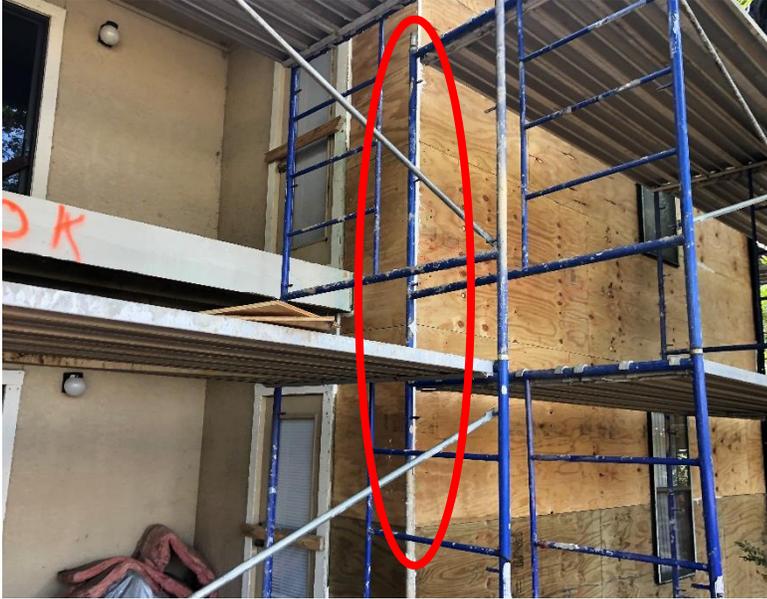
PHOTOGRAPH #15

**BUILDING 7
SECTION G**

BASF urethane applied at sheathing gaps larger than 1/8".

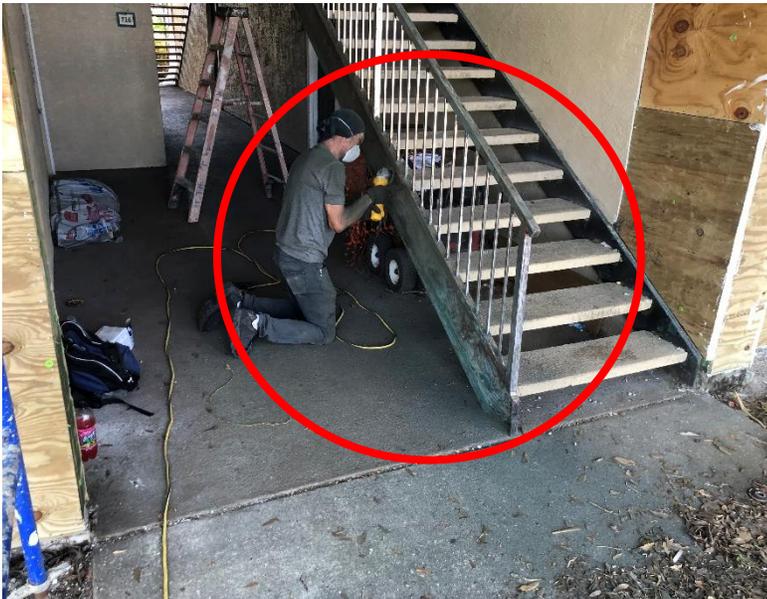
PHOTOGRAPH #16

**BUILDING 7
SECTION G**

Contractor preparing Steel stairway railings for painting utilizing hand grinders to remove loose and deteriorated coatings.

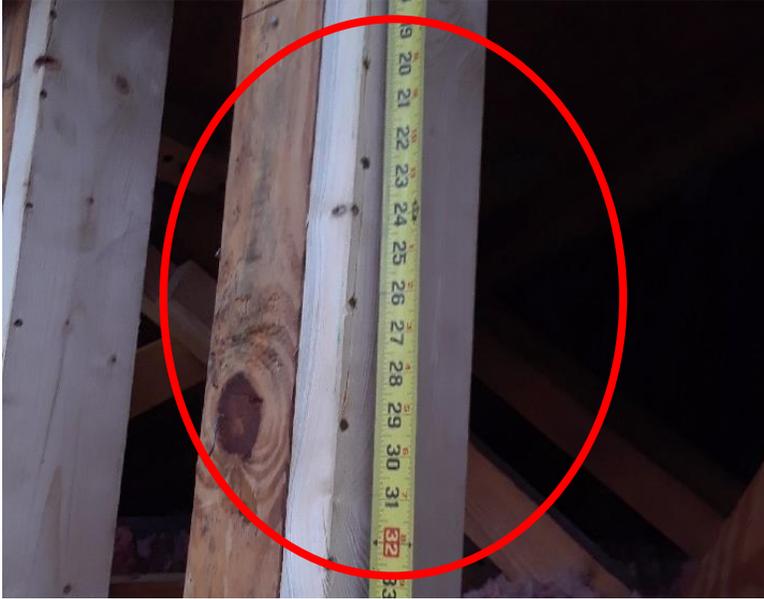
PHOTOGRAPH #17

**BUILDING 7
SECTION H**

L-SCAB reinforcement at gable end fastened as per specifications with 10d nails 6" O.C. minimum.

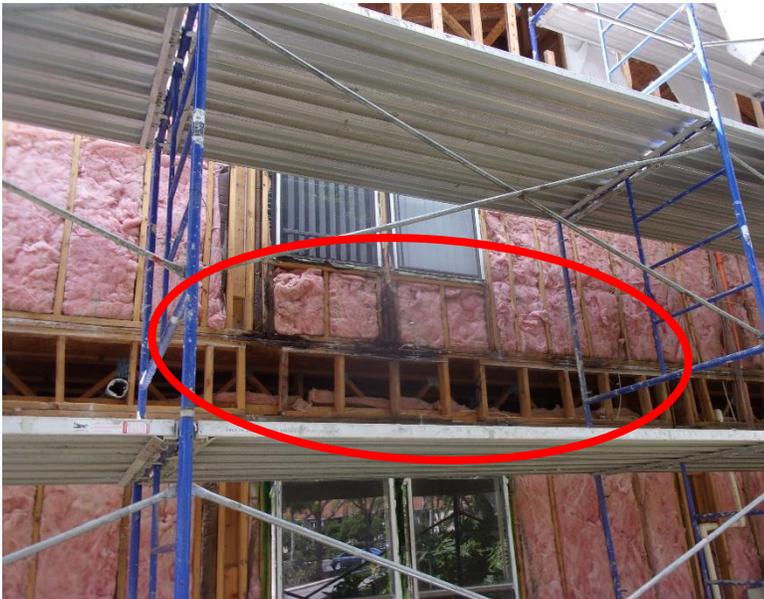
PHOTOGRAPH #18

**BUILDING 8
SECTION H**

Wood framing (termite and dry rot) damage inspected and marked for repairs.

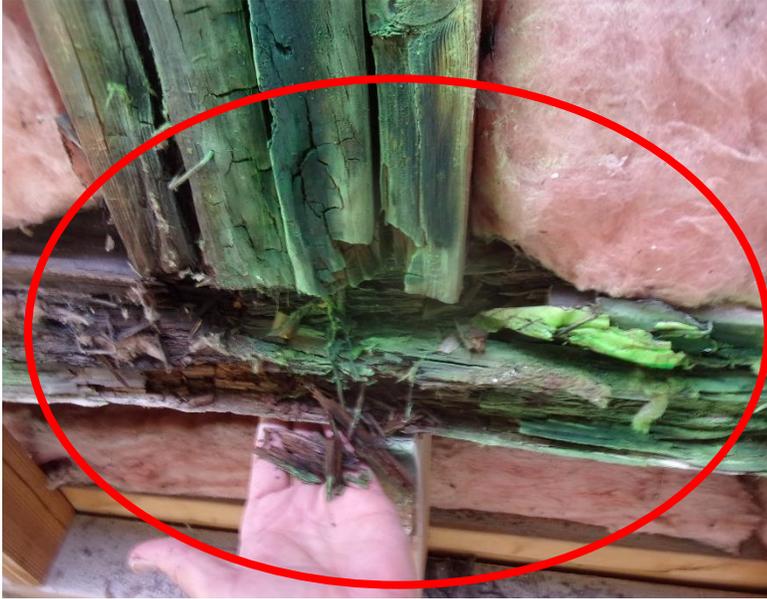
PHOTOGRAPH #19

**BUILDING 8
SECTION H**

Collapsing wood framing damage at window framing and 2nd floor bottom plate marked for repairs.

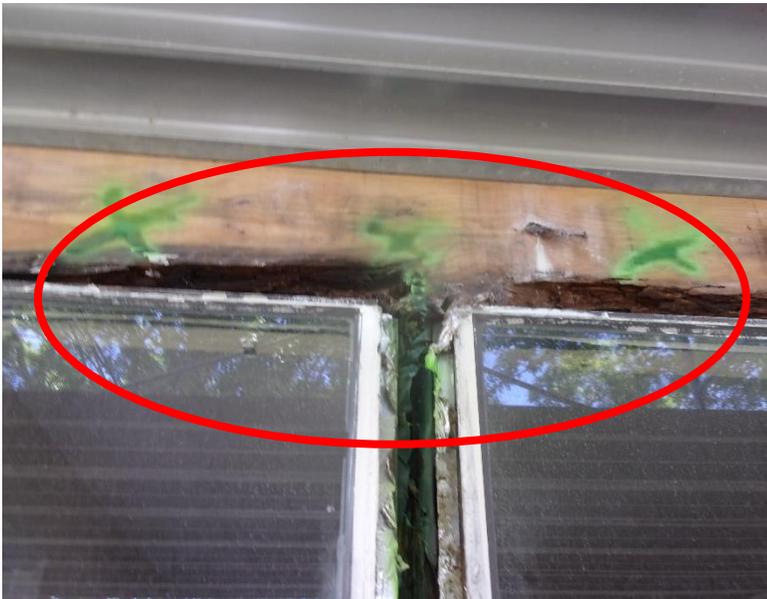
PHOTOGRAPH #20

**BUILDING 8
SECTION H**

Double window header damage marked for repairs.

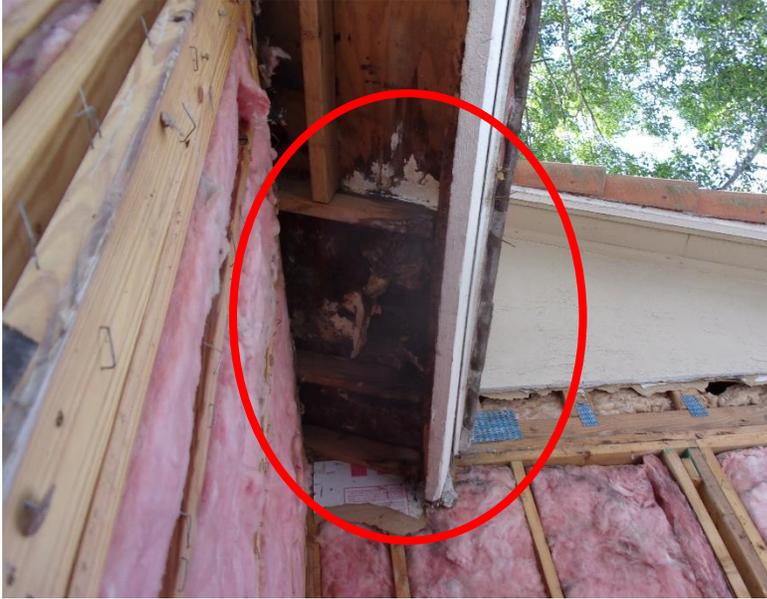
PHOTOGRAPH #21

**BUILDING 8
SECTION H**

Previous and current leaks have damaged roof sheathing. Owners to have repairs done by others.

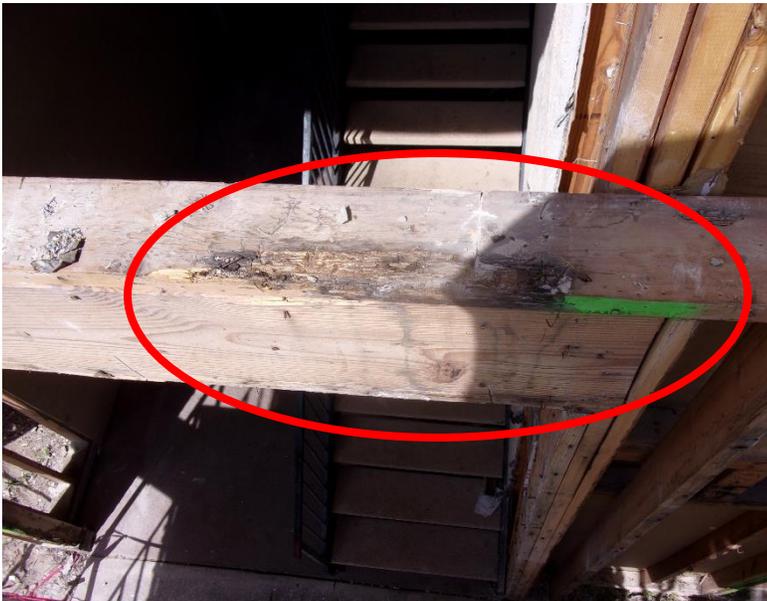
PHOTOGRAPH #22

**BUILDING 8
SECTION G**

Breezeway box beam damage marked for repairs.

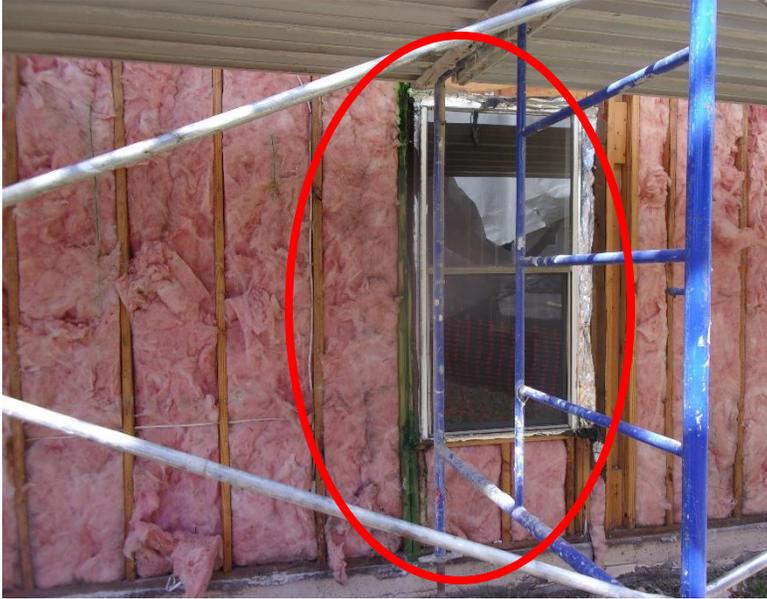
PHOTOGRAPH #23

**BUILDING 8
SECTION G**

Window framing damage and bottom plate marked for repairs.

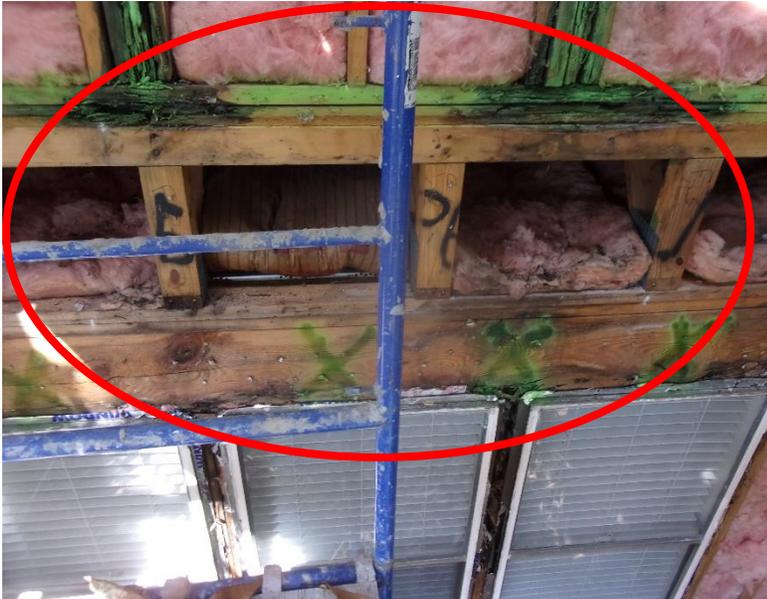
PHOTOGRAPH #24

**BUILDING 8
SECTION F**

Framing damage at wall studs, 2nd floor bottom plate and double window header marked for repairs.

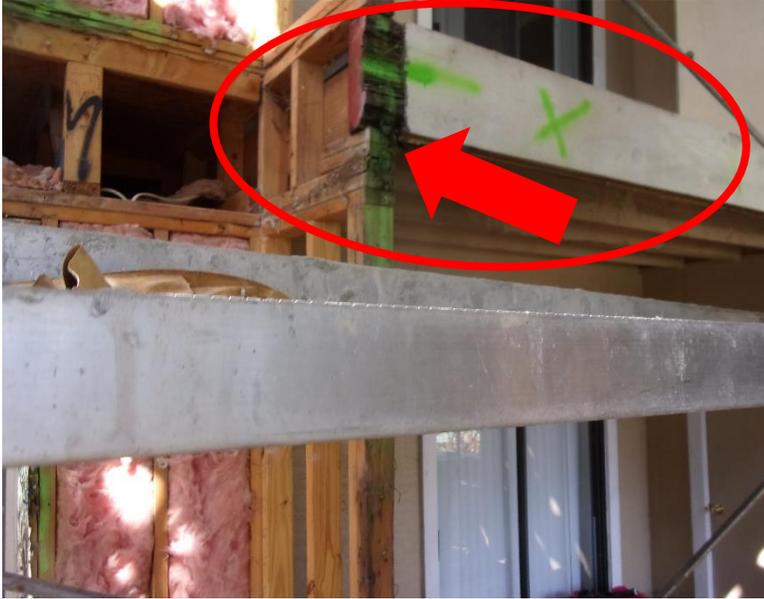
PHOTOGRAPH #25

**BUILDING 8
SECTION F**

Previous balcony built up beam repair is not properly bearing on support post framing and will require removal and replacement repairs.

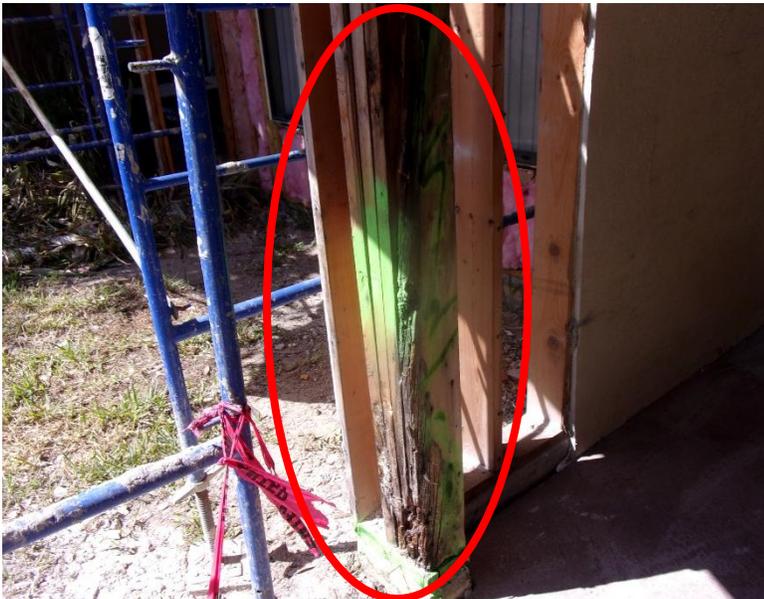
PHOTOGRAPH #26

**BUILDING 8
SECTION E**

Collapsing wood framing damage at breezeways marked for repairs.

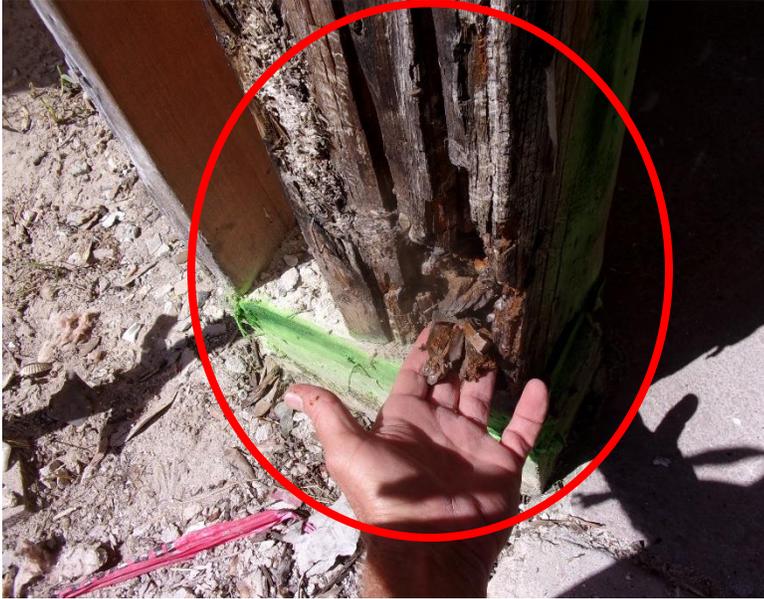
PHOTOGRAPH #27

**BUILDING 8
SECTION E**

Collapsing wood framing damage at breezeways marked for repairs.

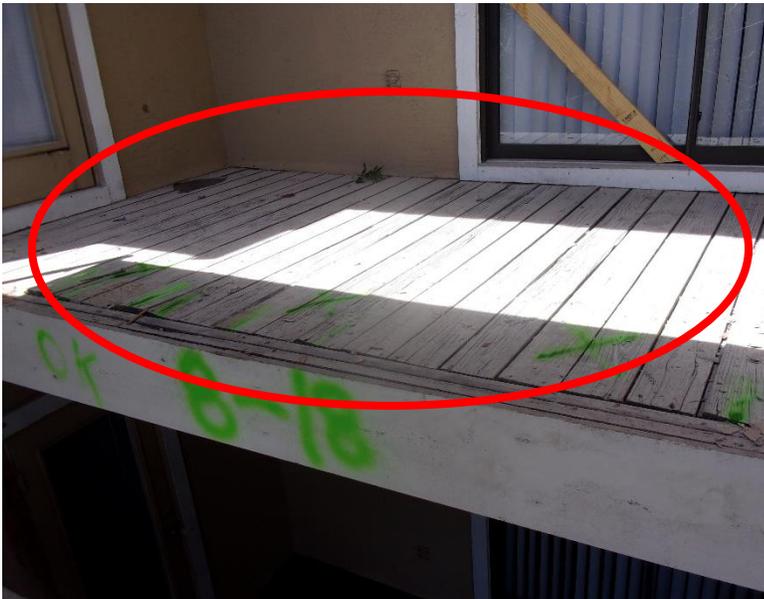
PHOTOGRAPH #28

**BUILDING 8
SECTION E**

Balcony decking damage marked for replacement.
