## PHOTOGRAPHS

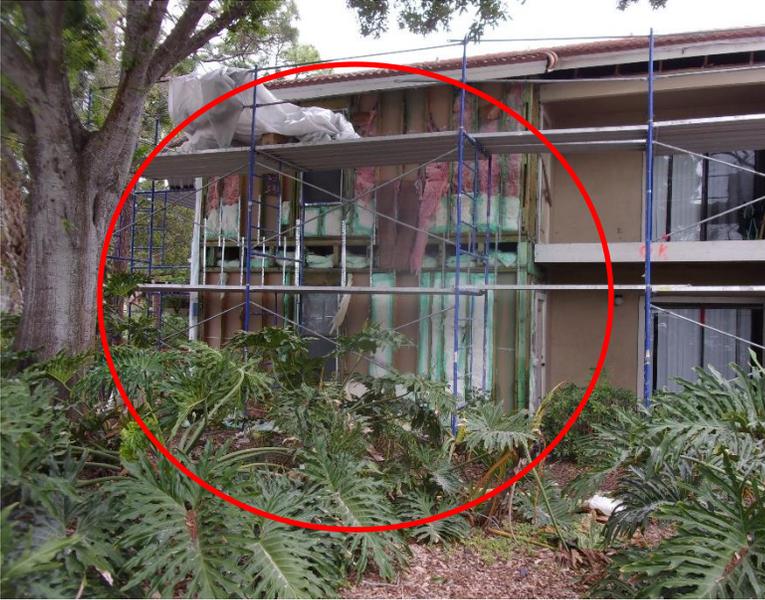
**PHOTOGRAPH #1**

### **BUILDING 7 SECTION A**

Bora Care termite treatment applied, and Simpson Strong-Tie connectors installed.

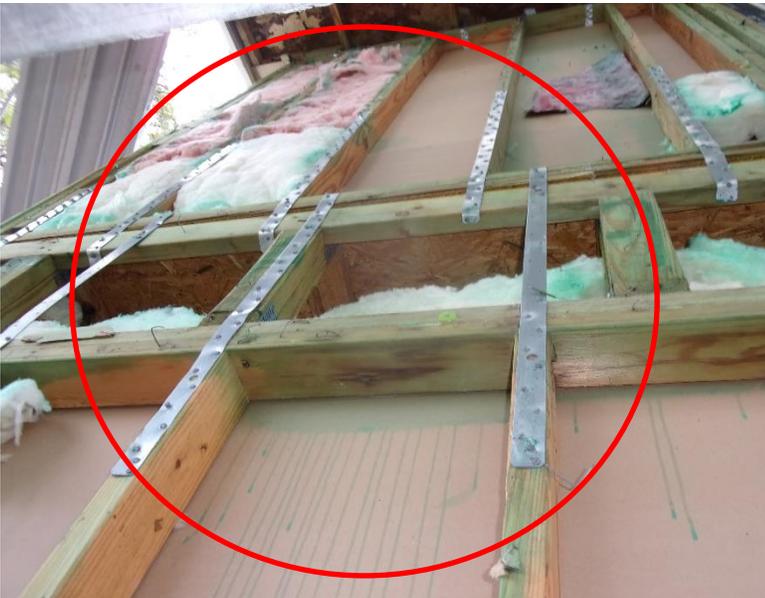
**PHOTOGRAPH #2**

### **BUILDING 7 SECTION A**

Simpson MTSA straps installed at each stud as per drawings and specifications.

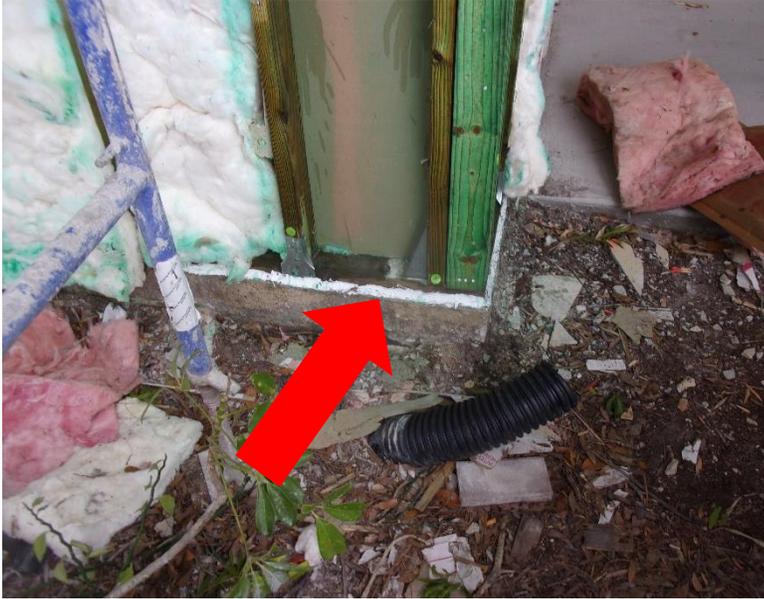
**PHOTOGRAPH #3**

**BUILDING 7  
SECTION A**

BASF Urethane Sealant applied at bottom plate to foundation as per ESI detail and Change Order.

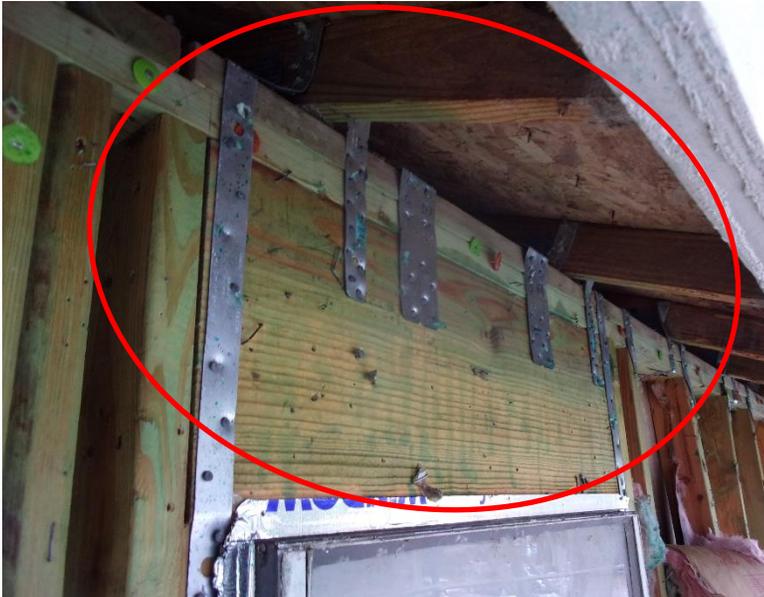
**PHOTOGRAPH #4**

**BUILDING 7  
SECTION A**

Simpson strong tie connectors properly nailed and screwed at headers, studs, top plate, and truss connections.

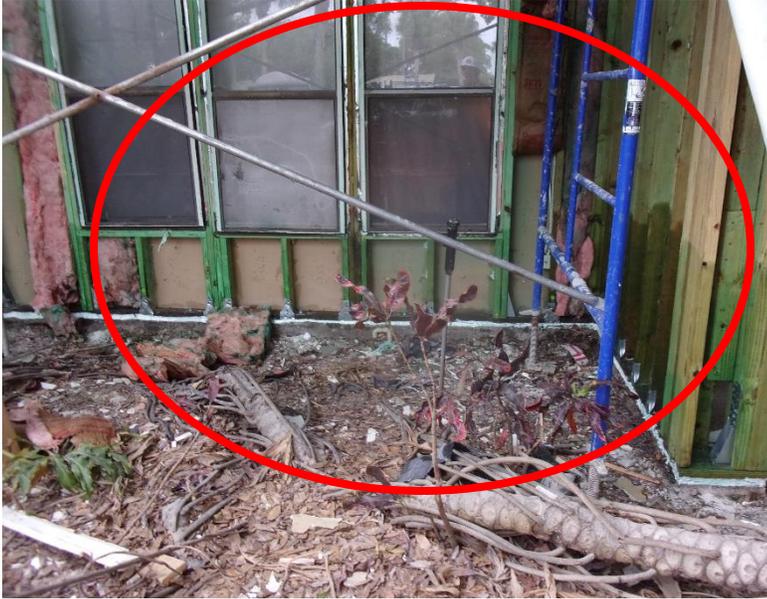
**PHOTOGRAPH #5**

**BUILDING 7  
SECTION B**

Bora Care termite treatment and Copper Green wood preservation applied as per specifications.

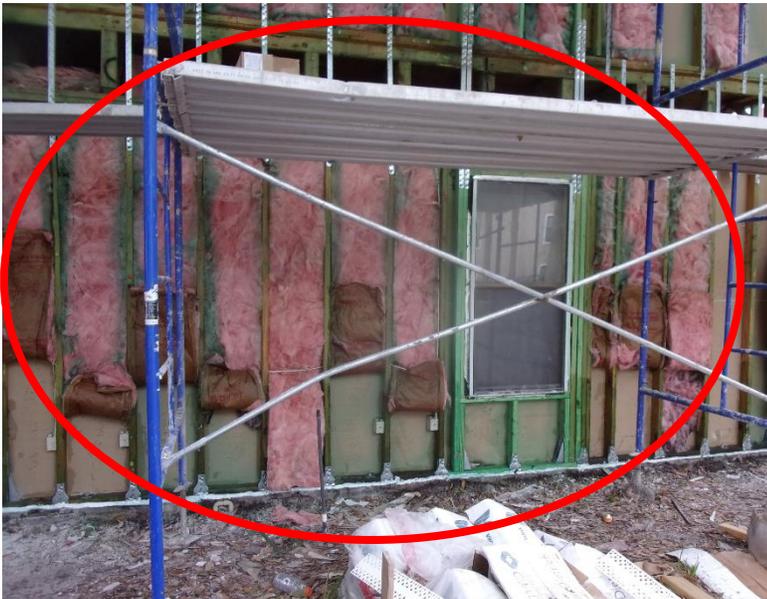
**PHOTOGRAPH #6**

**BUILDING 7  
SECTION C**

Bora Care termite treatment applied, and Simpson Strong-Tie connectors installed.

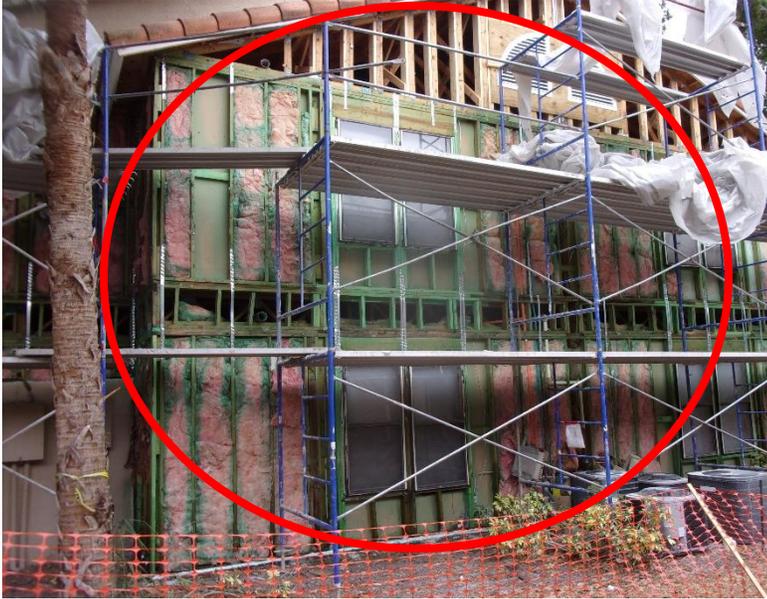
**PHOTOGRAPH #7**

**BUILDING 7  
SECTION D**

Bora Care termite treatment applied. Simpson Strong-Tie connectors installed, and new Green Heck louvers placed for installation.

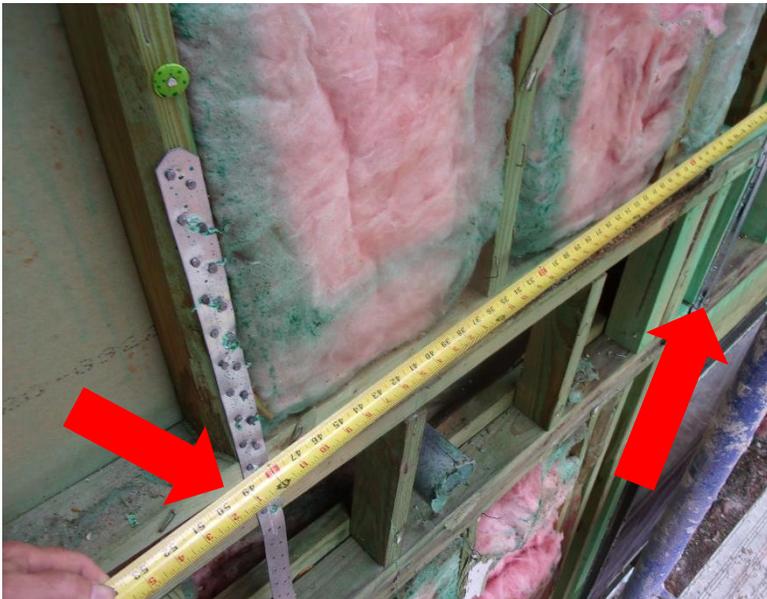
**PHOTOGRAPH #8**

**BUILDING 8  
SECTION D**

Simpson Strong -Tie straps MSTA 49 attached at 48" O.C. to studs above and below floor trusses.

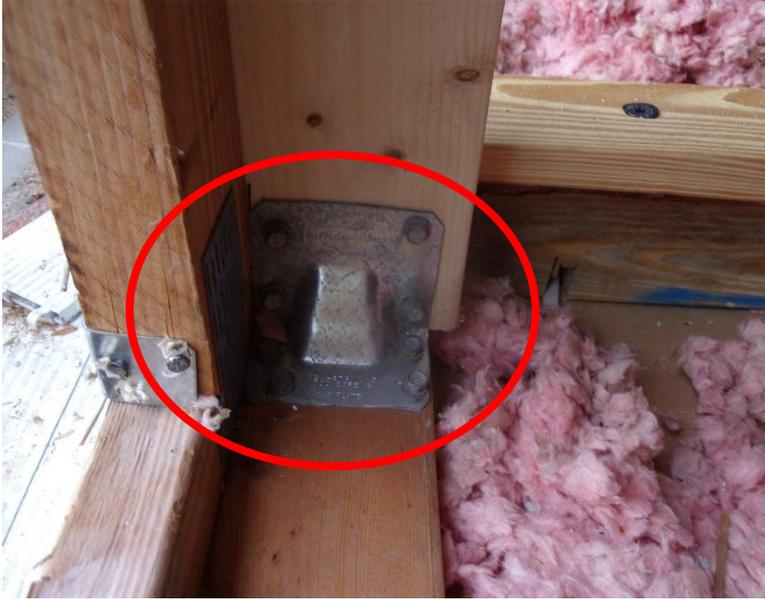
**PHOTOGRAPH #9**

**BUILDING 7  
SECTION D**

Simpson Strong-Tie HGA10 Clips  
attached at gable truss to plate at 48" O.C.

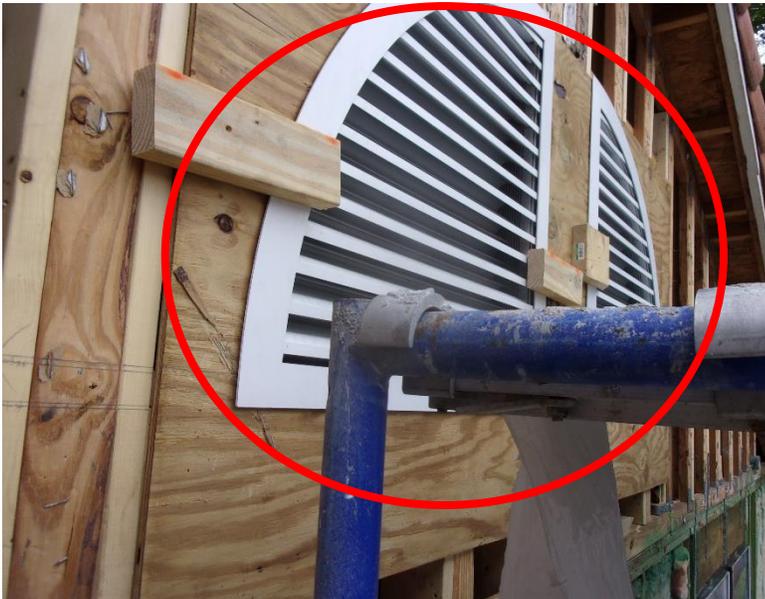
**PHOTOGRAPH #10**

**BUILDING 7  
SECTION D**

Green Heck louvers placed for installation  
at gable end.

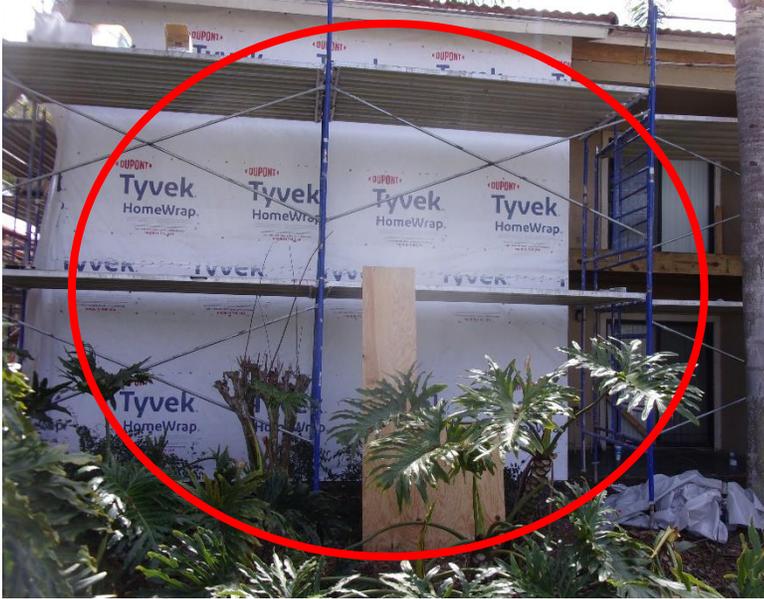
**PHOTOGRAPH #11**

**BUILDING 7  
SECTION E**

Dupont Tyvek HomeWrap water vapor barrier applied over new plywood sheathing as per drawings and specifications.

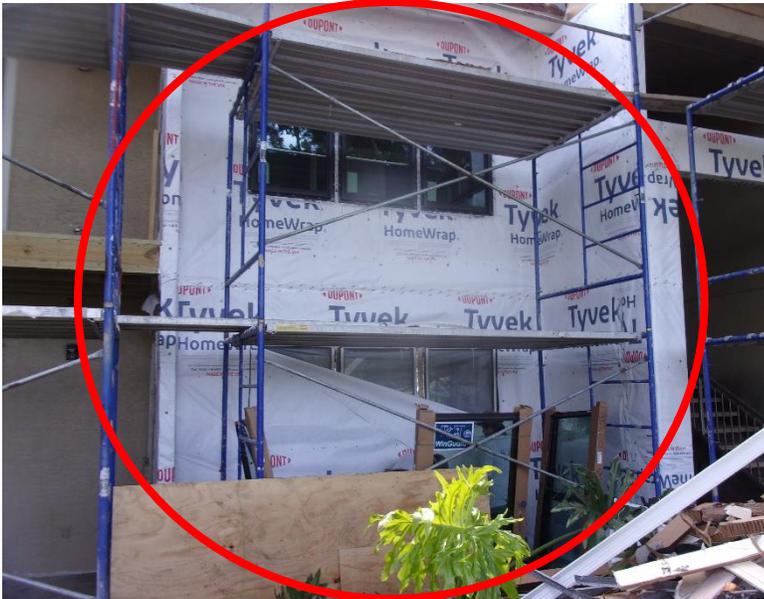
**PHOTOGRAPH #12**

**BUILDING 7  
SECTION F**

New Dupont Tyvek HomeWrap water vapor barrier and New PGT windows flashing and installation in progress.

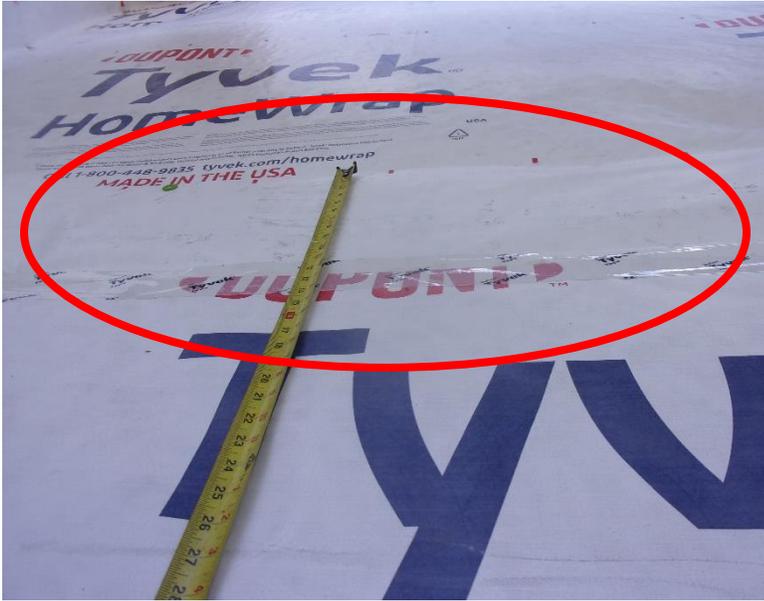
**PHOTOGRAPH #13**

**BUILDING 7  
SECTION F**

Dupont Tyvek HomeWrap water vapor barrier overlapped, and seam taped as per specifications and manufactures recommendations.

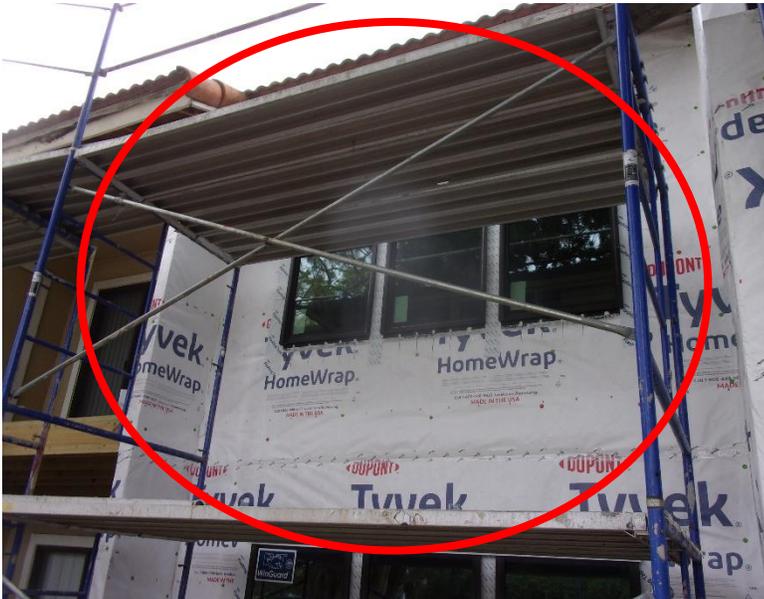
**PHOTOGRAPH #14**

**BUILDING 7  
SECTION F**

New Dupont Tyvek HomeWrap water vapor barrier applied and New PGT windows installed.

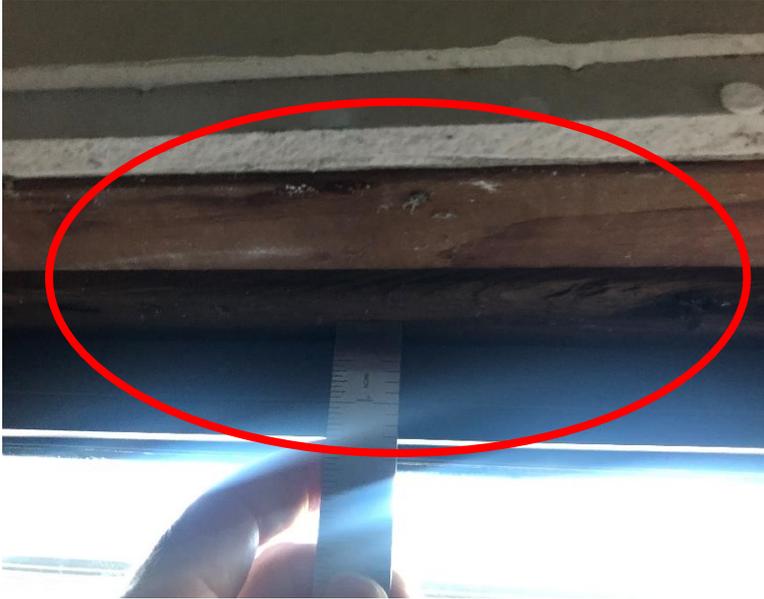
**PHOTOGRAPH #15**

**BUILDING 7  
SECTION F**

Unit #714- Window installation gap at header, confirmed to be within PGT minimum 5/16" requirements.

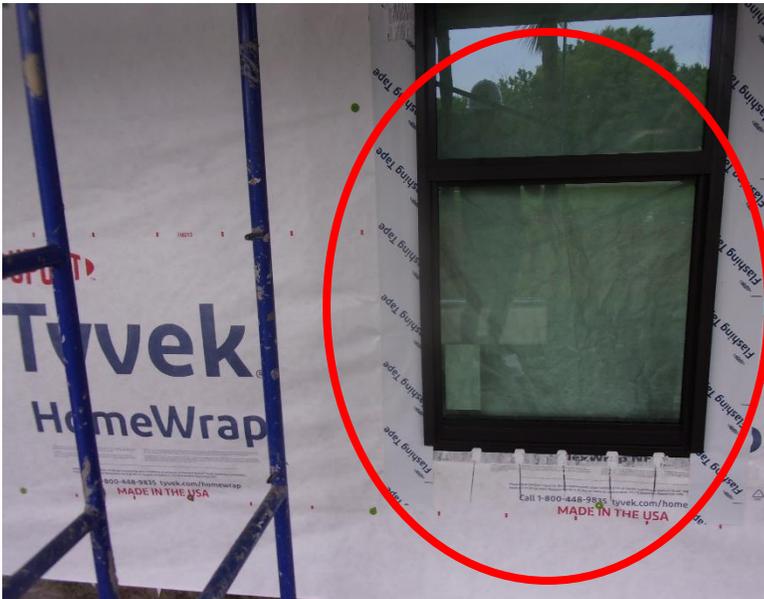
**PHOTOGRAPH #16**

**BUILDING 7  
SECTION G**

Unit #712- PGT window installation with Dupont Tyvek flashing as per specifications and drawings.

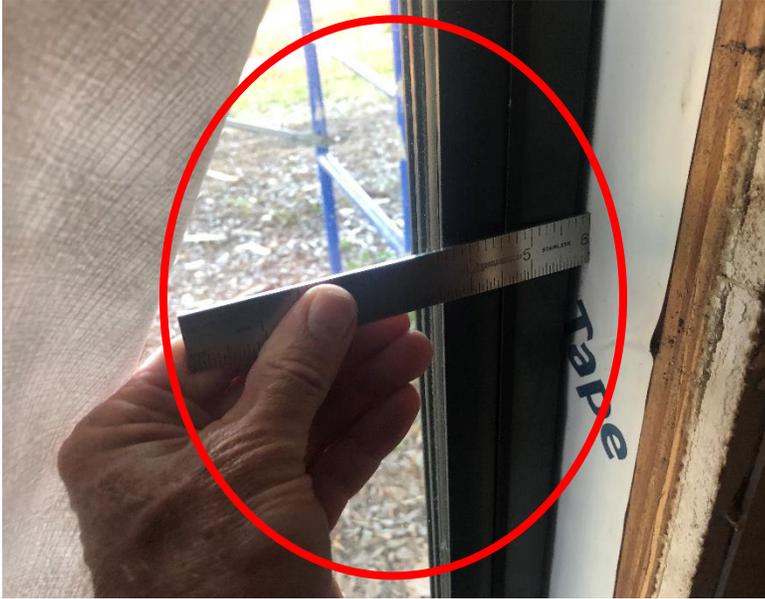
**PHOTOGRAPH #17**

**BUILDING 7  
SECTION G**

Unit #712- Window installation gap at jamb, confirmed to be within PGT minimum 5/16" requirements.

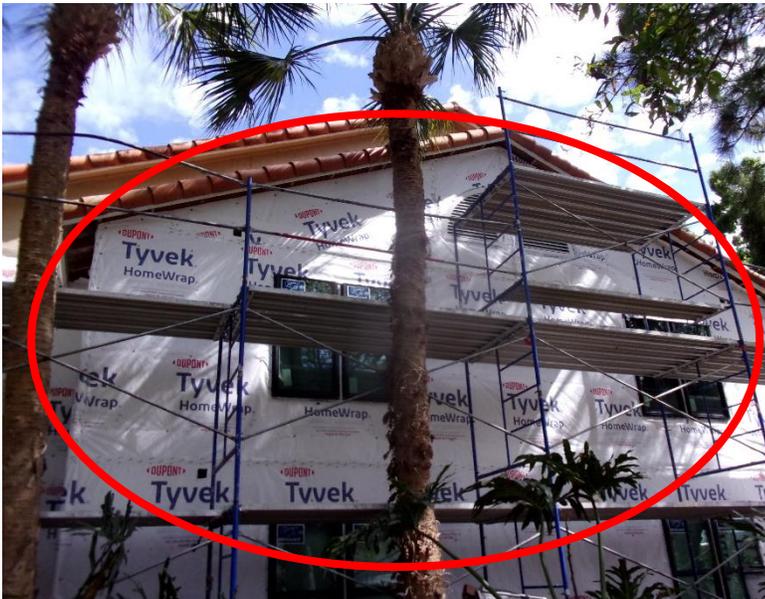
**PHOTOGRAPH #18**

**BUILDING 7  
SECTION H**

New Dupont Tyvek HomeWrap water vapor barrier applied and New PGT windows installed.

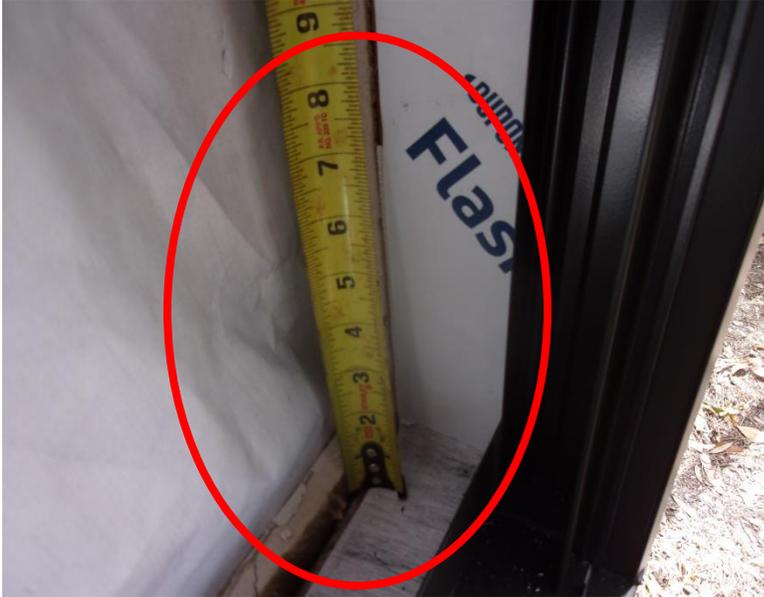
**PHOTOGRAPH #19**

**BUILDING 7  
SECTION H**

Unit #711- Dupont Flashing at window opening sill to jamb overlap confirmed as per specifications and manufacture's recommendations.

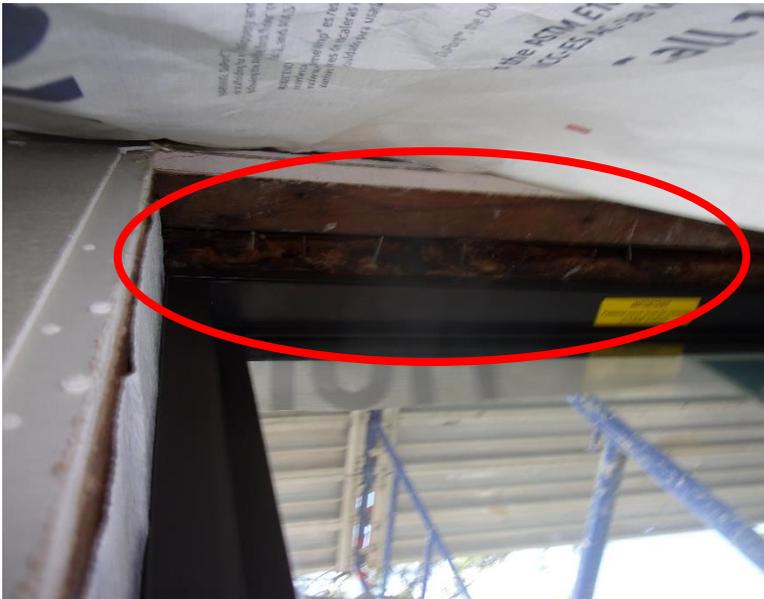
**PHOTOGRAPH #20**

**BUILDING 7  
SECTION H**

Unit #711- damaged window header framing has not been replaced prior to installation of new PGT window.

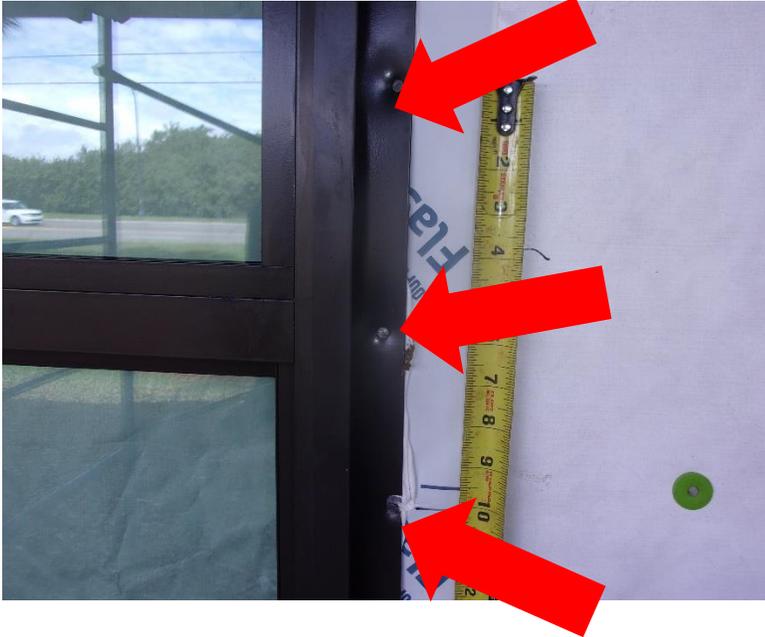
**PHOTOGRAPH #21**

**BUILDING 7  
SECTION H**

Fasting of new window flange marked and nailed at 5" O.C. as per Manufactures NOA and specifications.

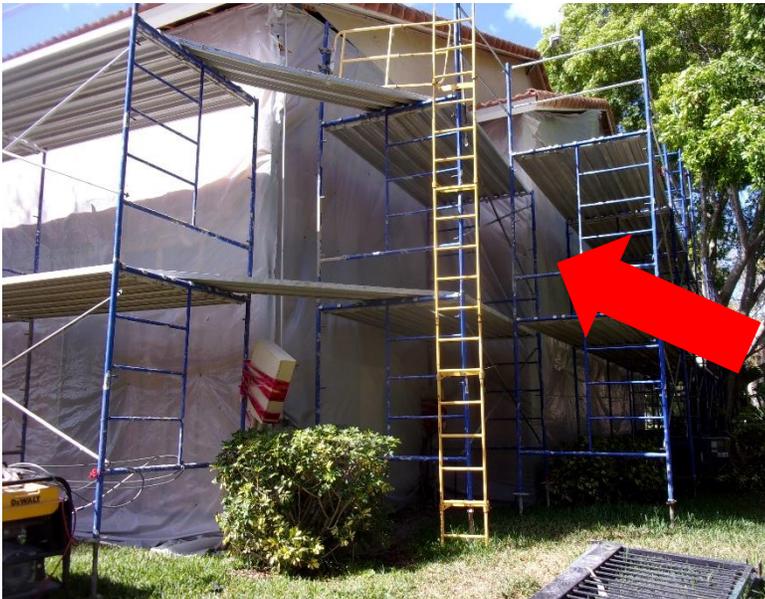
**PHOTOGRAPH #22**

**BUILDING 8  
SECTION H**

Contractor has begun framing repairs at marked locations and covered open wall sections with heavy Ply plastic for weather protection.

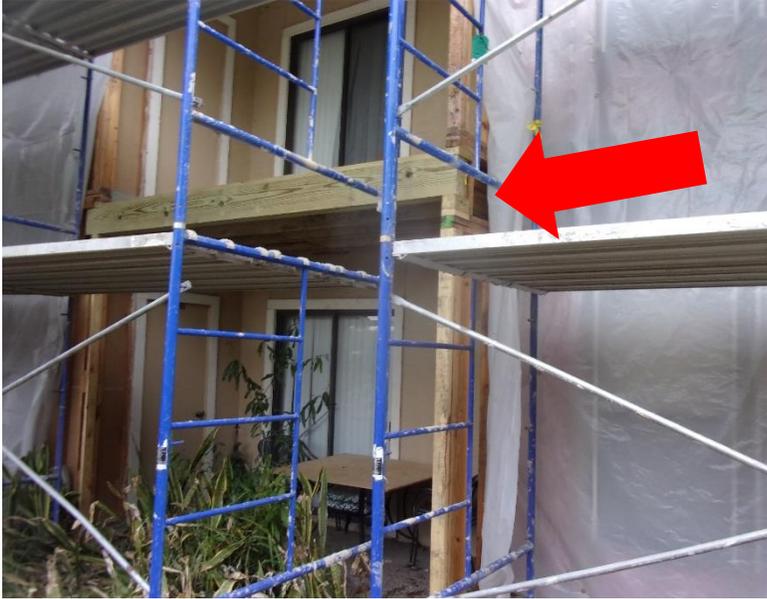
**PHOTOGRAPH #23**

**BUILDING 8  
SECTION F**

Built up beam balcony repairs in progress.

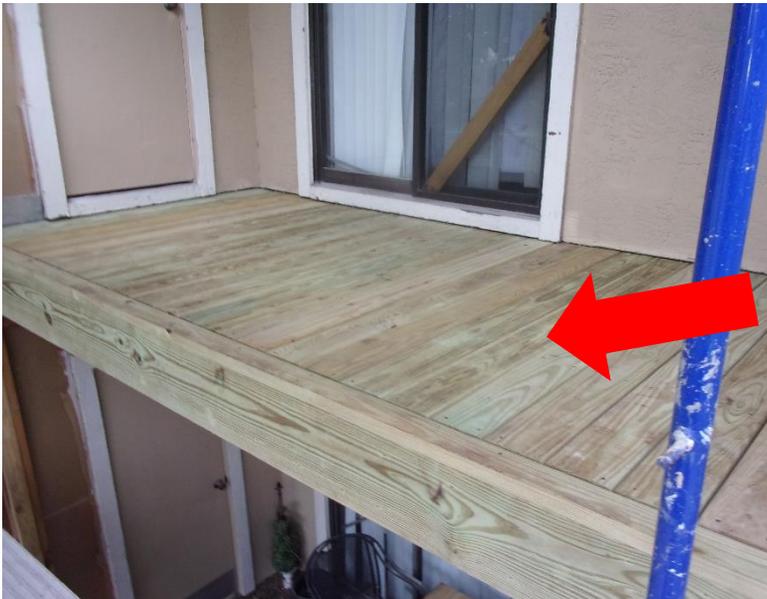
**PHOTOGRAPH #24**

**BUILDING 8  
SECTION F**

Built up balcony beam repairs and new 2"X 6" PT wood decking replace on two balconies.
