PHOTOGRAPHS

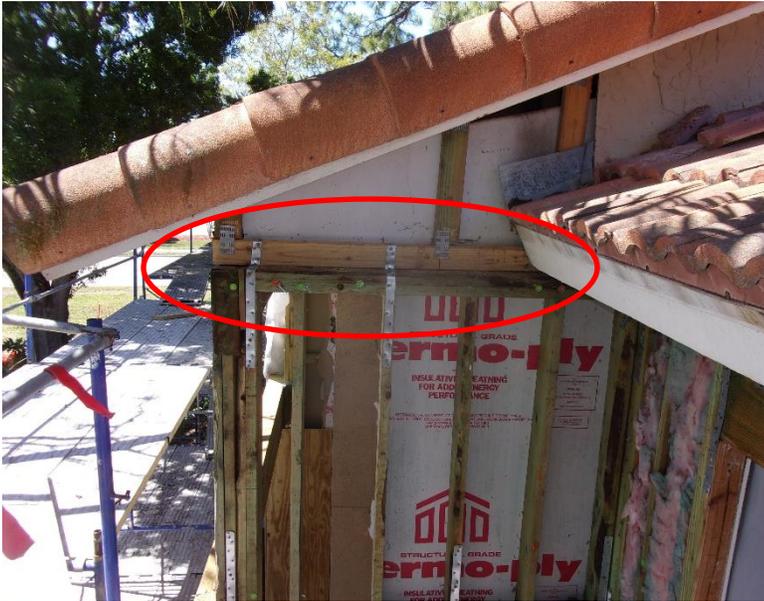
PHOTOGRAPH #1

**BUILDING 7  
SECTION A**

Added truss framing member repaired where termite damage was discovered at top of breezeway wall.

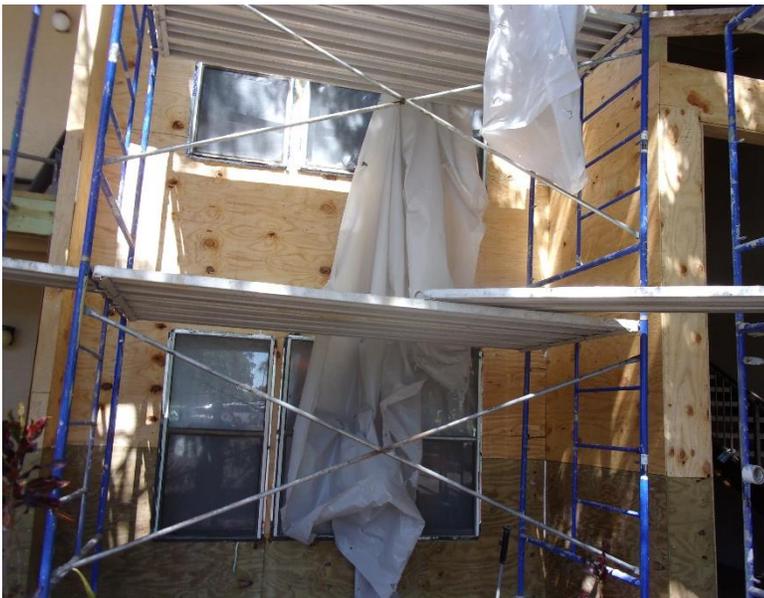
PHOTOGRAPH #2

**BUILDING 7  
SECTION B**

New 15/32" plywood sheathing fastened to framing members as per drawings and specifications.

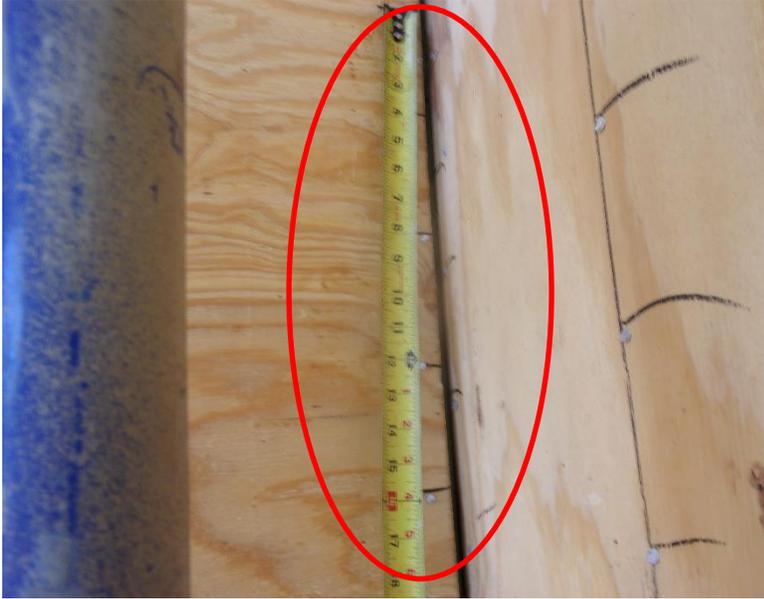
**PHOTOGRAPH #3**

**BUILDING 7  
SECTION B**

Plywood marked by contractor for consistent attachment to framing at 4" O.C.

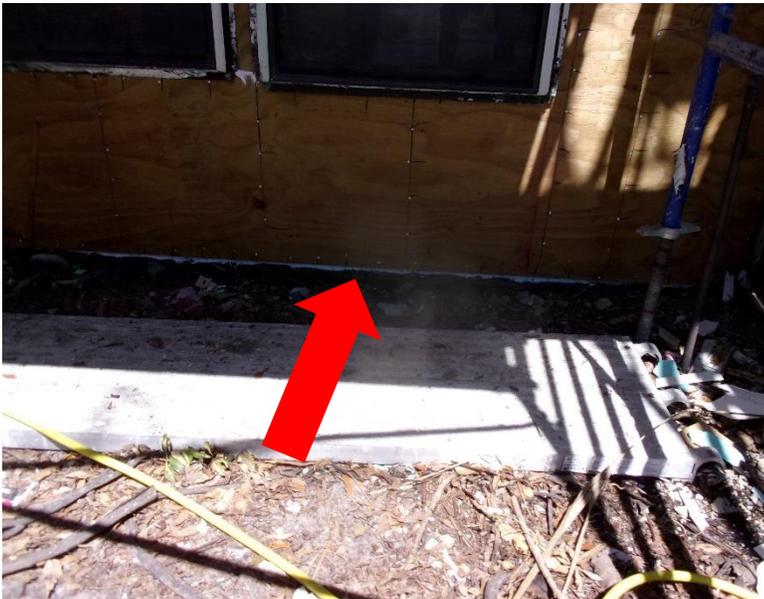
**PHOTOGRAPH #4**

**BUILDING 7  
SECTION B**

BASF urethane sealant applied at bottom plate to PT plywood sheathing as per ESI detail and change order.

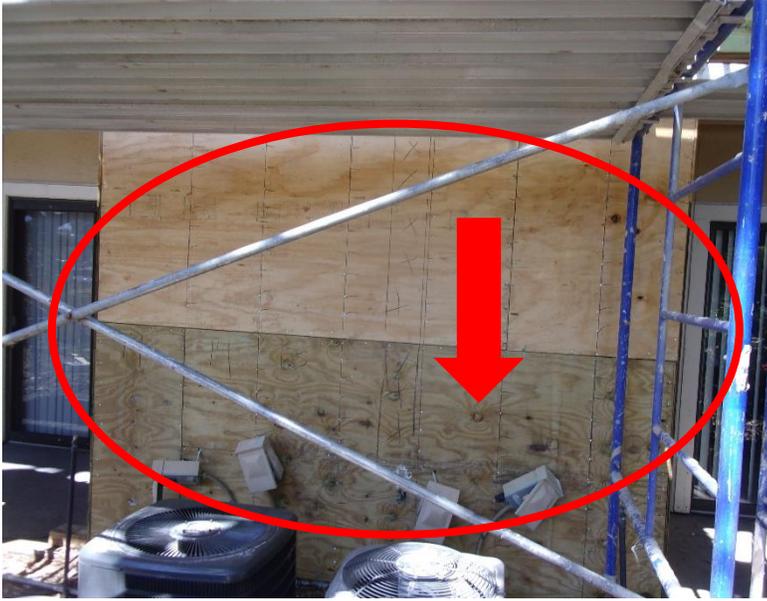
**PHOTOGRAPH #5**

**BUILDING 7  
SECTION B**

New 15/32" plywood sheathing fastened to framing members as per drawings and specifications with pressure treated plywood use at bottom 4'X8' sheet.

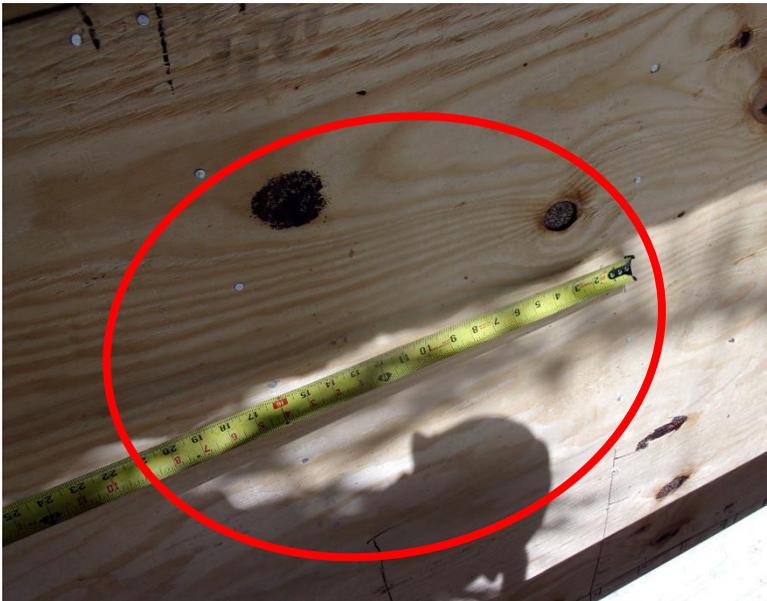
**PHOTOGRAPH #6**

**BUILDING 7  
SECTION C**

New 15/32" plywood sheathing fastened to framing members at 16" spacing as per drawings and specifications.

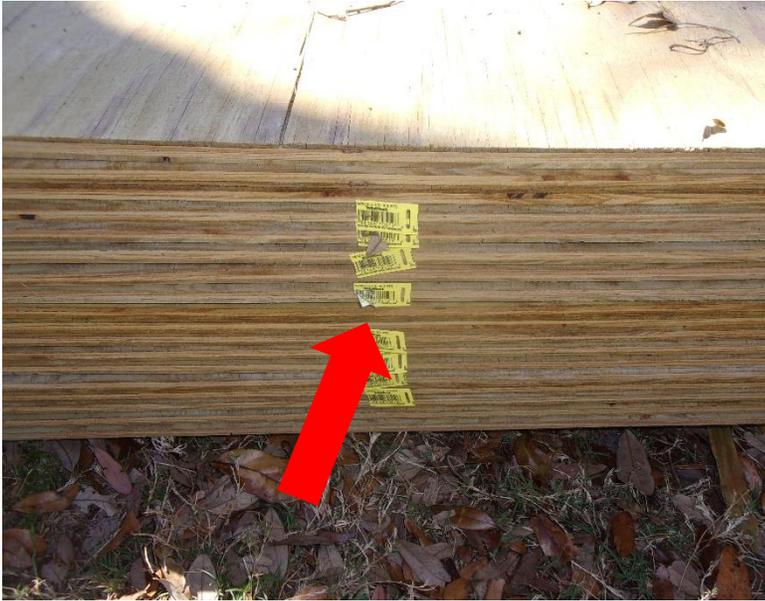
**PHOTOGRAPH #7**

**BUILDING 7  
SECTION C**

New 15/32" pressure treated plywood used for bottom sheet marked with tags naming treatment.

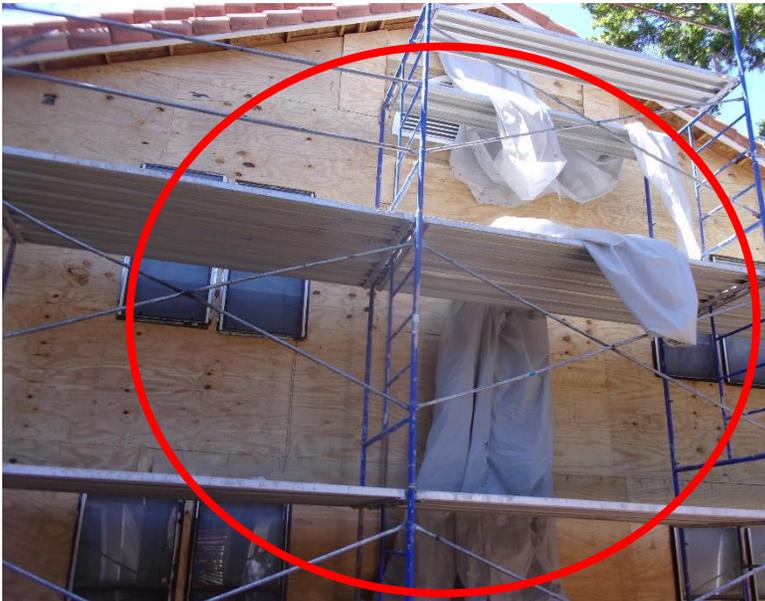
**PHOTOGRAPH #8**

**BUILDING 7  
SECTION D**

New 15/32" plywood sheathing fastened to framing members as per drawings and specifications.

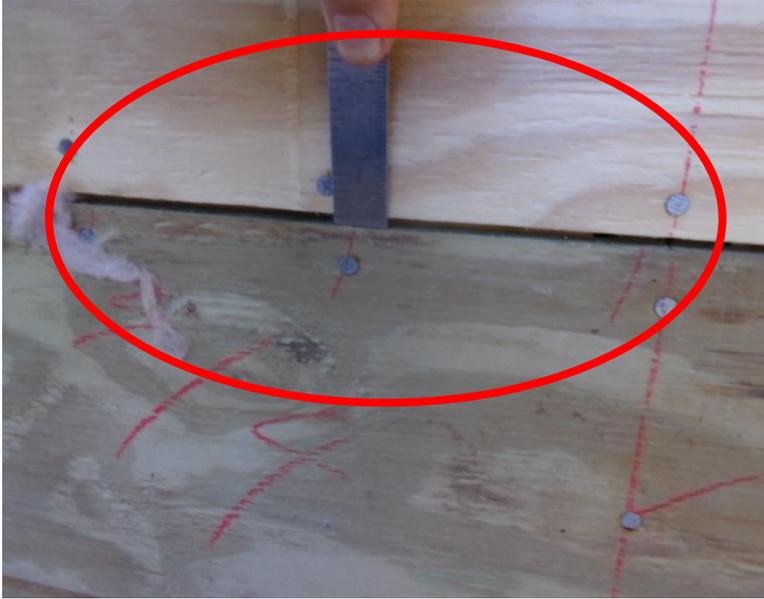
**PHOTOGRAPH #9**

**BUILDING 7  
SECTION D**

Spacing required between plywood sheathing at minimum 1/8" and not to exceed 1/4".

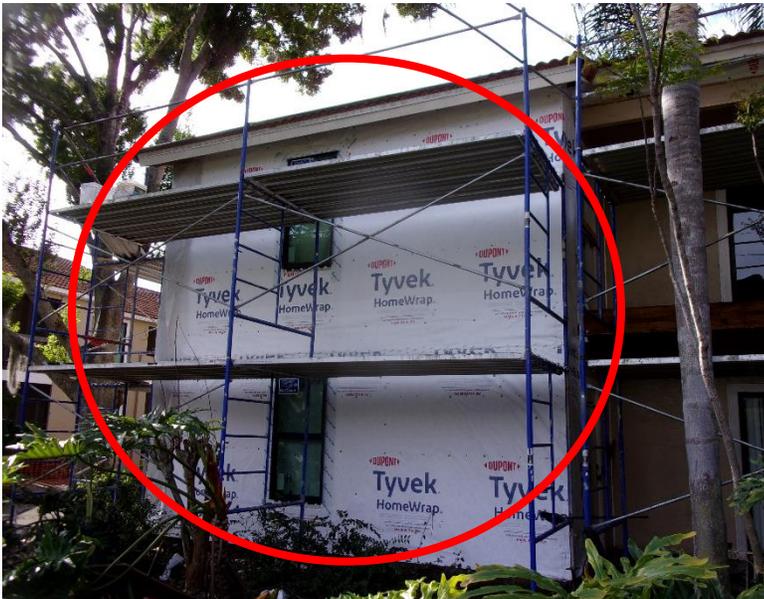
**PHOTOGRAPH #10**

**BUILDING 7  
SECTION E**

Dupont Tyvek HomeWrap water vapor barrier applied and new PGT windows installed and flashed with Dupont / Tyvek flashings as per drawings and specifications.

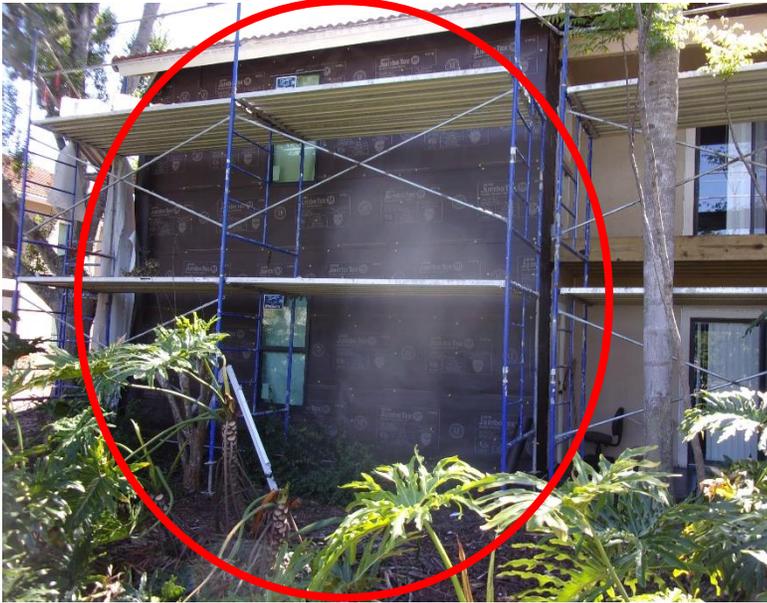
**PHOTOGRAPH #11**

**BUILDING 7  
SECTION E**

Stucco subcontractor has applied second water vapor barrier with Super JumboTex 60.

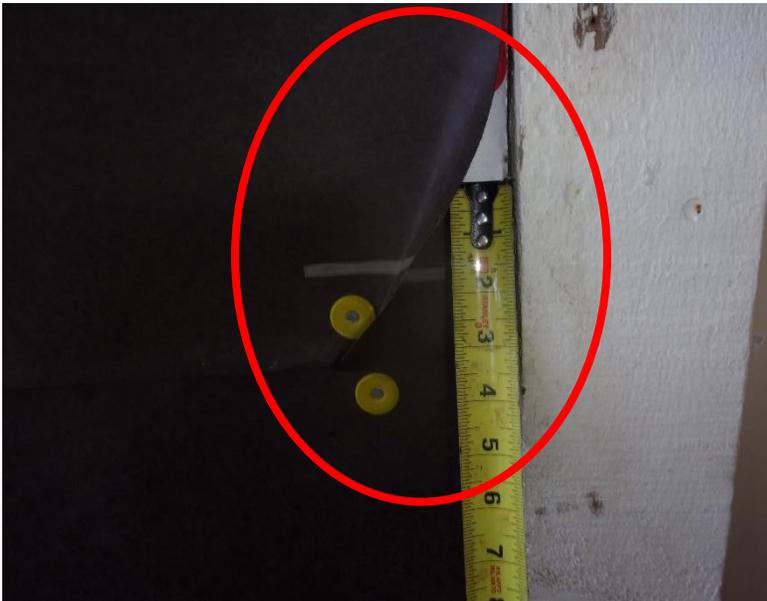
**PHOTOGRAPH #12**

**BUILDING 7  
SECTION E**

Super JumboTex 60 water vapor barrier overlapped at seams with minimum 2" positive overlap as per manufacturer's requirements.

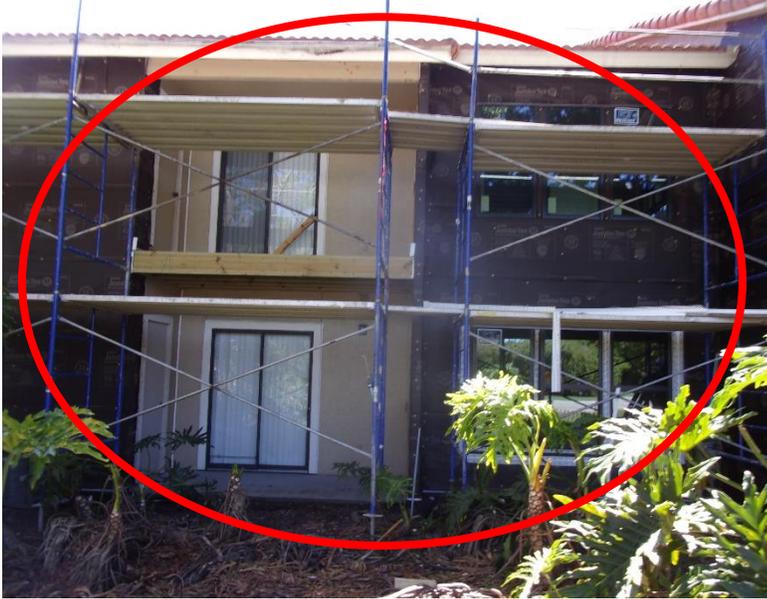
**PHOTOGRAPH #13**

**BUILDING 7  
SECTION F**

Stucco subcontractor has applied second water vapor barrier with Super JumboTex 60.

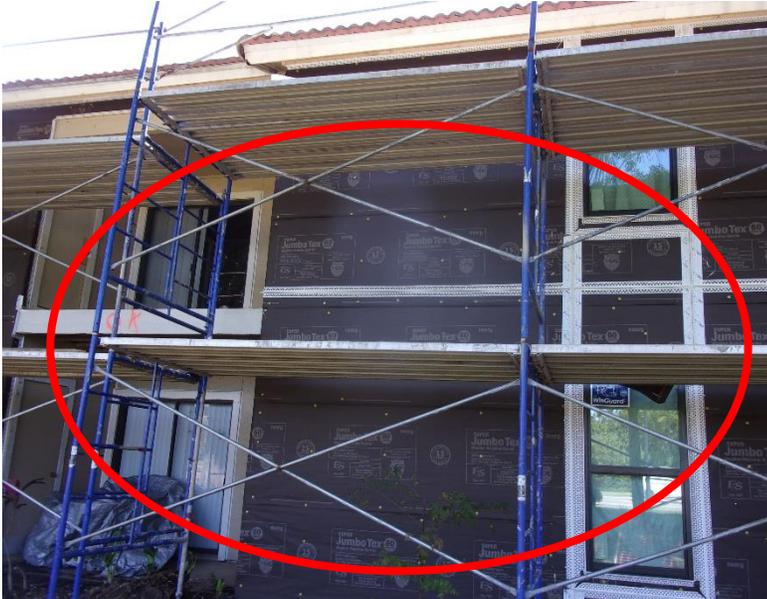
**PHOTOGRAPH #14**

**BUILDING 7  
SECTION F**

Stucco subcontractor has begun to install vinyl stucco accessories over secondary water vapor barrier at windows and control joints.

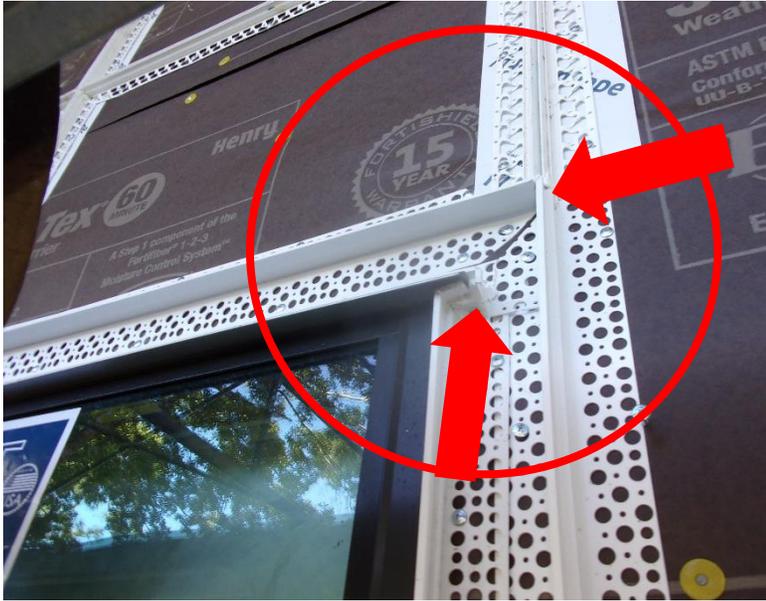
**PHOTOGRAPH #15**

**BUILDING 7  
SECTION G**

New vinyl stucco accessories fastened to framing around windows and caulked at transitions and joints.

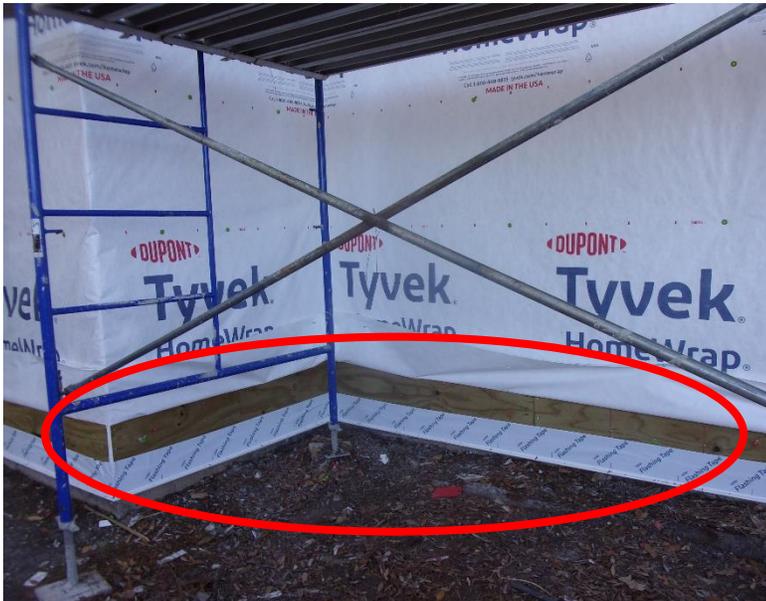
**PHOTOGRAPH #16**

**BUILDING 7  
SECTION H**

Vinyl weep screed stucco accessory at base of wall assembly fastened to framing and flashed over with Tyvek straight flashing.

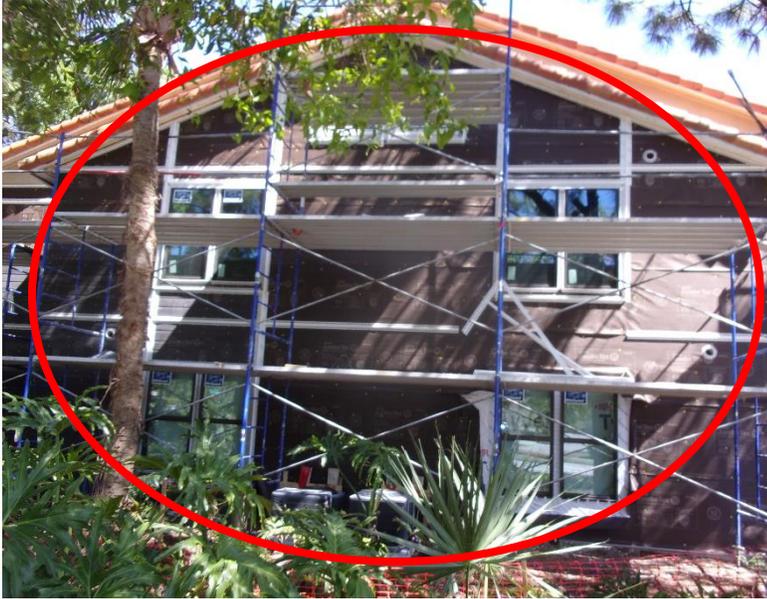
**PHOTOGRAPH #17**

**BUILDING 7  
SECTION H**

Stucco subcontractor has installed vinyl stucco accessories over secondary water vapor barrier and begun to install galvanized metal lathing.

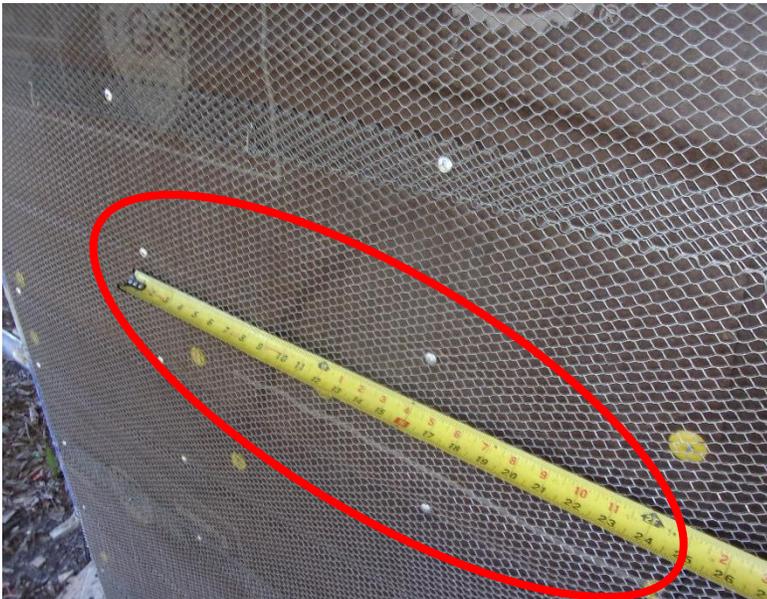
**PHOTOGRAPH #18**

**BUILDING 7  
SECTION H**

Self-Furring Galvanized metal lathing attached to framing at 16" O.C. as per drawings and specifications.

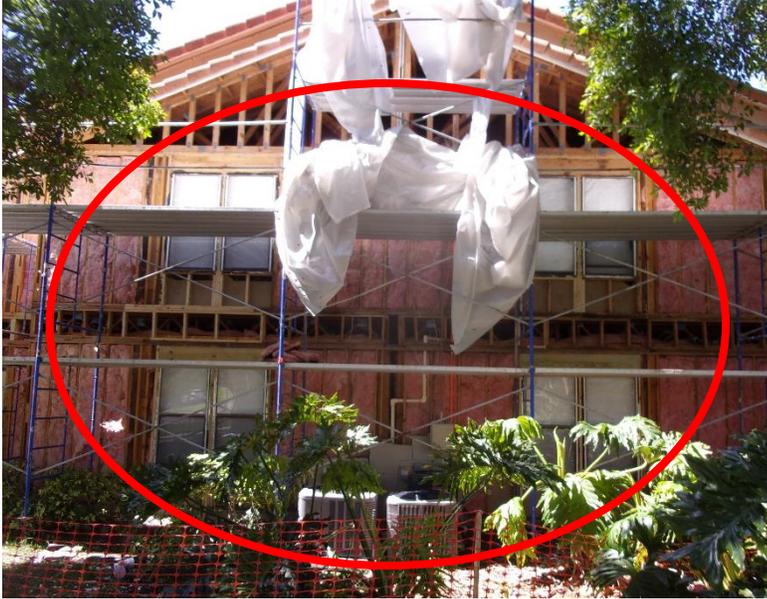
**PHOTOGRAPH #19**

**BUILDING 8  
SECTION H**

Framing repairs at gable end walls and windows have been performed and quantified by Delta.

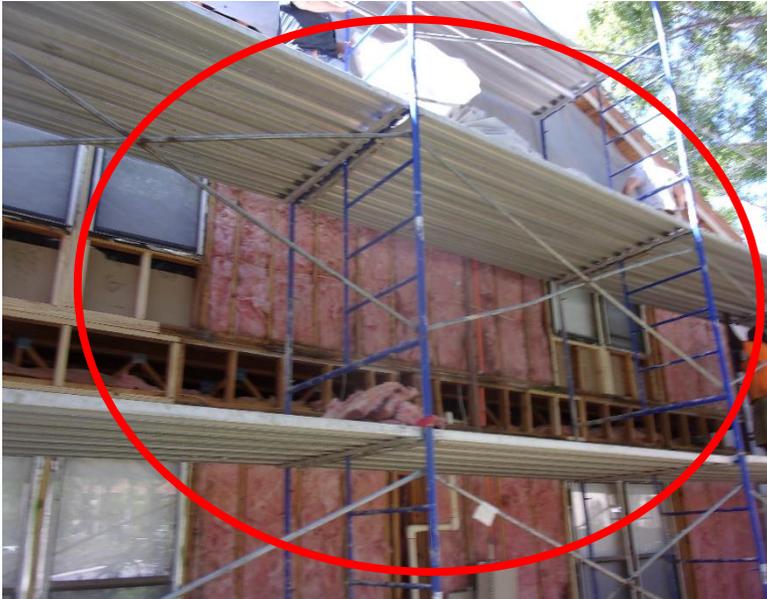
**PHOTOGRAPH #20**

**BUILDING 8  
SECTION H**

Framing repairs at gable end walls and windows have been performed and quantified by Delta.

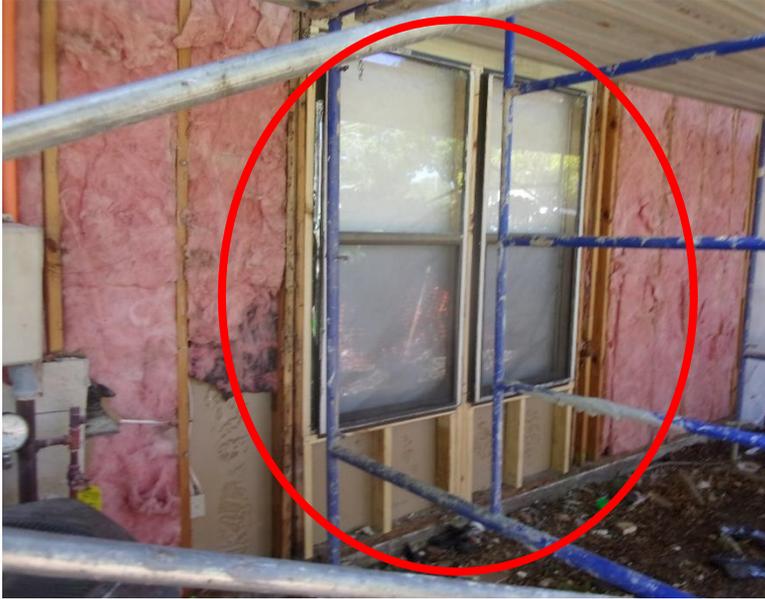
**PHOTOGRAPH #21**

**BUILDING 8  
SECTION H**

Framing repairs at gable end walls and windows have been performed and quantified by Delta.

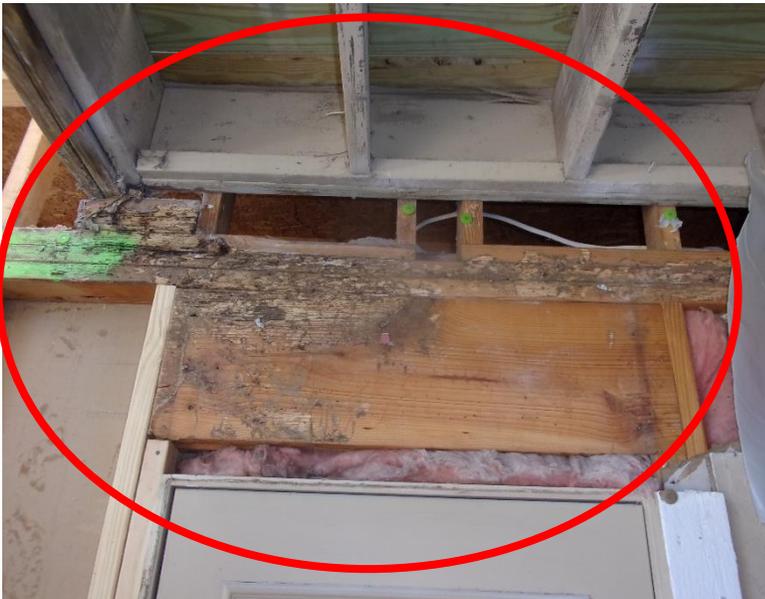
**PHOTOGRAPH #22**

**BUILDING 8  
SECTION F**

Additional stucco removed where marked at balcony wall and door header and Additional framing repairs will be required.

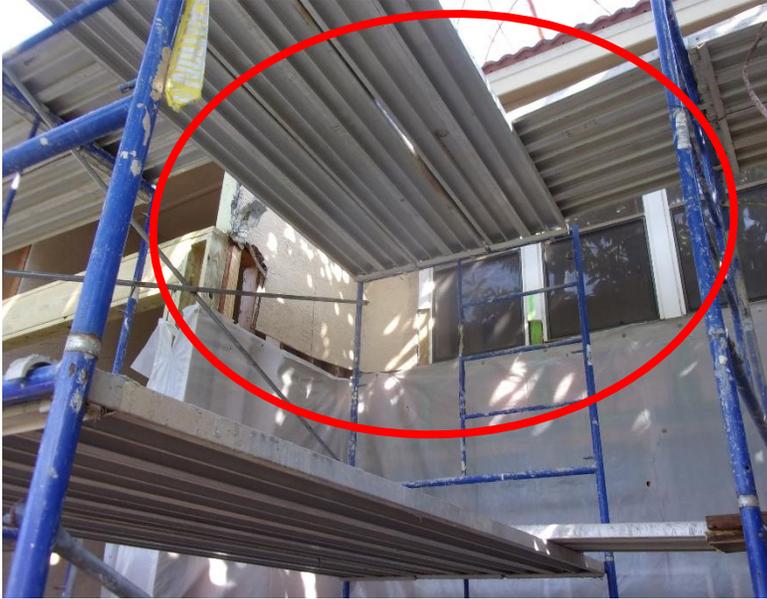
**PHOTOGRAPH #23**

**BUILDING 8  
SECTION F**

Stucco still in place at second floor triple window and breezeway wall due to bee infestation to be removed by owners pest contractor.

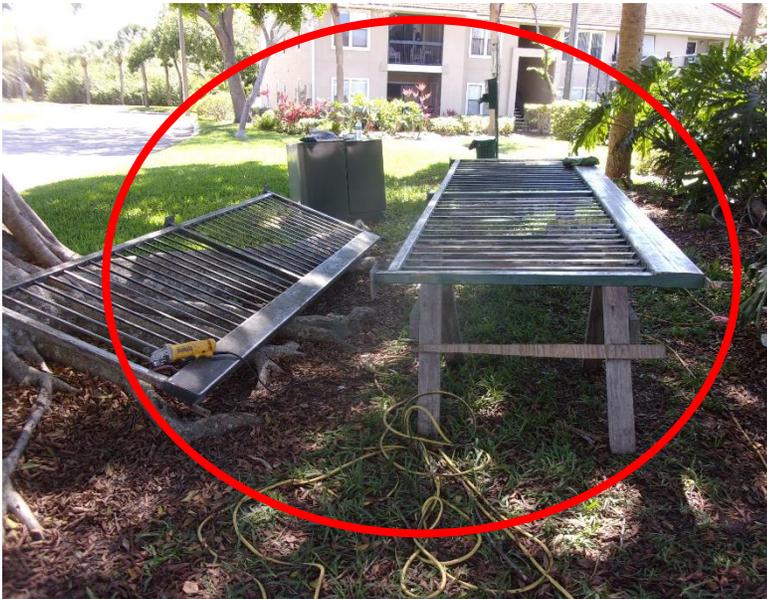
**PHOTOGRAPH #24**

**BUILDING 8  
SECTION F**

Balcony railings have been removed and surface preparation is in progress with grinders to removed loose paint and rust.
