PHOTOGRAPHS

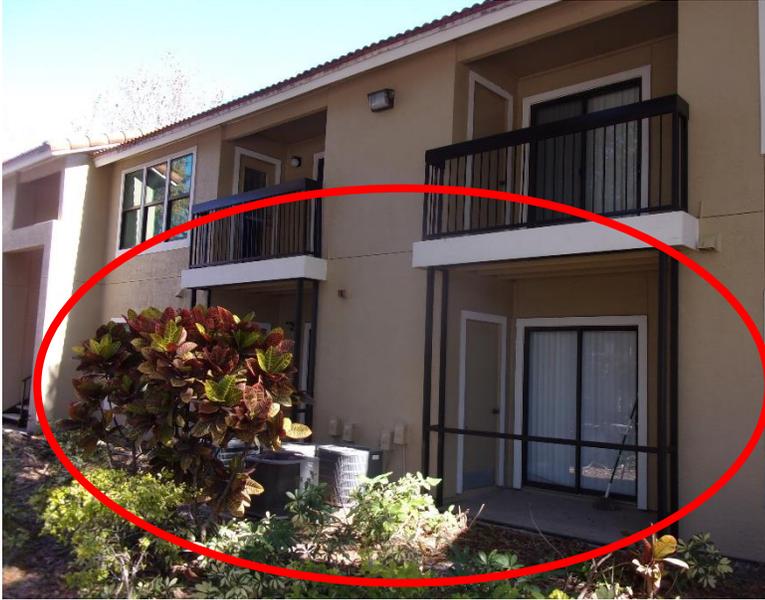
PHOTOGRAPH #1

BUILDING 6 SECTION B

Contractor installing new bronze aluminum screen enclosures where previously existed at owners lanai.

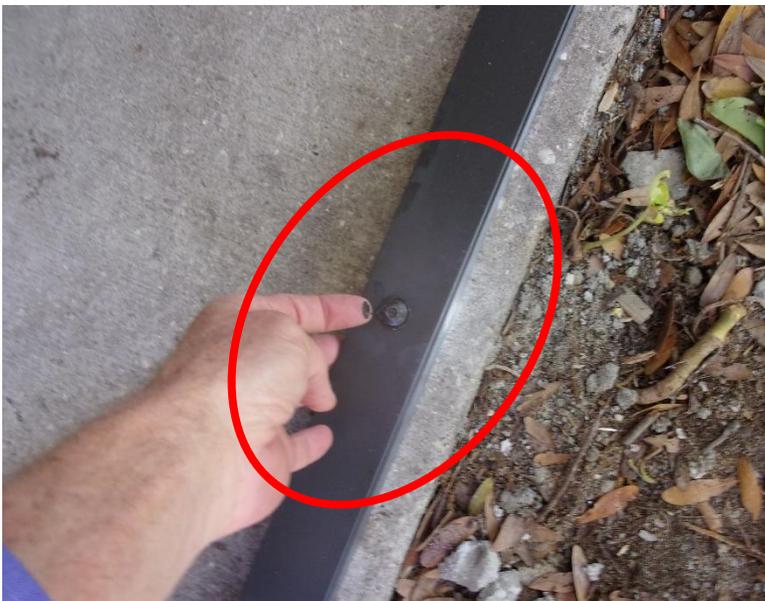
PHOTOGRAPH #2

BUILDING 6 SECTION B

New aluminum screen enclosure fastened at concrete slab with 3" stainless steel fasteners and sealed with BASF urethane sealant.

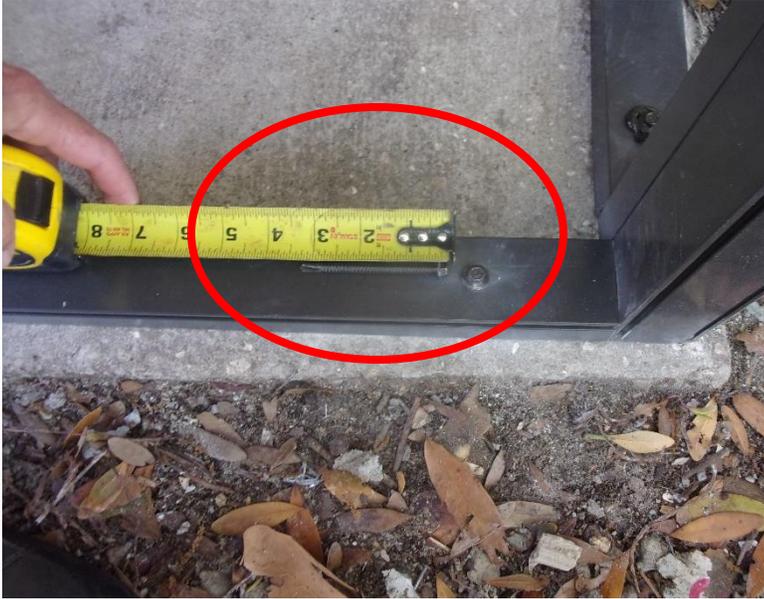
PHOTOGRAPH #3

**BUILDING 6
SECTION B**

New aluminum screen enclosure fastened at concrete slab with 3" stainless steel fasteners and sealed with BASF urethane sealant.

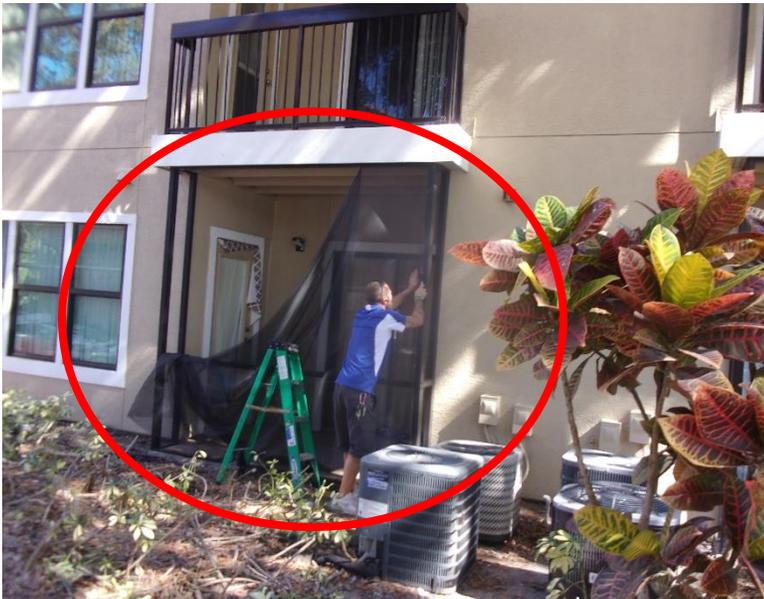
PHOTOGRAPH #4

**BUILDING 6
SECTION B**

Contractor installing new screen at new enclosure.

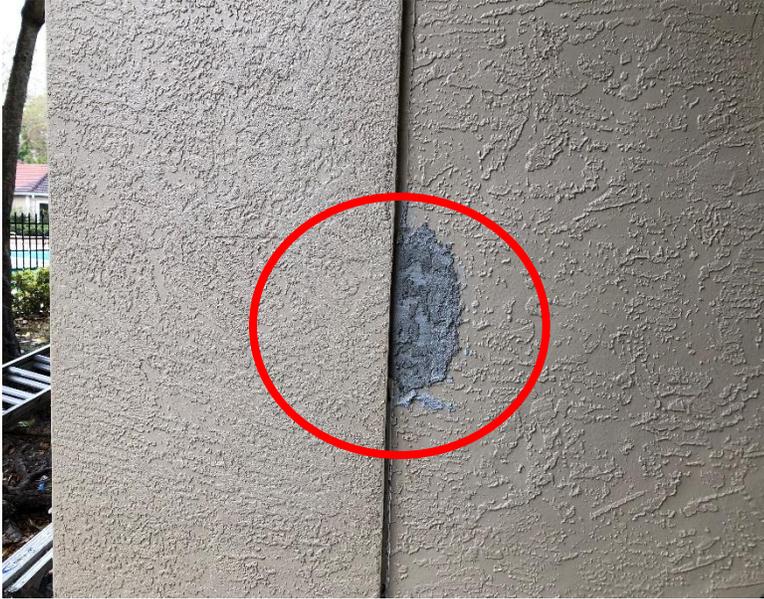
PHOTOGRAPH #5

**BUILDING 6
SECTION E**

Stucco patching at breezeway wall.

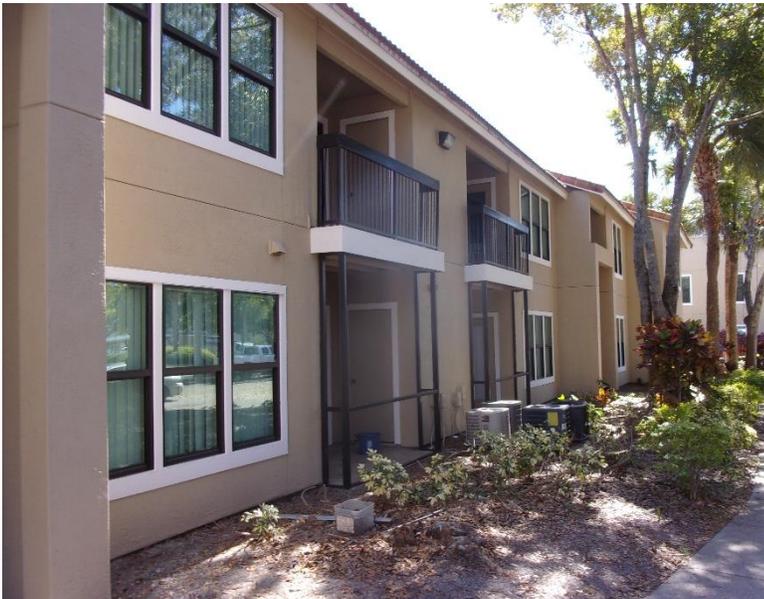
PHOTOGRAPH #6

**BUILDING 6
SECTION F**

Contractor installing new bronze aluminum screen enclosures where previously existed at owners lanai.

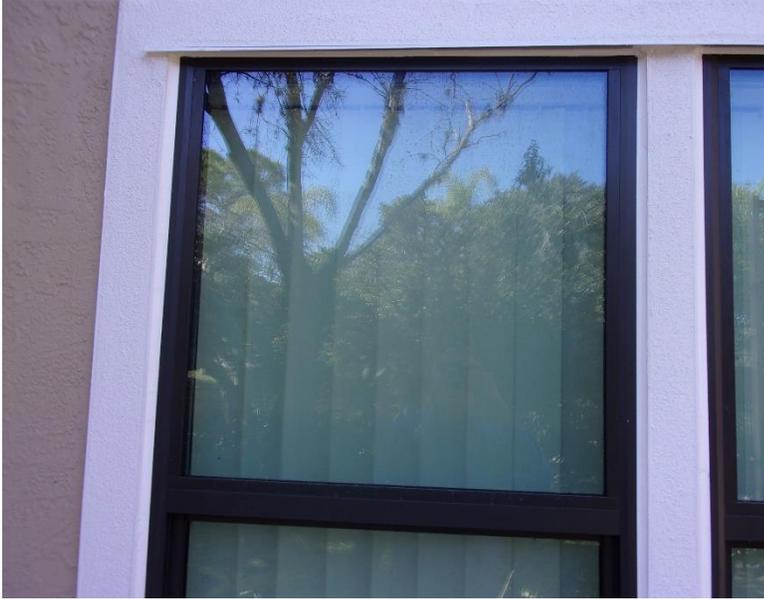
PHOTOGRAPH #7

**BUILDING 6
SECTION F**

Contractor has removed and replaced window perimeter sealant where plastic was attached to sealants.
